Ford Colliery Engine Houses

Ford and Etal Estate, Northumberland

Archaeological Evaluation : May 2016

Job number 1819.03

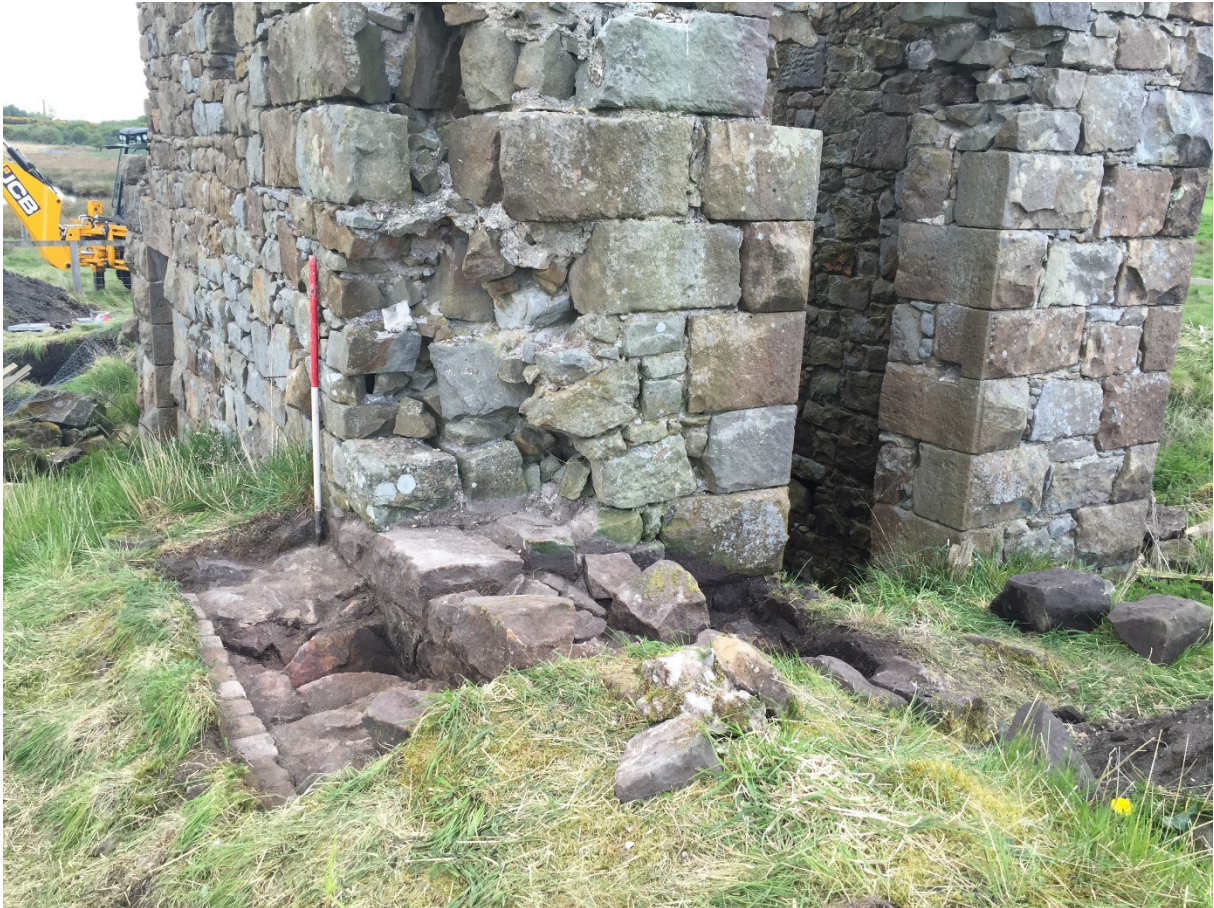
Trench 1 was deturfed by hand; this quickly revealed the underlying wall structures (*plate 1*). Immediately abutting the east wall of Engine House Wall (designated Wall [100] here) on its east side lay brick rubble derived from the walling of the possible 'boiler house' ancillary building to the east. This brick rubble, little more than a single brick deep, overlay the more substantial sub-angular sandstone blocks associated with this boiler house building clearly abutting Wall [100]. The clearance of this rubble in a small area, and the clearance of rubble and tumble on the west face of Wall [100], revealed the lower courses of the walling in the NE angle of Engine House 1. The stonework revealed that the east wall of Engine House 1 continues to the north as a single phase of keyed-in construction. The north wall of Engine House 1, Wall [101], is a keyed-in return to this wall, running east-west. This area to the north had been identified during building recording as a later phase of construction, possibly the chimney base. It appears, however, that the structure to the North of Engine House 1 also comprises elements contemporary with the original construction of Engine House 1.

Plate 1 Trench 1 post-excitation. Facing SW.

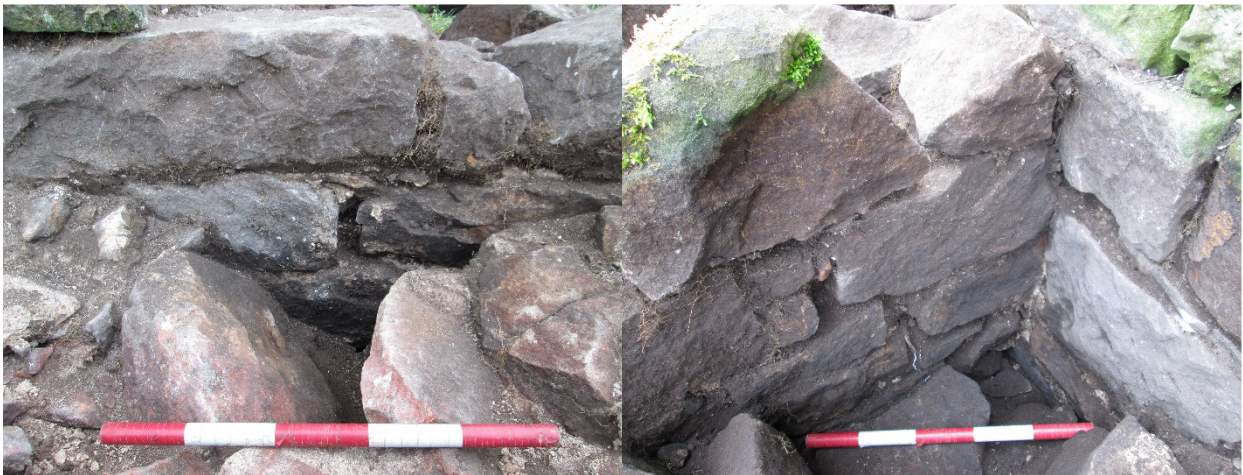
Plate 2 Trench 1. Detail of east face of east wall of Engine House 1, Wall [100], showing the wall line continuing to the north, beyond the collapsed return with the north wall of Engine House 1.

Plate 3 Trench 1. Detail of west face of Wall [100] with keyed-in return to North wall of Engine House 1.

The east wall of Engine House 1, Wall [100], had been recognised during the building recording phase as being constituted by two phases of construction; the lower, northern section is the earlier phase, characterised by greyer, larger angular blocks, clearly visible in *plate 4*. This earlier phase appears on the evidence of the evaluation to have continued to the north, beyond the existing apparent corner of the building which has suffered collapse. This northern building, labelled 'site of chimney' on *figure*

2, appeared, during the building recording phase, to have been a later element inserted against the north wall of Engine House 1. It is clear that the south-eastern element of the 'site of chimney' structure on *figure 2* is indeed of a later phase, abutting the north-south Wall [100], but this must be a separate structural element to Wall [100] itself. It follows from this evidence that the north wall of Engine House 1, Wall [101], was, in its original phase, a keyed-in internal cross-wall, not the external north wall of the Engine House. In this case the stretch of wall now appearing as the NE corner of the building may not have been quoined at all. The collapse now apparent would then represent the collapse of a wall junction, rather than the collapse of a quoined building corner. If this northern element of the structure were later reduced, or the original structure was a single storey high, and a new external corner of the building created with inserted quoins, these may have been subject to the more pronounced collapse visible today. It is clear, however, that there is a degree of structural complexity at the north end of the complex.

Trench 1 revealed that the collapse on the north-eastern corner of Engine House 1, and apparently missing quoins, are to be understood as a result of the presence of early phase structures on the north end of Engine House 1. The relationship between the possible chimney site, boiler room, and Engine House 1 itself, is poorly understood from surface and non-invasive investigations alone, and presents some degree of complexity. Any ground-disturbing works taking place in this area would no doubt be subject to watching brief conditions at the least. Targeted archaeological investigations of the north end of the complex, even if limited to deturfing or minor rubble clearance, may, of course, provide more information as to the structural history of this part of the Engine House.

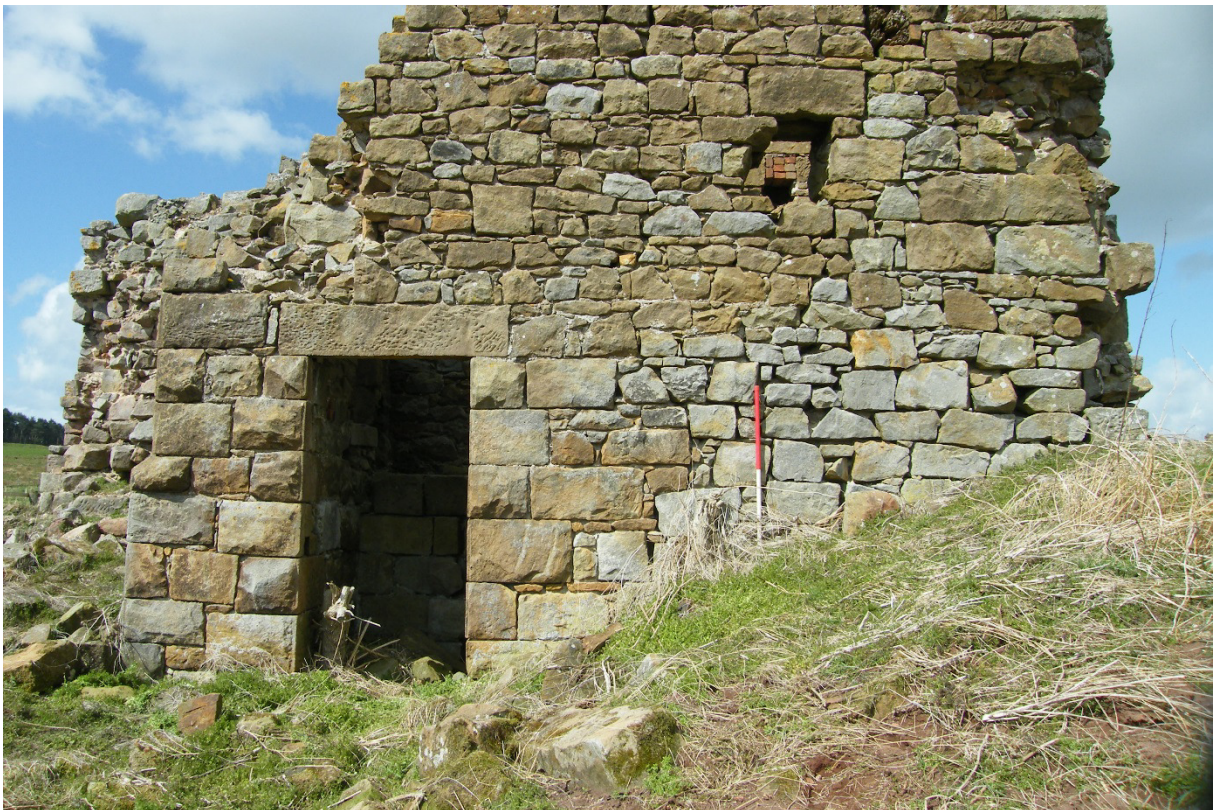
Plate 4 Engine House 1 east wall [100] showing earlier construction phase of grey angular blocks in its northern extent. Facing west..

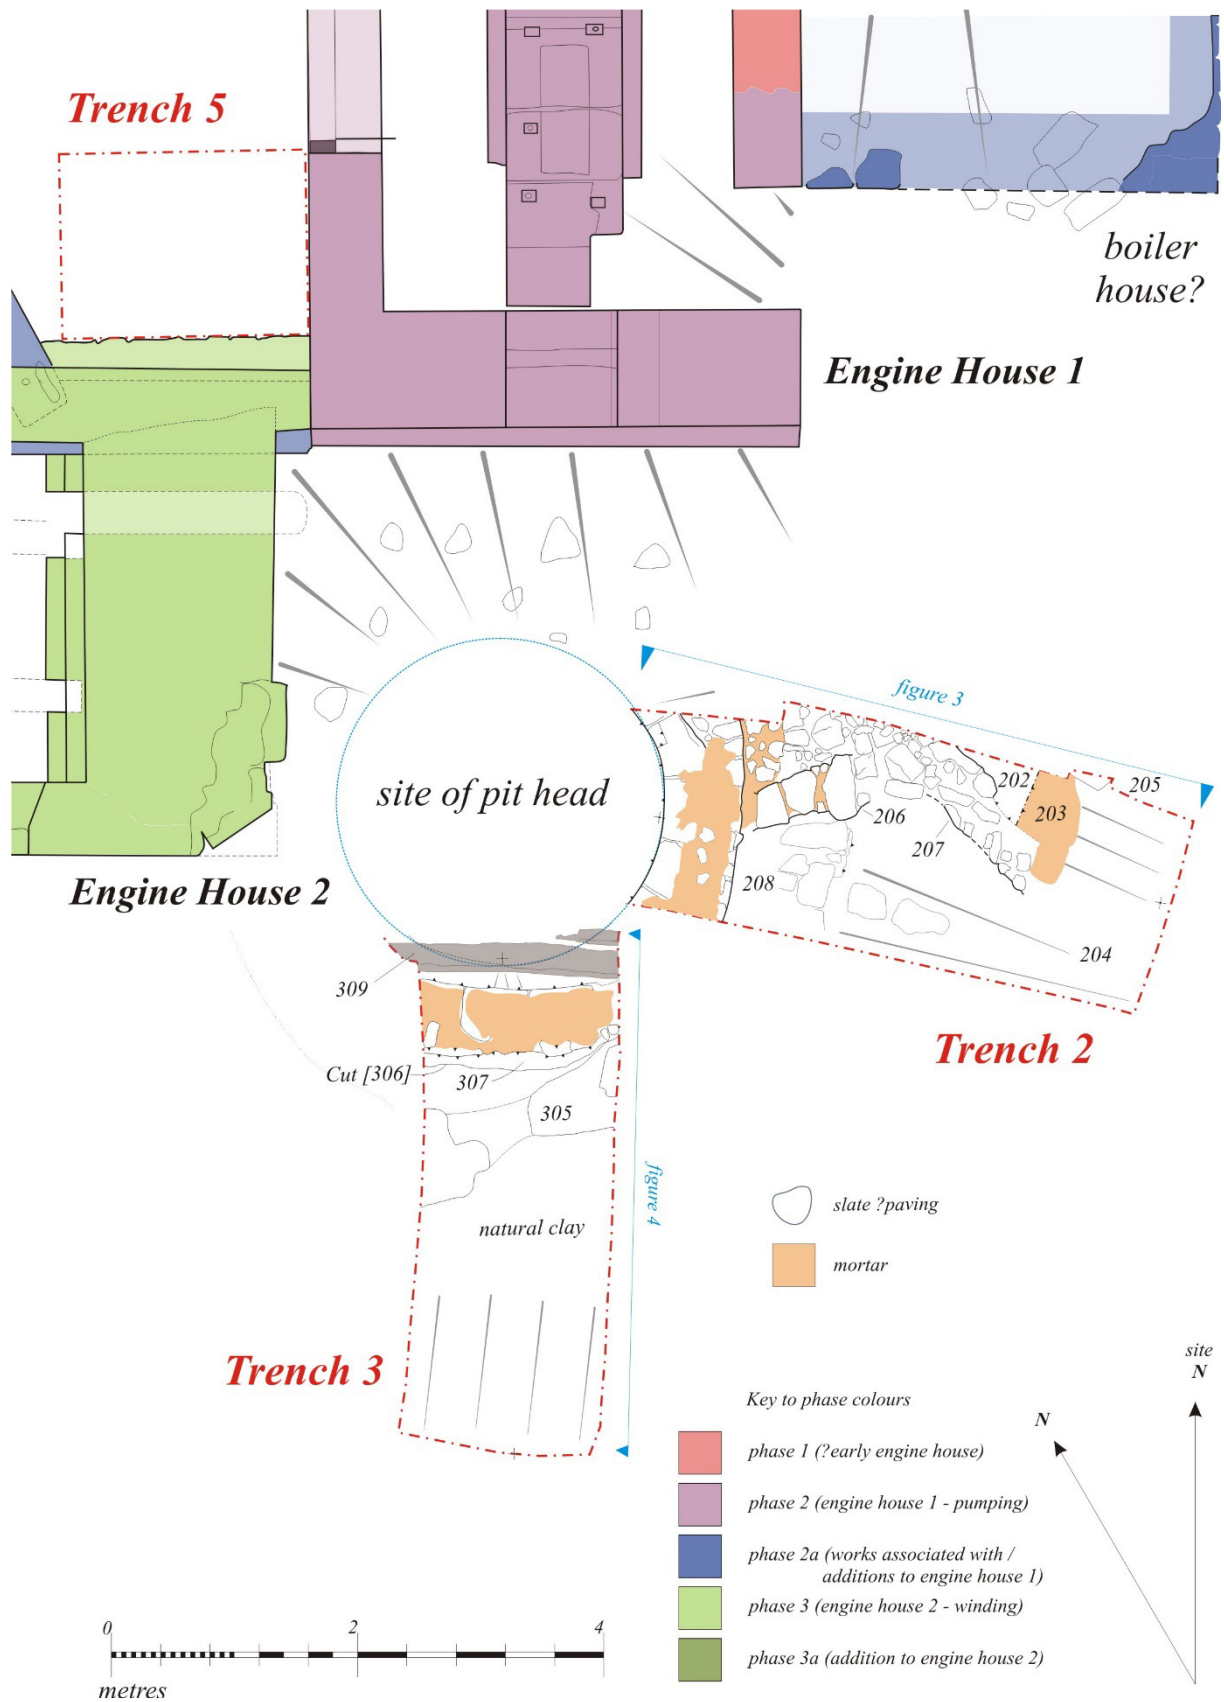
Figure 3 Detail of Trenches 2 and 3 with features identified

Trench 2 ran from the mid-point of the pit head eastwards for 4m and was *c.* 1.80m wide (*figures 2, 3*).

The aims of Trench 3 were identical to Trench 2. It ran southwards from the exposed pit head for 4m and was 1.80m wide (*figure 3*).

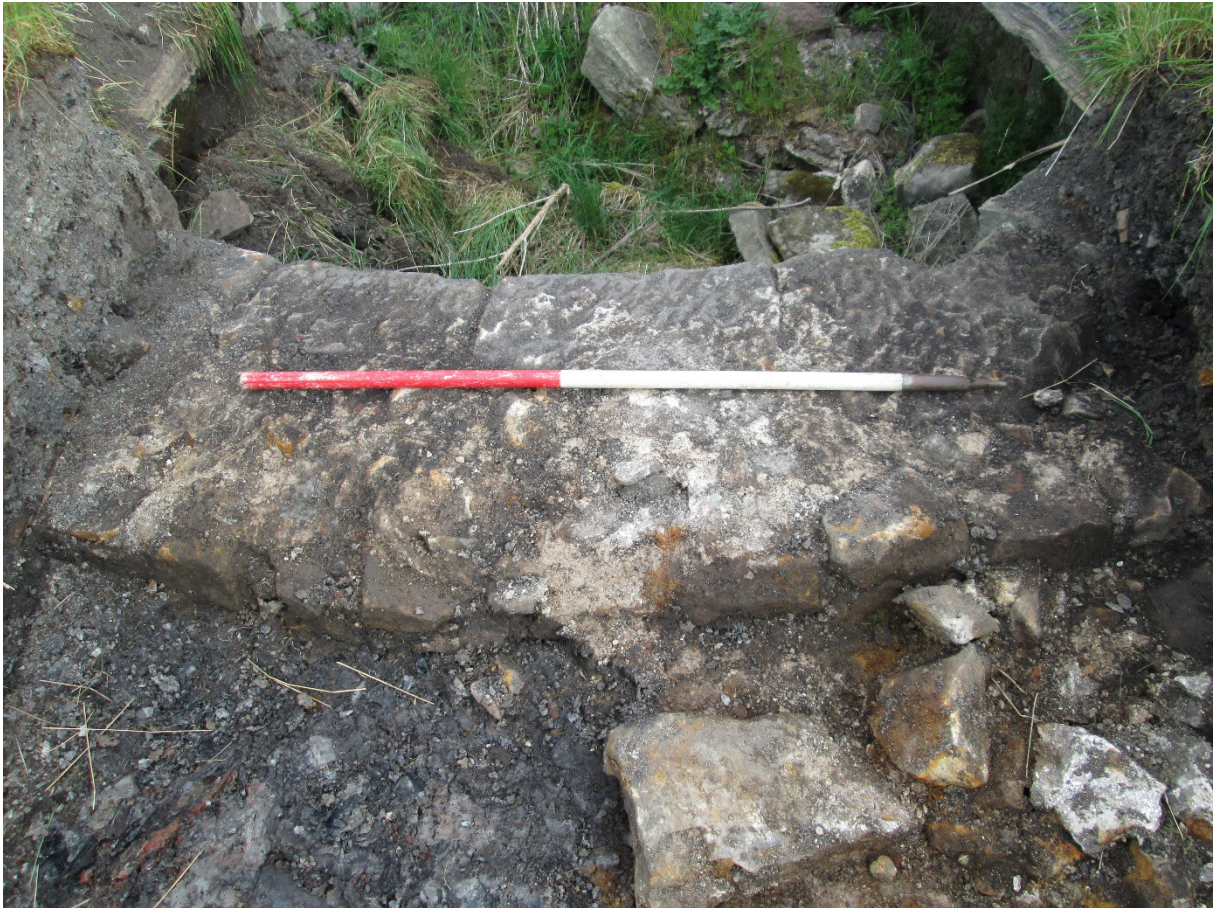
The pit head lining itself (*plate 5*) is composed of angular grey fine-grained sandstone blocks, obliquely tooled into concave outer faces and roughly tooled flat on their upper surface. Stones are approximately 0.40m long, 0.30m wide and 0.20m deep. One coping stone is cut with a rectangular slot, 0.20m long and 0.10m wide. The lining itself is one course wide, curving gently to form the mine shaft, 2.66m in diameter. The outer face (that is, away from the mine shaft) of these lining stones is partially overlain and abutted by walling bonded in pale yellow lime mortar and composed of small and medium subangular sandstones for a width of *c.* 0.70m.

Plate 5 Trench 2. Detail of pit head lining. Facing west.

Collapse since the initial programme of building recording has revealed the inner edge of the stone mine shaft-lining along its entire circumference. The pit-head is covered with from 0.30m to 0.54m of overburden (of little archaeological significance). Trench 2 revealed that, in the area to the north and east of the pit head, sub-surface structures, surfaces and deposits exist, and exist with some degree of complexity. Features to the east immediate abut the pit head lining and would be subject to disturbance during any groundbreaking works. Excavations around the pit head would enable mitigation through preservation by record, requiring a small-scale archaeological excavation. A pit head capping involving the minimum disruption to the pit head and its surrounding area, therefore, is strongly recommended, and a surgical insertion of an internal gridded-structure, such as those capping wells at other Scheduled Ancient Monuments, may be appropriate in this instance.

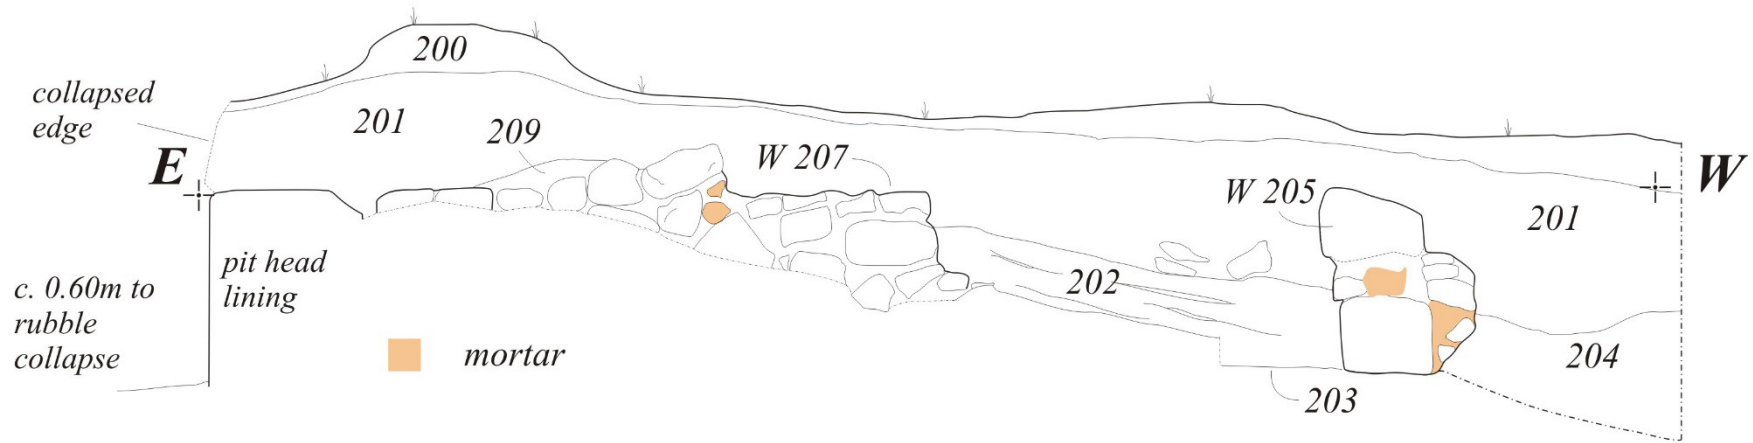
Figure 4 Trench 2, South-facing section

The pit head lining itself was clearly identified in Trench 2. *Figure 4*, the south-facing section of the trench, shows that the coping stones as preserved lie below a thin layer of turf and topsoil (200) and a deposit of mixed blueish-grey humic silt containing ash, slate and colliery upcast material, (201); this overburden ranges from 0.30m to 0.52m in depth above the coping stones of the pit head lining.

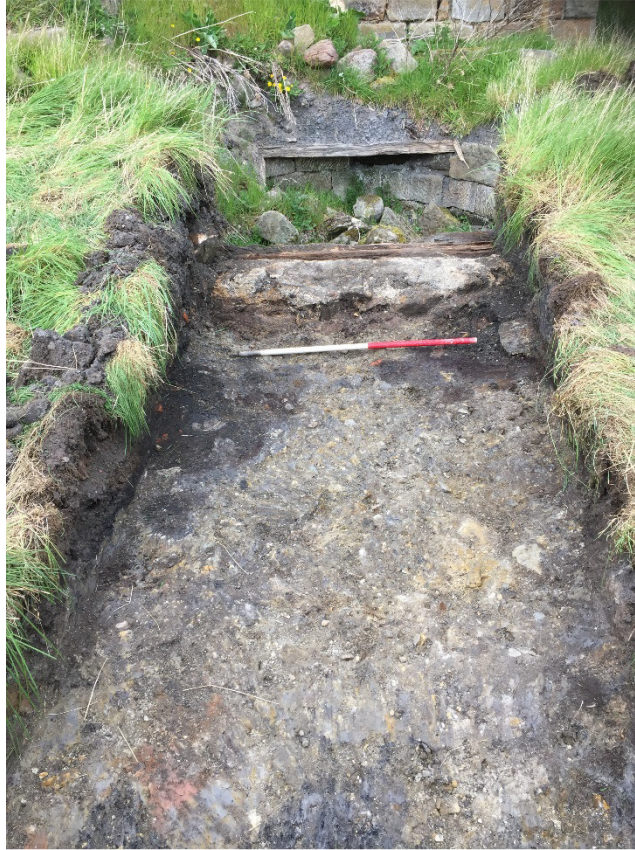
Trench 3 revealed the pit head lining, its original timber capping, a possible turf banking associated with the mine head, and the natural ground surface to the south of the mine shaft (*plate 6*). This area is characterised by less archaeological complexity than Trench 2 to its north and east.

Plate 6 Trench 3 post excavation with pit head and possible turf bank. Facing north

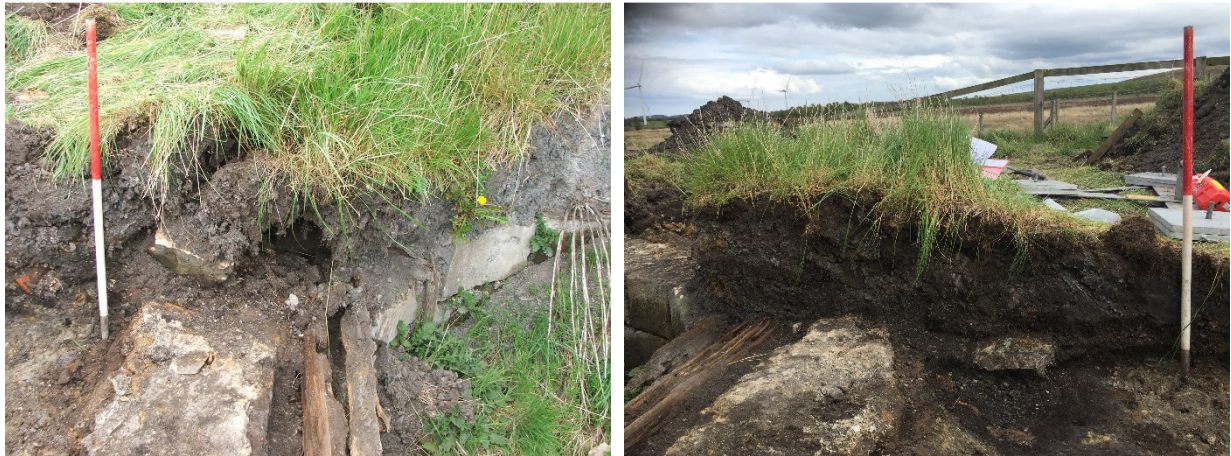
The pit head lining, as expected, is essentially similar to that revealed in Trench 2, above. A notable difference is in the preservation of the timber beam capping (309), set into beam slots cutting the coping stones of the pit head lining. Because these beams are cut into the coping stones, the top edge of the pit head lining is lower in this area, and the surrounding backing wall stands slightly proud of the coping stones proper. *Figure 5*, the west-facing section of Trench 2, shows these relative elevations, and shows that the capping beams (309) and backing wall are overlain by turf/topsoil (301), and redeposited colliery upcast deposits (302) and (308) to a depth of 0.46 to 0.54m (*plates 7, 8*).

Plate 7 Trench 3 east-facing section at pit head with beam capping 309.. Facing west

Plate 8 Trench 3 west-facing section with pit head, beam capping and possible turf bank. Facing east

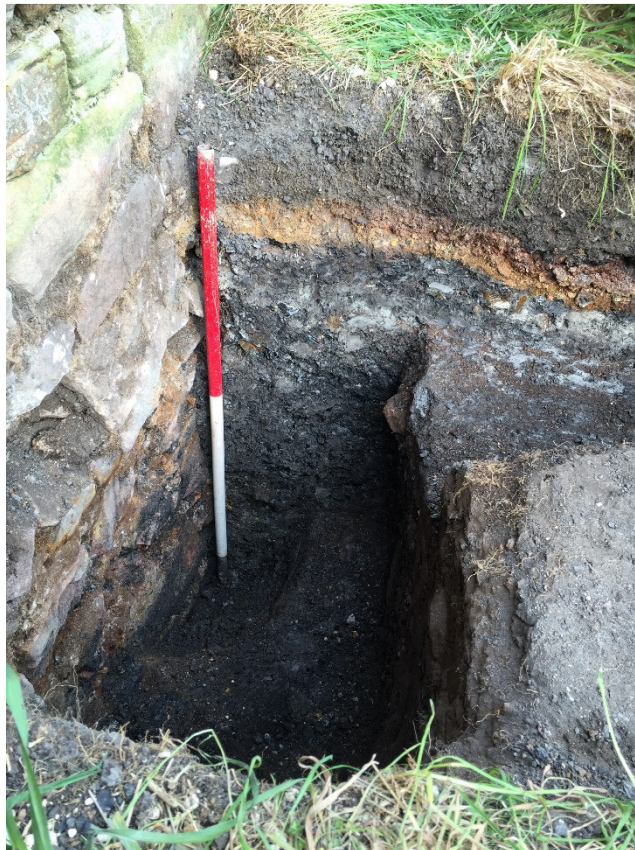
Trench 4 was excavated to a depth of 1.25m against the wall face of the south wall of Engine House 2 (*plate 9*). This revealed wall footings (*plate 11*) continuing to the full depth of the excavated trench, 1.20m, at which point excavation was ceased due to Health & Safety regulations and the difficulty of excavation by hand. The full depth of the wall footings, therefore, was not reached in these excavations.

Plate 9 Trench 4 general view post excavation. Facing north-east

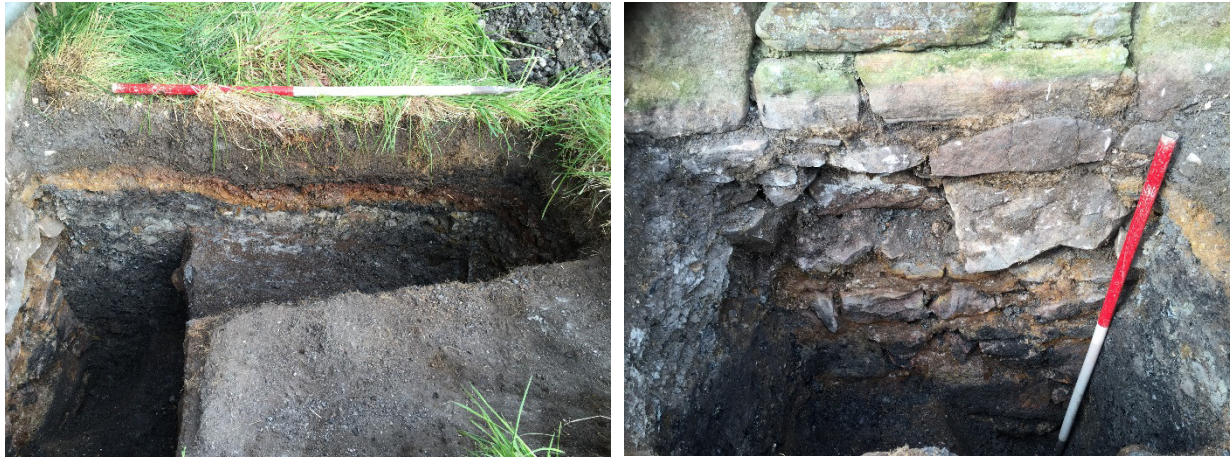
It was clear, as in Trench 2 (above) and Trench 5 (below), that the site is characterised by a large accumulation of colliery upcast material, which has in some cases directly affected the preservation of the structural elements remaining. The west-facing section of Trench 4 (*plate 10*) shows a sequence of deposits related to this colliery upcast material. Below c. 0.20m of turf and topsoil (402), Deposits (403) – (411) represent a series of compact cinder-, gravel-, coal- and clay-rich layers, none of which can be definitively identified as the natural underlying geology. The natural clay found in Trench 2 (above) was not apparent in Trench 4. Further, it was impossible to identify any foundation trench in which the south wall of Engine House 2 was sitting, and these deposits therefore presumably represent colliery upcast material accumulated against the building during its working lifetime. It also implies that the natural clay subsoil, apparent at around 0.50m below topsoil in Trench 2, must at this point lie considerably deeper.

Plate 10 Trench 4 west-facing elevation showing colliery upcast deposits. Facing east

Plate 11 Trench 4 detail of S wall of Engine House 2 S elevation. Facing north

The full depth of the wall footings in this area could not be ascertained in a small hand-dug trench, nor could a definitive existing ground level be identified. It is clear, however, that the wall footings lie at a depth of greater than 1.20m below the present ground surface, and are abutted by colliery upcast material to that depth. The borehole data are consistent with this finding; borehole MBH2, to the SW of Trench 4 and closer to the southern fringe of the upcast mound, showed made ground to a depth of 1m from the surface, with underlying peat to a depth of 2.60m before the clay horizon was encountered⁵.

Trench 4 was not able to investigate the full foundations of the south wall of Engine House 2, as the sub-surface footings extend beyond 1.20m below the present ground surface. It is clear from bore-hole data, however, that the walls of Engine House 2 are abutted by colliery upcast material – which may mask underlying earlier structures – and may be overlying a raft of peat which occurs above the

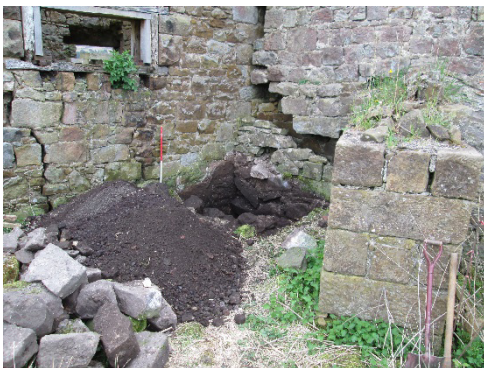
Plate 12 Trench 5, general view post-excitation. Facing south-east

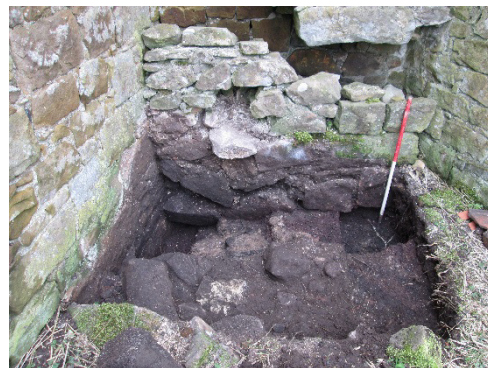
This excavation revealed the collapsing masonry skin, Wall [507], down to its foundations and somewhat below them. It became apparent that the stones of Wall 507 had been built directly on very loose, friable ashy material – Deposits (504) and (501). It is likely that Surface (503) represents a constructional surface of Wall [507], perhaps an attempt to stabilise what was then essentially a mound of colliery upcast material on which this section of walling was built. By contrast, the walling of the west wall of Engine House 1 continued downwards beyond the level of excavation in Trench 5, and, by extension from findings in Trench 4, may be deeply founded indeed.

It seems likely that the cause of the state of collapse of Wall [507] may be attributed to its shallow founding on a pre-existing mound of loose, friable, and ashy colliery upcast material. The skin of masonry of Wall [507] had been added as a separate facing to the earlier wall, the north wall proper of Engine House 2, which is itself of a later phase than the earliest structural elements apparent on site. The earliest elements appear to be the oblique wall running into the north wall of Engine House 2. It appears possible, therefore, that the area north of Engine House 2 and west of Engine House 1 preserves earlier colliery activity, deposits and installations not immediately indicated on the surface.

Plate 13 Trench 5, facing south, with Wall [507]

natural clay. In the case of the masonry skin on the north side of Engine House 2, its collapse may be attributed to a shallow foundation on ashy, loose colliery upcast material. It should be noted that the structure immediately to the west of Trench 5, which underlies Engine House 2, represents an early phase of building – perhaps even a previous Engine House? – and that the evidence from Trench 5 suggests the possibility of previous structures, features, and deposits existing in the area north and west of the existing pit head. These deposits and features may be crucial to understanding the structural history of the site as a whole, and particularly its early phases, and therefore, particularly given the site’s status as a Scheduled Ancient Monument, are particularly sensitive. Any groundbreaking works here would no doubt have watching brief requirements imposed.

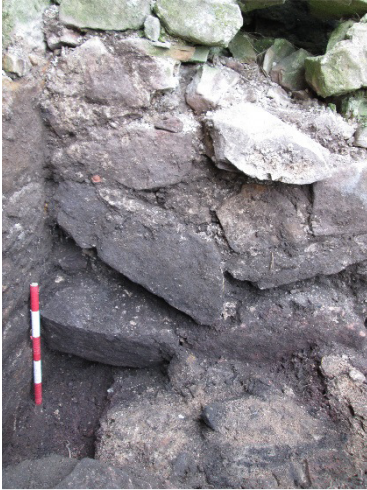
Plate 14 Trench 5, detail of east end with mortar surface (503). Note collapsed basal stone of Wall [507] and ashy deposit (504) directly underlying. Facing south.

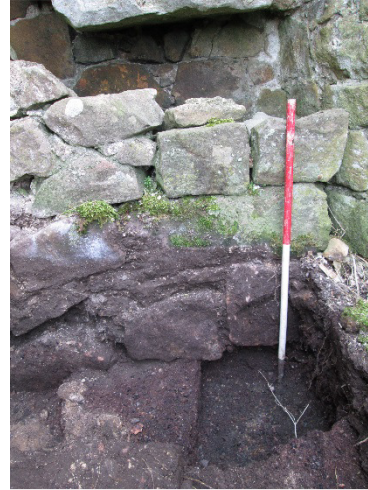
Plate 15 Trench 5, detail of west end with Deposits (501) and (506) directly below Wall [507] footings
