# Nelson Monument Calton Hill, Edinburgh

## *Archaeological evaluation*

### *Archaeological evaluation September 2016*

*Job No. 2235*

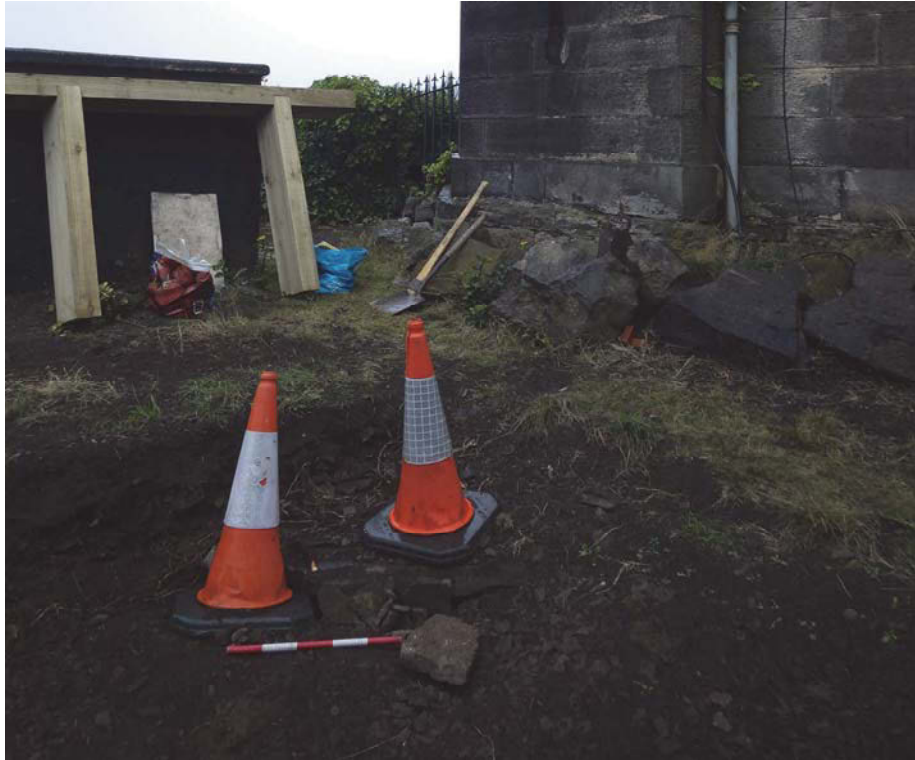
Within the terraced bedding the feature had been partially exposed and left as found once the void beneath the capping was noted (*figure 4; plate 1*).

*Plate 1 masonry feature as found*

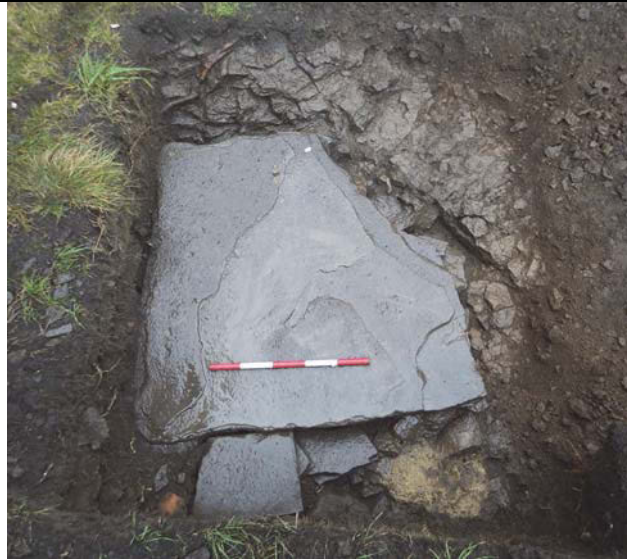
An initial clean-up of the loose debris and roots uncovered a large slab of stone 007 approximately 1m square and lying roughly horizontal. The NE corner appeared to have been damaged with a chunk missing; this potentially happened during the initial uncovering, but the damage allowed a look under the slab (*plate 2/3*).

*Plate 2 Slab capping 007 as exposed looking NE (0.5m scale)*

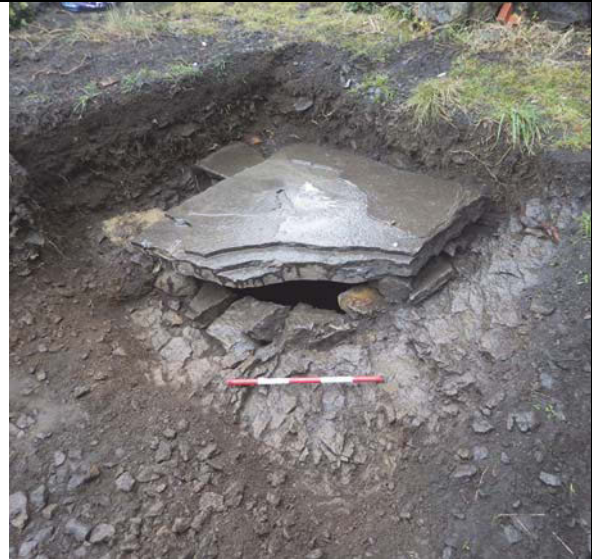
*Plate 3 Slab capping 007 as exposed looking SW (0.5m scale)*

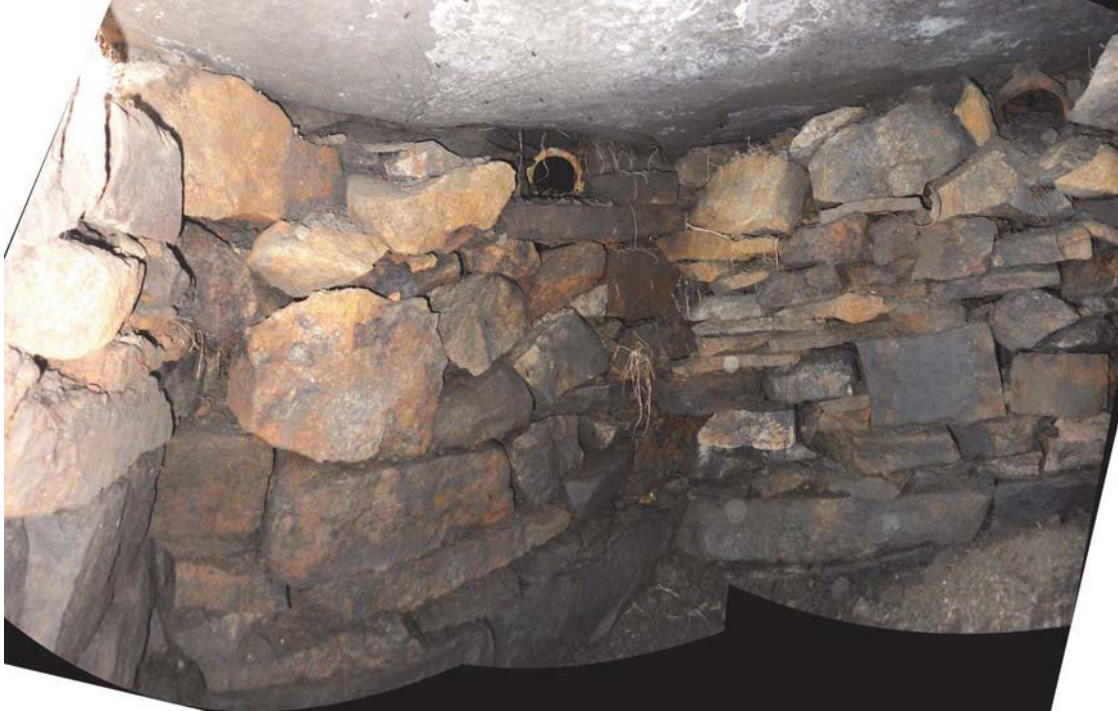
The slab was too big to move by myself so the interior was not fully exposed but by putting a camera down into the chamber, photographic coverage was made of the interior. This showed the chamber to be roughly square and roughly formed from unbonded blocks of rubble stone (*plate 4 & 5*).

*Plate 4 composite detail of W and S sides (006 masonry) with pipes 008 to left and 009 to right*

The chamber was approximately 0.85m square and measured approximately 0.75m from base to the underside of the capping. The only other features noted were two ceramic pipes built into rubble channels within the masonry sides. The first 009 came in from the west and may have formerly come from the nearby corner downpipe; however it is clearly blocked /damaged and not been in use for a long time. This was only seen from within the chamber and appeared to be of terracotta clay construction.

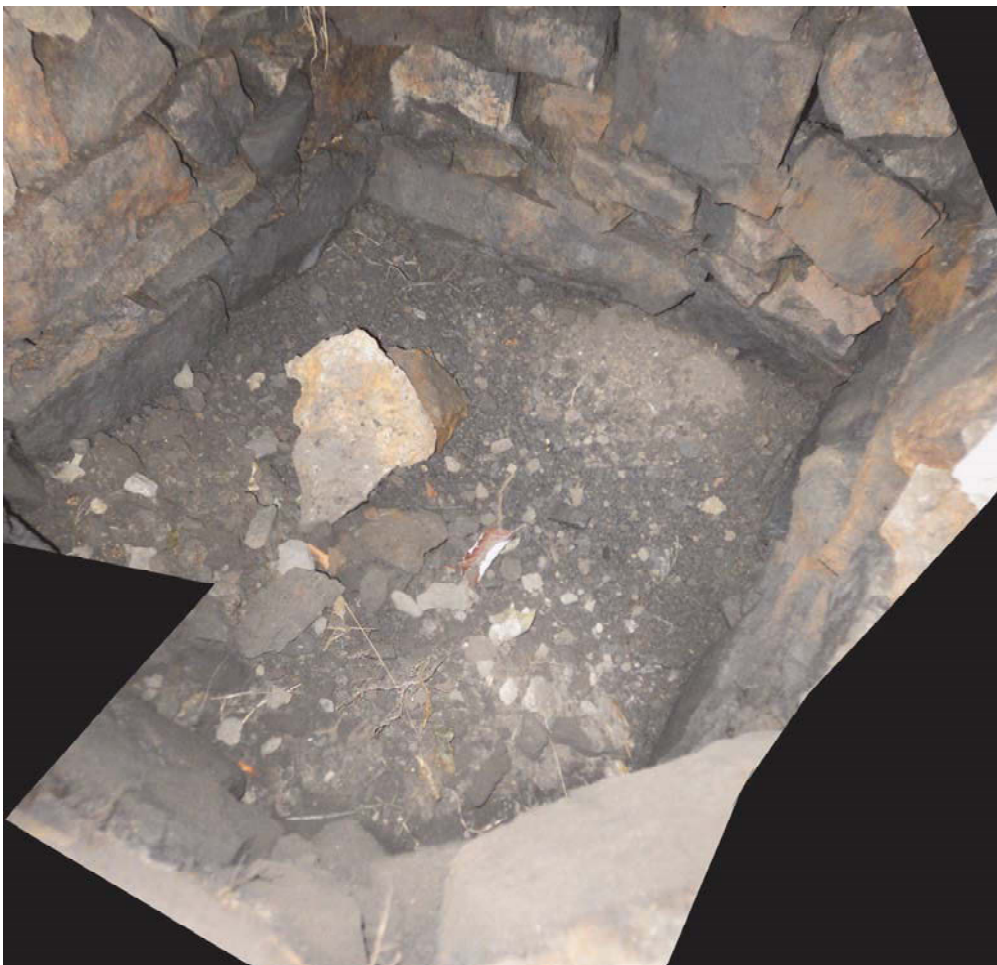
The base was covered with a light spread of silts and some spoil fallen in from the recent exposure; a probe pushed into the silts showed them to be shallow and only a few centimetres deep overlying a hard base - presumably a flagged floor or even just bare bedrock.

*Plate 5 composite detail of chamber base*

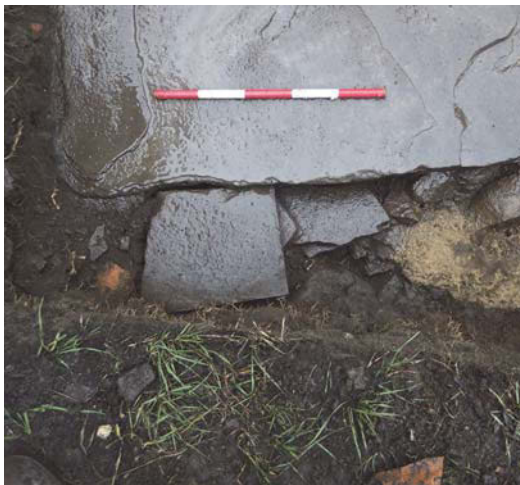
The second pipe 008 came in/out to the southwest and likely ran towards the edge of the hill top. This pipe was of glazed clay and was laid in a rough rubble-lined channel running through the masonry side of the chamber and capped with a stone slab (*plates 6 & 7*). The rubble channel seemed to be contemporary with the chamber although the general construction is so poor that an intervention might not be easily identified. Further out from the chamber it is possible the pipe may just sit within the soil.

*Plate 6 008 with capping intact*

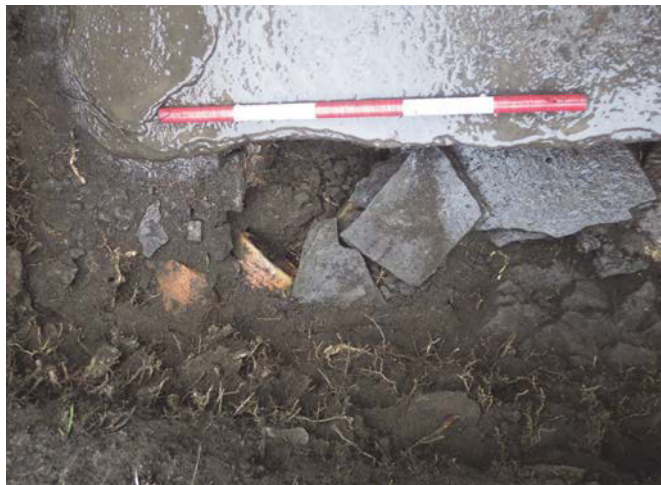
*Plate 7 008 after capping lifted showing the pipe part exposed*

The pipe itself does not run into the chamber but stops short with the stone lined channel continuing the run into the chamber.

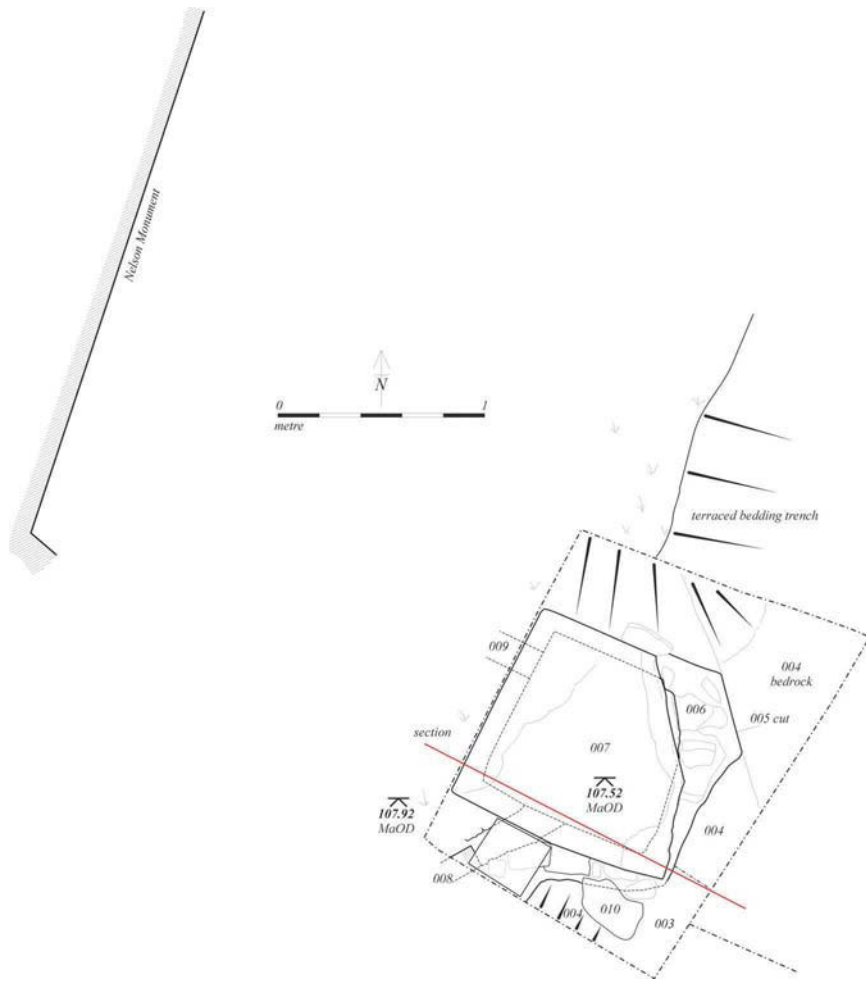
Figure 5 Plan of feature exposed

The surrounding lower deposit is of bedrock 004 that forms the hill. In places the bedrock is exposed only a few centimetres below the surface, extending to up to 0.60m below elsewhere. The stone lined chamber 006/007 and the pipe channel 008 to the south were cut (005) down into this bedrock; the cutting down utilised natural cracking lines in the bedrock in part giving the slightly off square shape to the cut. The upper part of the bedrock is quite friable and breaks up easily. Overlying the bedrock was 0.15m of degraded bedrock 003 with a little soil; above this was 0.25m of stony dark soil 002, effectively a mix of degraded bedrock and soils. This was overlain by 0.25m of lightly stony dark soils 001, which is probably an imported top soil (*figures 5 & 6*).
