# Former North British Rubber Company 2 Gilmore Park, Edinburgh *City of Edinburgh*

*Archaeological Watching Brief of Geotechnical Investigations*

### *Archaeological Watching Brief of Geotechnical Investigations*

Job number 2252.00

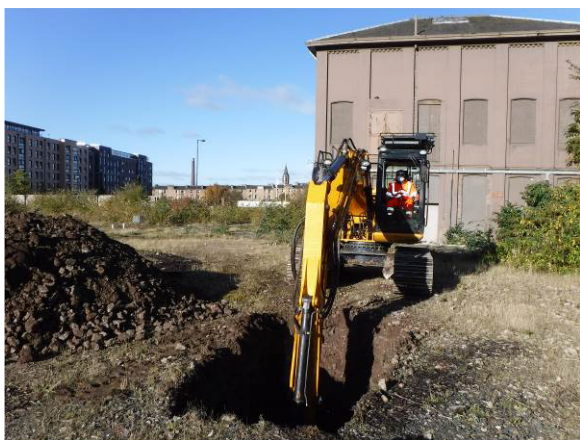
Plate 1 TP1 Location (photo 017)

Test-pit 1 (TP1) was located approximately 11.2m west of the southernmost corner of the building (**Figure 1**), and was excavated to maximum achievable depth in order to reveal the site's underlying soil morphology (**Plate 1, Plate 2**). Orientated northwest/ southeast, TP1 measured 1.5m in width by 4.2m in length, and extended to a depth of 3.9m –the maximum reach of the excavator arm. The trench section revealed over 2.0m of made ground/ demolition rubble made up of crushed brick, concrete, and rebar that could be seen to form two distinct horizons. Underlying the made ground was approximately 1.0m of loose, wet sandy clay with frequent medium angular stone inclusions, overlying orangey-brown sandy natural and possible bedrock. The depth of the trench and instability of the sections meant that a close inspection of the stratigraphy was not possible due to health and safety reasons. No archaeological finds or features were noted.

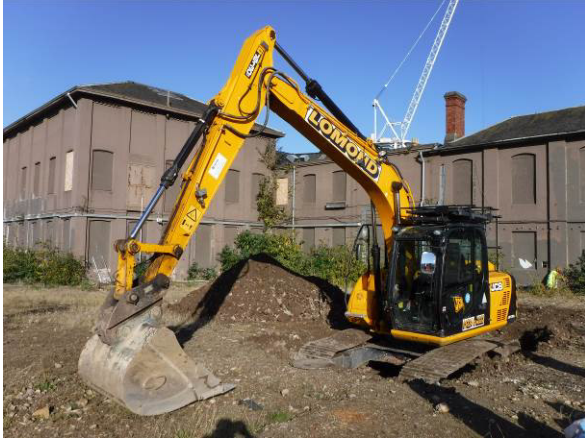
Plate 3 TP2 Location (photo 022)

Test-pit 2 (TP2) was located roughly 16.2m west of the building's southernmost corner (**Figure 1**), and was excavated in order to perform a plate load test to assess the load bearing capacity of the underlying soils (**Plate 3, Plate 4**). Measuring 4.5m in length by 3.7m in width, the trench was orientated northeast/ southwest, and was excavated to an overall depth of approximately 1.0m. The depth of the trench meant that it did not extend below the made ground/ demolition rubble recorded in TP1. No archaeological finds or features were noted.

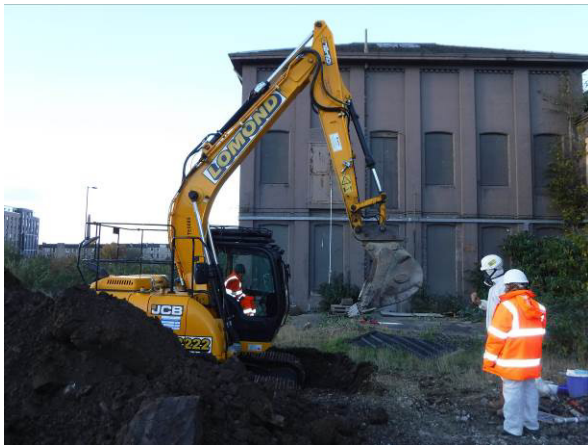
Plate 5 TP3 Location (photo 027)

Located approximately 10.4m southeast of the building's western extension (*Figure 1*), test-pit 3 (TP3) was excavated in order to perform a plate load test on the underlying soils (*Plate 5, Plate 6*). TP3 measured 5.8m in length by 3.9m in width, and was orientated northeast/ southwest. Excavated to a depth of 0.8m, the excavations did not extend below the level of the made ground, and no archaeological finds or features were noted.

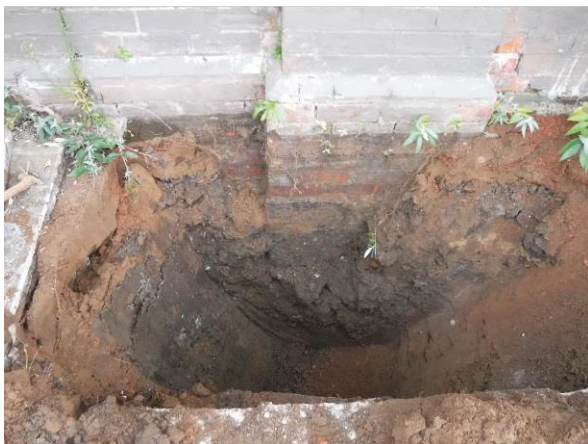
Plate 7 TP4 Post-ex (photo 028)

Test-pit 4 (TP4) was located approximately 8.3m northwest of the building's southernmost corner, next to the third buttress along the southwest facing wall (**Figure 1**). The trench was excavated in order to test the depth of the building's foundations, and was orientated northwest/ southeast due to a large concrete pad adjacent to the wall (**Plate 8**). Measuring 2.4m in length by 1.0m in width, TP4 was excavated to a maximum depth of 1.8m, and showed the building to have been set into firm grey-brown boulder clay. The base of the building's foundations was not fully seen within this trench due to the limited range of the excavator bucket determined by the adjacent concrete slab.

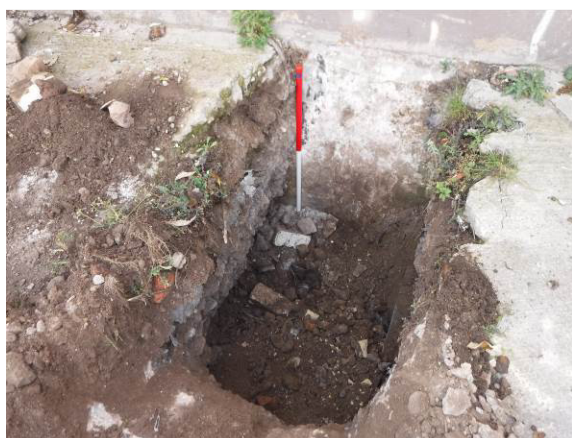
*Plate 9 TP5 Facing northwest (photo 032)*

Stratigraphy within TP5 showed that a considerable depth of made ground/ demolition rubble exists below the concrete slab (**Plate 10**). The exposed lower wall of the building is plastered and retains remnants of a green paint, indicating that this wall had been exposed in the past, either as an external wall or an interior room or cellar within an extension or structure no longer extant (**Plate 9, Plate 10**).

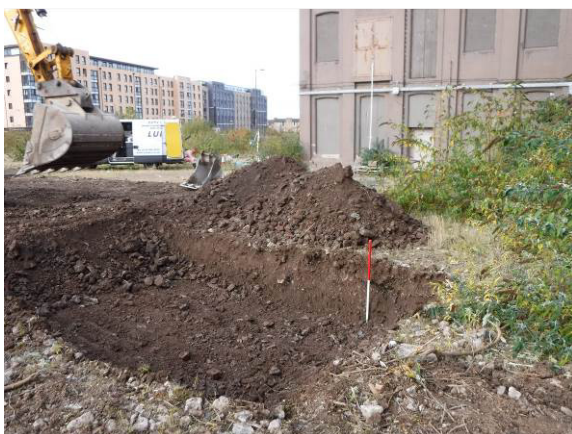
*Plate 11 TP6 Location (photo 037)*

Located approximately 10.1m west of the building's southernmost corner (**Figure 1**), Test-pit 6 (TP6) was excavated in order to perform a plate load test to assess the load bearing capacity of the underlying soils, and was orientated roughly northeast/ southwest. Measuring 4.9m in length by 3.4m in width, and an overall depth of 0.8m, excavations in this trench were entirely within made ground (**Plate 11, Plate 12**).

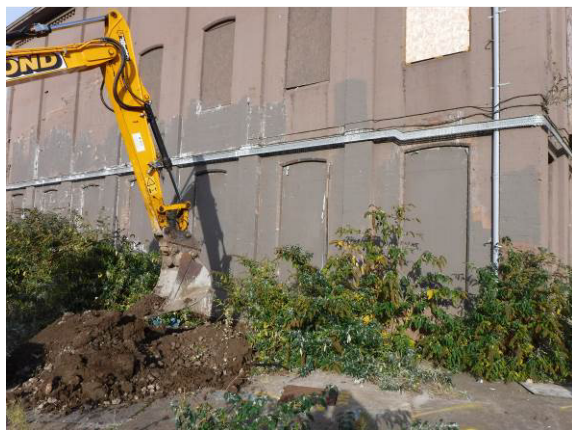
Plate 13 TP7 Location (photo 040)

Test-pit 7 (TP7) was located roughly 5.3m northwest of the southern corner of the building's west wing (**Plate 13**), and was placed in order to assess the depth and structure of the building's foundations in this area. Orientated northeast/ southwest, the trench measured 1.7m in length by 0.9m in width, and was excavated to an overall depth of 2.0m. Stepped building foundations were encountered at a depth of 1.3m below the present ground surface, and consisted of an aggregate material 0.2m thick and protruding 0.2m from the brick wall face (**Plate 14**). The building foundation was set within firm grey-brown boulder clay that was found to underlie successive bands of made ground and modern service trenches.

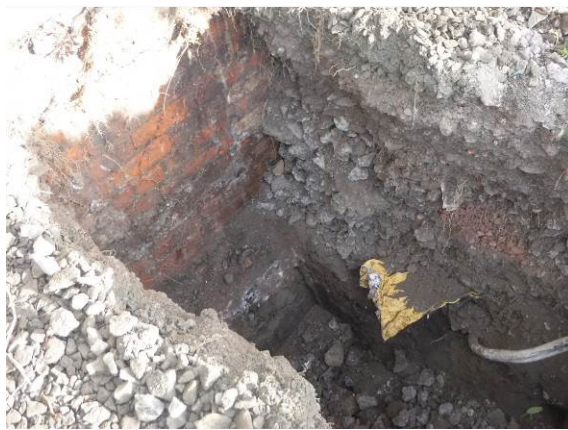
Plate 14 TP7 Building foundation (photo 039)

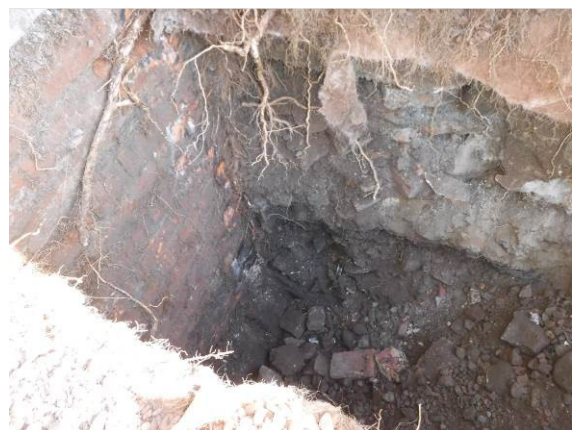
Plate 15 TP8 Wall foundation (photo 041)

Located approximately 16.6m northwest of the southern corner of the building's west wing (**Figure 1**), Test-pit 8 (TP8) measured 2.0m in length by 0.90m in width, and was placed in order to locate the building's foundations. The base of the foundations was noted at a depth of 1.60m below ground, while the trench excavations reached a maximum depth of 1.8m. Foundations did not step out as seen in TP7, suggesting that the brick structure is set within a foundation trench cut into the boulder clay, with projecting aggregate 'feet' set at regular intervals rather than along the entire length. Stratigraphy was found to be made ground overlying compact grey-black boulder clay.

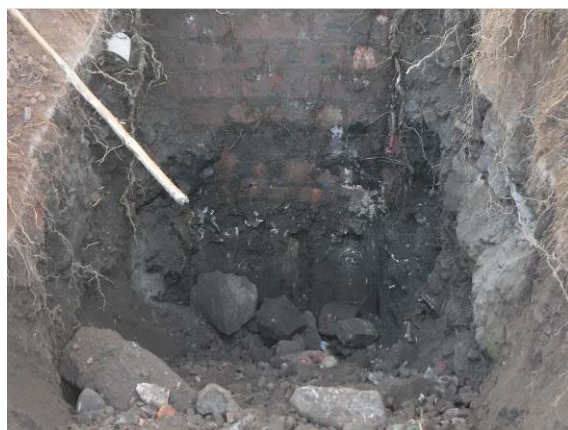
Plate 16 TP8 Foundation base detail (photo 043)
