# Larkhall Steading

## *Jedburgh, Scottish Borders*

*Historic Building Recording and Archaeological Watching Brief*

Job number 2246.00

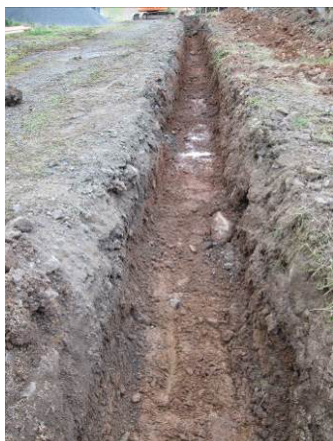
All three trenches were excavated below the level of undisturbed natural subsoil. Trench 1 (*plate 1*) had a maximum depth of 0.7m, Trench 2 (*plate 2*) was 0.9m at its deepest point and Trench 3 (*plate 3*) was excavated to a depth of 1.10m. The overburden, which varied in type but was always a compact hard surface, was 0.3m deep. Below this lay the reddish brown sandy clay subsoil to a depth of 0.7m below the ground surface. This lay directly on top of compact pink clay natural, which was streaked in places by grey/blue patches.

*Plate 1 General view of Trench 1 looking N (photo 014)*

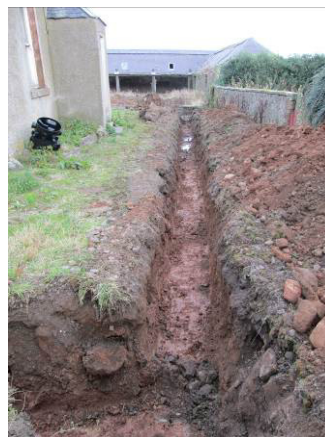
*Plate 2 General view of Trench 2 looking E (photo 010)*

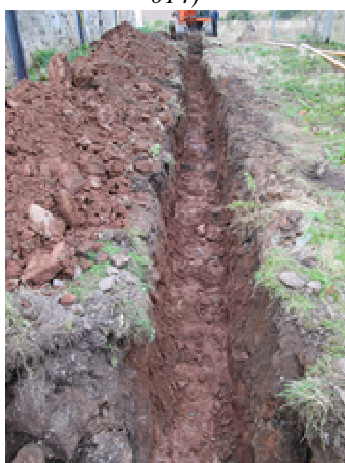
*Plate 3 General view of Trench 3 looking N (photo 009)*

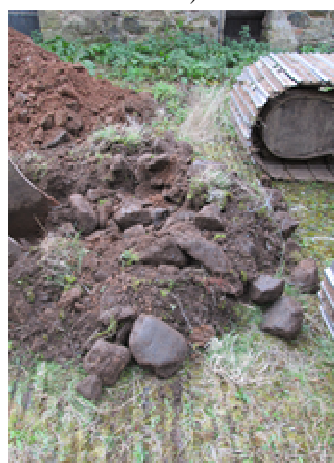
There were no archaeological features or finds pre-dating the steading uncovered during the watching brief. Two features were uncovered in Trench 3 relating to an earlier layout of the steading. An area of cobbles (*plate 4*) was uncovered to the north of the gable end of the farmhouse, indicating that this area of the courtyard had formerly had a cobbled surface. The second feature was a concrete base with the remains of a timber post which appeared to be *in situ*. The location of this post was in line with a scar visible on the side of the farmhouse, this also relates to a structure visible on the 1897 plan. It may have been that an open sided shed similar to the upstanding example in Building 4 had formerly filled the space between the western range (Buildings 1 and 2) and the farmhouse.

*Plate 4 Cobbles excavated from Trench 3 (photo 007)*

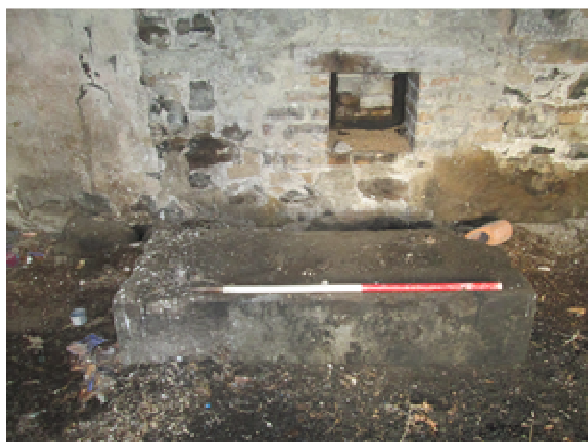
*Plate 5 Large stone base, with aperture behind (photo 032)*

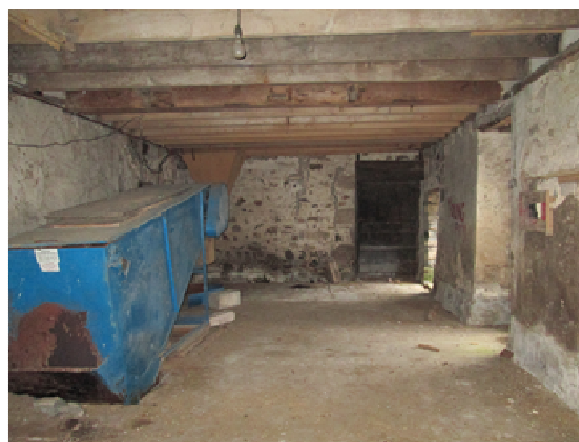
Building 1 forms the south-east end of the west range of buildings. The plan of the building as it survives consists of a long barn (*plate 6*) with a separate area to the north for housing animals, with a hayloft above and a separate room on the south-west open to the rafters, most recently used as a workshop. This separate room originally housed an engine which would have driven some form of machinery, possibly a threshing machine or similar located in the adjacent barn. There are a number of blocked openings which would have given access to the barn, together with a large stone block on which the engine would have sat (*plate 5*). A window has been slapped through the south west facing gable to insert a long low window above the work bench area.

*Plate 6 Interior of building 1 south end (photo 47)*

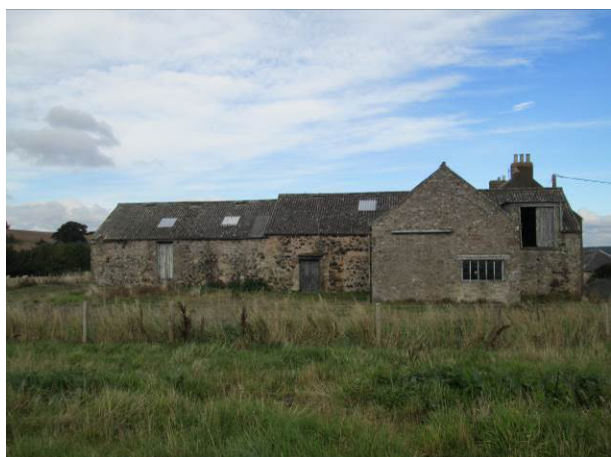
*Plate 7 General view of Building 1 and 2 from west (photo 019)*

Although the first edition map shows Buildings 1 and 2 as a single structure, built before 1859, the physical evidence indicates that Building 1 existed first. The quoins visible at the wall head on the south-west elevation (*Plate 8*) show it was constructed before Building 2. The roof heights also vary slightly suggesting it was not a single phase of construction.

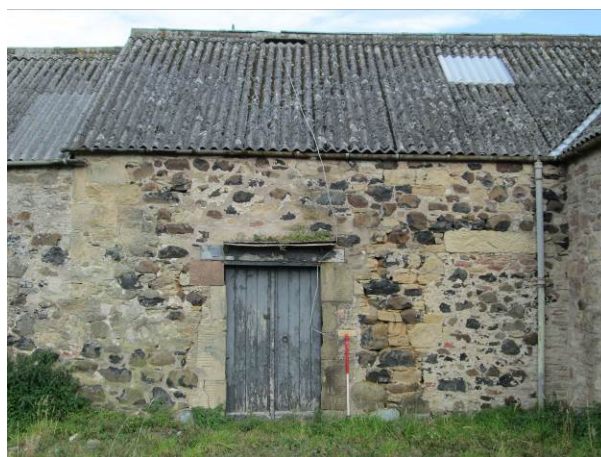
The northern part of the main barn has low walls dividing areas for animals; it also houses the timber stair which gives access to the hay loft. It can be entered from the main barn, and externally from east and west. The door on the west side has been altered and an earlier door, now blocked is visible to the south.

*Plate 8 Building 1 west elevation with blocked door (photo 025)*

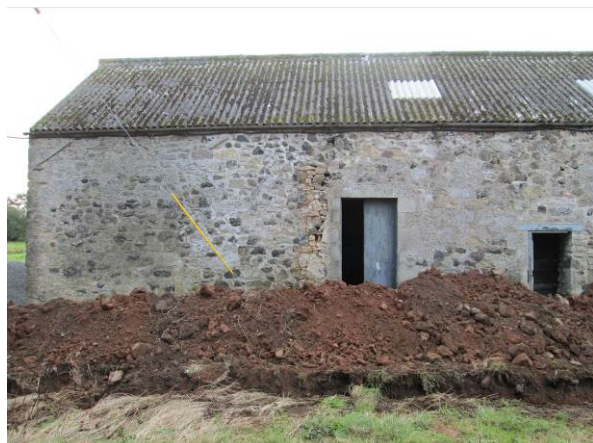
The north-east facing elevation of Building 1, at the south end, shows the scar of an earlier building than ran perpendicular and joined on to the farmhouse (*plate 9*). A building in this location is visible on the first and second edition maps, by 1917 only the south wall survives, but this is located right at the front of the buildings. There are also mortar lines showing two different roof lines (*plate 10*), possibly reflecting the two different arrangements as shown on the first and second edition maps.

*Plate 9 Building 1 north east elevation (photo 032)*

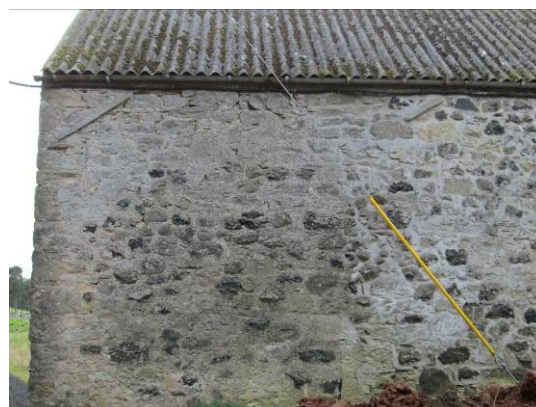
*Plate 10 Building 1 roof scars (photo 033)*

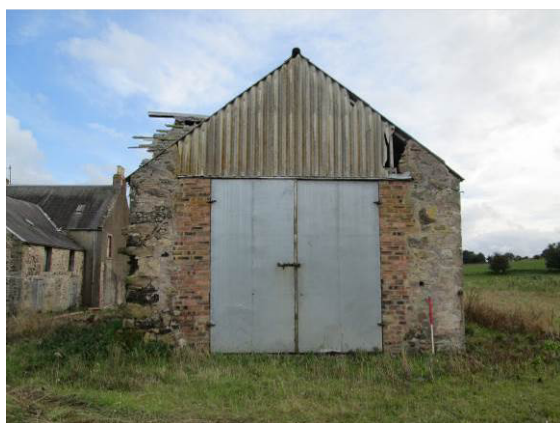
*Plate 11 Exterior elevation, south range (photo 027)*

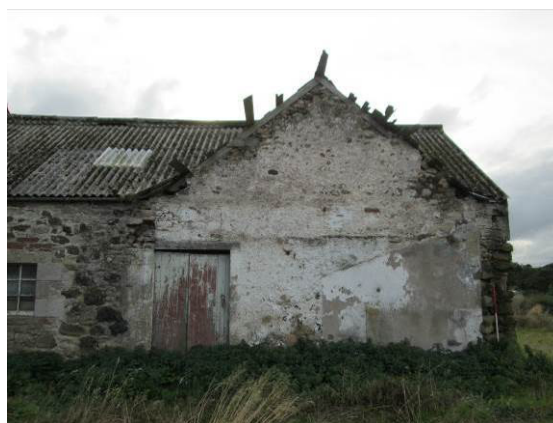
The north range was demolished recently for health and safety reasons, therefore only the short section abutting Building 1 survives. The building was not entered for safety reasons. The exposed former internal wall has been plastered in places and whitewashed (*plate 12*).

*Plate 12 Interior/courtyard elevation, south range (photo 028)*

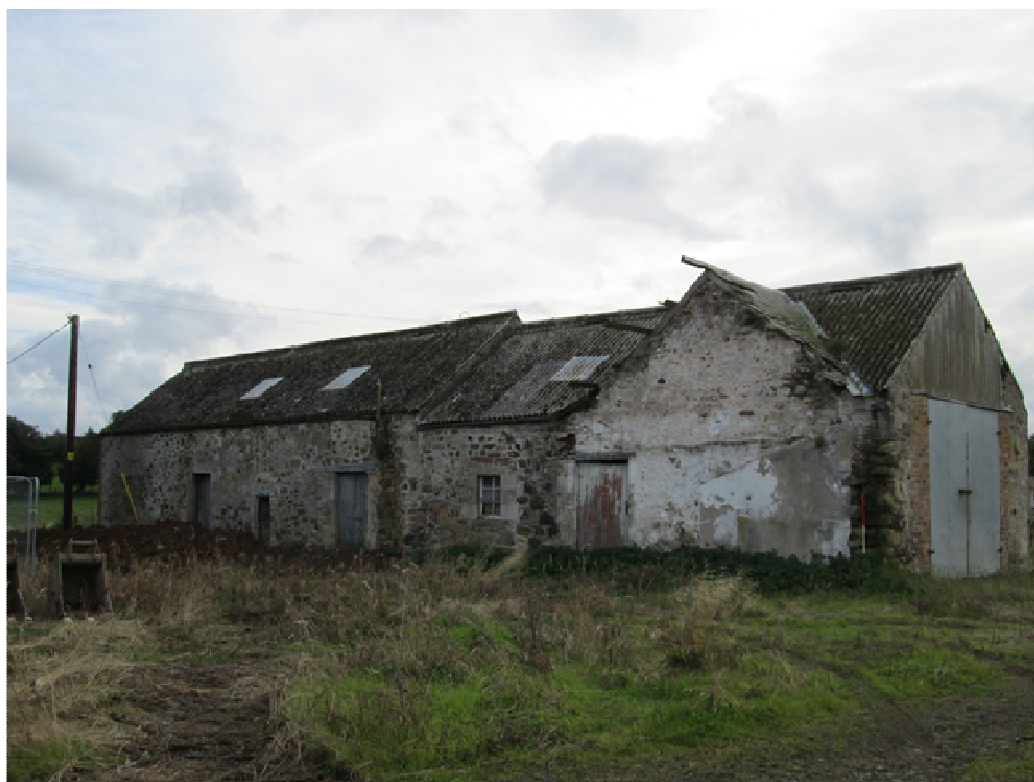
*Plate 13 Exterior elevation of south range showing different phases (photo 29)*

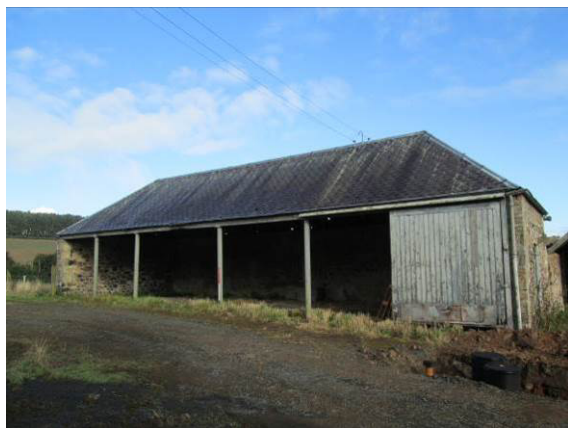
Plate 14 South West elevation Building 3 (photo 118)

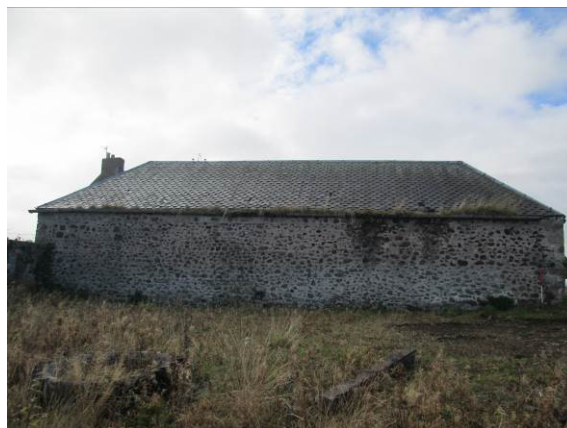
Plate 15 North East elevation Building 3 (photo 124)

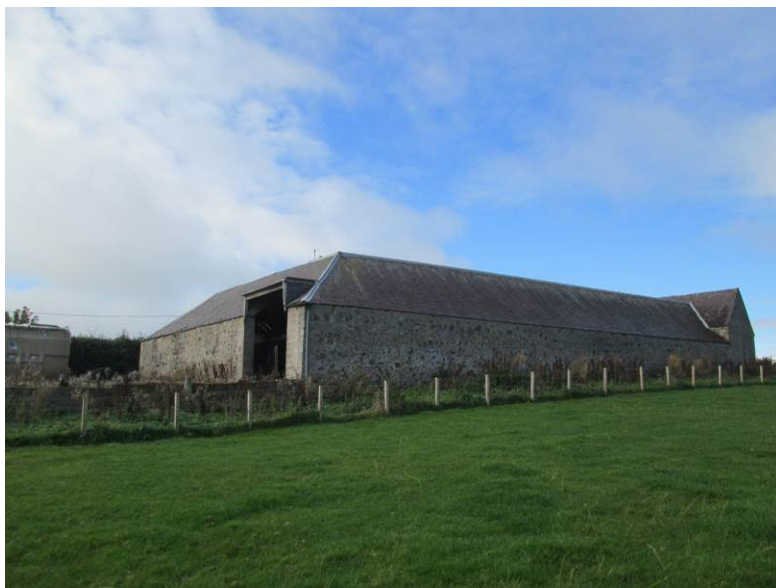
Plate 16 General view of Building 4 looking north west (photo 134)

Building 4 (*plate 16*) is the only one of the buildings that does not appear in its current form on the first edition map. There are three small buildings in this area of the site, one of which is located at the south-east of Building 4. There is no evidence within the fabric of the building to indicate that the earlier building was retained and added to, as the long elevation appears to be of a single phase. This shows that the two small buildings at the south-east were demolished prior to the construction of Building 4. On the first edition map and all subsequent maps there is a building at the north-east,

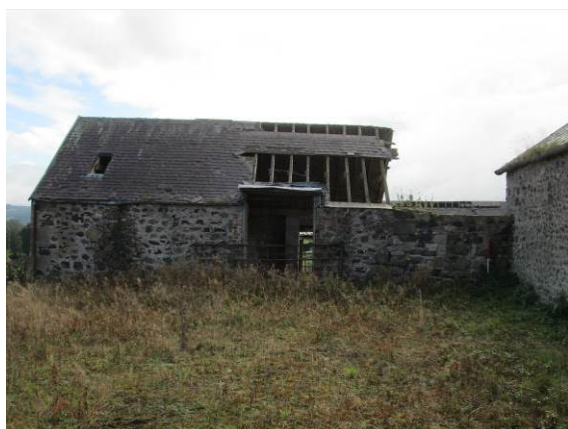
which is abutted by Building 4. Although it has been mostly demolished, there are still the remains of this building, some of which have been incorporated into the north end of Building 4. The upstanding stretches of wall show a complex patchwork of blocked openings, rebuilding and slapping through (figure 9, plates 17, 18 and 19).

*Plate 17 Exterior elevation, south range (photo 127)*

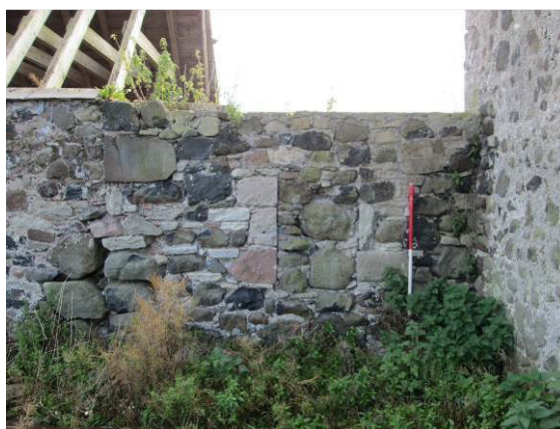
*Plate 18 Interior/courtyard elevation, south range (photo 129)*

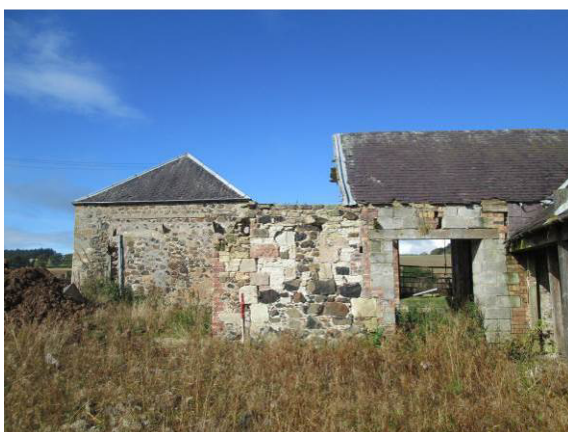
*Plate 19 Exterior elevation, south range (photo 143)*

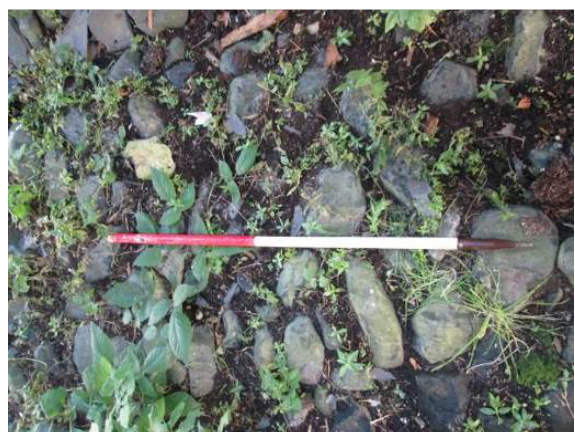
*Plate 20 Interior/courtyard elevation, south range (photo 154)*

The remains of a cobbled floor survives in the south west part of the building (*plate 20*), which would most probably have extended to cover the whole shed floor.

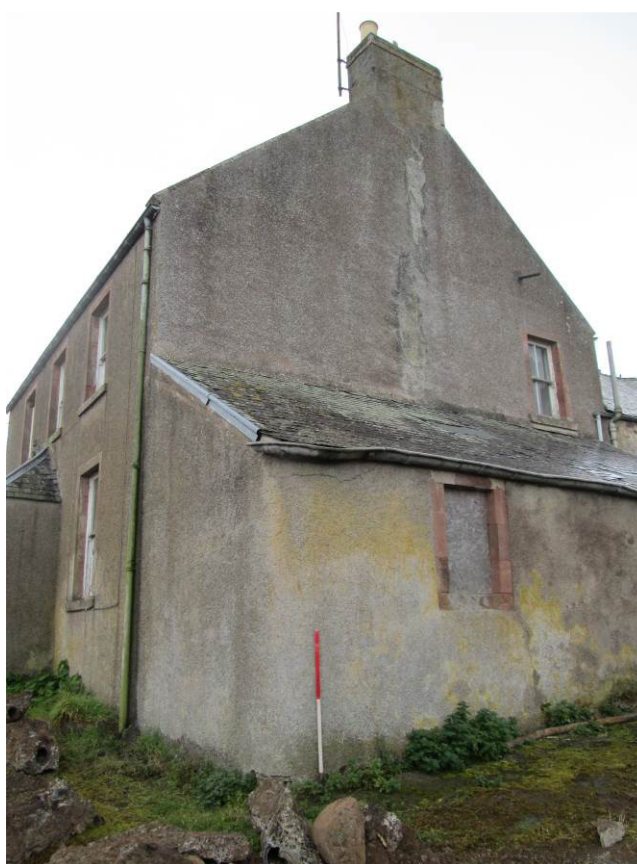
The main farmhouse appears to be of late 18th or early 19th century date, contemporary with the steading buildings. However there are several features that may indicate that parts of it are earlier and the main body may include reused elements from an earlier building. An initial assessment would indicate that the east end of the farmhouse appears to be abutted by a single storey lean-to structure (*plate 21*). Whilst carrying out the photographic survey evidence was revealed which may suggest that this part of the building existed before the farmhouse was built rather than being a later addition. Other anomalies include the curved south east corner, the level of wear on the sandstone surrounding the north window of the lean to and the bar holes on both windows. Several of the window cills and lintels on the main part of the house also have bar holes. Some of the jambs showed evidence of horizontal bar holes that had been blocked.

*Plate 21 South East corner of farmhouse showing curve (photo 099)*

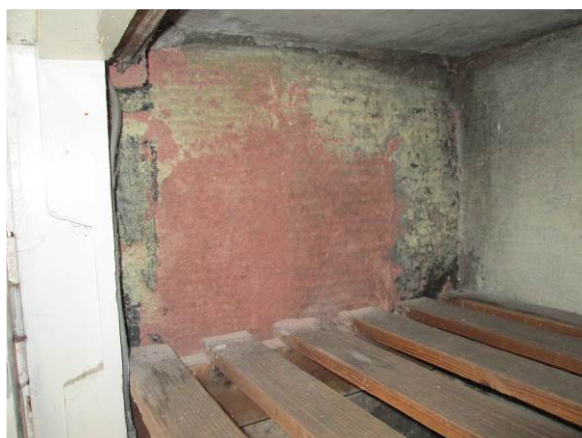
This positioning of the dressed stone on what should be the interior face of the wall was duplicated within the boiler cupboard further north along this wall (*plate 22*).

*Plate 22 West elevation of farmhouse extension (photo 80)*

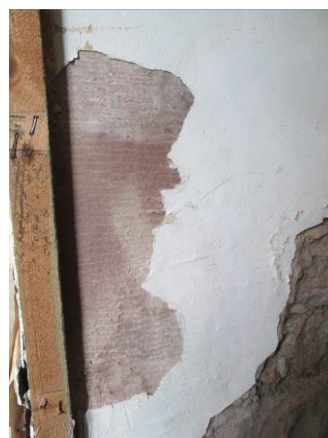
to the lean-to had red sandstone jambs with broached dressing on what should have been the interior wall face, whilst the side within the lean-to, which was where the dressed stone should have been, if in fact the lean-to was a later addition, had rough jambs (*plate 23*).

*Plate 23 East elevation of farmhouse extension (photo 82)*

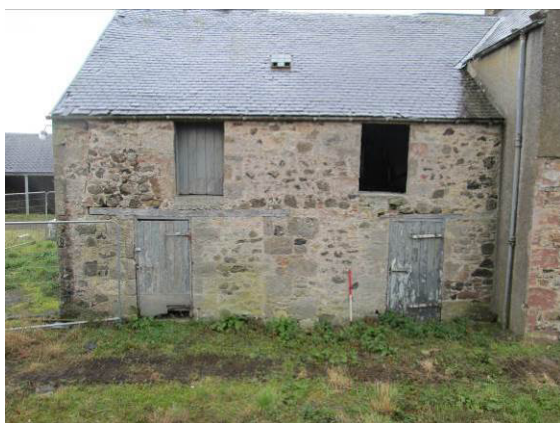
There is also a much larger two storey extension built at the rear of the farmhouse (*plates 24 and 25*). Although also depicted on the first edition Ordnance Survey, it was clearly built after the farmhouse. The evidence for this is a large window at first floor designed to light the staircase of the farmhouse. It now looks into the extension. The extension has seen alterations to the openings at ground floor and first floor level, which presumably are a result of change in use. Latterly the south end of the ground floor was turned into a large kitchen. Due to safety issues the rear section and first floor were not entered. The openings into the first floor suggest it was used as a hay loft. The large crack in the wall, partially separating the north-west gable, may have been caused by the remodelling or indeed creation of the new door at first floor level, the jambs have been made of yellow brick, similar to the surrounds of the other windows on the north-east facing elevation.

*Plate 24 West elevation of farmhouse extension (photo 106)*

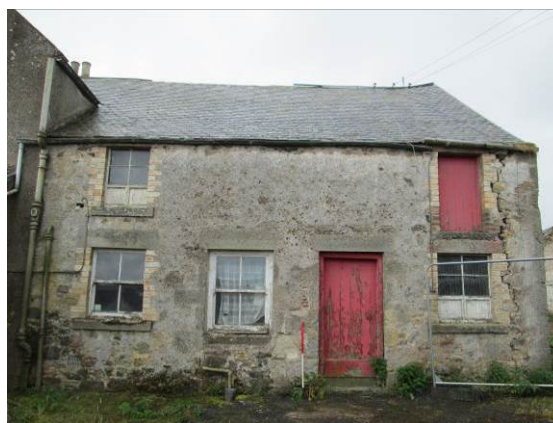
*Plate 25 East elevation of farmhouse extension (photo 110)*
