# Woolsington Hall

*Woolsington, Tyne and Wear*

Post-fire recording works, clearance and materials recovery

Project AA.1964

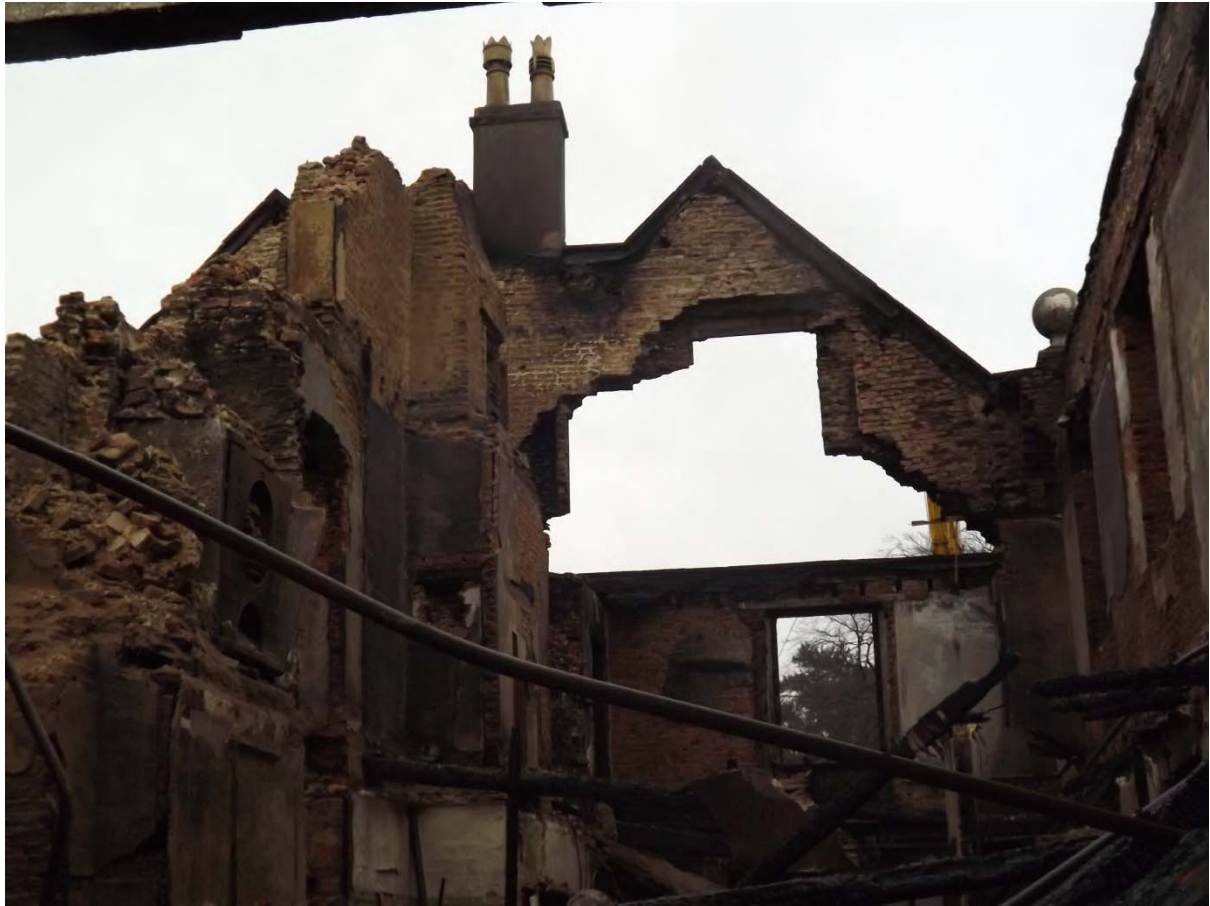
*Plate 5 South-east gable before demolition on 9 January 2016, illustrating its perilous state*

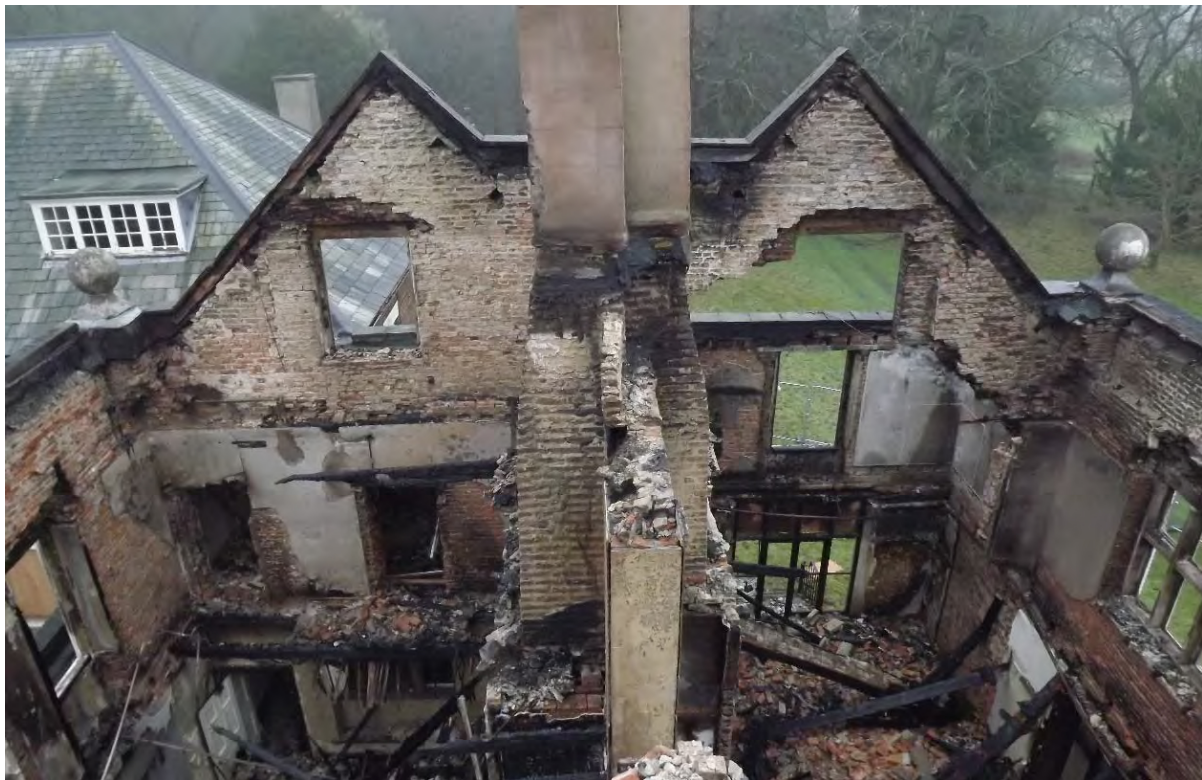
*Plate 10 east gable post fire pre collapse /demolition*

With the gables, arranged double-pile in pairs to east and west, the main collapses during the fire were associated with major historic slappings-through of the masonry walling at ground floor level (to the south-west and south-east) or at both levels (as with the bay window to the north-west). To the south-east where the southern ground floor room had been extended, the masonry above had been supported by a major timber beam which failed in the fire, being completely burnt through, and the masonry immediately above at first floor level had fallen. This weakened the gable that still precariously bridged the void above to such an extent that it subsequently collapsed at the first attempt at dismantling.

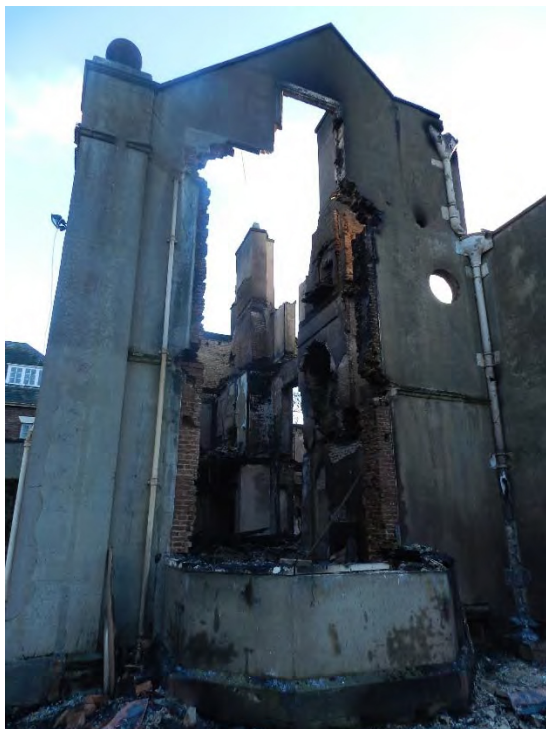
To the south-west the southern ground floor room had also been extended outwards; here the supporting timber beam had also failed, in this case bringing down all of the walling above including the gable. The north-west gable had had much of the lower two stories slapped out to fit a bay window in the 19<sup>th</sup> century, as described, this leaving the attic level hanging precariously following the fire. This gable was dismantled in the first phase of making the building safe; it was possible to recover the coping stones.

*Plate 11 west gable north half post fire*

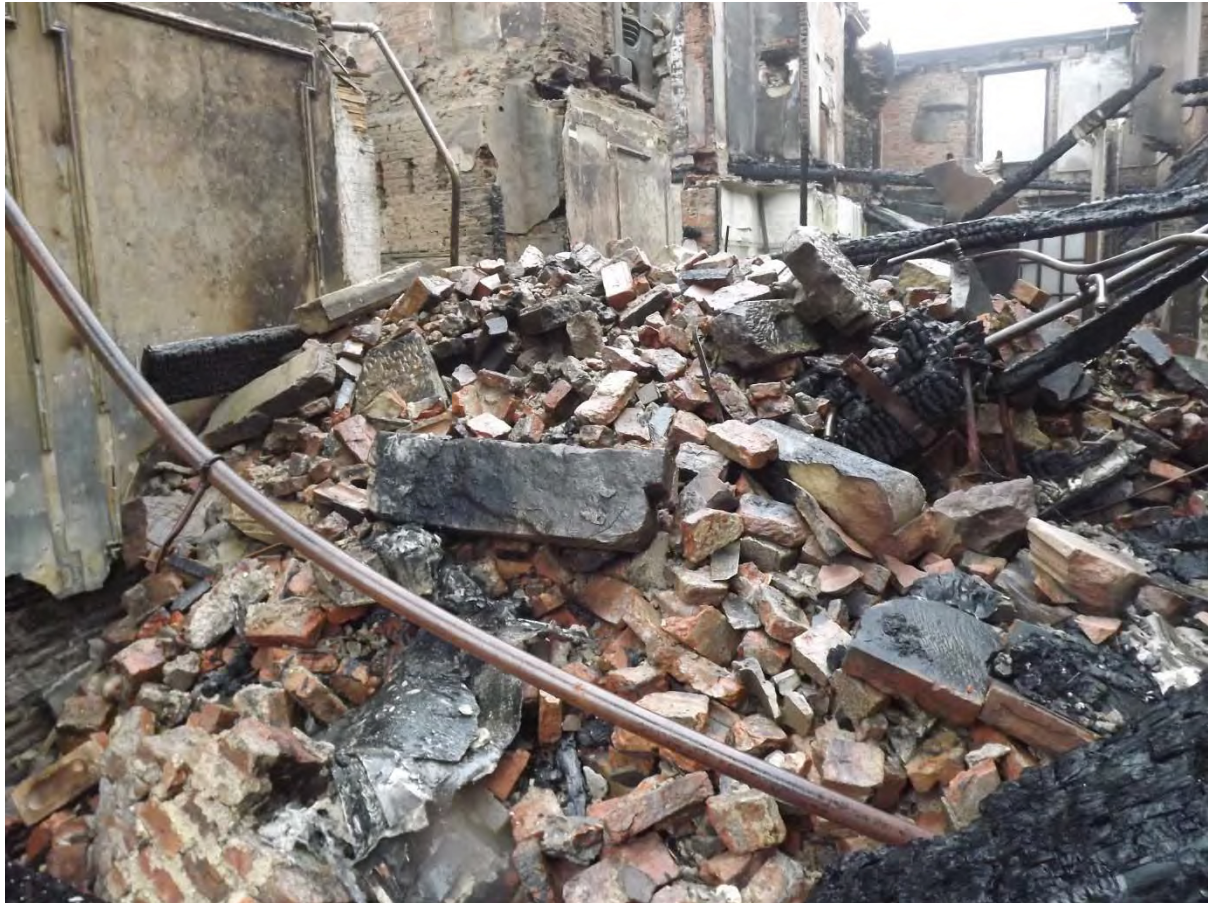
*Plate 15 Rubble collapse within Woolsington Hall*

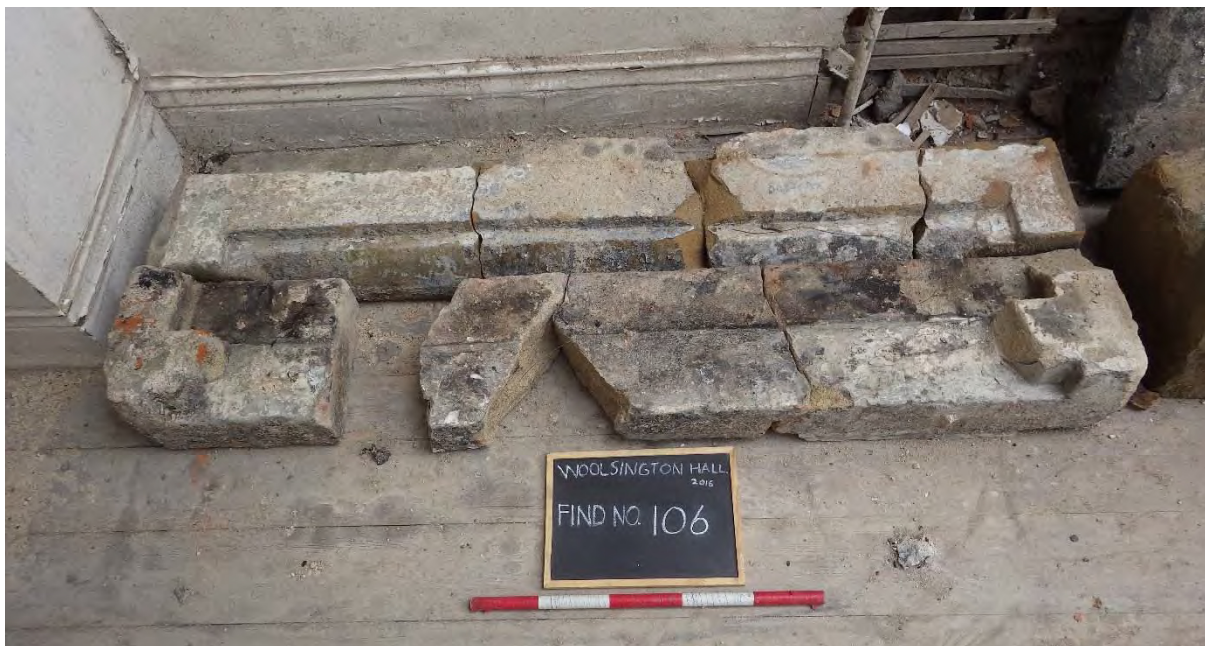
The stonework of the window surround in the east wall was largely recovered in pieces, all fire-damaged but enough to identify this (and the other attic windows) as not having the same detail as the surviving early windows on the floors below. Unlike those the window was not mullioned and may have been replaced (or modified) when the roof configuration was adjusted in the 18<sup>th</sup> century; evidence for this can be seen where one of the jambs was cut down from an early sill with matching profile to the original windows.

Plate 22 Room S09 - window lintel and sill (find no 106)

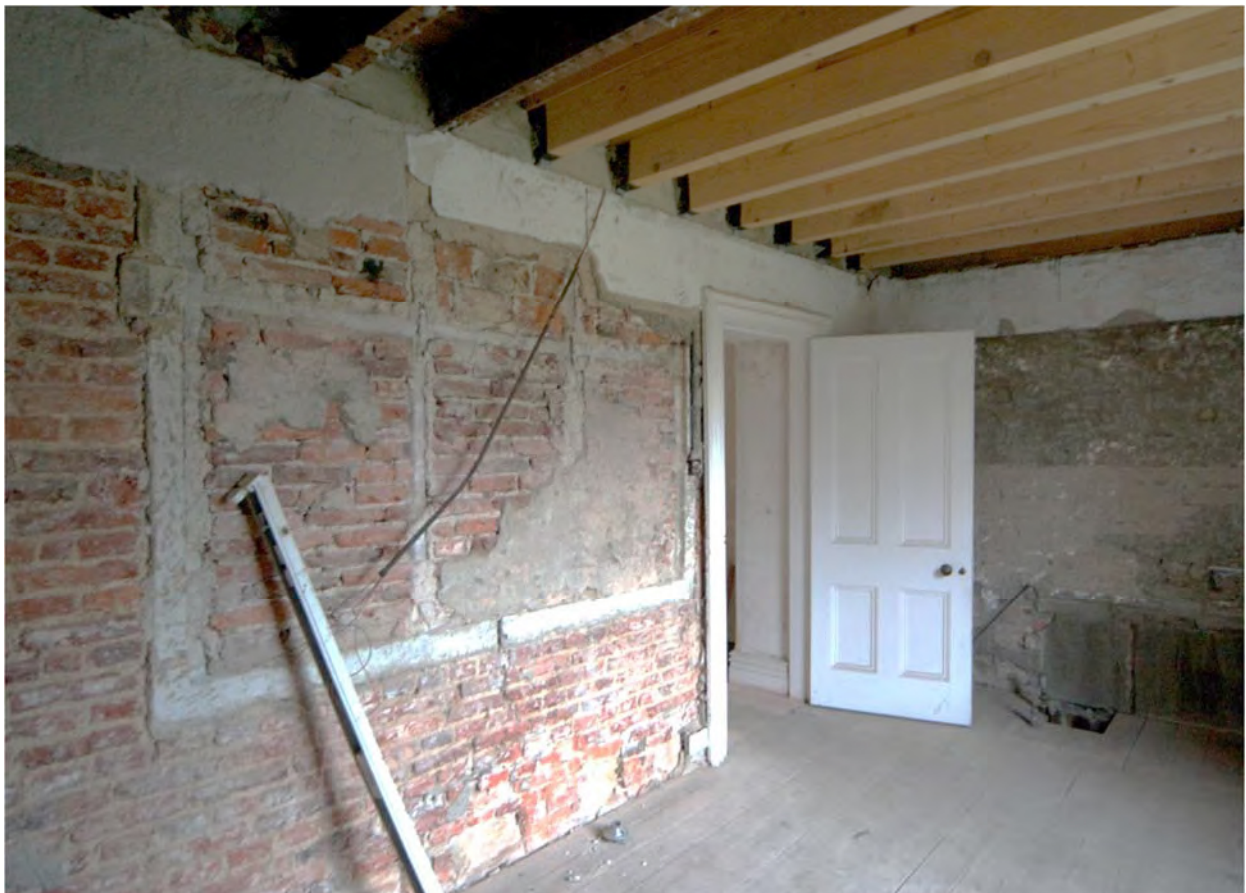
The blocked up original mullioned window within the west wall of room F04 had been visible within the later westwards extension (room F05) before the fire. This fell when the walling and gable above collapsed. Its masonry (find 097) was recovered but the pieces were mostly broken. However by piecing the bits together a record and reconstruction of the original form was made from measurements from the fragments.

Plate 38 The former window within the west wall of Room F04, as seen in situ before the fire within room F5 (find no 097)

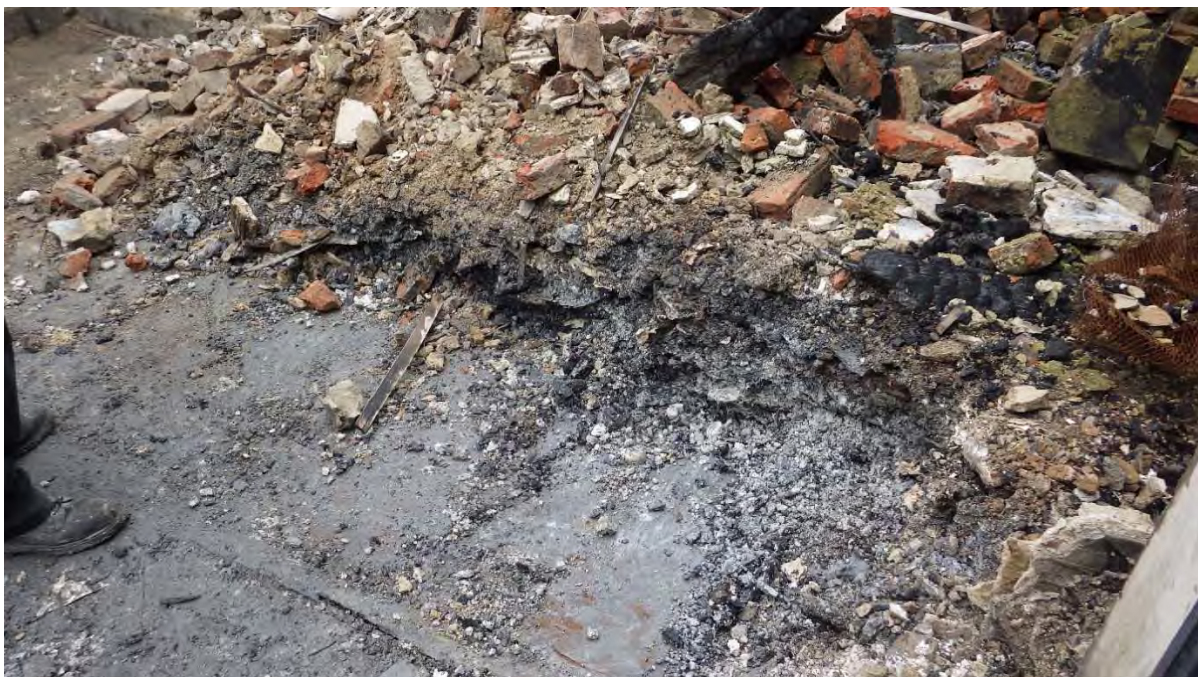
Much of the flooring remained intact throughout the ground floor level, though with the exception of parts of rooms G03/4 and G09 and the complete loss of the floor in G05. The floor was covered with 0.3m + of cinders and collapsed/ melted plasterwork representing the remains of the floors and roof above a deep deposit of brick and masonry; on top of this was the result of the demolitions.

Plate 55 Ground floor flooring with the burnt remnants of the structure above reduced to 30 cm of ash

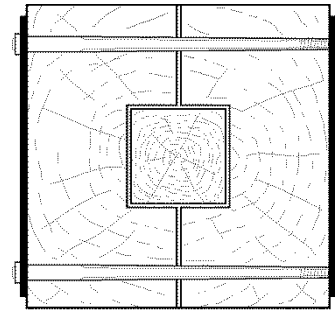
Figure 10 detail of major beam G03/4

This beam, despite its size, had completely burnt through to the south and the gable above had collapsed as a result.

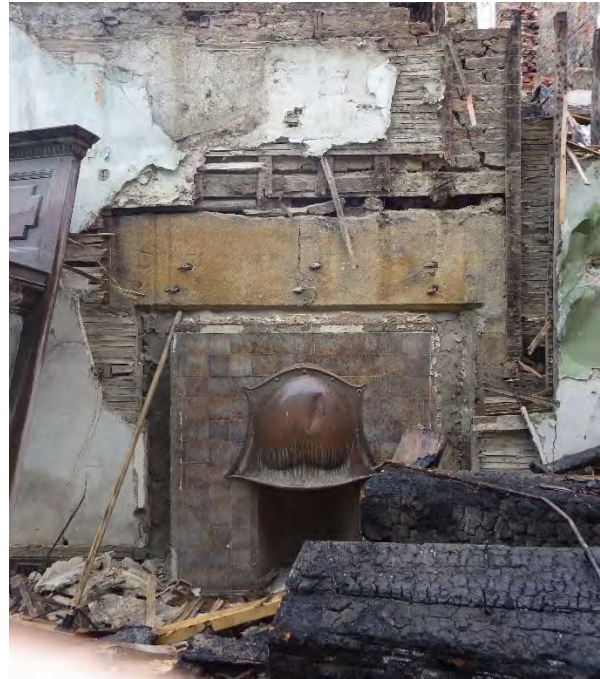
The timber surround for the fireplace had survived mostly intact, although it had been slightly damaged and knocked loose. Exposed behind this was a plain chamfered sandstone lintel and jambs from an earlier fire; this may not be original as partially exposed above the lintel was a timber over lintel and voids, perhaps showing this was inserted. Further investigation/stripping of plaster would be required to confirm this.

The lintel had a series of six lead-set cramps for an attached timber surround and a light shadow of this surround can be seen on the stone.

Plate 71 room G09 shows early fireplace lintel

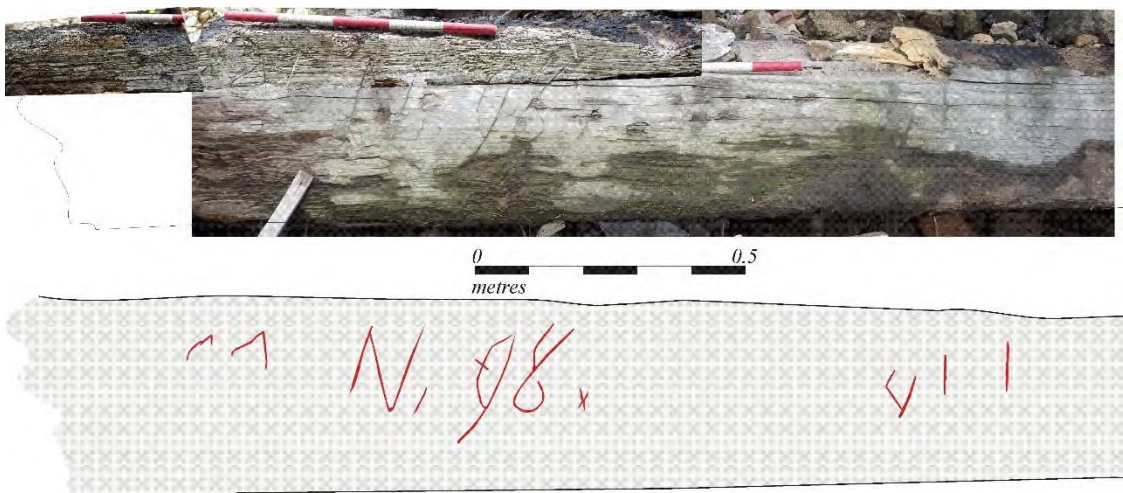
The extension to the east slapping out the original ground floor masonry required a major timber support beam to hold up the gable above, as at the western gable and this timber also burnt completely through as did the one at the west; the remnants had shattered when it collapsed and brought down much of the gable in the fire. The timber was different in composition to the western one as it was a simple single major pine beam approximately 0.40 m square and in excess of 80 yearly growth rings were counted.

Cut into the side of surviving fragments of the beam were some race marks. The beam had shattered and the bits had to be sawn up into manageable pieces to remove them from the building but the pieces with the surviving race marks were reassembled and they were recorded, see *figure 11* below.

Figure 11 partial race-knife marks on main support beam

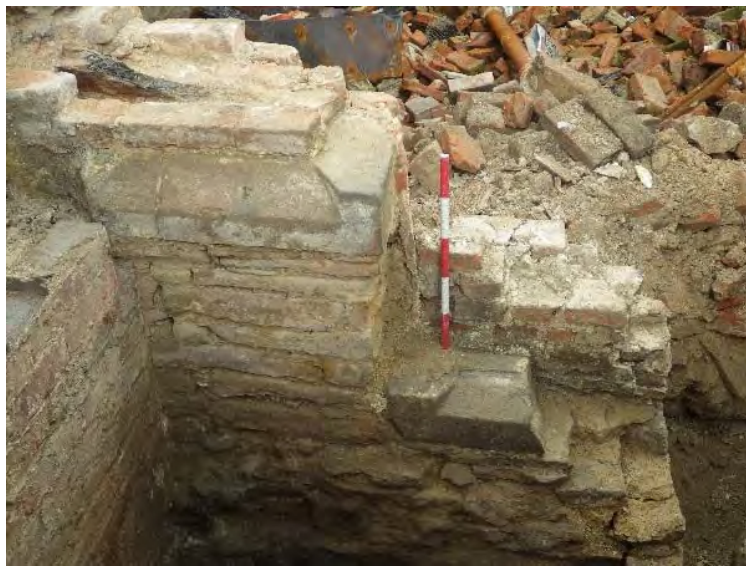
The construction of the bay window and the formation of the basement beneath involved exposing the foundations of the building. These were stepped out by 0.1m and were of much coarser construction than the above-ground masonry. The slapping of the entrance through to the space below the bay window also involved the bricking up of the surviving half of the pre-existing cellar window.

Plate 84 Room B03 - basement window remnants, looking east
