Lady Well

Dumfries House, South Ayrshire

Evaluation and Stone Catalogue : December 2015

for The Great Steward of Scotland's Dumfries House Trust

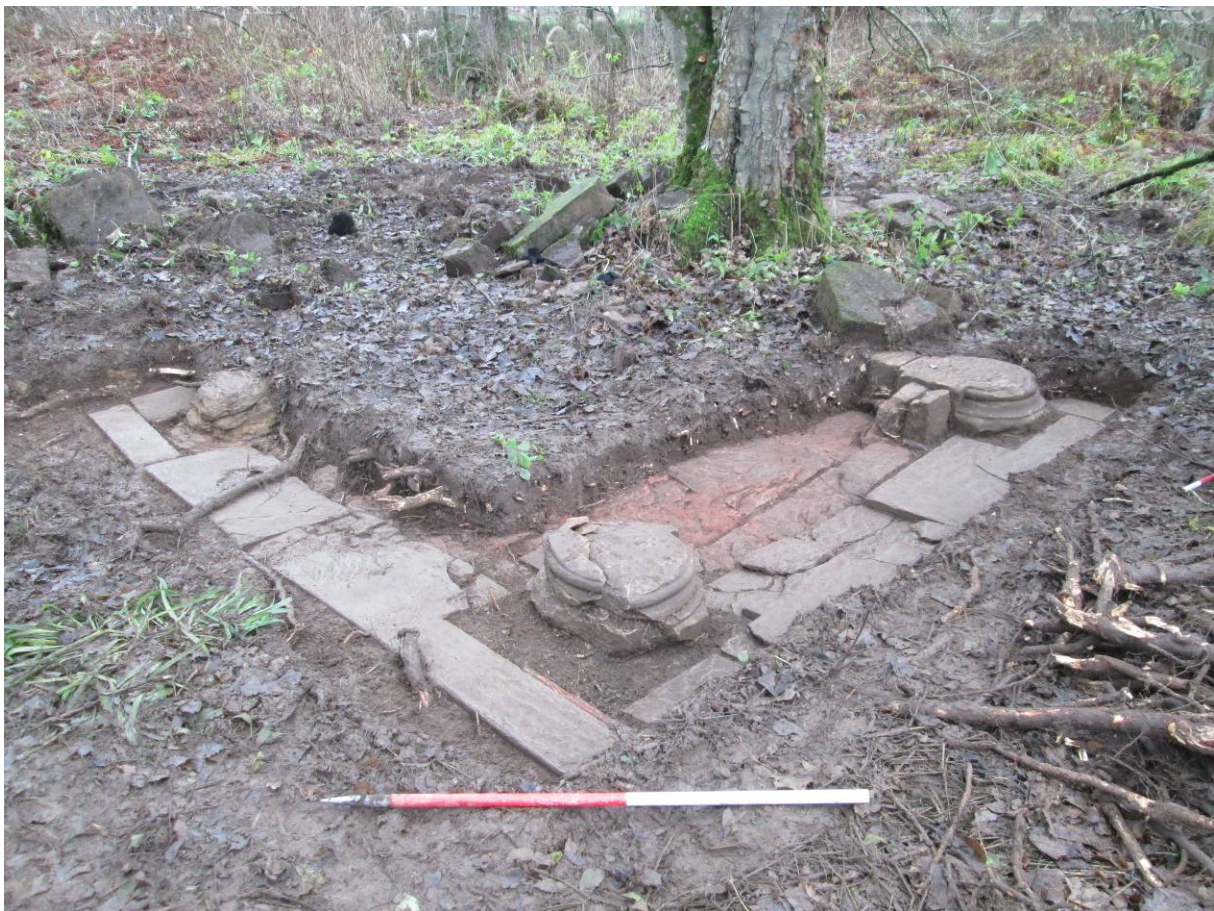
Plate 3 South and East footings of the Lady Well, looking north-west (042)

The evaluation revealed that the area under the arches and within the interior of the superstructure was surfaced with cut blocks and flags of red sandstone (*Plate 3*). Large slabs of a fine-grained pale grey polished sandstone formed the outer edging of the structure, this extending beyond and around the column bases. The red sandstone slabs were considerably fractured and delaminated, it is possible that this damage was caused in part by the explosives used to destroy the building. This stone type was clearly more susceptible to decay processes. Some of the outer slabs were also heavily damaged, however it was not possible to tell whether this was the result of an explosion or the slower process of damage by ground water and penetrating tree roots causing delamination along bedding planes.

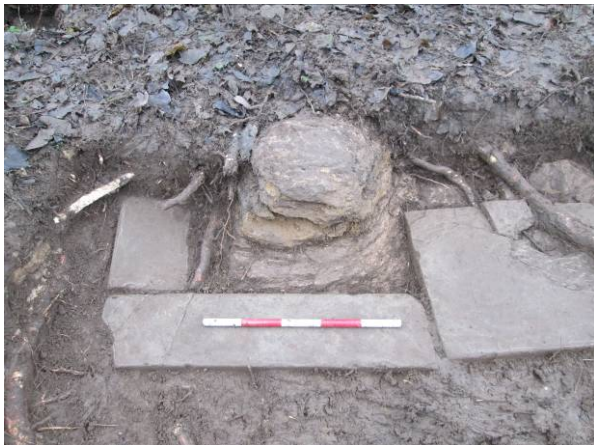
Three of the superstructure's column bases were exposed, these laid out within a square of about 3.3m. The bases were integral to the underlying platform structure. The south-west base was in very poor condition, much eroded. The south-east base was in somewhat better condition, retaining most of the moulded detail around its base, but with some significant structural cracking. The north-east base was in good condition retaining its original form and moulded detail. These moulded bases are not visible on any of the historic photographs and it is notable that their profile is at variance to that shown in the 1944 drawn survey.

Plate 4 South-west column base (45)

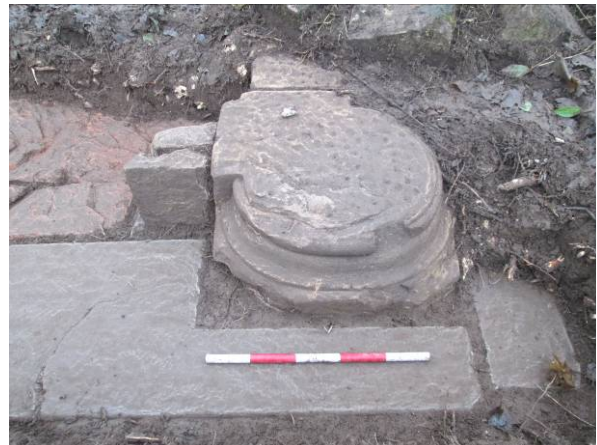
Plate 5 North-east column base (46)

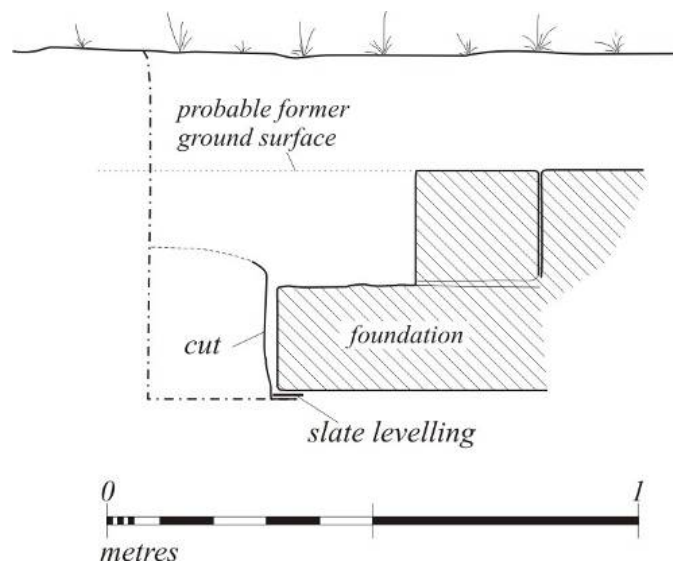
Figure 3 Section of foundations

The sondage excavated against the south side of the structure showed the foundations to extend to a depth of 0.75m below the current ground surface. The footing consisted a single course of squared blocks that projected by 0.3m and extended to a depth of just over 0.20m - *figure 3, plate 6 and plate 7*.

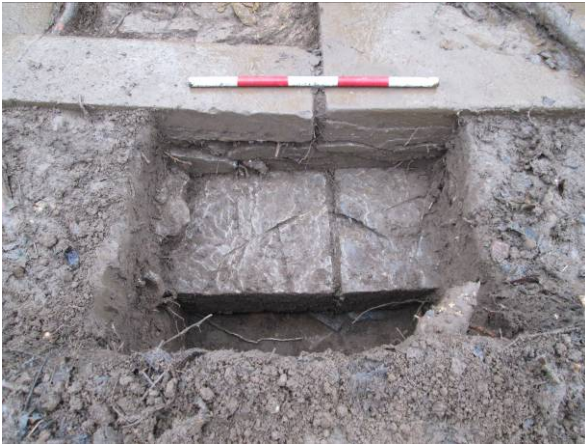
Plate 6 Sondage through foundation looking north (75)

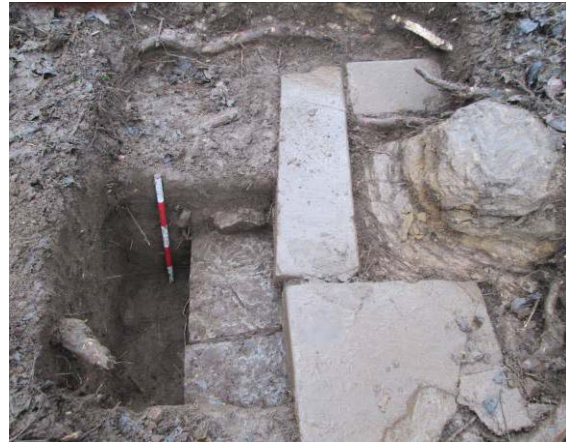
Plate 7 Sondage through foundations looking west(76)

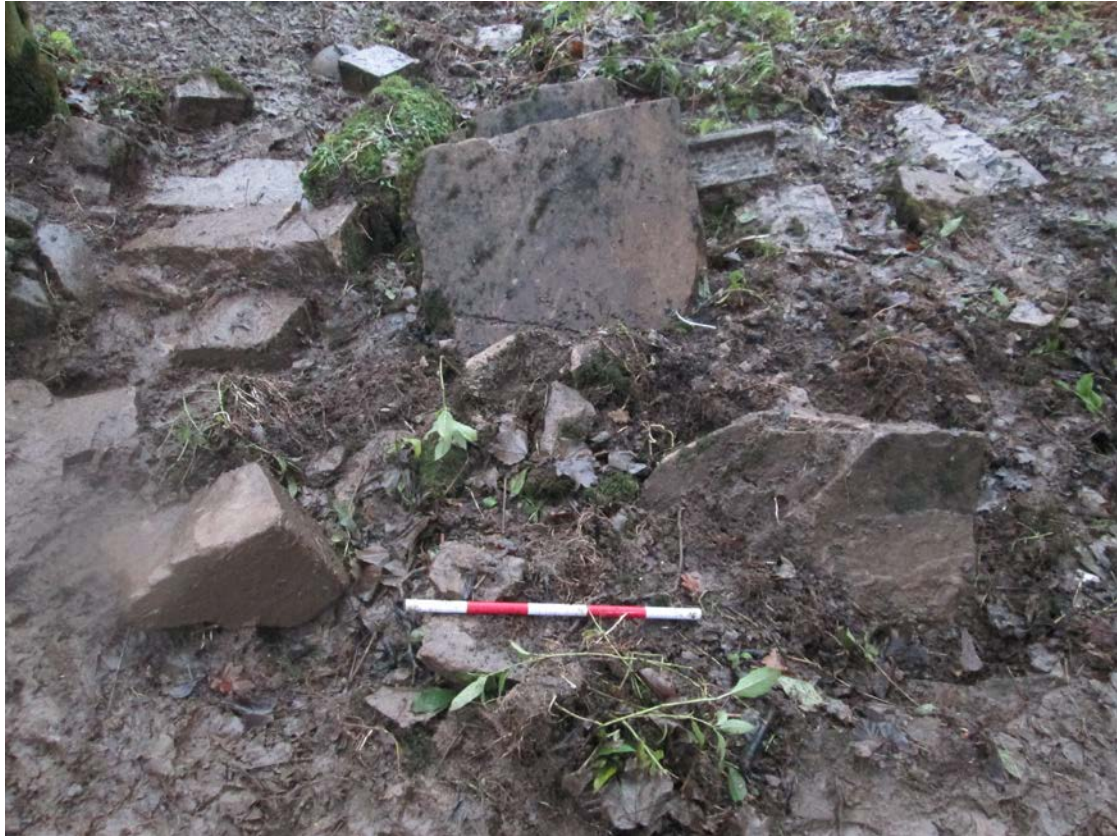
The majority of the stones identified were found to be shaped or moulded architectural elements rather than squared ashlar blocks. The almost complete absence of plain blocks suggests that the remaining masonry is not a fully representative sample. Some stones had evidently been organized into groups according to type. Roof elements were located in one area, stones that formed the corner columns had been set aside in another. However other blocks were more randomly strewn around, *Plate 8*. It is

Plate 8 Ex situ stones as revealed

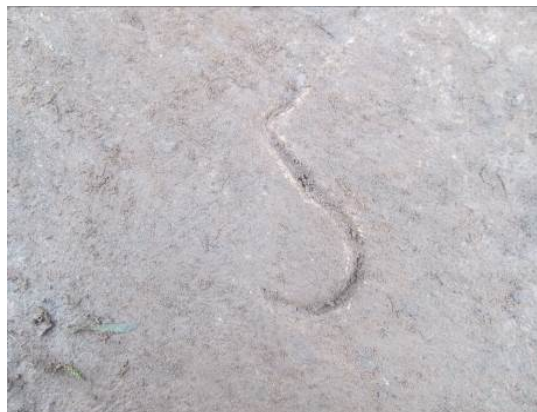
One of the stones that formed part of a corner column (*stone 7*) bore an incised mark on its upper surface (*Plate 9*); this had the appearance of a mason's mark or an assembly mark. While no other stones at Lady Well were found to have marks, similar marks were found upon the disassembled stones of the arch of The Temple during recording works there. The latter were thought to represent assembly marks. The similarity in character of the two suggest the same masons may have been involved (as was likely the case).

Plate 9 Masons mark on stone 007(033)

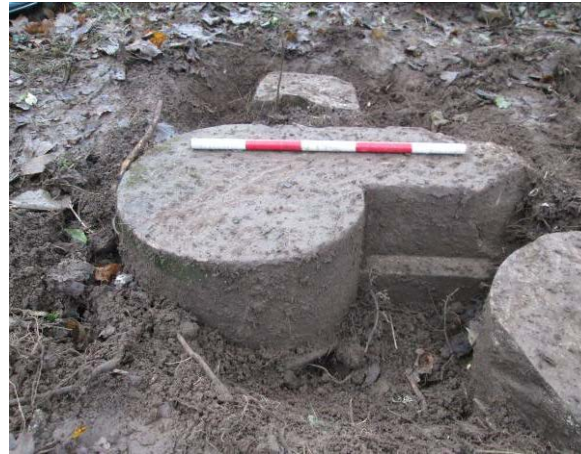
Plate 11 A stone drum with stepped base, stone 5 (019)

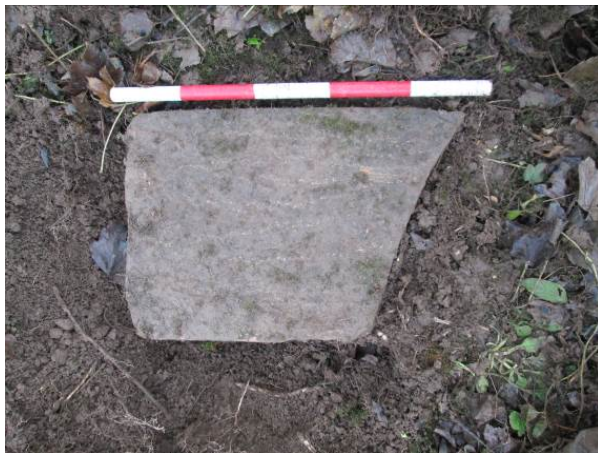
Plate 12 Stone from arch, stone 10 (029)

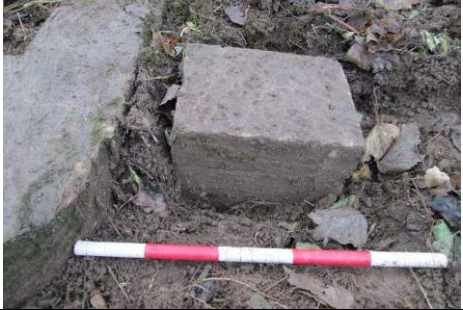
A009	Moulded capital which formed the corner, two projections.	Moderate, chipped and damaged in places.

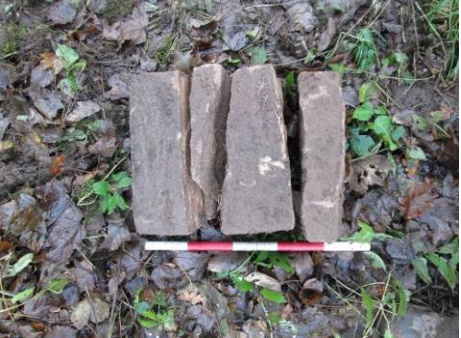
A011	Squared block now split into four.	Poor

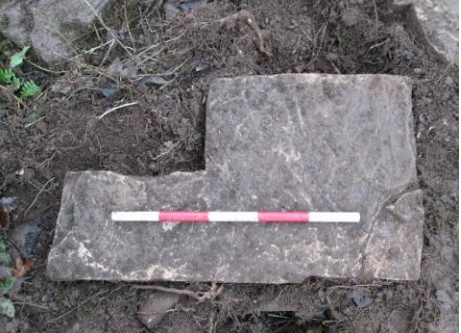
<i>Stone No</i>	<i>Description</i>	<i>Condition</i>	<i>Photo</i>
A013	Squared block with socket, possibly to take a railing or other metal work.	Poor, split into 3 parts.

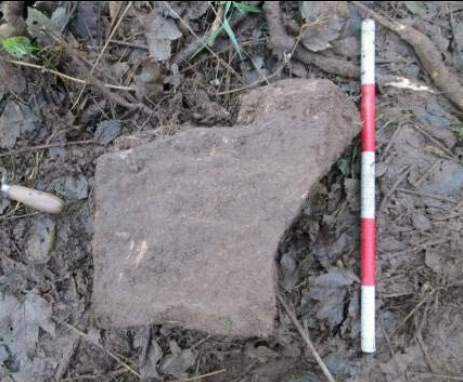
017	Squared block.	Poor, split in two by roots.

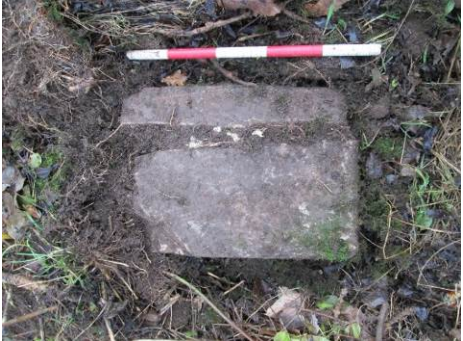
018	Triangular shaped in profile, large slab with groove carved in long edge. Possibly part of the roof. Not fully excavated. Marked by red dot in picture.	Moderate, damaged corner.

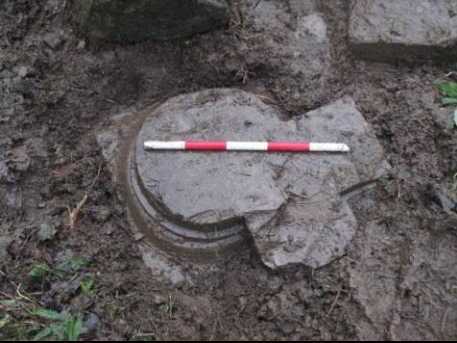
E047	Stone drum which would have formed part of a corner column. Projection has broken off, badly damaged by roots.	Poor

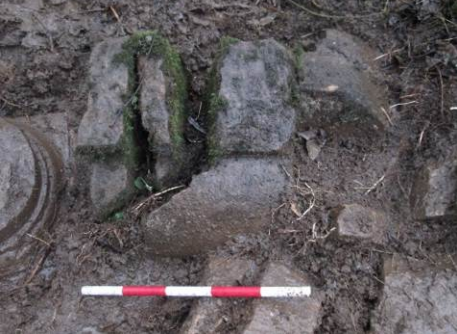
E048	Stone drum which formed part of the corner columns, probably originally one stone that has been split by roots.	Poor

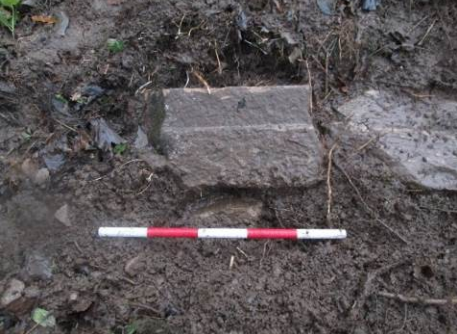
Stone No	Description	Condition	Photo
E055	Thin irregular shaped stone with broached dressing, indicating it formed part of the interior. Not clear if shape is due to damage, or design. May have been part of internal vaulting.	Poor, cracked in two.

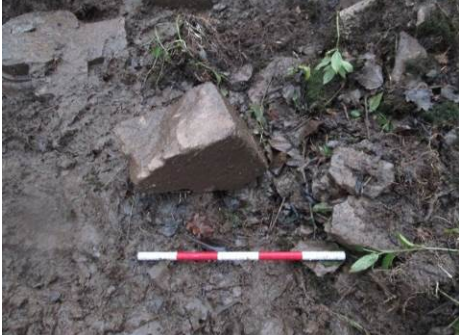
<i>Stone No</i>	<i>Description</i>	<i>Condition</i>	<i>Photo</i>
058	Large block only partially excavated, sloped edge possibly part of the roof.	Poor, split along bedding planes.
