# Panmure House

*Canongate, City of Edinburgh*

Archaeological Watching Brief: works related to Demolishing and slapping of historic fabric, November-December 2016: Data Structure Report

*Project No. AA.1910*

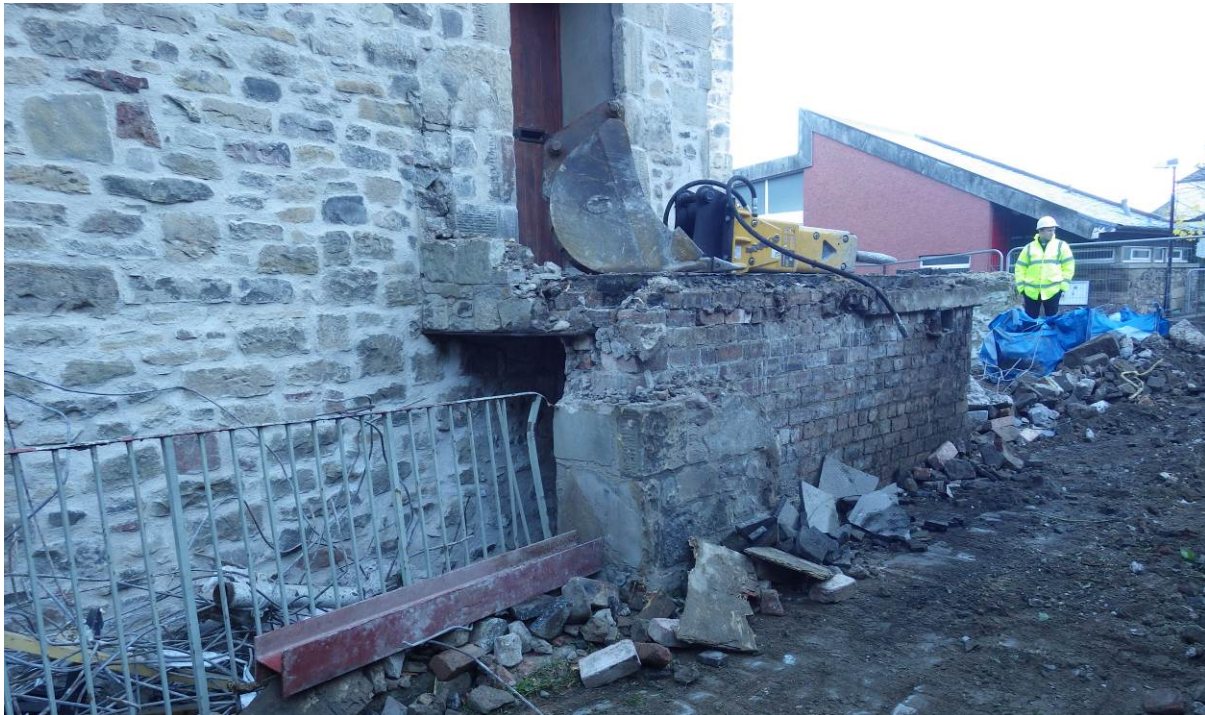
The demolition of the stairs leading up to the ground floor level concrete platform covering the basement showed this to be in part of mid-20<sup>th</sup> century build and mainly of a brick construction, skinned with rubble stone on the exterior (*plate 1*). The upper western half of this was of poured concrete poured over corrugated sheeting and the (earlier) eastern half was a timber shuttered concrete slab. Under the stairs there was an access to the basement. This arrangement mirrored stairs seen in an historic photograph from the 1920s but without the rubble skin and with the western half reduced in height (*plate 2*).

It seems probable that the earlier stairs to the basement were just modified in the mid-20<sup>th</sup> C with the western part reduced to fit the level of the new door opening in the south gable; this required the shifting of the basement steps to the west to fit them below this lower level, involving ground reduction in this area at the gable wall foot.

*Plate 1 Stairs under demolition, showing rubble skin over brick*

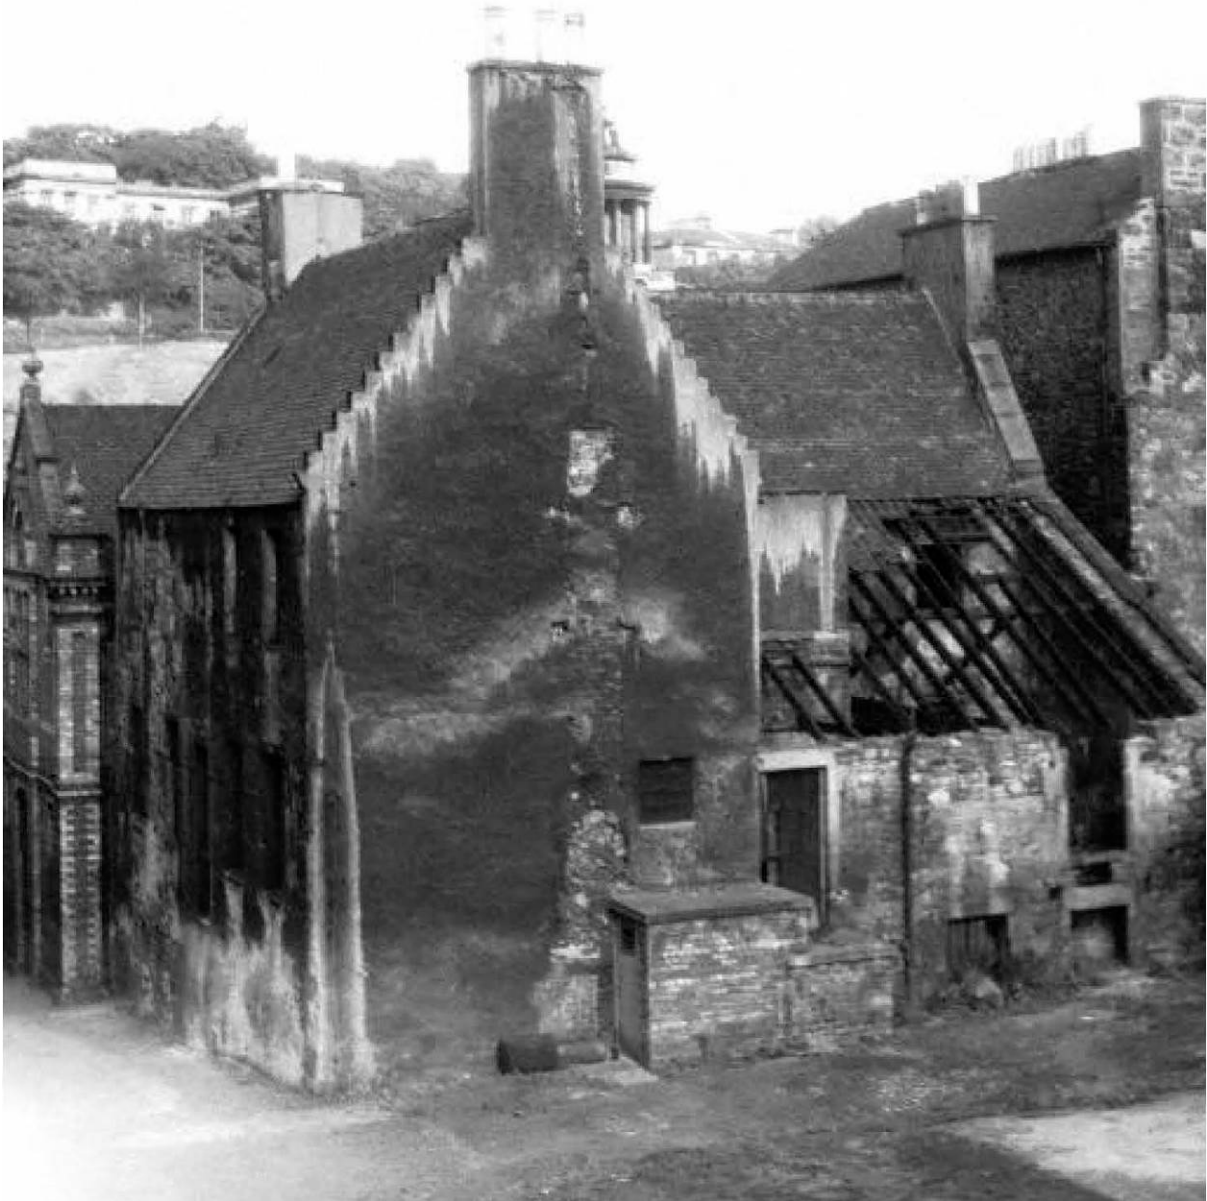
These stairs to the basement may be a secondary reordering of the lean-to following the raising of the ground to the south, which put the door in the middle of the wall out of use; the bricks are unlikely to be earlier than the late 19<sup>th</sup> century.

*Plate 2 Historic photo from the 1920s? Shows earlier stair arrangement to the basement at the south gable*

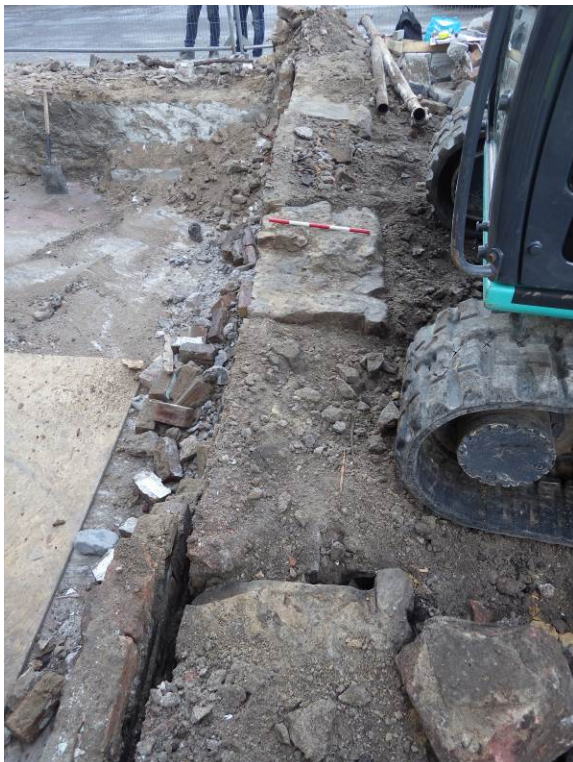
The removal of the later rebuild exposed the remnants of the earlier structure in plan. A door and a splayed window were exposed, both with square rybats (*plates 3 and 4*). These can be seen in historic photos (*plate 2*). Interestingly both of these appear to relate to a much lower exterior ground level (1m below current) perhaps showing evidence for extensive recent ground raising to the south exterior.

*Plate 3 Door exposed on south elevation of lean-to*

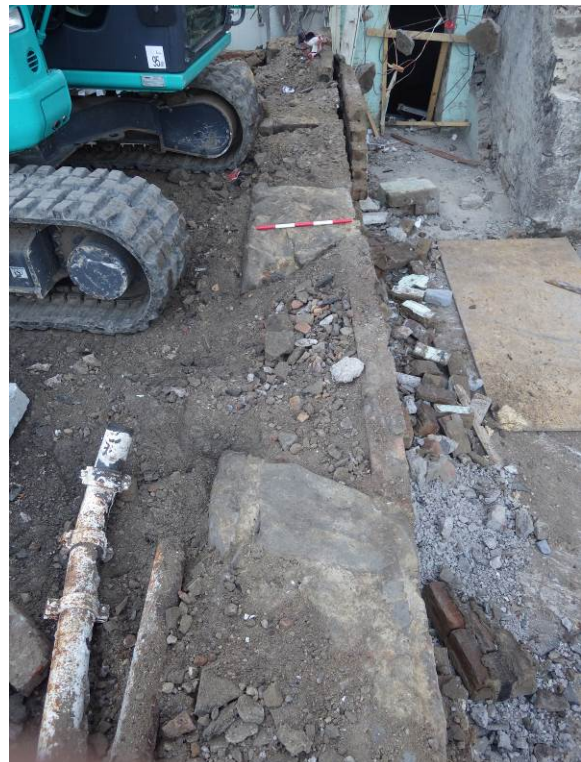
*Plate 4 Window exposed on south elevation of lean-to*

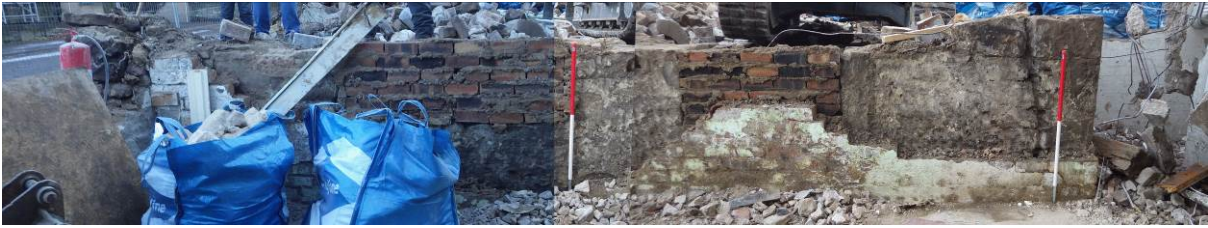
The openings had been bricked up with mid-20<sup>th</sup> century cemented brick on the interior face with loose fill to the exterior and infilling the openings.

Plate 5 Interior face of south wall, lean-to shows blocked openings

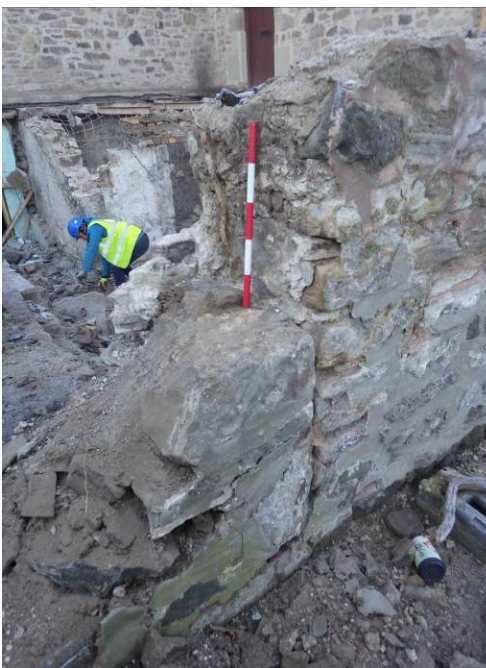
Cleaning up around the south-east corner exposed two phases of structure and a flue. The earlier phase is represented to the east by a small remnant of clay bonded rubble walling forming the street wall face. This was of similar character to that seen within the south gable of the south jamb and predating the 17<sup>th</sup> century build of Panmure House as revealed in the earlier underpinning works (*figure 2*; Macfadyen and Morrison 2013). This has a square rubble jamb to the north where the walling terminates and was reduced to the south by the mid-20<sup>th</sup> century gate (*plates 6 and 7*).

Plate 6 Vertical jamb at end of clay masonry to west under excavation. Lime bonded masonry of lean-to formerly abutting to right

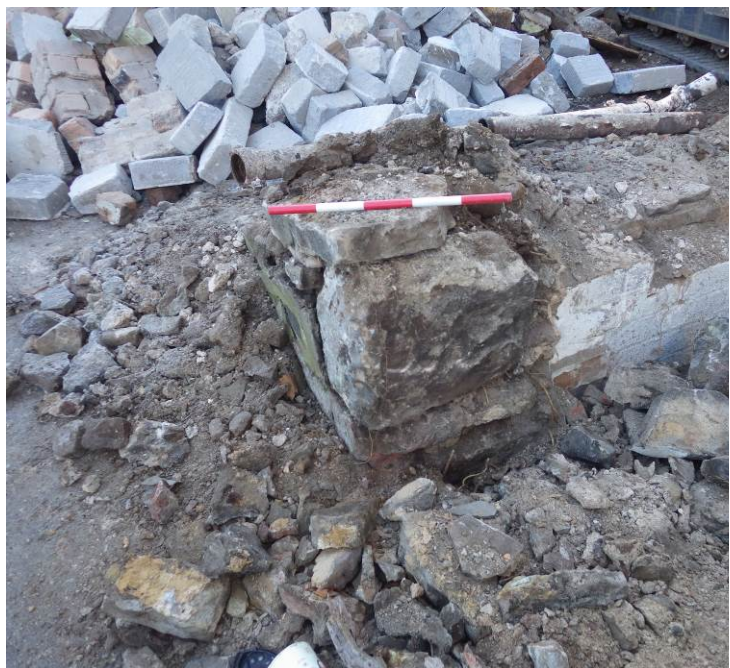
Plate 7 Vertical jamb at end of clay masonry

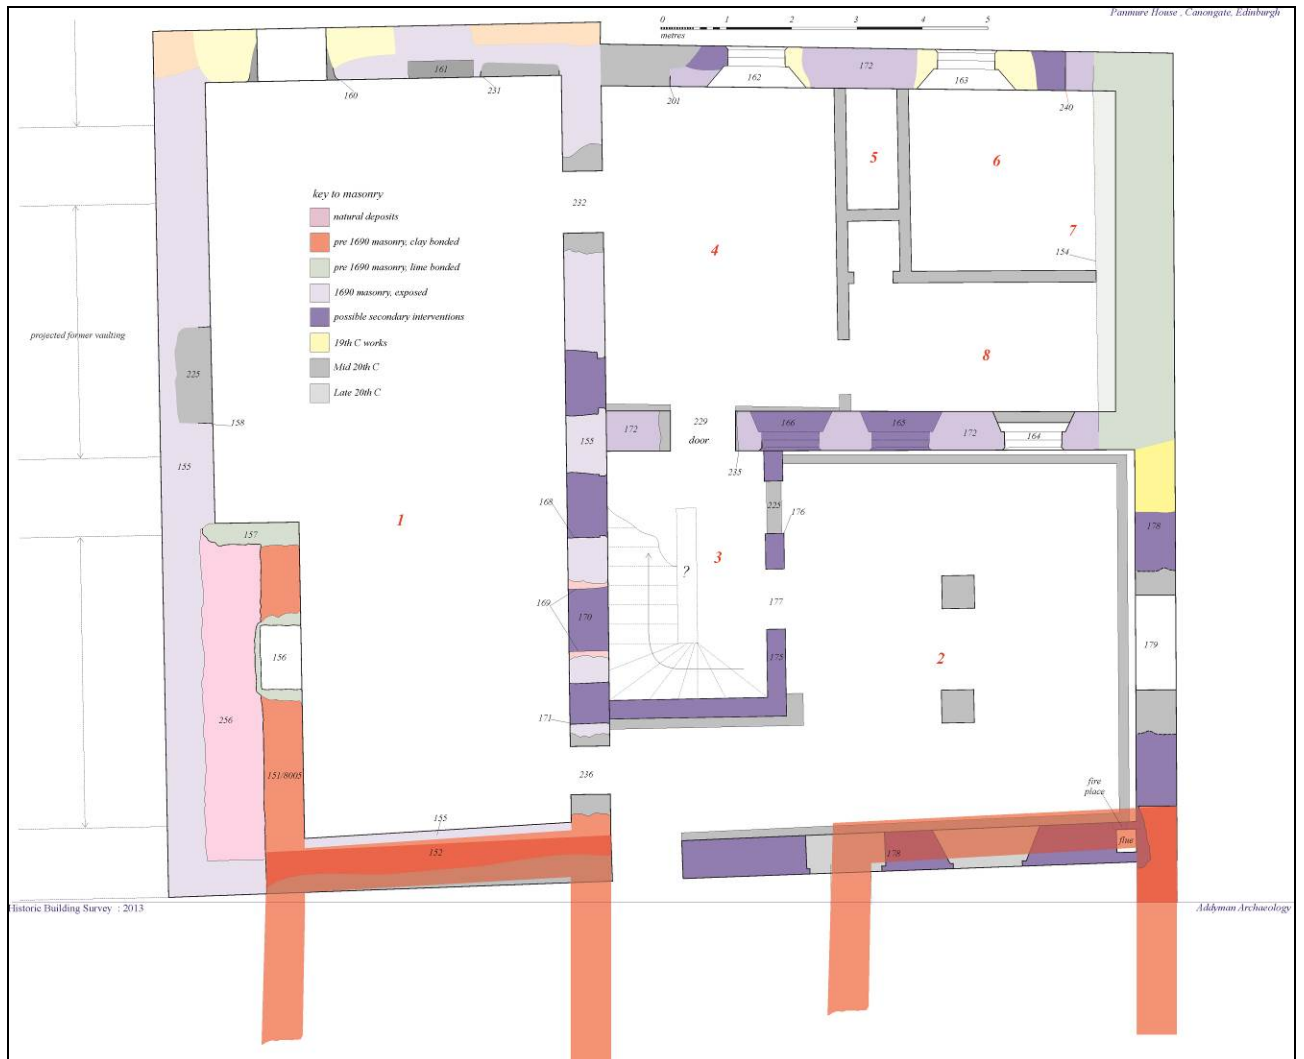
Figure 2: Plan showing pre-Panmure House clay-bonded walls in red, with conjectural extensions to south and flue in south-east corner. A3 drawings in Appendix B

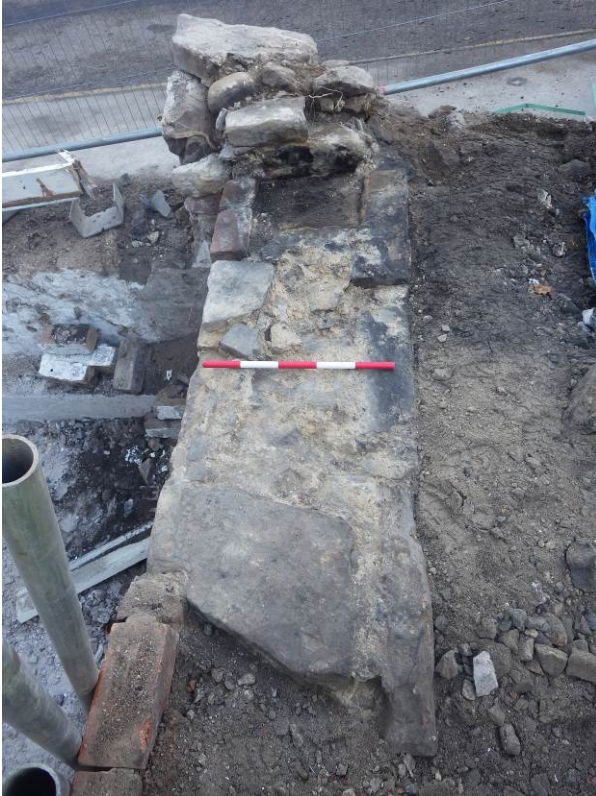
The later phase relates to construction of the lean-to, which was built from lime-bonded rubble. In addition to the door and window to the west there was evidence for a fire in the south-east corner. This was represented by an approximately 0.30m square flue infilled with soot and a little lime mortar (figure 2; plate 8).

*Plate 8 South elevation of lean-to, shows flue at east end (top)*

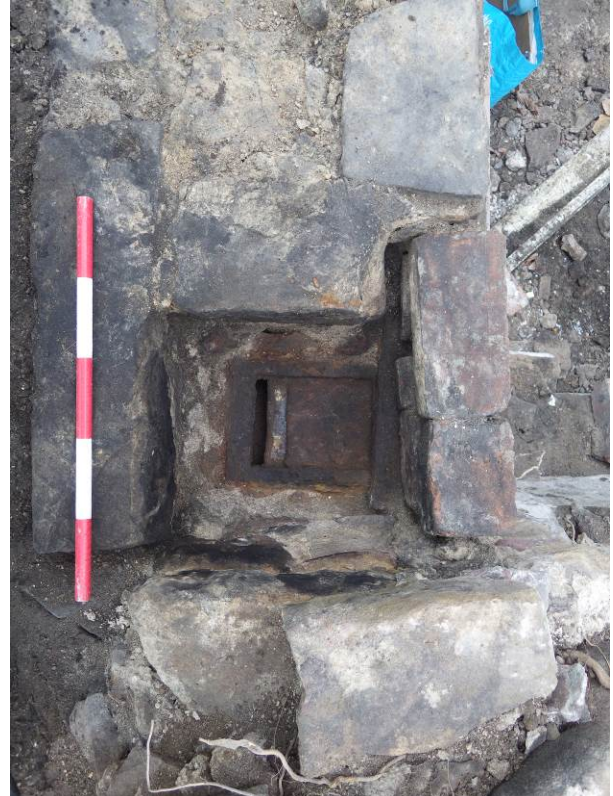
Noted within the flue was a metal flue damper *in situ* and still slightly open (plate 9); the handle for this was also still *in situ*, although bent flat with the wall face. Above this flue damper the flue was built up from an iron bar/lintel with brick on the internal wall face (plate 10). Below the damper there was no obvious fireplace within the masonry although a couple of blackened bricks appeared to be patching up a small opening. It is thought perhaps to have been a freestanding stove with a flue running into the wall or a very small fireplace.

*Plate 9 South elevation of lean-to detail of flue emptied shows flue damper in situ and partially open*

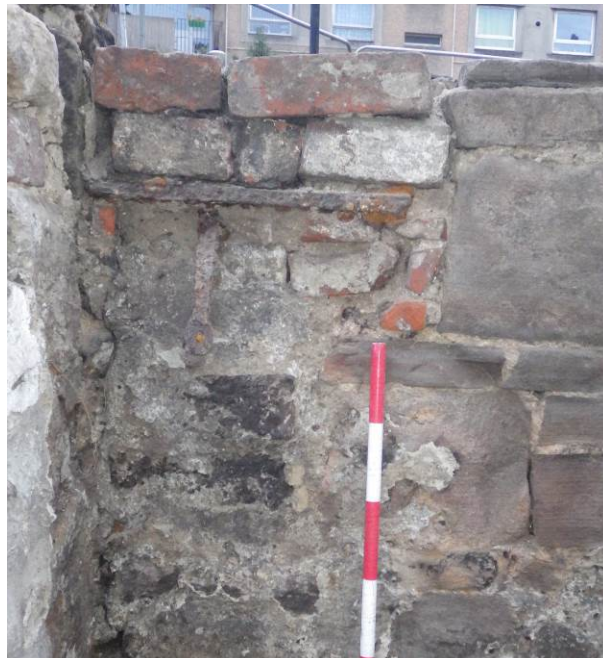
*Plate 10 Wall face of flue shows damper handle (bent over) and bricked up opening below?*

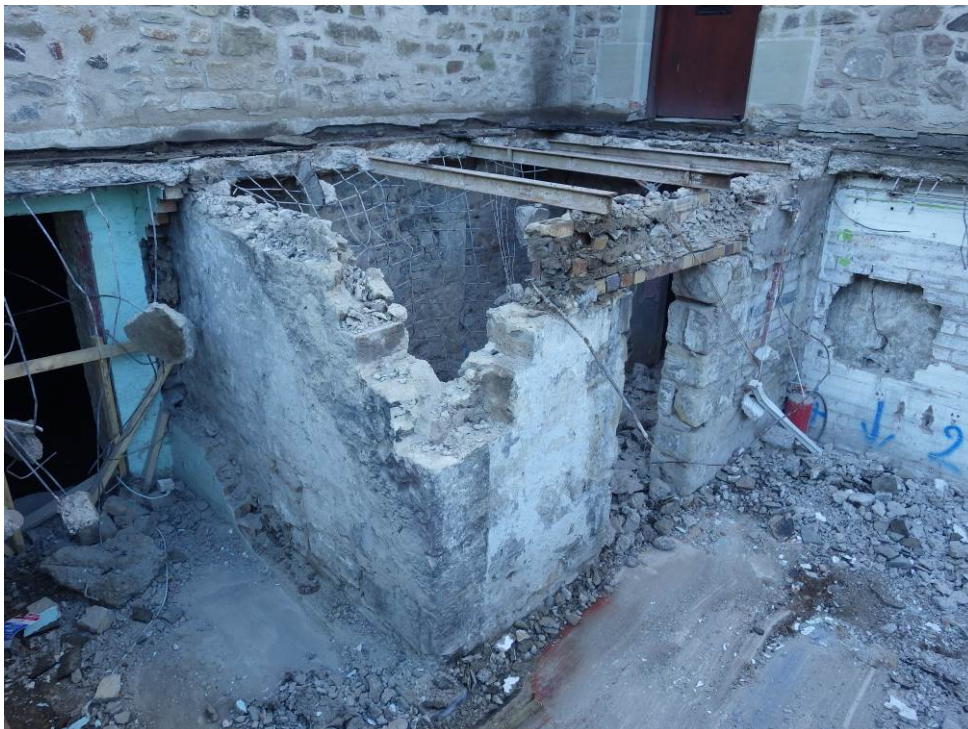
*Plate 11 Stair tower remnant as exposed following demolition of concrete roof*

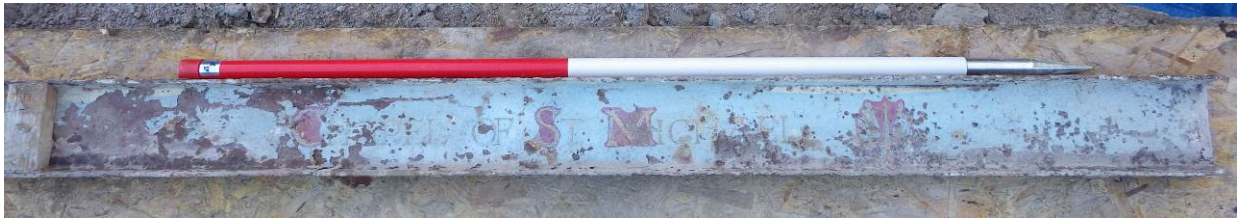
The former lintel of the door had been replaced with iron lintels in the mid-20<sup>th</sup> century works, the internal lintel had been painted with the inscription “Chapel of St Michael” (plate 12).

Plate 12 Iron door lintel inscribed with "Chapel of St Michael"

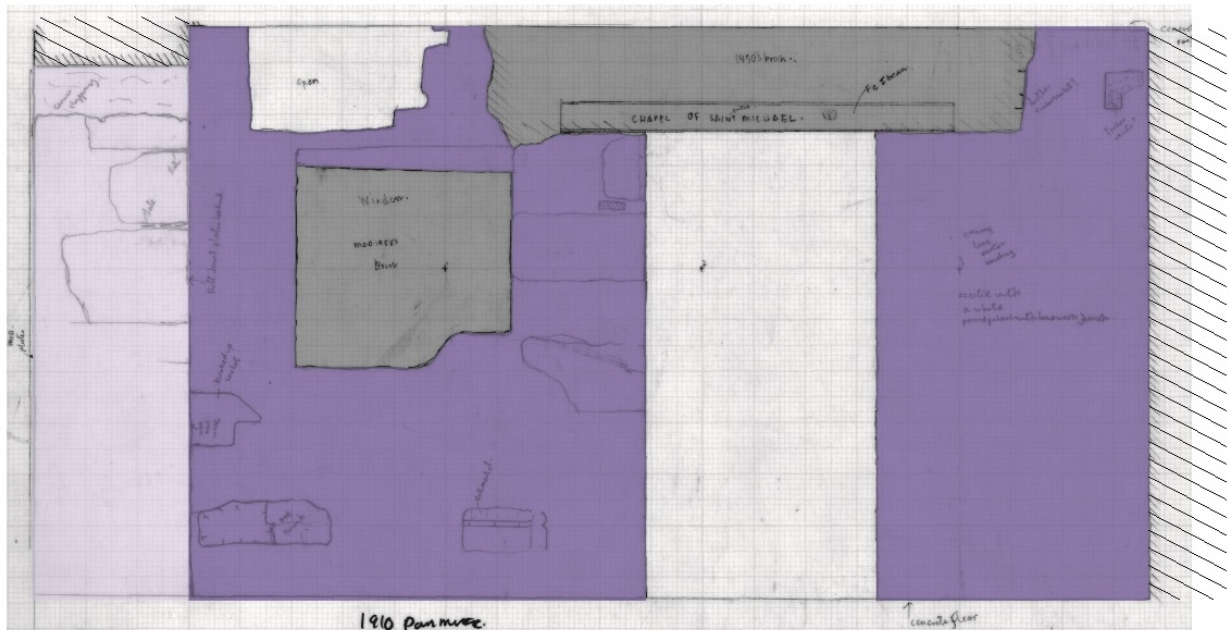
The stairs were accessed at ground level from the east through a door offset to the south and lit from a window to the north (*figure 3*); the south elevation was blank. Much of the rubble within the construction is likely to be reused from an earlier structure as many of the blocks are squared and some have had mouldings clawed back flush.

Figure 3: Eastern elevation of remnant stair tower with original masonry to left, possible secondary interventions in purple and 20<sup>th</sup> century alterations in grey

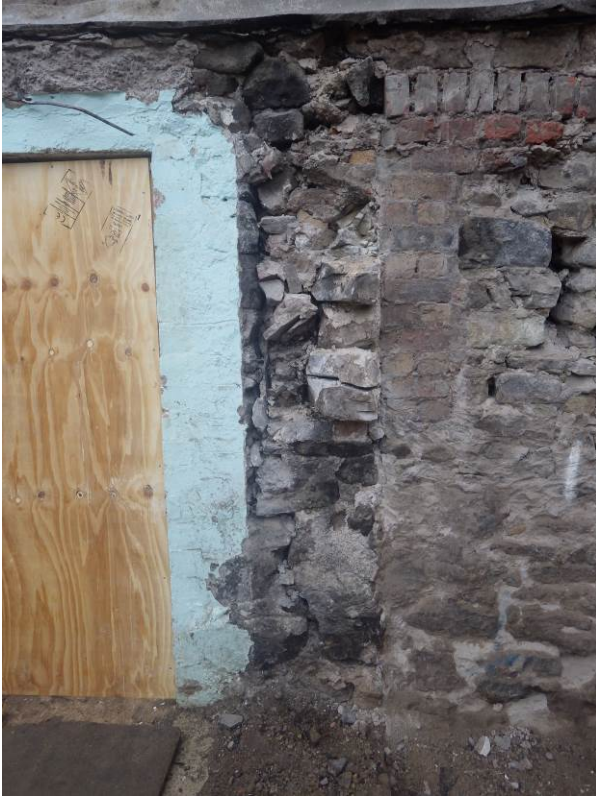
The removal of the tower masonry exposed some former historic exterior harl of Panmure House. To the west this was noted in a small area below the window 171 and is potentially early. To the north the exposed harl is overlying rubble blocking of the window 166 indicating that this harl relates to a secondary phase (plates 13 and 14). The harling over the blocking of the window also shows that it was blocked up prior to the stair tower and lean-to phases.

Plate 13 Stair tower demolished showing tower masonry built into window 171 with a little historic harl in situ below the window

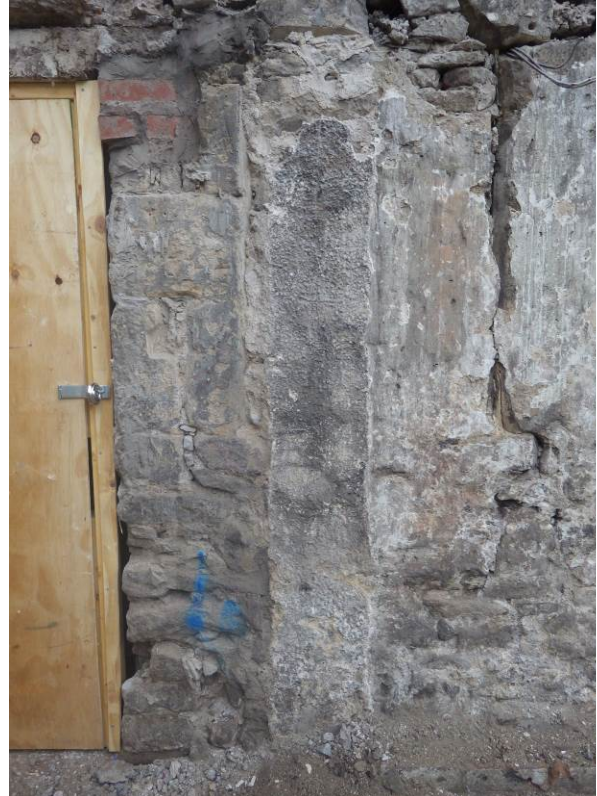
Plate 14 Stair tower demolished showing tower masonry built over blocking of window 166 and survival of former historic harl

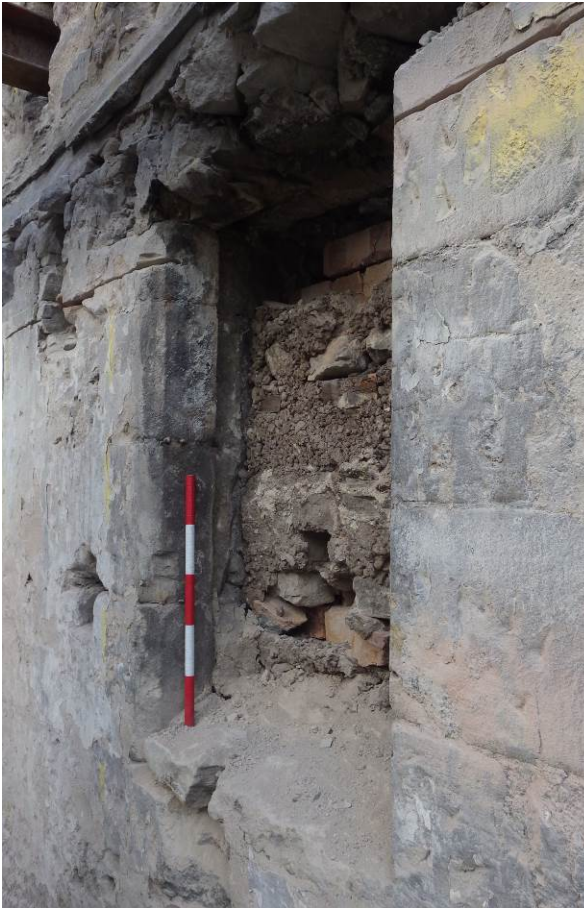
The outline of the opening was cut by a saw to attempt a neat edge through the rubble masonry. First the rubble blocking of the window was removed; this proved to be a 0.20-0.25m thick skin of lime bonded rubble stone on the exterior originally leaving the bulk of the window in situ as a recess on the interior. This recess was infilled with an internal brick skin and filled with poured concrete and broken brick and rubble in the works of the mid 20<sup>th</sup> century (*plates 15 and 16*).

*Plate 15 Window exterior rubble blocking removed exposing back of modern infill*

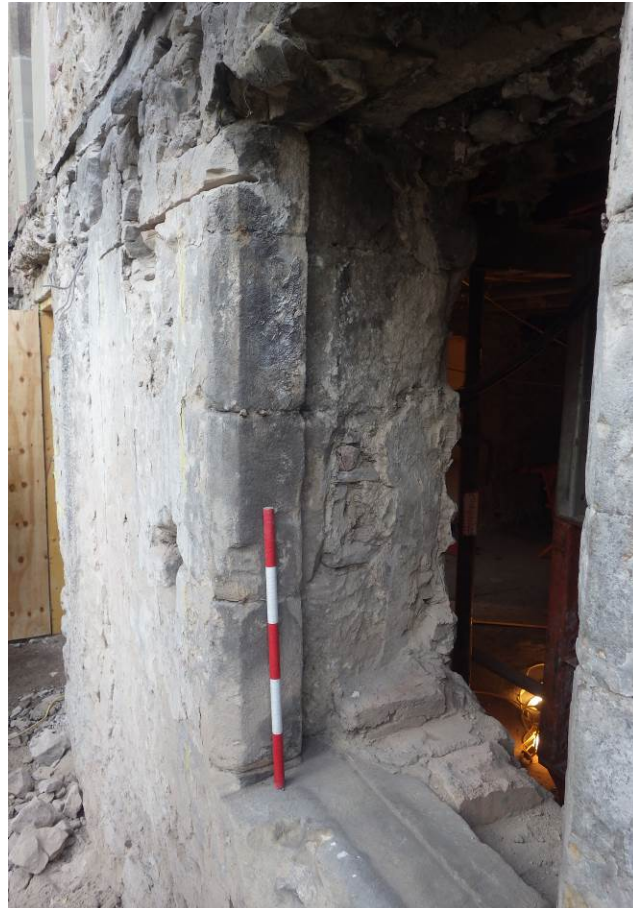
*Plate 16 Window fully opened up shows west jamb*

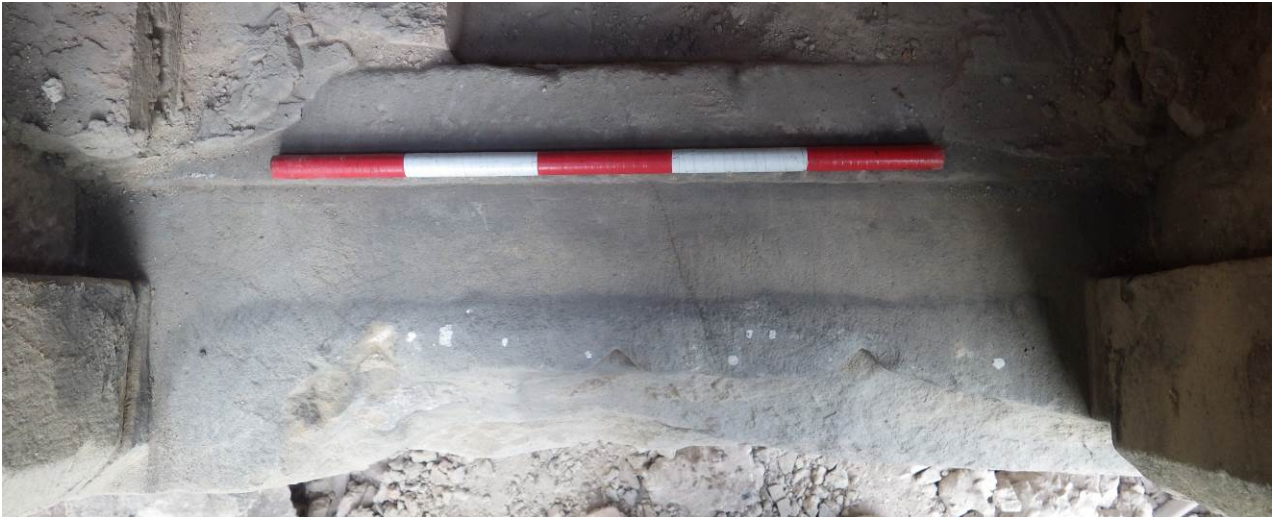
On the lintel remnant there was an apparent glazing groove running behind the bar socket; this did not continue onto the jambs or cill and may indicate the lintel was reused from an earlier window (*plates 17 and 18*).

Plate 17 Window cill showing imprint of window case and 3 bar holes

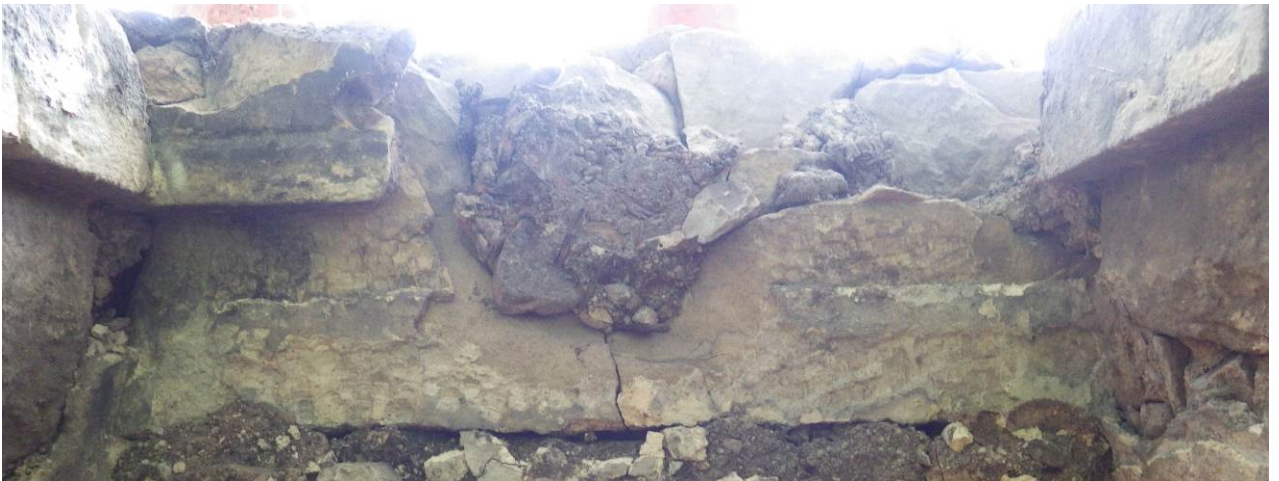
Plate 18 View up to lintel remnant, shows imprint of window case, one bar hole and a possible glazing groove

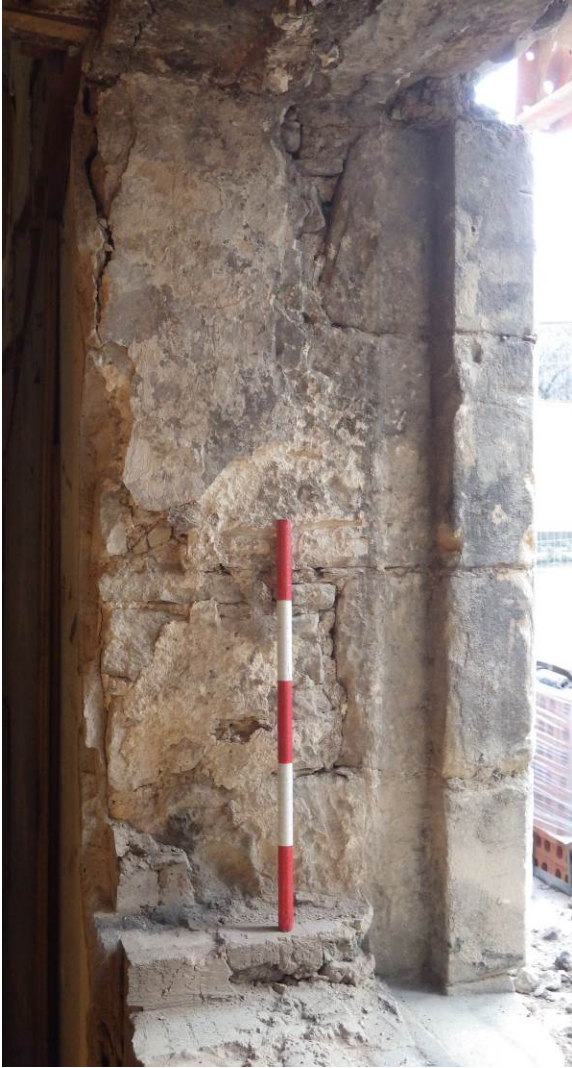
Upon the exposed ingos some historic plaster on the hard had survived (*plates 19 and 20*). This showed many episodes of lime wash of variable light colours. This plaster was of two phases with the earlier solidly plastered to the masonry and coated with multiple layers of lime wash. This original phase was overlain by a thin skim coat, again with multiple layers of lime wash. This later plaster peeled away from the earlier cleanly and easily; both layers were sampled.

*Plate 19 East ingo of window showing plaster in situ*

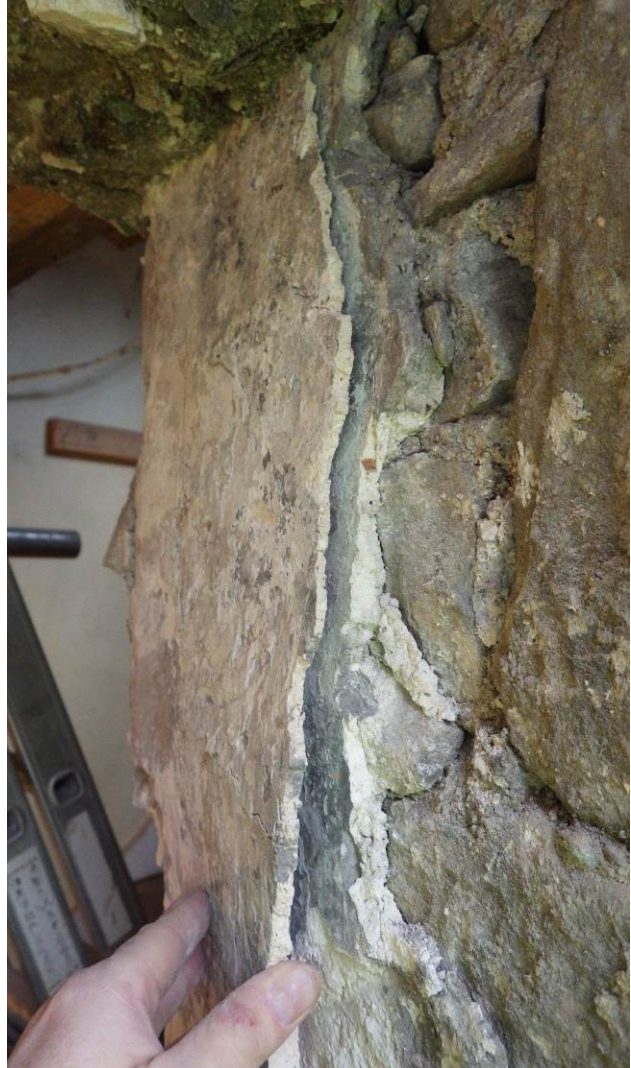
*Plate 20 Plaster on ingo showing 2 phases*

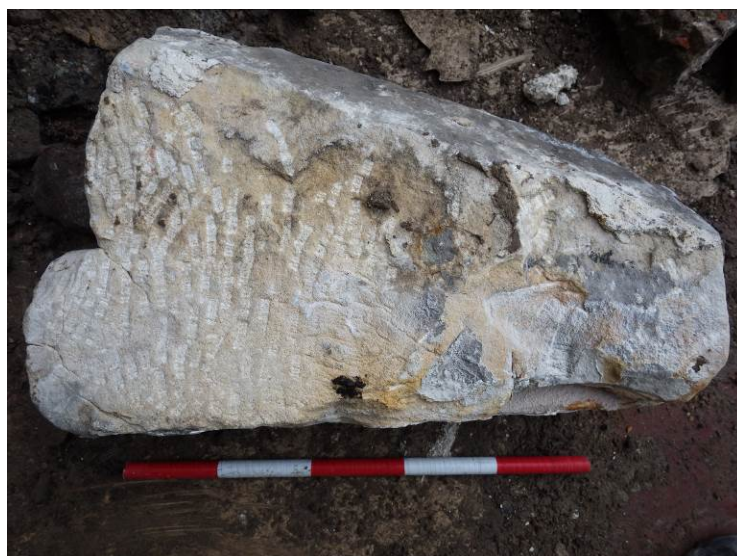
Some of the window jamb stones were recovered largely intact while others needed to be broken up to get them to come out. These recovered jamb stones allowed an examination of the tooling of the internal faces (*plate 21*). The tooling was of a broad chisel characteristic of the 17<sup>th</sup> century; no mason's marks were noted.

*Plate 21 Underside of jamb stone from window detail of tooling*

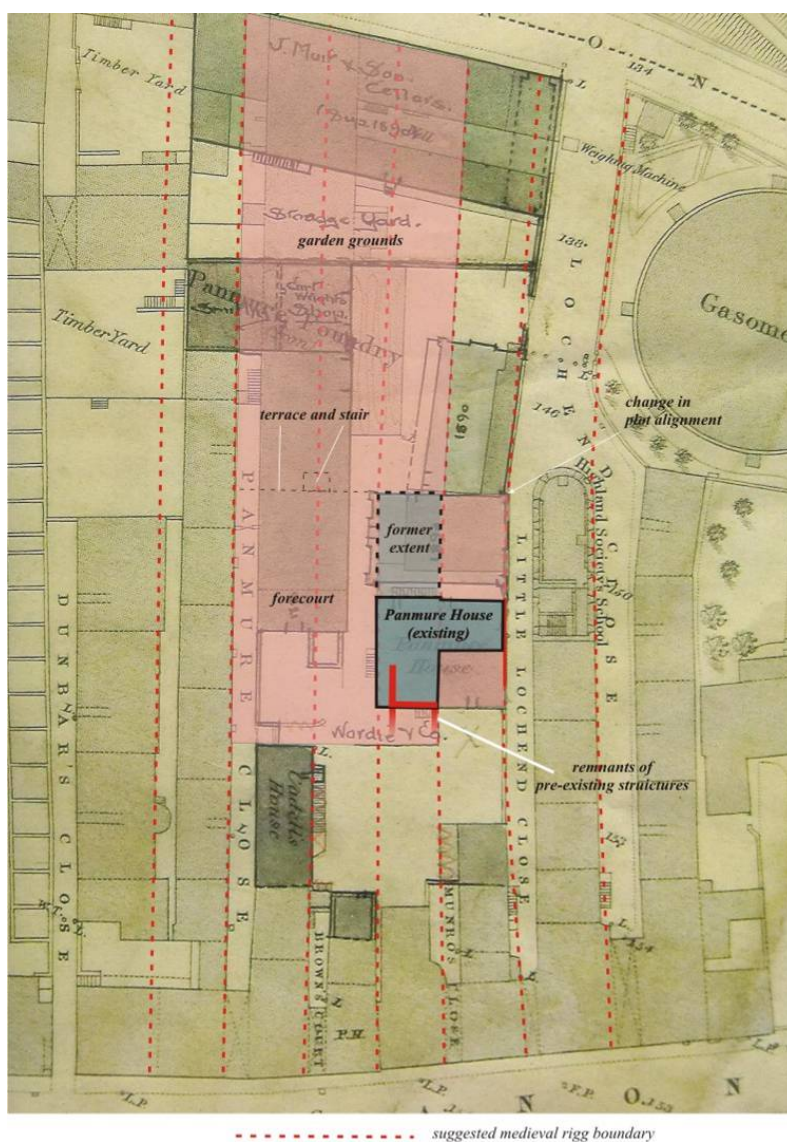
The demolition of the lean-to structure confirmed the layout as seen in historic photos and suggests that the ground to the south has been raised considerably since its construction. A previously unknown early clay bonded structure potentially similar to the one fossilised in the south gable of Panmure House was identified as a small stub of masonry with corner quoining, also fossilised within the east boundary wall. The layout of the wall and its relationship with that below the southern gable of Panmure House, suggests that these represent two rows of cottages within the burgage plots, separated by a narrow alley. This corresponds well to the layout of burgage plots in the area (*figure 4*).

Figure 4 Ordnance Survey town map of 1852, with subsequent annotation of c1890 for proposed new buildings (City of Edinburgh Council, Dean of Guild records). Superimposed is a collation of evidence from earlier maps. The clay-bonded walls found during the archaeological works are shown in red.
