# Dalmeny Church Hall

*Dalmeny, City of Edinburgh Council*

*Watching Brief and Building Recording: 2017*

Dalmeny Parish Church

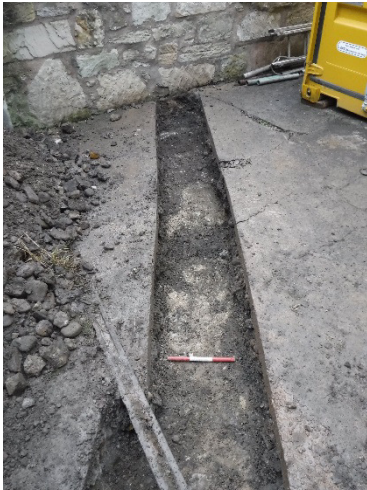
*Plate 3 Gas trench showing deposits (003), (004) and service trench [007]. Facing W*

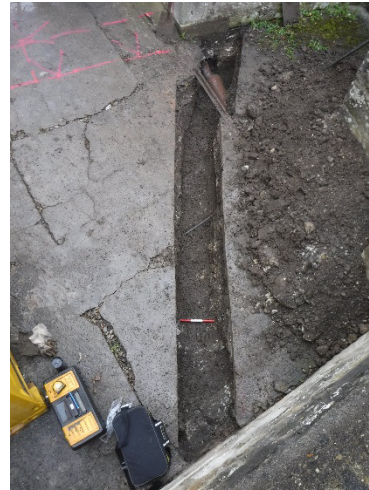
*Plate 4 Gas trench post-ex. Facing SE*

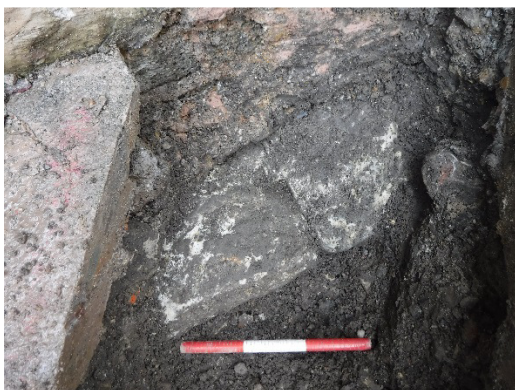
Also found in the gas trench was a single course of the foundations [005] for the western boundary wall. Its foundation trench cut [010] ran parallel along the wall (*plate 5*).

*Plate 5 Wall foundation [005]. Facing W*

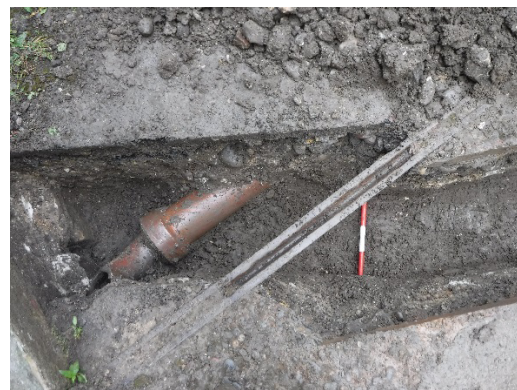
A linear ceramic drain [006], running NE-SW, was discovered at the east end of the gas trench (*plate 6*). No sign of a downpipe was found on the concrete surface (001), though there were, however, some faded traces of fastening on the building exterior elevation above it. This indicates that the downpipe was removed before the concrete surface was laid.

The east end of the gas trench also revealed the stepped-out foundation course for the west wall of the church hall, [009] (*plate 6*). Both wall foundations [009] and ceramic drain [006] seem to share one cut, [013]. This might be because both were made at the same time or because both back-fills are indiscernible. The fill was assigned a single context number, (014).

*Plate 6 Wall foundation [009] and ceramic drain [006]. Facing S*

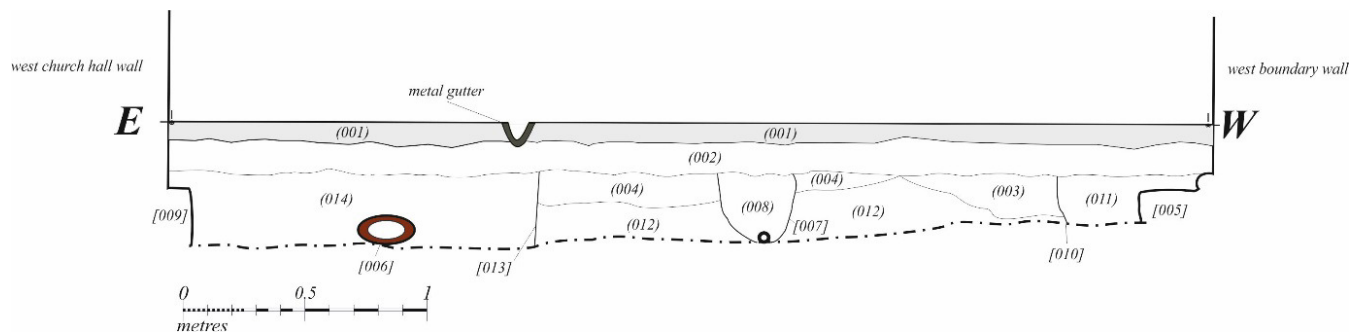
Figure 6 North-facing section of the gas trench

The trench revealed a two service features and wall foundation trenches, as well as a midden-like deposit to the west, a mortar-rich deposit to the east and an occupation deposit in the lowest depth reached for the purpose needed. These are described below; *table 1* summarises the contexts encountered in the gas trench, and *figure 6* gives its north-facing section.

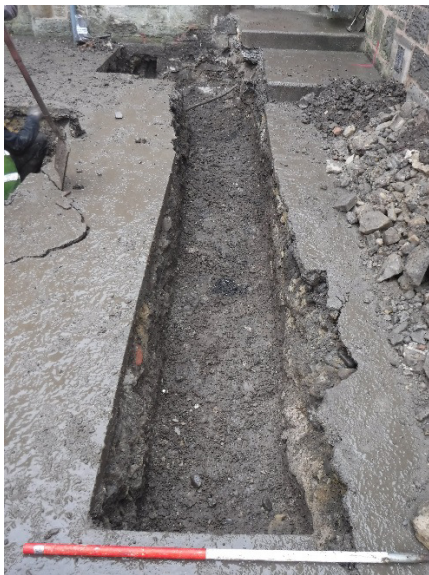
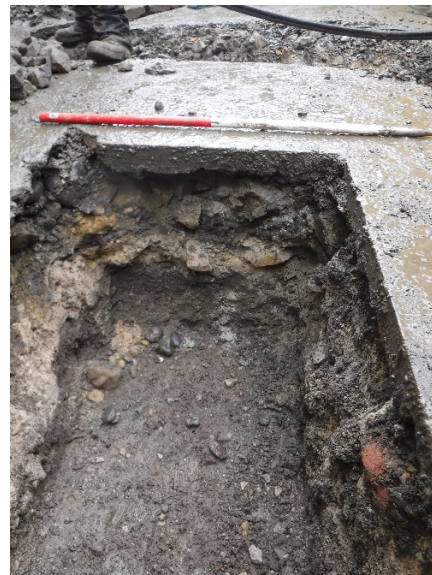
The south trench was located against the west wall of the eastern projecting range (*figure 9* and *plates 7-8*). It was L-shaped in plan, and ran 5.45m x 0.80m E-W, returning to the north at its eastern extent to run 1.30m northwards. It was 0.80m wide and was excavated to an average depth of 0.65m.

*Plate 7 South trench, general view, post ex. Facing E    Plate 8 South trench, west end showing stratigraphy. Facing W*

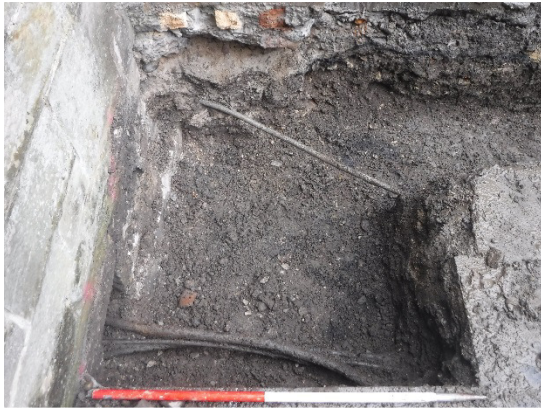
The second service trench [019] accommodated three cables, including the electricity main, and ran east to west, entering the building through an opening in the west wall. Service trench [019] cut the foundation trench [021] for the foundation of the west elevation of the building (*plate 9*).

Plate 9 South trench, east end showing service trenches [017], [019] and [021]. Facing S

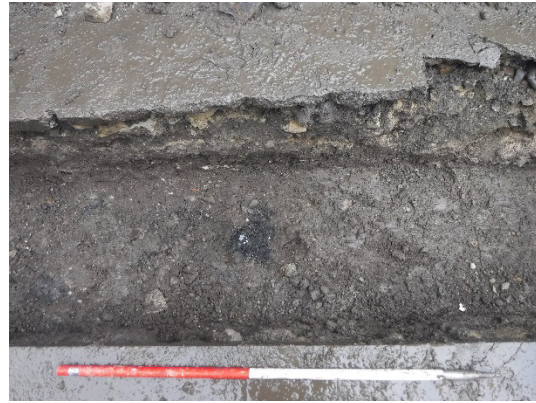
Plate 10 South trench, charcoal area in deposit (016). Facing S

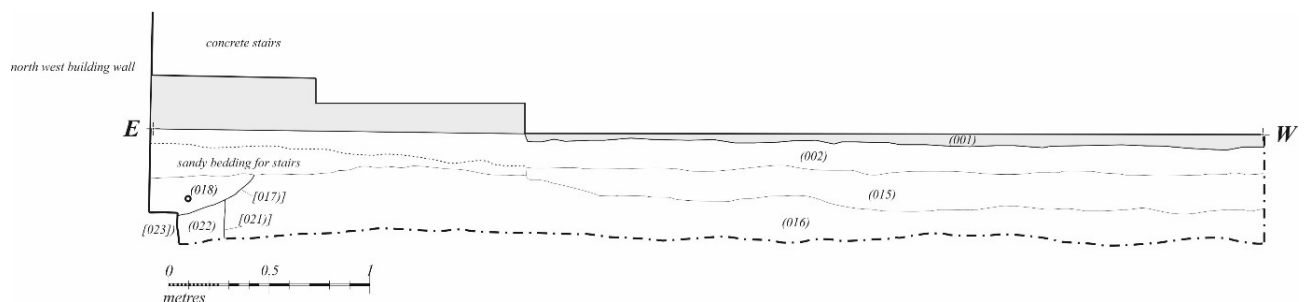
Figure 7 North facing section of the south trench

The south trench revealed two service trenches to the east, as well as a wall foundation trench. The rest of the trench was quite homogenous in its stratigraphy (see *figure 7, north-facing section*).

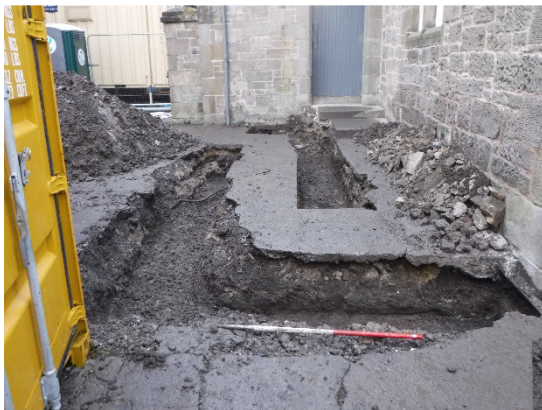
Plate 11 North trench, general view, post ex. Facing E

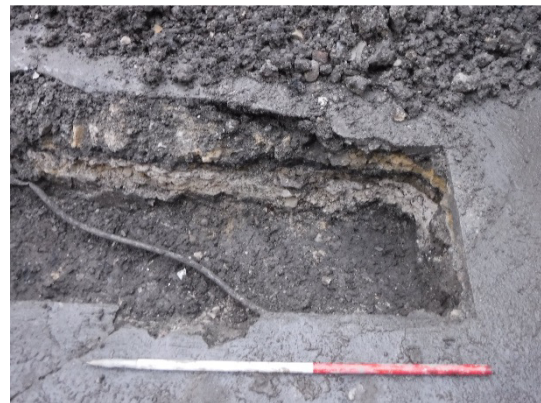
Plate 12 North trench, east end showing rubble concentration in (015). Facing N

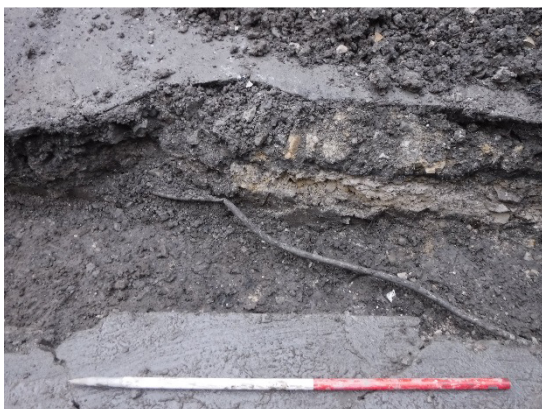
The stratigraphy consisted again of two deposits below the concrete surface (001) and bedding (002). A mortar-rich deposit (015), similar to that found in the south trench, contained occasional rubble, most likely related to renovation activity on the Hall. At the eastern end of the trench, a higher concentration of rubble was noted (*plate 12*) as part of (015). As in the south trench, directly below mortar-rich deposit (015) was mid-brown silty clay deposit (016) containing frequent ceramic fragments (*plate 13*).

Plate 13 North trench, section with deposits (015) and (016) and trench [017]. Facing N

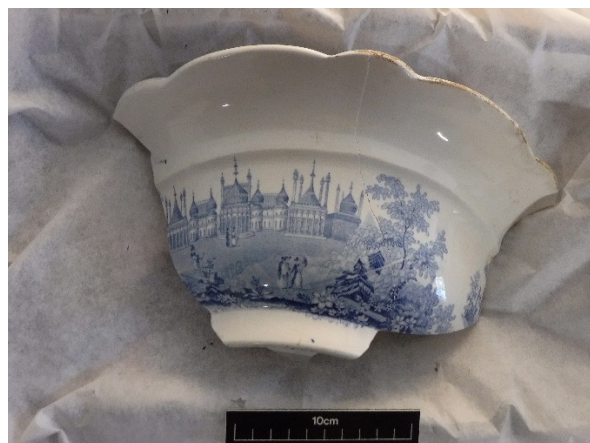
Most notable were *SF014*, two large fragments of a wash basin (*plates 16-17*). Its exterior is decorated with a depiction of Brighton Pavilion with visitors in its grounds. The interior shows discrete arrangements of thistles and roses, and the word 'QUI' in a decorative band, enclosing a further Willow-pattern decorative field, at its base. This may be a fragment of the popular motto, *Honi soit qui mal y pense*, used as the motto of the Order of the Garter, incorporated as an encircling band on a version of the Royal Arms (though not that displayed most often in Scotland), and popular also with military groups and schools (which function the Hall served before its adoption as the Church Hall).

*Plate 16 SF014, Wash basin (exterior)*

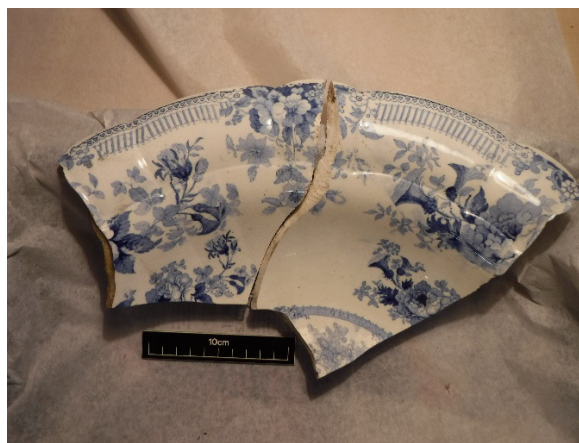
*Plate 17 SF014, Wash basin (interior)*

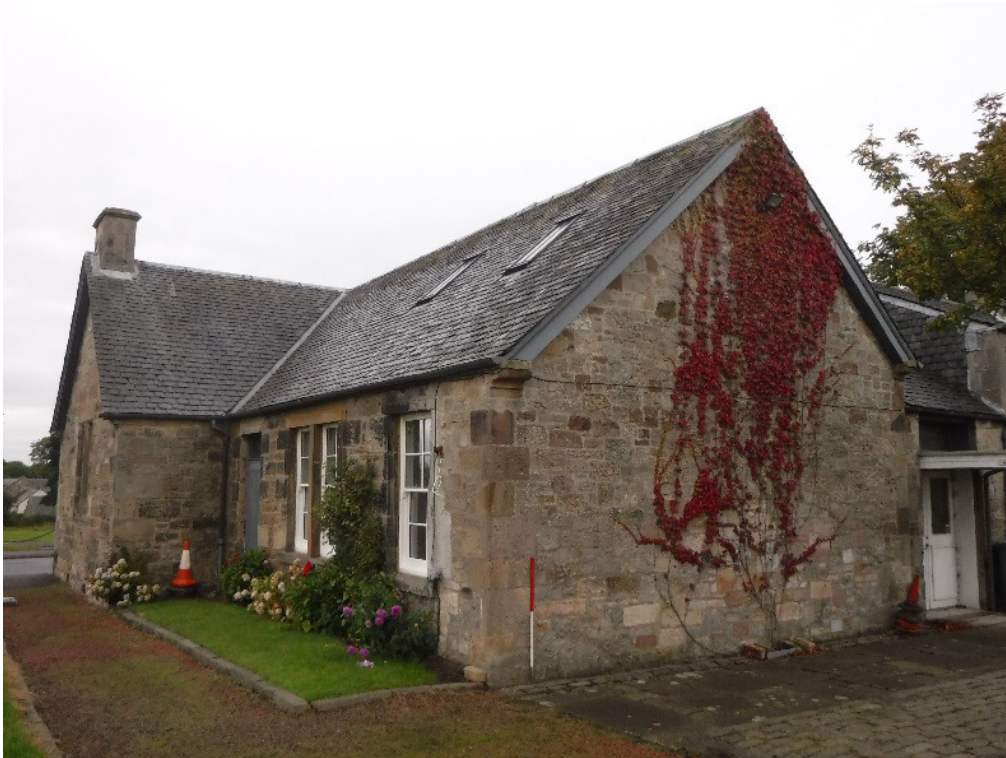
*Plate 20 South east corner of the building, general view. Facing NW*

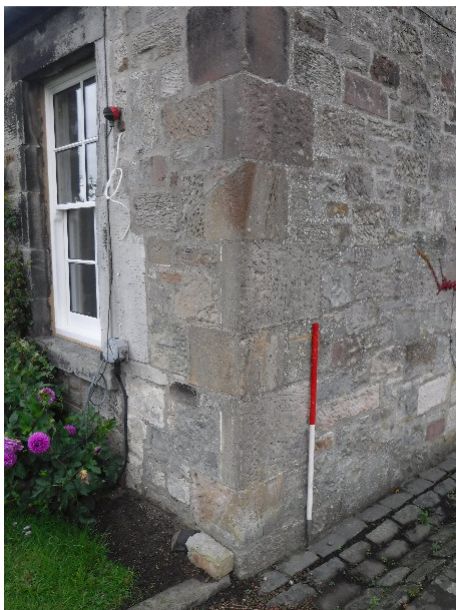
*Plate 21 South east corner of the building, detail.  
Facing NW*

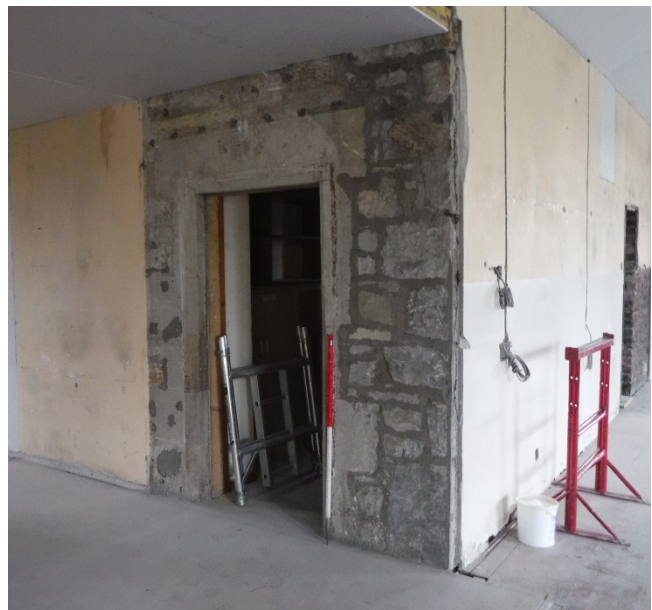
*Plate 22 Lounge internal door with raised surrounds.  
Facing SE*

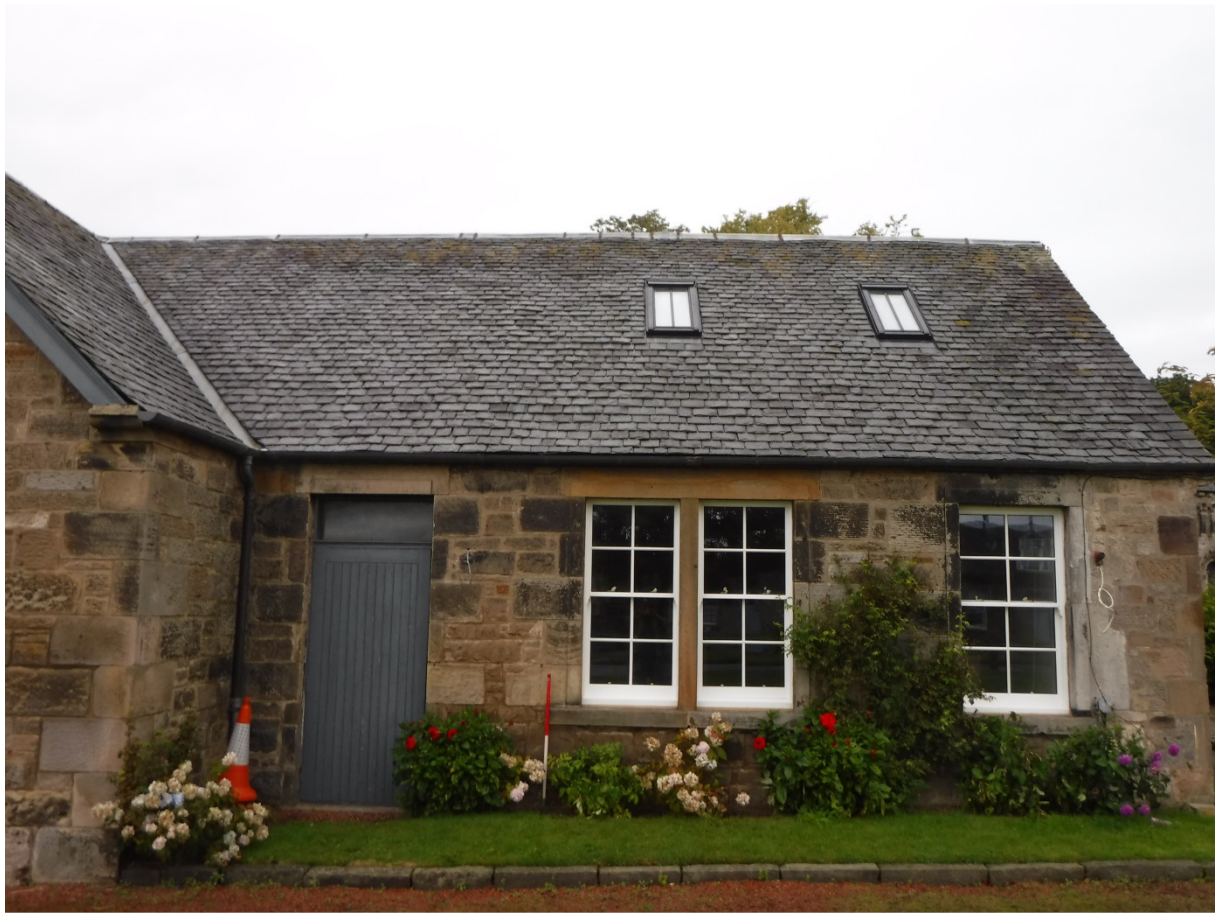
The central double window of the south elevation (*plate 23*), just to the west of the window just discussed, is also furnished with shallow squared surrounds. The lintel and central mullion, however, are later insertions, and a distinction is evident in the cills: the east cill is both more heavily worn and ends off-centre to the mullion. This cill may be original to the window. The central mullion, however, was inserted later, replacing the original shallow surround, which was inserted as the jamb of the newly-expanded, now double-lighted, window on its western side, this western side also receiving a new cill.

The existing doorway to the west of the central windows just discussed appears to be a slapped-through window (*plate 23*). The door-jambs do not display the shallow-relief squared surrounds of the windows as might be expected if they were contemporary features: instead, its eastern quoins are cut and shortened. (Shallow relief squared door surrounds are seen internally, in the north-west door of the Hall Lounge: *plate 22*). The lintel preserves traces of a shallow-relief squared surround, which however stop short of the full width of the existing doorway. The western jamb of the door also appears to cut through existing stonework and is not quoined, or displays truncated quoins. This door, therefore, appears to have been slapped through an existing window aperture.

*Plate 23 Main range south elevation. Facing N*
