Culross Bothy Shed

Culross, Fife

Historic Building Recording: August 2017

the National Trust for Scotland

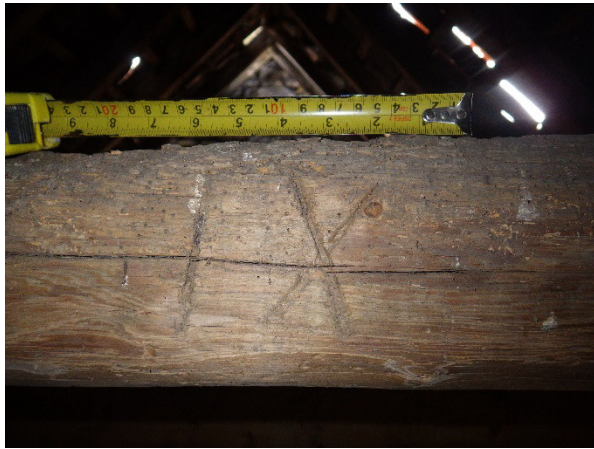
Collars 031 and 034 (from trusses 11 and 12) are noticeably different to all the others in that they are much neater squared although still just squared cabers, these were formerly rafters and were numbered with saw cut numbering of "IX" (or XI) and "II" (*plates 1 and 2*).

Plate 1 Feature 087 Sawn "IX" on rafter 031

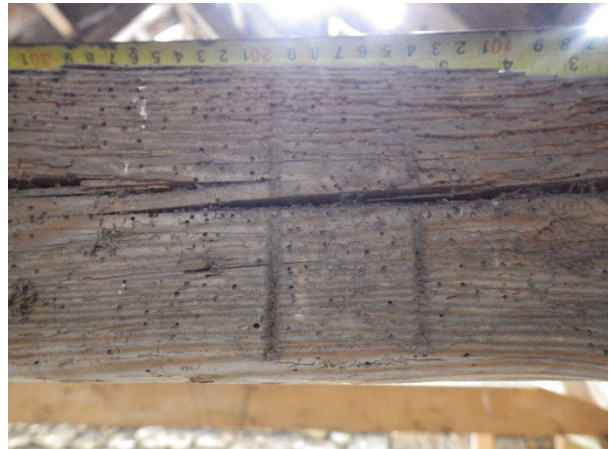
Plate 2 Feature 094 Sawn "II" on rafter 034

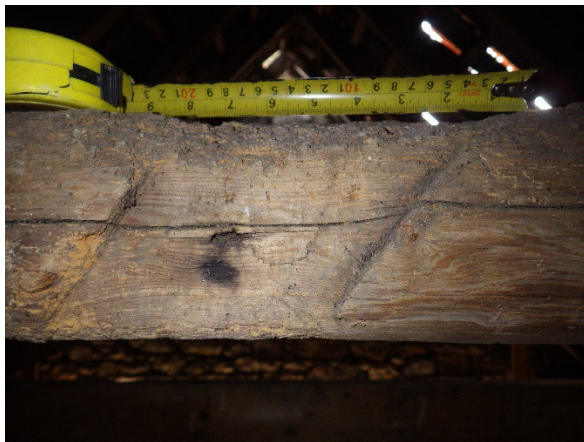
The full dimensions of the rafters has been lost as they were cut down at either end in *phase B* but one relic cut half lap dovetail joint survives on each for a collar beam. The collars were nailed.

Plate 3 Rafter 031 , collar joint 086

These are likely remnants of the early roof which was probably in poor repair by *phase B*, perhaps with the rafter ends rotted and so the rafters were cut down for collars.

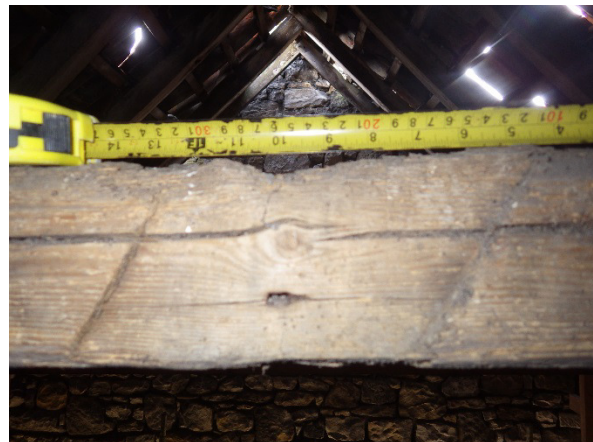
Plate 4 Rafter 034 , collar joint 091

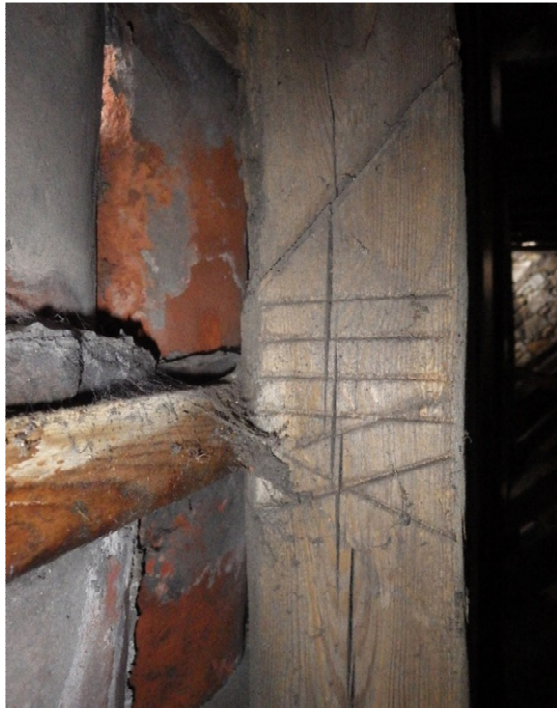
Truss pair 03 (006,007) is formed from a pair of adze-squared cabers of larger dimensions than the others within the roof and of a different former arrangement. That the truss is a pair can be seen from the saw cut numbering with both trusses numbered "XIII" (features 054 and 055). The numbering on the east truss 006 has an extra stroke upon the first "I" which was interpreted as indicating the

alignment of the pair within the original roof ie meaning left truss (or right); it is probably not distinct enough to be another X and thus from another pair (*plates 5 and 6*).

Plate 5 Truss 3 rafter 006 , shows cut number 054

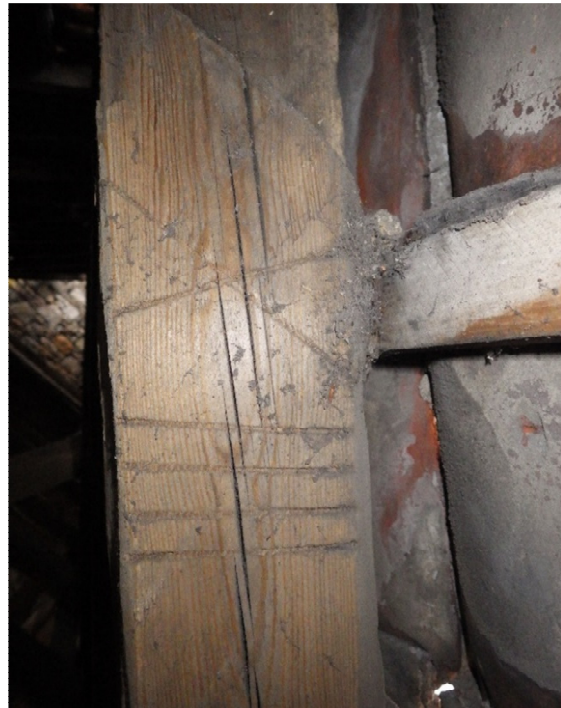
Plate 6 Truss 3 rafter 007 , shows cut number 055

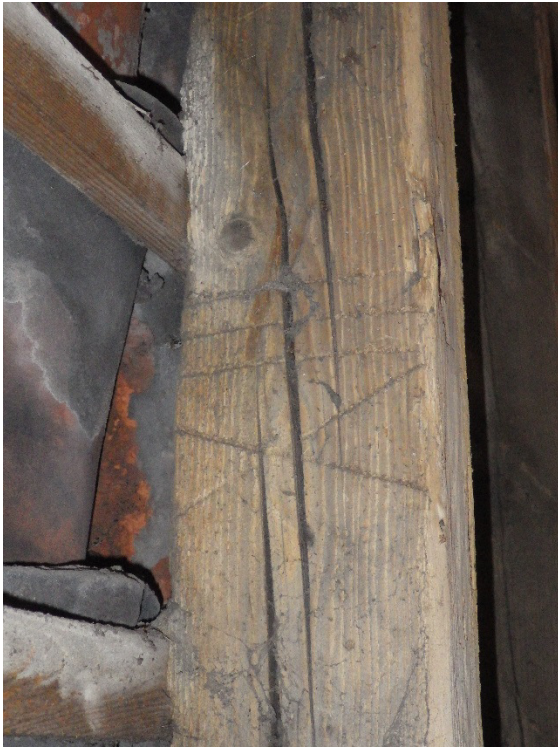
Truss pair 09, *024,025* was another reused truss of larger dimensions (*plates 7 and 8*). This was a simple rafter pair with no collars formed from adzed square cabers; both were numbered with a saw cut “XIII” (*078,079*). This numbering was similar to that seen on truss 3 but didn’t have the extra stroke indicating orientation, together with the completely different build this indicates that they are likely to have come from different roofs despite being sequentially numbered 13 and 14. Alternatively they may have been from an earlier roof that had itself reused a variety of even earlier roof structures.

Plate 7 Truss 9 rafter 024 cut no 078

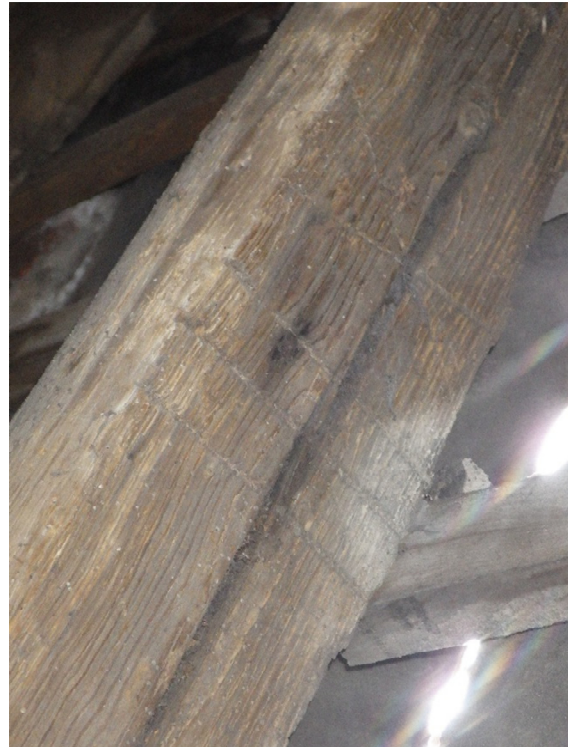
Plate 8 Truss 9 rafter 025 cut no 079

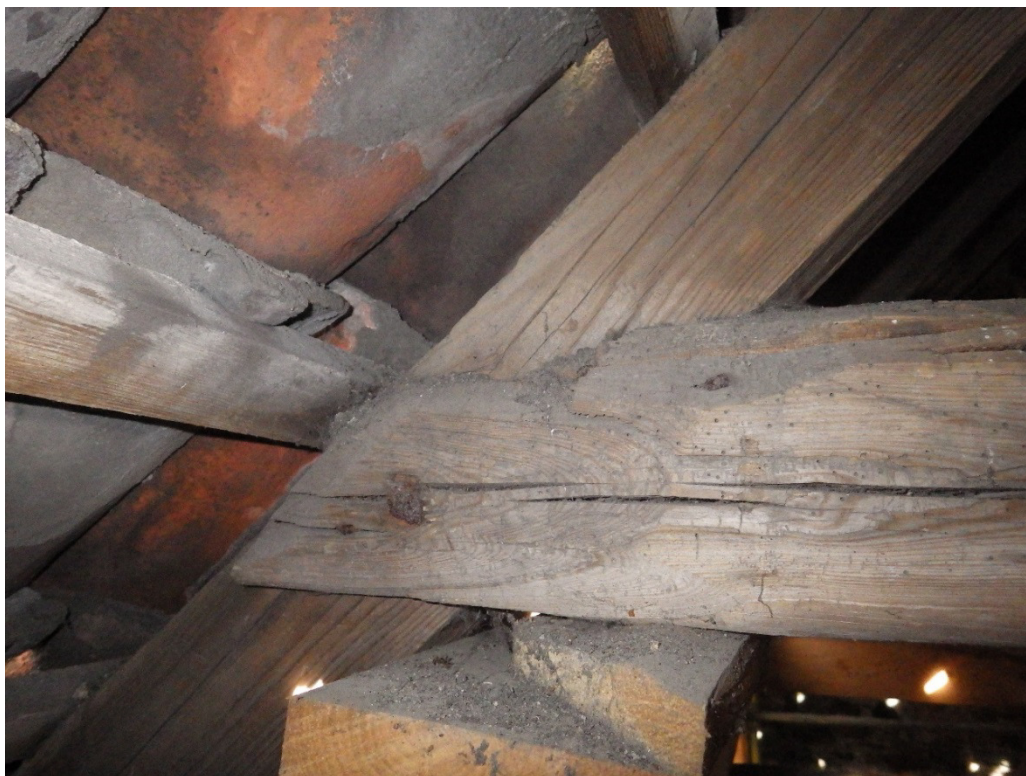
The two surviving full truss pairs show the original construction on these possibly cut down *phase A* rafters. The ends of the collars have been trimmed down with a chamfered end and were affixed onto the face of the rafter with a single large iron spike/nail. The height of the collar base on the rafter was scribed into the rafter.

Plate 9 Collar 031 shows original form with end chamfered and spiked

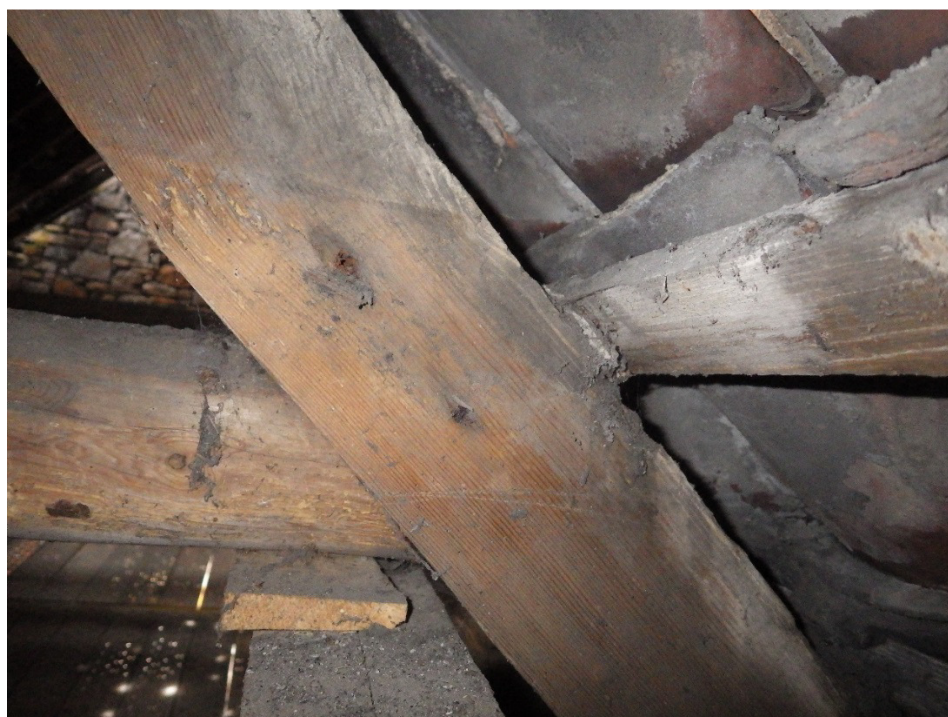
On most, if not all, of the rafters with collars replaced in *phase C*, the scribe marking out for the collars can be seen, as well as the stub of a large iron spike (occasionally two) showing them all to be of one phase (in some cases the later collars obscure these details). This scribing and spike for the collar was also noted on trusses 3 and 9, the reused truss pairs showing these to be of the same phase as the rest rather than a later replacement.

Plate 10 Truss 6 rafter 016 shows scribing and spike/s for original collar

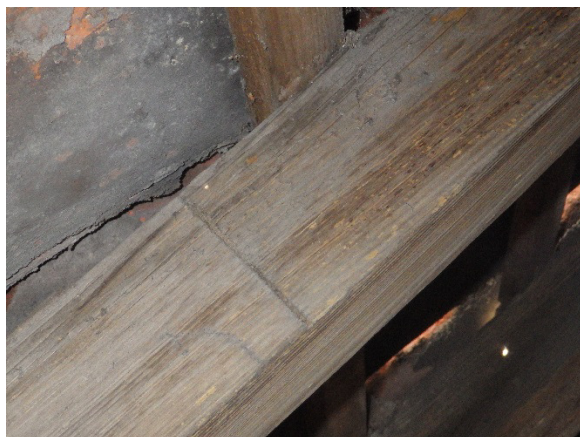
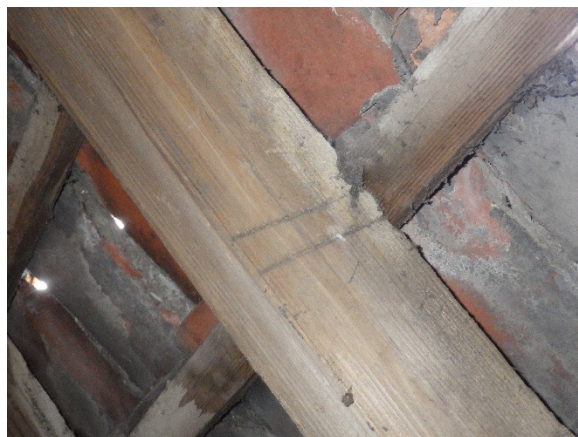
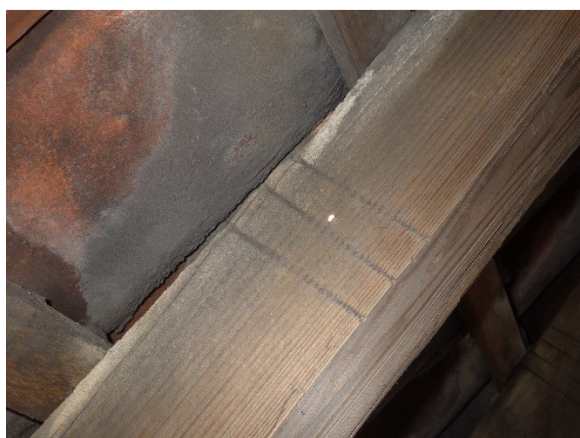
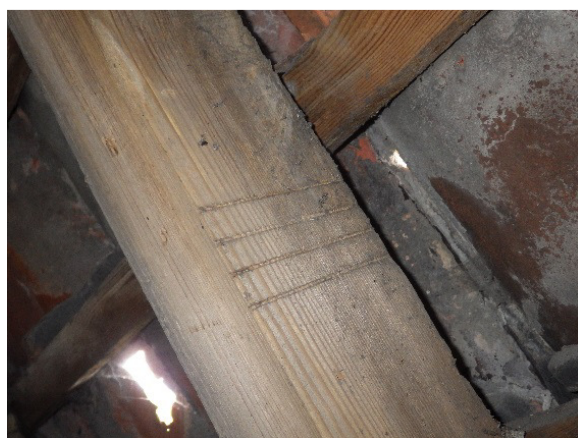
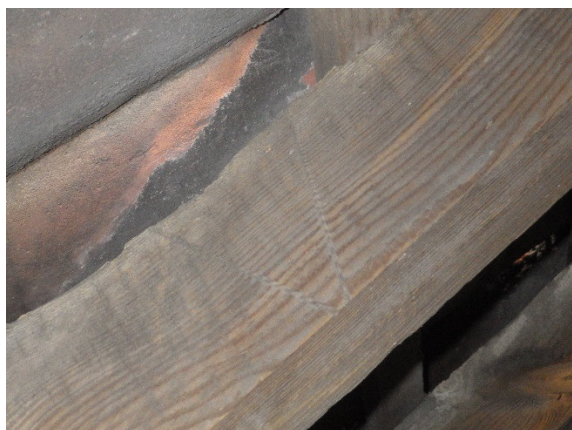
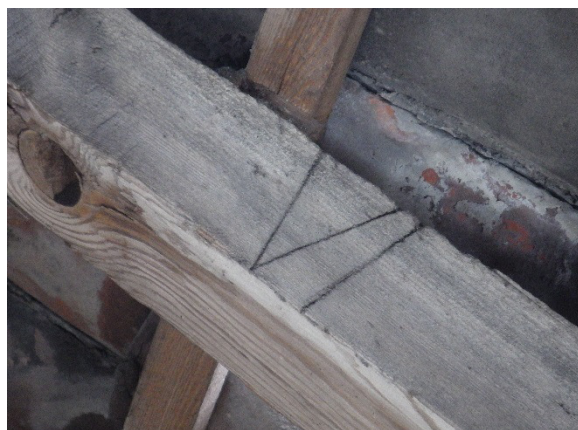
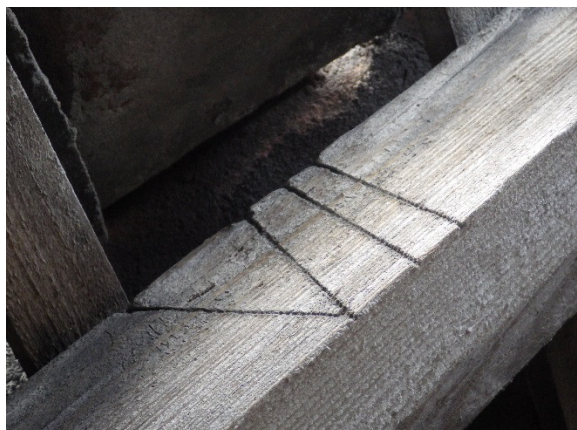
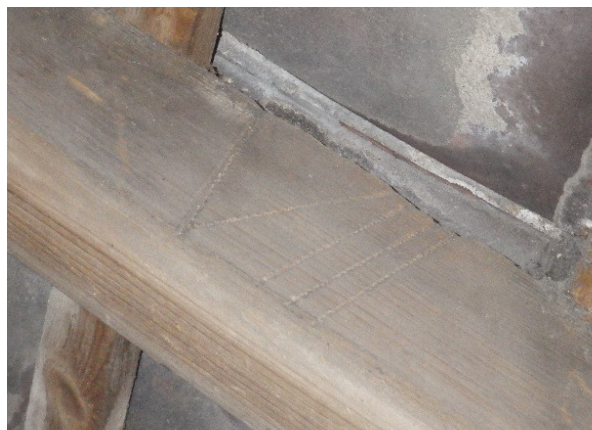
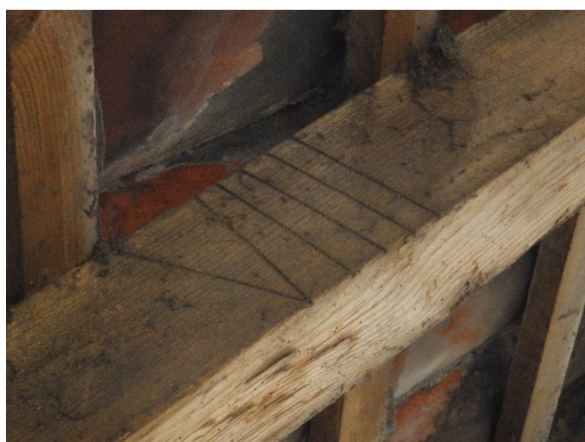
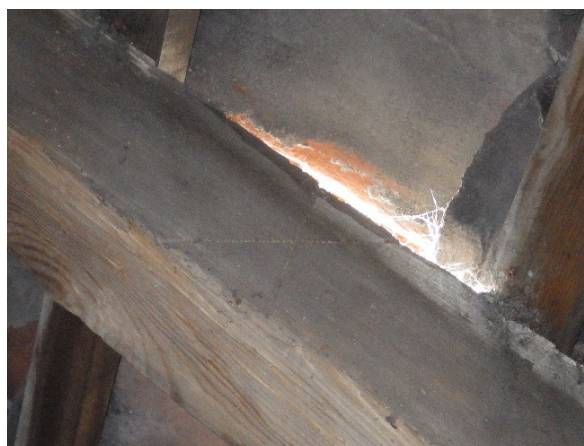
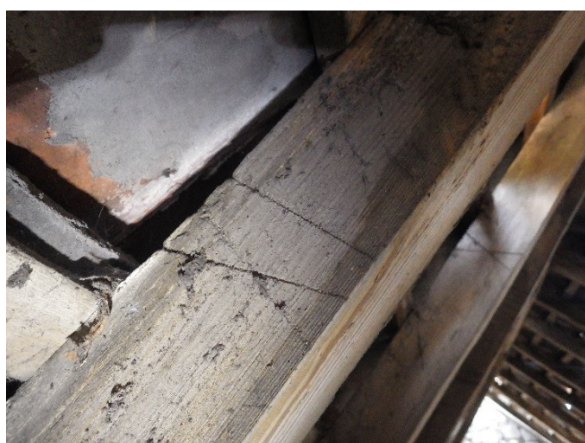
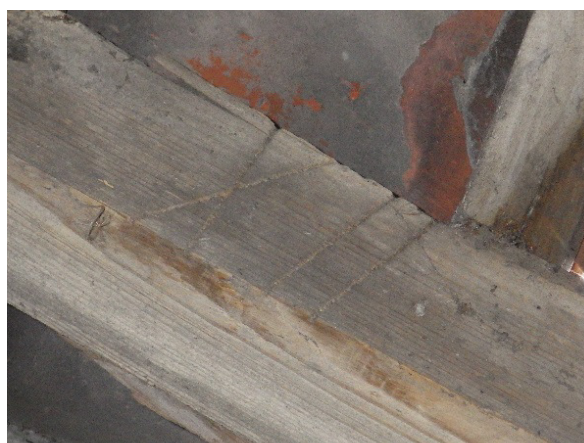
Truss pairs 4, 5, 6, 7, 8, 10, 11, 12, 13, 14, 15 and 16 are all similar and make up the bulk of the roof (*plates 9-22*). These are all of sawn square timber and generally 7-8 cm wide and 10 – 15cm high. These appeared to be possibly machine cut on three sides or very neatly hand sawn, but the fourth side, generally the underside, was clearly hand sawn and fairly rough in places with the cut wandering in and out. This face had been variably finished with an adze and/or a plane to remove much of the rough saw cuts, but many survive. It was considered possible these represent larger beams latterly halved to form rafters; the beams may have originally been floor joists.

These pairs are sequentially numbered from 1-12 with saw cut markings, but are now out of sequence.

Only two trusses appear to be complete in their original form, trusses 11 and 12, while all the others have had their collars replaced; this and the trusses sitting out of sequence indicates a major repair of the roof involving taking it down completely and not being too careful to put them back in order.

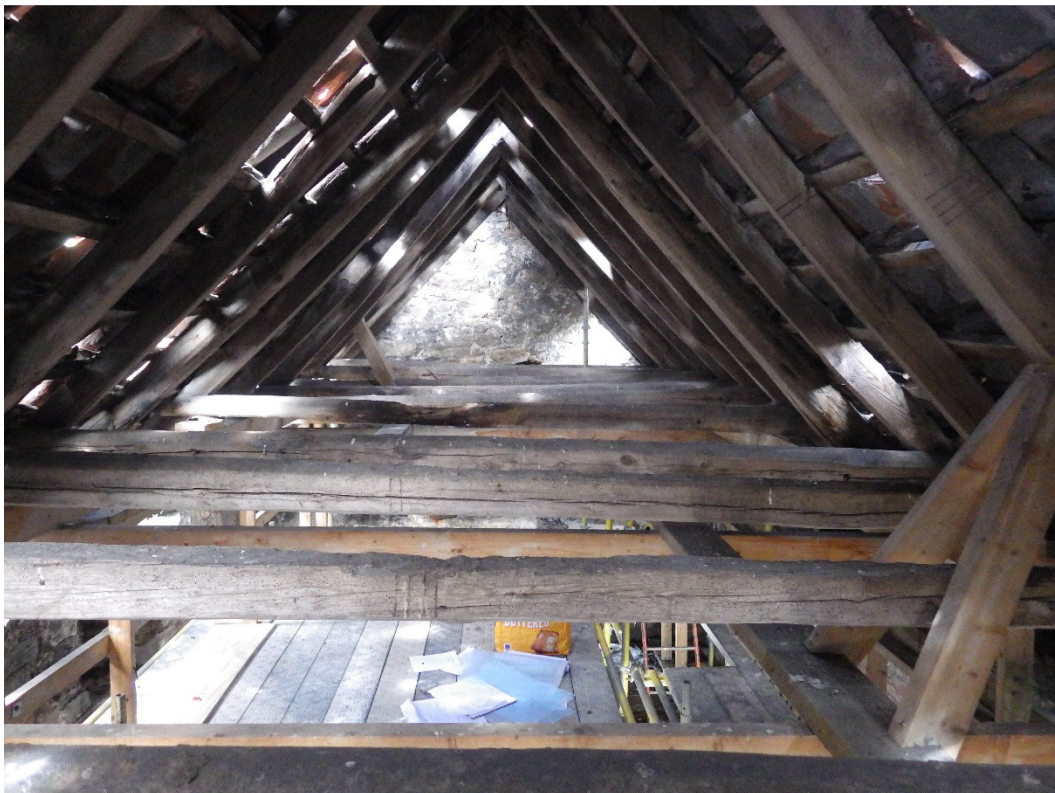
In the mid to later 20th century a phase of major roof repairs was undertaken and at this stage the roof was likely in a state of disrepair. These works appear to have involved the complete dismantling of the roof and its reconstruction reusing the *phase B* rafters but replacing nearly all of the collars, tile batons and rafters along the gable at either end.

The collars were replaced with reused early rafters. These were roughly squared cabers with relic cut half lap dovetail joints for upper collars (*plates 23 – 35*). On two of these (truss 5 & 14, collars 14 & 40) a second lower collar/tie joint also survives at the end of the beam. These are all very similar and likely come from the same salvaged and potentially old roof structure.

Plate 23 View along roof showing phase C collars

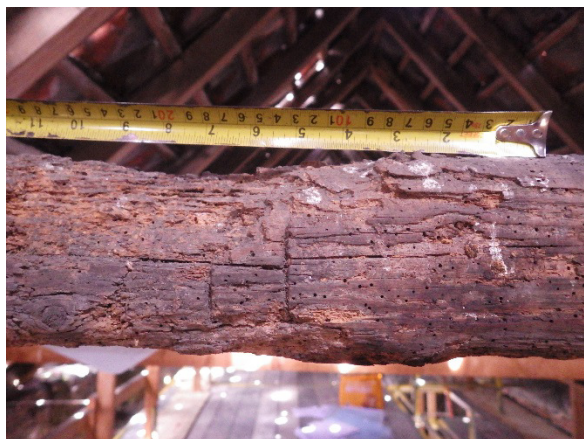
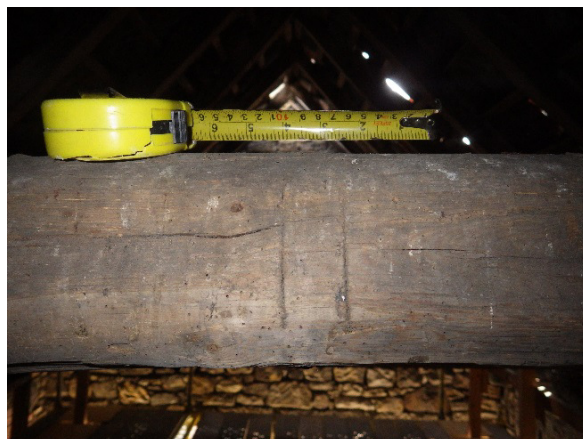
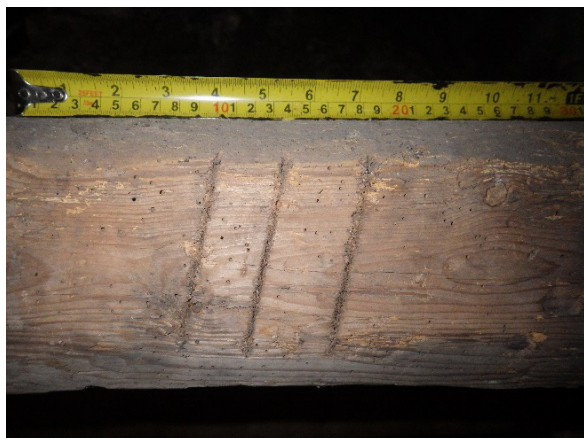
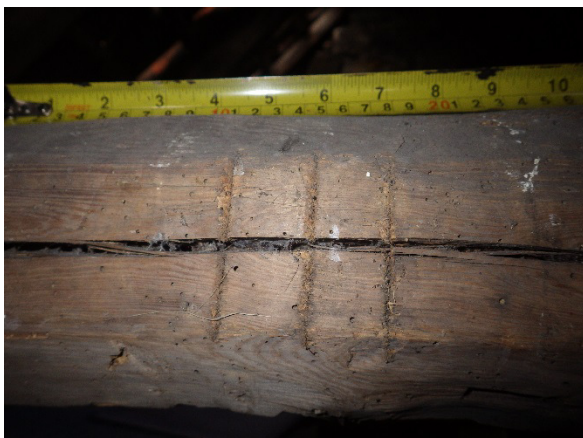
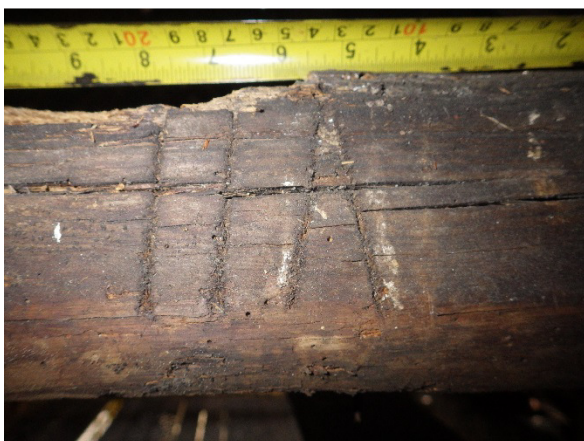
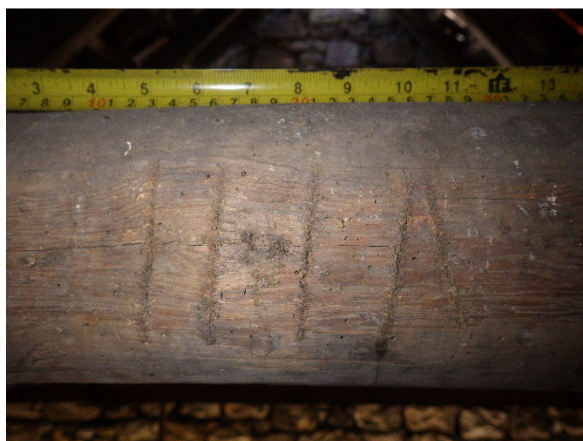
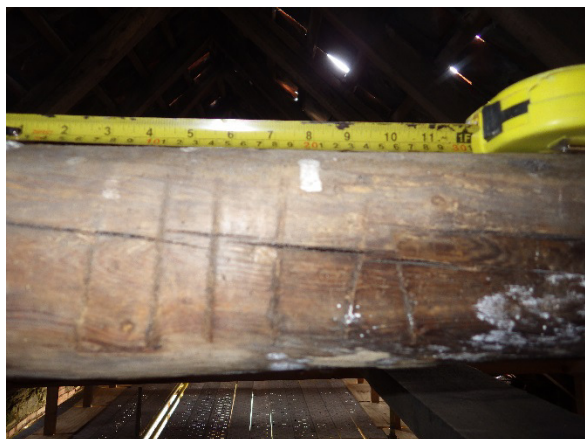
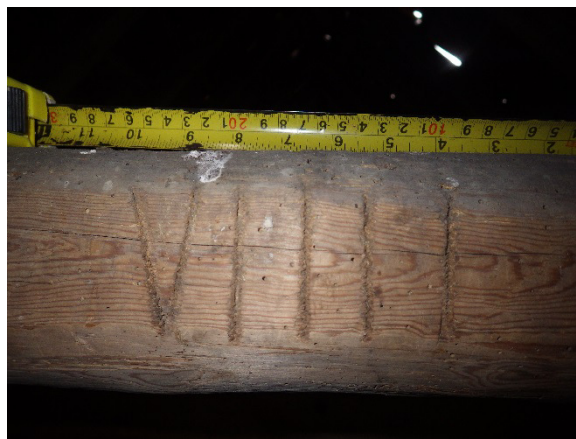
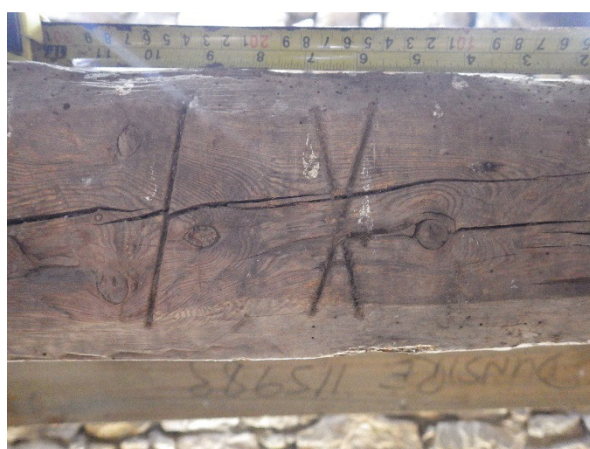
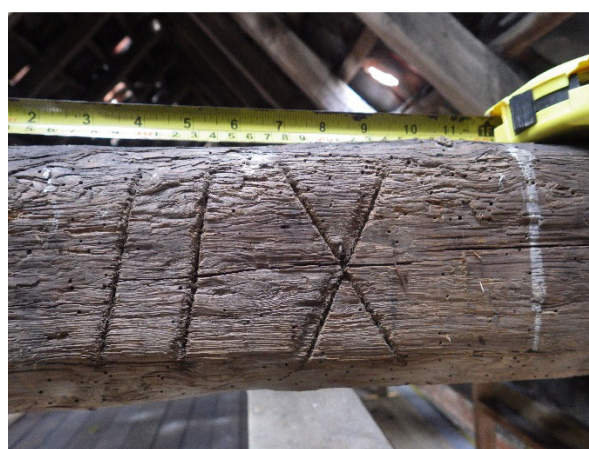
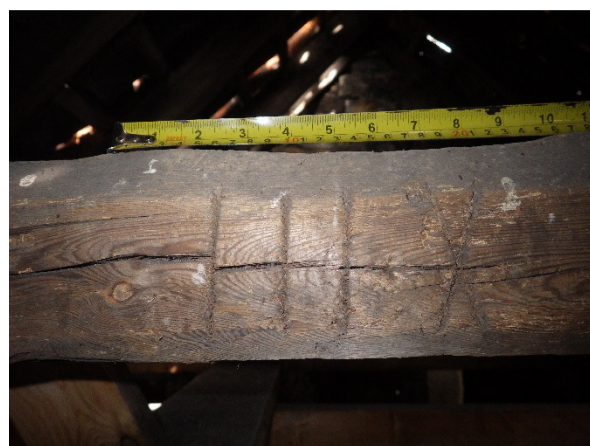
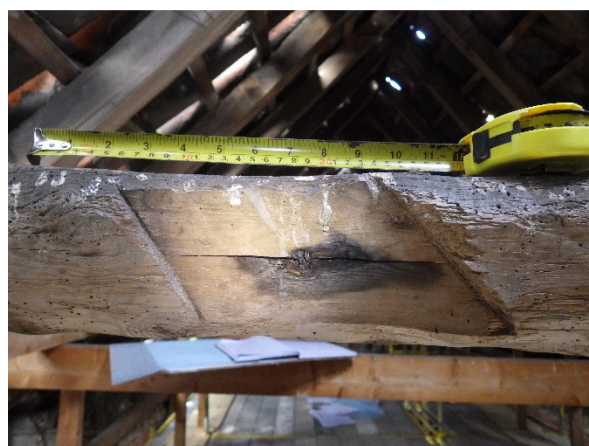
These collars were also numbered with a sequence of incomplete sawn numbering; eleven numbers were noted on the collars all cut into the face with the relic collar joint. Ten of the numbers were complete but one had been part lost to rot. Two of the numbers were duplicated: “III” and “VIII”, showing them to be former pairs; the rotten one may have been “II” which would represent a third pair. The largest number was 13 showing the salvaged roof to have had 13 or more trusses.
