Carsewell Steading

Penicuik, Midlothian

Historic Building Appraisal: 16/10/2017

Hope & Co Architects on behalf of Penicuik Estate

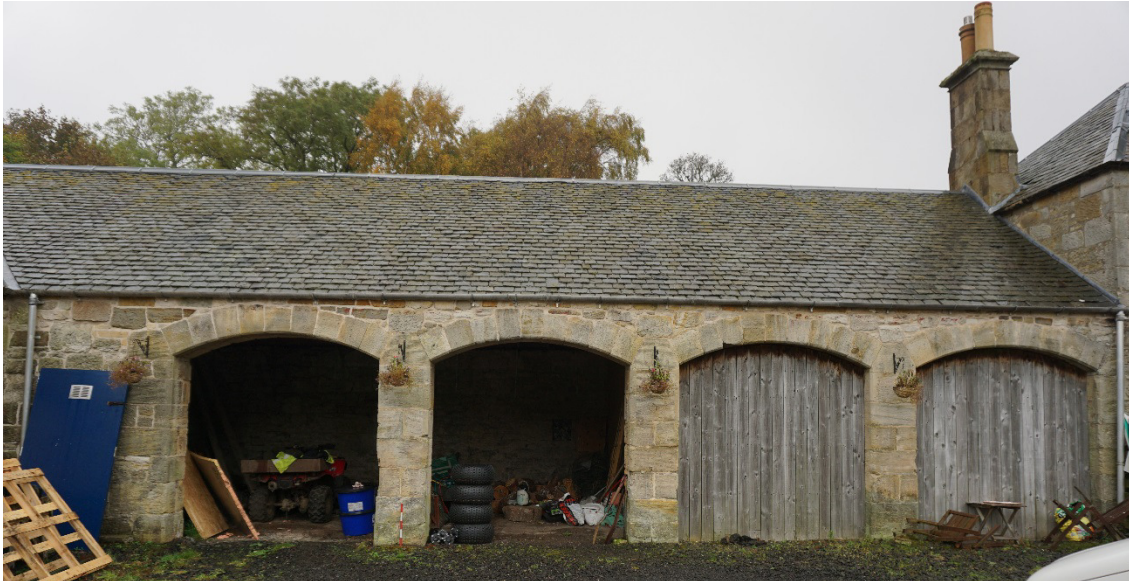
This was a simple cart shed with four arched openings (*plate 1*) leading into an open interior. Four small recesses in the internal masonry were evenly spaced on the north-east and south-east walls.

Plate 1 Building 1 shows arched openings

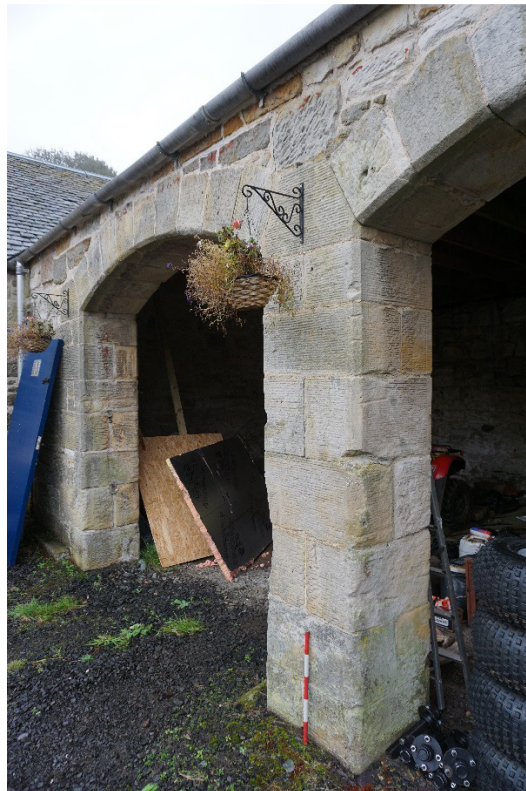
Plate 2 Building 1 detail of jamb detailing

The jambs of the openings were formed from neatly cut blocks of blond sandstone with a narrow chamfered corner and horizontally broached tooling (*plate 2*).

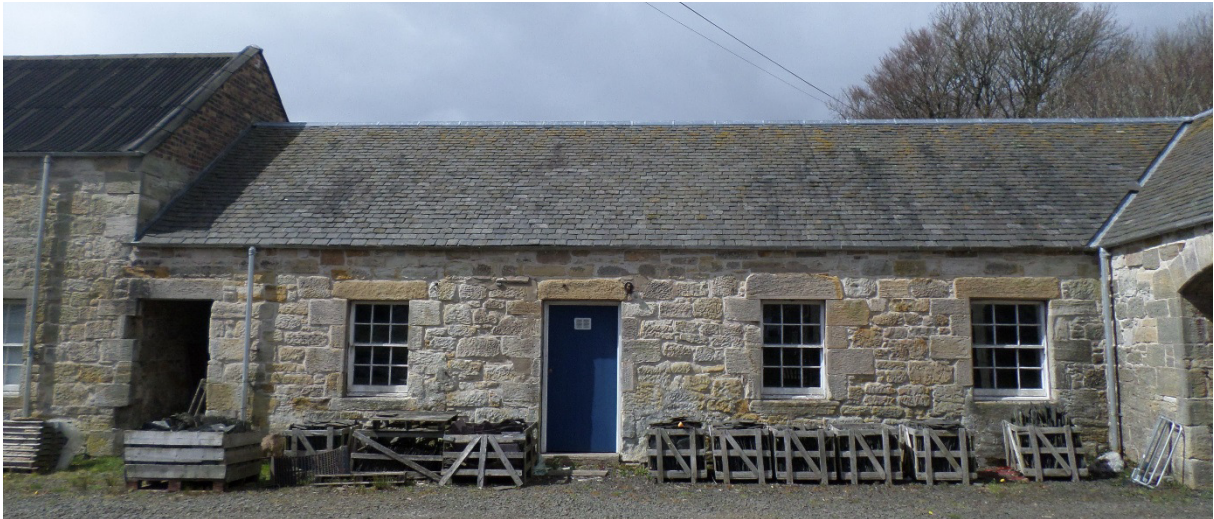
Plate 3 Building 2 SE frontage, (supplied by client)

The structure was a single storey building with a pitched slated roof replaced in the early 21st century (plate 3). The south-east frontage elevation has a number of openings, all original to the building but occasionally altered. All openings are formed from light coloured sandstone with some lintels of browner sandstone. The doors all display a narrow chamfer on the corners within a narrow droved margin and horizontal broached tooling beyond on the jamb stones (plate 4). The windows were more simple with a square jamb detailed with a narrow droved margin and broached tooling beyond (plate 5).

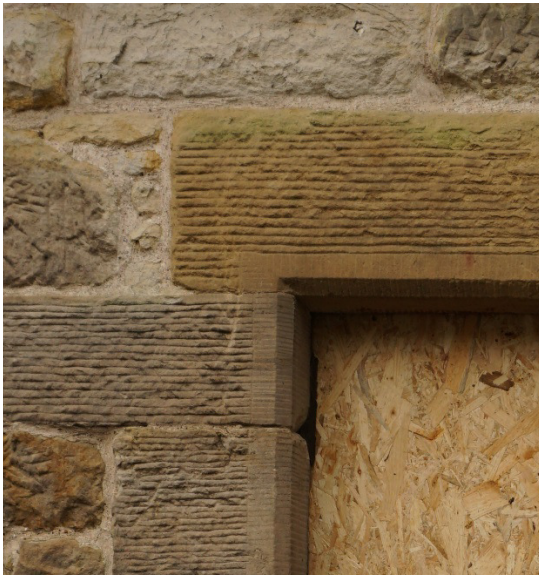
Plate 4 Detail of door chamfer and tooling on jambs

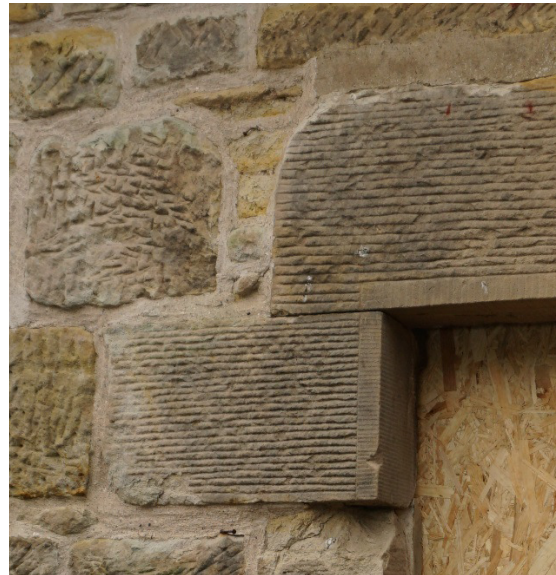
Plate 5 Detail of window jamb tooling

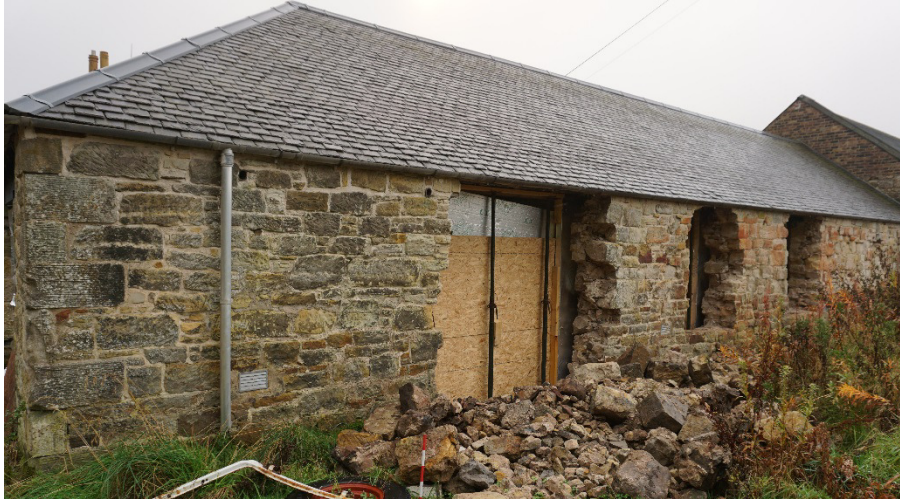
The north-west elevation (*plate 6*) was originally blank with the only features a series of low down secondary vents (*40*) through the wall formed from salt glaze drainage capped with metal vent covers. There was a further series of original high up vents formed from terracotta drainage pipes (*50*).

Plate 6 Building 2 NW elevation

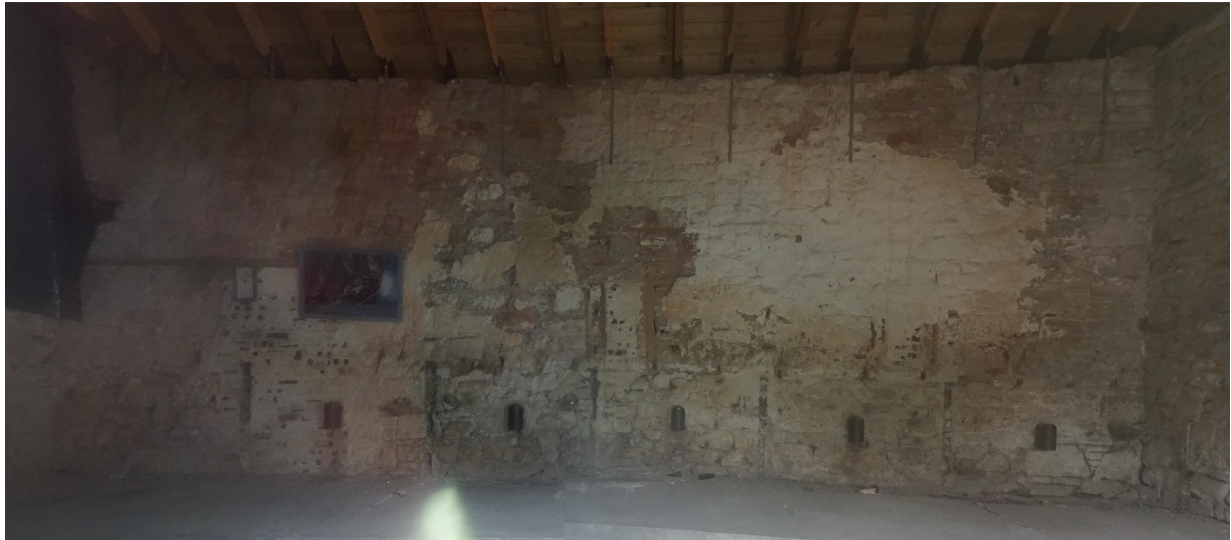
The *northern room* looks to have been a single space open to the roof, as no obvious evidence for floor joists of an upper floor could be made out from the window. The current/ last use of the interior appears to have been for livestock as the outline of a series of pens can be made out on the walls (*plate 7*). These were associated with water basins and central to each pen was a downward projecting large pipe, which is likely to represent the interior end of the vent (*40*) system.

Plate 7 Building 3 north room composite north internal elevation (shot through glazed window)

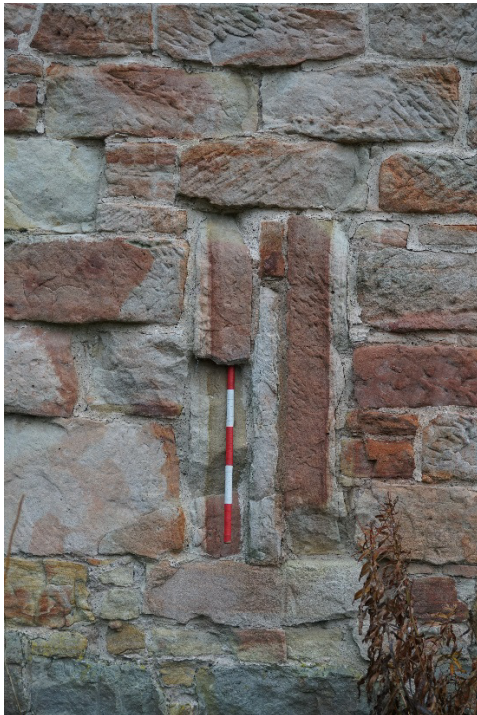
On the north-west exterior elevation a number of blocked features can be made out; two blocked vertical vents (38 and 41; plates 8 and 9) and a door (43).

The vents could be made out on the interior showing them to have been splayed internally. The door (43) was also blocked up. Built into the blocking or cutting through the blocking was one of the vents (40), showing these to be secondary and not original to the structure.

Plate 8 Blocked vent 38

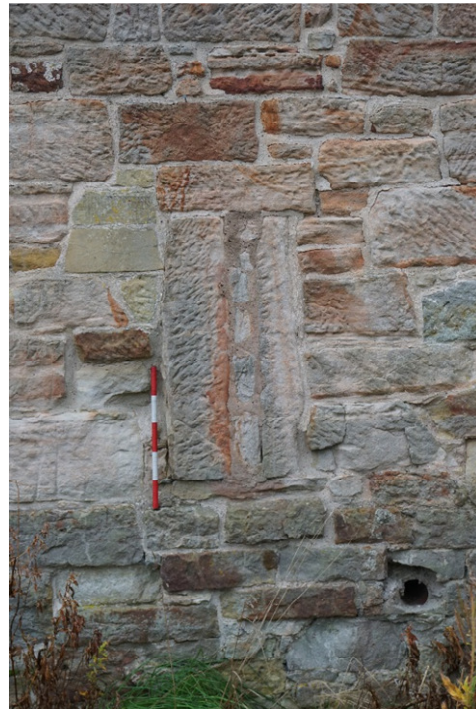
Plate 9 Blocked vent 41

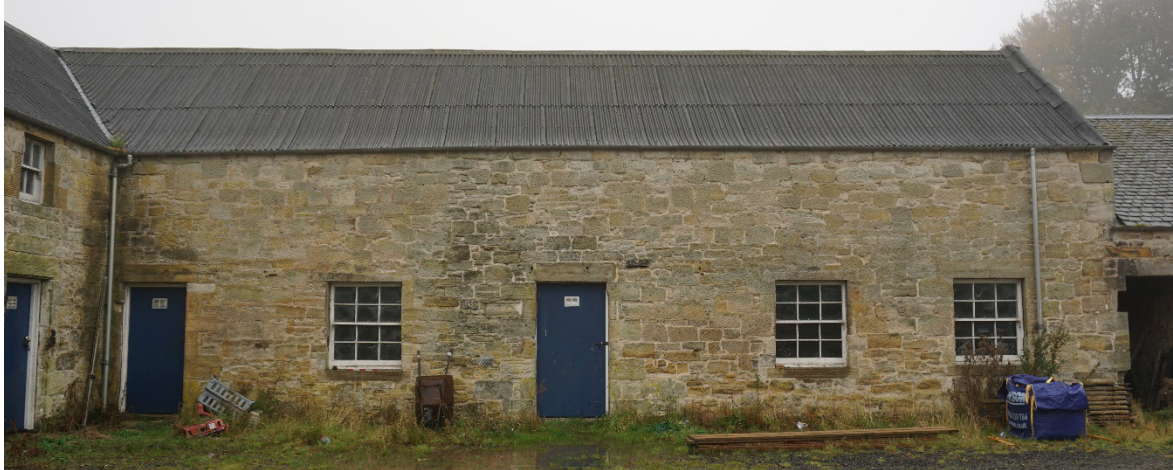
Plate 10 Building 3 southern room to left and northern room to right

On the south-east frontage elevation of the *northern room* (figure 4; plate 10) there is a door and two windows; the door (11) appears to be an original door with the same chamfer and tooling detailing as on Building 2, the north jamb has been widened. The two windows (13 and 16) are different and show evidence for three phases of use.

The southern room on its south-east main frontage has a door and a window (plate 10; figure 4); the door (08) is original with the same detailing as elsewhere but the window (09) appears to be a slapping. The window appears to have been a new slapping and formed up with cement to similar dimensions as (14 and 17) and likely at the same time. Latterly the window sill has been dropped similarly to (15 and 18).

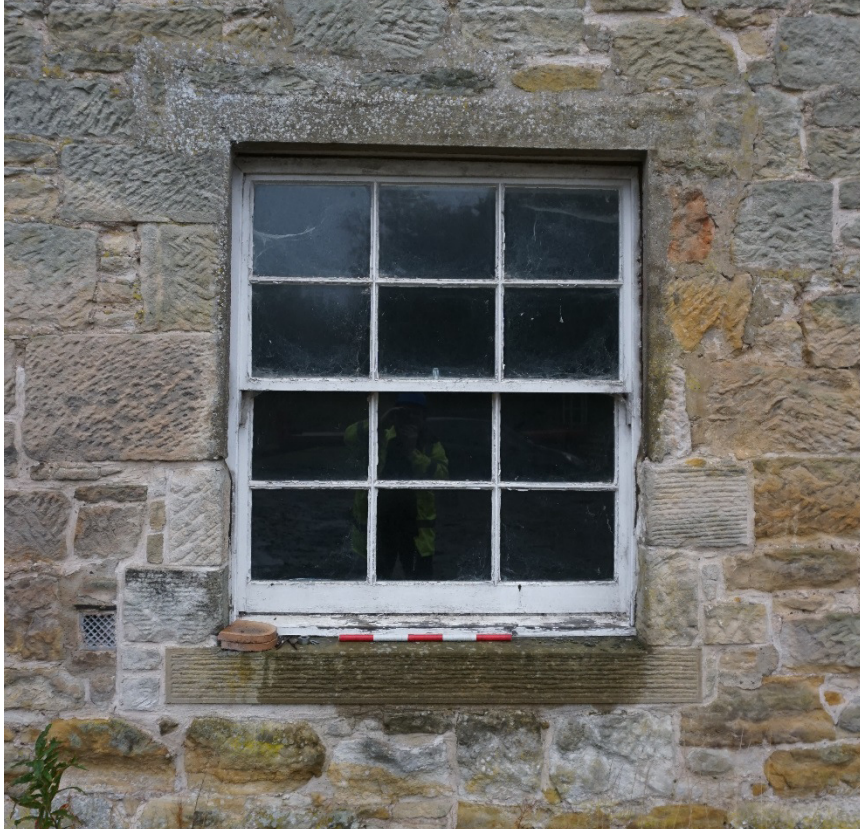
Windows 13 and 16 appear to be remnants of *in situ* jambed openings; both have three apparent jamb quoins surviving to the south (numbered 13 and 16), however the tooling detailing is different to all the other windows with the finish the same as the surrounding rough tooled rubblework (plate 11). It is likely that these were originally narrow vents to pair the ones on the north-west elevation.

The quoins were likely better detailed than the vents on the north-west elevation as this is the main frontage and highly visible, but not important enough an opening to warrant the full tooled margins of a window. Latterly both of these have been widened (14 and 17) considerably to form a window opening, this work was done with cement and is likely 20th century in date.

Plate 11 Window 13

More recently the sills of both windows have been dropped to form a larger window (15 and 18), this work appears to have been done with lime mortar and is likely to be related to early 21st century works to the steading.

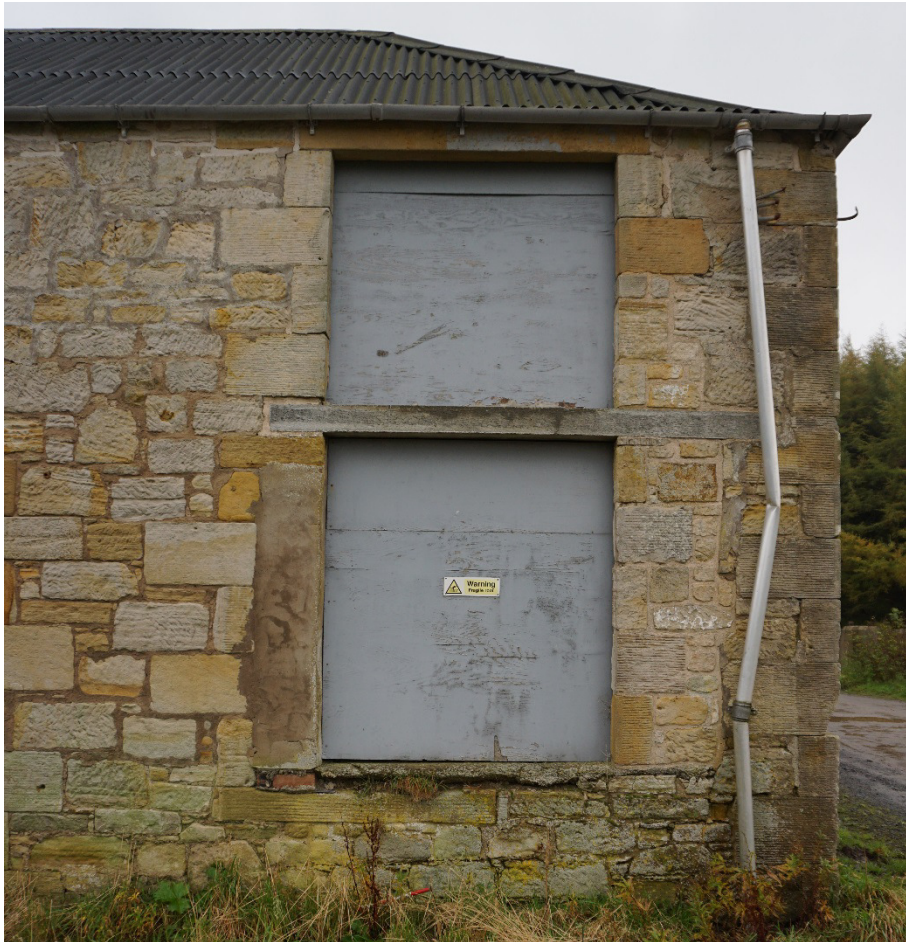
The window (47) was an original window that has been heavily affected by the insertion of a large opening (49) which cuts the window (plate 12).

Above the window (47) some quoining of a wide opening (48) may be original but partially rebuilt as part of the new opening below (49).

Plate 12 Building 3 NW elevation original window 47 bottom left cut by later opening

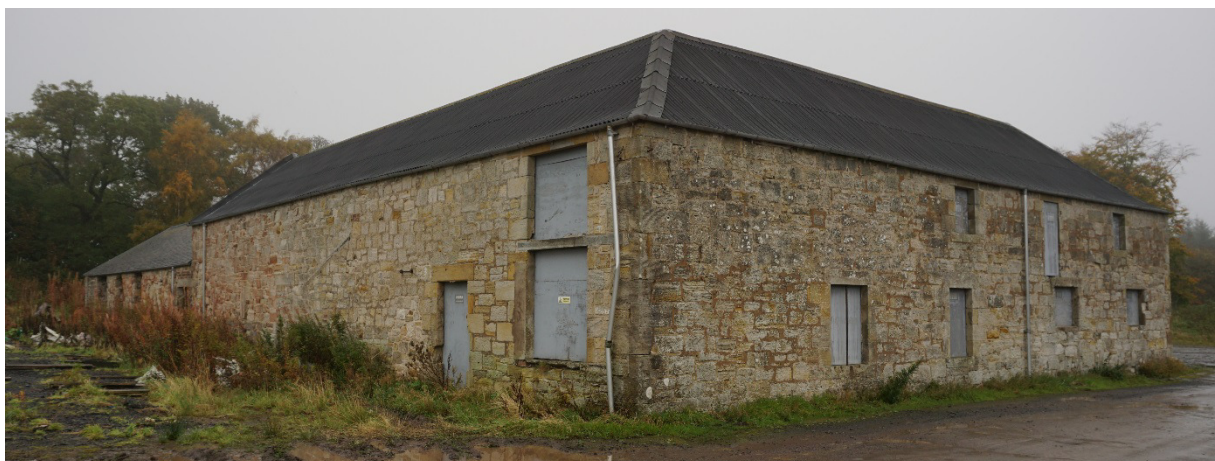
This was a two storey structure with openings at ground and first floor level (*figure 4; plate 13*).

Plate 13 Building 3 to left and Building 4 to right

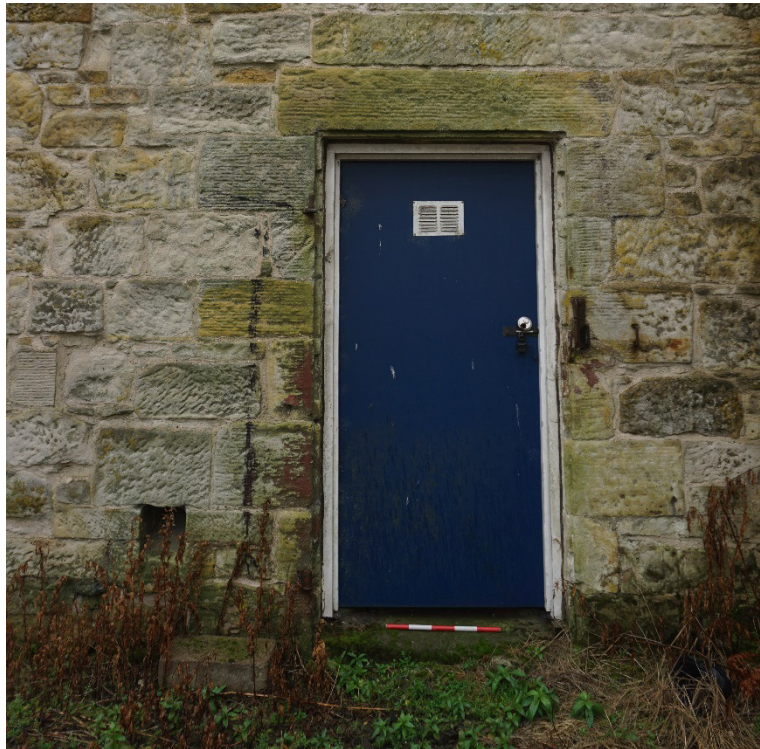
The western room at ground level has a door into the courtyard and a window to the exterior south-west elevation, both original. The door (26) is an original door with the same detailing as elsewhere with the exception of a cut check around the exterior face of the quoining replacing the chamfer (probably a secondary alteration, but could be original; *plate 14*).

Plate 14 Building 4 west room door 26

Associated with this cut check were two large iron pintles on the southern jamb; three large checks were also cut further into the masonry on either jamb apparently to fit a plank and rail door flush with the masonry. The main check would have been to fit the plank door and the three deeper checks would have taken the three rails.

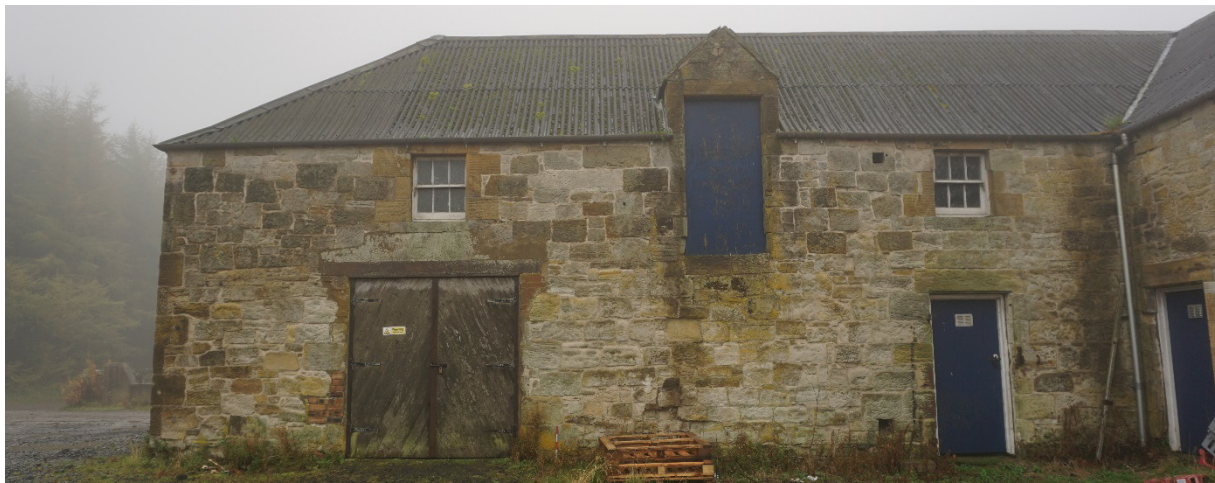
Plate 15 Building 4 NE elevation

The eastern room at ground level appears to have remnant quoining of an original wide opening (20). The quoining of the original openings have been eroded and damaged by later works, the door may have been slightly widened. The tails of the surviving quoins show horizontal broached tooling similar to elsewhere on the steading but the corners are lost.

The opening has been repaired in 20th century brick and cement with a replacement lintel.

On the north-east elevation two windows (33 and 34) have been slapped and with no evidence for any other openings other than the large (20) opening, it is suggested this building could be a cart shed (figure 4; plate 15).

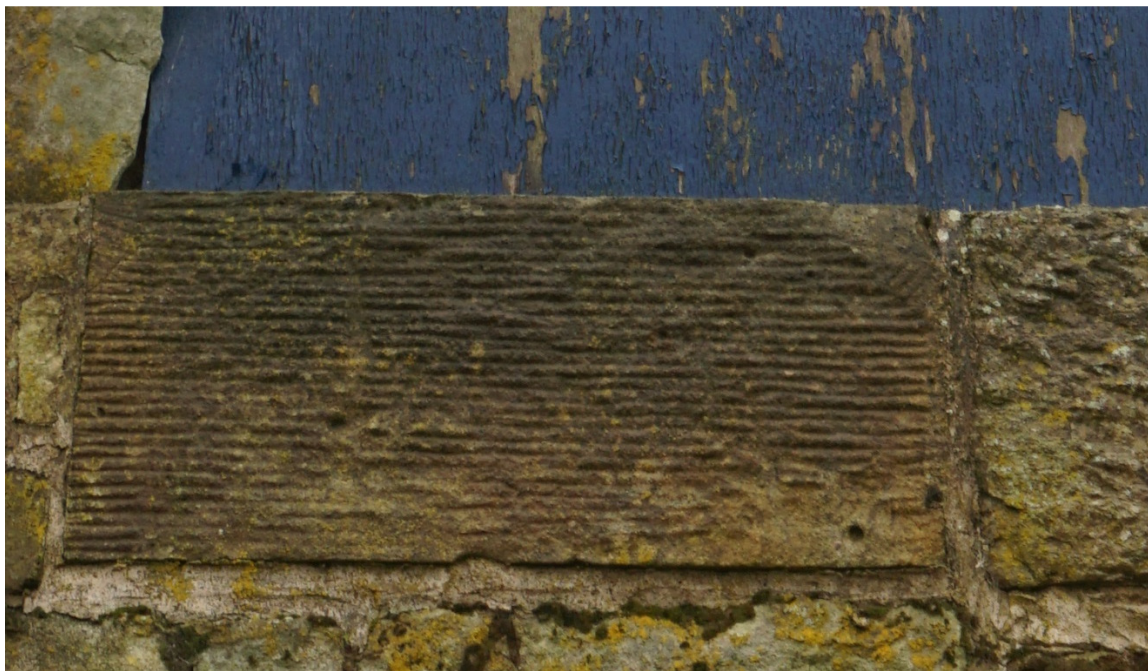
One other feature of note was a reused stone used for the base of loft door (22) this stone appears to have curved droved margins on at least one and possibly two corners maybe relating to arched cartshed openings (plate 16).

Plate 16 Reused stone with droved margins
