The Canons

Mitcham, South London

Archaeological Monitoring during investigative works

Job number 2191.01

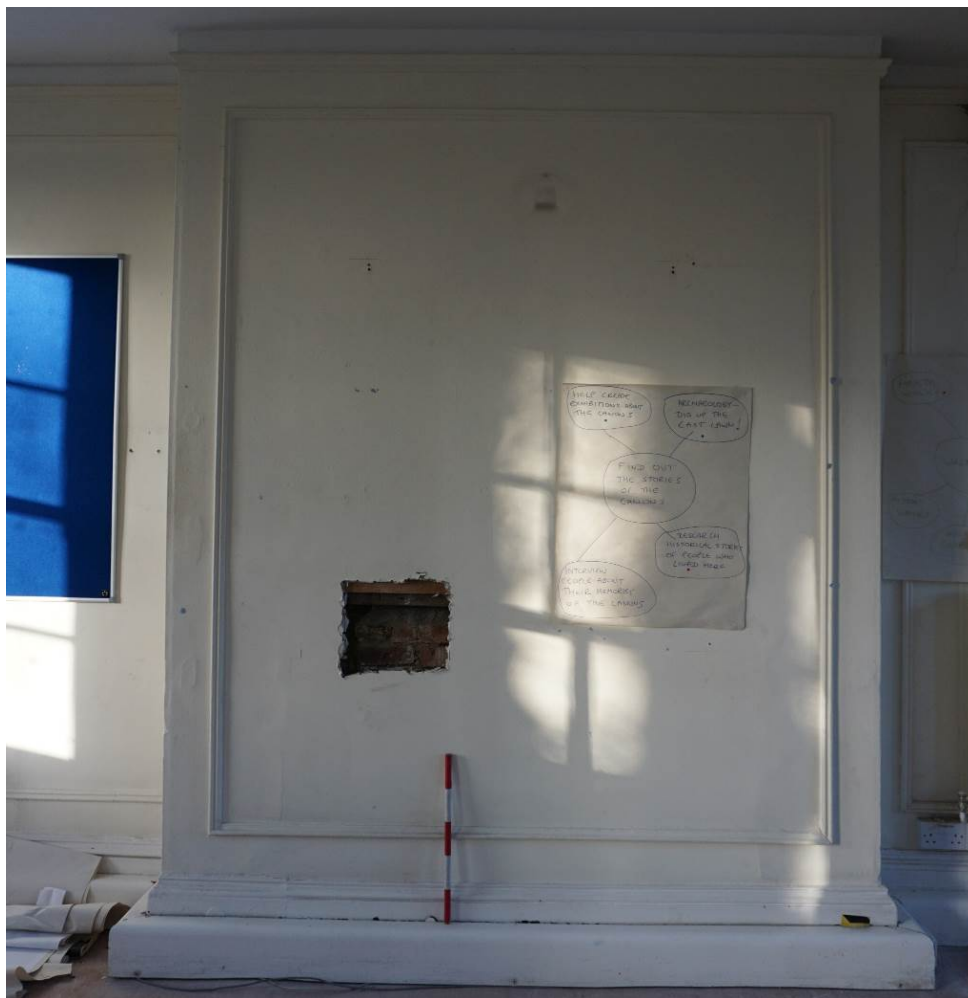
A small opening was made in the lining covering the central fireplace exposing 20th century brick blocking of the opening (*plate 1*). The ends of a modern steel ceiling joist were also exposed. All of the openings only exposed modern 20th century fabric.

Plate 1 room G.04 brick blocking of fireplace exposed

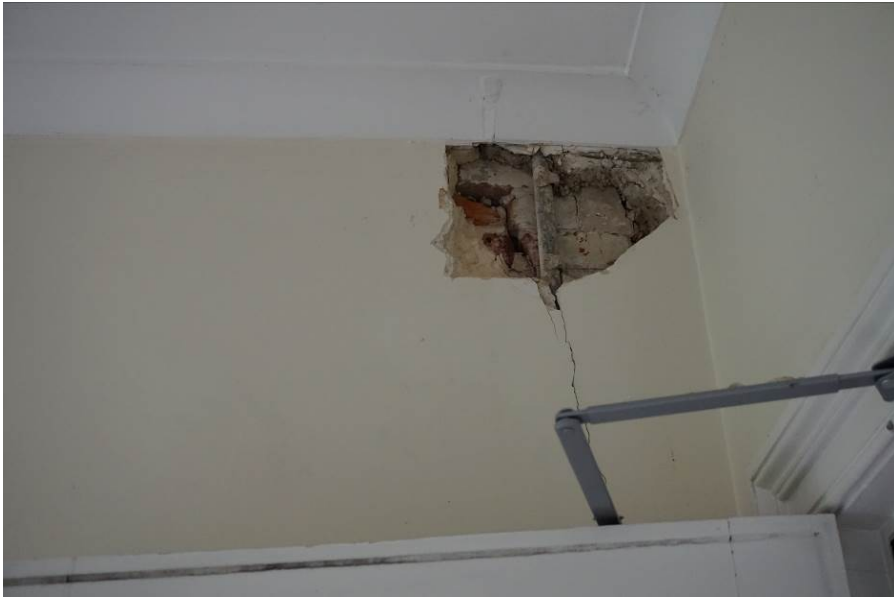
A small area of plaster on the hard was removed around a visible cracking, exposing the early brickwork of the masonry and cracking in the brickwork (*plate 2*).

Plate 2 room G.05 wall plaster removed around crack

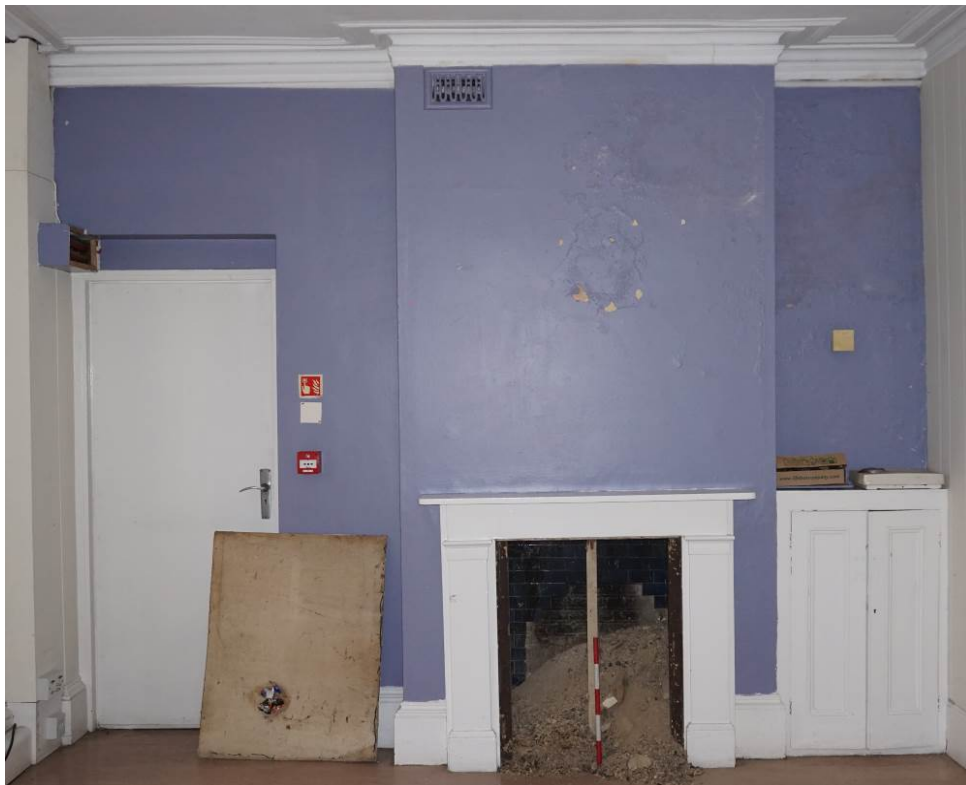
The fireplace was exposed by removing a covering panel exposing a glazed brick interior. The interior of the fire was also heavily infilled with debris from the chimney (*plate 3*).

Plate 3 room G.06 fireplace uncovered

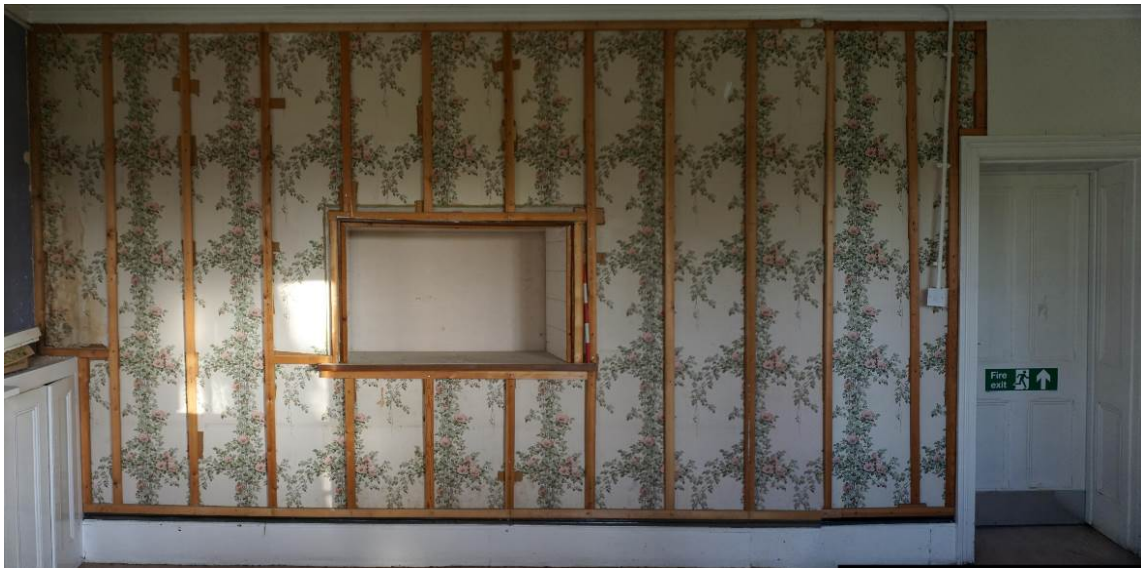
The modern board lining was also removed from the wall exposing a historic floral design wallpaper *in situ* (plate 4).

Plate 4 room G.06 floral wallpaper exposed

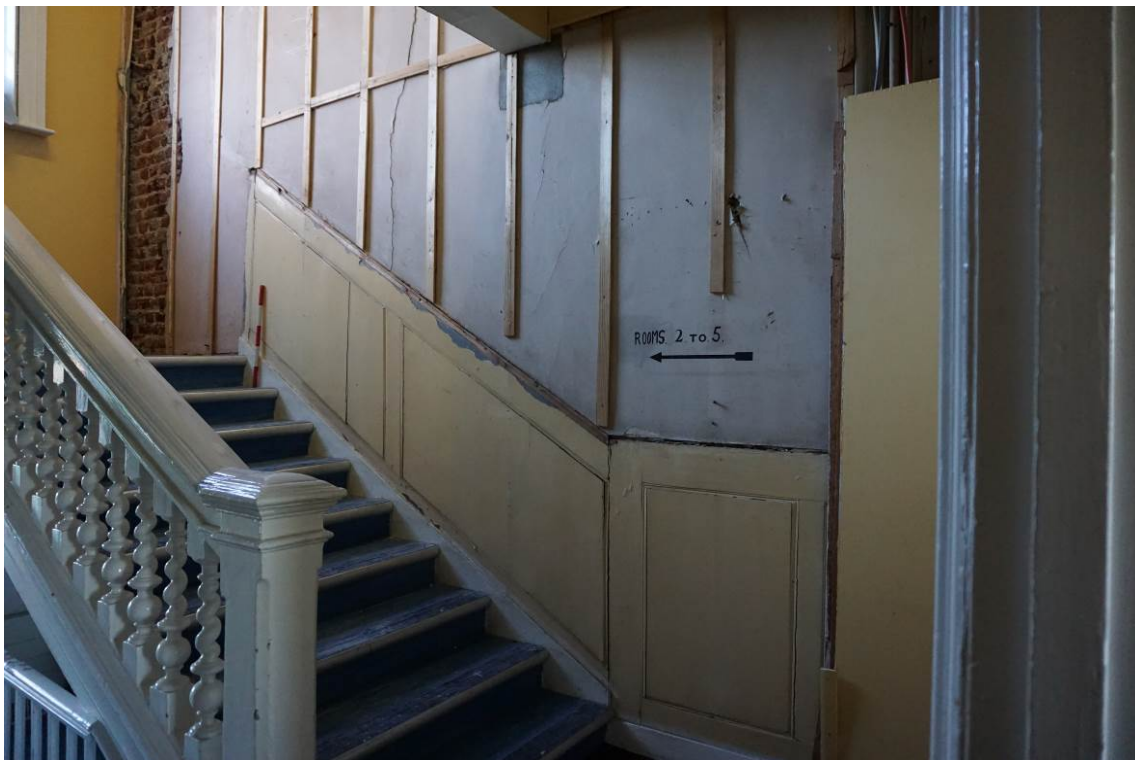
The modern board lining of the first floor stairwell was largely stripped to expose the underlying early structure. This board lining was nailed onto narrow battens which were securely nailed into the wall plaster with large nails (plate 5).

Plate 5 room F.01 stairwell shows exposed panelling on south elevation

On the south elevation this early structure comprised wainscot panelling running up the stairs with a formerly projecting handrail hacked back flush, presumably to fit the latter board lining. Above the panelling was plaster applied directly to the brick; major (apparently historical) cracking runs up the wall through the wall plaster.

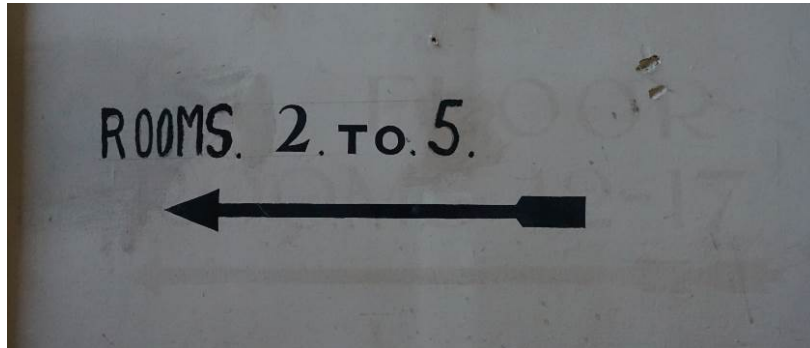
Plate 6 room F.01 painted directions

Also noted on the plaster was some painted directions with an arrow pointing upstairs; this is of two main phases with the earlier painted over and the latter crudely changed (plate 6).

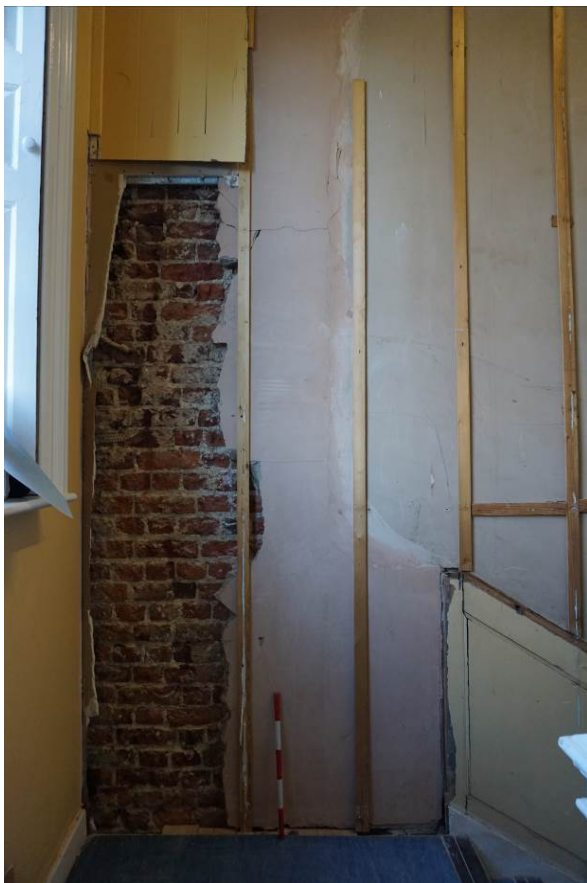
Plate 7 room F.01 elevation showing multi-phase repairs of south elevation

The wainscot panelling stops at the first floor landing but originally continued. It has been removed from the landing area on the south elevation and the east window elevation in relatively recent times (plates 7 & 8). A strip of wall plaster approximately 1m wide has also been stripped back to the

brickwork up the south elevation against the east wall; latterly the void left by the removed panelling and plaster has been repaired with modern plasters.

This repair has even more recently been re-stripped in a strip about 0.60 m wide up the wall along the east window elevation and then fairly crudely repaired with plasterboard.

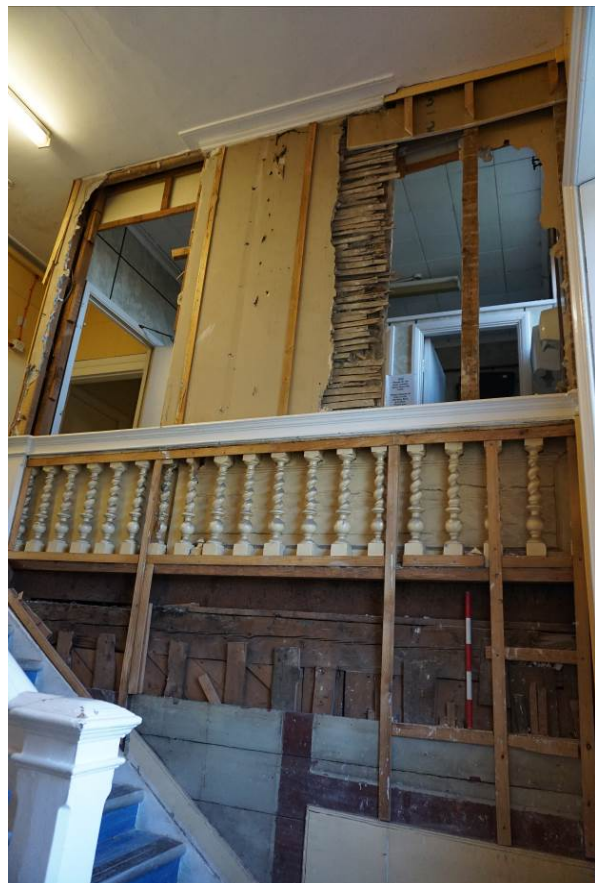
Plate 8 room F.01 stripped elevation showing exposed early structure on north elevation

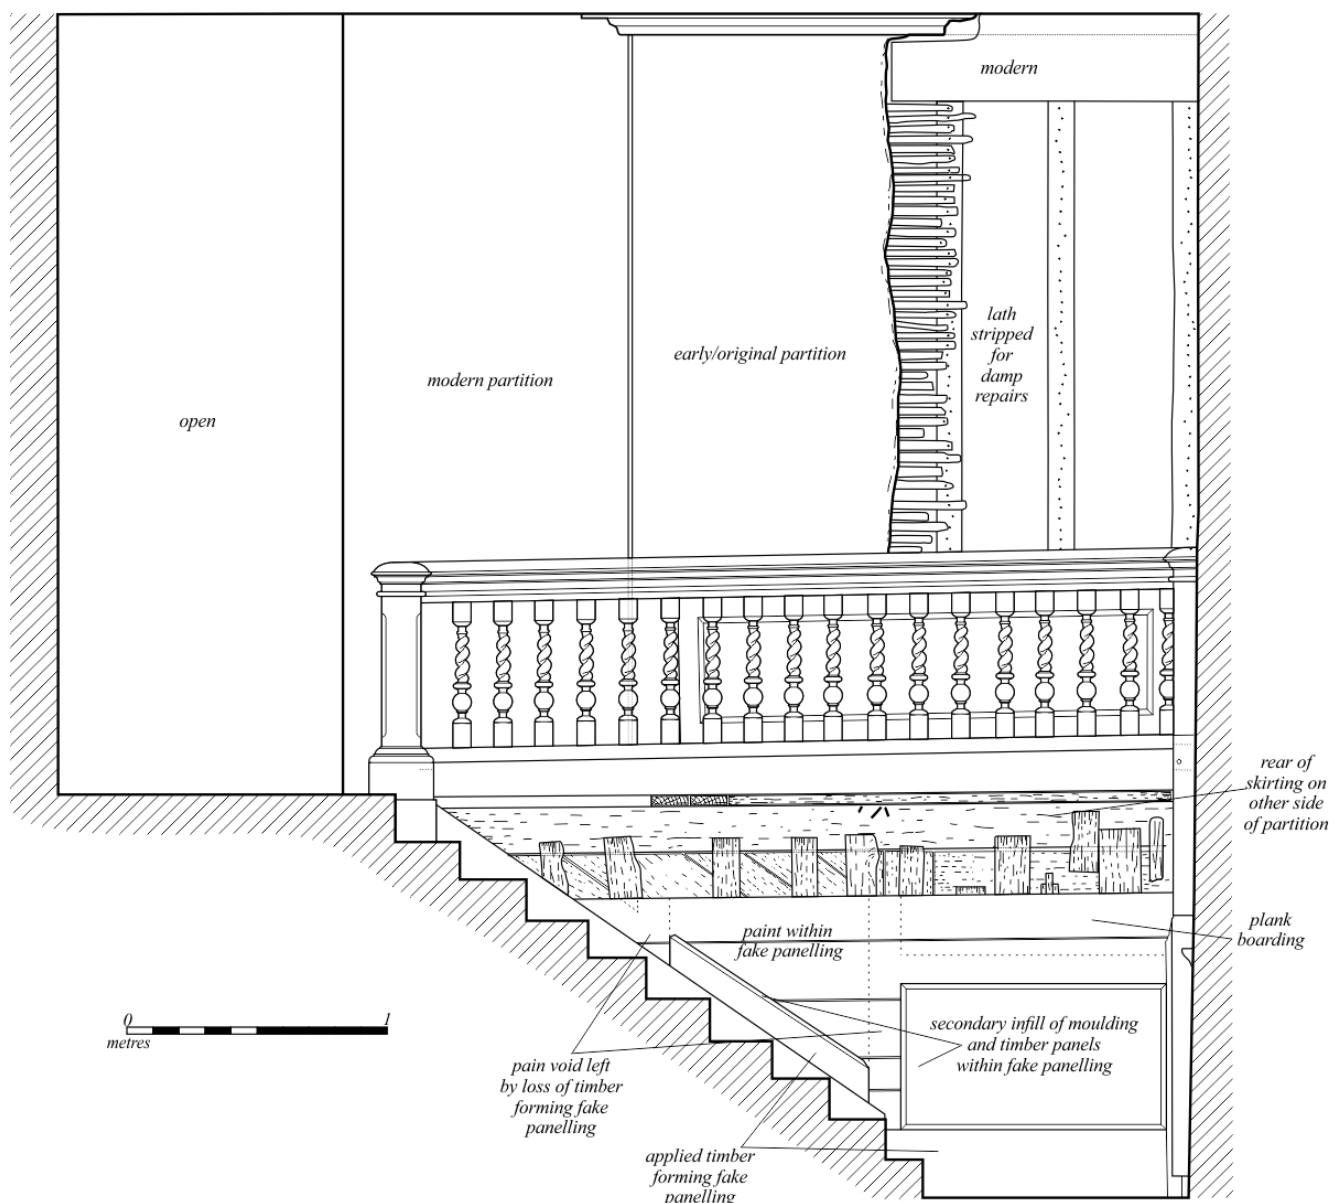
Figure 4 F.01 stairwell exposed panelling on the northern elevation

The modern board lining covering the northern elevation was also stripped exposing the early structure behind (figure 2). Following this a more extensive soft strip of 20th century lining and partition structure was removed to identify the extent of the early structure.

The early wainscot panelling within the stairwell was exposed, though in this area the panelling was partially dismantled, presumably to fit the 20th century lining. A moulded skirting (matching the skirting on the other side of the elevation) to the baluster was also removed at this stage. This revealed the makeup and phasing of the wainscot panelling, which is of at least two (possibly three) main phases.

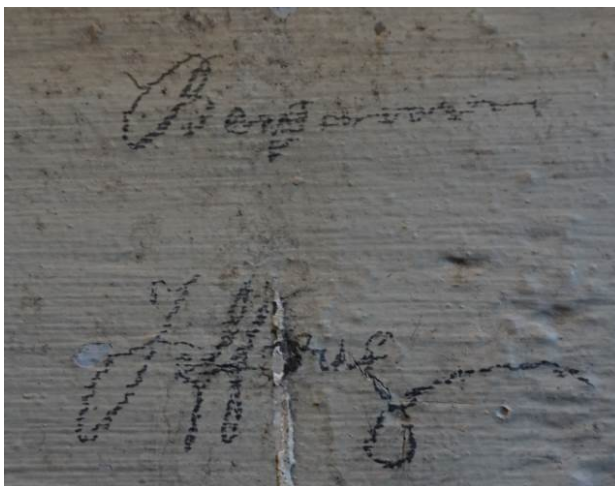
Either as part of this phase or probably as a later (phase 2) addition, fake panelling was marked out by applying simple undetailed timber rails or stiles onto the boarding defining square panels. The panels and rails were then at some point painted a light green (*plate 9*); similar green paint can be seen on the stair balusters beneath modern paints.

Plate 9 graffiti on early green paint within panel on panelling

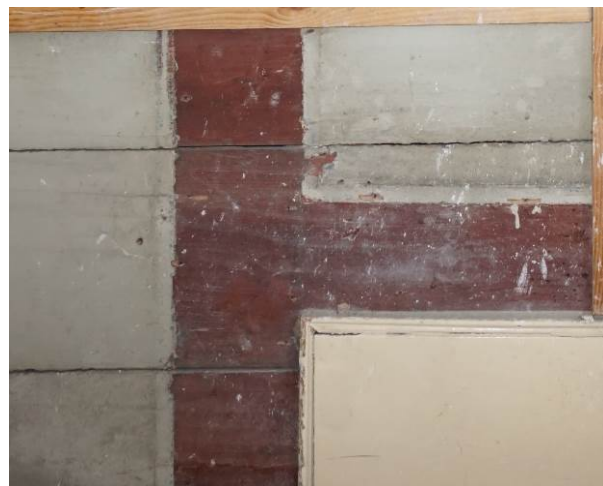
The basic structure of the panelling is of horizontal square edged boarding; this has possibly had a reddish-brown applied finish or patina (*plate 10*). The rough rear of what is likely to be the boards of the other side of the partition could be partially seen behind these, square edged boards. Interestingly, some of these sat at a steep slope, which was initially thought to perhaps indicate a patterned design in the boarding on the other face. However, it seems this just represents the boarding following the slope of the panelling beneath the stairs below.

Latterly (phase 3) a timber moulding was applied around the edges of the rails overlying the green paint. The panels within these new mouldings were infilled with further timber panels applied to the original boarding flush with the top of the rails. The dirt shadow of the applied mouldings on the underlying paint may suggest there was a lag between the moulding being applied and the secondary panel infill.

Plate 10 panelling detail showing original reddish finish and dirt shadow on paint around lost applied mouldings

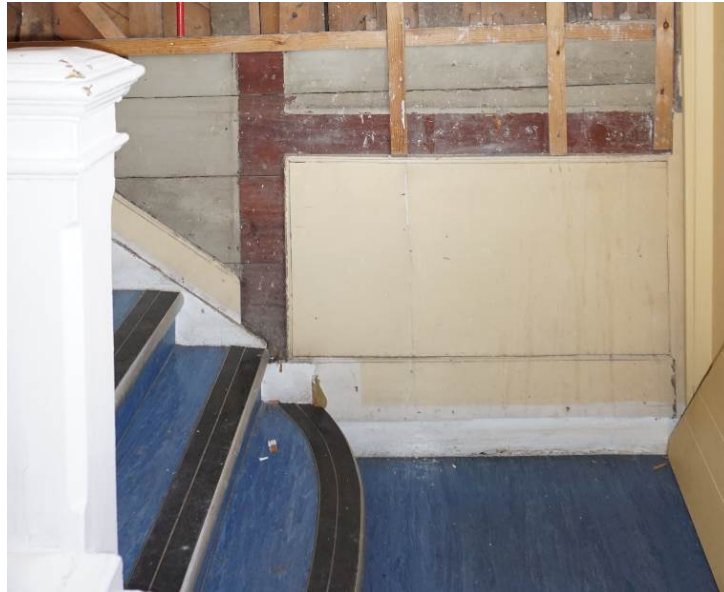
The skirting/base rail along the landing on the north elevation seems very deep compared to the panelling elsewhere; this may help explain the extra stair at the base of the upper landing which is currently strangely bowed out at the base of the flight. If this step was original, a wider step sitting at 45° to the skirting/ base rail of the panelling would have originally been the same visible height as elsewhere (*plate 11*).

Plate 11 half landing showing bowed step and deep skirting beyond

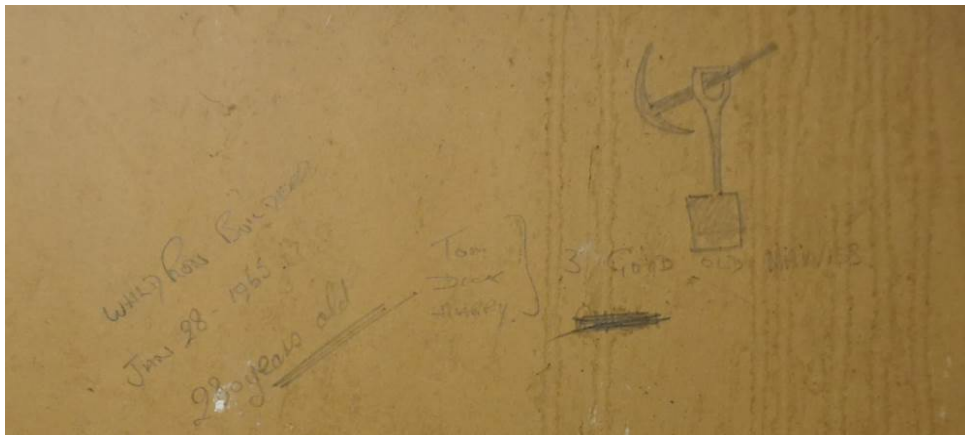
The partition between F.01 and F.04 toilets was investigated and much of the later 20th century material removed. The later phases of this were often of poor quality construction. The western third of the partition proved to be a modern stud partition and the lining was stripped back to studs. Noted on the rear of the removed plasterboard was an inscription likely to have been made during the construction of the partition (*plate 12*).

Plate 12 room F.01/F.04 partition graffiti

This pencilled inscription read “WHLDRON BUILDERS, JAN 28 1965, 28^o YEARS OLD” and “TOM, DICK, HARRY, 3 GOOD OLD NAVVIES” with a pick and shovel logo.

This suggests these partitioning works were undertaken in January 1965.

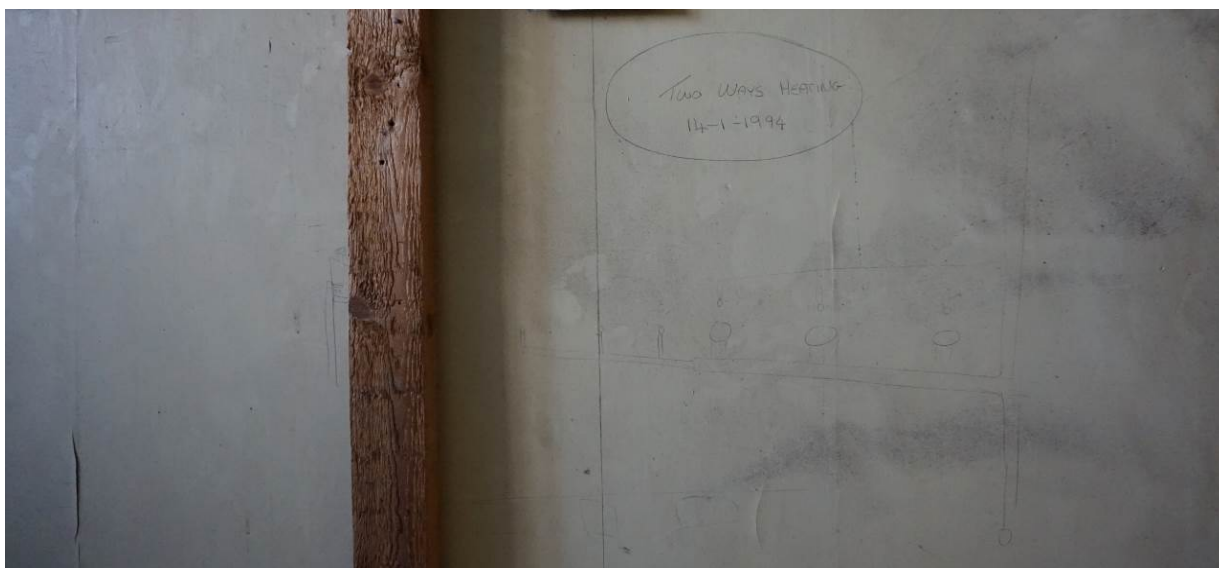
Further graffiti was noted behind the latest lining written on the lath and plaster of the early fabric (*plate 13*). This was “TWO WAYS HEATING, 14-1-1994” and a sketch of some possible plumbing, giving a date for some heating works undertaken January 1994. The latest linings within the toilets overlie this and must postdate 1994.

Plate 13 room F.04 graffiti behind modern lining

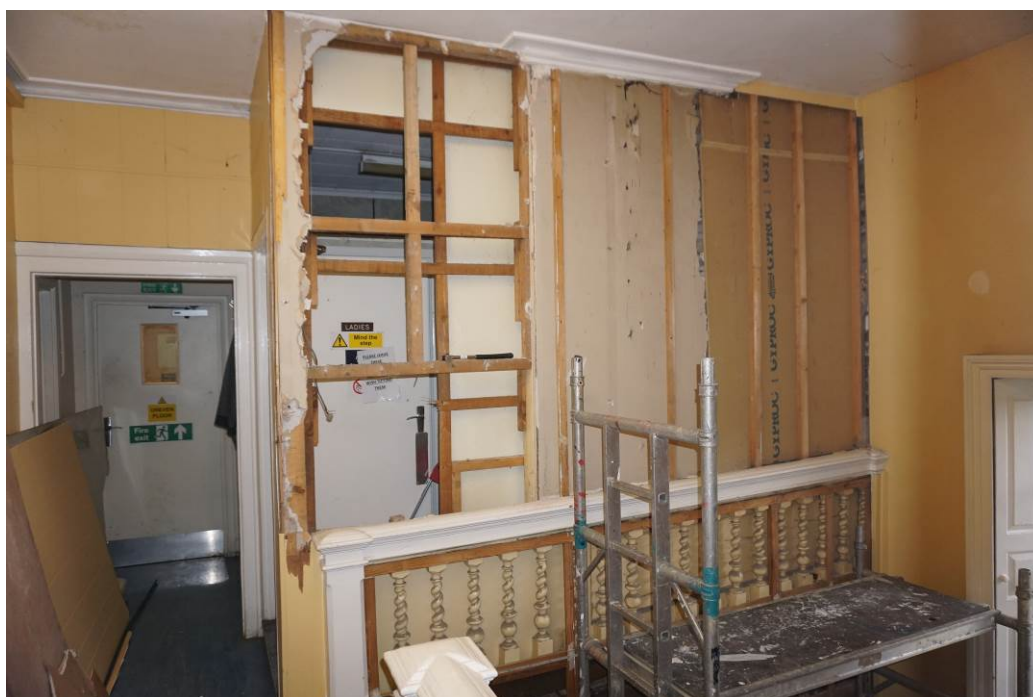
As in the south and east elevations the lath and plaster of the partition had been stripped back to the stud structure in a 1m wide strip down the east wall and the cornice within the stairwell was lost in this area (*plate 14*). Some evidence for rot can be seen in the ends of the lath exposed in this former opening up showing damp was likely the cause of the opening up and repair.

The stripped area was crudely infilled with plasterboard sheeting and removal of these exposed the original studwork of the elevation and phasing details of the early arrangement.

Plate 14 1st floor partition between stair F.01 and toilets F.04 showing surviving strip of original fabric down the middle with mid-20th C stud partition extension to left and later 20th C repairs to the right pre removal. Note truncated cornice

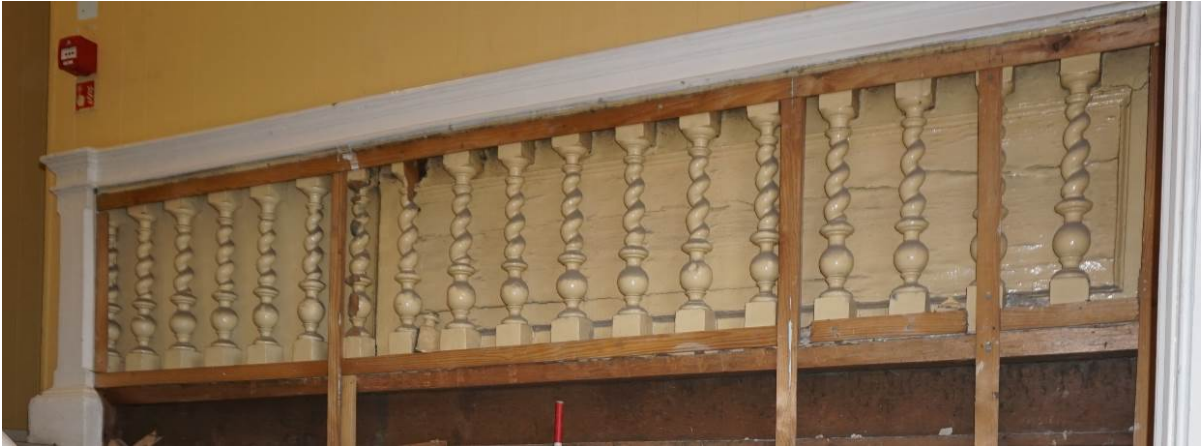
The surviving early fabric within the partition is of two main phases, the earlier and presumably original is represented by horizontal timber board panelling to the lower wall facing the stairwell. Applied timber rail and stiles forming a single large panel may be secondary as on the panelling below. The panels have been papered over so the original finish is not visible (*plate 15*).

Plate 15 papered over boarded panelling behind baluster

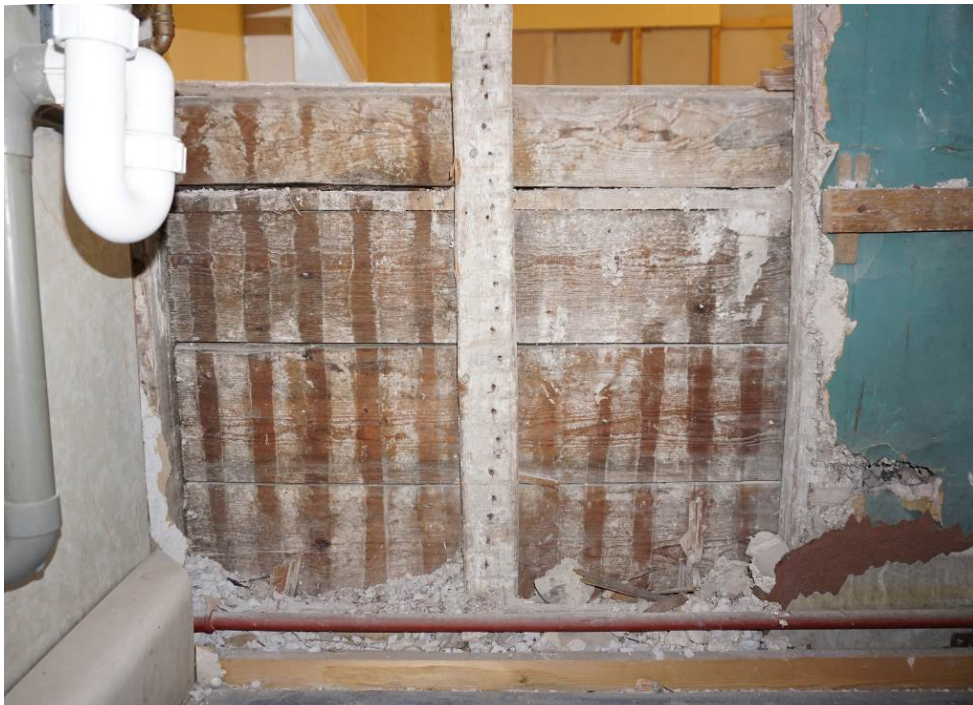
The other side of the partition showed the studs to have been originally visible, fairly well squared and heavily lime washed over. The rough rear of the timber board panelling was also exposed; this had vertical lath directly applied to the timber and plastered over between the studs. The lath and plaster above was likely to have been plastered on both sides of the lath as the line of the plastered face can be seen running up the sides of the studs (*plate 16*).

Plate 16 rear of partition showing rear of panelling and neat lime washed studs

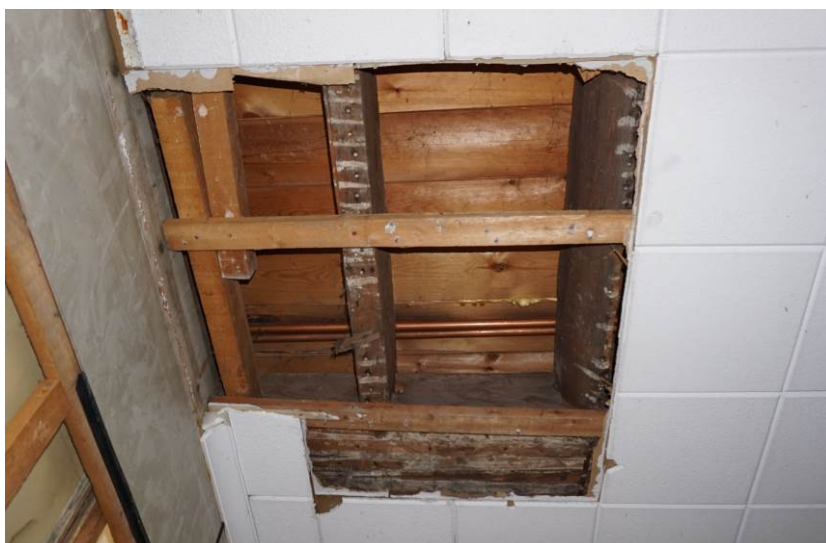
A small opening up was also made in the ceiling. This removed modern lining to expose the structure above to see if any proof for a suspected stairwell that formerly may have ran through here could be identified (*plate 17*).

Plate 17 room F.04 ceiling investigation shows floor structure

The underside of the flooring above was exposed as well as the floor joists. A major squared beam ran north to south to the west of the opening (bottom of *plate 17*) with joists running east to west from this to the east wall. No definitive evidence for a stairwell was seen and it was not clear what was supporting the north end of the north-south beam; the end may have originally sat on a partition that was removed to form the toilets.

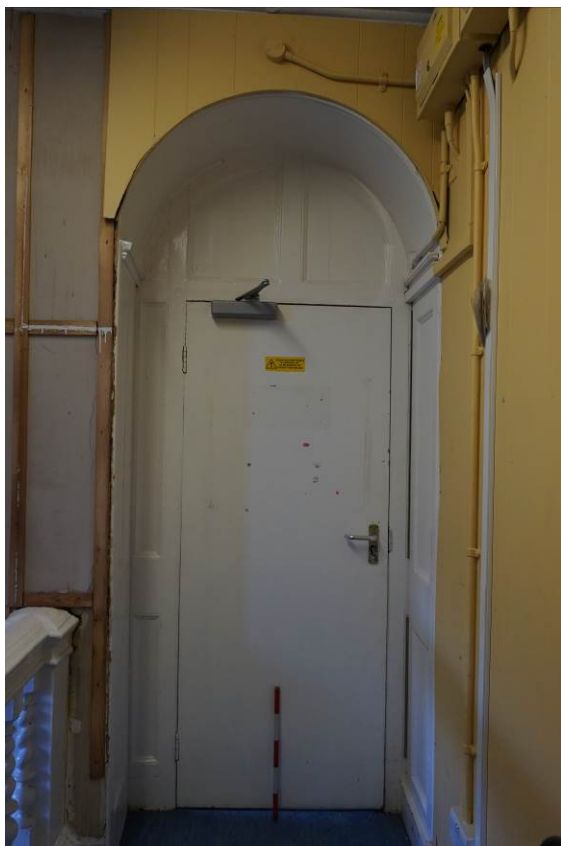
The surround to the door to F.02 showed some reworking. The panelling above the door on the F.02 side was of square panels but on the F.01 side was an arch over the door with curved panels (*plate 18*). Close examination of this showed the curved stiles/rails to be secondary and not centred on the panelling. The panelling surround to the door was also wider than the current door entrance within F.01; the moulded panelling can clearly be seen heading to the west behind the west elevation of F.01 (*plate 19*).

Plate 18 room F.01 door to F.02, note secondary arch over door off centre

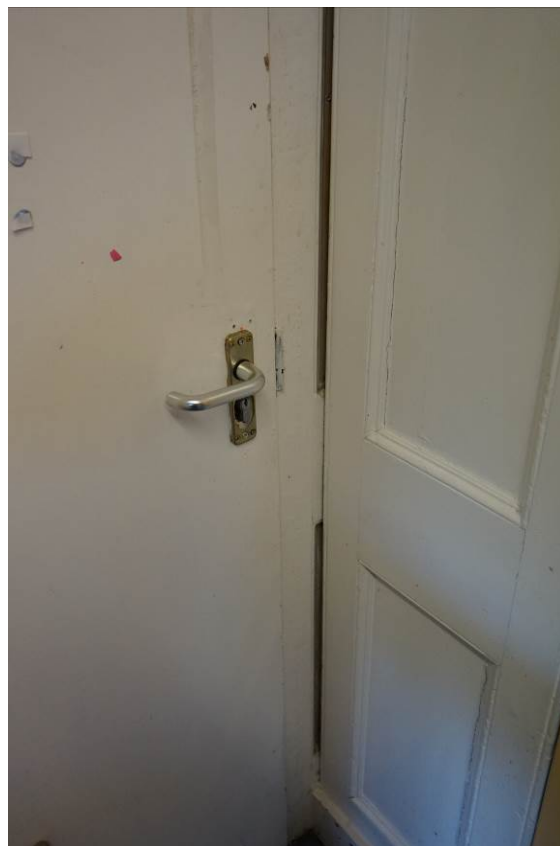
Plate 19 room F.01 door to F.02 detail of moulded panelling round door heading behind western partition

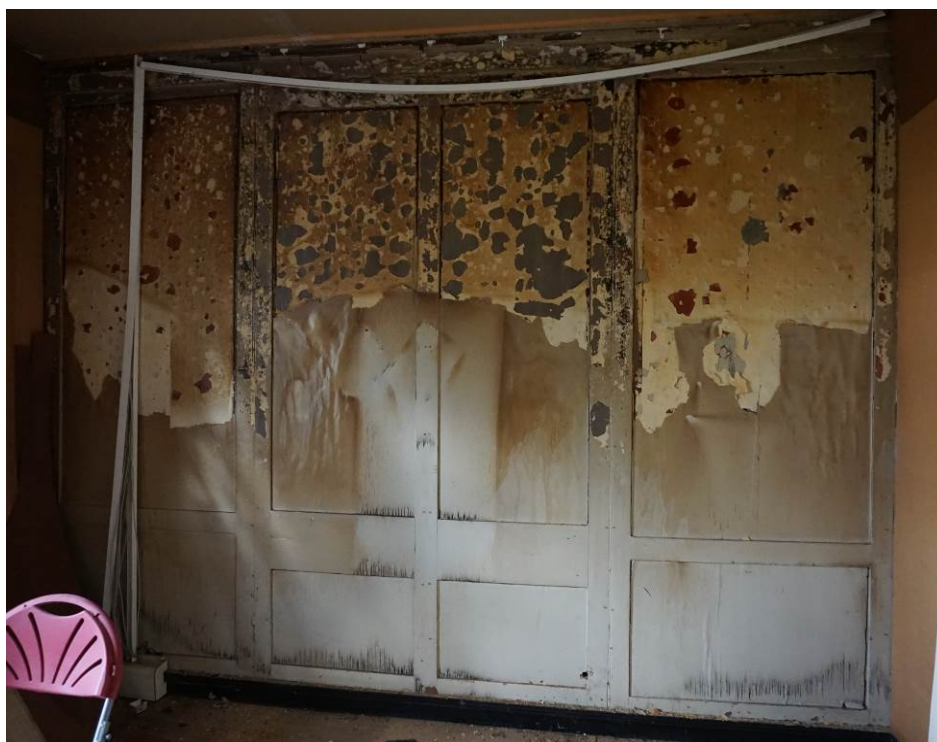
Modern hardboard lining was removed from the wall exposing a further elevation of heat damaged early wooden panelling, matching the visible panels (*plate 20*).

Plate 20 room F.03 early panelling exposed
