AA2346.00
Greenridges, 99 Ballam Road, Lytham

Historic Building Recording: July 2018

Sanderson Borland Architects

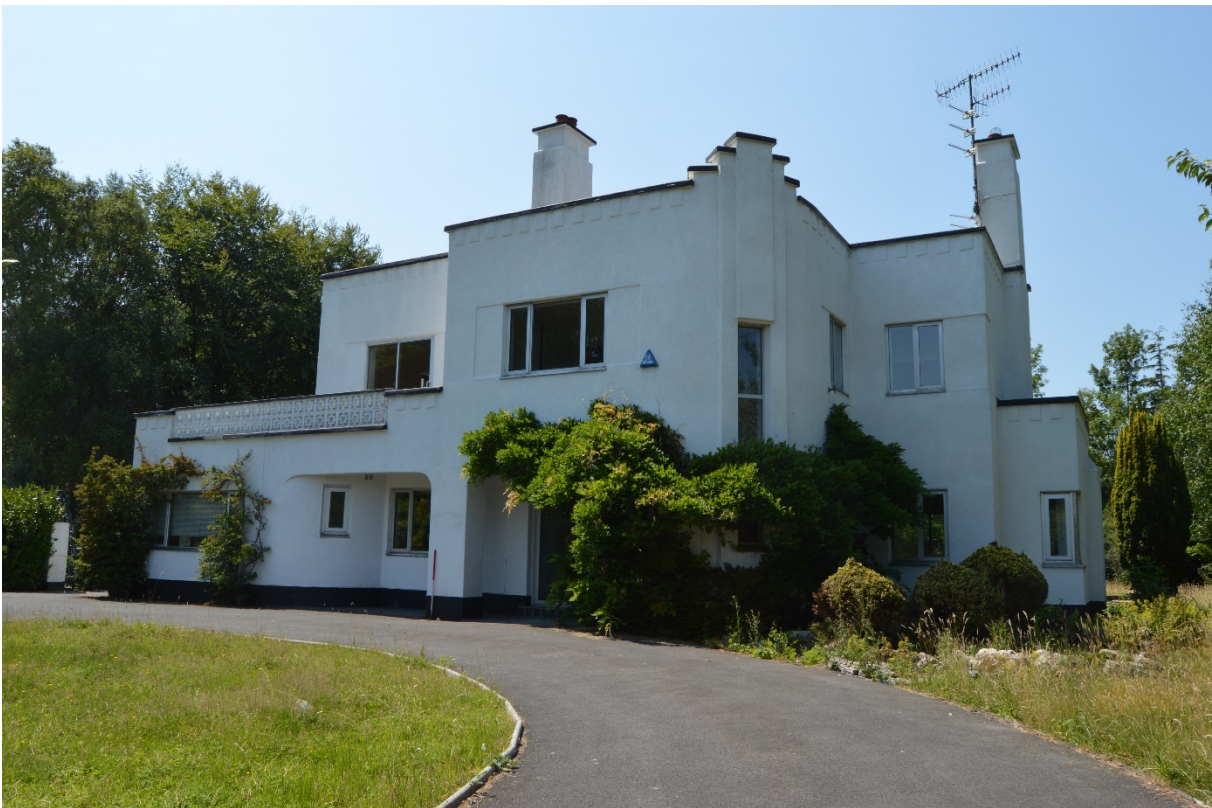
Plate 1 Principal elevation of Greenridges (photo 008)

The principal elevation of the building (*plates 1 and 2*) can broadly be divided into four bays at ground floor level. From north to south this comprises lights to the lounge, an entrance and two lights to the hall, lights to the morning room and store, and finally a light to the games room. The entrance and lights to the hall and morning room respectively are sheltered under an arcade, supported by a single pier. The north end of the ground floor also extends a short distance beyond the line of the first floor, which is supported in turn by a buttress. The first floor exhibits decreased massing and its reduced extent is divided instead into three bays, with a light to the master bedroom, a light to bedroom 3 and an entrance to bedroom 2. In addition, the entrance to bedroom 2 provides access to a roof terrace, which extends south over the remainder of the footprint of the ground floor. A parapet bounds this roof terrace. The first floor is crested by a flat roof, again bounded by a parapet though this time punctuated by a central pair of chimney stacks, accompanied by a third chimney stack on the north side of the building (*plate 3*).

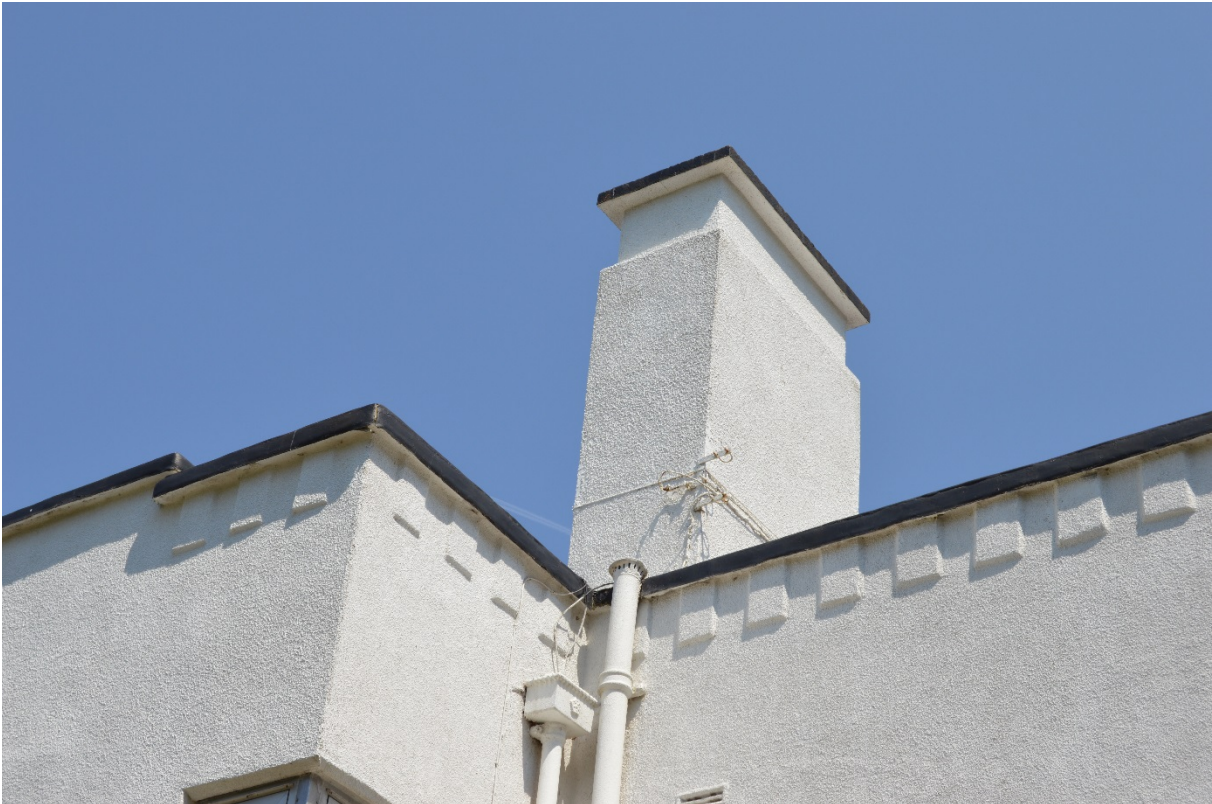
Plate 3 Detail of chimney stack (photo 089)

Several other features are distinct to particular elevations. The most prominent of these is a long, thin stepped panel positioned above the first floor windows on the west elevation (*plate 11*). As with the north-east corner of the building, the otherwise flat parapet steps up in line with the panel. On this same elevation, moulded lintels can be identified above the master bedroom window and the conservatory entrance, directly below. These mouldings are clearly a pair. They are either associated with the later addition of the conservatory, or else the conservatory moulding apes an earlier design once associated with the lintel of the lounge window/entrance. Given the absence of this decoration from the flat window to bedroom 1, and therefore an absence of symmetry, it is tentatively proposed that these mouldings form later additions dating to the addition of the conservatory. A porch with dentil decoration overhangs the south entrance to the building on the south elevation (*plate 12*). A hexagonal porchlight is positioned central to the underside of this porch and may represent one of the few surviving original fittings. Finally, the chimney stacks each have a broad inset course positioned along their length just prior to flat and squared flaunching, from which the pots rise.

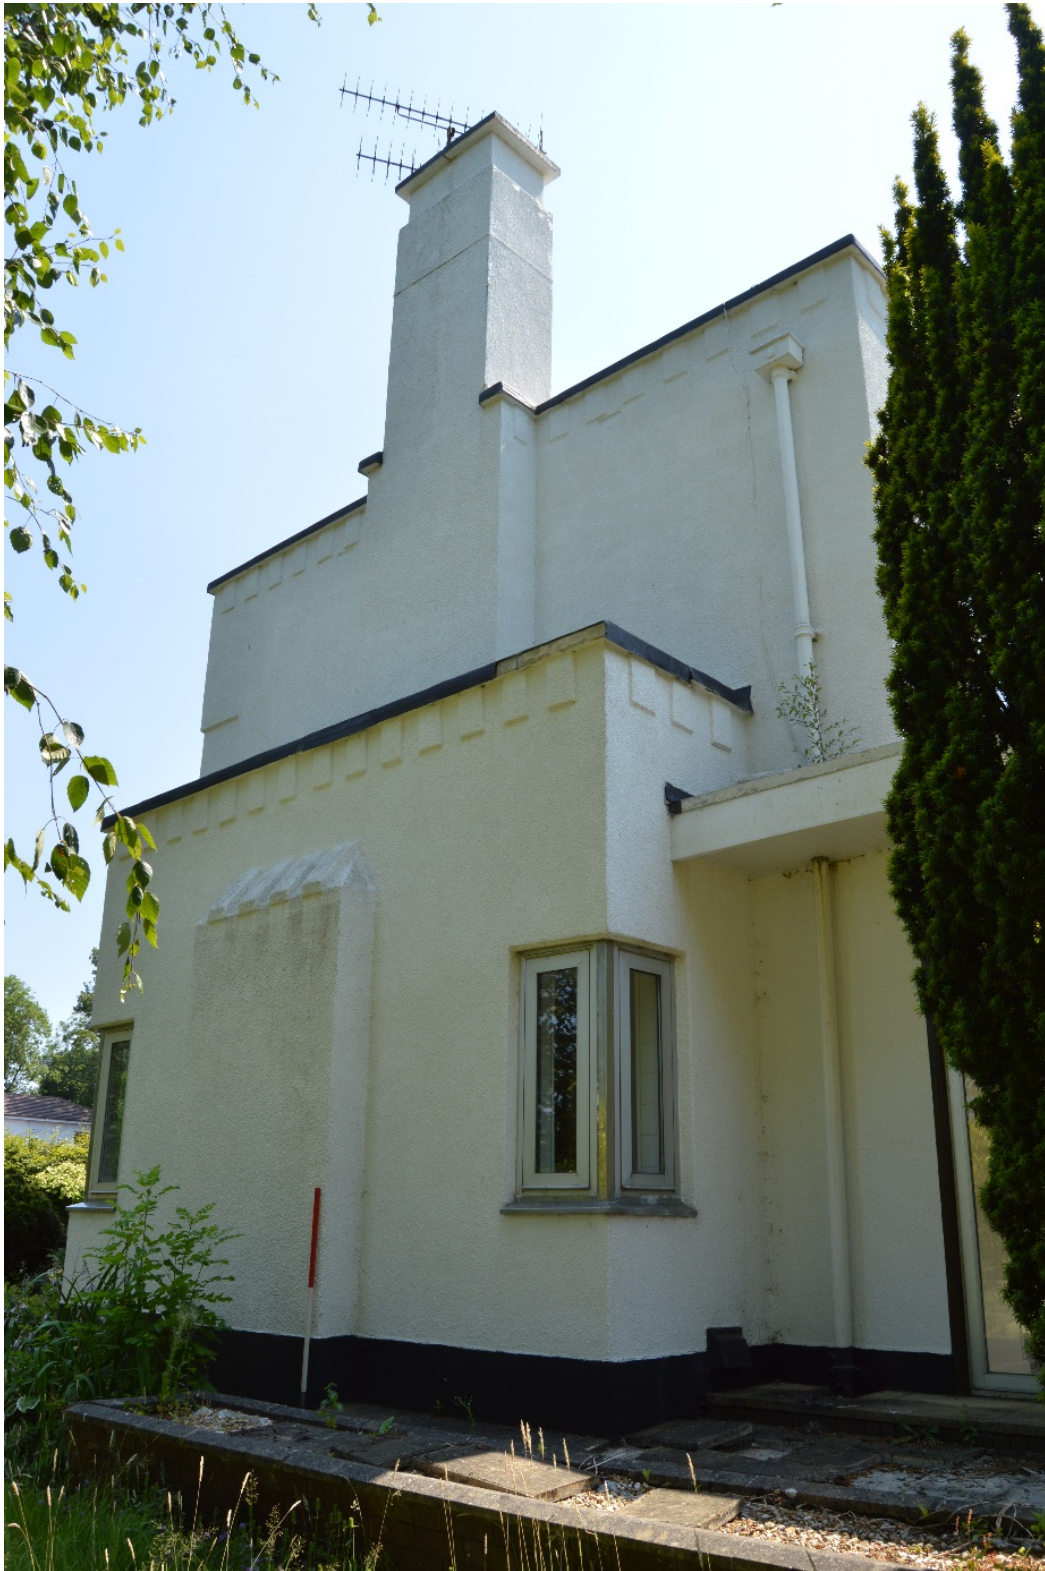
Plate 4 North elevation of Greenridges (photo 027)

Two original bays are visible on each of the ground floor and first floor areas of the north elevation (*plate 4*). At ground floor level from east to west these comprise the lights of the hall on the one hand and the wrap-around lights of the lounge on the other, with the latter including a buttress (as support for the chimney flue). At first floor level these comprise lights for the hall (1F) and again the chimney flue. At ground floor level the later addition of the conservatory could be considered to constitute a third bay. Beyond this storey, the north chimney stack rises to its height.

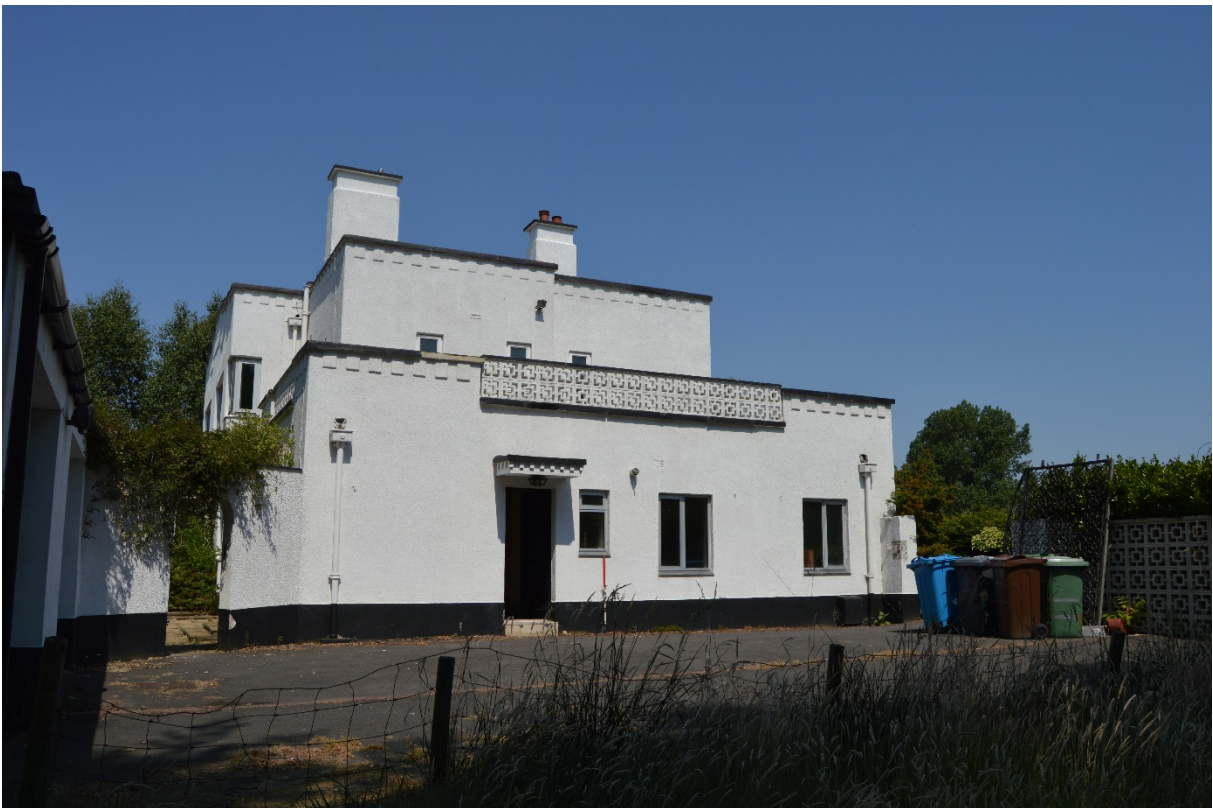
Plate 6 South elevation of Greenridges (photo 017)

There are two bays apiece on each of the storeys of the south elevation (*plate 6*). From east to west at ground floor level these comprise the lights of the games room and the entrance to the kitchen/diner. At first floor level on the same vector these comprise the lights of bedroom 2 and the bathroom.

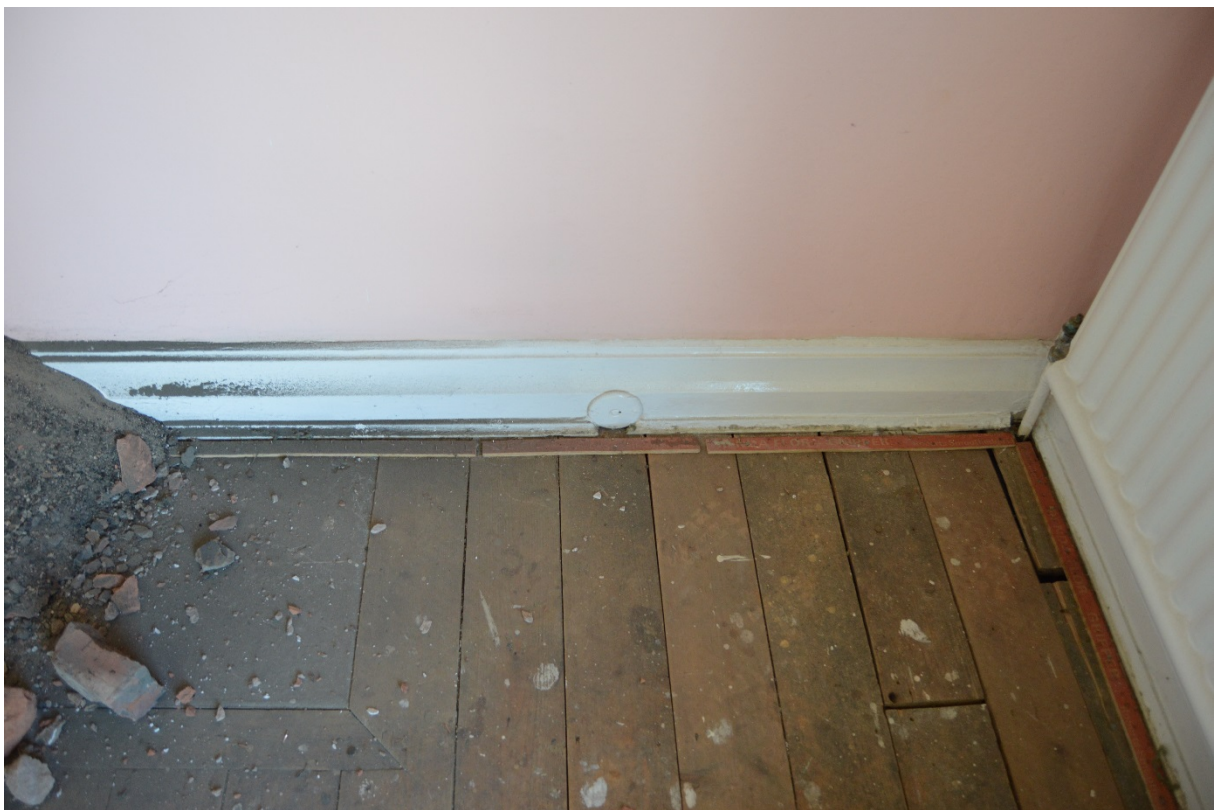
Plate 15 Example of lapsed electrical fitting, bedroom 2 (photo 331)

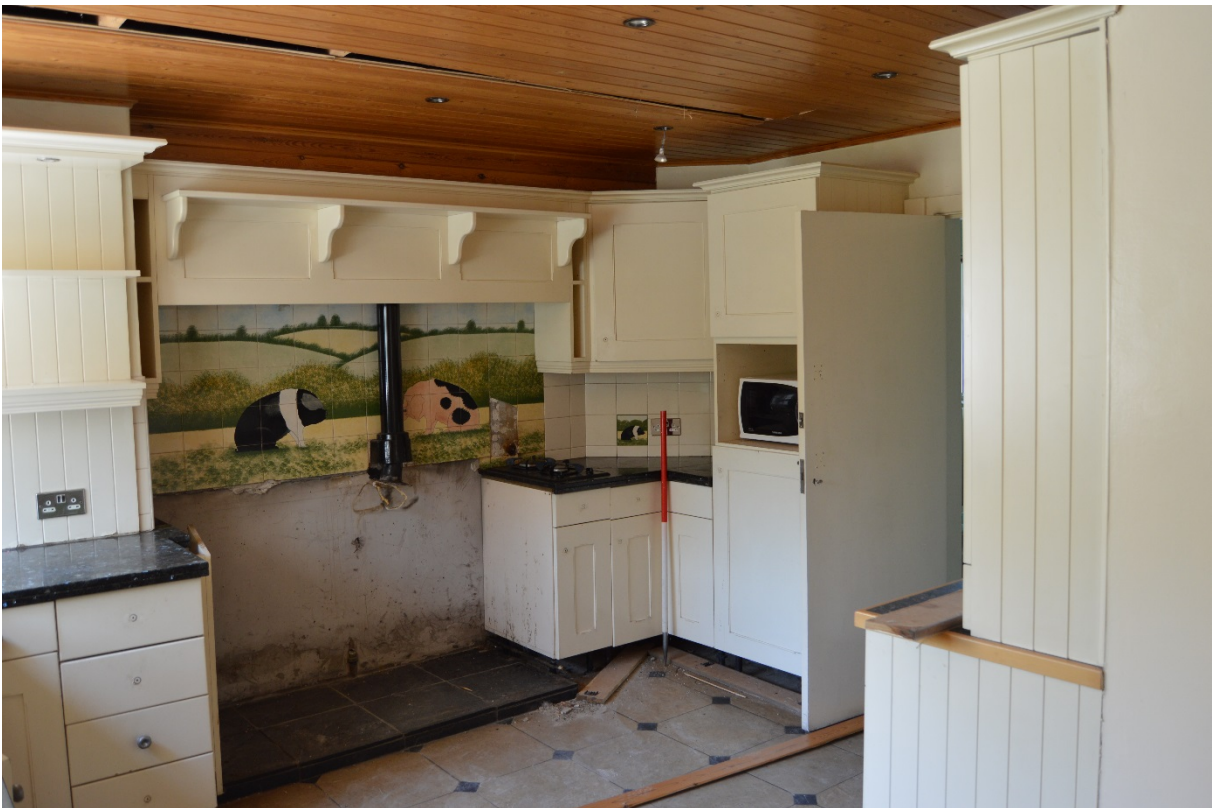
Plate 20 Kitchen (photo 164)

Further reconfiguration of the layout is apparent in the kitchen/diner and cloaks/utility areas (*plate 20*). A sketch of the original layout shows cloaks/utility as a smaller coal store. This has since been extended along the width of the games room, with a further recess at its northern end, intruding within the games room itself. Meanwhile, the south side of the kitchen/diner was divided between three sub-compartments, for a cloakroom, washing room and larder respectively. In the intervening period, these have been knocked through, with the exception of the larder, which was instead reduced in length to form the present pantry. This reconfiguration resulted in the present open-plan kitchen/diner area. The terms of the 1950 sale indicate that the compartments were still in place by this point, although the original kitchen (in the morning room) had moved to the north side of the present kitchen in order to allow for breakfasting in what is now the morning room. As such, the kitchen/diner reconfiguration cannot be fixed in time more precisely than the second half of the 20th century. The addition of the conservatory can be assigned to the more precise date of 1977. This obscured an earlier casement window, replacing it with a French door that connected to the lounge.

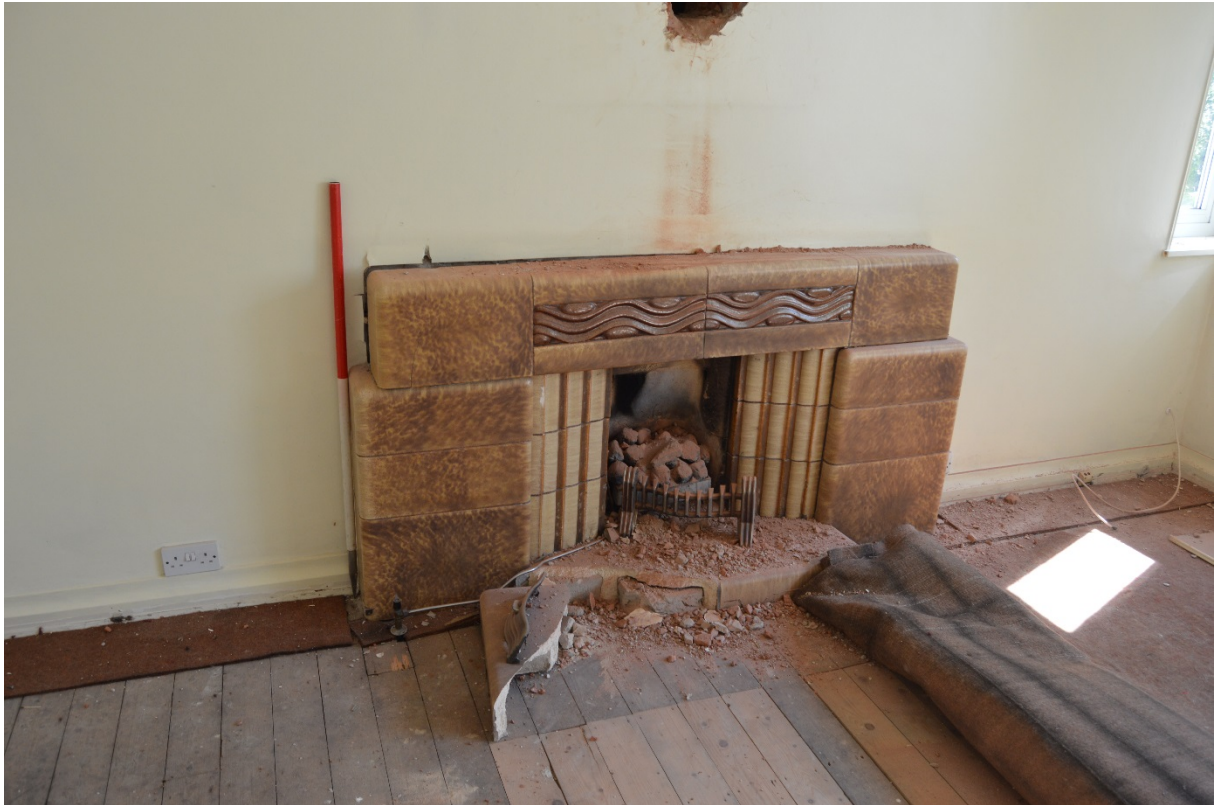
Plate 21 Fireplace, dining room (photo 223)

The fireplaces on the ground floor are all modern replacements with the exception of the Art Deco tiled fireplace on the south wall of the dining room (*plate 21*). Original inset lighting is located on either side of the recess for the fireplace in the lounge (*plate 22*). The stepped motif found on the exterior (and on the door handles) is repeated once more on the banister rail of the staircase itself (*plate 23*). The other side of the rail is matched by a chrome rail, though it is unclear whether this actually represents a surviving original fitting.

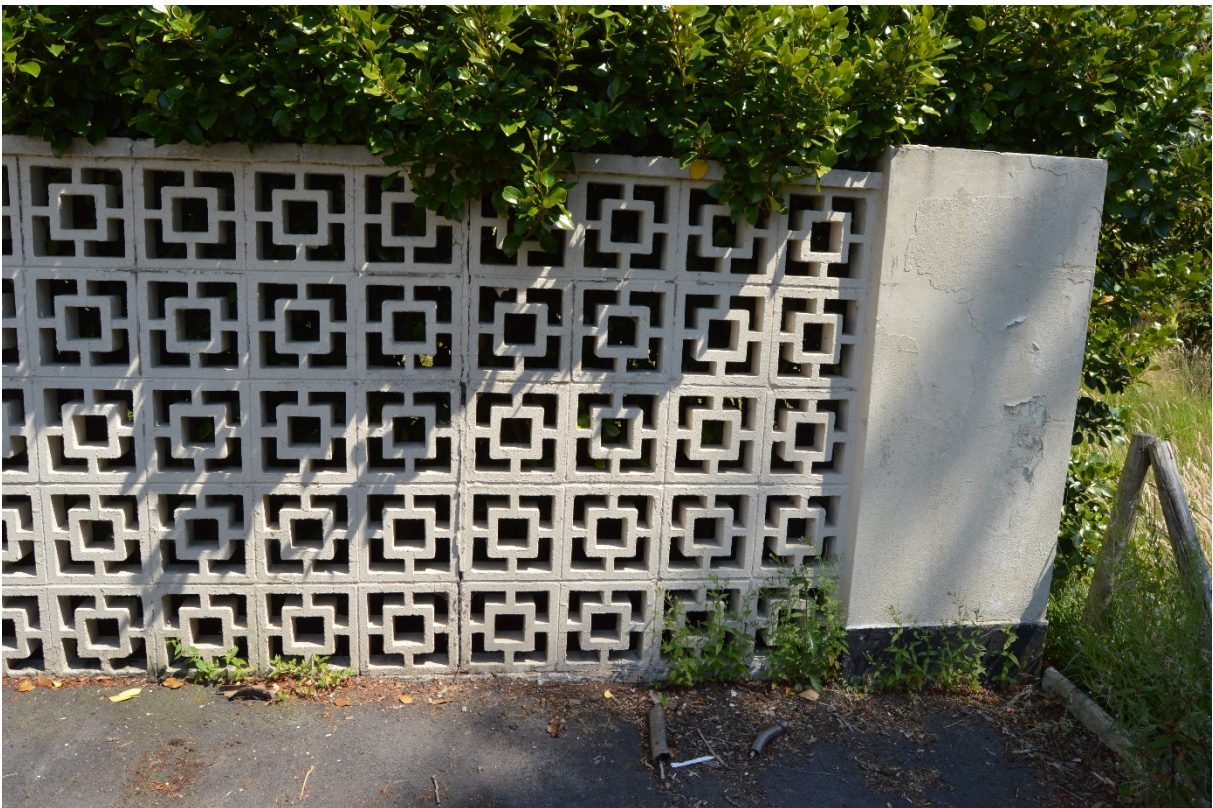
Plate 31 Courtyard wall with decorative blocks (photo 092)

Three substantial ancillary structures are present within the property boundary of Greenridges. A pair of garages is located immediately south-west of the residence linked to the main house by a panel wall, with a greenhouse abutting the west wall of each (*plates 29 and 30*). Ordnance Survey mapping, as noted above, confirms the presence of both garages by 1966. Sketch plans of the property assume that the outbuildings referred to in the 1950 sale of the property in the *Yorkshire Post* and *Leeds Intelligencer* include both garages. The lack of mention of an integrated garage in the sale makes it reasonable to assume that parking facilities had been moved outside of the house itself by this time, but it is also clear that the garages were not constructed as a pair. Garage 2 is the earlier of the two, constructed of red brick, a flat asphalt roof and with two windows looking into the garden. The panel wall is contemporary with this garage. Garage 1 meanwhile is of breezeblock construction, with a single light in the south wall and an entrance with flanking lights in the west wall, connecting to the abutting green house. Given the presence of windows and an entrance in the west wall, the greenhouse is almost certainly of the same date as the later garage. Further evidence for the later addition of garage 1 comes from the asphalt surface of the courtyard, which preserves the former southern boundary, aligned with the southern edge of garage 2. The eastern wall of the courtyard, constructed of decorative blocks in the same style as the Roof Terrace, also shows evidence that it has been extended to encompass an expanded courtyard (*plate 31*).
