Barnbogle Castle

South Queensferry, City of Edinburgh

Historic Building Recording and Archaeological Monitoring: July 2017 – July 2018

August 2018

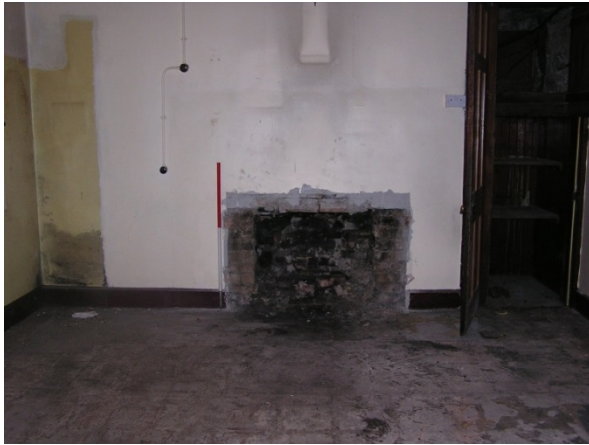
A blocked fireplace was situated on the east wall of the kitchen (*Plate 1*) with a lined wooden press to the right (*Plate 2*); a modern kitchen unit was on the south wall in front of the window opening. The dumb waiter, located outside the kitchen (*Plate 3*) is to be replaced by a cupboard. The press was removed and the fireplace partially unblocked during the later monitoring.

Plate 1 Blocked fireplace in kitchen

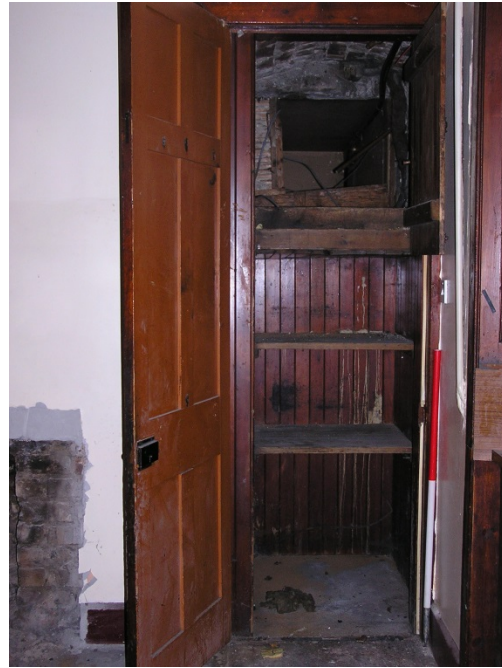
Plate 2 Kitchen press

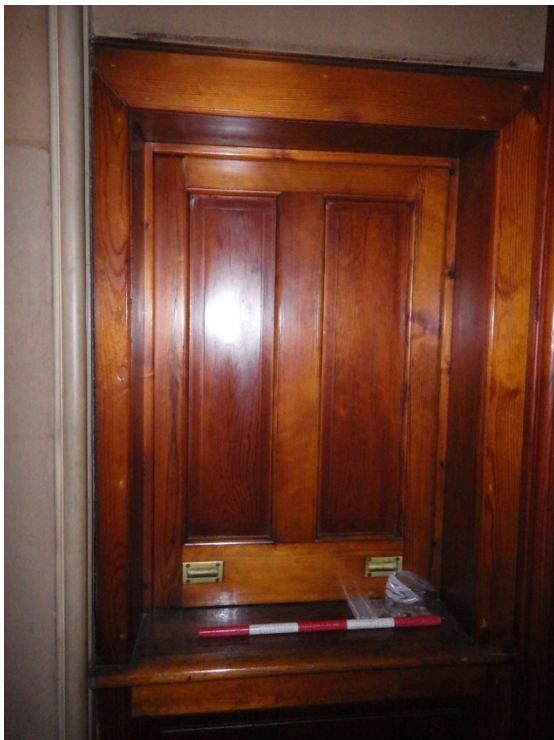
Plate 3 Hoist in hallway

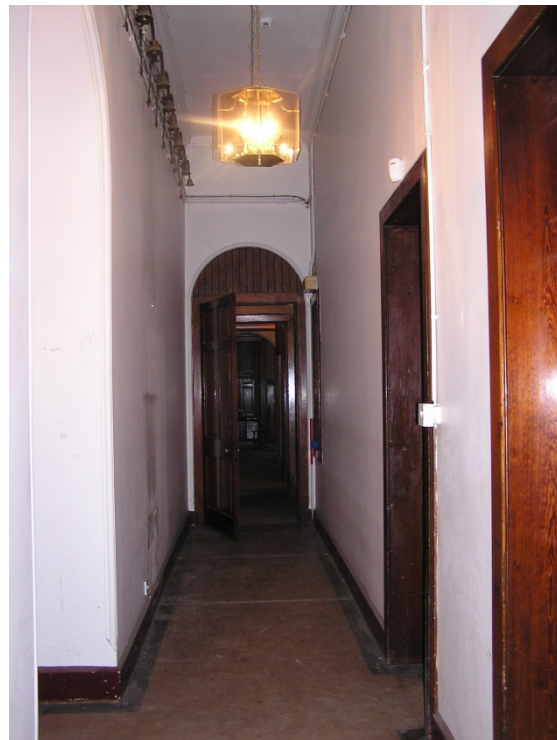
Plate 4 Bells on north wall of hall

Within the hallway servants bells are installed on the north wall, which are to be retained *in situ* (Plate 4) and at the west end of the corridor are two telephones, both to be removed (Plate 5 and Plate 6).

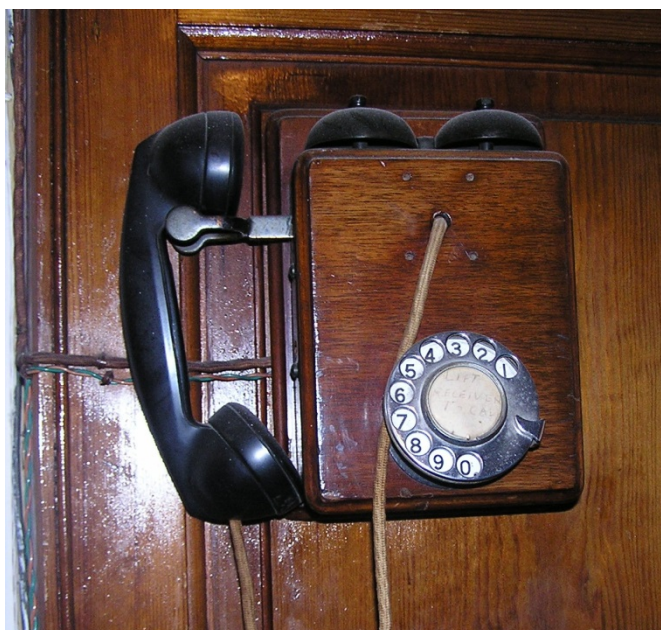
Plate 5 Telephone affixed to wooden shutters in hall

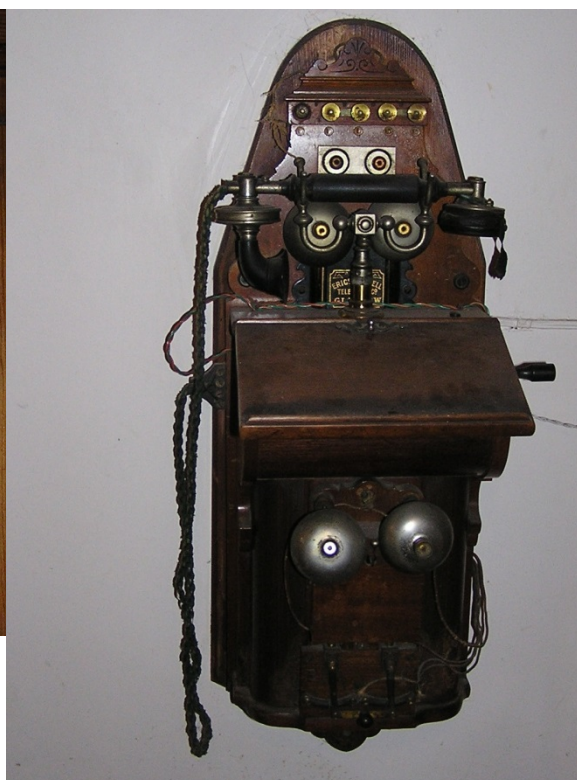
Plate 6 Telephone affixed to south wall of hall

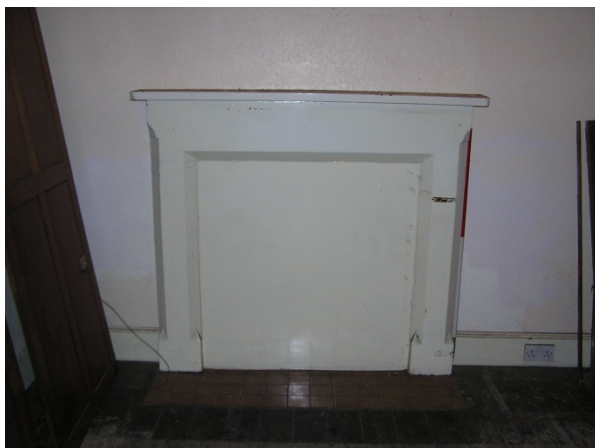
To the west of the kitchen is the archive room. This contained windows on the south and east walls and a modern blocked fireplace on the east wall (*Plate 7*). The window recess was lined with white painted wooden panelling with wooden shutters (*Plate 8*). The room was filled with removed wooden panels and is currently used for storage.

Plate 7 Blocked fireplace on west wall of archive room

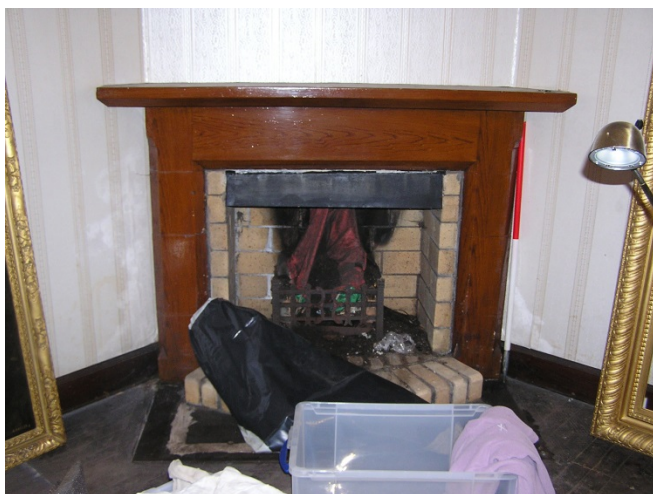
The bedroom was wallpapered and lit by a chandelier. There was a fireplace in the north-east corner of the room (*Plate 9*); this was relatively late, constructed of yellow firebricks with a wooden surround. The windows were recessed and had wooden panelling beneath, with wooden shutters (*Plate 10*). Monitoring in May 2018 revealed the ceiling joists and floorboards above, following opening up of part of the ceiling.

Plate 9 Fireplace in north-east corner of bedroom

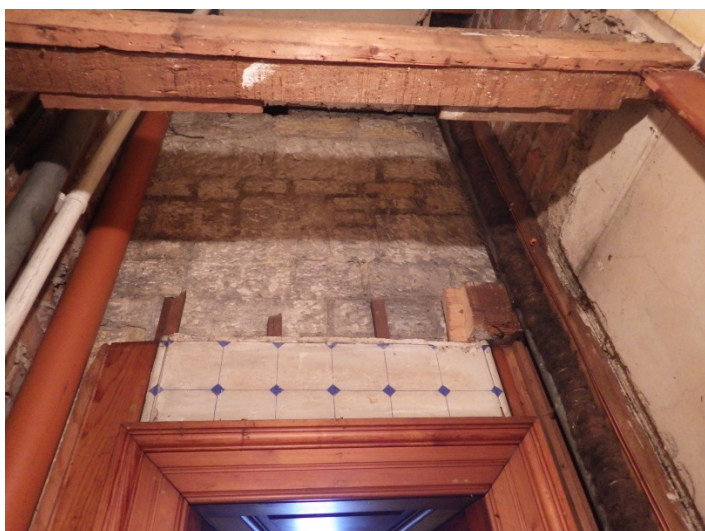
Plate 17 Exposed masonry behind wall of second floor WC

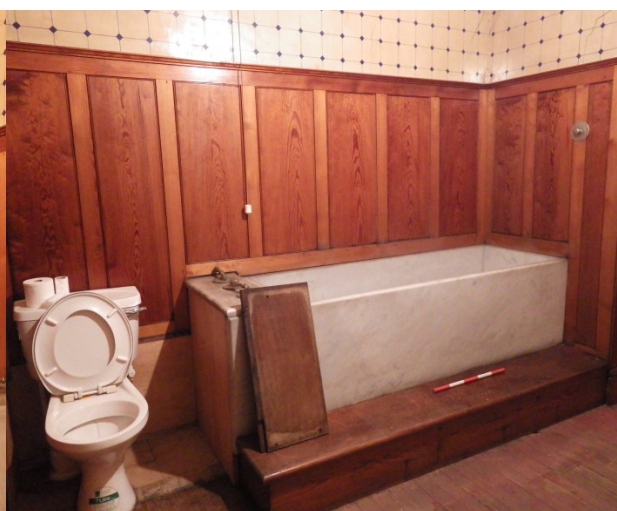
The bath was c2m long and c0.6m deep and was sloped at the south (tap) end (*Plate 20*). There was a handle on the wall marked 'PULL' within a circular metal plate marked with 'OPEN', 'SHUT' AND 'SALT WATER' (*Plate 21*); the owner confirmed that the bath was fed by water from the sea. There were three handles at the end of the bath, made by 'STEWART & RAE, EDINBURGH'. From left to right the handles are marked 'HOT'; 'WASTE' and 'COLD' (*Plate 22*). The hot and cold taps are within a circular metal plate marked with 'OPEN' and 'SHUT'; the waste plug is a handle that is pulled upwards to let the water drain.

Plate 20 Marble bath and fittings second floor

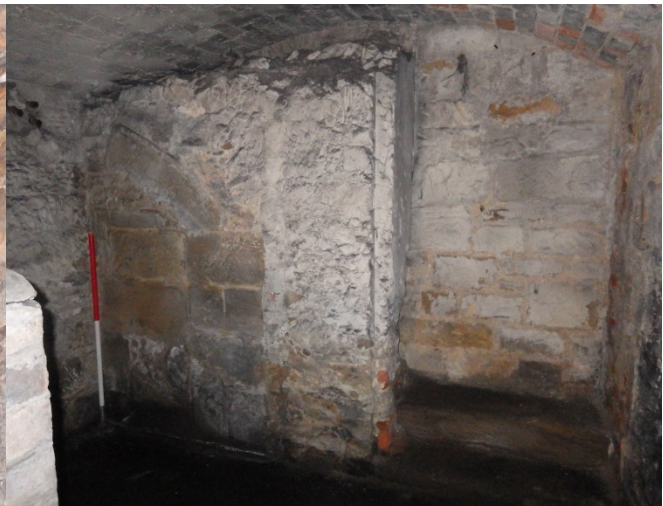
Evidence for the early castle wall can be seen at the west end of the room (*Figure 6; plate 26*). This shows a stone springing arch, which presumably would have originally extended across to meet the cut bedrock wall on the north. This has been latterly truncated and the opening in the arch filled in with stone, probably at the time of the building of the 17th century castle. To the north of the arch is further walling, which extends to a series of steps, leading into a further cellar room (N room, see plans in *Appendix D*), again assumed to be associated with the 17th century castle. The third phase sees the 17th century wall truncated at the top in order to insert the brick barrel-vaulting of the 19th century castle. At this point access into the adjacent cellar room was blocked with stone. Further evidence of the modifications is evident on the east wall of the furnace room, where traces of an early wall may survive against the cut bedrock but the opening has been infilled with stone and much later, brick (*Plate 27* and *Plate 28*).

Plate 26 West wall of furnace room, with evidence for medieval castle wall on left and steps on right

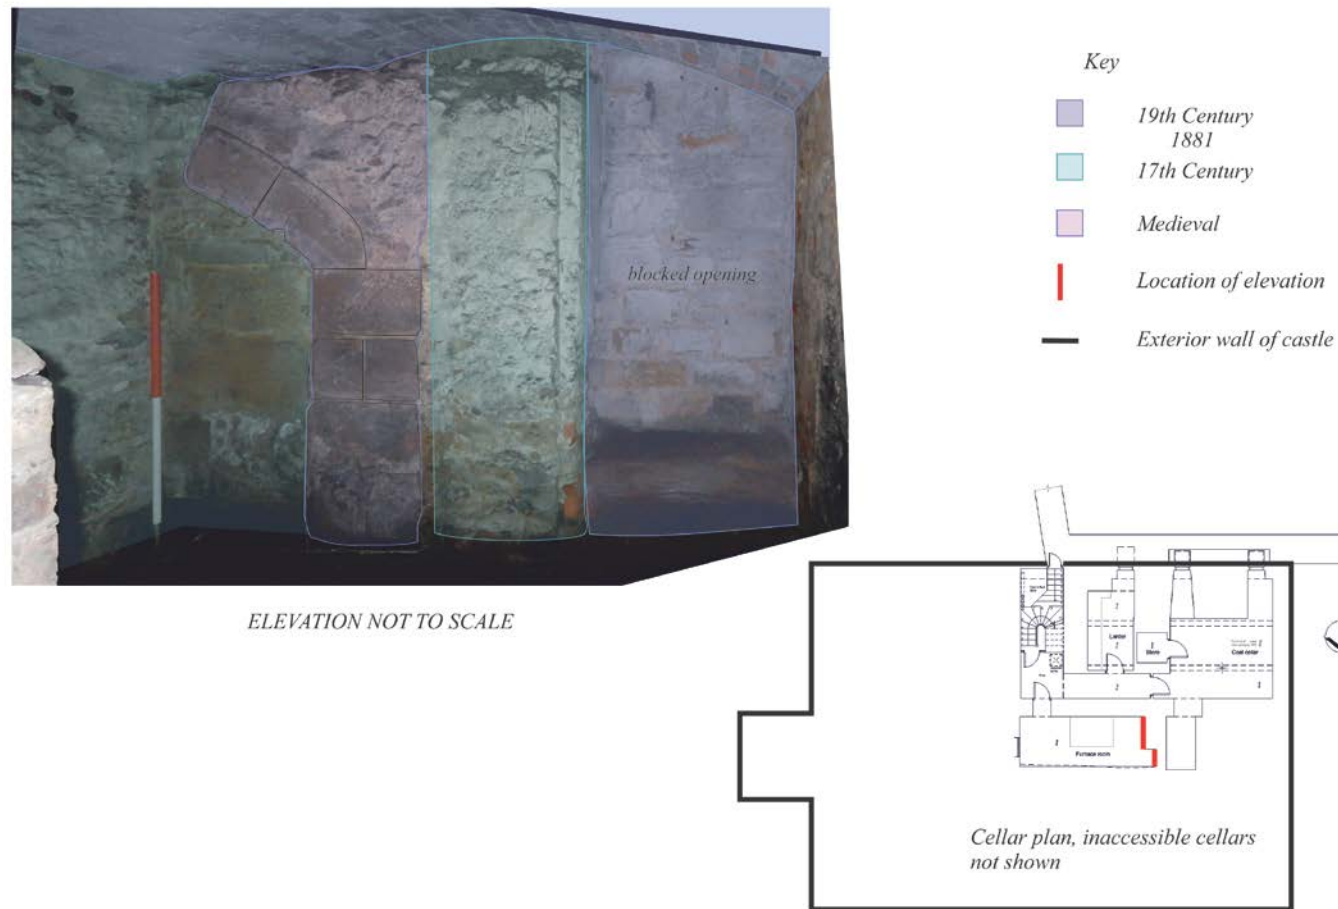
Figure 6 Sketch section showing phasing on west wall of furnace room in the cellar

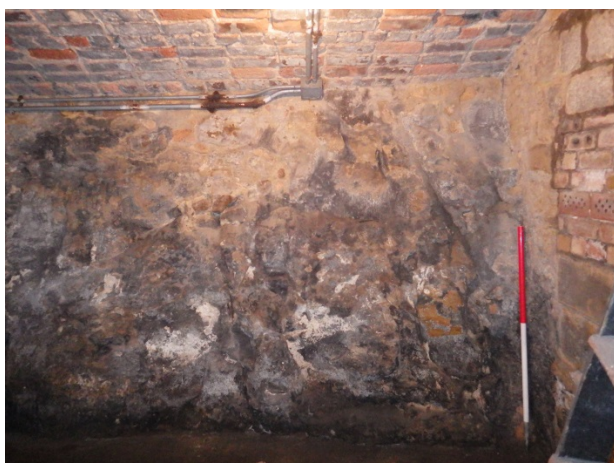
Plate 27 North and east walls of furnace room; showing early masonry against cut bedrock and later infilling of opening

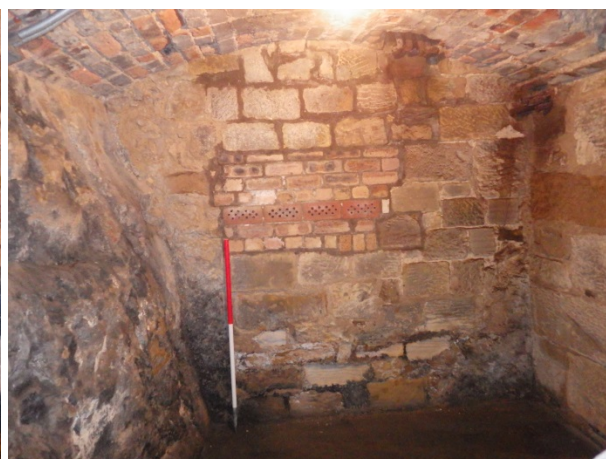
Plate 28 East wall of furnace room; line of medieval masonry is in line with scale; infilling to the right

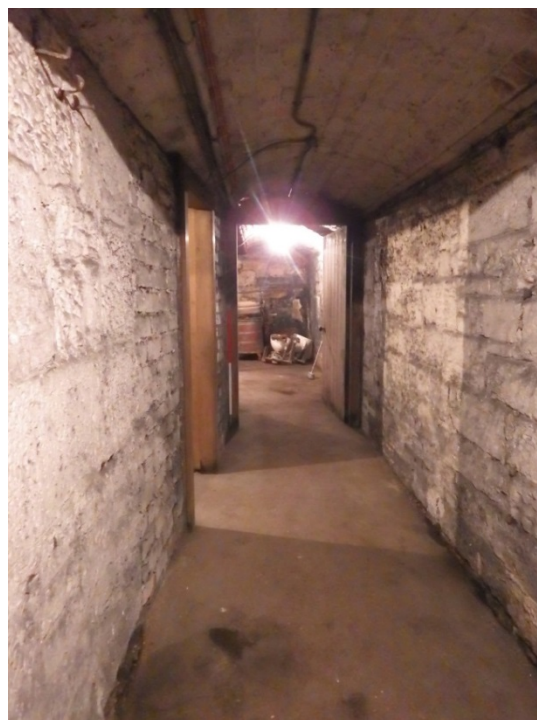
The larder is whitewashed and contains a stone bench around the east wall, with a wooden shelf above and a freestanding table (Plate 29). On the outside wall, there is evidence that this room was originally open and the doorway is a later insertion. There is brickwork either side of the doorway; this has been whitewashed along with the rest of the room and the corridor (Plate 30).

Plate 30 Looking west along passage with larder door on left; brick infill on either side of door

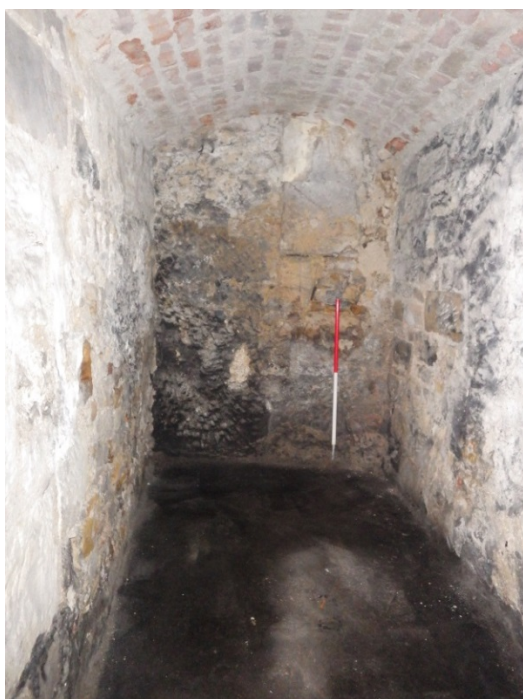
Plate 33 N room off coal cellar; showing change in masonry on N wall and E wall

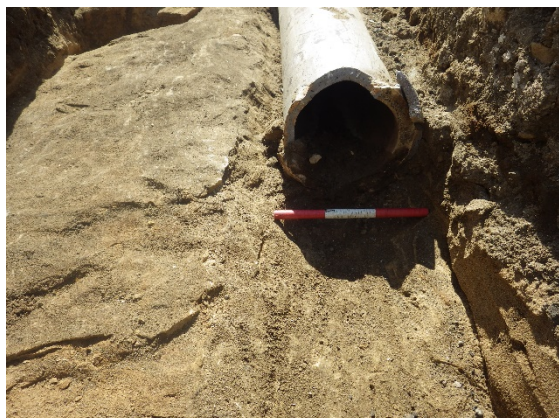
In the terrace area surrounding the Castle, a linear salt-glazed ceramic sewer drain [007] was found overlying the bedrock; cutting it on occasion [006] (see Plate 34 and Plate 35). Considering the late 19th century date of such a drain, it is most likely that this sewer line was installed during the renovation of the building. Over the drain were a series of three levelling backfills, patches of clean sand directly over the bedrock (004), and two loose sandy deposits with high frequency of shells (003) and (002). The whole terrace is covered with a gravel surface (001).

Plate 34 Drain [007] and Cut in Bedrock [006]

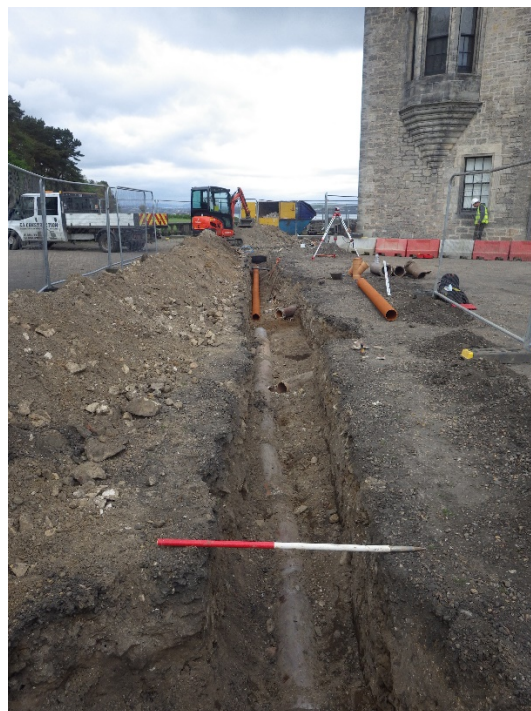
Plate 35 Drain [007]

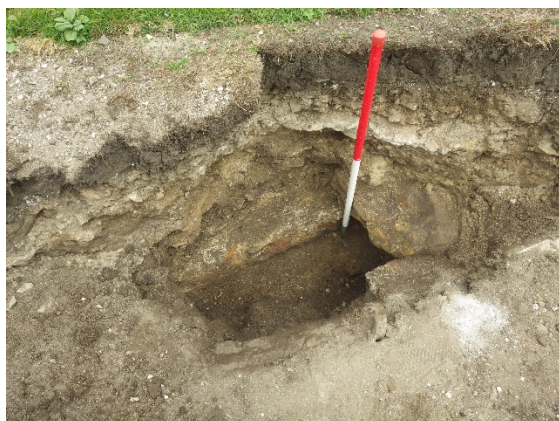
The trench extended to the south beyond the baluster encircling the terrace and traversed the landscaped area. Only one feature was discovered in this section: a vertical sided, stone lined and capped drain, comprising sandstone squared blocks bonded with beige and grey lime mortar over a flat stone base [011]. The drain ran east-west and was filled up to a fifth of its depth by waterborne sand and silt (012) (see *Figure 8* and *Figure 9*). The mortar bounding drain [011] is a tan earth-lime mortar, with shell inclusions and fine sand aggregate, dating to the late medieval period. This drain predates the 1881 renovation of the Castle and was most likely part of the 17th century castle or earlier. No cut was visible. The landscaped garden area is composed of turf (008), overlying topsoil (009) which contains a high frequency of shells and some mortar lumps. This seals slightly lighter brown subsoil, also containing a high frequency of shells and occasional mortar lumps (see *Plate 36*. to *Plate 39*).

Plate 36 Drain [011]

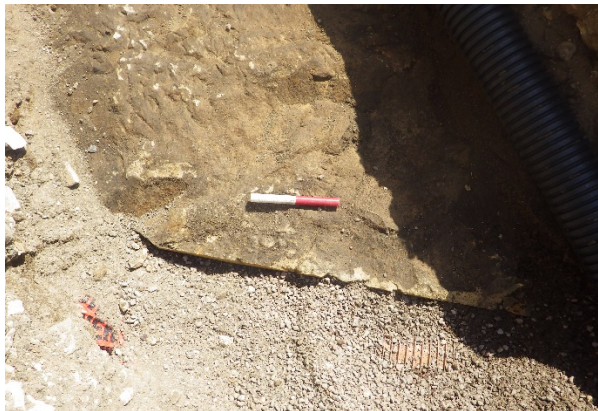
The central section of the Trench 2, running across the Castle terrace, revealed the cut into the bedrock that was made to level the terrace for the construction of the building [025]. It is unclear when the bedrock was terraced and only the west end of the bedrock had been treated that way. A recently installed service trench cut the bedrock on the west side (see *Plate 44 and Plate 45*).

Plate 44 Bedrock [025] with recently installed service

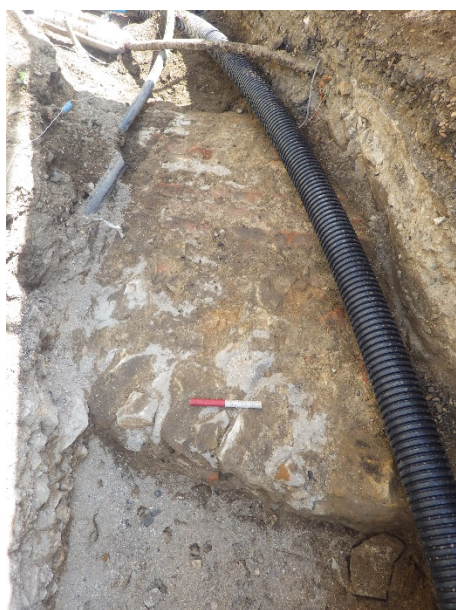
Two built structures were also recorded, side by side, within the trench. One made of squared sandstone and bonded by grey lime mortar [023], the other of brick and grey lime mortar [024] (see *Figure 10 and Figure 11*). Their function and date is unclear, it seems likely, however, that they are wall foundations related to the 17th century rebuild (see *Plate 46 and Plate 47*).

Plate 46 Feature [023], [024] in Background

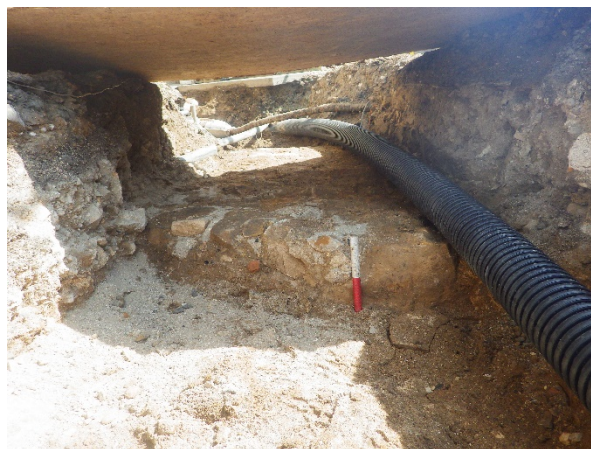
Plate 47 Feature [023], [024] in Background

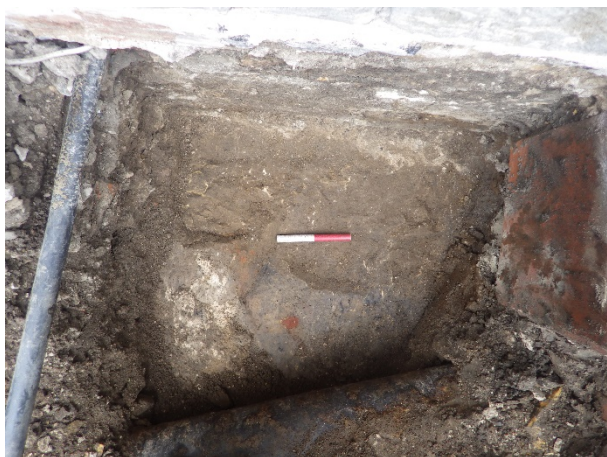
Trench 2 extended to the south elevation of the building and exposed the foundations. The Castle is built directly upon the bedrock, which has been terraced (see *Figure 12*). A layer of mortar was noted between the lowest course of the building and the bedrock, to cement the squared stone directly on the bedrock table.

Plate 48 Castle Foundations

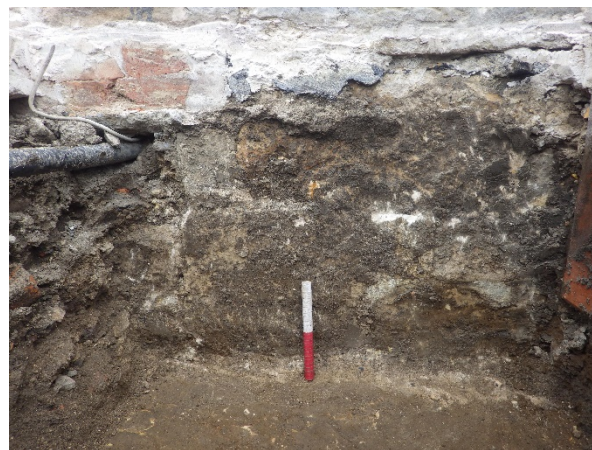
Plate 49 Castle Foundations and Elevation

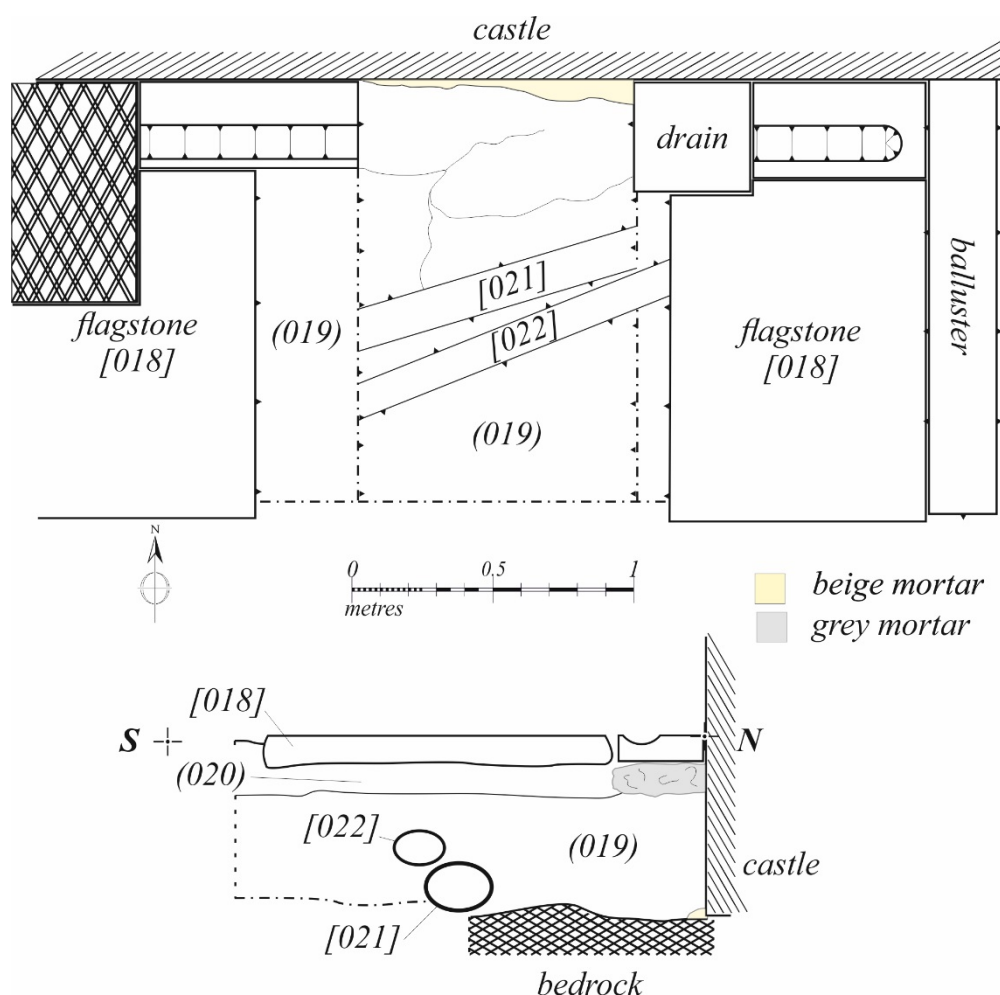
Figure 12 Plan and Section of Castle Foundations
