Black Bull Close

Dunbar, East Lothian

Phase 1: Historic Building Recording, monitoring and evaluation: May – October 2018

October 2018

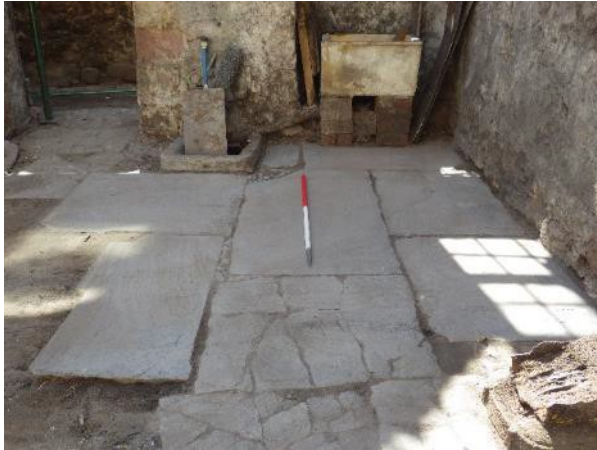
The west end still retained some of the earlier flagstones (*Plate 1*). There were also a number of fittings thought to relate to its use as a butchers shop. A large ceramic sink sits beneath the window onto the close, and a large cast iron boiler was built into a blocked former range/fireplace within the west wall. This room has a window at the north end of the west gable opening out on to Building 2; it appears that this window was formerly a door (*Plate 2*).

Plate 1 Surviving flagstones at south west end (0209)

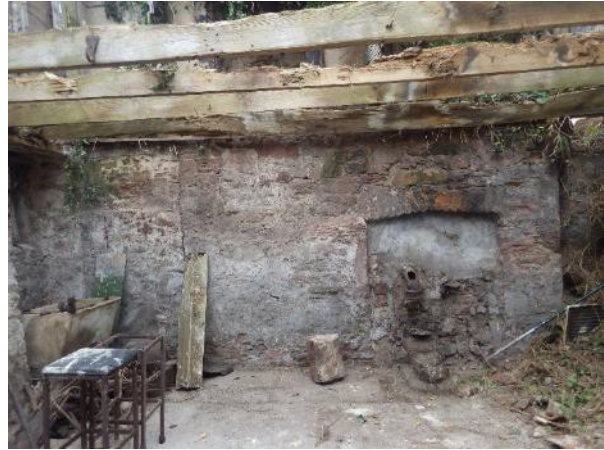
Plate 2 West wall of Building 1 (0160)

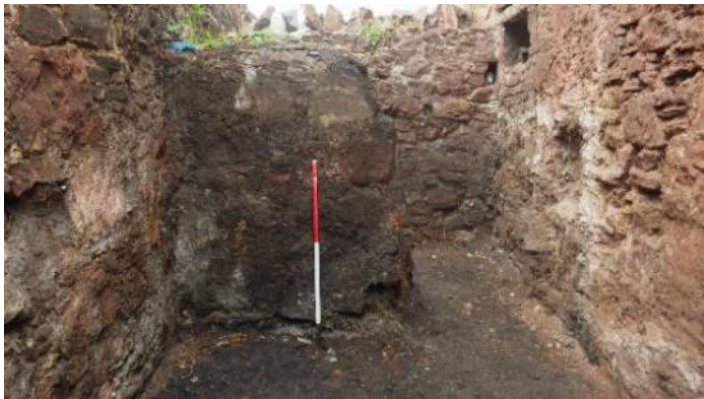
Plate 3 Masonry cross wall Building 2 (0223)

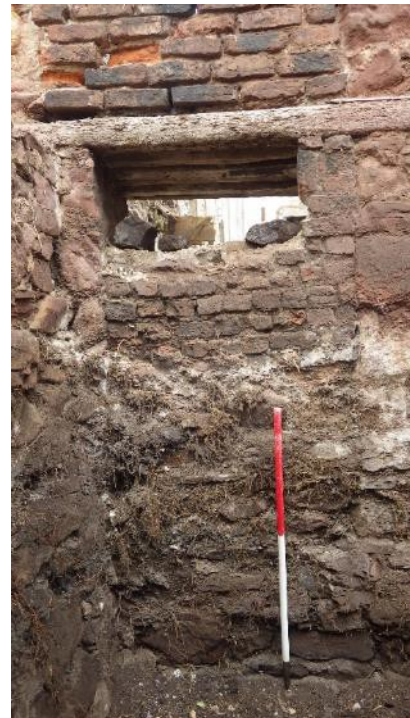
Plate 4 Blocked doorway window between Buildings 1 and 2. (0232)

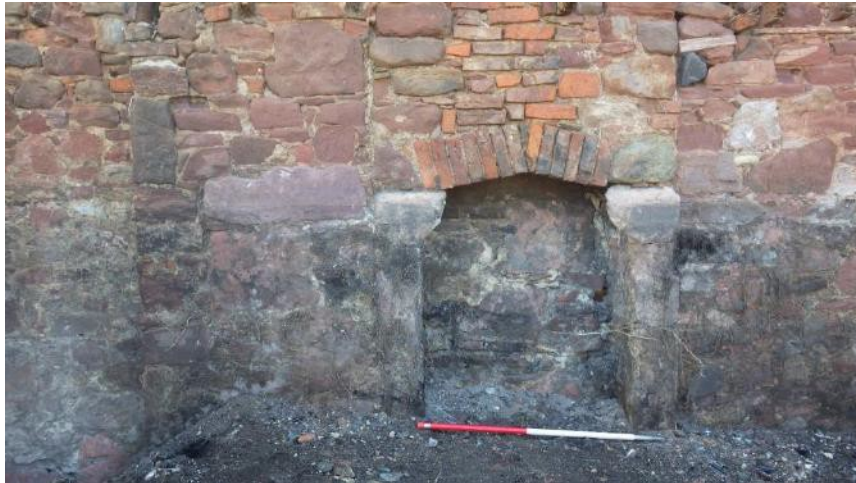
Plate 5 Fireplace in Buildings 3. (0278)

The east gable has several phases represented within the fabric (*Plate 5*). The further excavation of the remainder of the interior may help to shed some light on this. Even following the removal of the vegetation and modern debris, a substantial depth of accumulated soil, pottery and glass had built up. The depth of the deposits and the condition of the building suggest that it has been derelict for longer than the other buildings. There was a large quantity of glass, including a particularly high number of complete bottles, particularly in the area in front of the hearth, recovered from the Building.

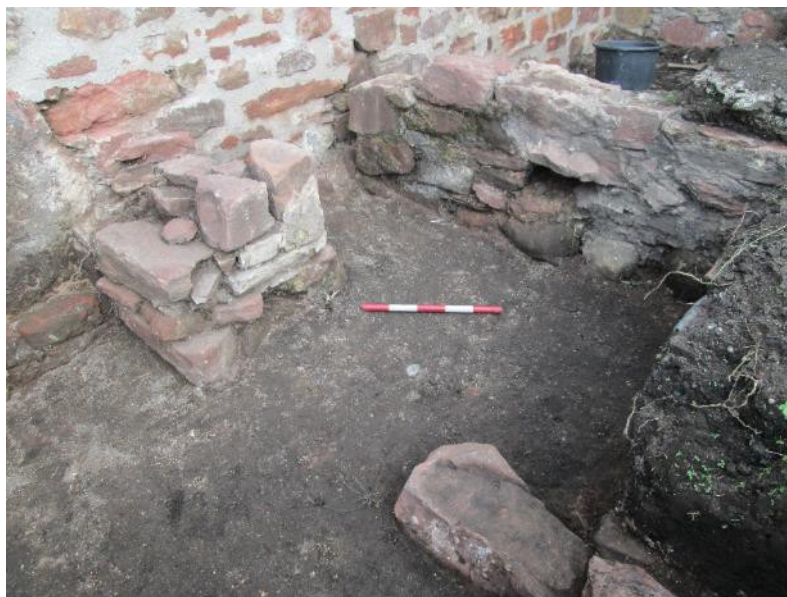
During the site clearance and subsequent community excavation the remains of several masonry walls were uncovered (*Figure 1*). A substantial wall (304) was found at a lower level, which ran parallel to the gable and was in alignment with a short section of upstanding wall forming the south east corner of the building. The excavated section of the wall included one side of an entrance and had the remains of wall plaster adhering to it (*Plate 6*). If this is indeed the rear wall of the building, it represents a very small structure, less than half the length of the other buildings. A second, narrower wall (307) was also uncovered, which ran at a slight angle to the gable and wall (304). This wall runs directly in front of the fireplace, which suggests it must have been built after the fireplace was no longer in use. It is possible that once Building 3 became derelict a smaller structure was built as some kind of outbuilding reusing some of the upstanding walls. Further excavation will determine if this wall is at the same level as the main gable or has other deposits beneath it.

Plate 6 Walls uncovered in Buildings 3, 304 in the foreground, 307 behind. (0324)

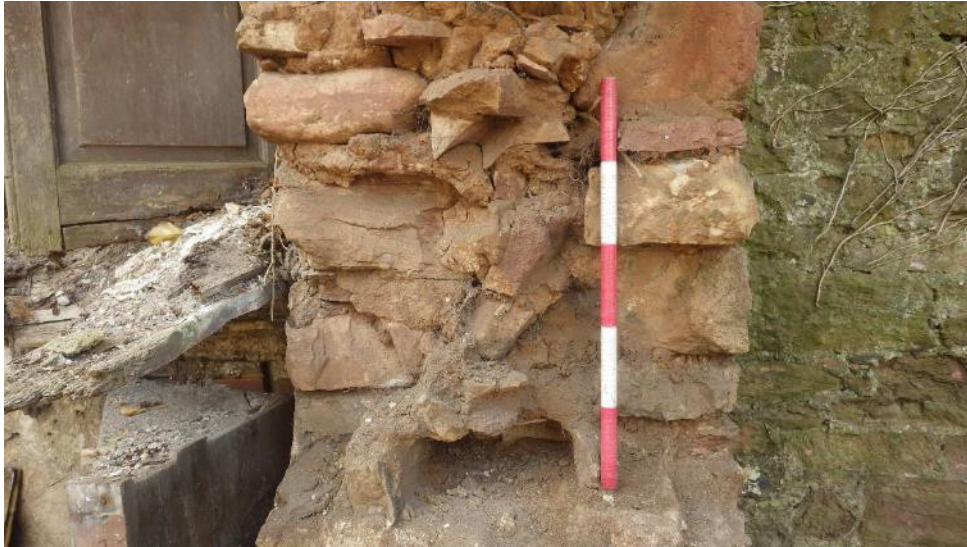
Situated on the south side of the close, Building 4 is generally well preserved, with many internal fixtures and fittings surviving. The walls are red sandstone masonry similar to the other buildings. The masonry had collapsed around the ground and first floor windows in the west wall, exposing the mortar. Interestingly, the bottom of the wall, up to the height of the ground floor window lintel, is bonded with clay/earth, while lime mortar being used above, where the wall is thinner (*Plate 7*). The main boundary wall of the plot, adjacent to Masons Close, is bonded with clay to its full height.

Plate 7 Buildings 4 wall showing junction between clay and lime mortar, (0260)

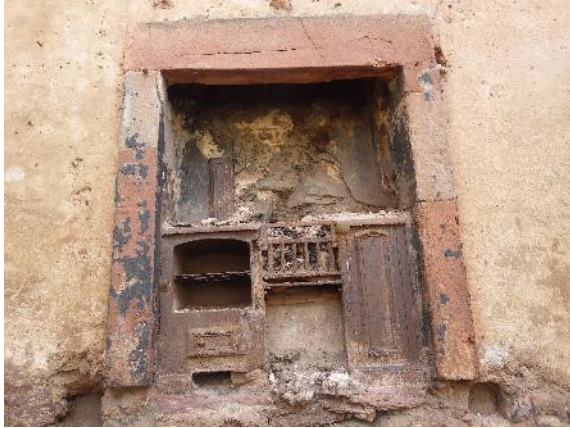
Plate 8 Building 4 first floor range (0117)

The first floor was entered via an external stone staircase off the close. The upstairs was divided into two separate rooms, with the scar of the partition visible on both north and south walls. The rooms were well lit, with windows facing east and west as well as overlooking the close. Each room had a fireplace with substantial sandstone surround, the east room had a cast iron fireplace, with a timber-lined and -shelved press. There is an additional recess in the west wall and a further press in the north wall, both of which show the impression of shelving (*Plate 10*). The outline of a timber molding around part of the room at dado height is also visible within the wall plaster. In common with the apartments upstairs in Building 1, the second room was more functional with a cast iron range for cooking (*Plate 8*).

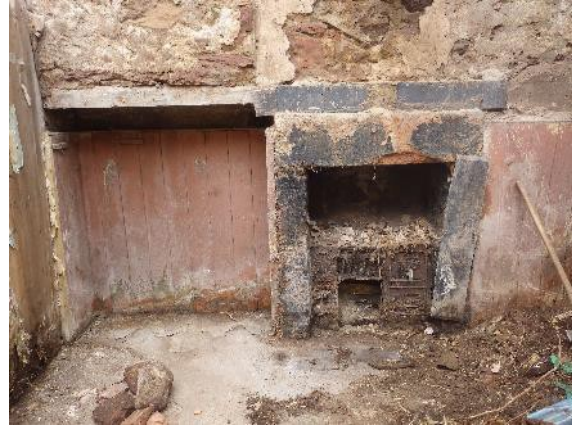
Plate 9 Building 4 ground floor range and press (0195)

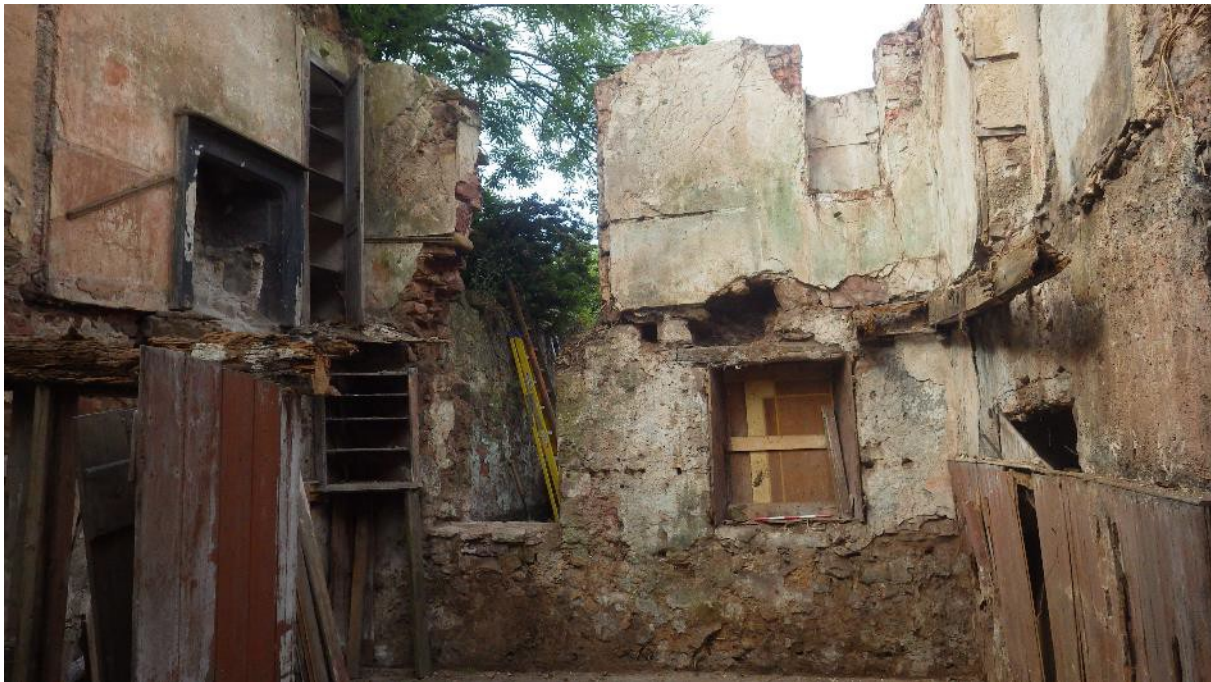
Plate 10 Buildings 4 interior west end (0264)

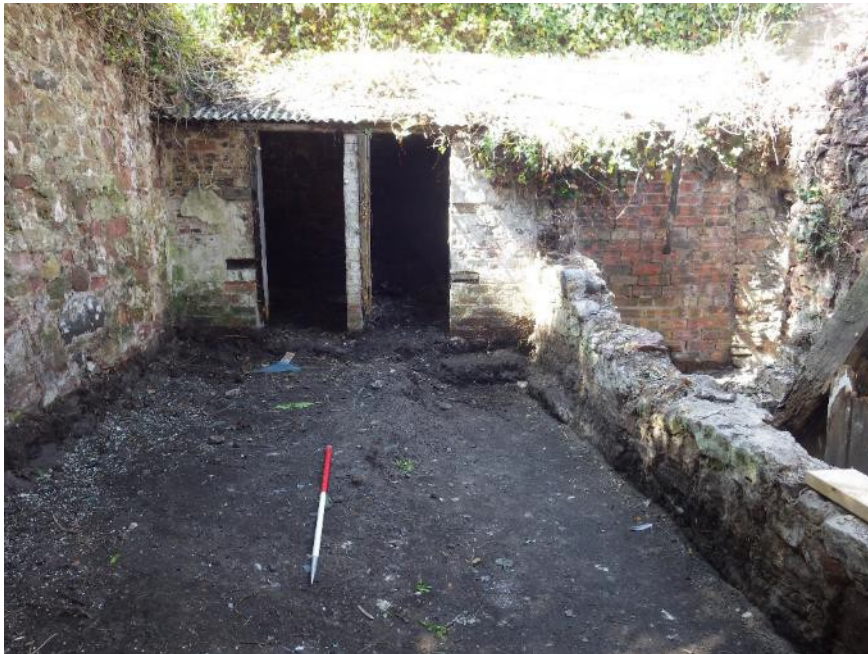
Building 5 is an enclosed yard behind Building 4; there is no evidence that it was roofed. The west windows of Building 4 overlook it and the only access is from Black Bull Close. As with the other buildings a large amount of rubbish, vegetation and accumulated soil were removed during the clearance. The area immediately inside the entrance was hand cleaned to establish the ground level uncovering a small area of rough stones, but not an even cobbled surface. A similar patch of stones was present in the south west corner, however the excavation of the test pit in the south-east corner did not reveal a stone surface. It is possible that these rough patches of stone were simply laid to cover particularly wet areas in the yard, which may have been bare earth or grass. The majority of the yard is open; with several brick outbuildings built along the inside west wall (*Plate 11*). A masonry wall runs parallel to the wall of the close, and subdivisions have been built from brick with entrances off the close. The open area may have been used as a drying green with the outbuildings being used as coal cellars, wash houses and an outside toilet. The arrangement of these buildings, and indeed their function, no doubt changed over time. An additional opening was slapped through the wall of the close to give access to the building in the south west corner.

Plate 11 Buildings 5 following clearance, showing brick outbuildings (0218)

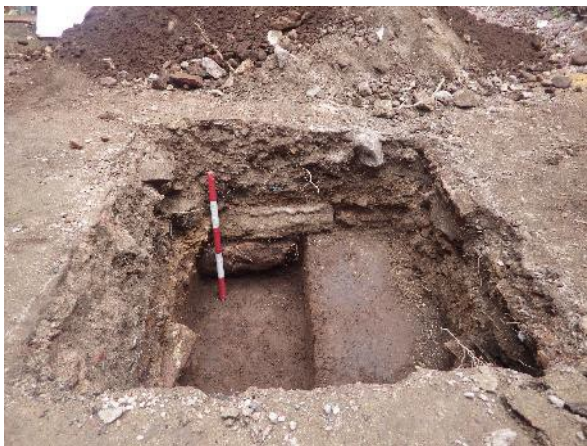
Three test pits were excavated in Building 1. Below the concrete floor [118], Test Pit 1 revealed a thick layer (0.30m depth) of heavily compacted crushed rubble and mortar [100]. This varied in composition across the trench, with patches of soil in some areas, and appeared to be a mixed demolition and rubble layer, overlying earlier possible structural layers. Below was a dark brown organic silt layer [101], 0.10m thick, containing a large angular stone in the north-west corner of the trench. The deposit became siltier and was mixed with charcoal towards the south. This overlay a compact layer of crushed lime mortar [102], which was thicker in the north-west corner (0.12m) and more compact. In the north-west corner this deposit overlay two faced sandstone blocks [103], which were laid one on top of the other and interpreted as the possible remains of a wall.

Plate 12 Test pit 1 north section (0385)

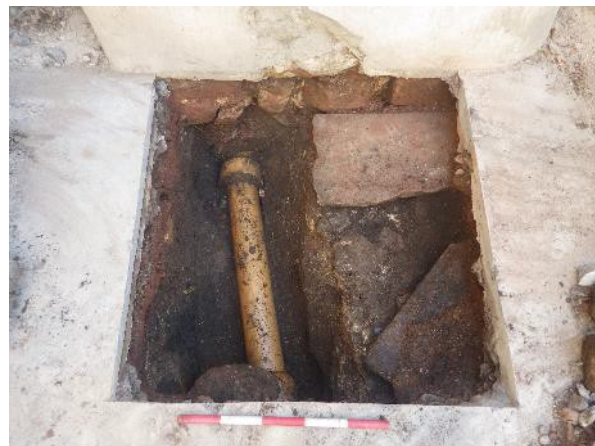
Plate 13 Test pit 2 plan view (0399)

Below the concrete floor [118] in Test Pit 2 was a large sandstone paving slab [108] with the long edge against the south wall [114], forming the earlier floor. A rough surface [109] formed of sub-angular red sandstone within a brown silt matrix was found adjacent to the floor and an iron plate was laid diagonally across this deposit. The plate was 0.5m long, 0.25m wide and 0.01m thick and was encrusted with rust on top. The east side of the test pit contained a cut [113] for a drain, which contained a ceramic pipe leading to a drain in the floor within the building. The cut was filled with loose grey silt [112], with frequent charcoal, stones and mortar.

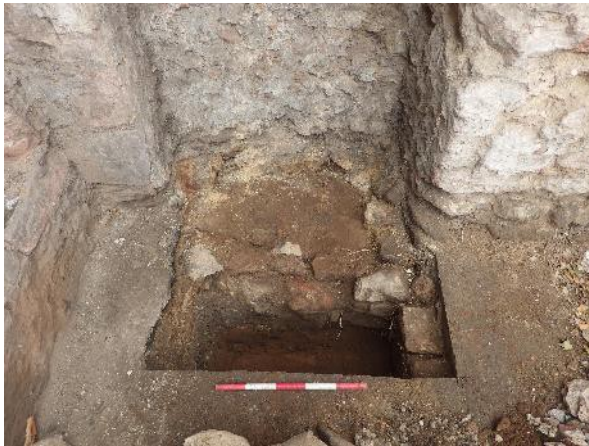
Below the concrete [118] and a layer of asphalt levelling material [119] was a layer of compacted lime mortar rich deposit containing frequent large angular stones and occasional large cobbles [120], 0.26m in depth. This deposit directly overlay a clay bonded rubble sandstone wall [121], which ran parallel to the north wall of Building 1. The wall was roughly coursed with 4 courses surviving, with a stepped out (eroded?) south face. No cut was evident and the wall was built directly on deposit [123] (see below). The wall returned to the south at its eastern extent.

Plate 14 Test pit 3 plan view (0460)

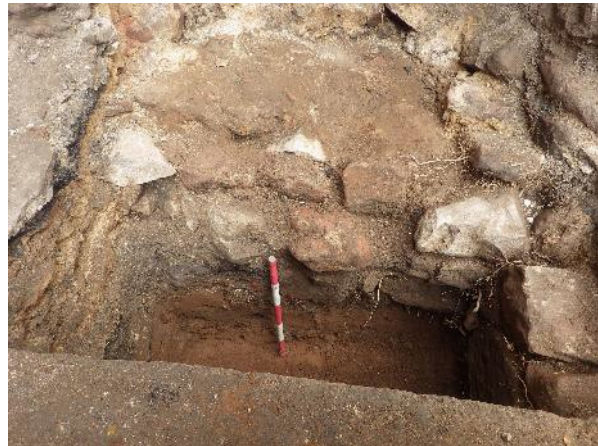
Plate 15 Test pit 3 foundations in section (0464)

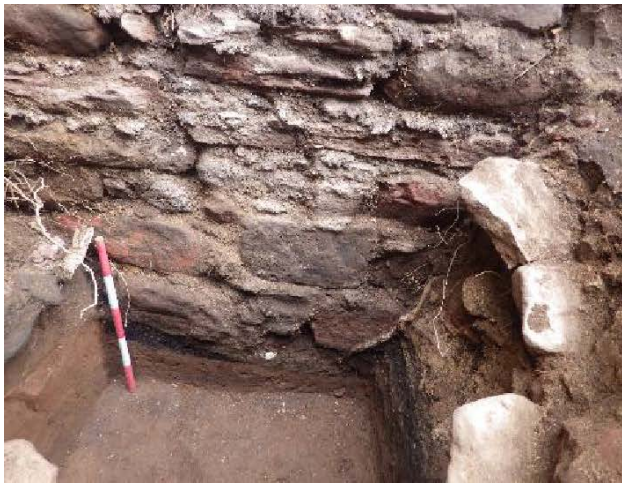
Plate 16 Test pit 4 base of wall in section (441)

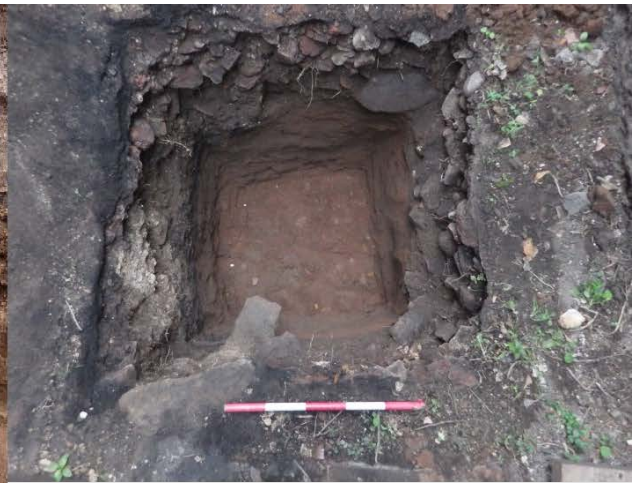
Test Pit 5 was located centrally within Building 2 (Plate 17). The upper deposit of loose black asphalt [201] was up to 0.08m thick and overlay a north-south cut across the trench [206] cut through this

Plate 17 Test pit 5 post-ex (0422)

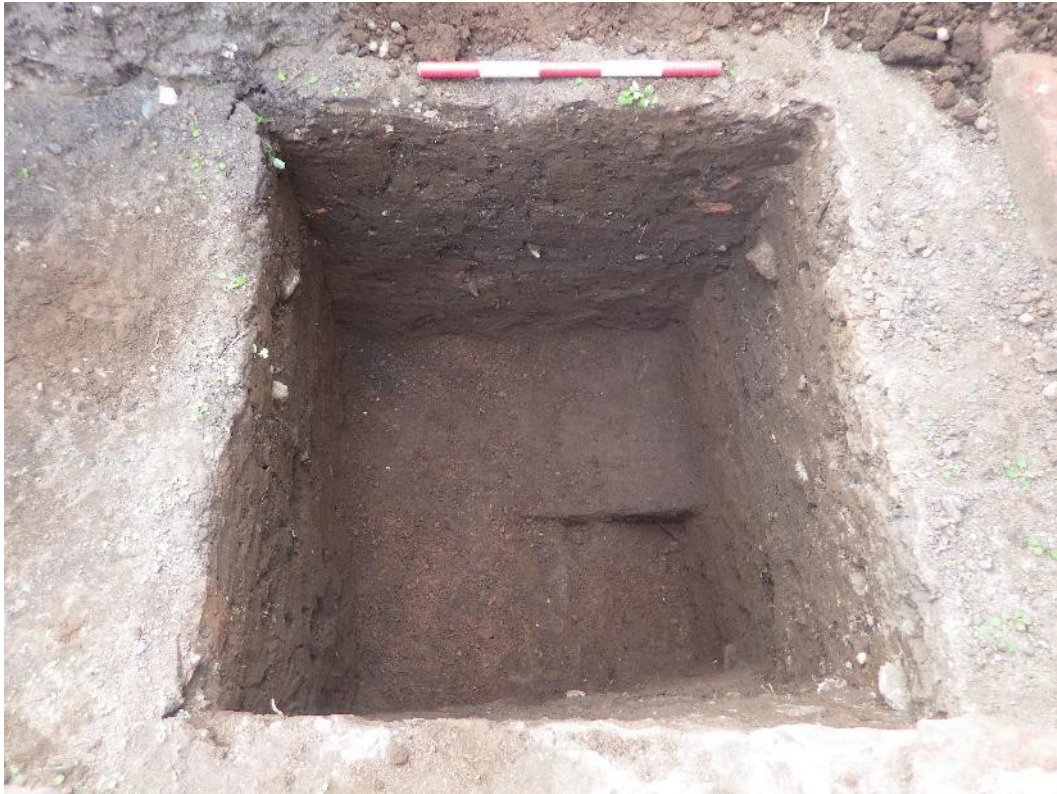
Wall [303] was constructed directly above deposit [306], which was a compact clayey deposit possibly representing a floor level. Below this was a series of midden deposits to a total depth of 1m. Deposit [306] overlay homogenous mid brown sandy silt [310], with occasional shell, sandstone and charcoal 0.25m in depth. Below this was a similar deposit [311] 0.30m thick but with fewer inclusions; the interface was marked by a number of larger stones and the deposit becoming more compact. Below this was a loose deposit consisting primarily of winkle shell [312], this was 0.15m thick and extended 0.2m from the east side of the test pit. This shell midden overlay a very mixed deposit 0.3m thick of dark greyish brown fairly compact sandy silt [313] with frequent animal bone and deposits of shell, ash charcoal and pale sand; white gritty and reduced lead-glazed pottery of likely 14th to 17th century date was also recovered. The Close wall [307] was built directly above this deposit.

Plate 18 Test pit 6 showing boundary ditch (0316)

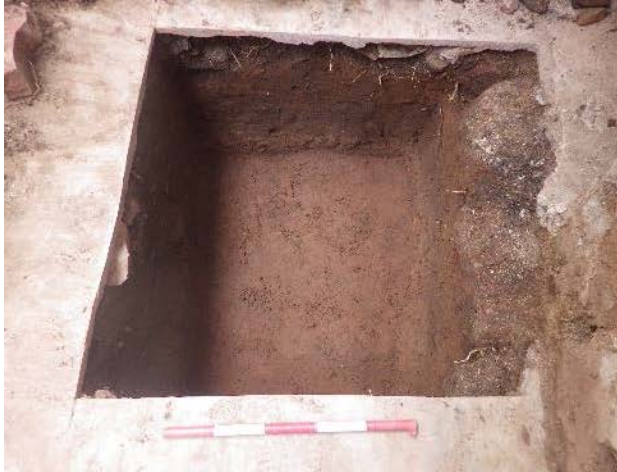
Below the concrete floor [408] was loose rubble infill [400=409]. This overlay the dark grey sandy silt [401] fill of pit [402]. The pit was 0.32m in depth and sub-rounded in plan with regular sloping sides and a rounded base. Small-medium sized sandstone fragments, animal bone, oyster and limpet shell were recovered from the fill. The pit was cut through orange brown sand [403=411] 0.18m thick. The footings for the north wall of Building 4 [404] were bedded onto this deposit (Plate 19).

Plate 19 Test pit 8 showing wall [404] (487)

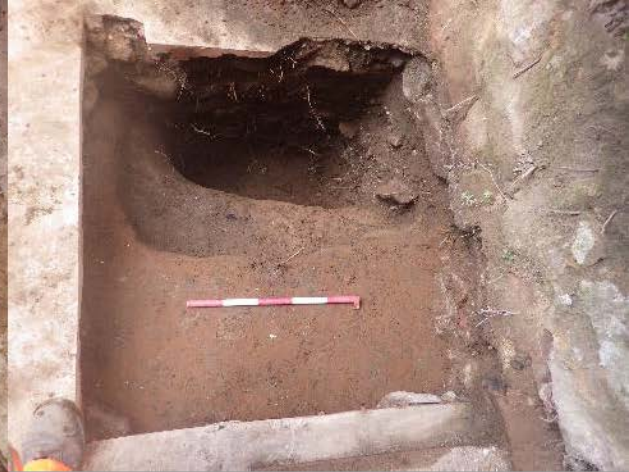
rectangular with a stepped vertical edge, breaking to steep sides; the base was not reached within the narrow confines of the trench (Plate 20). The pit was filled with a mixed midden deposit, with clear tip lines evident. This comprised loose mid grey sandy silt [413] with moderate sub-angular stones and high concentrations of shell up to 0.65m thick. On the south side of the cut were traces of clay, suggesting clay lining. Two sherds of lead-glazed grey wares, perhaps of the 16th/17th century, frequent animal bone and shell were recovered from fill [413].

Plate 20 Test pit 9 post-ex showing pit [412] (500)

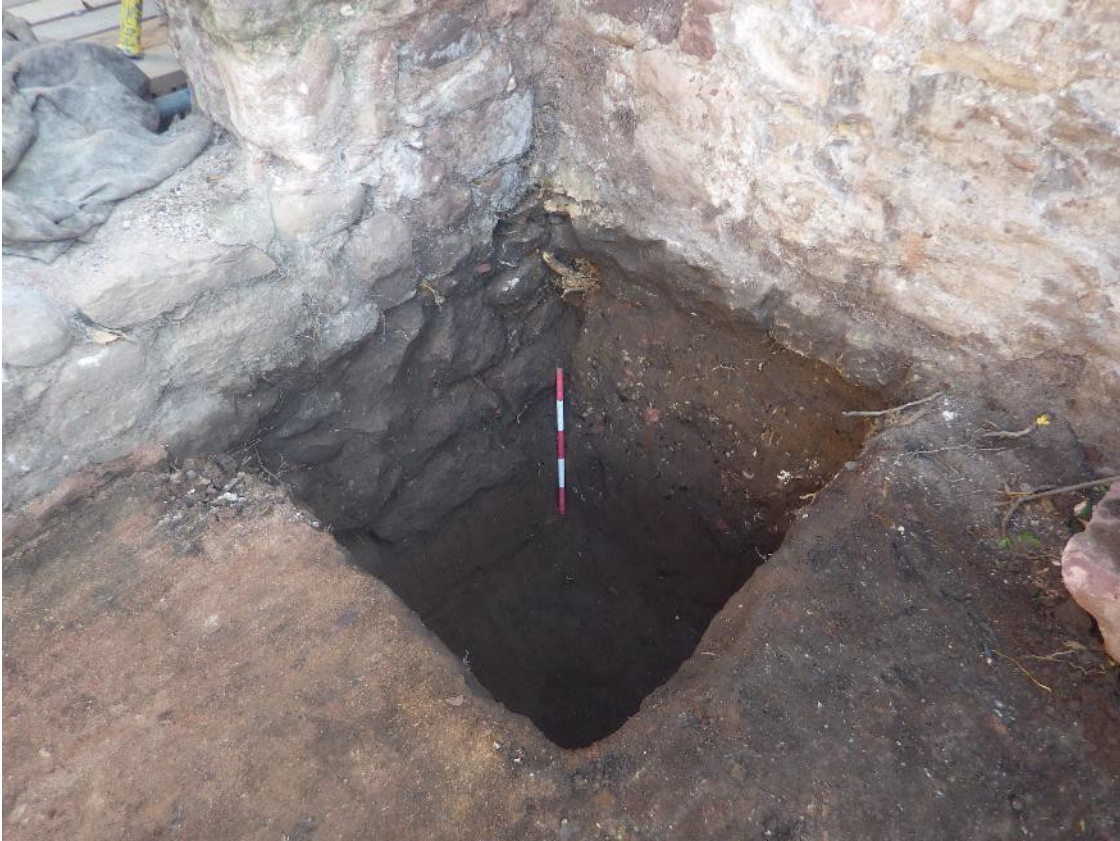
Test Pit 7 was excavated in the south-east corner of Building 5, adjacent to the west wall of Building 4 and the property to the south (Plate 21). The soil in this area is heavily built up so that the floor of Building 4 is at least 0.5m lower than the current ground level in Building 5. The upper deposit comprised reddish brown silty sand [501] with charcoal inclusions, up to 0.3m thick. This overlay dark reddish brown silty sand with frequent shell [502] 0.3m thick. This overlay orange brown sand [503].

The test pit exposed the footings for Building 4 [504] to be 0.6m below the present ground surface. As seen in Building 4 these were built upon orange brown sand [503] with occasional charcoal inclusions. This was excavated to a depth of 0.35m; natural deposits were not reached. Exposed in the north facing section was the wall of the building to the south. Although no masonry footings were present, the wall was built upon compact yellow brown sandy clay [505] with shell and occasional rubble, as visible in the section.

Plate 21 Test pit 7 showing foundations of building 4(394)
