# Kellie Castle

*Library Ceiling: investigation of floor structure holding up early 17<sup>th</sup> century plaster ceiling*

The National Trust for Scotland

*February 2019*

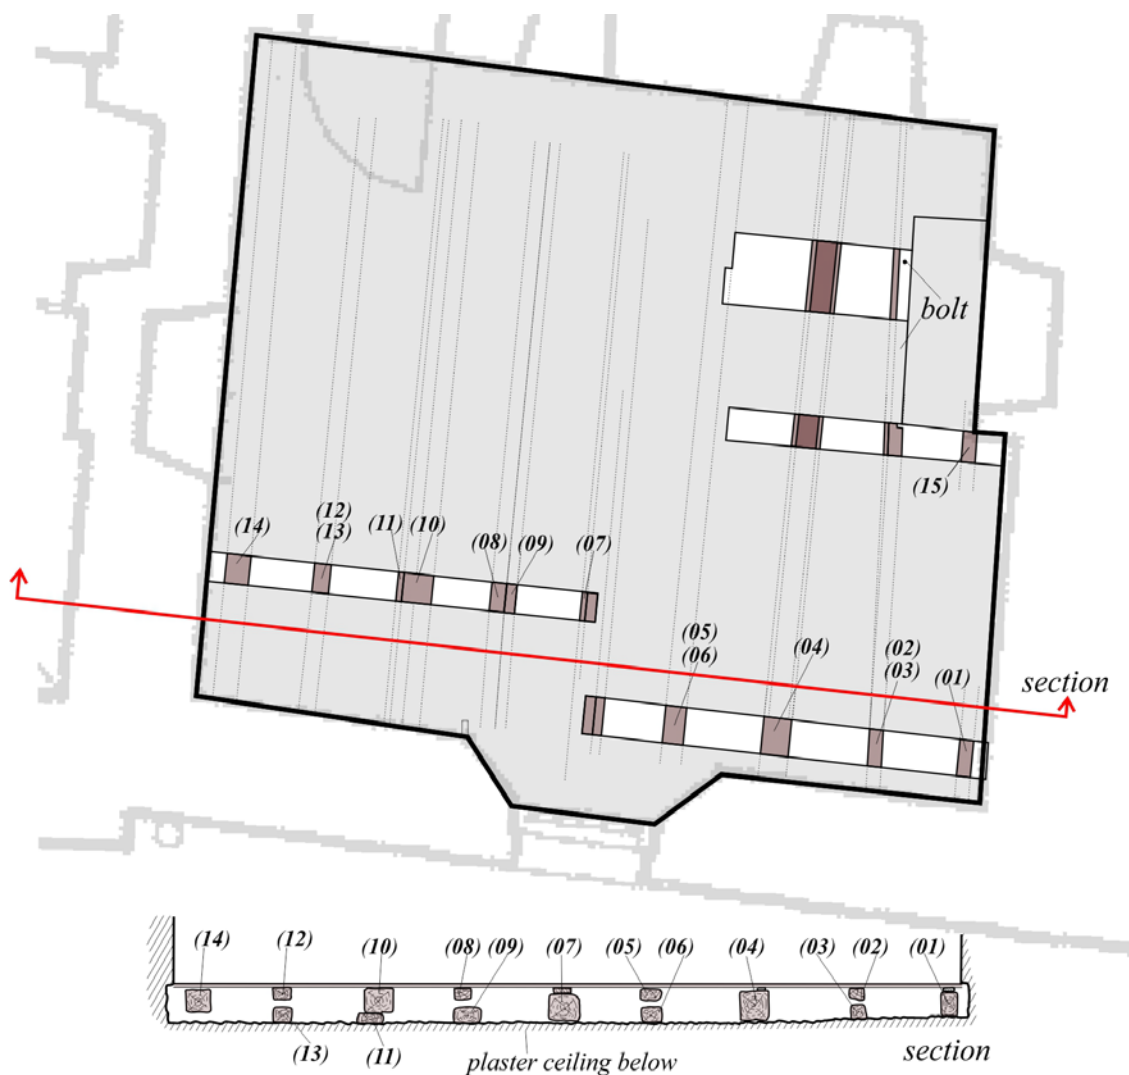
Figure 2 plan and section of exposed timbers overlain onto supplied plan

Within the floor board lifting each joist was at least in part exposed allowing some investigation of each. A basic description and measurements were taken and photographs taken along the joists below the floor. Due to the irregularity along the length of the joists the measurements are approximate. All joists ran NNW-SSE but are described in the text as running N-S for ease of description (*figure 2*).

Following the investigations the structure was believed to be of one or two phases, the first phase comprising a series of widely spaced large joist floor structure followed by the flooring and ceiling of 1617.

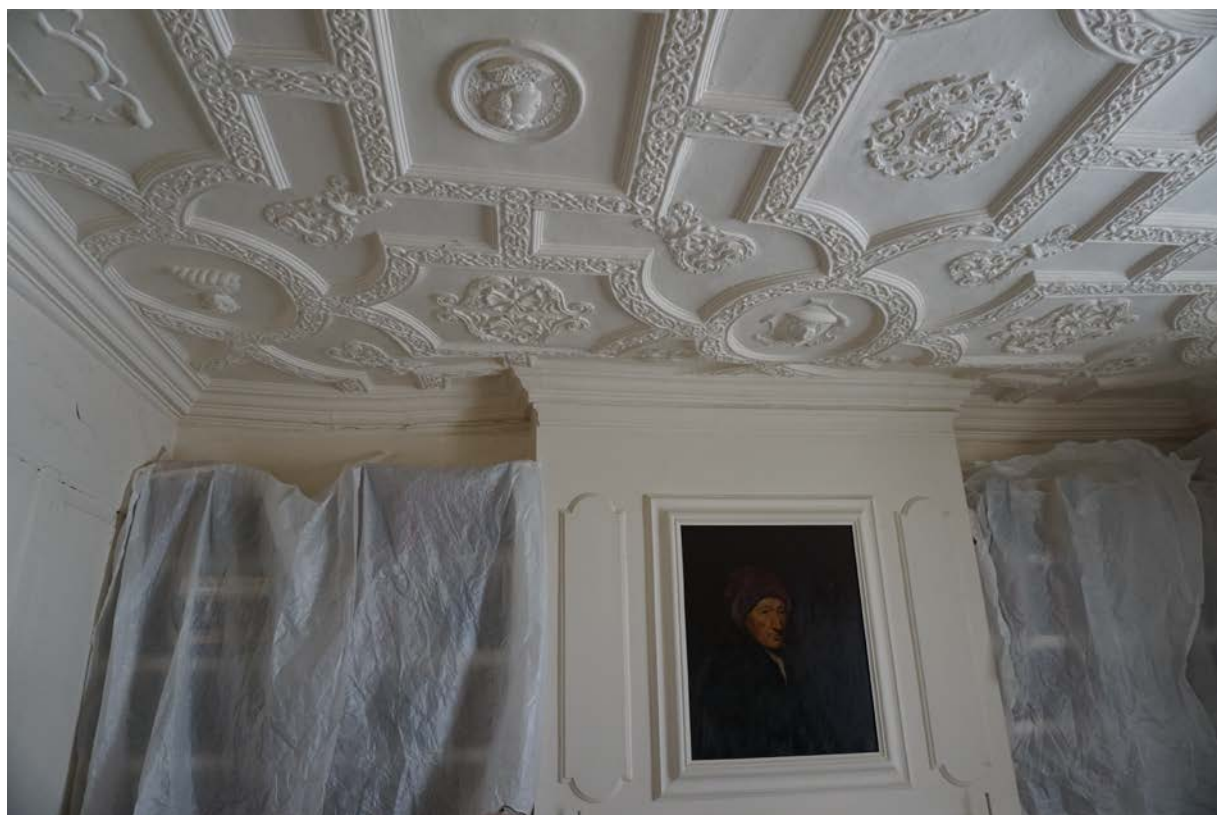
The decorative plaster ceiling of the library (*room 25*) is dated 1617 and is of historical importance; part of this ceiling directly above the fireplace had locally dropped considerably, but historically. It was suggested that cracking associated with the distorted ceiling had recently extended and there was concern that the ceiling and structure above was failing (*plate 1*).

*Plate 1 early 17th C plaster ceiling of library slumping above fireplace (photo 01)*

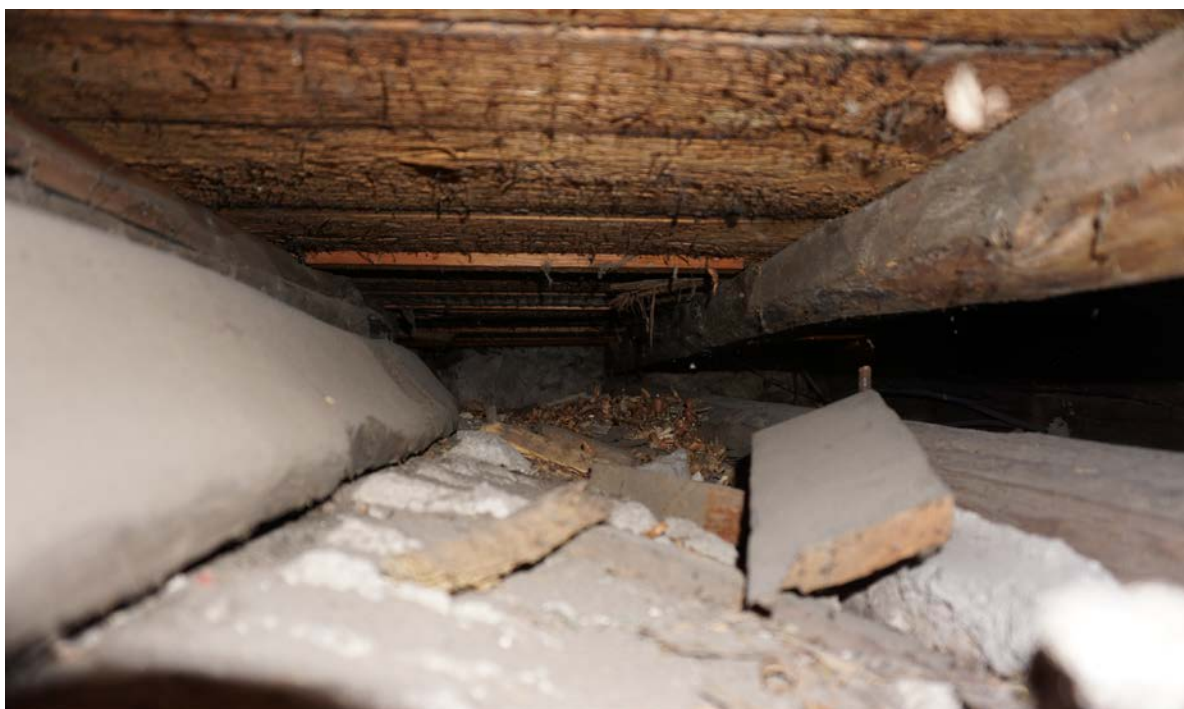
This joist was a 0.10m wide and 0.07m high ¼ caber still with some bark on waney edges. It sits directly below and supports the floor. Beneath this is *Joist 3* with a large gap in-between, a couple of large nails join the two at the south end but the majority of the beams are unconnected (*plate 2*).

*Plate 2 joist 2 and 3 to right, 2 at top 3 at bottom showing gap between and bolt from below, joist 15 to left looking south, note sloping of plaster below (photo 22)*

This is an irregular beam that may run along the top of the fireplace below and is possibly related to the cornice around the fire breast (see plate 2 /photo 22).

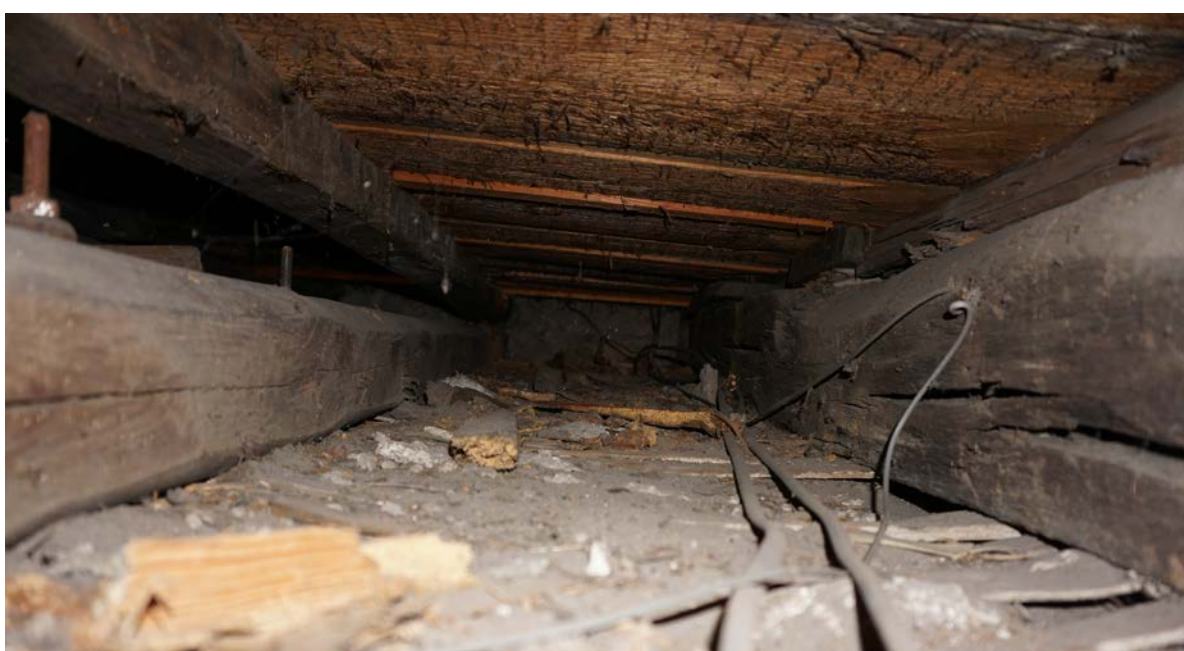
A 0.10 x 0.10m squared beam with waney edges and some light shakes, this beam appears to be located along the line of the main drop in the ceiling below. The plaster ceiling below appears to be attached to the underside of this beam. A number of threaded bolts run through the beam also appear to support the ceiling below (*plate 3*). Most of these visible only run through this beam and not into the overlying *Joist 2* with the noted exception of one in front of the fire hearth (*photo 48*).

*Plate 3 joists 2 and 3 to left and joist 4 to right, note bolt in joist 3, looking south (photo 23)*

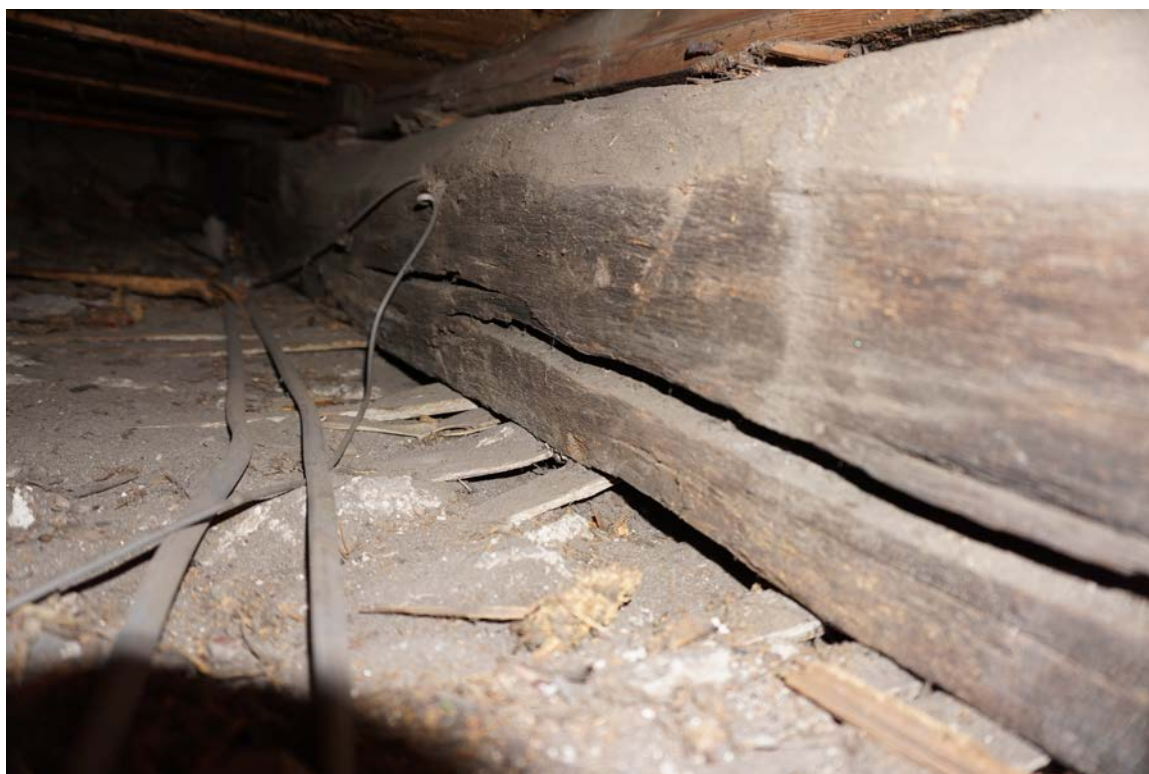
This joist was a 0.20m wide and 0.16m tall large rough squared beam with some waney edges and deep shakes noted down the beam's length. The plaster ceiling appears to be possibly attached to the underside of this beam; although there appears to be a little gap beneath the beam, so either there is a smaller beam beneath to hold the plaster or maybe the ceiling has detached a little (*plate 4*).

*Plate 4 joist 4 showing deep shakes and possibly detached plaster, looking south (photo 24)*

It is possible that bolts run through this beam supporting the plaster below as on *joist 3* but these were not seen within this limited exposure. These bolts are suggested by a client supplied photo of magnets attached to the bolt ends hidden within the plaster below; this suggests some bolts further out than *joist 3* and may strengthen the theory of the plaster detaching and requiring being bolted up into the floor structure.

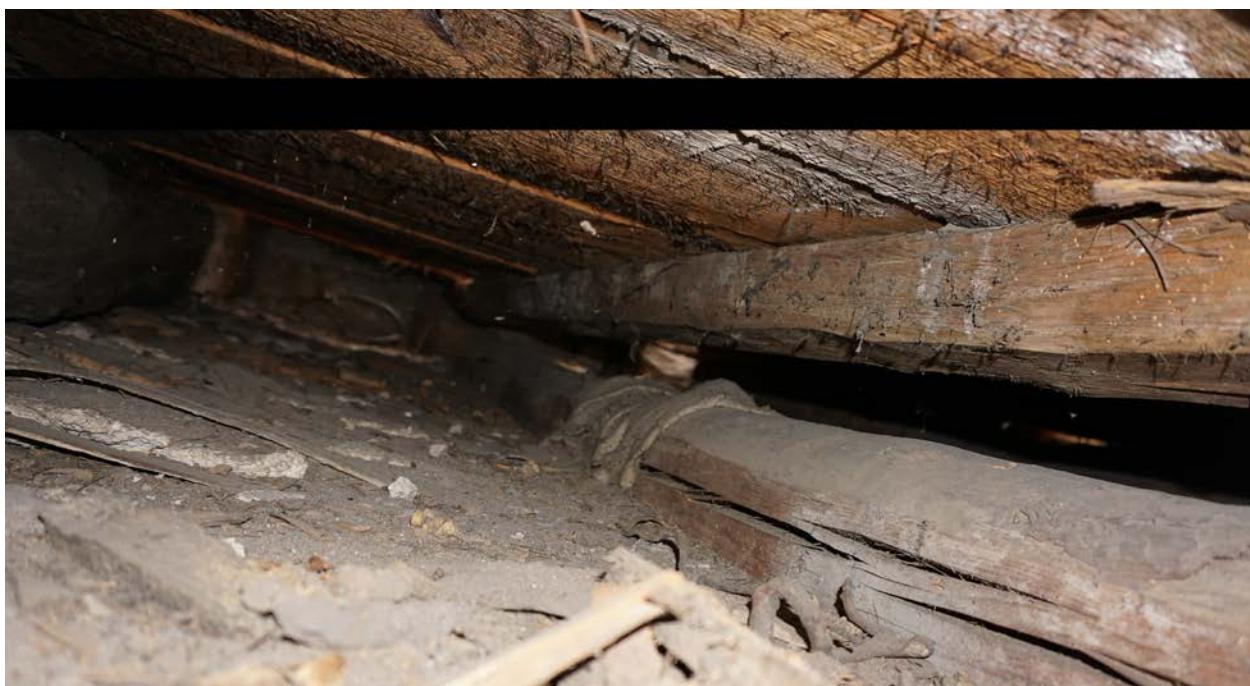
This was a 0.12m wide and 0.06m high rough squared ¼ caber beam with waney edges directly supporting the flooring and with a large gap between this and the underlying *joist no 6* (*plate 5*).

Plate 5 joists 5 and 6, 5 at top right, 6 at bottom right shows gap between, shakes and bark on the timbers, looking south (photo 28)

This joist was a 0.13m wide and 0.11m high rough squared beam with the bark still on waney edges. The beam directly underlies *joist 5* with a large gap between. The plaster ceiling is attached to the underside. Deep shakes run down much of the length of the beam (photo 28/51)

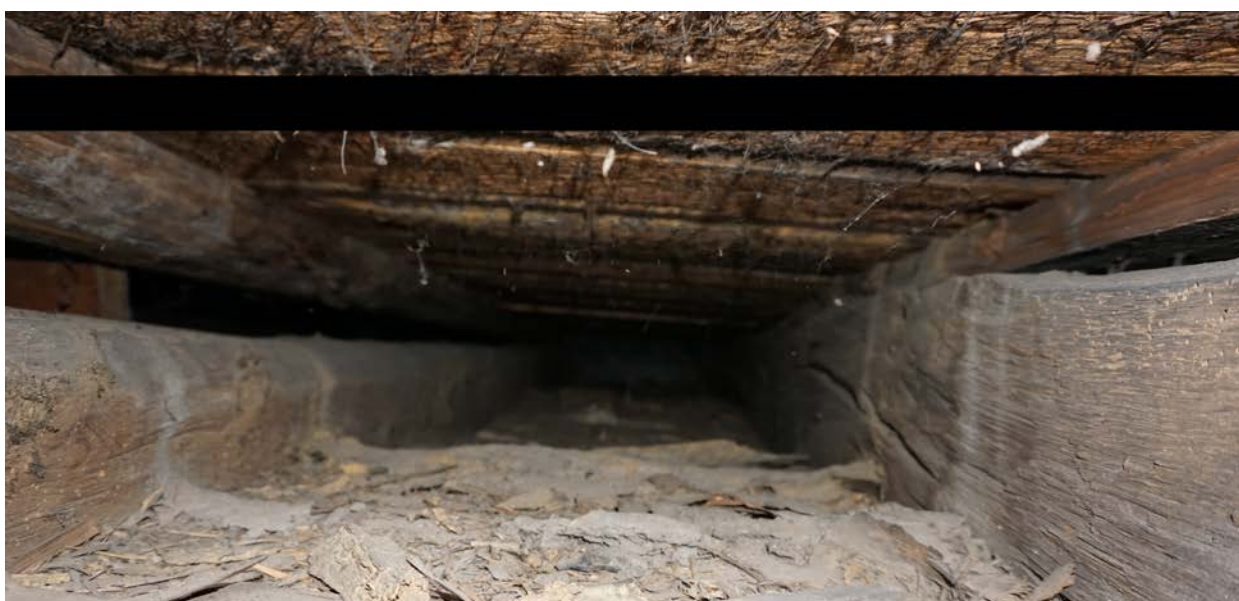
A 15 cm wide and 18 cm high rough squared large beam, the plaster ceiling is attached to the underside of the beam. The uneven upper face is levelled with reused timber boards for the floor (plate 6).

Plate 6 joists 7,8 and 9, joist 7 to right, joist 8 top left and 9 bottom left looking north (photo 40)

This was a 0.11m wide and 0.06m tall ¼ caber with waney edges, the beam directly supports the floor with a gap between this and the underlying *joist 9* (*plate 6*).

Joist 09 was a 0.13m wide and 0.10m tall rough squared beam with waney edges. It sits below *joist 8* and supports the plaster ceiling below. Some shakes were noted on its west face (*plate 6*).

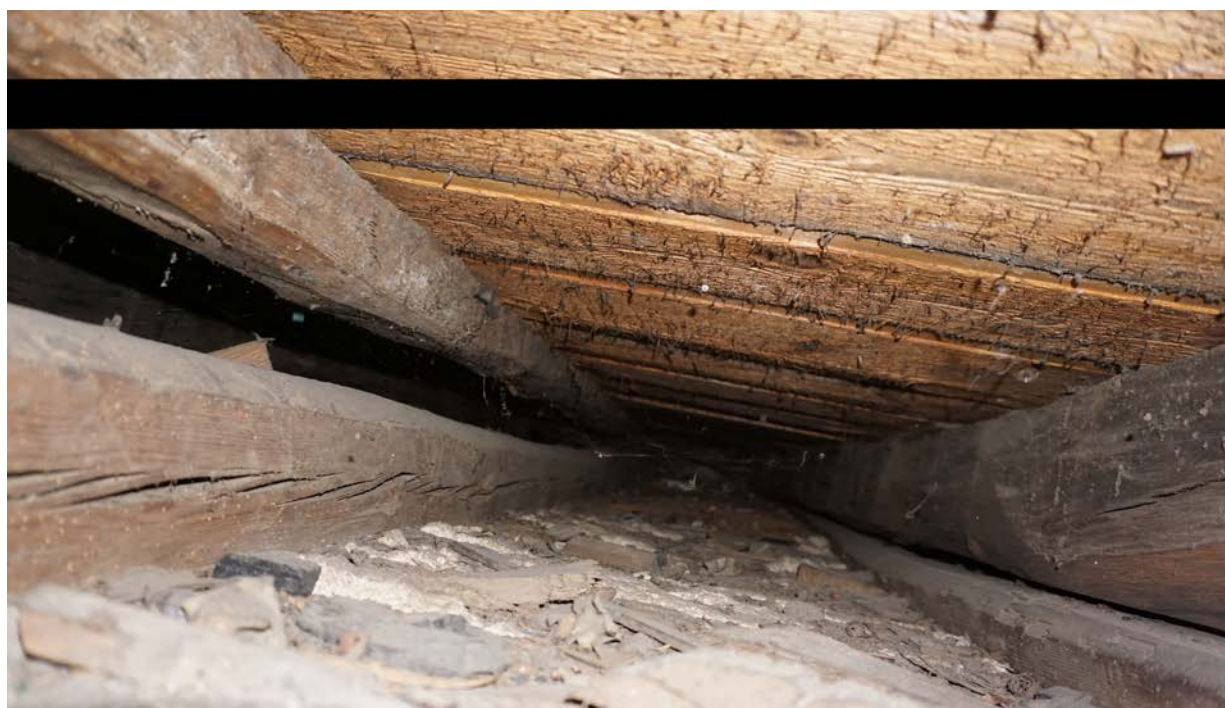
This was a 0.18m wide and 0.15m tall squared large beam, the floor sits on top. *Joist No 11* appears to be attached to the underside of this to carry the plaster ceiling below (*plate 7*).

This was a 0.12m wide and 0.06m tall rough squared timber apparently attached to the underside of *joist 10* to fill the gap below and support the plaster ceiling (*plate 7*).

0.11m wide and 0.08m tall squared caber supporting the floor with a wide gap between this and underlying *joist 13* (*plate 7*).

*Plate 7 joists 10,11,12 and 13, joist 10 to upper right, joist 11 lower right, joist 12 top left and 13 bottom left, looking north (photo 45)*

0.11 x 0.11m squared caber still with some bark on waney edges and shakes down its length. The plaster ceiling was attached to the underside and there was a wide gap between this and overlying joist 12 (plate 7).

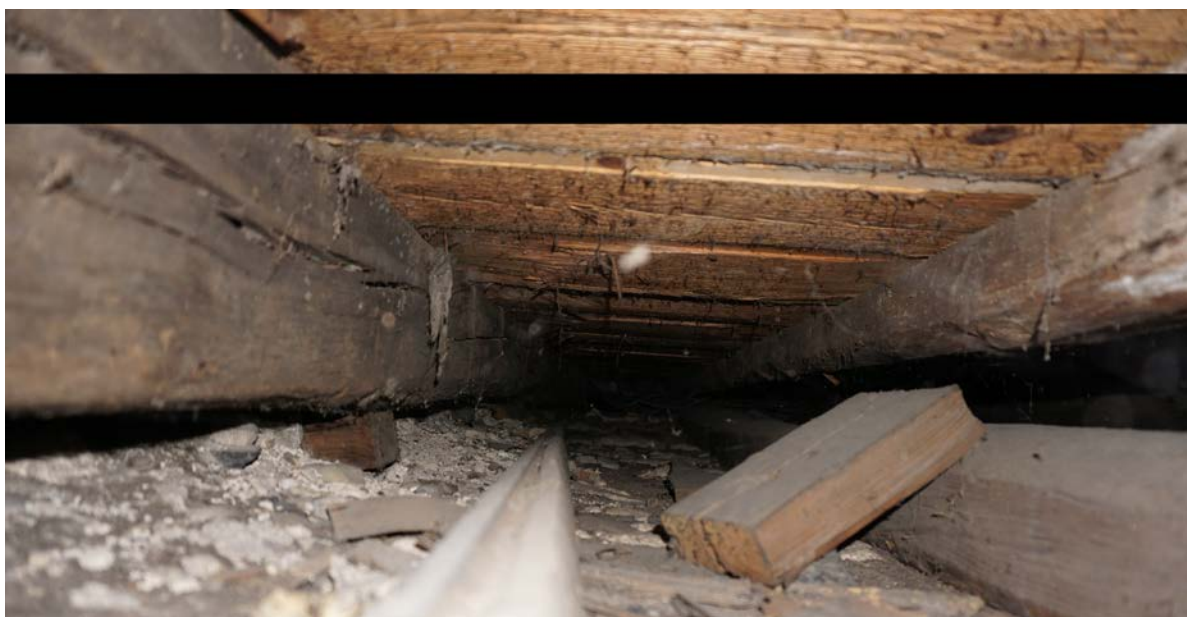
0.12m wide and 0.15m tall large squared beam with shakes along its length; the flooring sits on top but the plaster ceiling doesn't reach the underside. A series of smaller timbers were attached to the underside running towards the west wall, which may suggest that this joist supports the cornice below (plate 8).

Plate 8 joists 14, 13 and 12. Joist 14 to left, 12 to upper right and 13 to lower right.

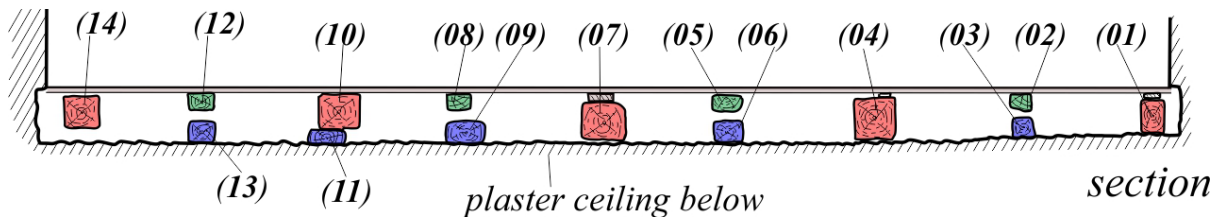
Figure 3 sample section through floor showing joists

The floor structure can be simplified and divided into three main phases/structural elements, with the first (*Phase 1*) represented by five larger widely spaced beams forming a floor structure made up by joists 14,10,07,04 and 01 (*figure 3, in red*); these are generally larger solid squared beams set into the masonry of the elevations. These are often quite irregular so unlikely to have been visible at any time. On the south elevation some surviving *in situ* wall plaster above the ceiling may run up to the joists and the floor boards above, although this could just have been done as preparation for the 17<sup>th</sup> century ceiling. These joists are likely to be original to the tower, although closer inspection of the junction with the masonry would be required to confirm this.

*Phase 2*, The flooring was given secondary support by quite slight quartered /halved cabers, which ran between the main beams, this was made up by joists 02,05,08,12 (*in green*). These may have been cut into the masonry of the south elevation but this was not clear as there was a lot of loose masonry in the wall and debris obscuring the elevation; as with the main joists above closer exposure along the wall foot will help determine this. These beams appear to relate to the current floor boards and so the reused bits of timber levelling out the top of the earlier main beams also must relate to this phase.

*Phase 3*, The plastered ceiling dated 1617 was held up by a number of lower joists (*in blue*); these then are likely to date to about 1617 and are better formed than the *phase 2*, comprising apparently whole cabers squared (where seen) rather than the split cabers above.

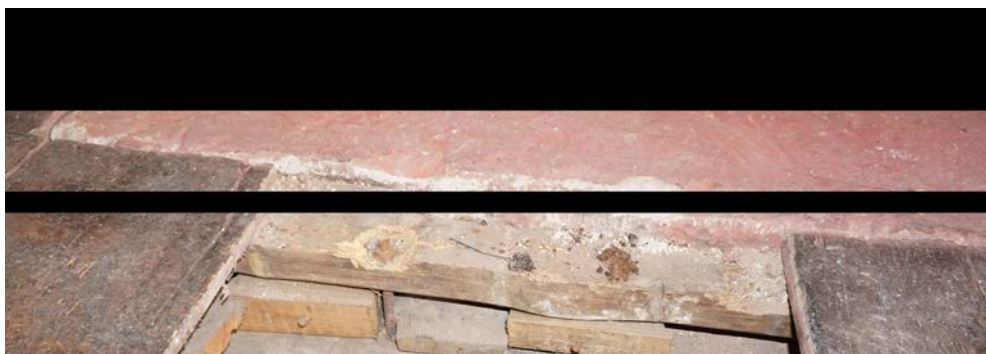
The wide gap between the upper *phase 2* and lower *phase 3* joists may be an attempt to reduce vibration transfer from the floor above to the plaster ceiling below. If the gap is indeed an original design to reduce vibration to the ceiling, then the modern bolting up rigidly fixing the plaster ceiling joists with the floor joist against which the overlying stone fire hearth rests may be transferring the vibration and weight of the hearth and floor directly into the ceiling below, and thus causing the observed movement within the plaster (*plate 9*).

Plate 9 bolt from plaster ceiling below joining joists 2 and 3 with timber packing between joists
