Gateshead College, Durham Road, Gateshead

Desk Based Assessment and Photographic Survey: May 2008

Desk Based Assessment and Photographic Survey (May 2008)
(project AA. 1672)

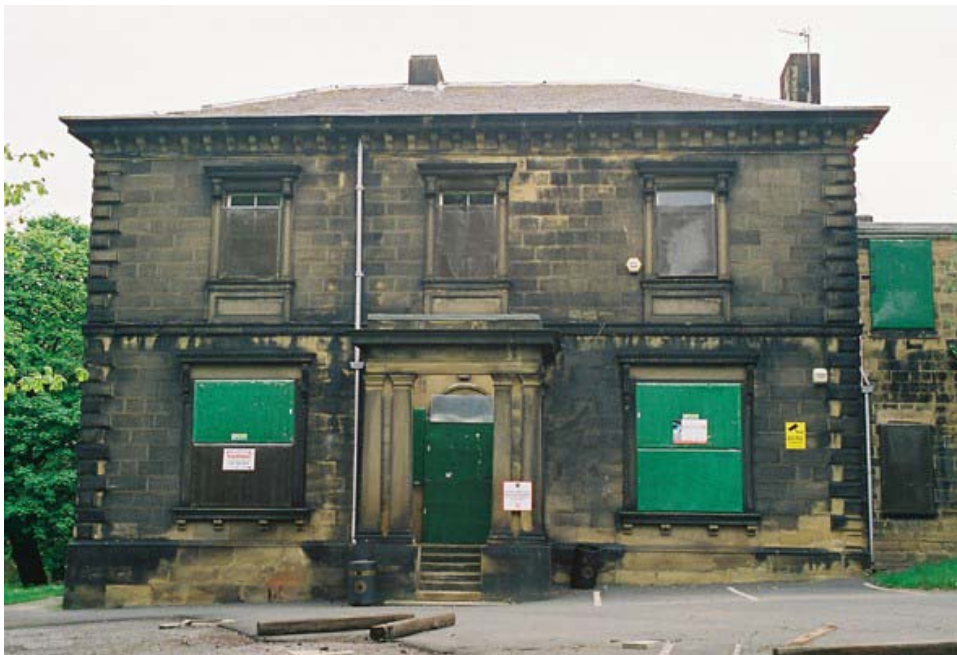
Figure 15 – Southern elevation of north Dene House, 2008. S&B.

The condition of North Dene House is fair. There are some holes in the slate roof and the lead flashings to the hips and ridges have been extensively patched. The cornice gutter appears to have been renewed with felt. There are many signs of active and previous leaks within the interior, particularly in an area of plasterwork in the upper corridor. The roof of the porch is missing entirely. The exterior sandstone walls are in good condition.

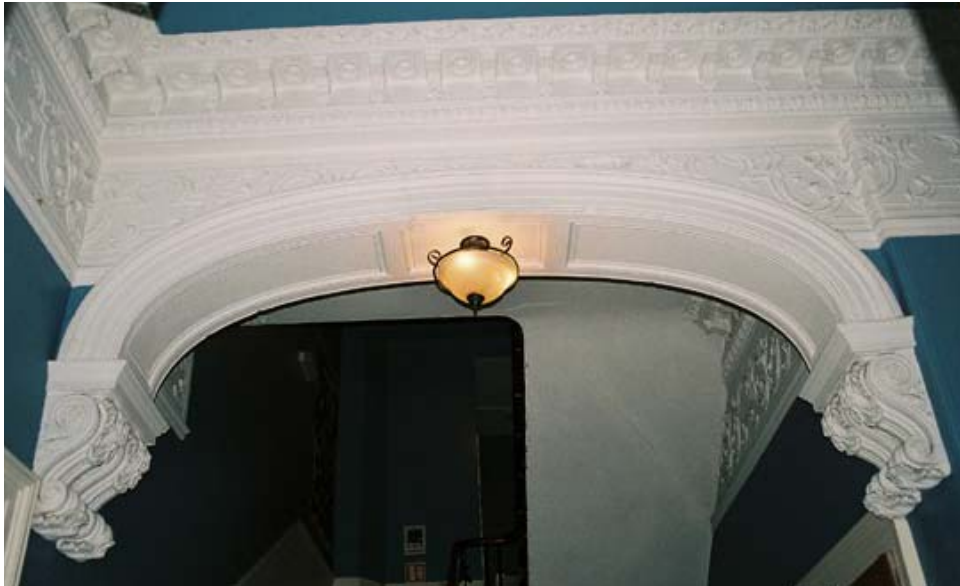
Figure 20 – Arch and frieze in main corridor, 2008. S&B.

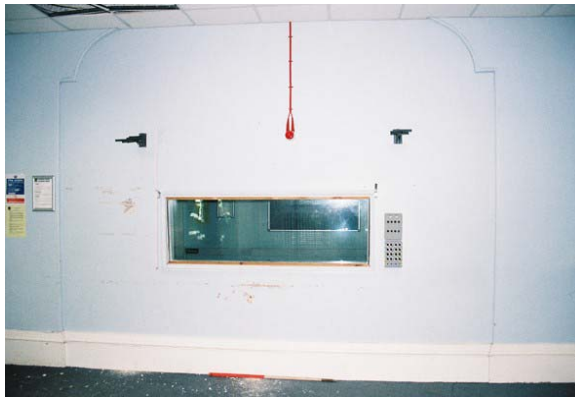
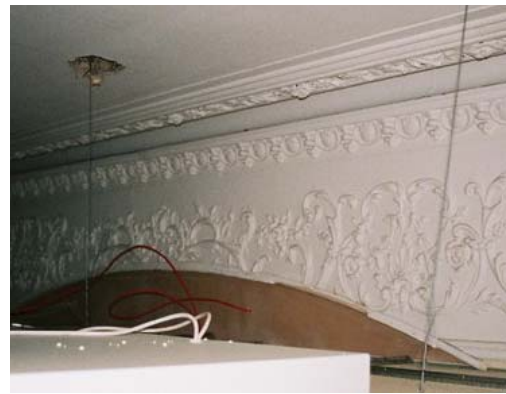
Figures 22 and 23- Blocked arch in breakfast room, top of arch above suspended ceiling, 2008. S&B.

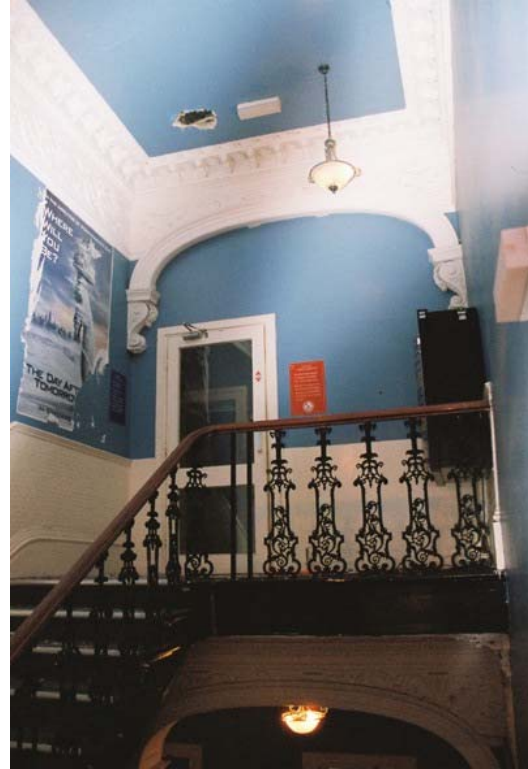
The cast iron balustrade on the stairwell is surmounted by a wooden handrail. A number of the decorative balusters are missing and have been replaced with plain cast iron bars. A number of these missing panels were located in the basement, in room 42 the former wine store. The balustrade and handrail curve into a wreath at the foot of the stairs.

Figure 25– Main stairwell, first floor. 2008. S&B.

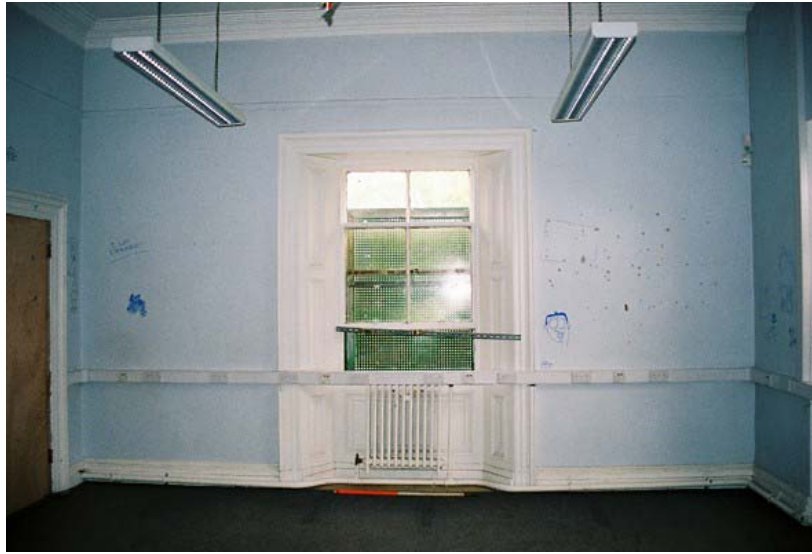
This room has high skirting with a simple moulded upper edge. There is a picture rail and simple moulded cornice around the upper stages of the wall. However, these features have been lost from the west wall. This may possibly have been a result of previous damage due to water ingress and damp as there are signs of water damage and staining across the ceiling and in the northeast corner.

Figure 26– Room 24 south elevation . 2008. S&B.

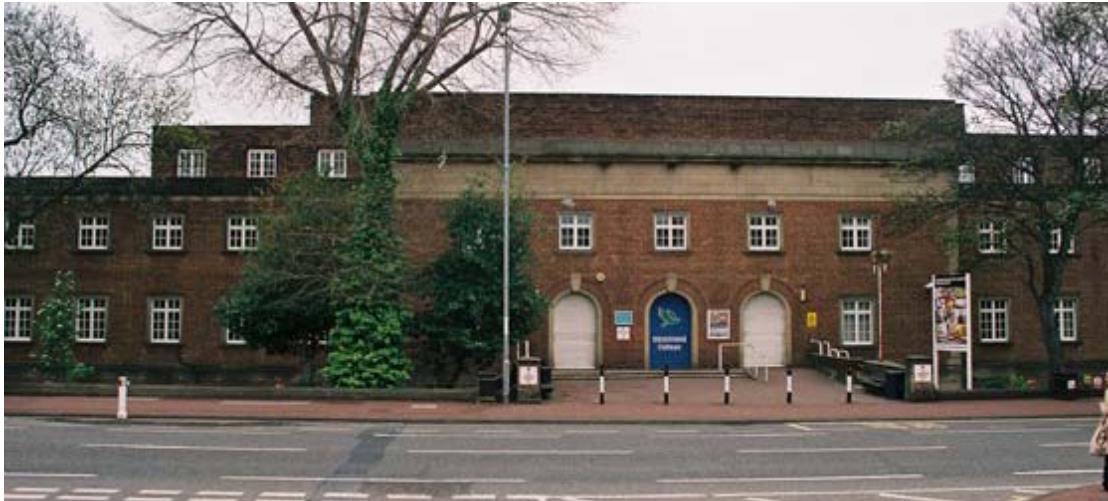
The college buildings are generally in fair condition. Their felt roofs are relatively short life material and require annual maintenance and periodic renewal. There are a few signs of structural damage and water ingress within the college building. There are some open joints between the stone course and various fixings, cables and accretions, particularly at the central part.

Figure 30– *Main college block, central eastern elevation.. 2008. S&B.*
