**THE WEIR GARDEN,
SWAINSHILL,
HEREFORD & WORCESTER**

**ARCHAEOLOGICAL FIELDWORK
1991-1995**

Cotswold Archaeological Trust

C.A.T JOB: 0156
C.A.T REPORT: 95298

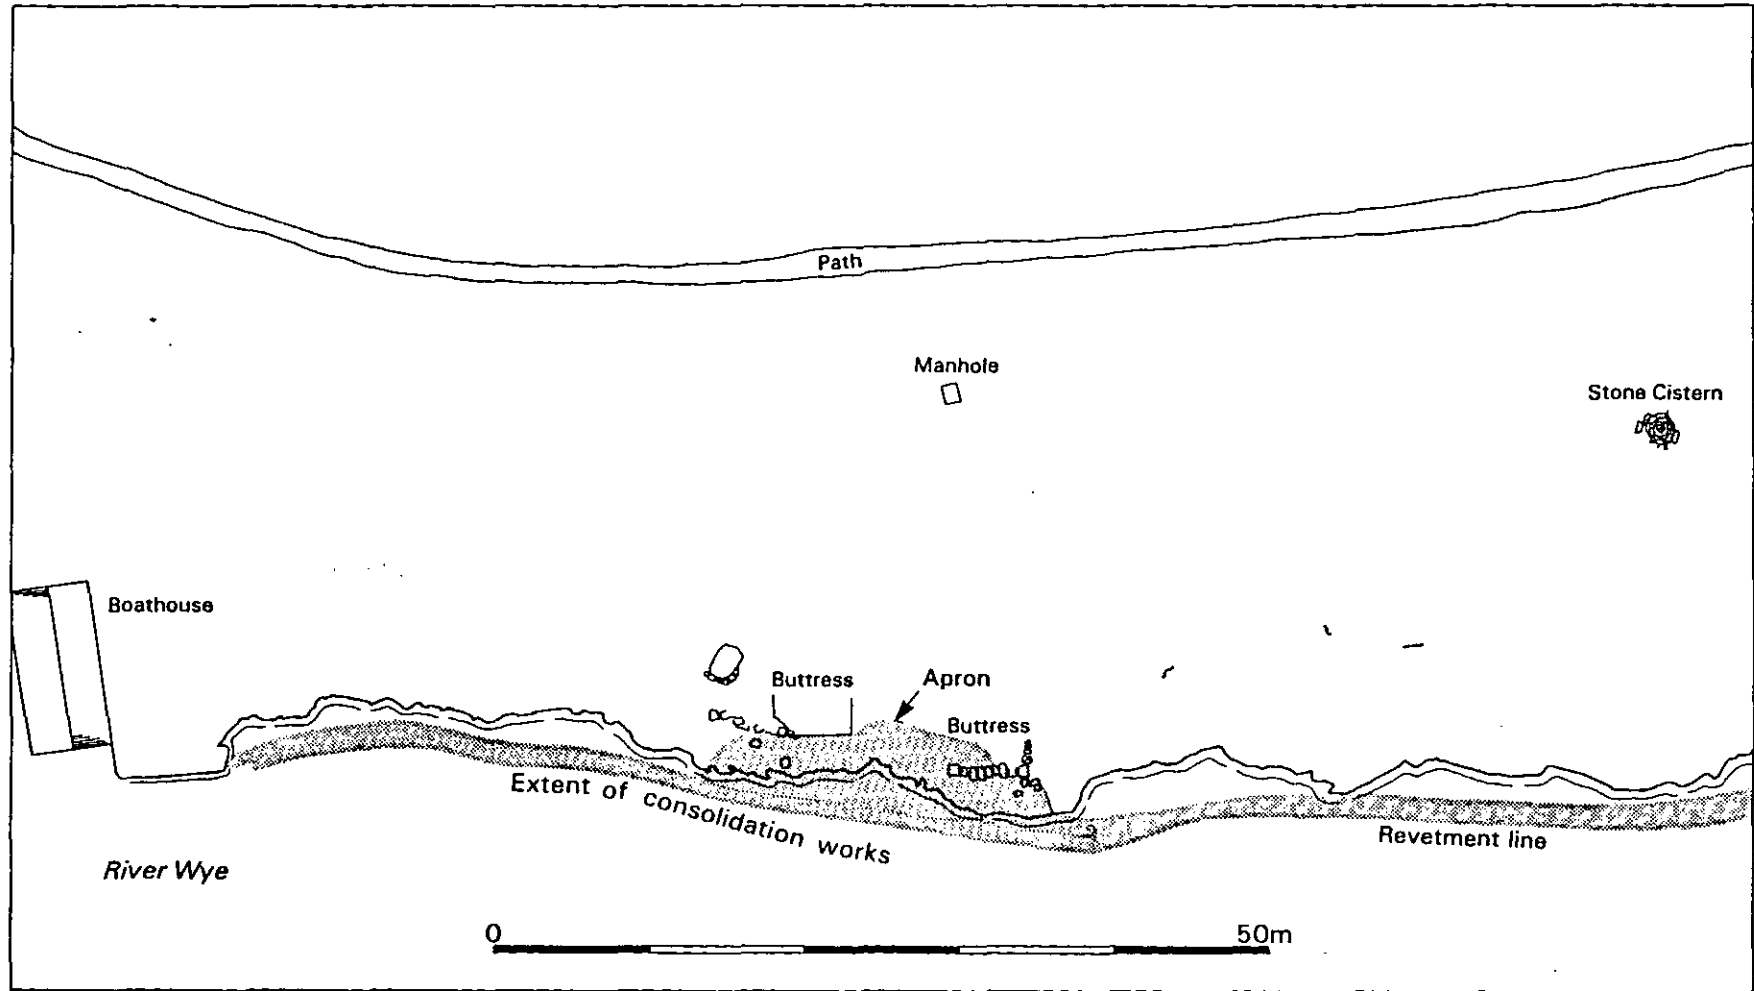
Fig. 3 Extent of riverside consolidation works

1.6.1 Immediately prior to the 1995 programme of works the condition of the upstanding masonry elements and archaeological features exposed in the face of the riverbank was unstable and causing concern. Erosion by the River Wye has been the principal factor in the decay of the two Roman masonry buttresses projecting from the riverbank. The most complete of the two, the upper buttress, was in urgent need of consolidation, to prevent irreparable damage, and has now been repaired as part of a general programme of riverside revetment carried out by the National Trust (Fig. 3).

2.8.8 The line of the blockstone revetment (Fig. 3) was routed in such a way as to run as close as possible to the shallower river-edge whilst avoiding cutting into undisturbed bank, which though disjointed from shearing and slumping potentially contained retrievable information. On several occasions a watching brief was necessary during trimming of the riverbank, where heavily undercut sections of bank projected out across the required line. No archaeological remains were found within these portions of bank material, even though large slumped sections of the bank certainly contain structural remains or occupation deposits.

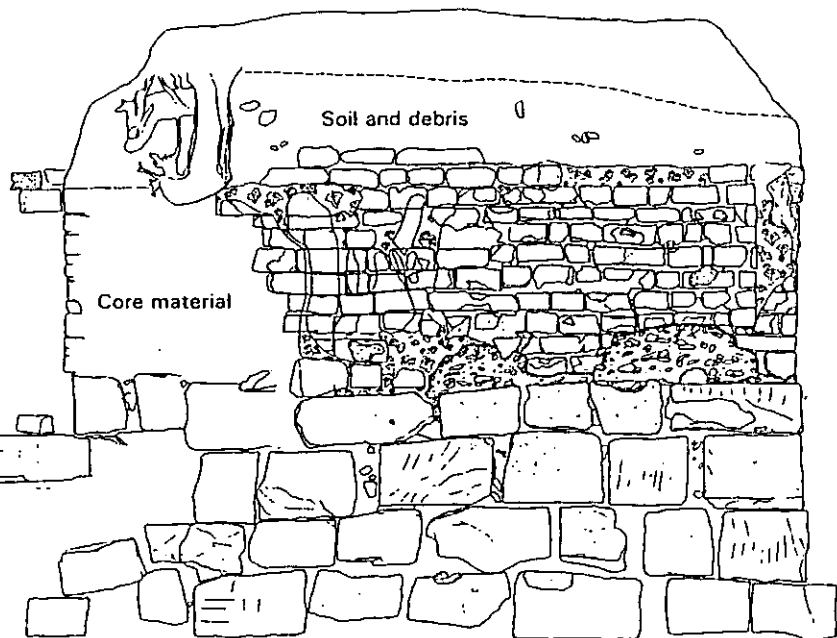
Fig. 7 SW facing elevation

3.1.14 That the entire structure was once completely rendered was clear from the extensive remains of such material, particularly on the smaller masonry courses of the superstructure; although the foundation blocks still possess some evidence of rendering on one or two blocks (as do several of the blocks of the associated monumental steps discussed in 3.1.42 below). The offset difference between the foundation and superstructure masonry of the buttress had been filled by a heavier type of mortar than that used for the overall rendering, the former containing much small stone and pebbles to give a rougher mortar. Two patches of this could be seen on the south-western elevation of the structure where the intention was clearly to blend away the offset difference to create a flush face (Fig. 7).

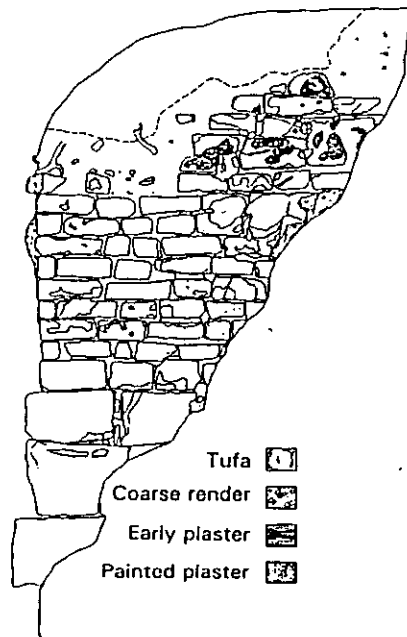
Fig. 8 SE facing elevation

3.1.17 In two areas of the same elevation (Fig. 8) an earlier plaster face could be seen below the uppermost rendered and plastered work (the exposed sections being too small for any decorative detail to be seen if present). This suggested the periodic routine maintenance of the structure. Further repair work was highlighted by the lower of two bands of stone tile fragments seen in the adjacent bank. The upper tile horizon appeared to reflect the collapse of a timber-framed roof spanning the area between the upper buttress and a wall emerging from the bank section. The lower band, of smaller sandstone fragments, alluded to a possible episode of reroofing or extensive repair (Fig. 12, plate 7).

2.10.4 Protection of the exposed painted plasterwork on the south-east facing elevation was achieved by fixing a series of projecting stone tiles over the standing walling immediately above, in order to channel rainwater away from the plaster faces. A decision was made not to spray the plaster with a lime-water solution at this stage but to continue to monitor its condition over time.

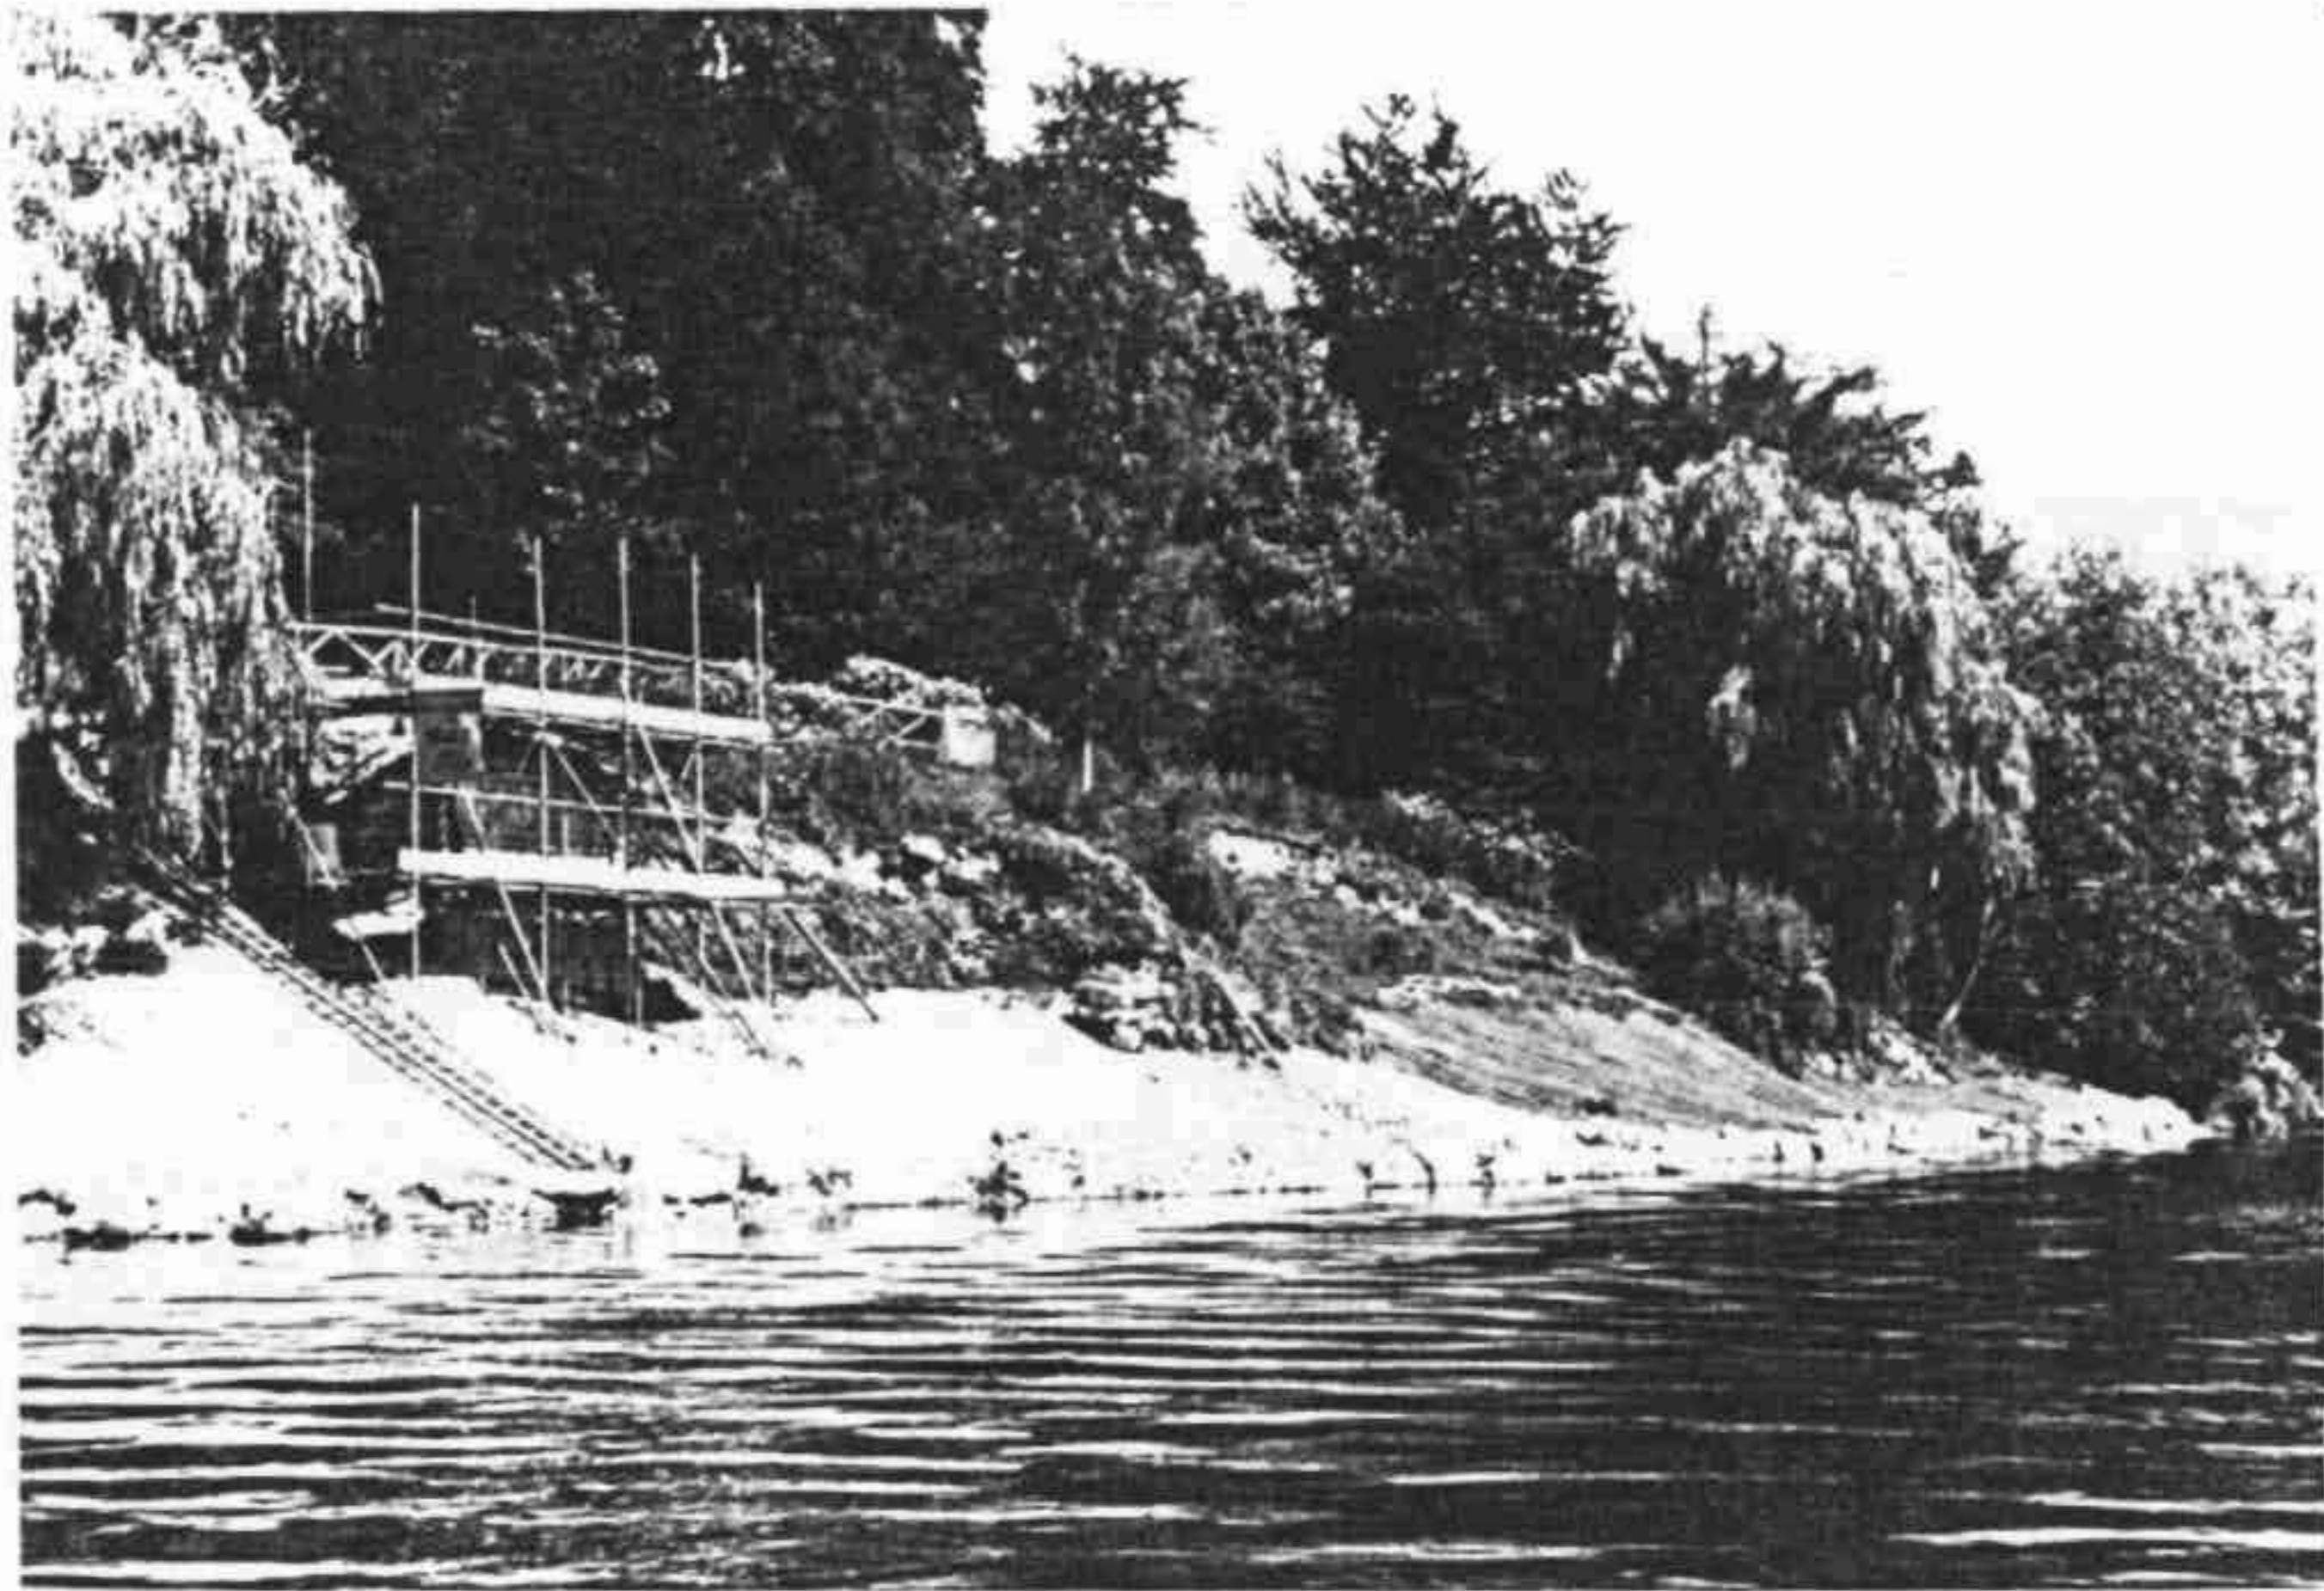
Plate 2

View, looking north-west, of the completed revetment line and protective stone apron; and of consolidation works to the Upper Buttress.

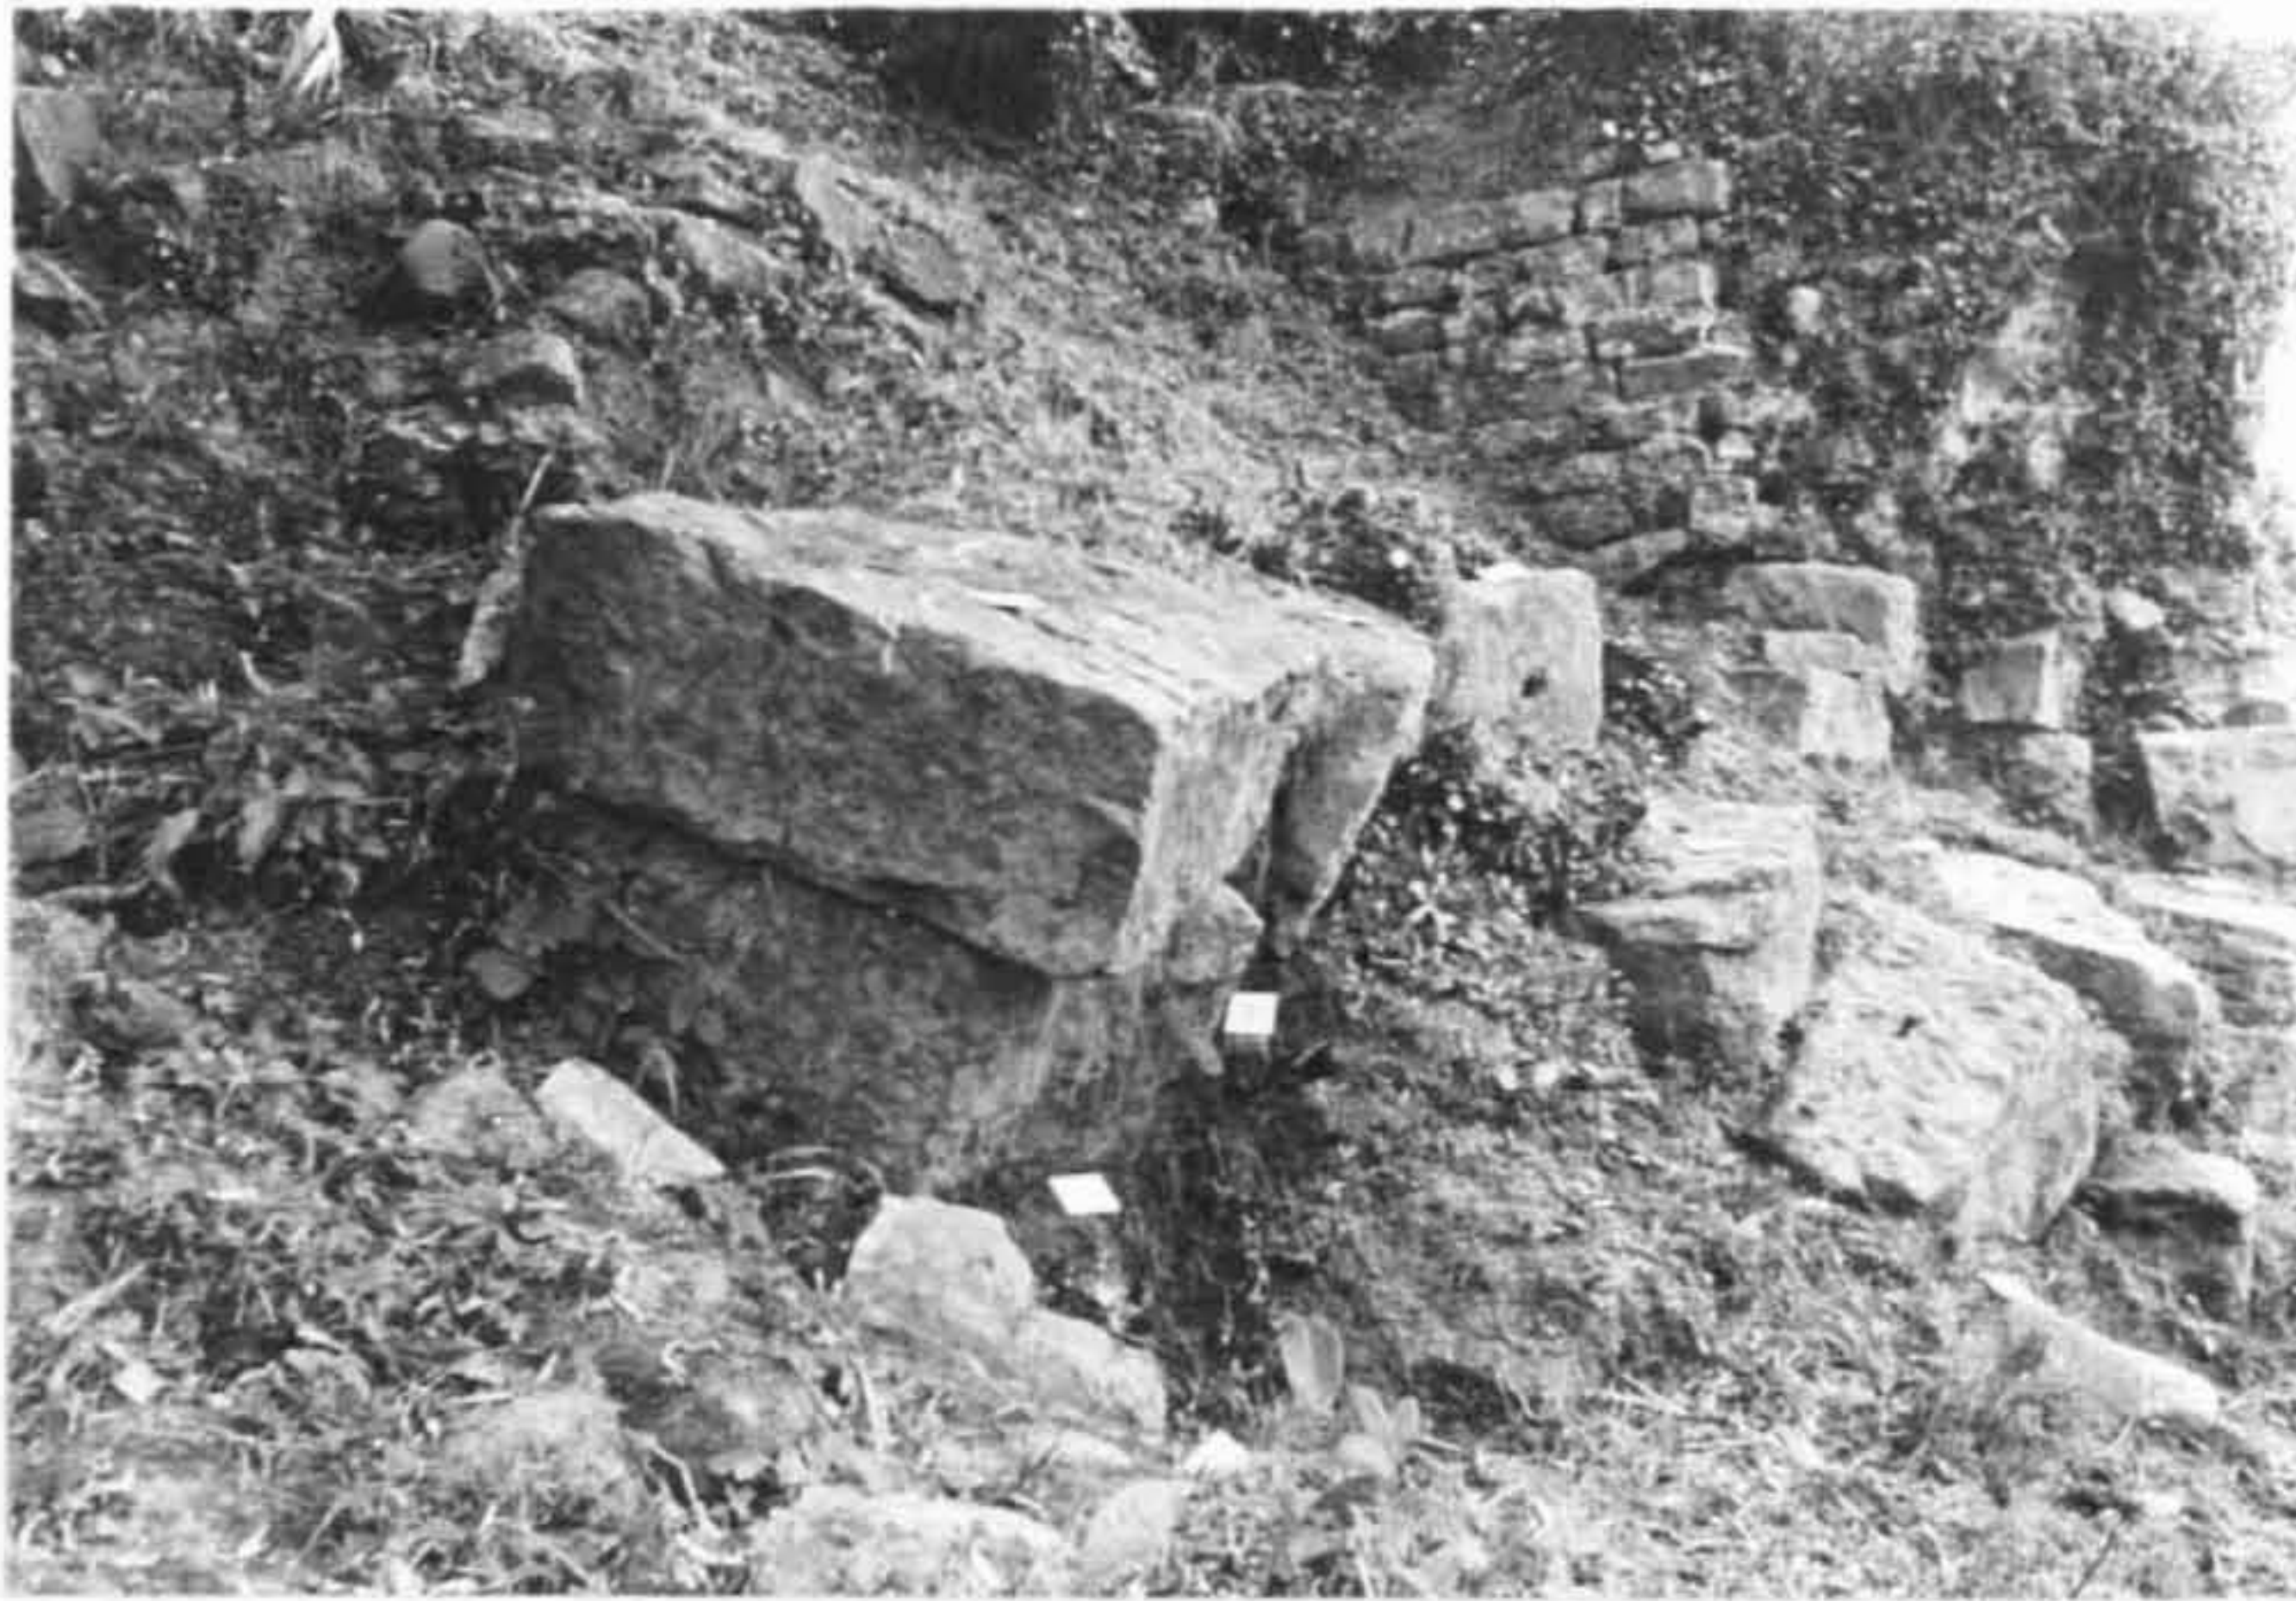
Plate 3

Pre-consolidation view of Upper Buttress and associated ?step structure. Four flights of steps appear to be recognisable.

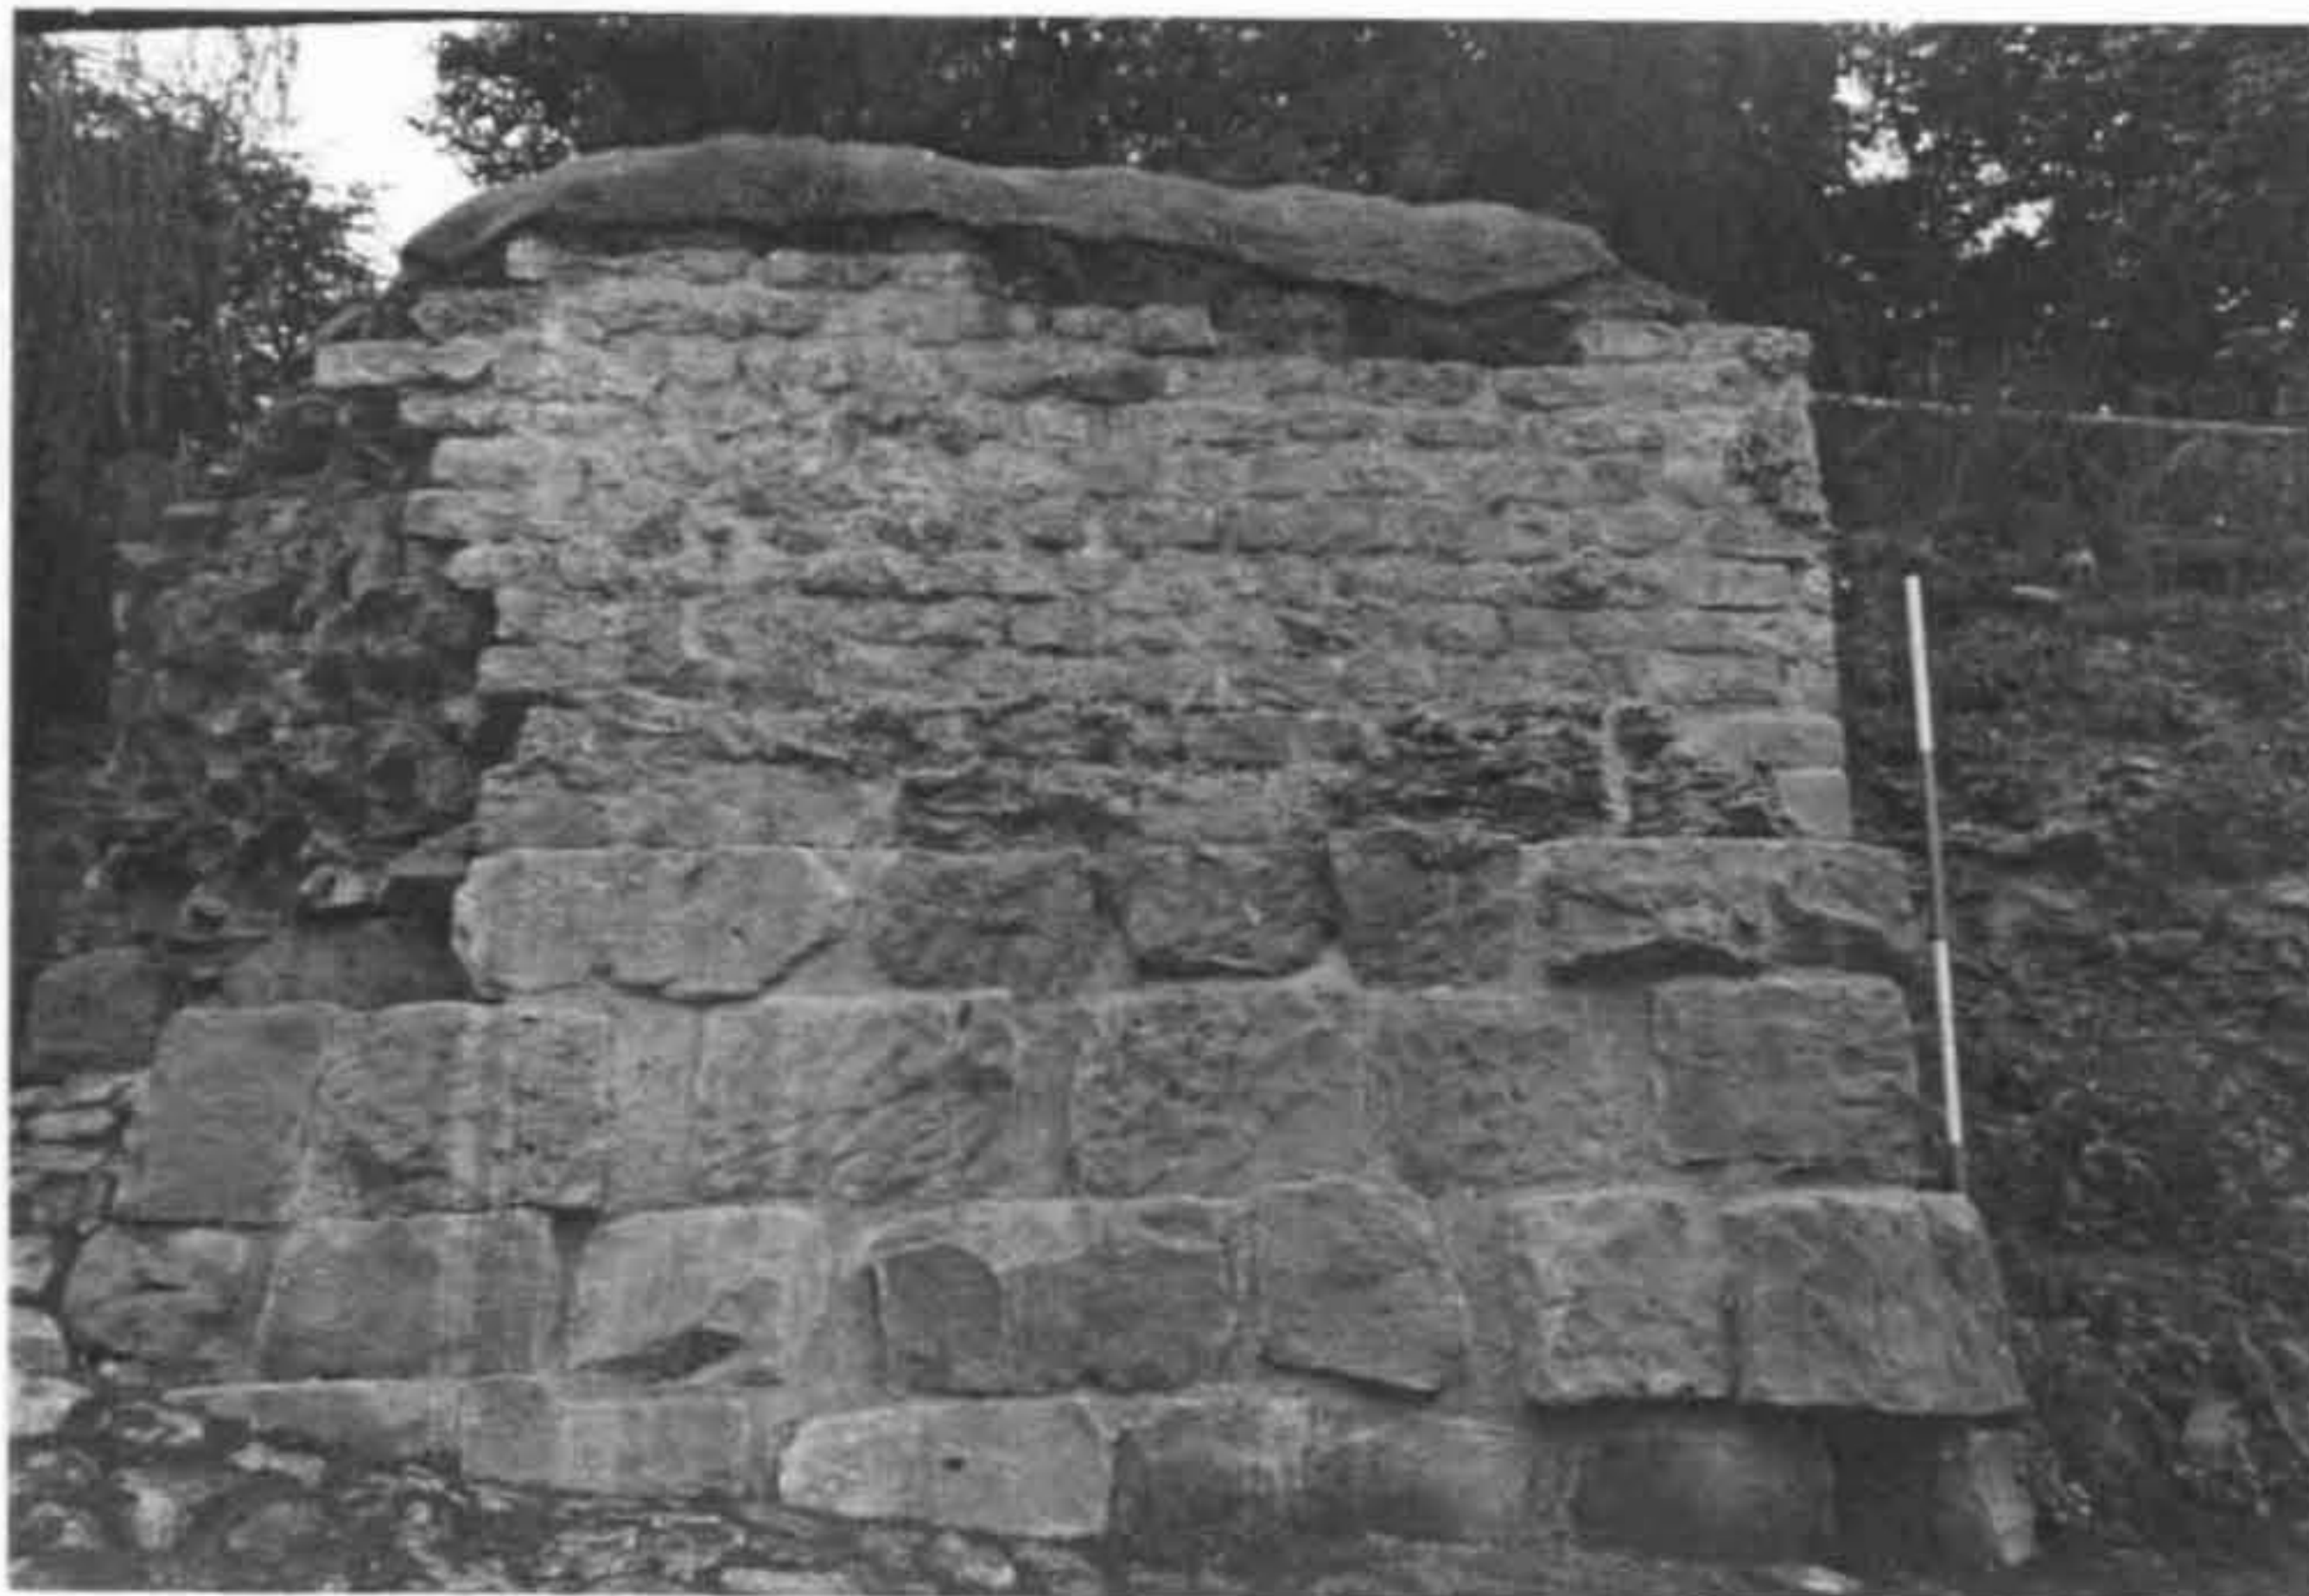
Plate 4

View of Upper Buttress after completion of structural repairs and archaeological investigations.

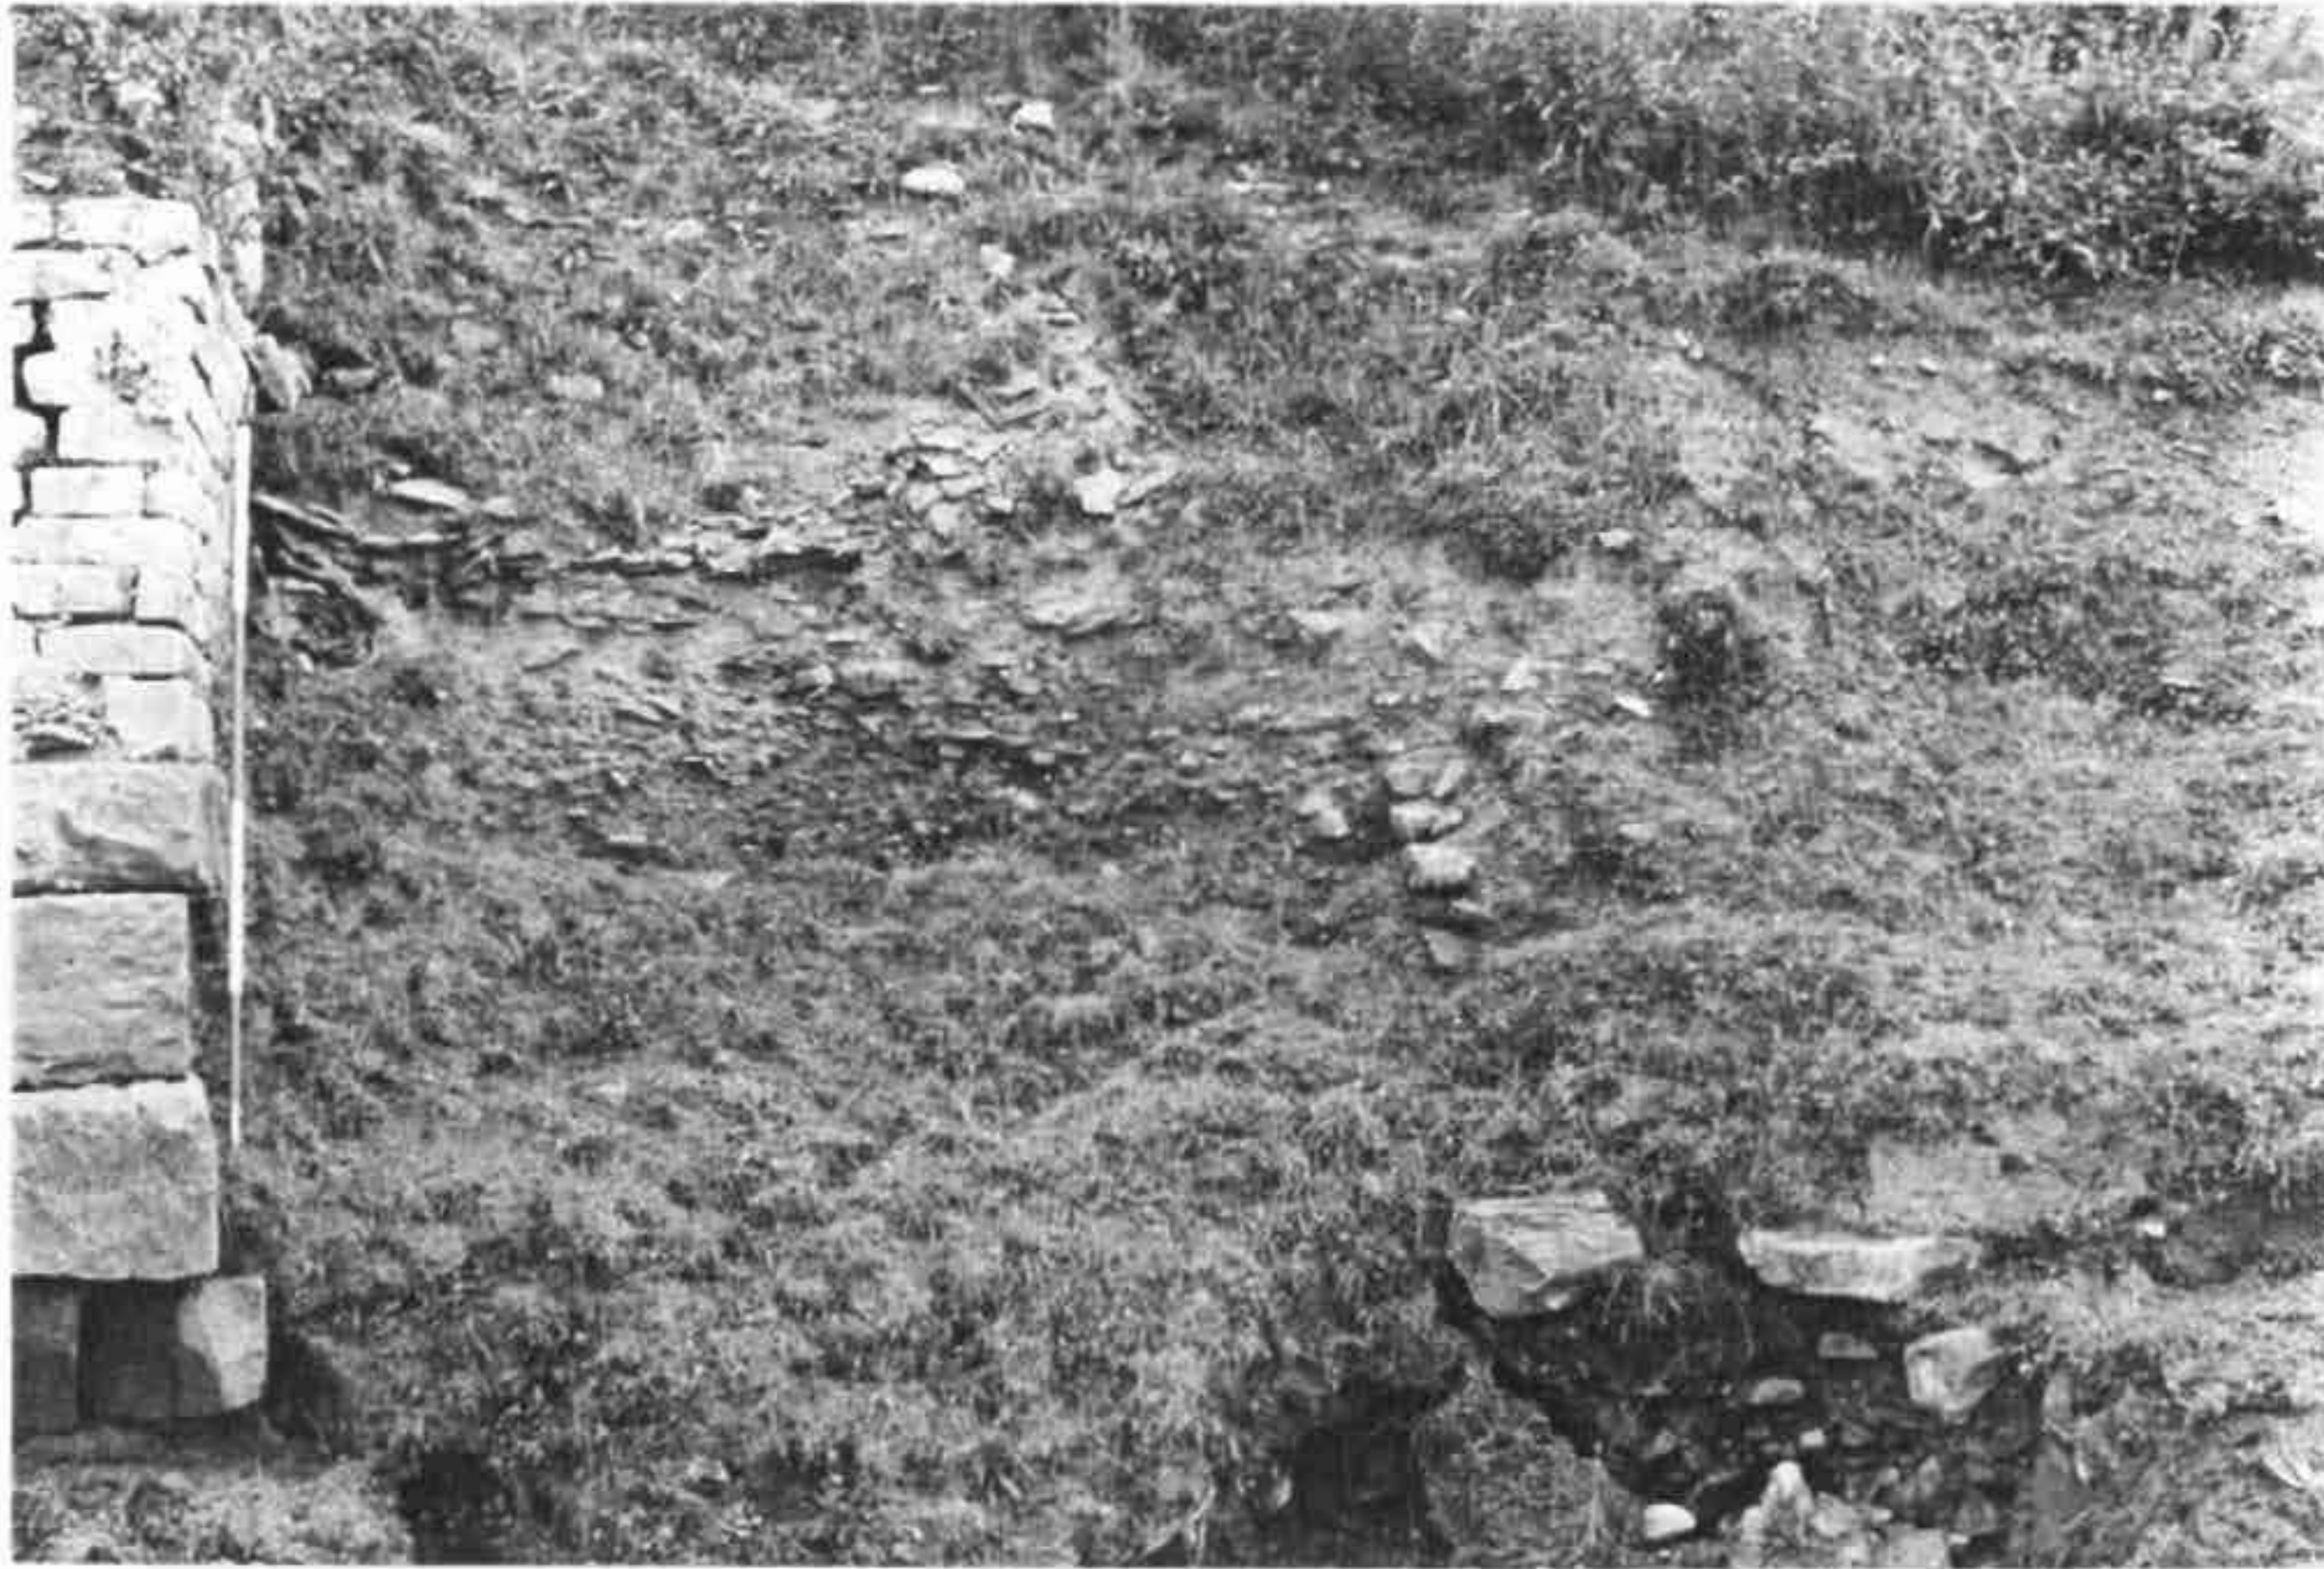
Plate 7

Roman remains in bank section between the Upper and Lower Buttresses. Two bands of sandstone roof-tile are recognisable, from a collapsed roof span, with the remains of a major wall emerging from the bank to their right.

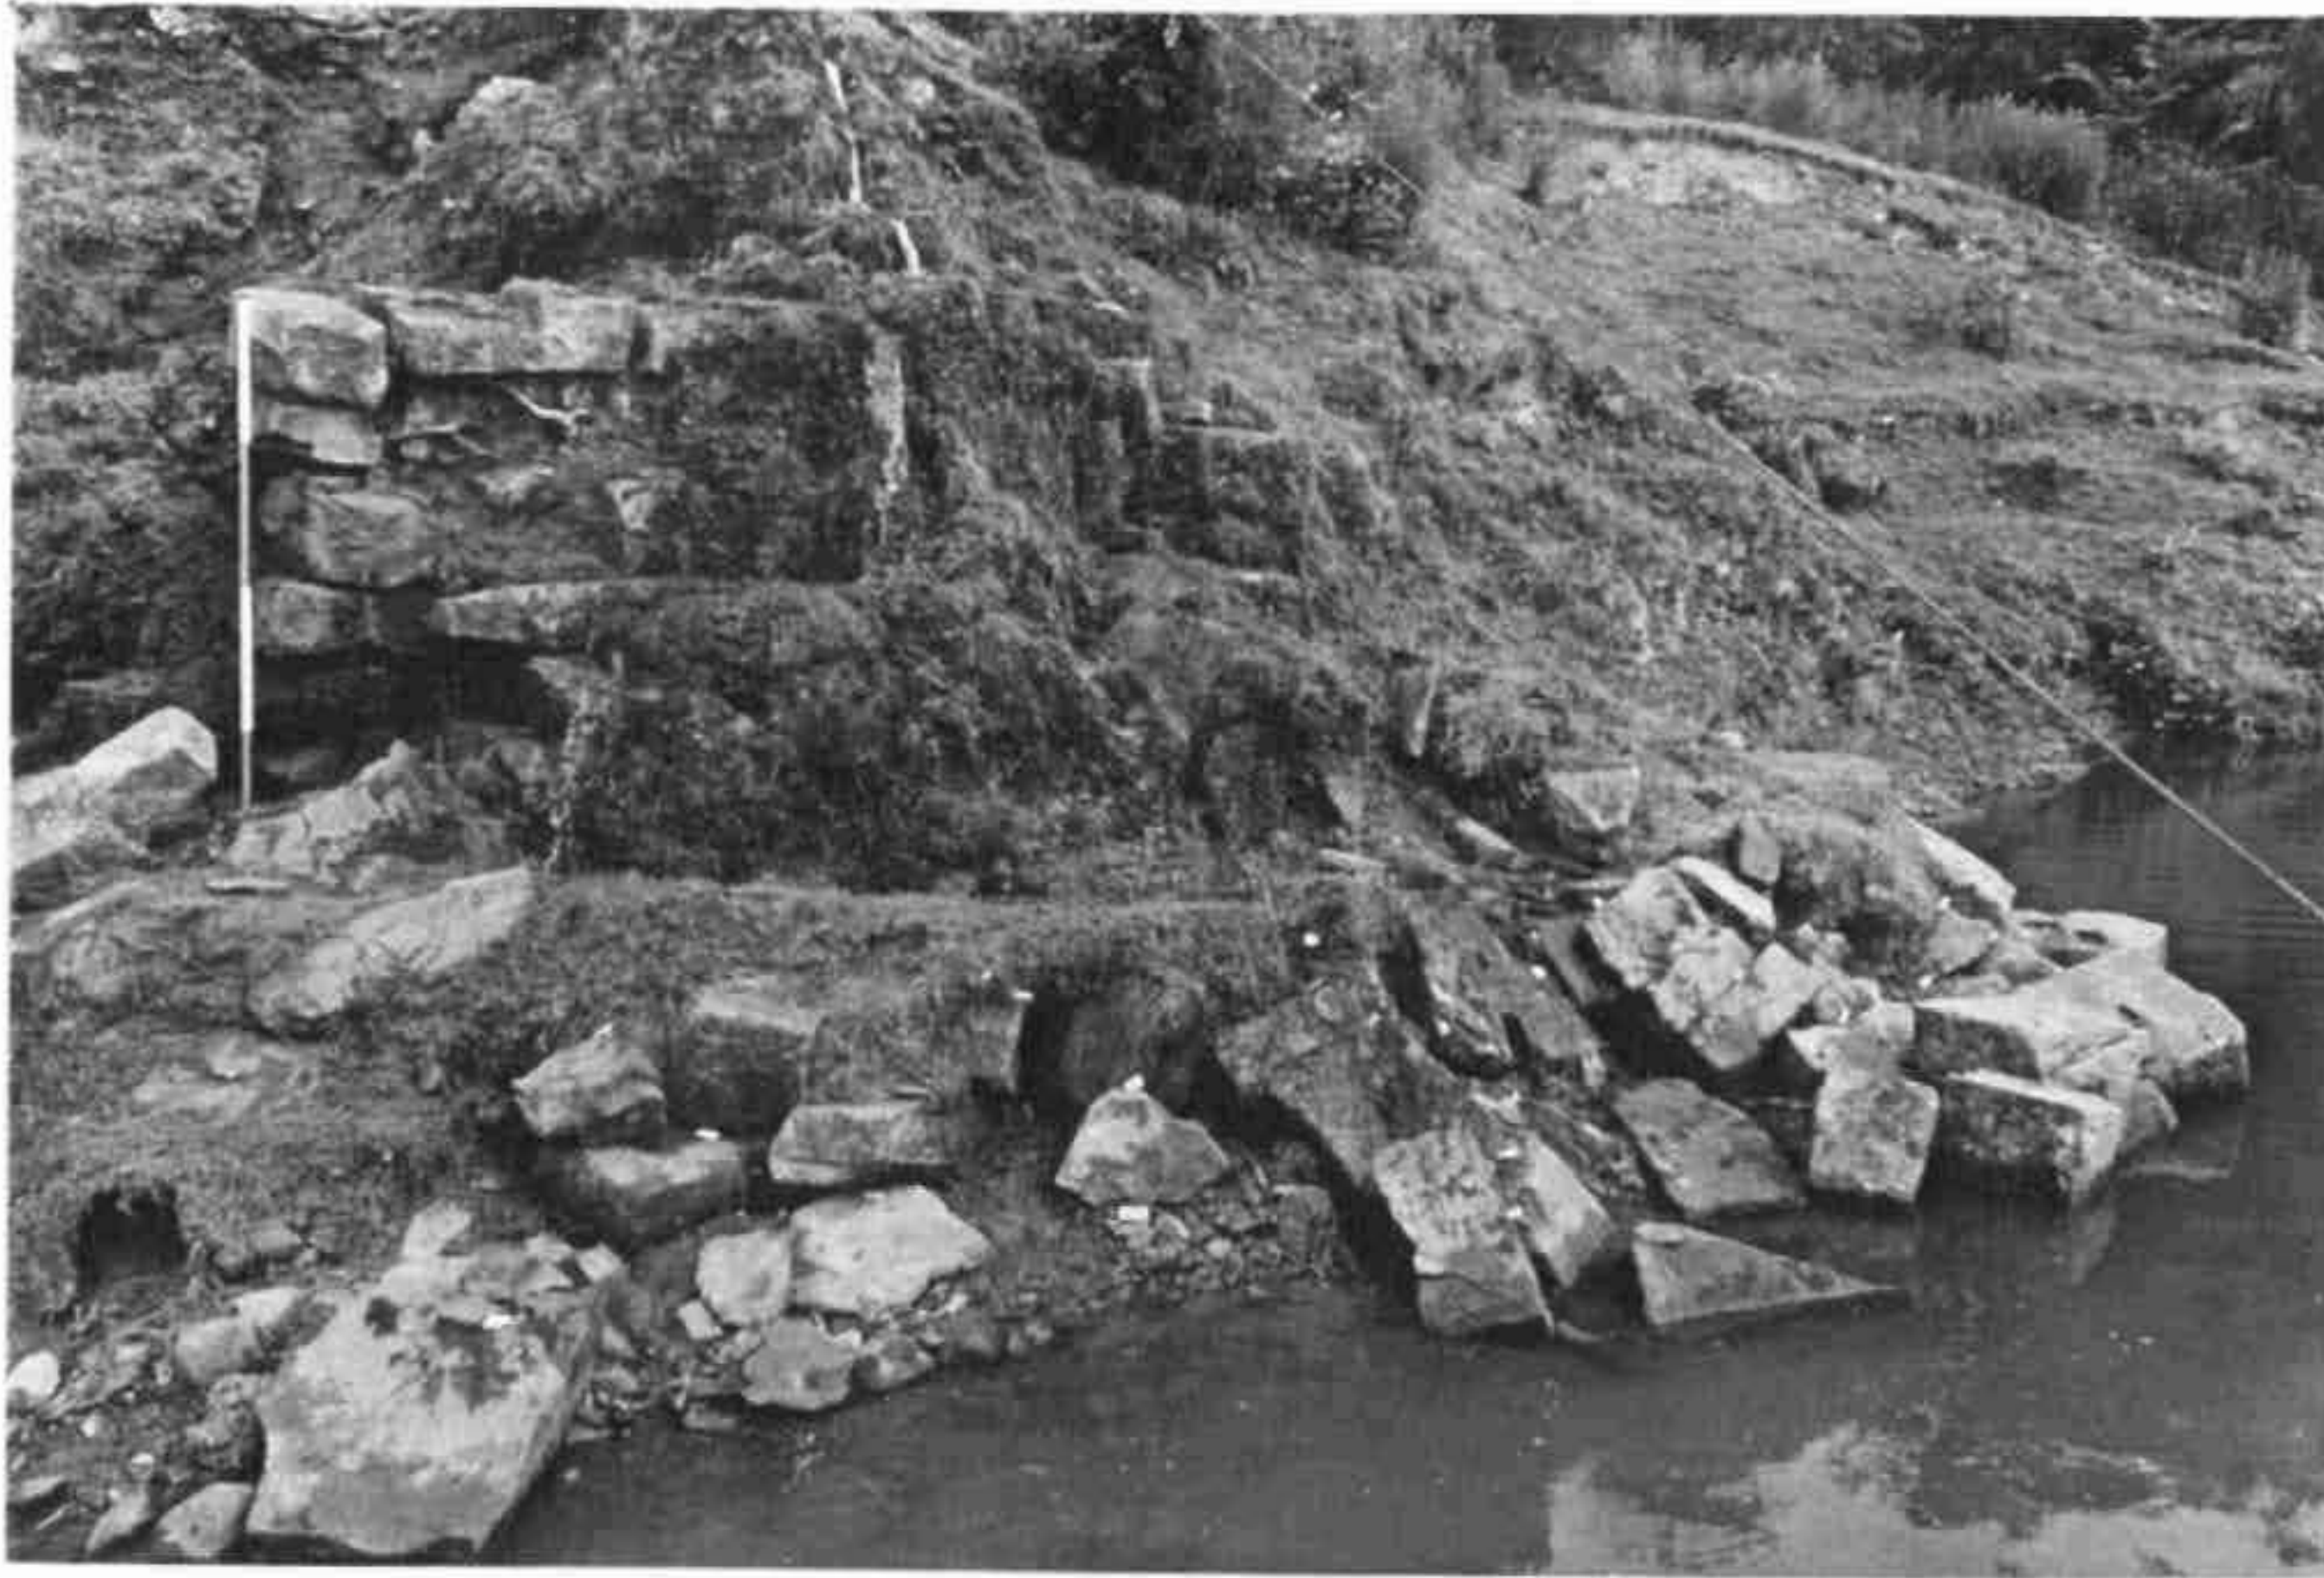
Plate 9

View, looking north-east, of the ruinous state of the Lower Buttress. The advanced state of collapse and extensive tufaceous cover make assessment of its original form and function problematic.
