**THE WEIR GARDEN,
SWAINSHILL,
HEREFORD & WORCESTER**

**ARCHAEOLOGICAL FIELDWORK
1991-1995**

Cotswold Archaeological Trust

C.A.T JOB: 0156
C.A.T REPORT: 95298

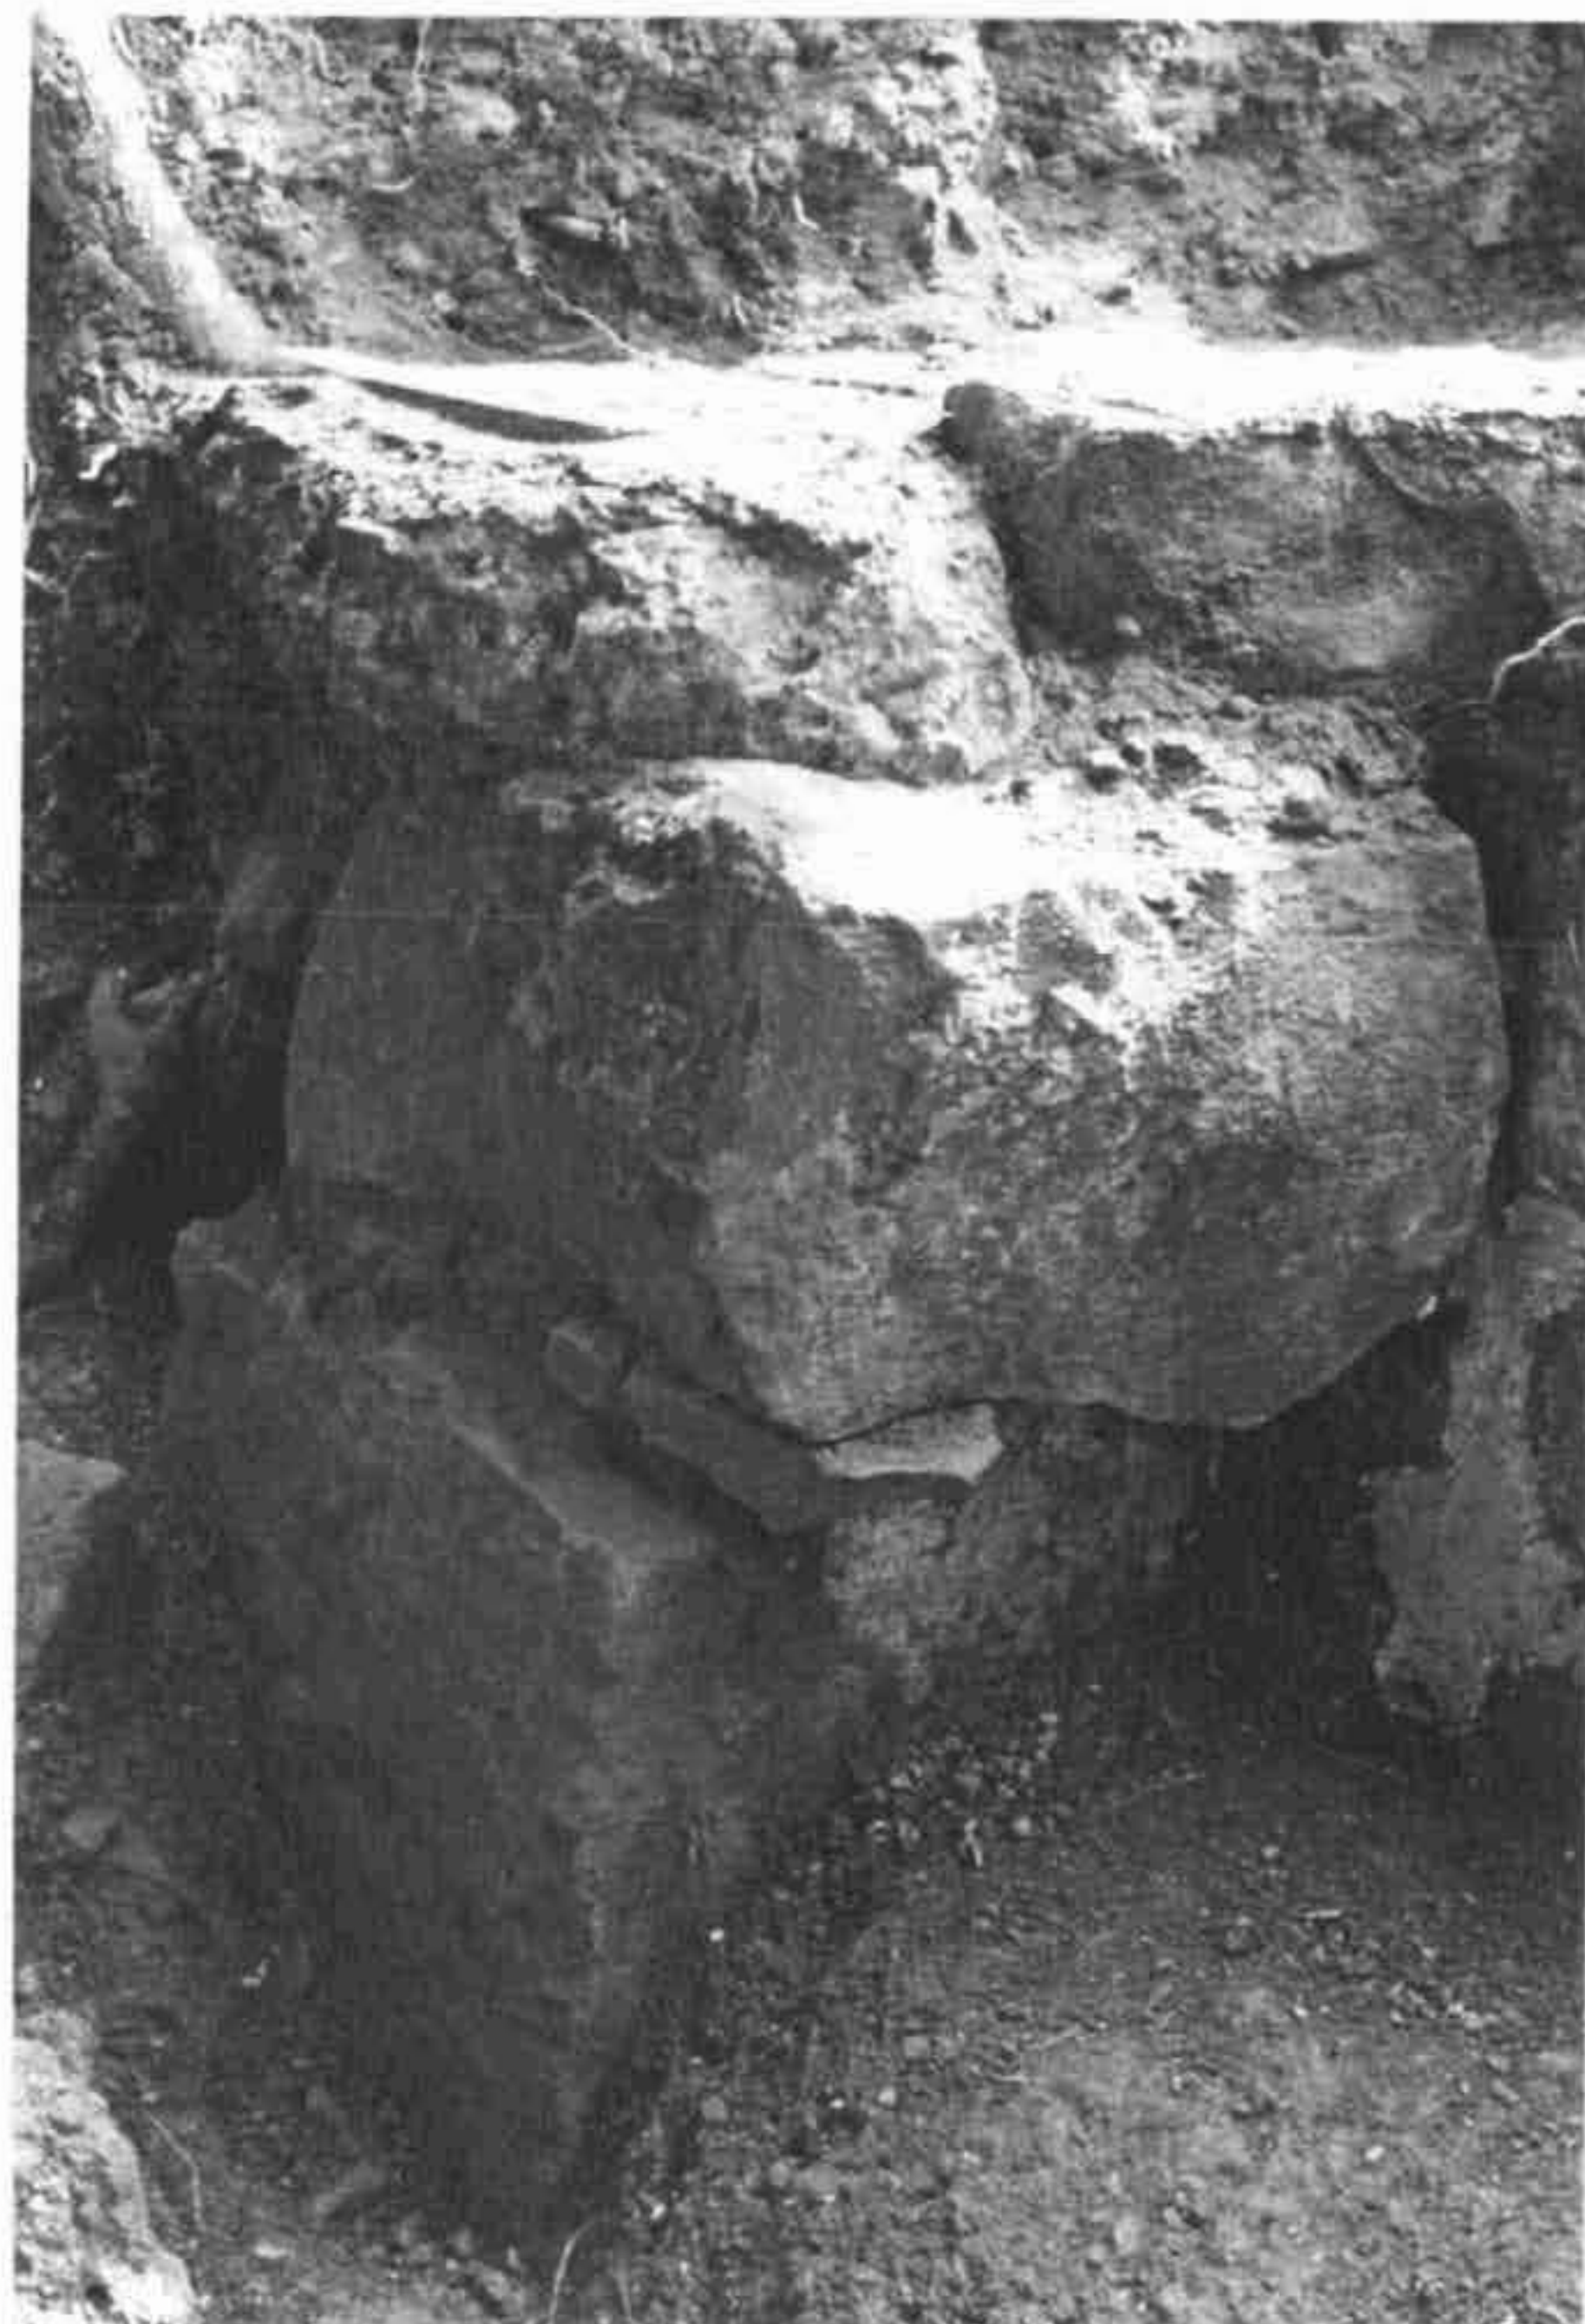
Plate 16

3.1.21 The nature of this floor fragment was difficult to understand when first noted in 1991. It emerged from the bank and ran right up to, and overlay, the lip of what initially appeared to be a facing block of a return wall; emerging from the north-western elevation of the buttress. This was interpreted as an internal wall-stone, keyed to an internal floor, forming part of a return wall that before eroding had originally projected further outward.

View, looking north-east, of return wall section abutting upstream elevation of Upper Buttress. The wall supported a mortar-skimmed concrete floor, ending where a doorway, now badly eroded, gave access to the monumental steps on the riverbank below.
