# Wheelwright House, Long Compton, Warwickshire

## **ARCHAEOLOGICAL WATCHING BRIEF**

### Archaeology Warwickshire Report No 1507 JANUARY 2015

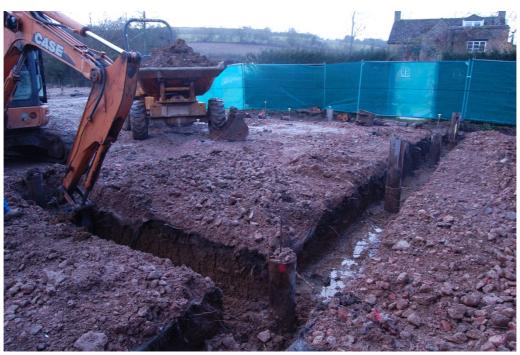
Fig 3: Ground beam trenches

5.1 The new dwellings were constructed on concrete ring beams over pile foundations. This necessitated the excavation of the topsoil and overburden across the site followed by the sinking of piles and then the excavation of individual ground beam slots (Fig 3). This construction method is not ideal for the identification of archaeological deposits or cut features. In addition, severe wet weather caused trenches to fill with water immediately after excavation and the water table to be artificially raised during the groundworks phase (Fig 4).

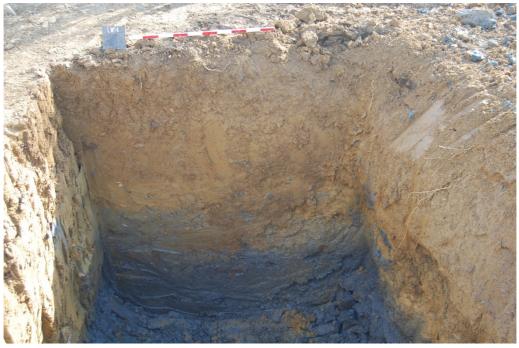
Fig 5: Soakaway

5.3 A consistent deposit sequence was observed across the majority of the site. Geological natural grey clay (6) was observed in the soakaway excavations and the cable trench (Figs 5, 6).

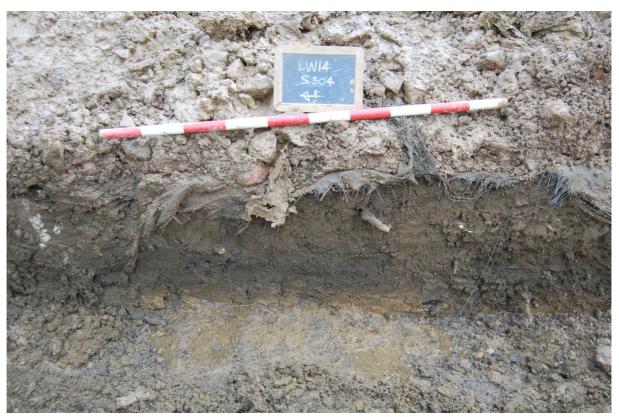
Fig 7: Layer 5 in section

5.5 Layer (5) was noted to the south of the access road within Plot 3. A fragment of oolitic medieval pottery (11th to early 13th century) and two fragments of animal bone were recovered from this layer (Fig 7).

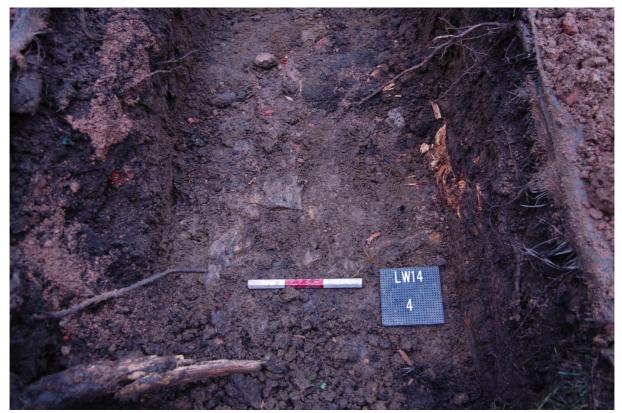
Fig 8: Top of wall 4

5.6 Within Plot 5 the top of a possible wall was revealed (4). No bonding material was apparent in the Cotswold stone feature (Fig 8).
