The Old Hall, Walton, Leicestershire

Photographic Recording

Archaeology Warwickshire Report No 1348
September 2013

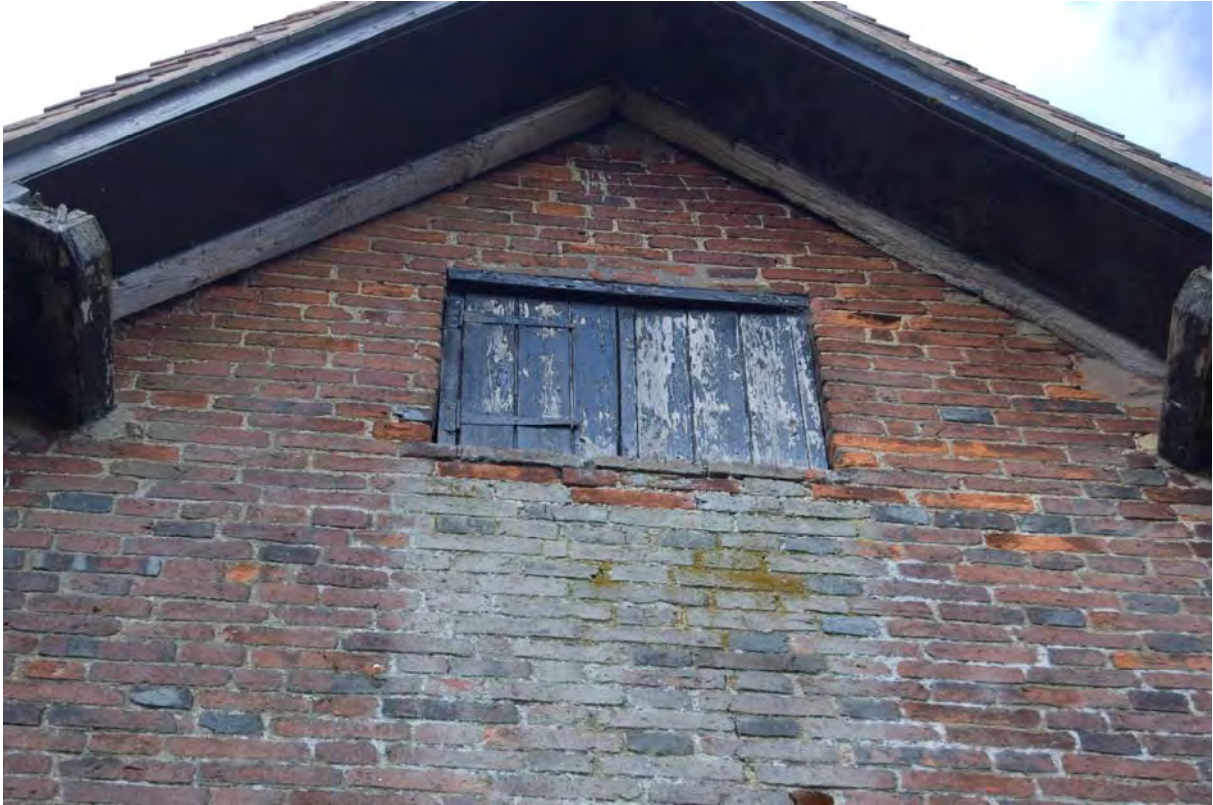
5.1 The Old Hall has seen many changes to its structure over the centuries. At present the western part, along with Old Hall Cottage, is rendered, while the eastern third is exposed brick (Figs 2-5). The chimneys are off-set to the north of the apex of the roof, indicating they are later additions. The window frames are all replacements and the only window in an original position is the first floor window in the central part of the property. Other windows in the Old Hall are in the secondary brick openings, or are later insertions such as that on the gable at ground floor level (Fig 6). The upper window on the gable, which accesses the attic, is shuttered, while a first floor door opening has been replaced by windows (Fig 8).

Fig 7: Shuttered window in gable end

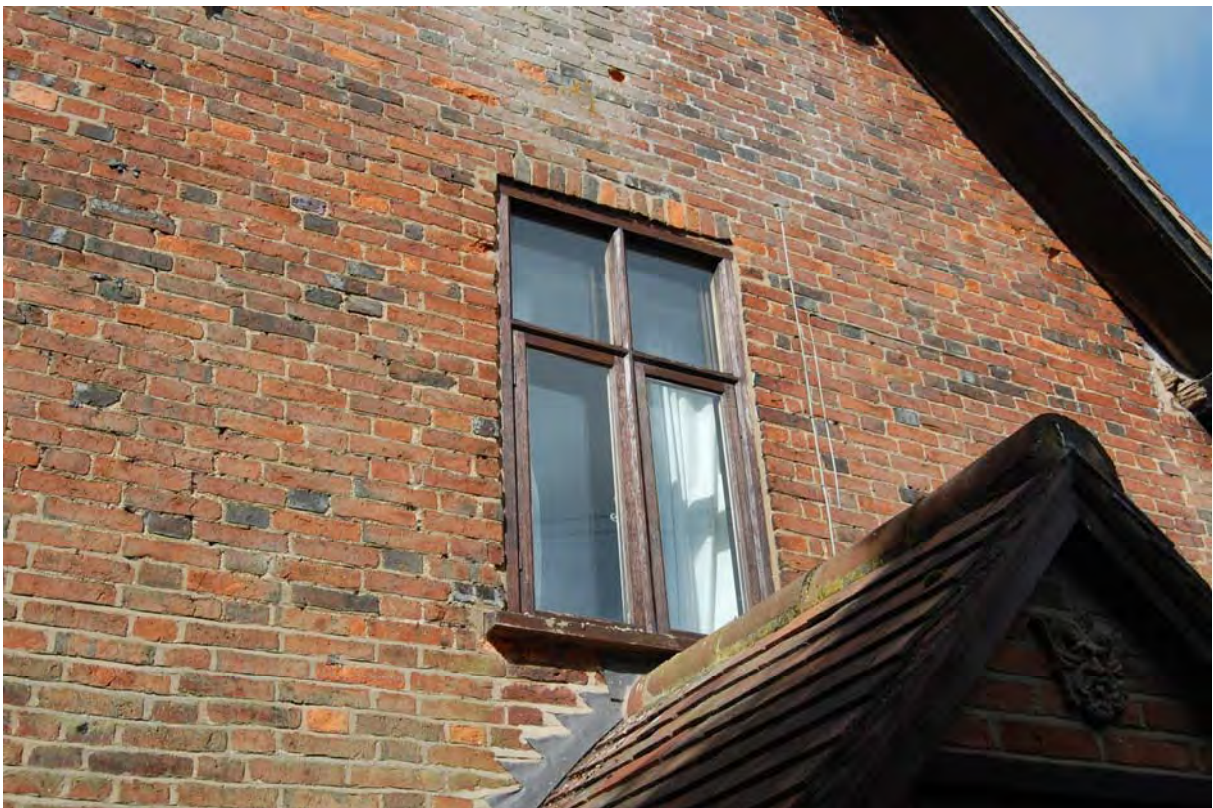
Fig 8: Window in former doorway in gable end

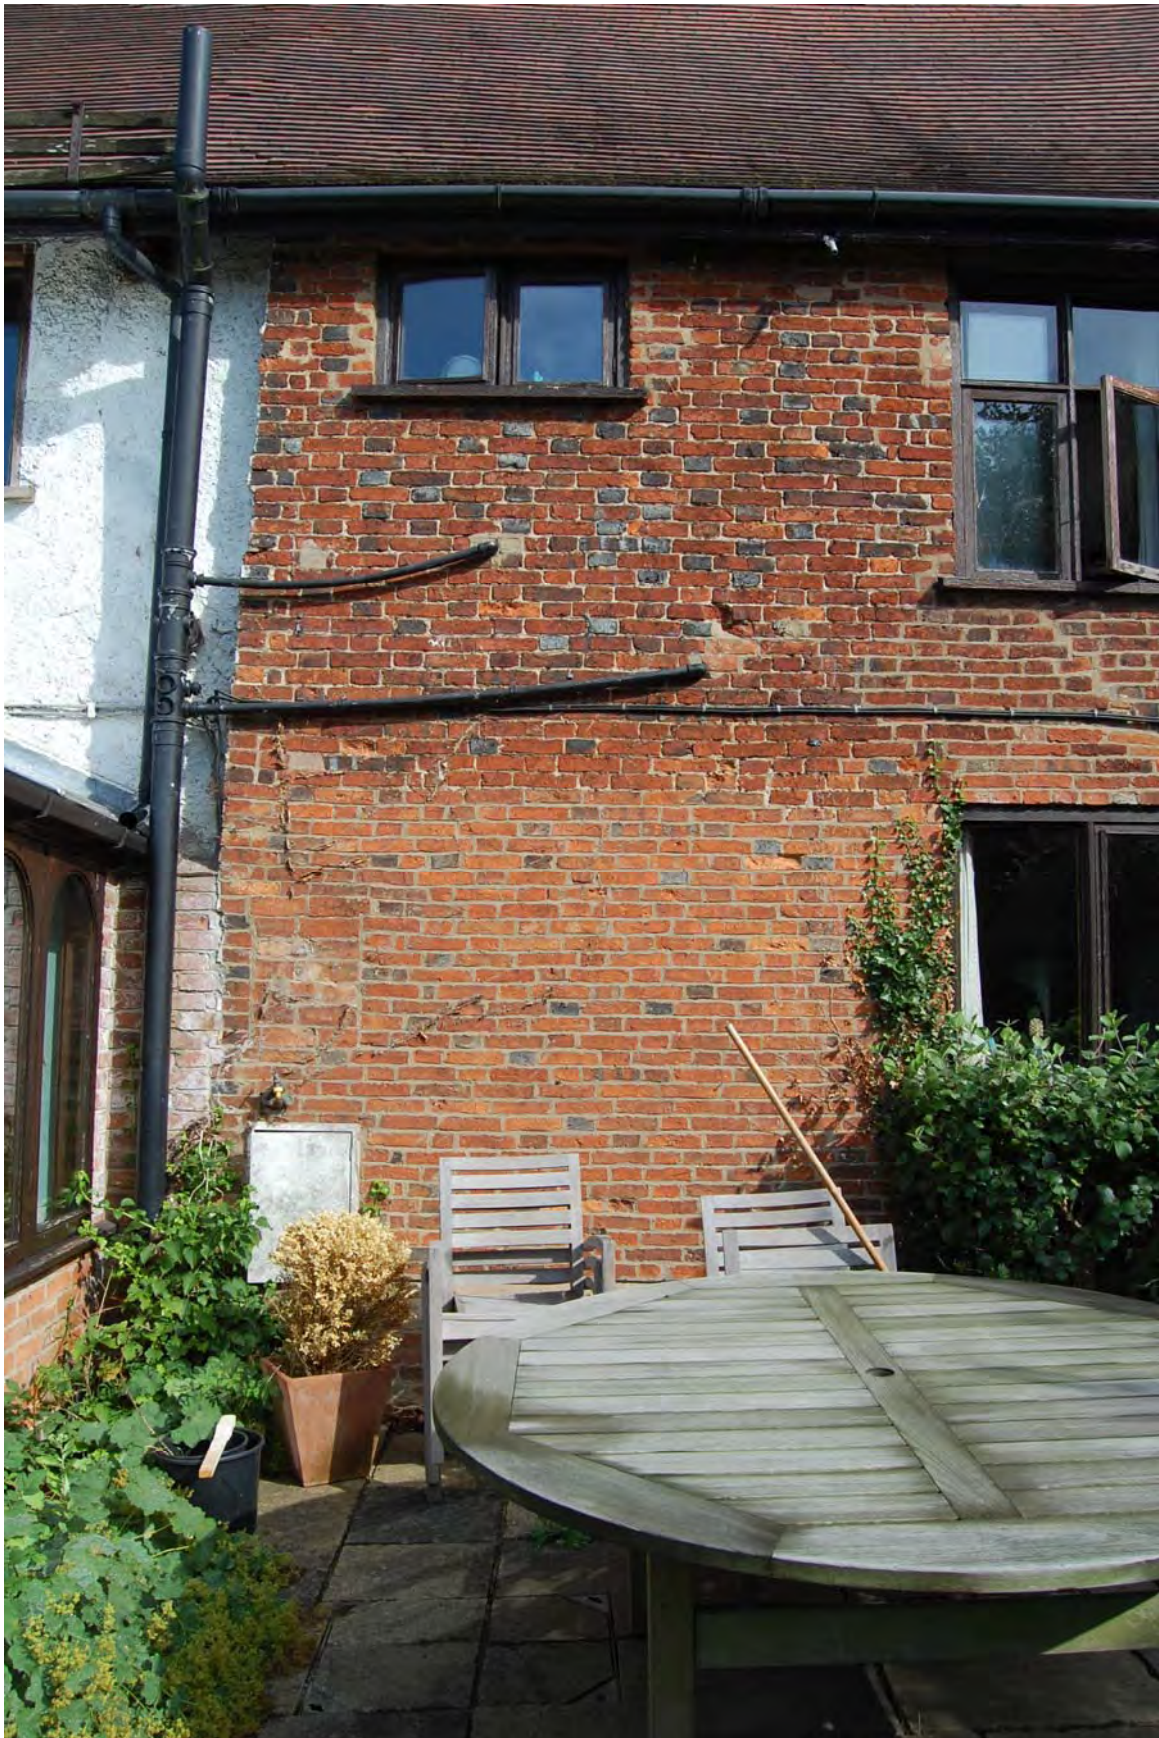
5.2 The brickwork around the ground floor level and first floor to attic differs markedly (Fig 9). The upper bricks are generally dark red and in Flemish bond, with over-fired headers (Fig 10). The bricks are clearly hand-made in both sections but the lower ones are lighter in colour, set in an irregular bond, with modern mortar (Fig 11). This clearly indicates a rebuilding of the lower brickwork, but using reclaimed bricks. A small window in the rear wall has been blocked up with modern bricks (Fig 12).

Fig 9: Rear of house showing change in brickwork between ground floor and first floor

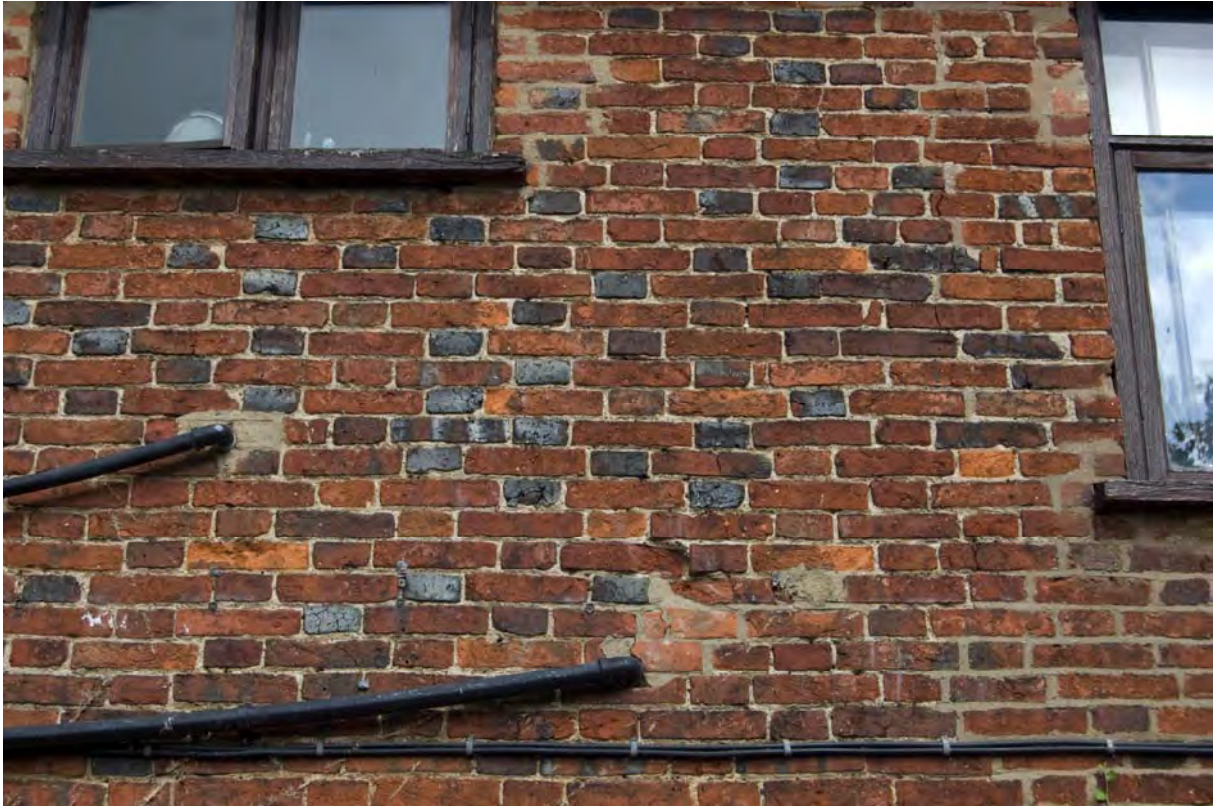
Fig 10: Flemish bond brickwork in upper part of rear wall

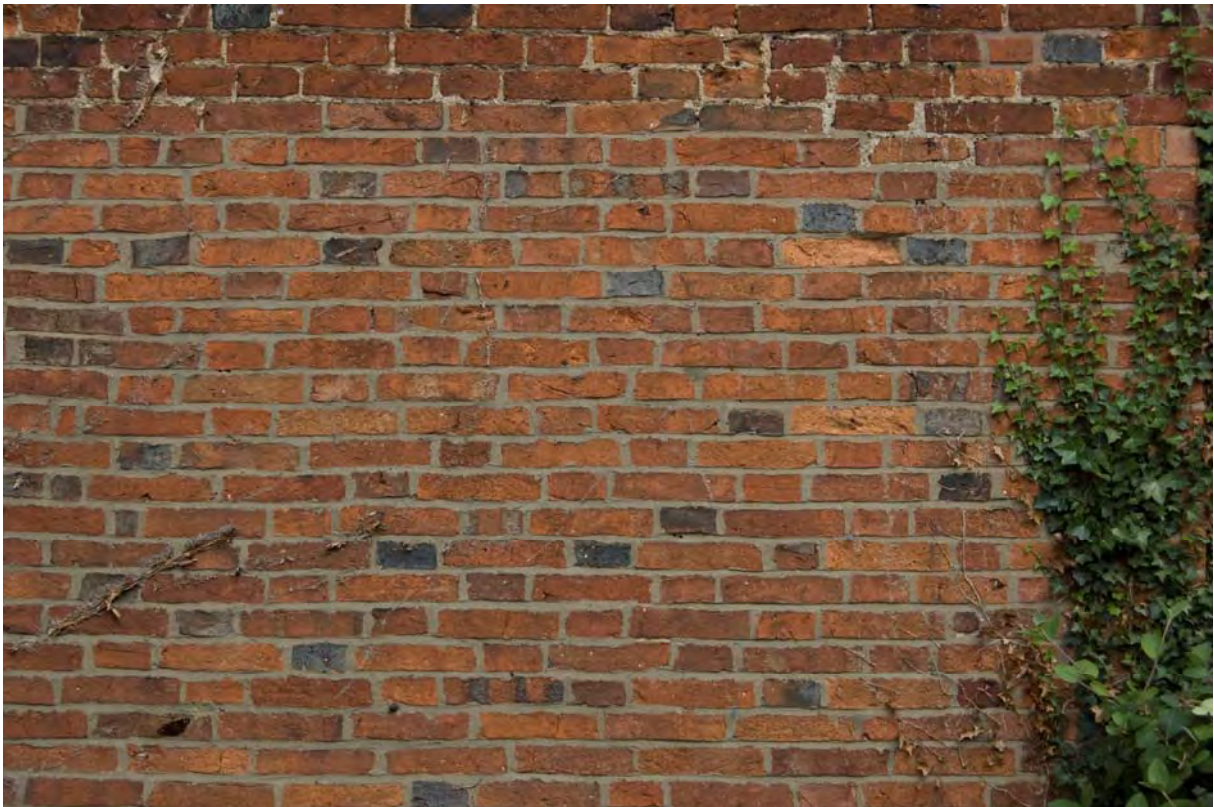
Fig 11: Brickwork in lower part of rear wall

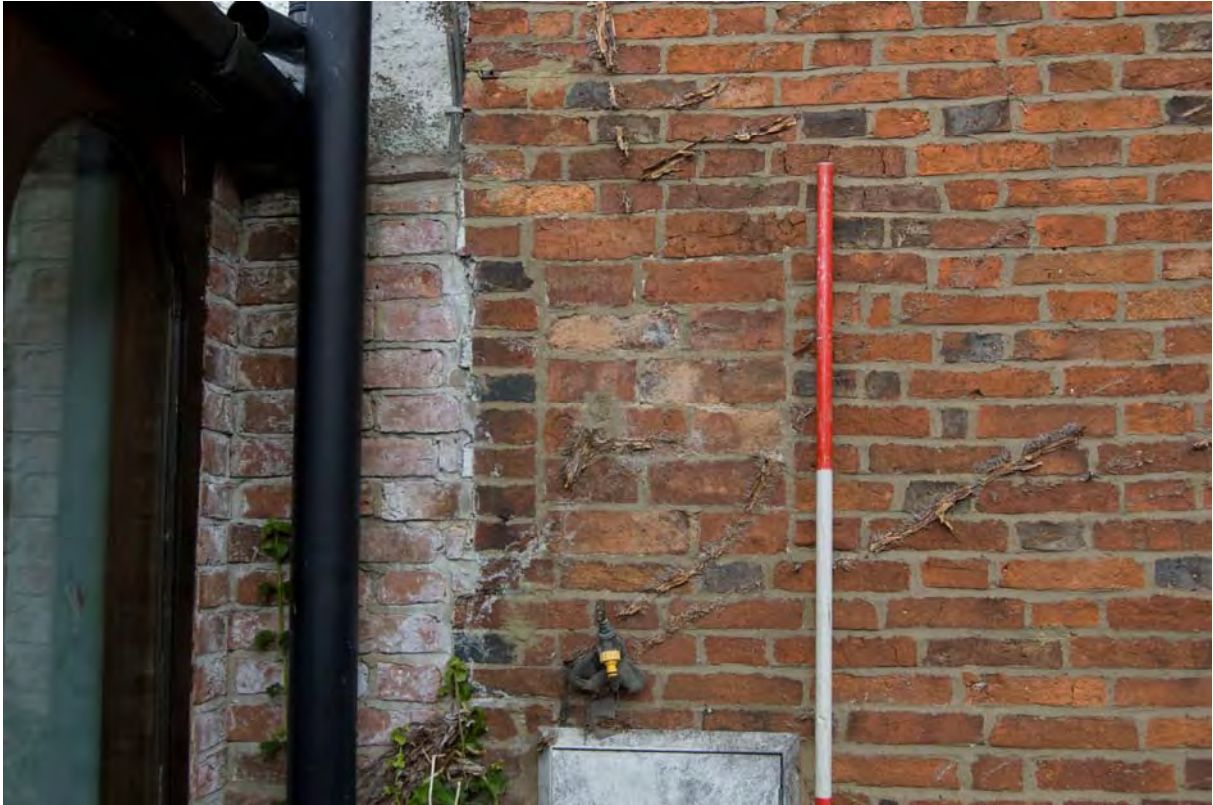
Fig 12: Blocked window in rear wall

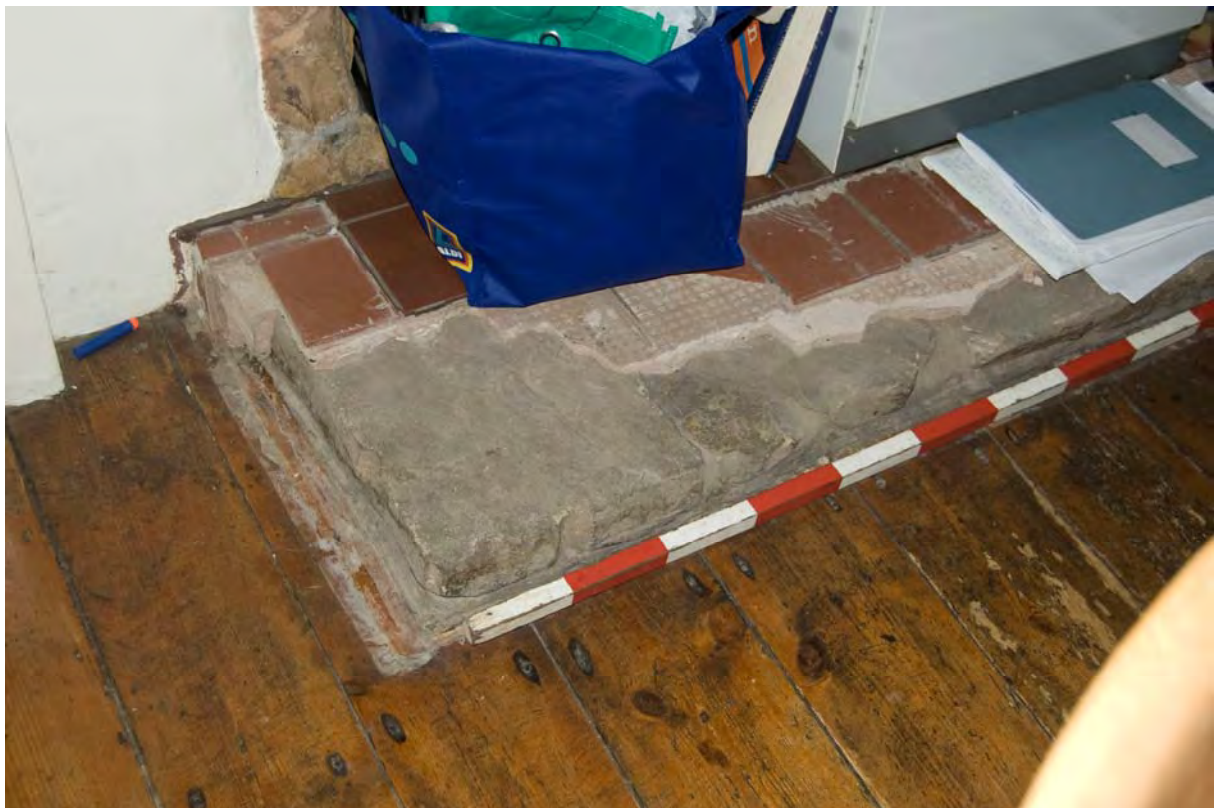
room (Figs 17-24). The kitchen is floored with wooden floorboards (stone cellar below) and a stone hearth exists beneath the quarry tiles in the fireplace in its north-west corner (Fig 15), which now houses a boiler. The heavy ceiling beams are exposed.

Fig 15: Stone hearth beneath quarry tiles

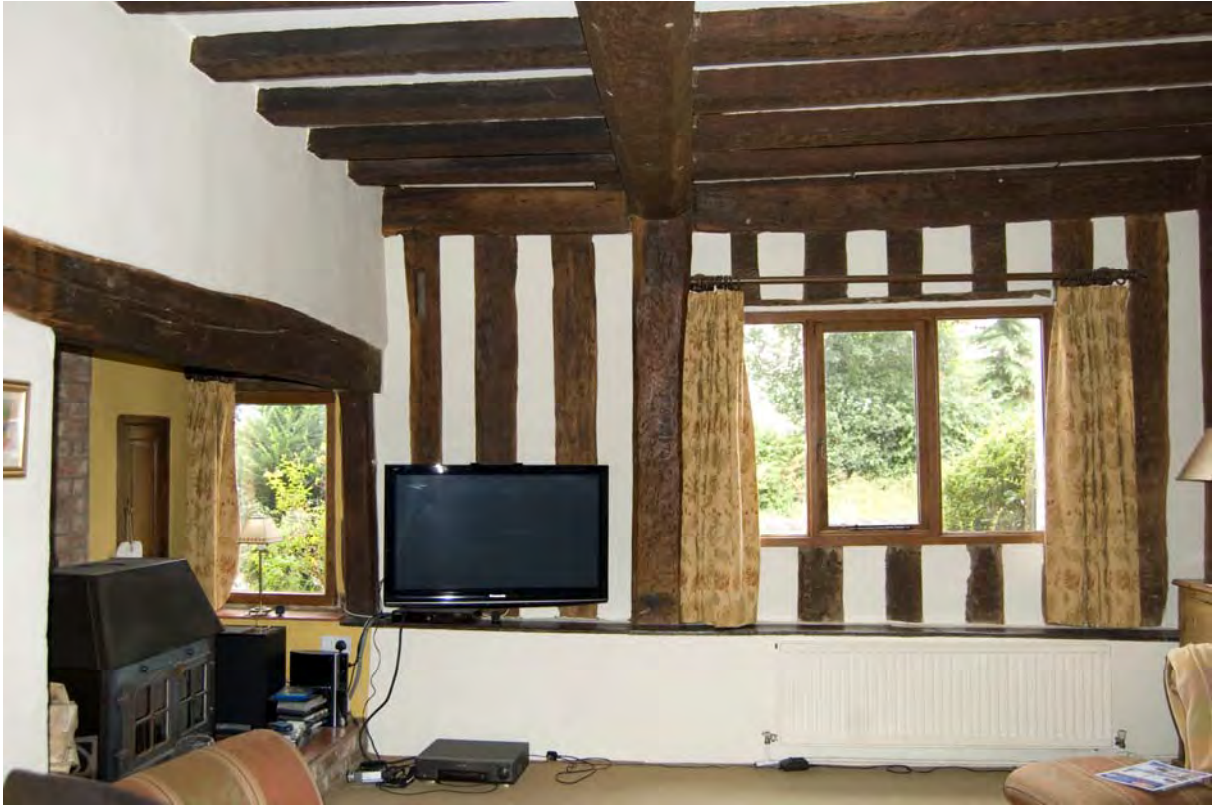
5.4 The living room has a large inglenook fireplace, again in the north-west corner of the room. Close studding exposed along north wall (Fig 18), and east wall, with a small amount on the south wall (Fig 19). The cross beam has chamfer stops (Fig 20) and the insertion of the staircase in the corner of the room has required the chamfering of the leading edge of a ceiling joist (Fig 21). There are few period fixtures and fittings left in the building. Hooks set into one of the beams are of unknown purpose (Fig 22), while a stair-rail bracket in the former cross-passage (now toilet) indicates where the stair used to run along the south wall (Fig 23), from the kitchen, before the present staircase, with period newel post (Fig 24) was inserted.

Fig 18: Close studding on interior wall

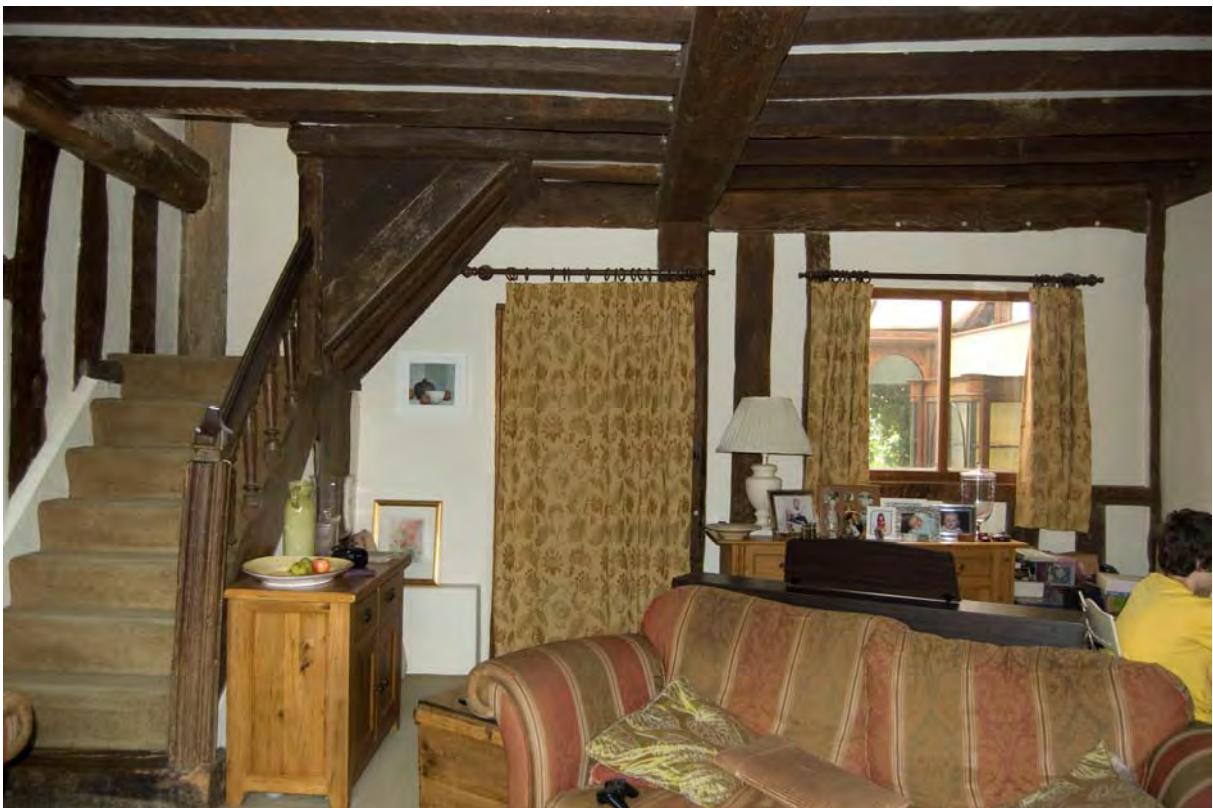
Fig 19: Close studding and inserted stair

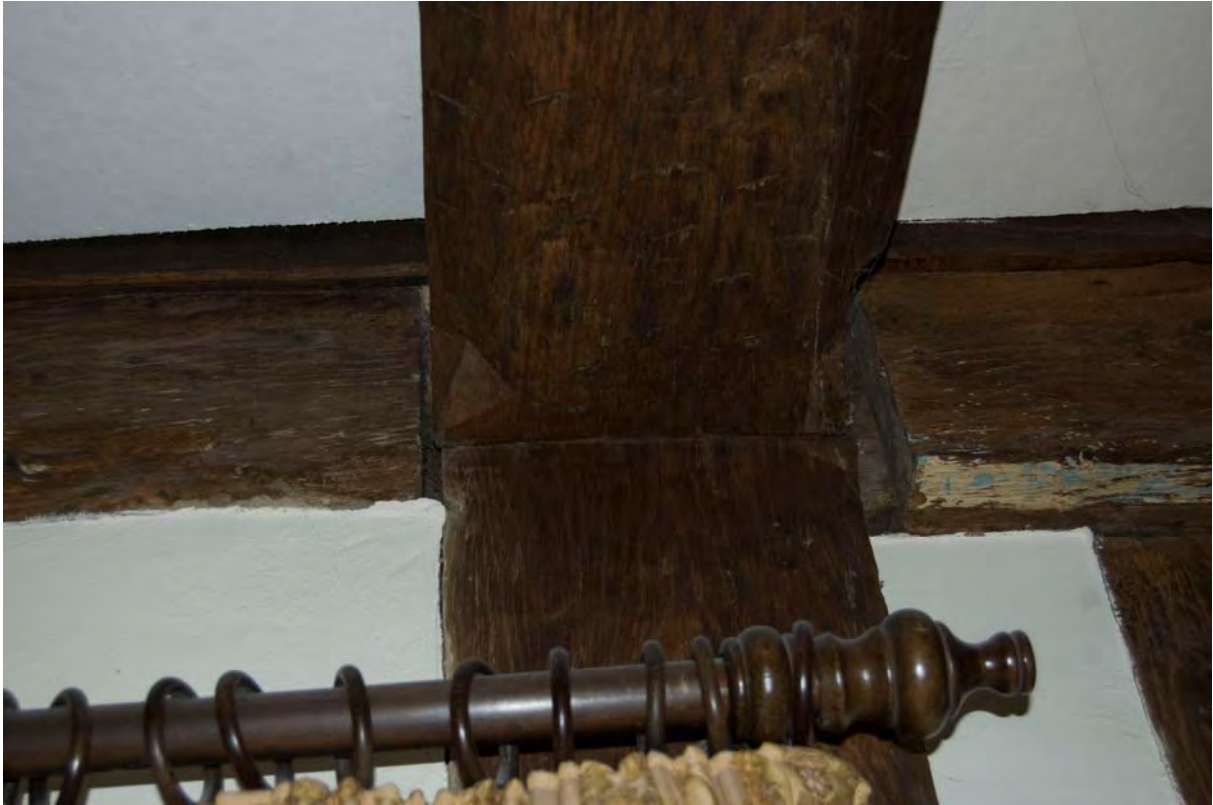
Fig 20: Beam with chamfer stops

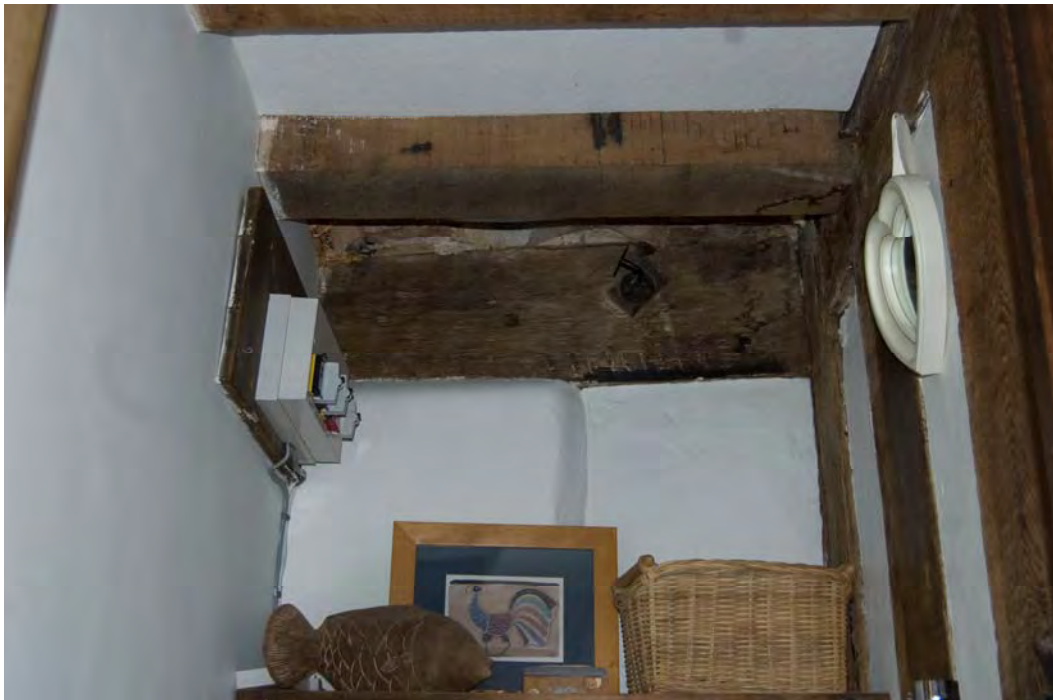
Fig 23: Blocked window and bracket for former stair rail on beam

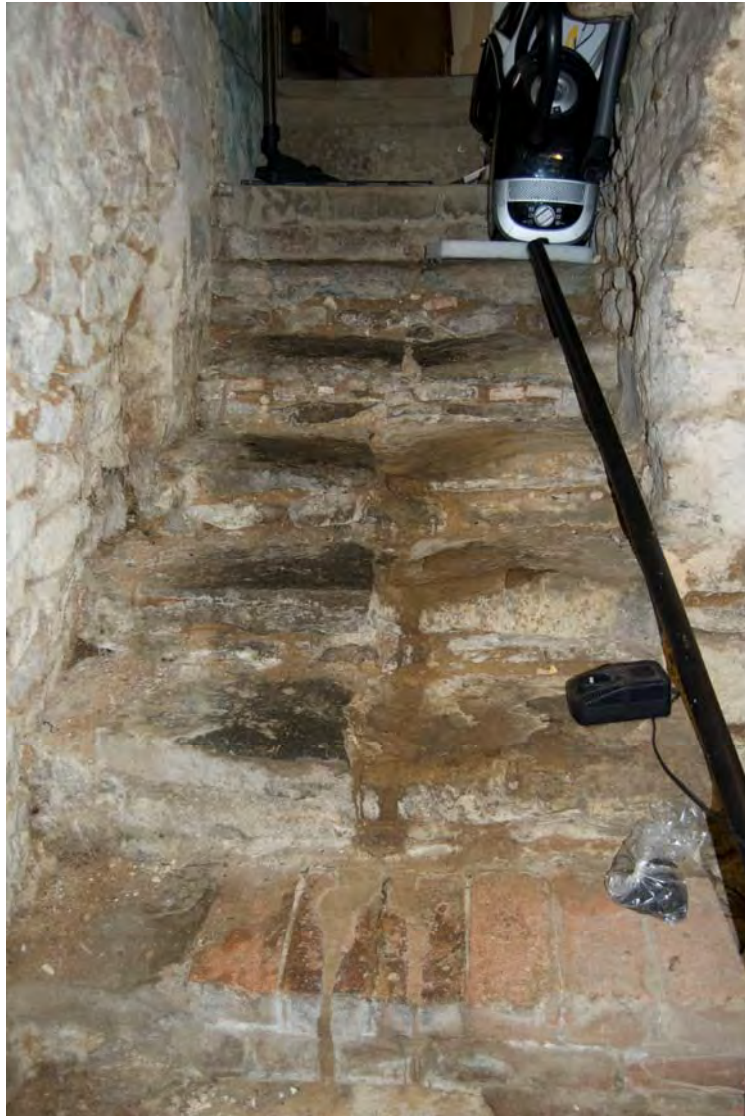
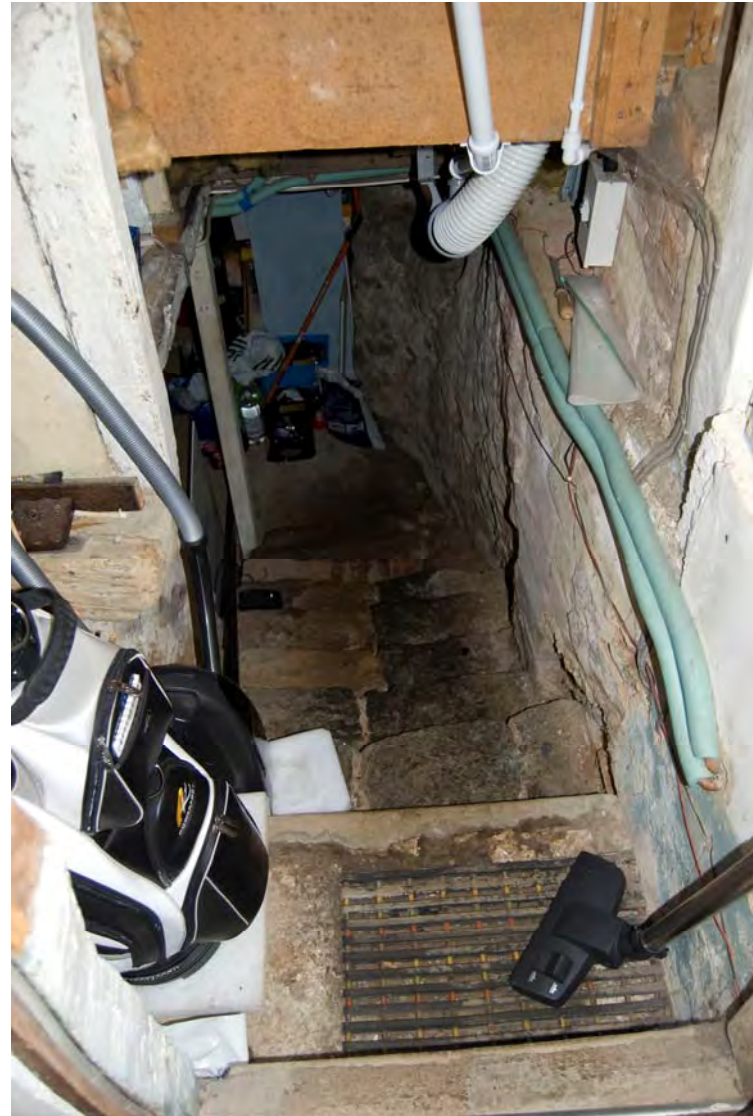
5.5 The cellar door has been shaped to fit below the stair (Fig 25) and the stone cellar steps are worn and brick-patched (Figs 26-27). The cellar is a curious room, smaller than the kitchen room below which it lies, with walls constructed of rough, whitewashed, stone (Fig 28). The floor is now concrete, but Palmer (no date, see Appendix) states that at the time of his examination was of brick 'similar to those used in the hall section'. The cellar walling supports the area of the kitchen fireplace. The recess in the rear wall suggests a possible alternative entrance to the cellar from outside (Fig 29).

Fig 26: Cellar steps, looking up

Fig 27: Cellar steps, looking down

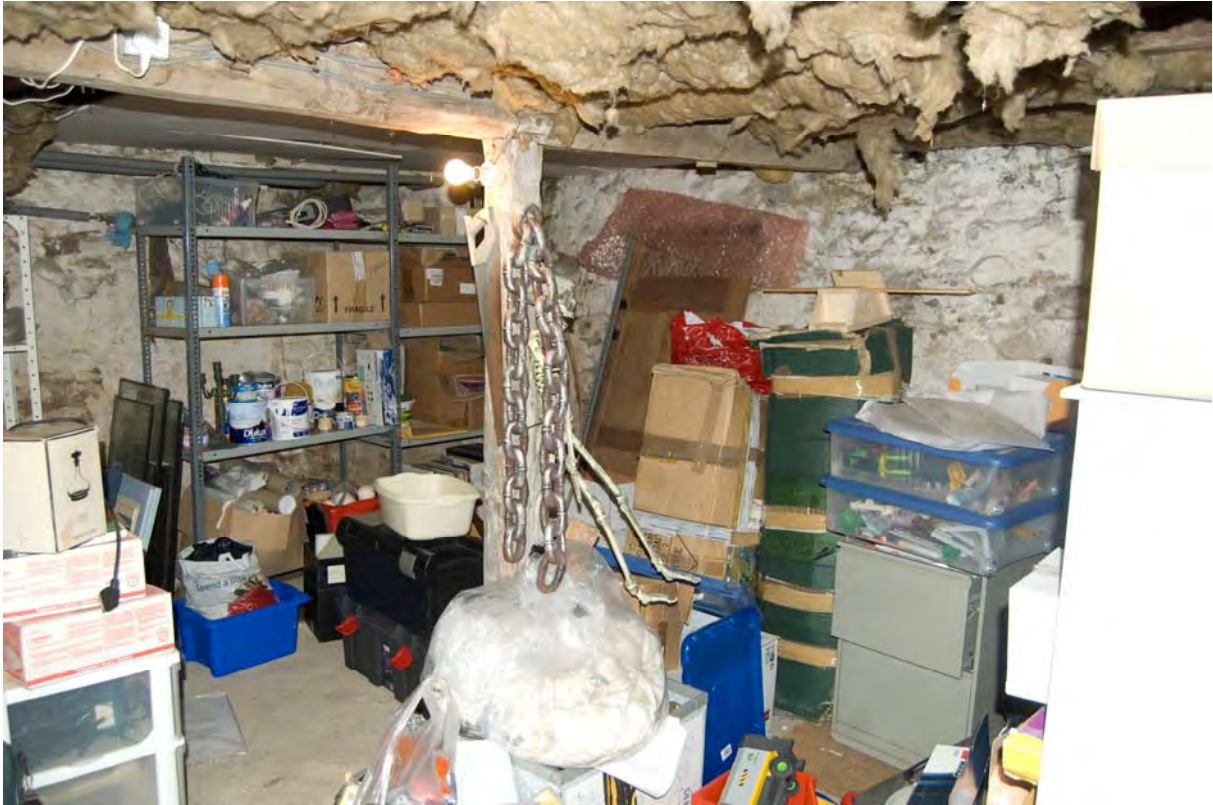
Fig 28: Cellar, looking north

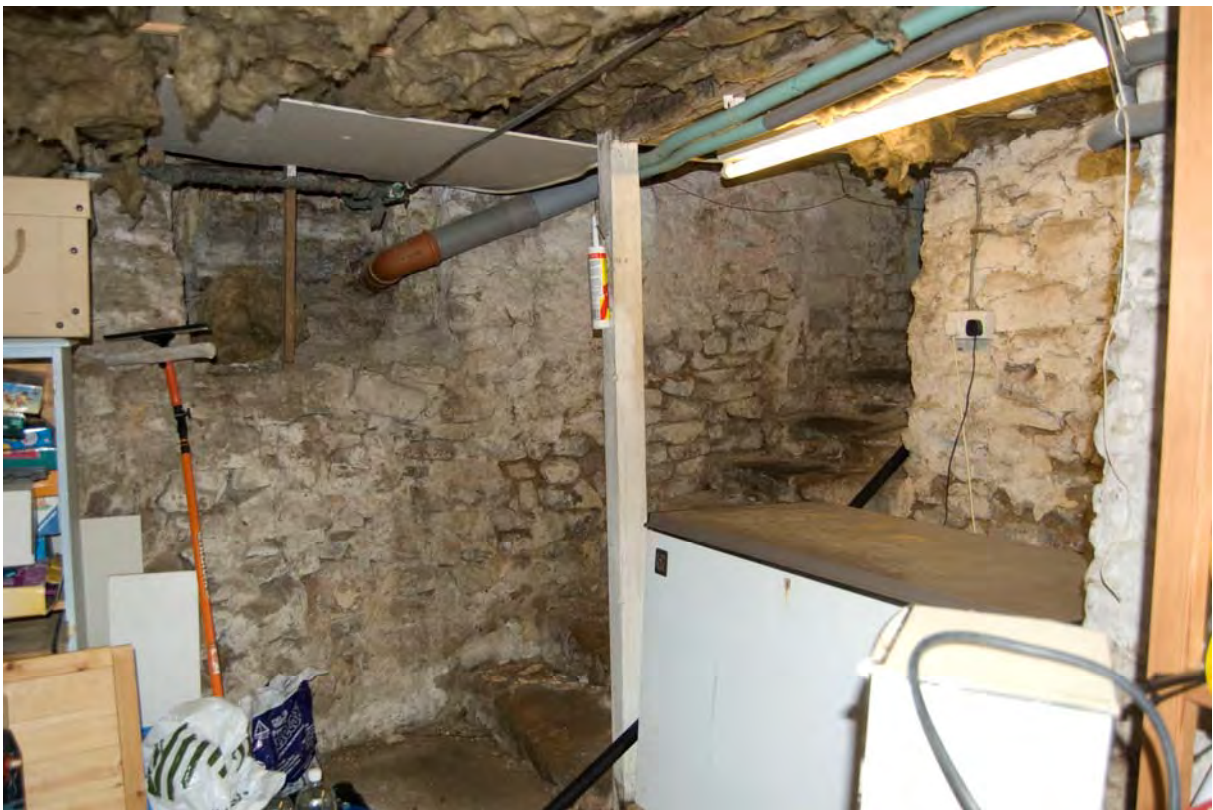
Fig 29: Cellar, looking south

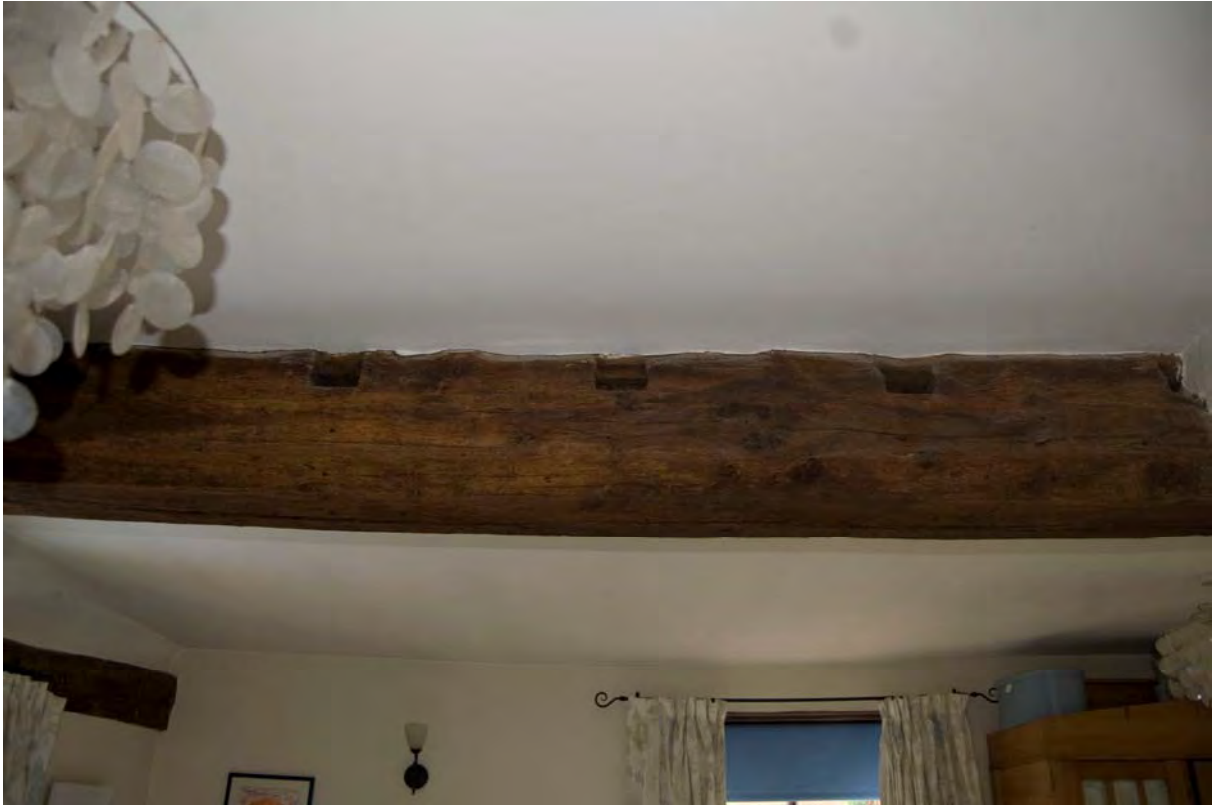
5.6 Upstairs the space has been divided into a bedroom, bathroom and passage in the north-east part and hall, stairs and two bedrooms in the south-west part (see Fig 52). The main bedroom, which occupies the northern part of the house, has a stone fireplace (Fig 30). The central ceiling timber is exposed, as are other timbers in the walls (Fig 31). The central beam has mortises visible for joists, suggesting the ceiling level has been raised (Fig 32).

Fig 32: Timber with joist holes

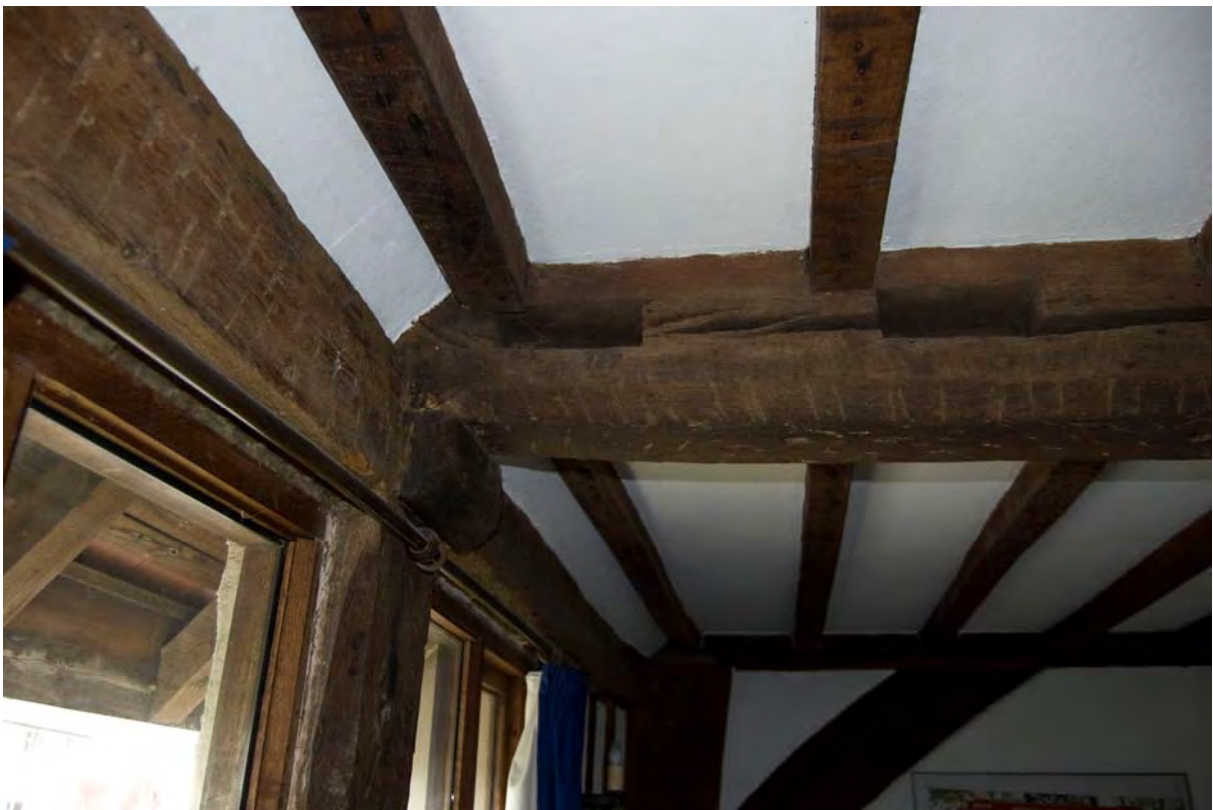
5.7 The small rear bedroom shows little of its original structure other than a timber in the corner and above the window (Fig 33). The front bedroom, however, has exposed close studding (Fig 34), an original window mullion and beam, the latter with exposed mortises and a heightened ceiling (Fig 35). The dividing wall with the hall has infilled staves (Fig 36), while on the south-west wall there appears to be the recess of a fireplace (Fig 37).

Fig 35: Detail of timberwork

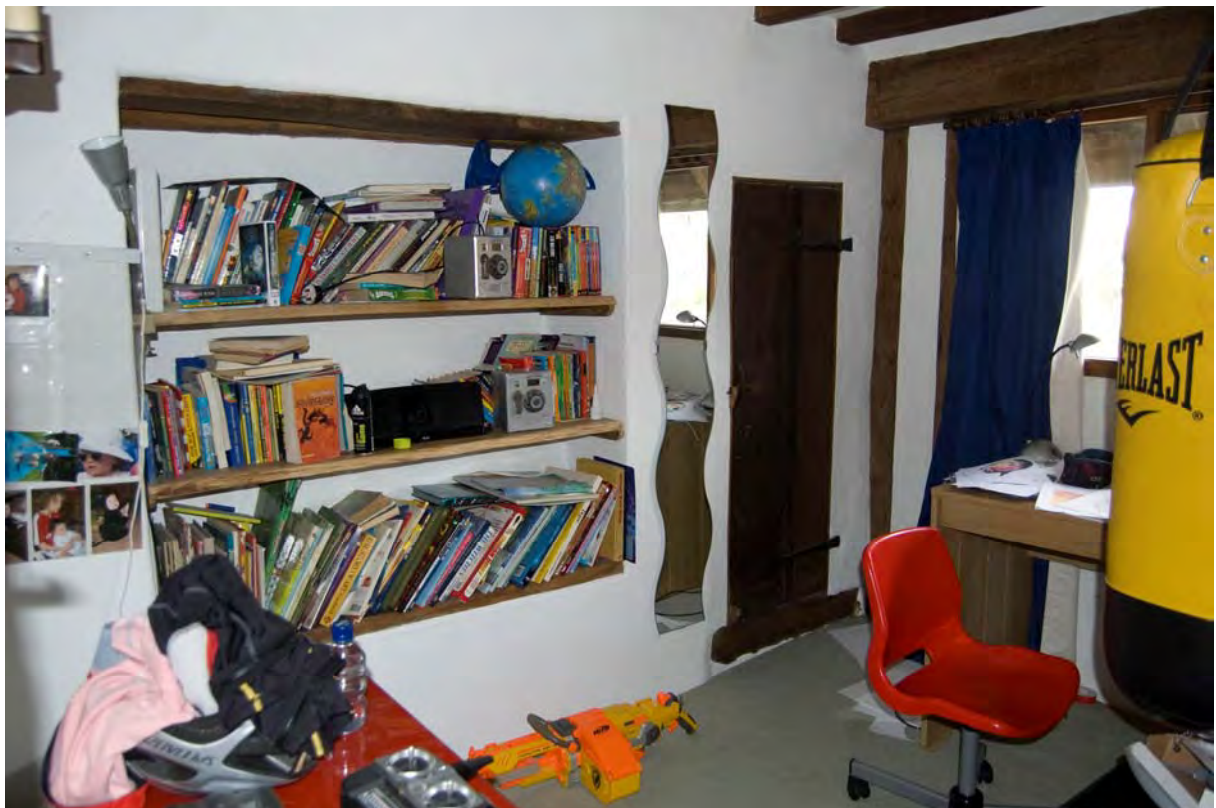
Fig 37: Recess of former fireplace

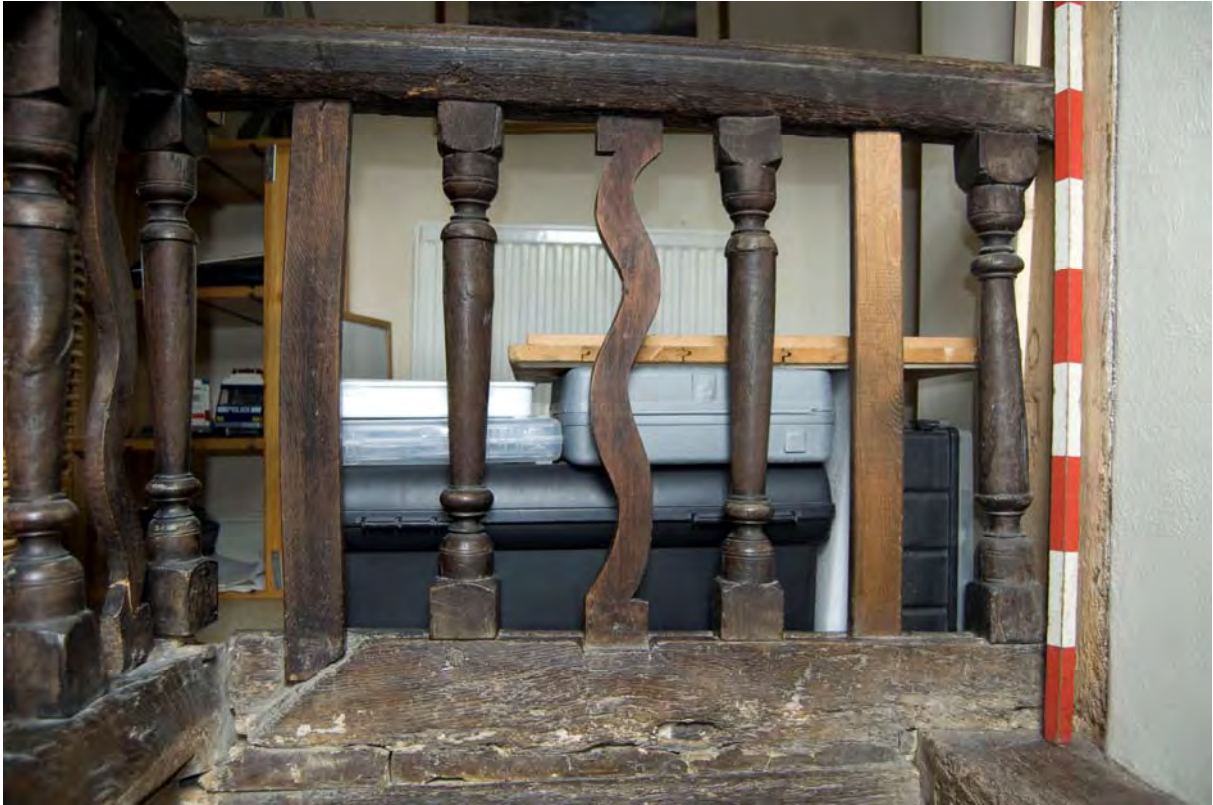
5.8 In the upper hall, the balustrade is made up of a curious mixture of old and newer balusters (Fig 38) and the cross-beam shows a number of carpenter's marks incised on its upper surface (Fig 39). The dividing wall between the bathroom and hall has large structural timbers (Figs 40-41).

Fig 38: Staircase balusters

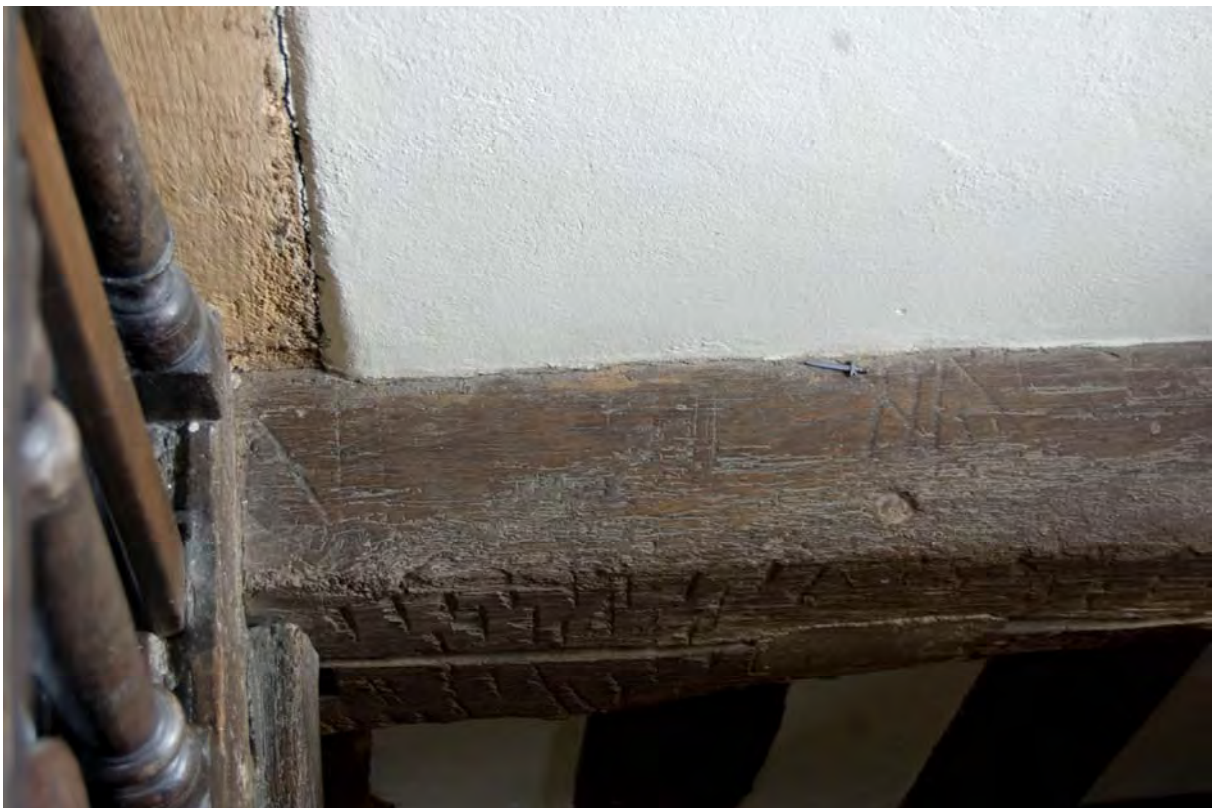
Fig 39: Carpenter's marks

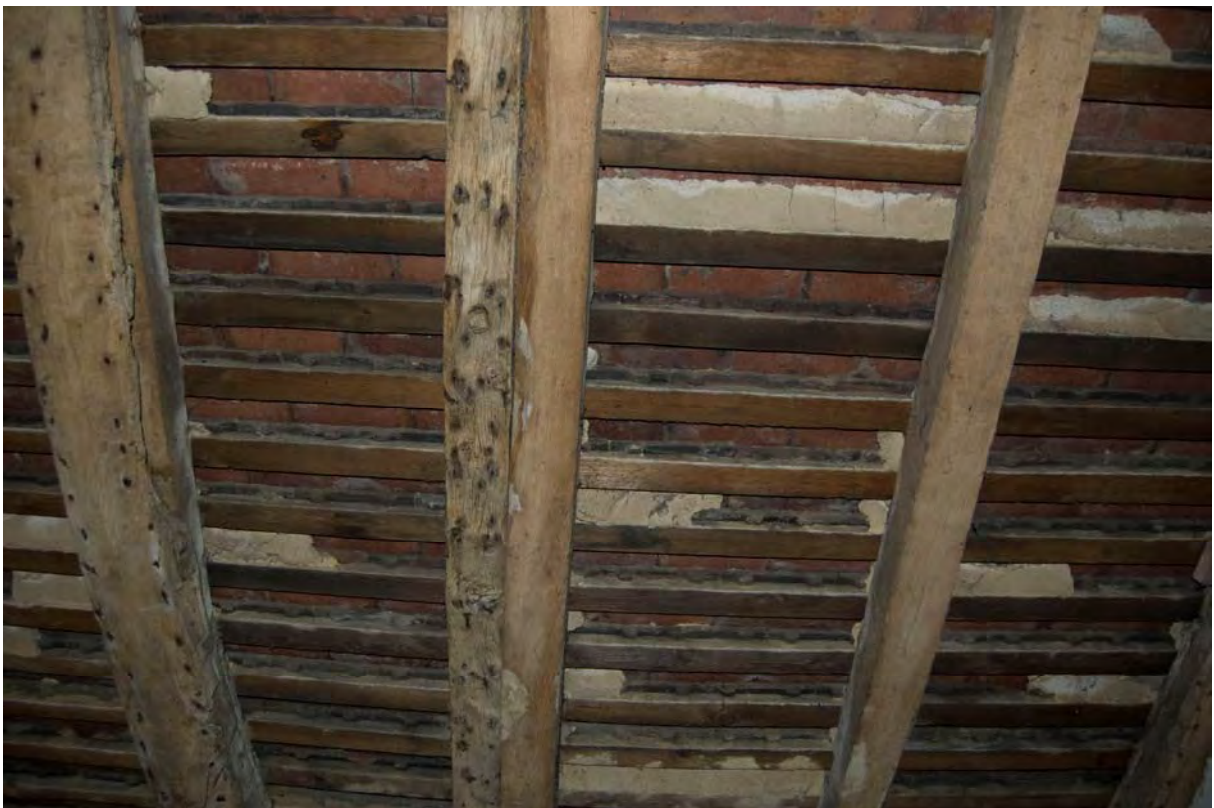
5.10 The large roof timbers themselves show no sign of the kind of smoke blackening which would be expected if they had been present in an open medieval hall and it is possible

that these timbers are not original, but are later replacements. Their substantial nature suggests an early date, however, and it would be interesting to compare dendro-dating of timbers in the close studding with those in the roof

Fig 49: Old and new rafters
