St Matthew's Church Nechells Birmingham

ARCHAEOLOGICAL MONITORING AND RECORDING

Archaeology Warwickshire Report No 1875
SEPTEMBER 2018

Project: Watching Brief at St Matthew's Church, Nechells
Commissioned by: Ian Jeavons on behalf of St Matthew's Church
Site Code: BMC18
Faculty Jurisdiction: Diocese of Birmingham
National Grid Reference: SP 0843 8810
Project Manager: Dr Cathy Coutts
Fieldwork: Rob Jones PCIfA
Author: Dr Cathy Coutts
Illustrations: Candy Stevens
Checked by: Nigel Page MCIfA
Approved by: Stuart Palmer MCIfA
Date: September 2018
Report reference: Coutts, C. M. 2018 *St Matthew's Church, Nechells, Birmingham: Archaeological Monitoring and Recording*, Archaeology Warwickshire Report 1875.

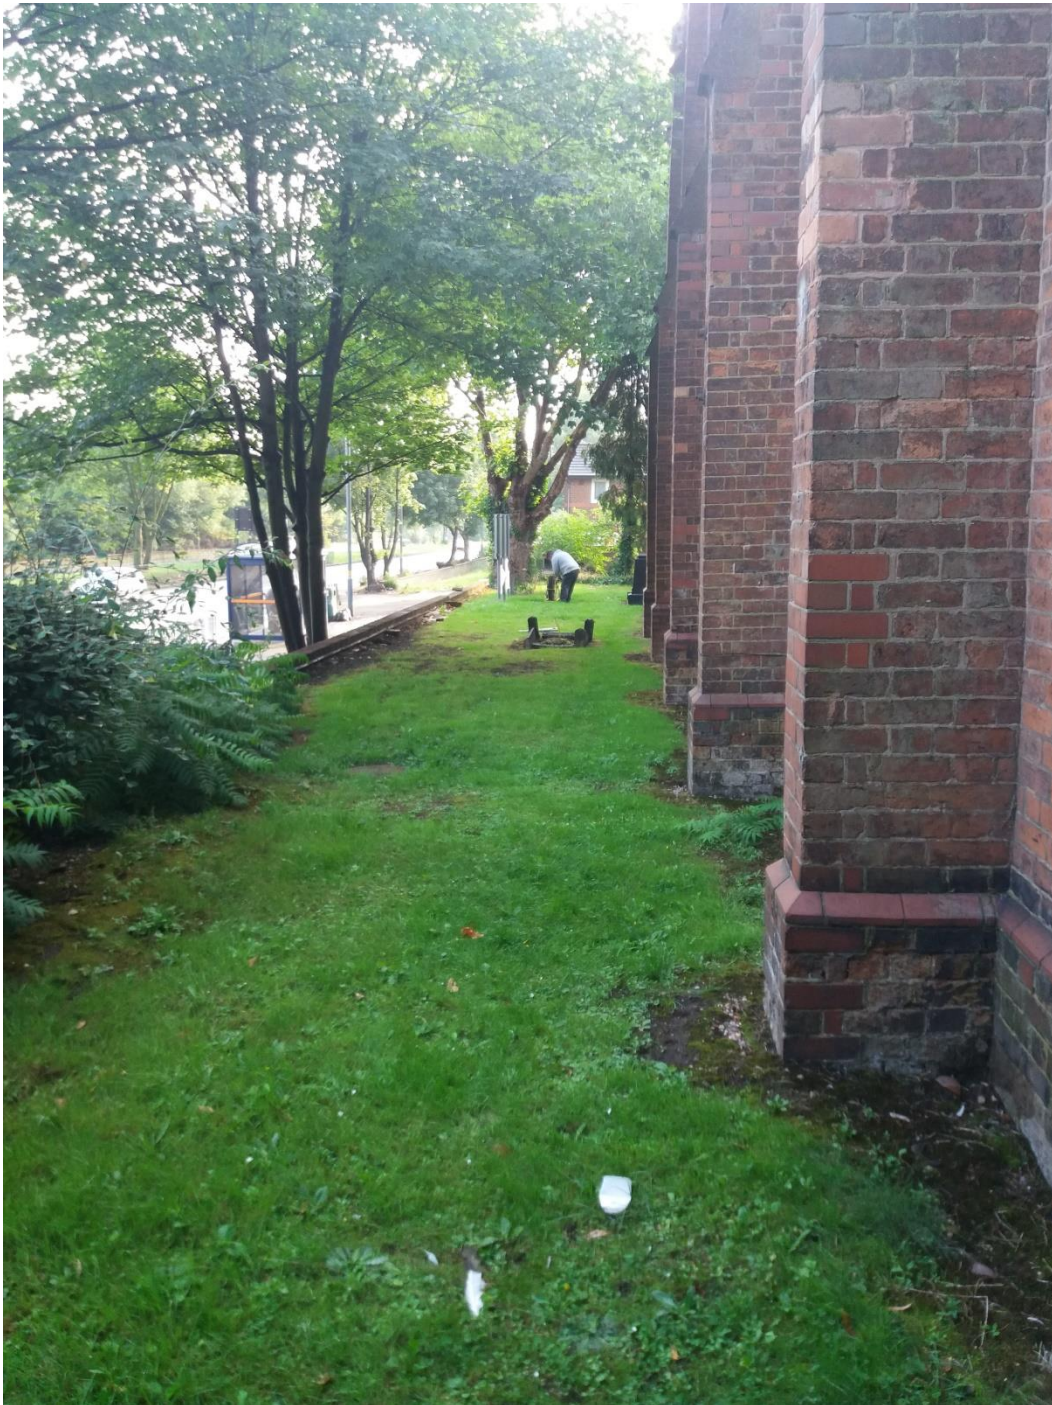
- 5.1 The main drain run taking stormwater away from the north side of the church runs parallel to the north wall of the church (Photo 1). The plan had original been to open up two small lengths of trench in order to replace areas of drain that had been partly blocked by the ingress of roots.

1: Area north of the church where drain was blocked

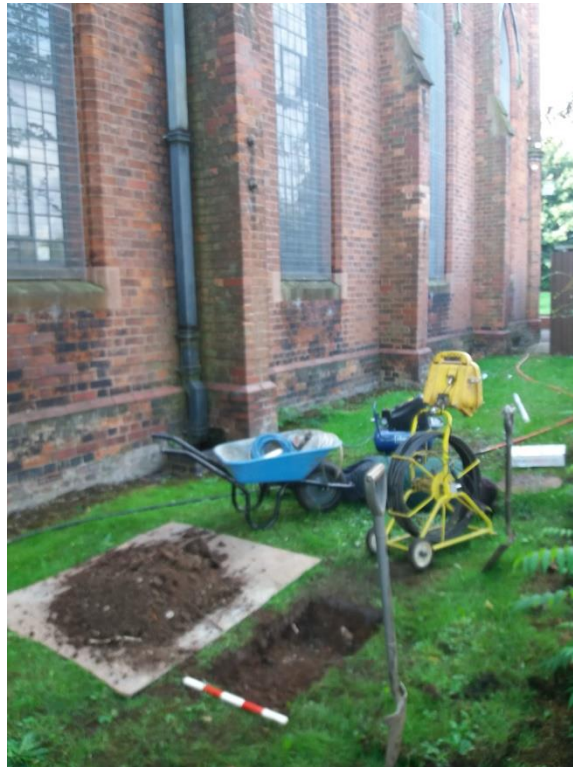
- 5.2 A small rectangular sondage was excavated over the line of the pipe (Photo 2). The sondage was excavated to a depth of 0.18m in an attempt to expose the pipe but the ground proved to be too compacted and a different repair technique was therefore utilised. Instead of excavating to fully expose the damaged sections of pipe and replace them, the contractor repaired the damaged sections by re-lining the damaged drain using a patch liner, after using a hose to wash the drain clear of debris. In order to line the drain a long inflatable 'bladder' was wrapped in cling film before being wrapped with resin-soaked fibreglass. This was then being inserted into the drain pipe via the inspection chamber (Photo 3). Once the device was in the correct place air was introduced to make the bladder expand to the diameter of the drain and when the resin had hardened the bladder was removed leaving an inner sleeve patch, thus repairing the pipe.

2: Sondage excavated to the north of church

- 5.3 The sondage was subsequently backfilled. No finds were recovered and no human remains were disturbed during the work

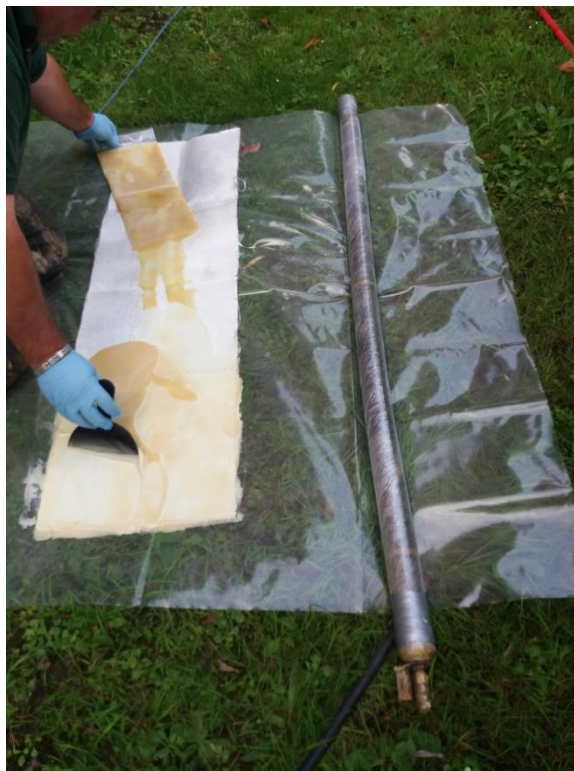
3: Preparation of patch-liner material

- 6.1 The damaged section of pipe was repaired using a resin-covered fibreglass patch liner, thus obviating the need for excavating and removing the damaged sections of pipe. Only a small area of ground was disturbed and no human bone or other finds were recovered.
