St Laurence's Church Bidford-on-Avon Warwickshire

ARCHAEOLOGICAL MONITORING AND RECORDING

Archaeology Warwickshire Report No 1908
JANUARY 2019

Project: St Laurence's Church, Bidford-on-Avon,
Warwickshire, watching brief

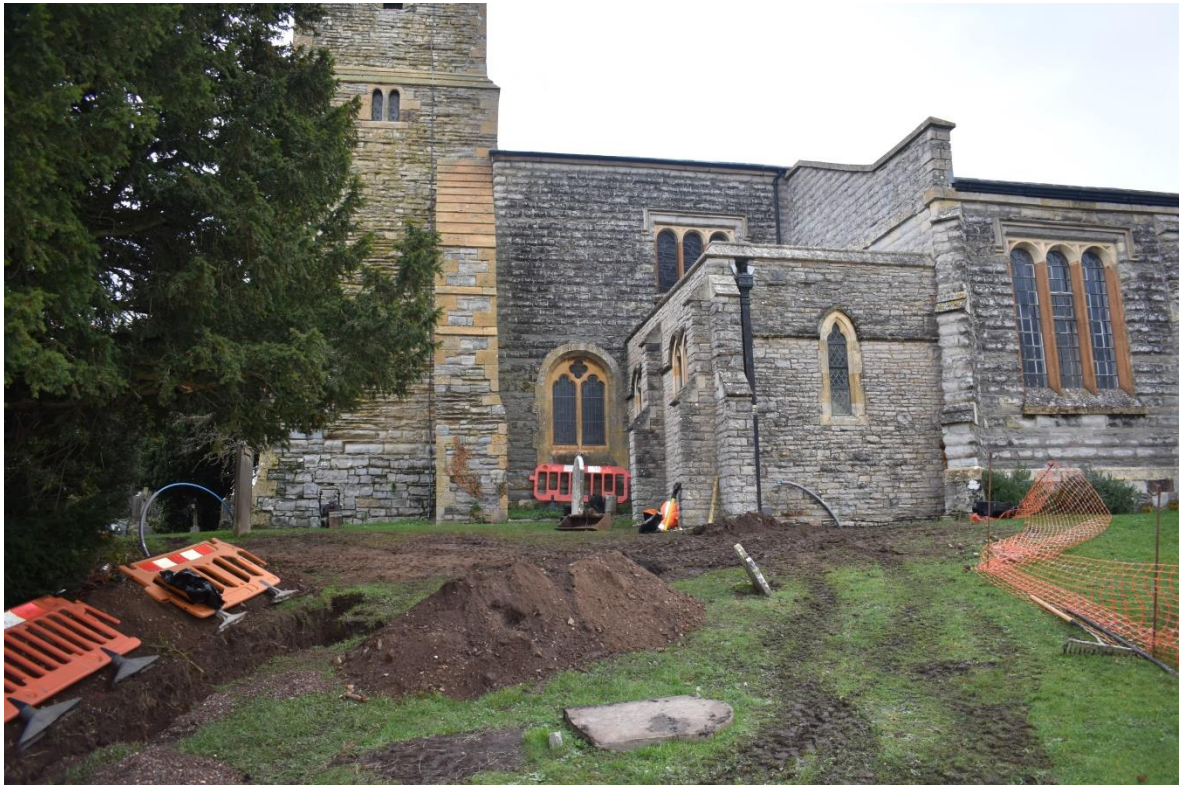
- 5.1 A trench was excavated for waste water which extended from the terrace on the bank of the River Avon and divided into two trenches leading to the west choir vestry wall, and the south choir vestry wall (Photo 1). Initial work at the boundary wall was 1m deep and 1m wide as the original intention had been to run the waste pipe below the boundary wall. The main service trench was 0.35m deep and 0.40m wide and cut 0.15m into the graveyard soil (101), overlain by 0.20m of dark grey brown topsoil (100). The trench was 23m long and produced fragments of disarticulated human bone which were reburied within the trench, and occasional fragments of modern glass.

1: Service trench for waste water excavated from the river to the south side of the choir vestry

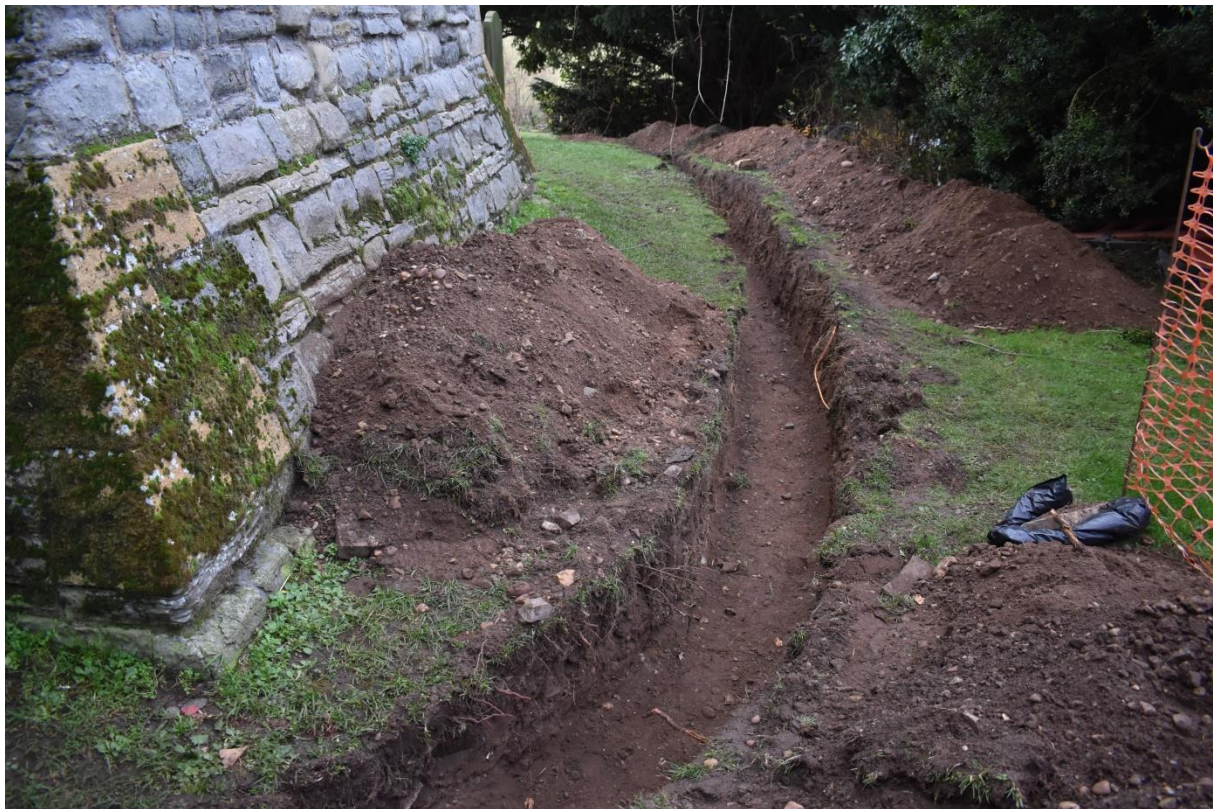
2: Service trench for water main around the church tower

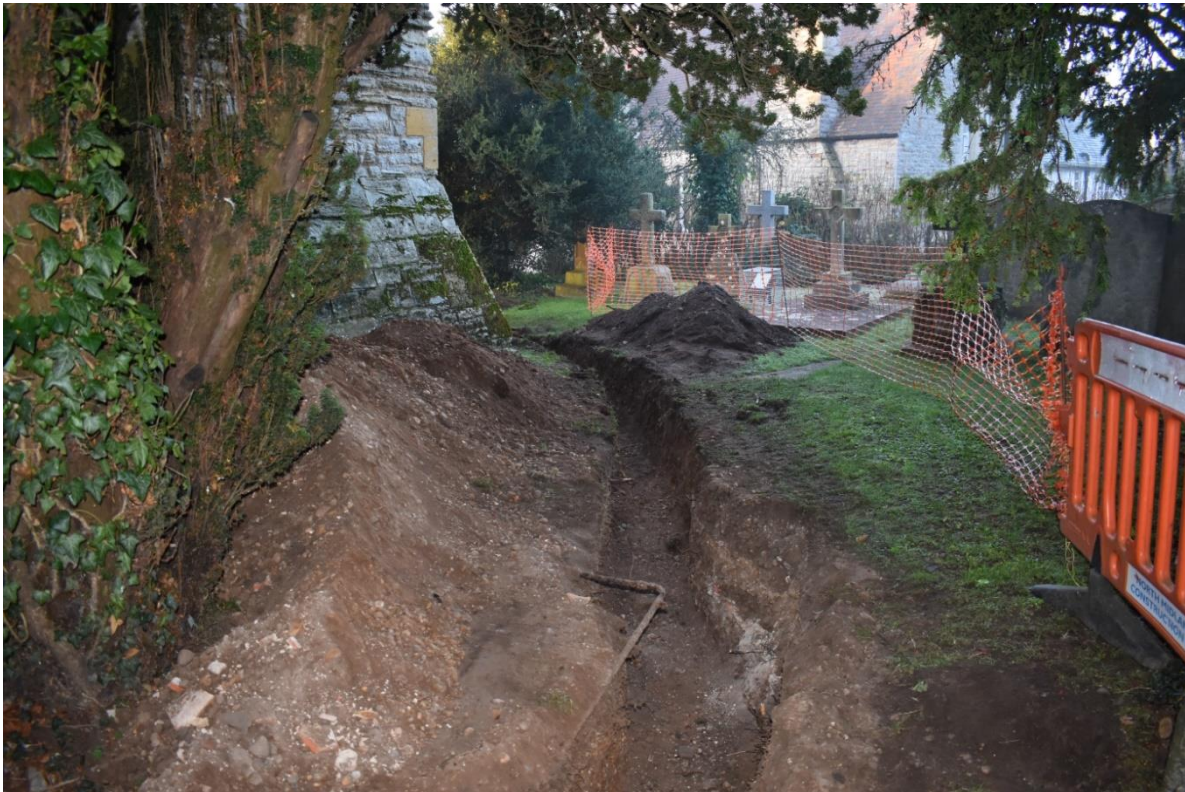
3: Service trench for water main on the north side of the church

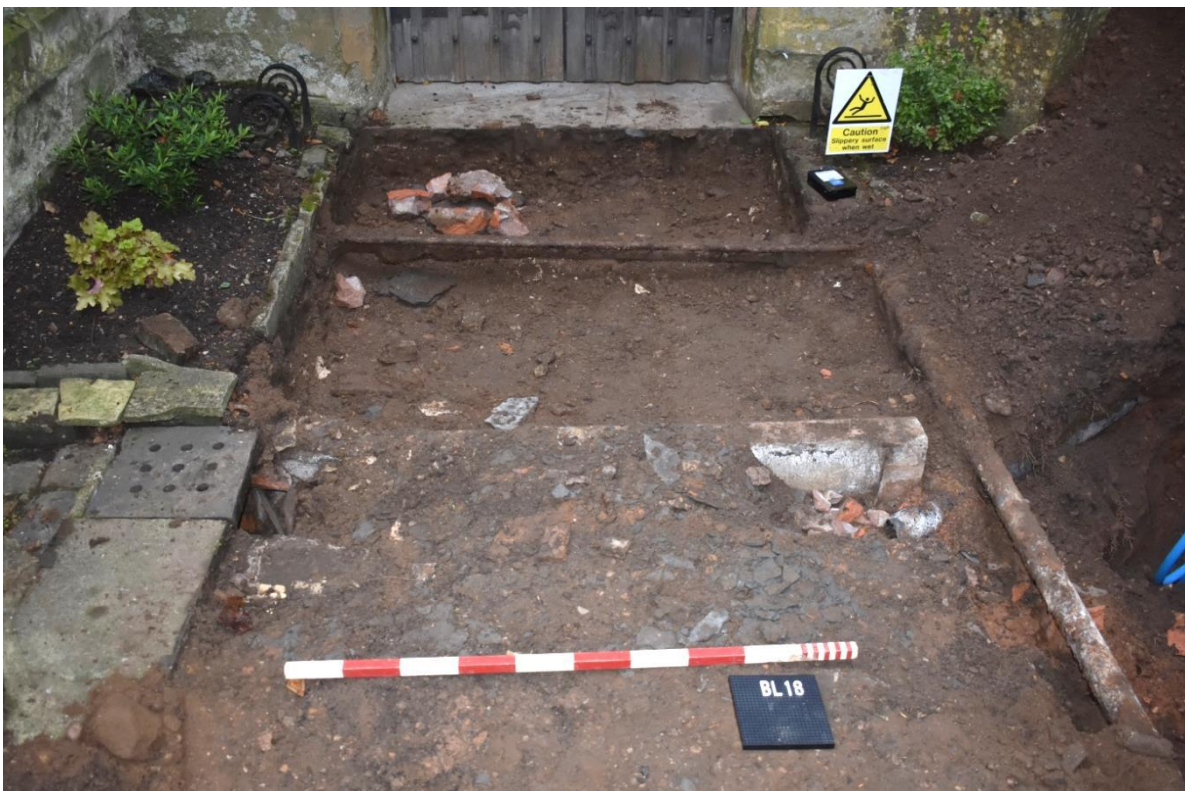
- 5.6 A 0.12m thick reddish brown silty soil (104) was recorded under the large paving slabs (105) at the entrance to the church on the north side of the grave yard. This contained occasional disarticulated human remains and sub-rounded pebbles. The concrete casing (107) for the soakaway drain that lies to the north of the entrance of the church was cut into layer 104. The service trench (108) for the drain and casing was excavated in 1978 (Chris Horn pers. comm.) It is not known when the paving slabs were laid.

4: Area in front of north door, where slabs 105, were lifted, exposing the reddish brown layer 104, and the concrete casing for soakaway 107

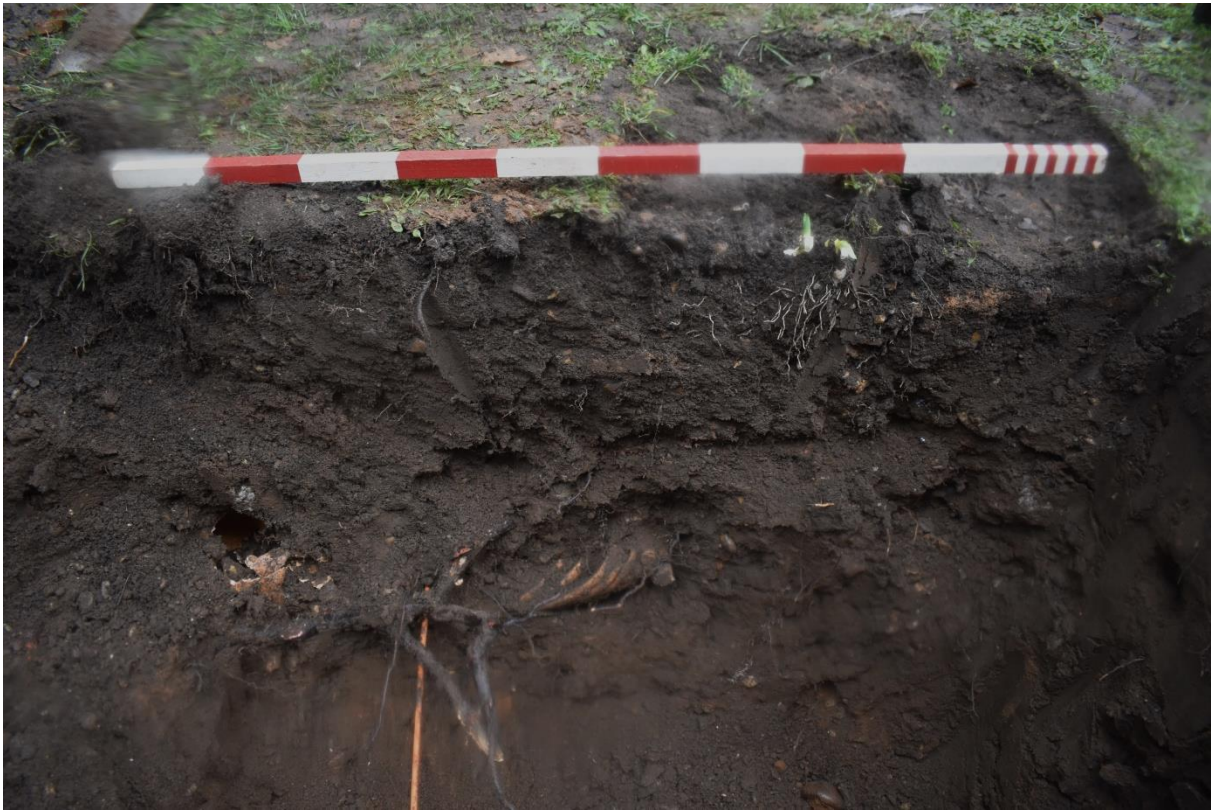
- 5.5 A trial trench measuring 3m x 1.6m with a depth of 0.8m was excavated to locate the existing water main immediately to the east of the tarmac path, on the north side of the church, butting the north aisle wall. The water main was ultimately found 1.5m to the north of this area. Within the south-facing section of the trial trench a partial, articulated, skeleton (109) was uncovered at a depth of 0.53m, within graveyard soil 101 (Photo 5). The remains were recorded but left undisturbed and the area was backfilled. The skull and ribcage were visible within the section, and the body was aligned west-east. An electricity cable was found above these remains. A gravestone was found at a depth of 0.45m, immediately above the skeletal remains, broken in two with the inscription weathered away. However, it is not clear whether this monument was associated the skeletal remains found below it.

- 6.2 Of interest is the relatively shallow depth (0.53m) of the partial articulated burial in the trial trench north of the church. The majority of burials in this area date from the 19th century onwards, during which time stricter practices concerning the depth of burials were put in place due to public health reforms. This shallow burial could indicate an episode of truncation within this part of the graveyard or perhaps an earlier grave.

5: Articulated remains of skeleton 109 found north of the church

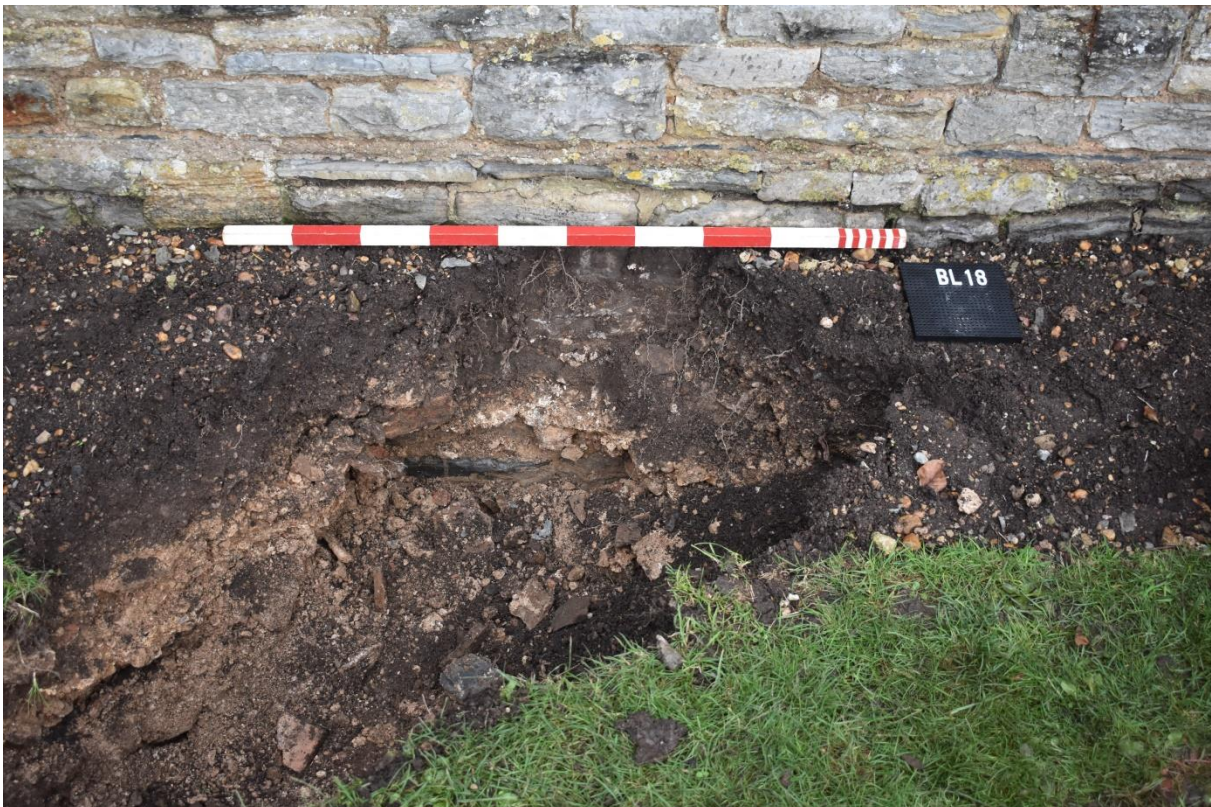
- 5.4 Immediately adjacent to the south side of the church was a layer of light brown material containing degraded building material and mortar (102, Photo 6). This could be seen adjacent to the south choir vestry wall, and stretched 0.80m south of the wall. Layer 102 was 0.22m thick at its deepest. This layer contained occasional fragments of ceramic roof tiles similar to those covering the chancel roof. The nave was widened and new aisles were added in 1835 and this deposit may well be associated with this rebuilding. Layer 102 was also overlain by topsoil (100).

6: South aisle wall with layer of degraded building material 102

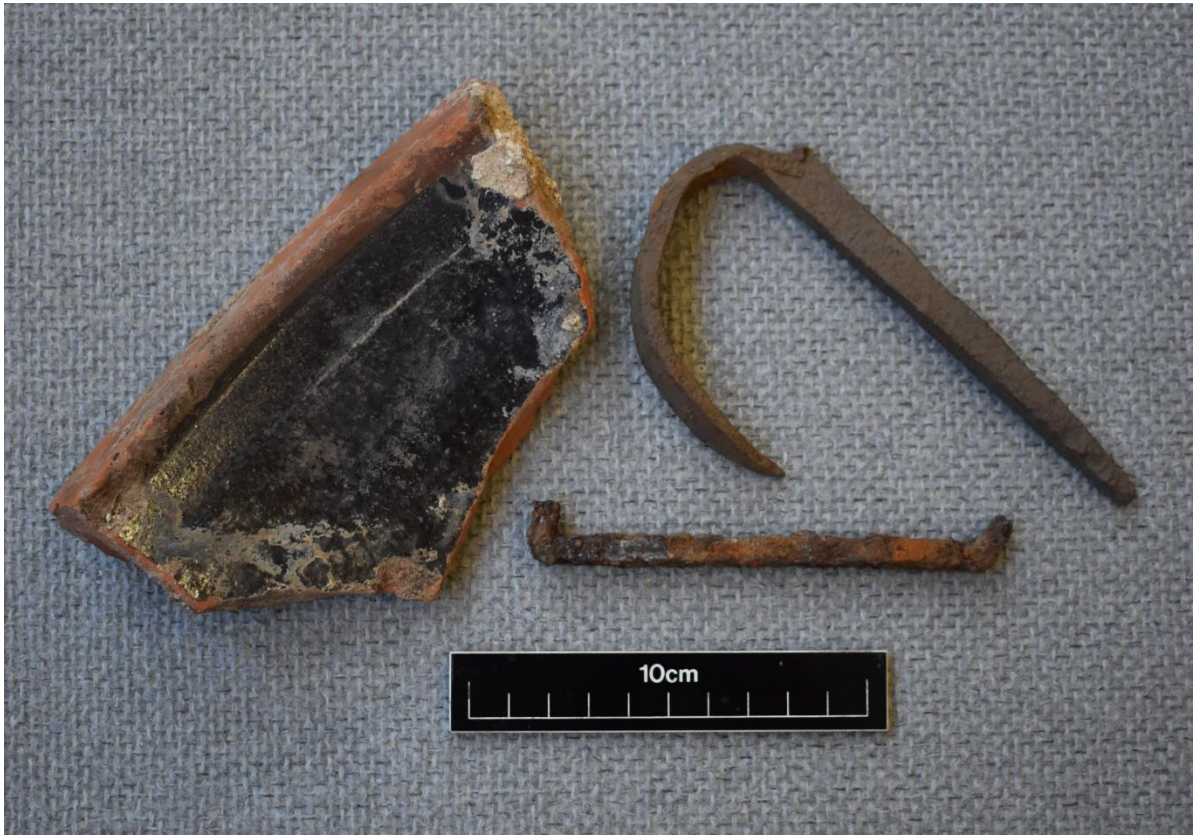
Context	Material	Quantity	Date/Comments
101	Pottery	1	Post-medieval coarseware rim with internal black glaze from large straight-sided vessel, lumps of mortar attached
101	Iron	2	1 x square-sectioned iron rod with one terminal at 90° angle, other 45° angle, 1 x iron hook with tapering end

7: Finds from context 101
