Historic Building Recording at
Fields Farm, Featherbed Lane,
Hunt End, Redditch, Worcestershire

Report 0809

March 2008

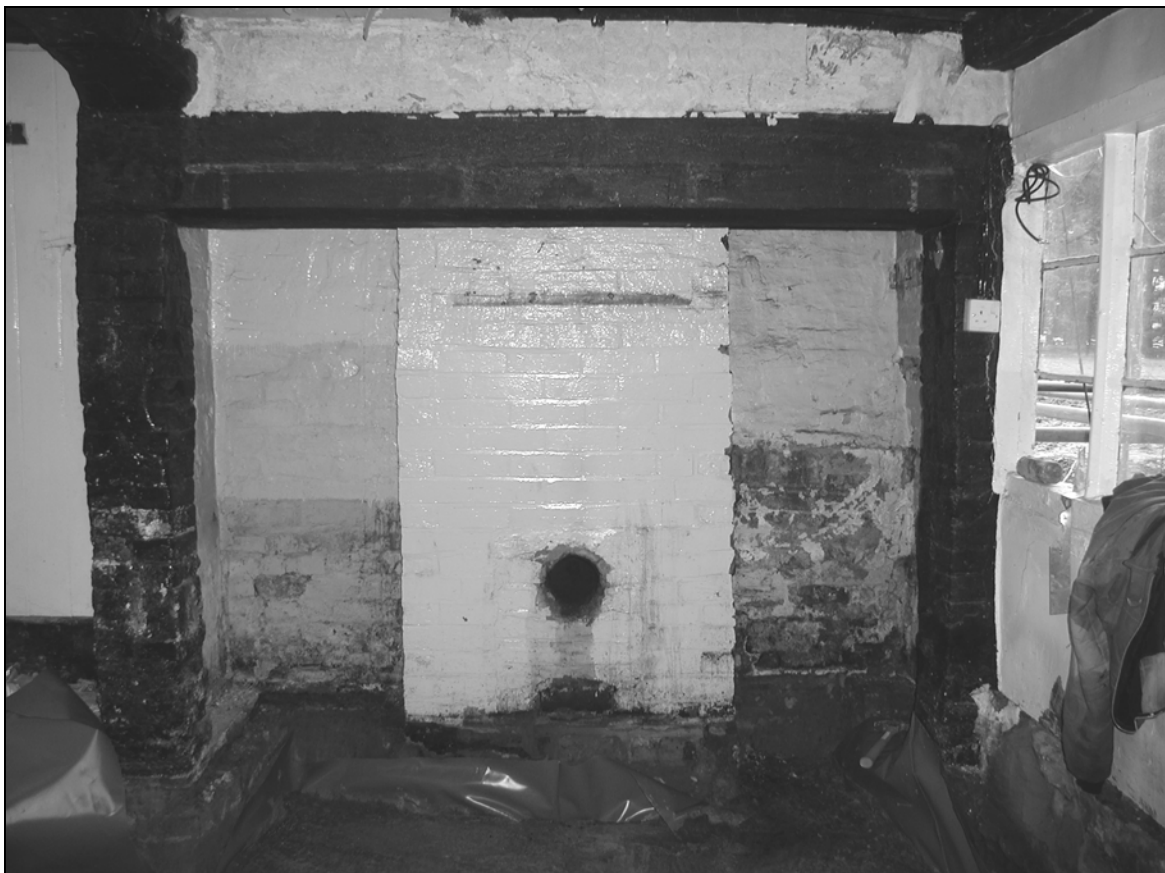
Fig 7: Fireplace with inserted brick flue

5.10 A brick-built fireplace was set against the south gable end wall of the house. This was 2.4m wide, 1.56m high and 0.6m deep and occupied the south-west corner of the room (Fig 7). The fireplace was constructed with a chamfered timber beam set on top of the brickwork pillars. A late 19th- or 20th-century brick-built flue had been inserted into the back of the fireplace possibly associated with the installation of a boiler.

5.11 The brickwork on the eastern side of the fireplace showed significant wear, presumably from kitchen activities. However, no other features of the hearth were apparent.

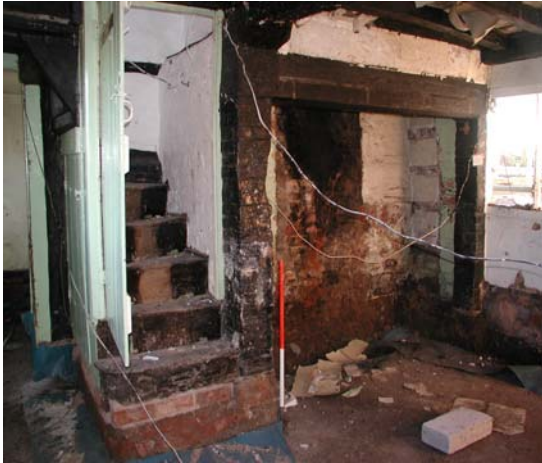
Fig 8: Staircase and fireplace (G1)

5.12 A winder staircase was located immediately to the left of the fireplace behind a wooden door (Fig 8). The staircase was 1m wide with irregular wooden treads and risers, which turned through ninety degrees. This provided access to upper rooms in the roof space.

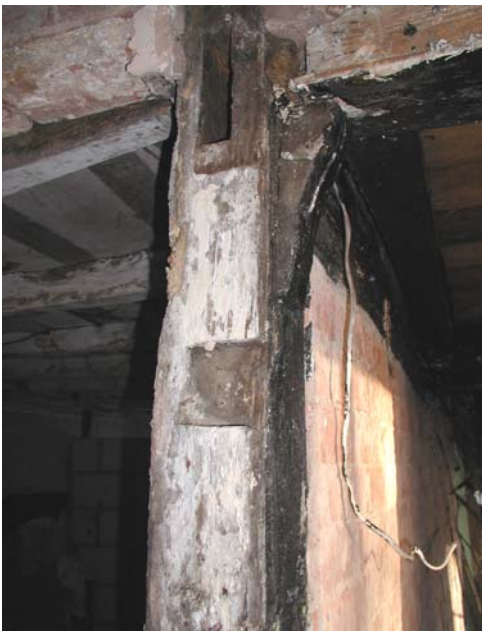
Fig 10: Detail of doorframe (G1)

5.8 A doorway in the west wall had been inserted opposite the front entrance. This doorway showed evidence for the cutting of the original timber framing and was probably created to provide access to the later rear extension (Fig 10).

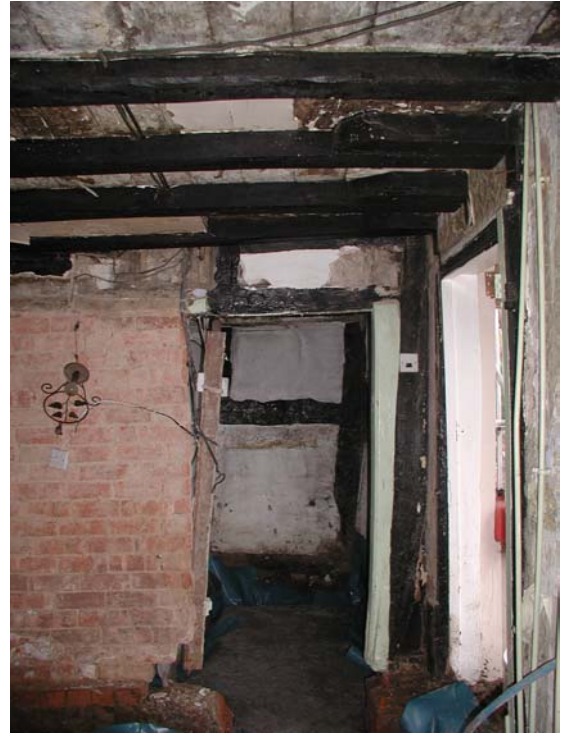
Fig 11: Exposed beams and doors (G1 and G2)

5.13 A smaller room at the north end of the house was 4.3m long and 2.3m wide between a dividing wall constructed of probably 20th-century bricks and the northern gable end wall. The internal dividing wall is likely to represent a repair or rebuild of an original possible internal timber framed wall in a similar position as a timber post for an existing doorway was recorded at the eastern end of the wall and this appeared to be part of an original frame (Fig 11). A two-light metal-framed casement window was set into the eastern wall.

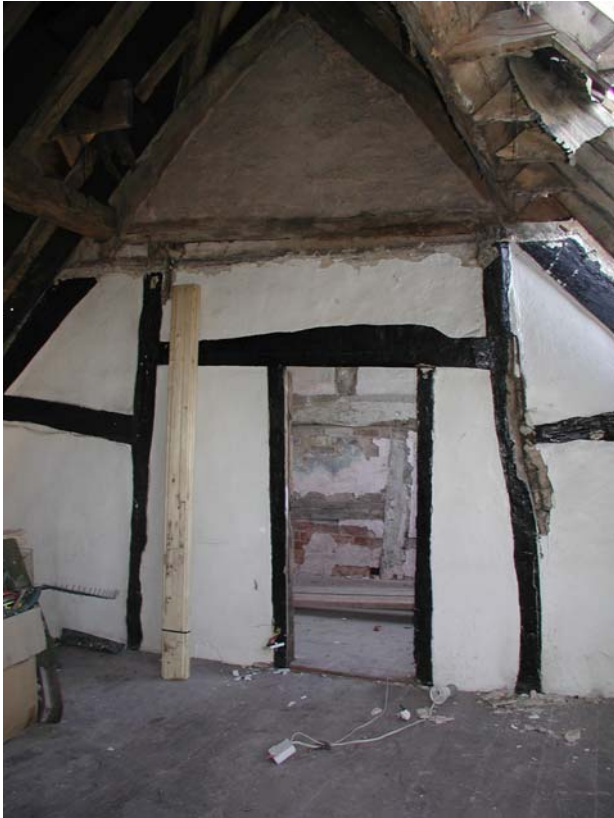
Fig 13: Detail of doorway and partition between U1 and U2

5.22 At the northern end of the upper part of the building a smaller room was accessed by a timber-framed doorway, which was 0.7m wide and 1.52m high (Fig 13). The timber frame appeared to include reused timber showing evidence of additional peg holes and joints. Reused roof beams were also visible in the cleared roof space (Fig 22).

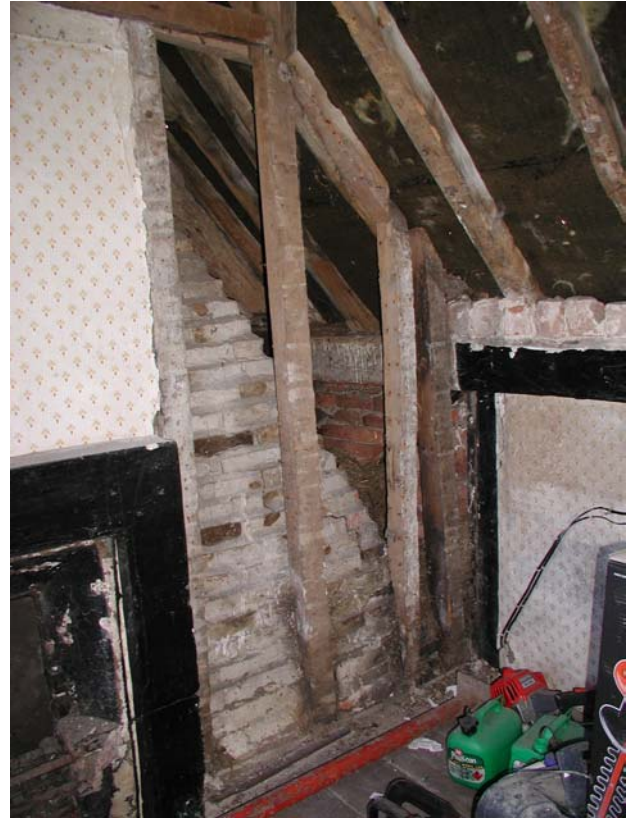
Fig 15: Inserted fireplace and chimney (U1)

5.21 At the southern end of the room the brickwork of the chimney was partly revealed (Fig 15) and a 19th-century fireplace had been inserted into the southern wall.

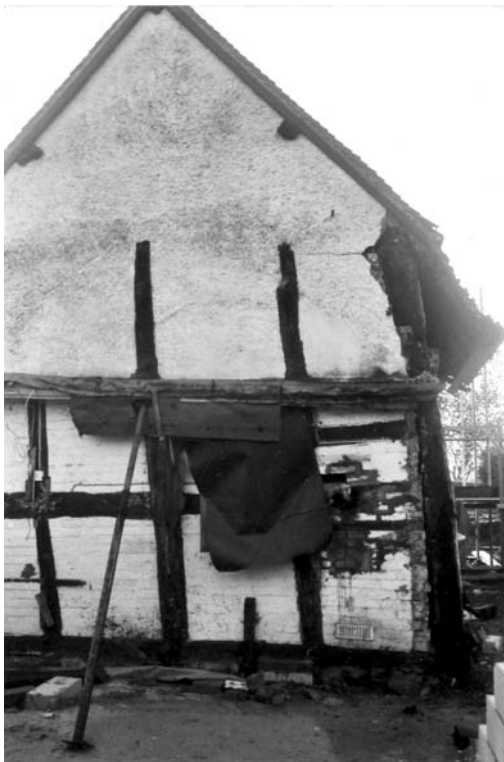
Fig 18: Northern gable end of the farm house

5.32 The northern gable end of the building showed evidence of timber framing with two sets of small square panels with brick nogging infilling (Fig 18). A sill beam was evident set on a small plinth of sandstone blocks. Two posts were visible to eaves level, but other possible surviving timbers or framing were obscured by the render present over much of the gable end.

5.33 The north-western corner post had been subject to significant decay and movement, and had shifted outwards and away from adjoining brickwork and timbers. The foot of the post had moved substantially and the original joint had probably broken or decayed. The adjacent brickwork had been broken out and repaired on previous occasions, including previous work to insert ventilation pipes and flues and repaired with modern brickwork.

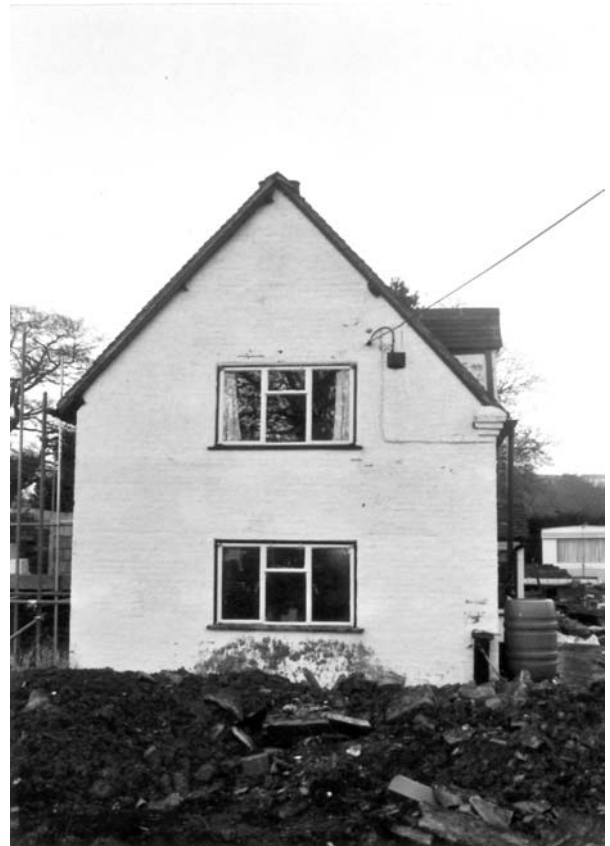
Fig 19: Southern gable end of the farm house

5.35 The southern gable end of the building was brick built with two casement windows (Fig 19) and is part of the 19th-century extension to the building. The southern gable also shows the variation in the pitch of the roof suggesting changes to the front of the original building when the brick façade may have been added. The original southern wall of the house was recorded in the north wall of Room G3 where timber framing was revealed during the removal of plaster (Fig 22).

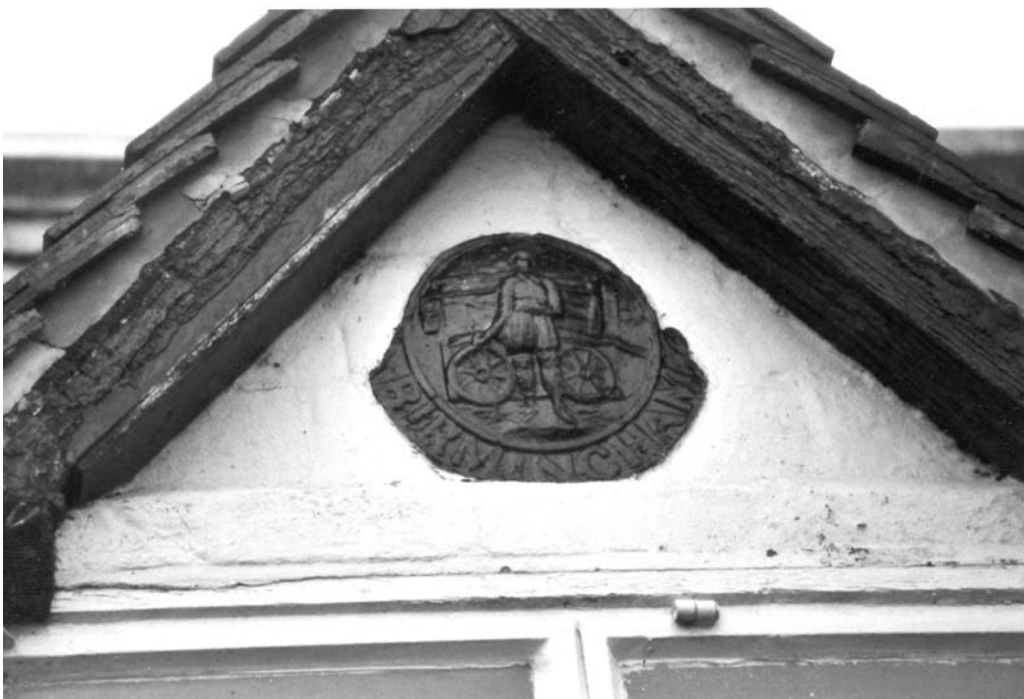
Fig 20: Detail view of Birmingham Fire Insurance plate

5.29 A fire insurance plate was located above the central dormer window (Fig 20). The plate, probably lead or iron, depicted a figure (fireman) and fire engine included the word Birmingham underneath. The insurance plate is one of the Birmingham Fire Office Company (1805-1867), which was based in Birmingham. The plate probably dates to the mid 19th century.

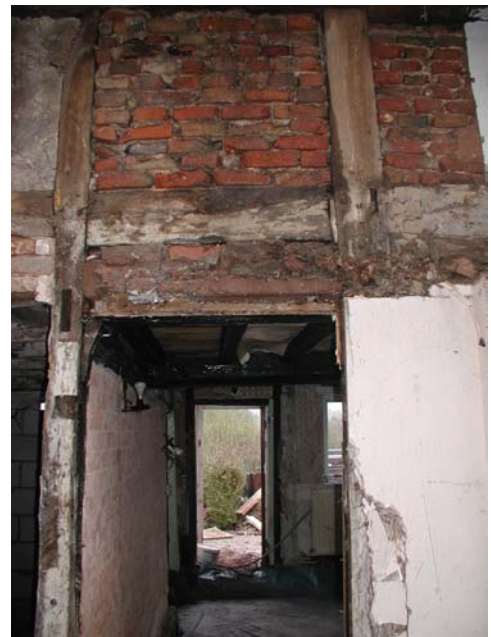
Fig 24: View of rear wall showing doorways

5.14 Access from room G1 was present at the eastern end of the room. This appeared to be an original doorway, but it had been subject to probable 20th-century repair work. An access point had also been inserted into the western wall of the room. This doorway provided access to the rear extension and originally the rear of the building. This was immediately adjacent to a doorway leading from the larger adjoining room (G1). Joints exposed in the upright timbers forming the door jamb suggested that either horizontal frame timbers had been removed to create the doorway or that reused timbers were used in the doorway (Fig 24).
