St. Leonard's Church Birdingbury Warwickshire

ARCHAEOLOGICAL OBSERVATION AND RECORDING

Archaeology Warwickshire Report No 1684
SEPTEMBER 2016

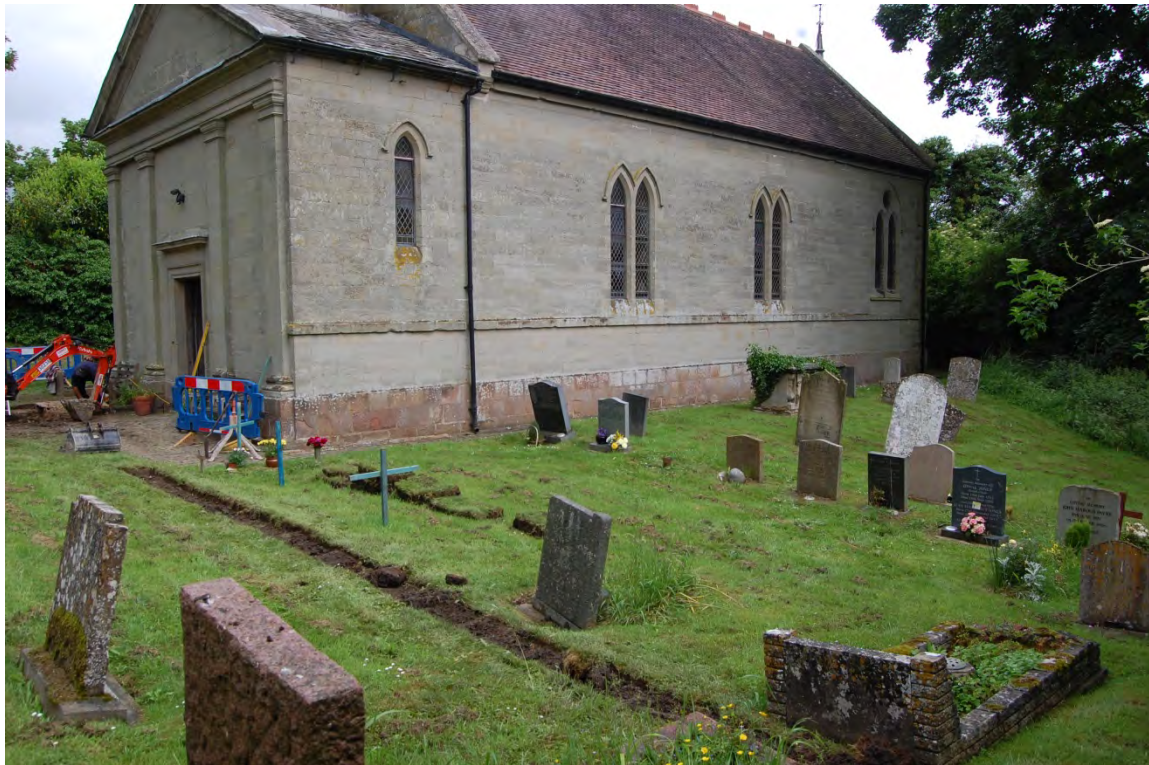
1. Church and soakaway

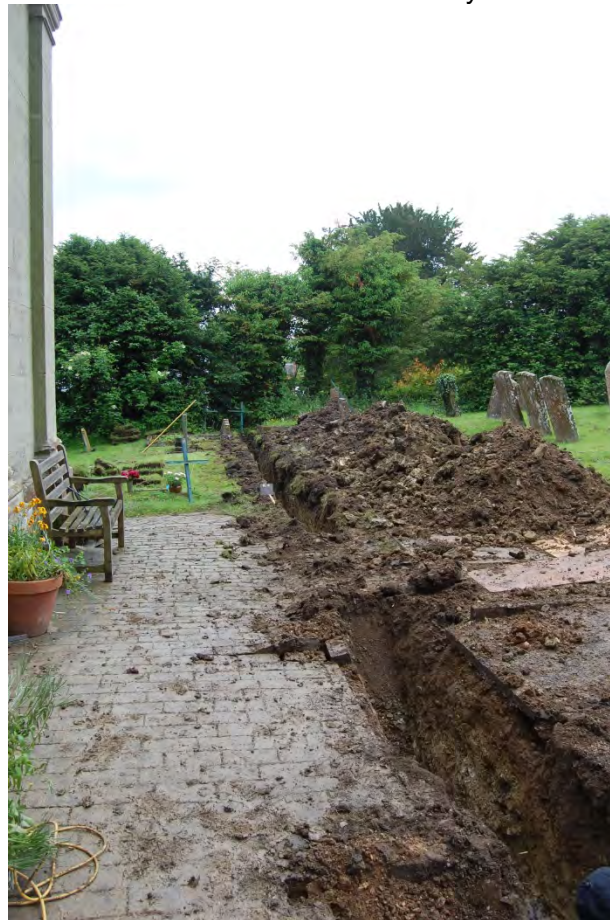
- 5.2 A trench and septic tank pit were machine-excavated, using a 0.4m wide toothless bucket. The trench extended for 18m north to south from the north-west corner of the church to the churchyard boundary. A 2.8m long and 2.2m wide pit for a tank was excavated at the north-west corner of the church.
- 5.3 A very simple deposit sequence was revealed. At the base of the trench and pit was natural clay (2). This was overlaid by a layer of yellowish brown clay loam (8) which contained occasional tile fragments and occasional small fragments of disarticulated human skeletal remains. The fragments identifiable by the supervising archaeologist were reburied. A layer of topsoil covered the area and at the northern end a brick path (3) extended around the church.

2. Excavated soakaway trench

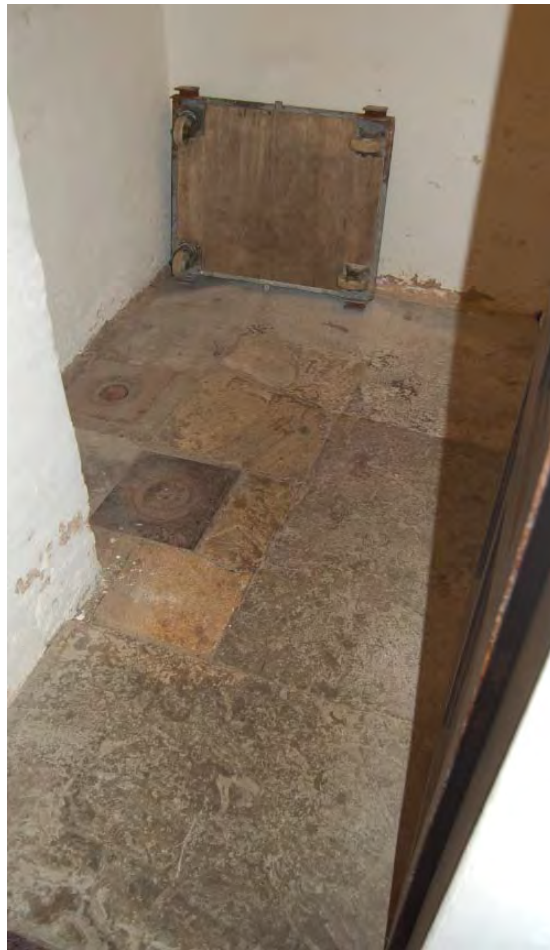
- 5.4 The vestry floor was recorded prior to being lifted. It was comprised of ten limestone slabs (4) with a small patch of concrete in the south-west corner (5) and two circular iron access covers (7) were recorded.
- 5.5 Below the floor was a layer of grey brown silty sand (10) with brick rubble including "Stourbridge" brick fragments and limestone fragments. No significant archaeological remains or human skeletal remains were revealed.
- 5.6 A small area, approximately 0.7m long and 0.6m wide, was reduced for the proposed waste pipe access. This revealed the sandstone foundations for the existing north wall (9) which were bonded with light brown sandy mortar.

3. Vestry floor (4) with iron access covers (7)

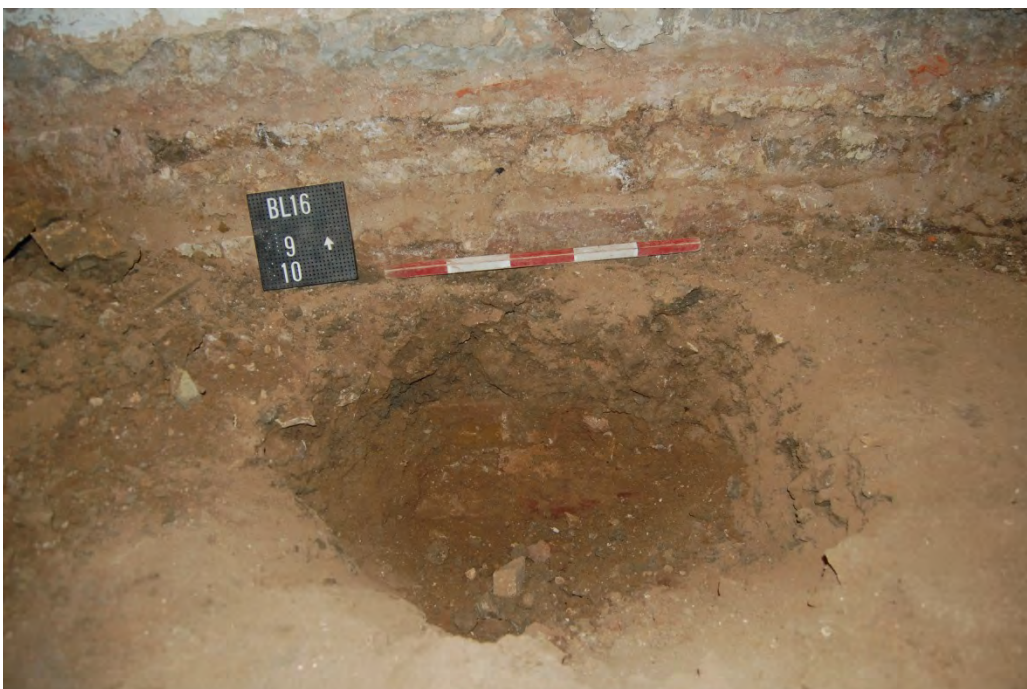
4. Wall foundation (9) and rubble layer (10)
