Charlecote Park Ha-ha, Charlecote, Warwickshire

Archaeological Watching Brief

Report No 1321
April 2013

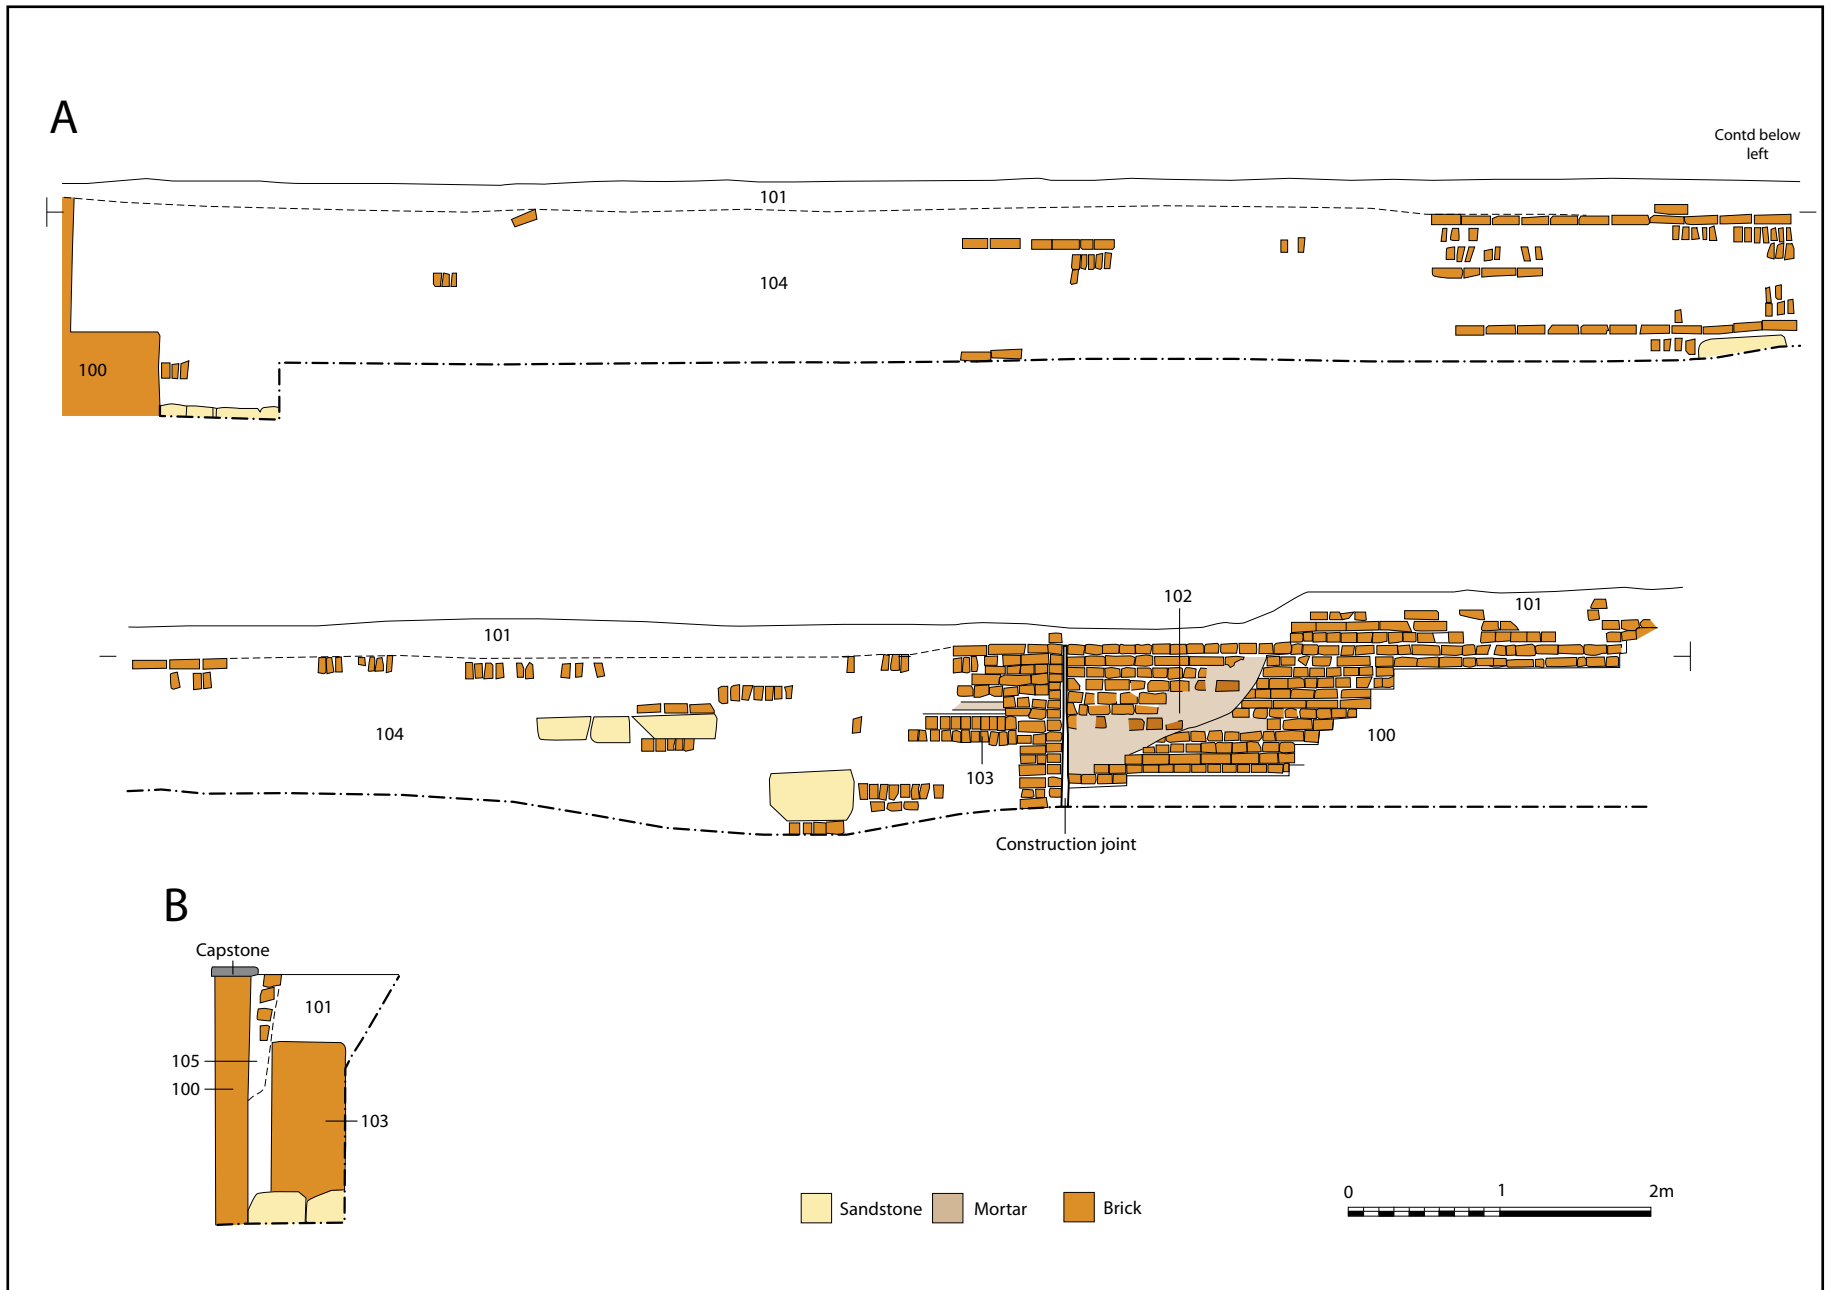
5.1 A 21m stretch of the existing ha-ha wall (100) was dismantled by building contractors and was recorded during the watching brief. An earlier ha-ha wall (Figs 3 and 4), 1.0m high and 0.45-0.50m wide, was revealed behind it, and consisted of a core of mortared brick rubble, faced with roughly coursed red bricks, average size 210mm x 100mm x 60 mm (8 ¼ x 4 x 2 ¼ inches), bonded with a beige mortar. Two structural elements to this earlier wall were identified, separated by a construction joint (Fig 5). The northern structural element (102) consisted of a well-preserved stretch of brickwork laid in what appears to have been a rough English Garden Wall bond. The first and second course of brickwork recorded at the base of the wall projected out by 0.10m. Brickwork 102 showed signs of previous collapse. Abutting 102, to the south of the construction joint, was another structural element (103), comprising roughly-coursed brickwork of non-uniform construction incorporating soldier coursing. The south part of this (104) was in poor condition and in a state of partial collapse. Occasional surviving fragments of roughly-coursed brickwork of non-uniform construction, again incorporating soldier coursing and reused green sandstone blocks was visible in places, along with the mortared brick rubble core mixed with a brown sandy loam. Brickwork 102-4 was overlain by a layer of topsoil, 0.20-0.30m deep.

5.2 Brickwork 102-104 was sealed by the existing ha-ha wall 100 (not illustrated in detail), 1.2m high and 0.11m wide, which was made of red bricks, average size 230mm x 110mm x 60mm (9 ⅙ x 4 ⅓ x 2⅓ inches), topped with sandstone capstones of rectangular profile. It was laid in English Garden Wall bond and bonded with an off-white mortar. There was no bond between wall 100 and earlier brickwork 102-104. A void between the existing ha-ha wall 100 and the earlier brickwork 102-104, up to 0.15m wide, was infilled, in places, with concrete and brick fragments (105, Figs 3 and 6).

Fig 3: East-facing elevation of ha-ha walls 100, 102-104 and north-facing section of ha-ha walls 100 and 102

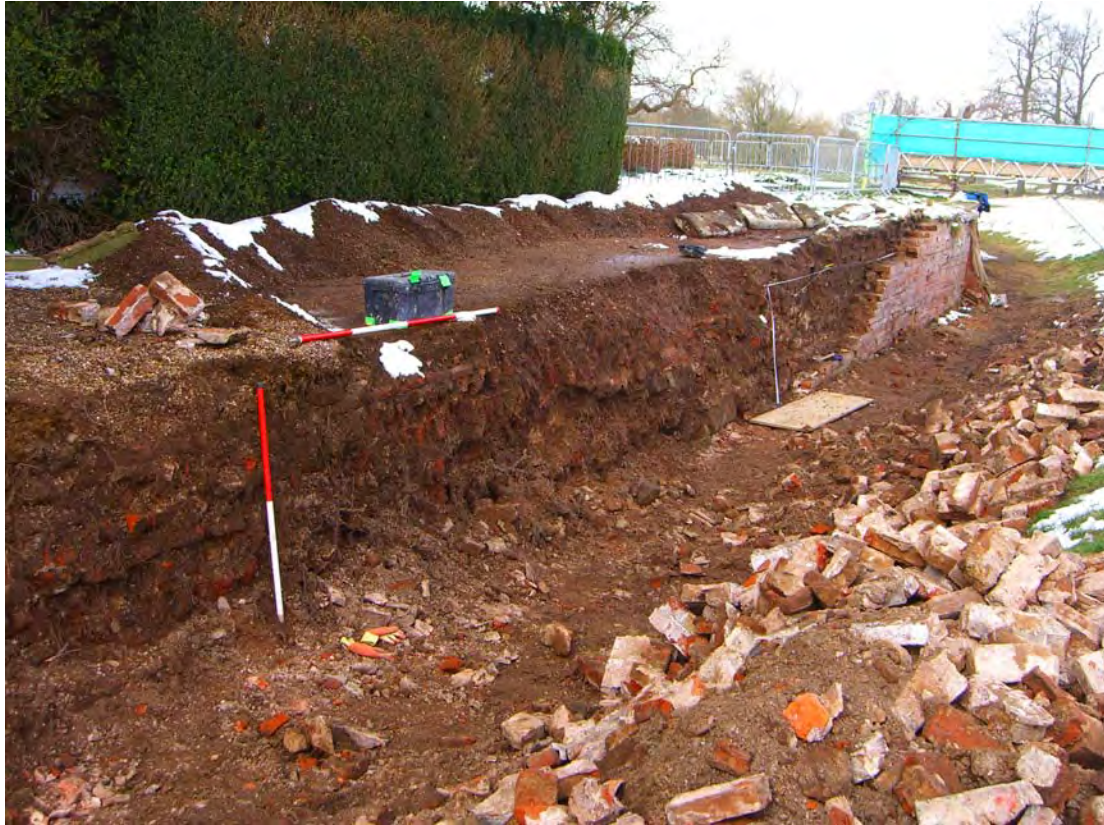
Fig. 4: View of east-facing elevation of ha-ha walls 100, 102-104

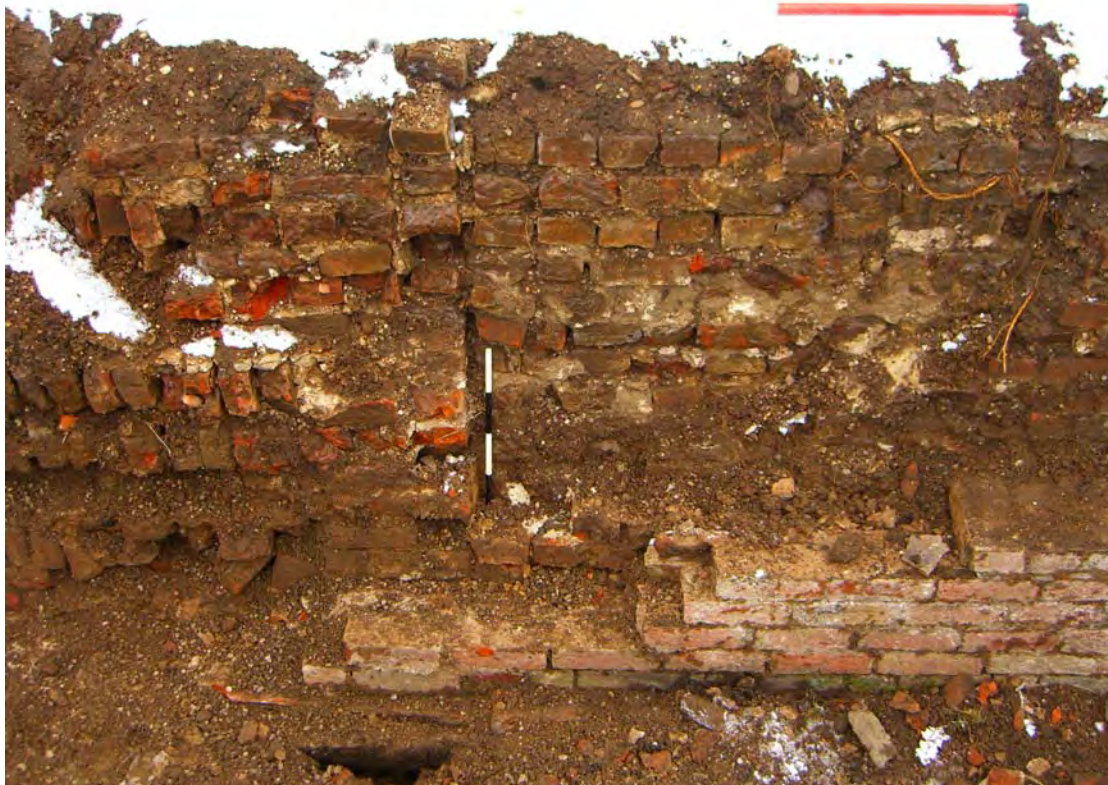
Fig. 5: Detail of construction joint between 102 and 103

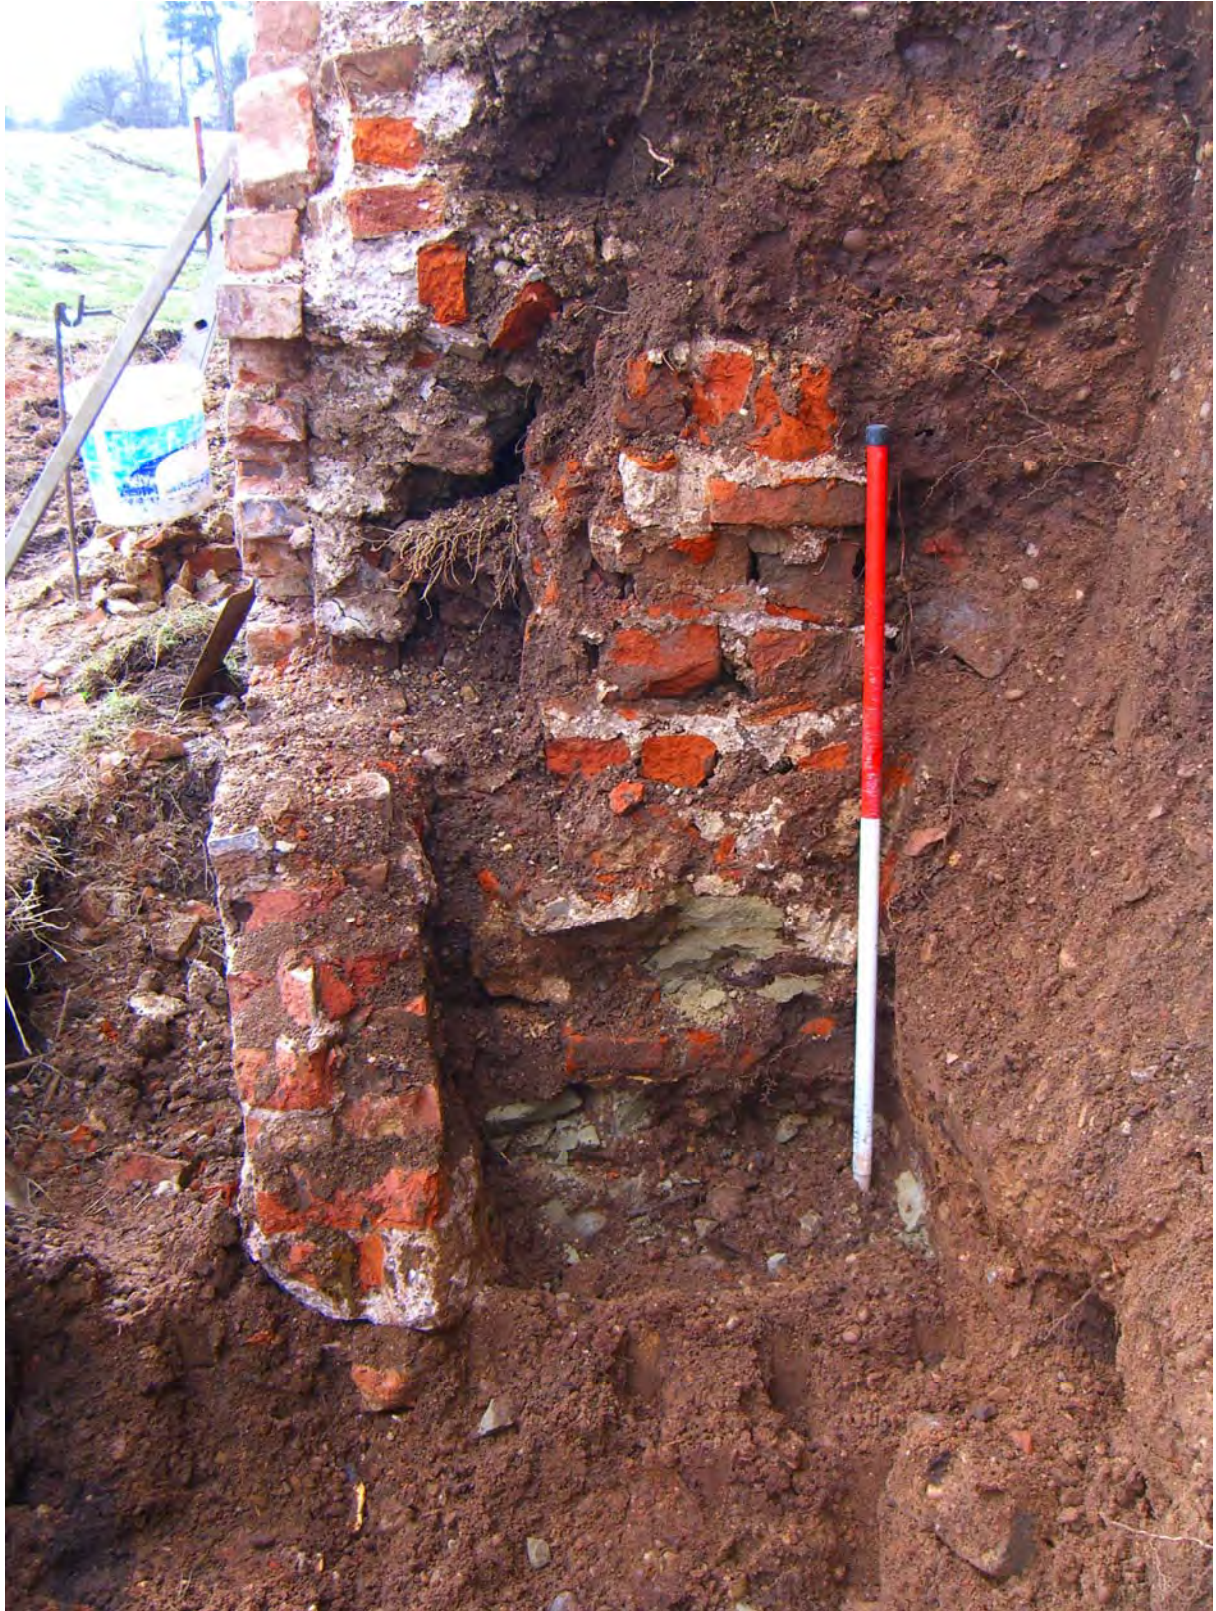
Fig.6: View on north-facing section of ha-ha walls 100 and 103
