St Lawrence's Church, Mickleton, Gloucestershire

ARCHAEOLOGICAL OBSERVATION AND RECORDING

Archaeology Warwickshire Report No 1639
MAY 2016

Project: St Lawrence's Church cemetery wall

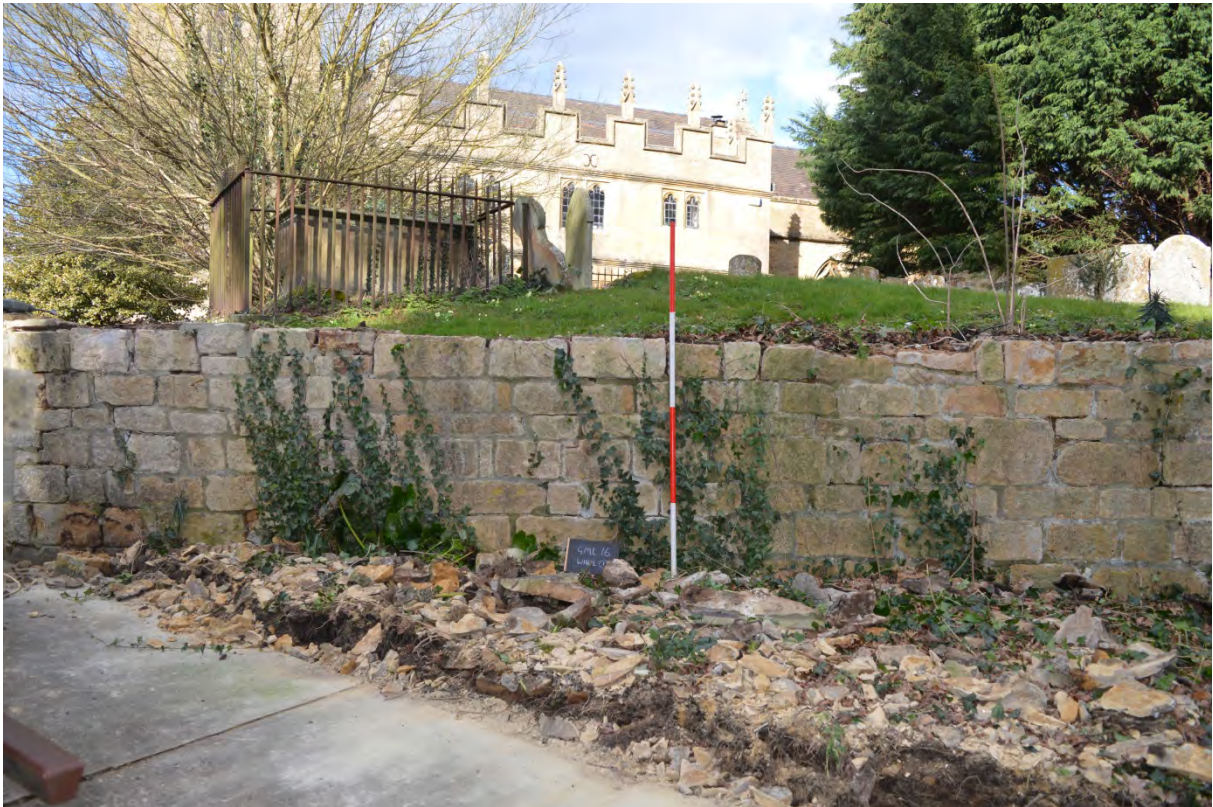
5.1 The section of wall (1) running NW-SE had its upper stonework dismantled by hand and the facing stones removed for use in later rebuilding work. The wall was 0.50m wide and originally standing 1.50m high. The face of the wall had been repointed with modern mortar, but to the rear of this the wall was bonded with soft brown lime mortar. The wall was well built, and stones graded in size with larger stones being used in the lower stonework

1 Graveyard wall before dismantling

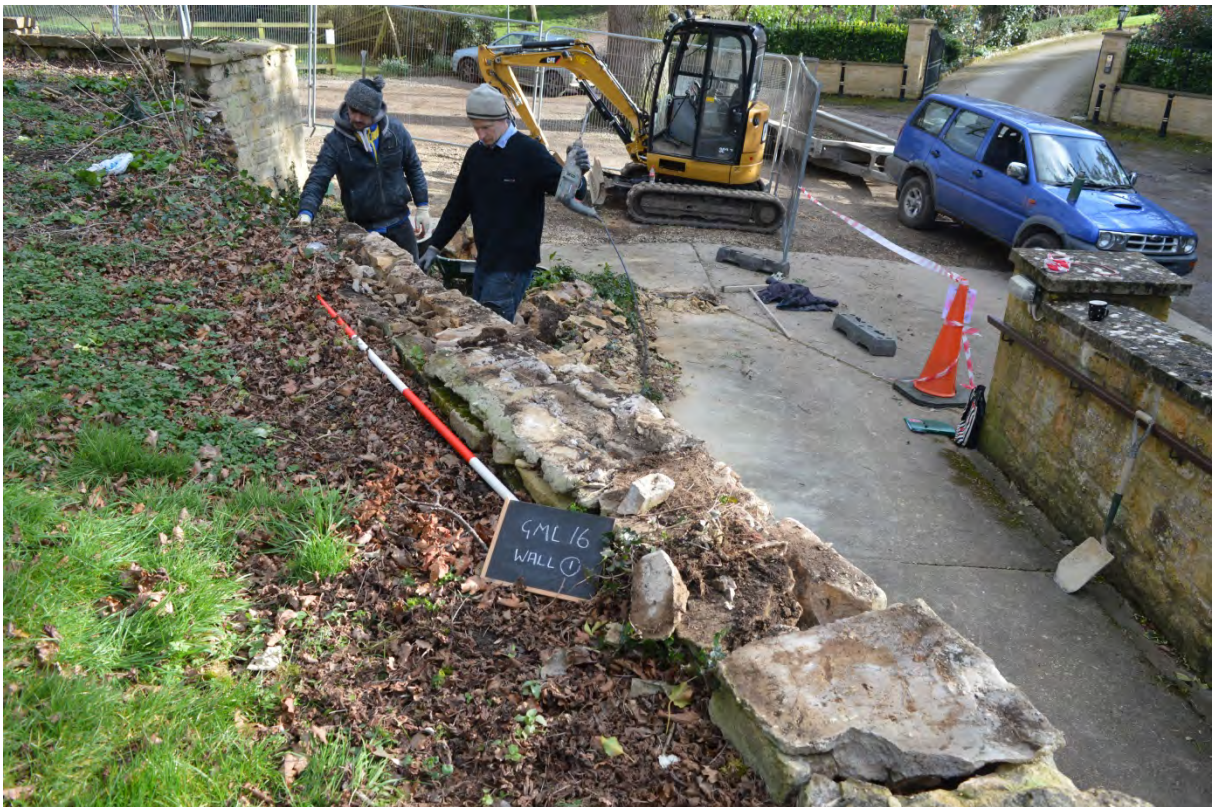
and smaller, more squared stones in the upper work. Topsoil had ingressed between the stones on the rear part of the wall and considerably animal activity was evident with small burrows visible in the soil to the rear. The upper 0.90m of stonework was removed, leaving the lower 0.60m *in situ*, as this was being overlaid by the newly graded bank.

2 Dismantling in progress

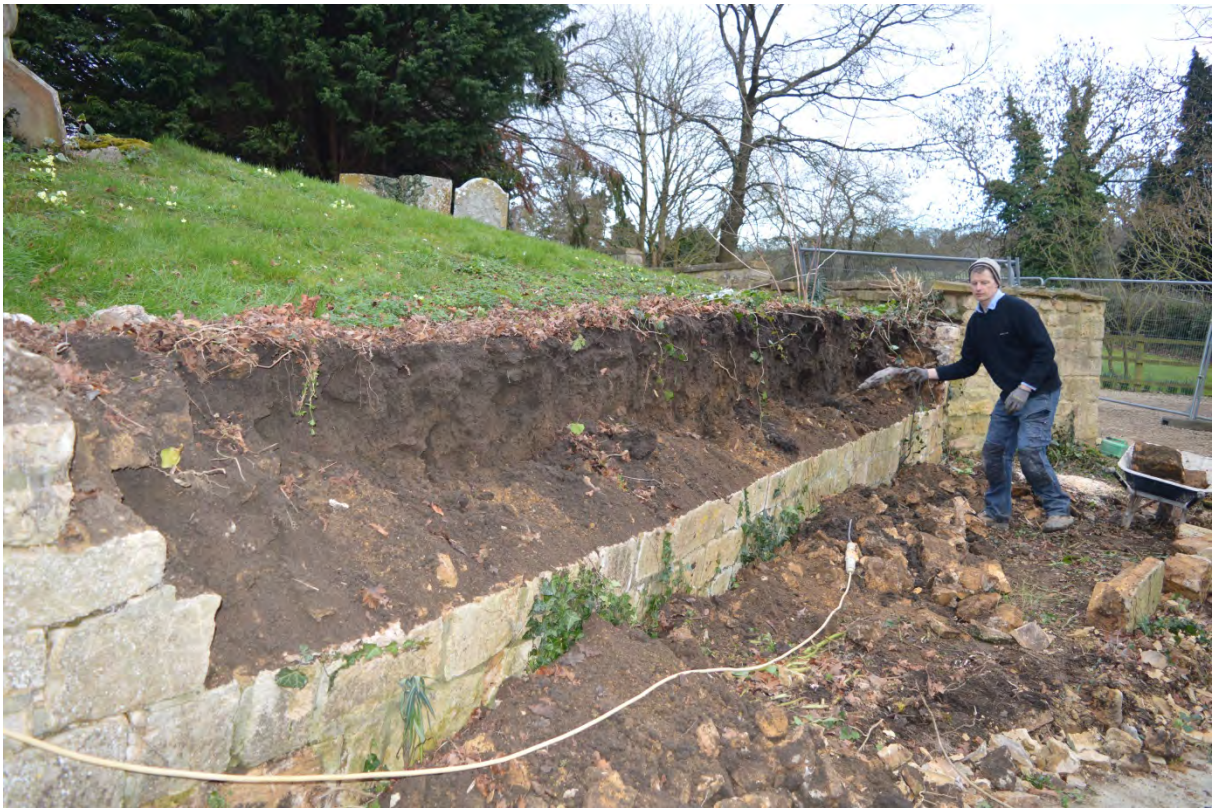
3 Wall dismantled

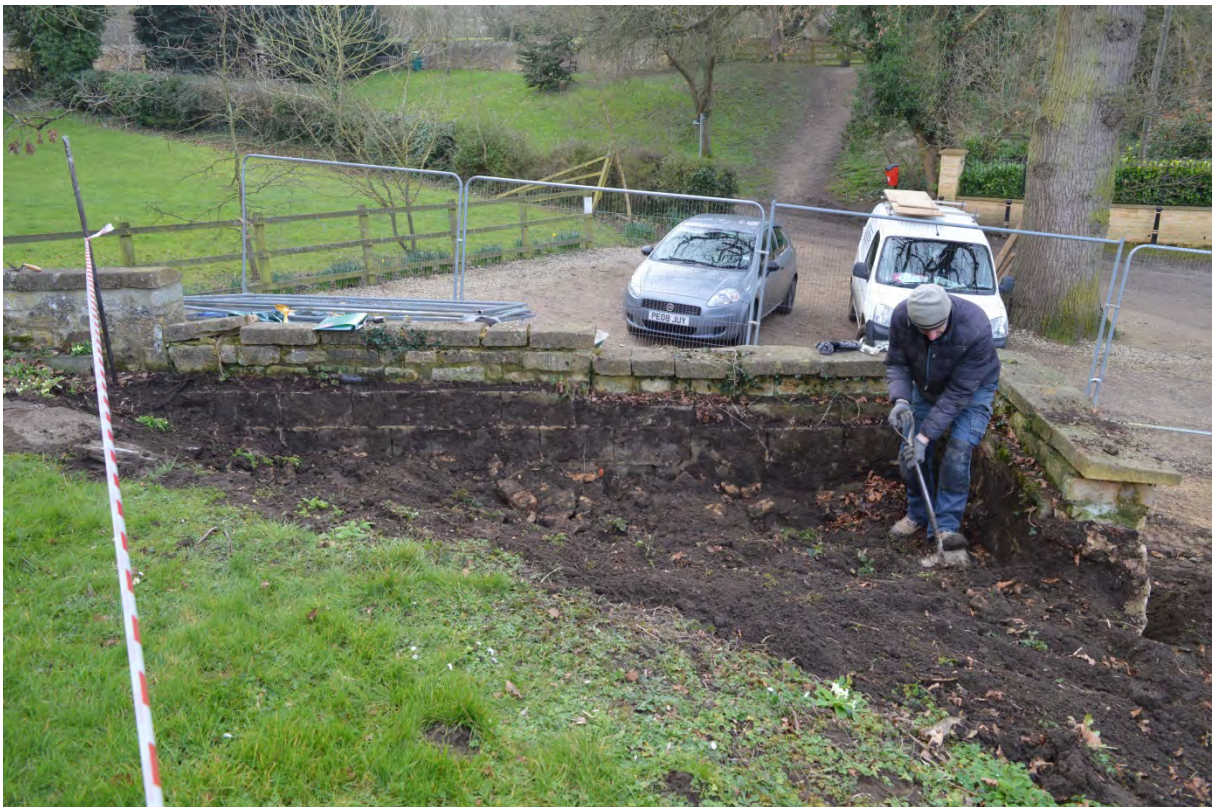
5.3 The section of walling adjoining wall 1, running SW-NE had been rebuilt in the recent past (5). This was a length of wall 5.40m long and 1.40-1.50m high with breeze blocks to its rear and grey plastic pipe at a low level to facilitate drainage. These pipes are the same as those in the wall (7) alongside the disabled access ramp, suggesting the rebuilding of this section of wall may have taken place at the same time as the construction of the ramp (9). A 2.06m length of wall (5) between walls 4 and 1 was rebuilt along with wall 4, with breeze blocks at the rear. The stones in these sections of wall are smaller than in the section of wall that was dismantled. To the rear of walls 4 and 5 the soil immediately behind the walling was removed to a maximum depth of 0.60m, cutting into a layer of topsoil mixed with modern bricks, rubble, and other debris (6). This material was graded back from the standing wall.

4 Grading of soil to rear of walls 4 and 5

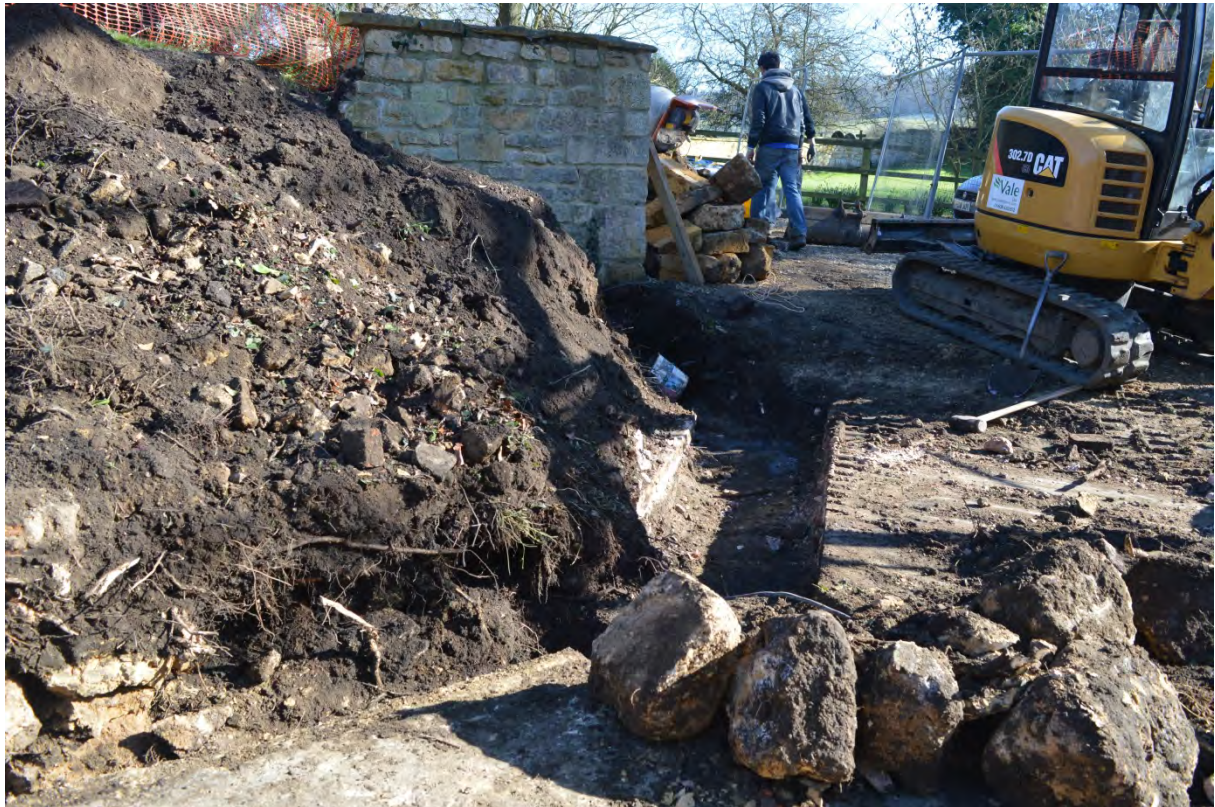
5.4 New foundation trenches were excavated 0.30m below the level of the present concrete ramp's surface using a narrow toothless bucket.

5 Excavation of footings for new wall

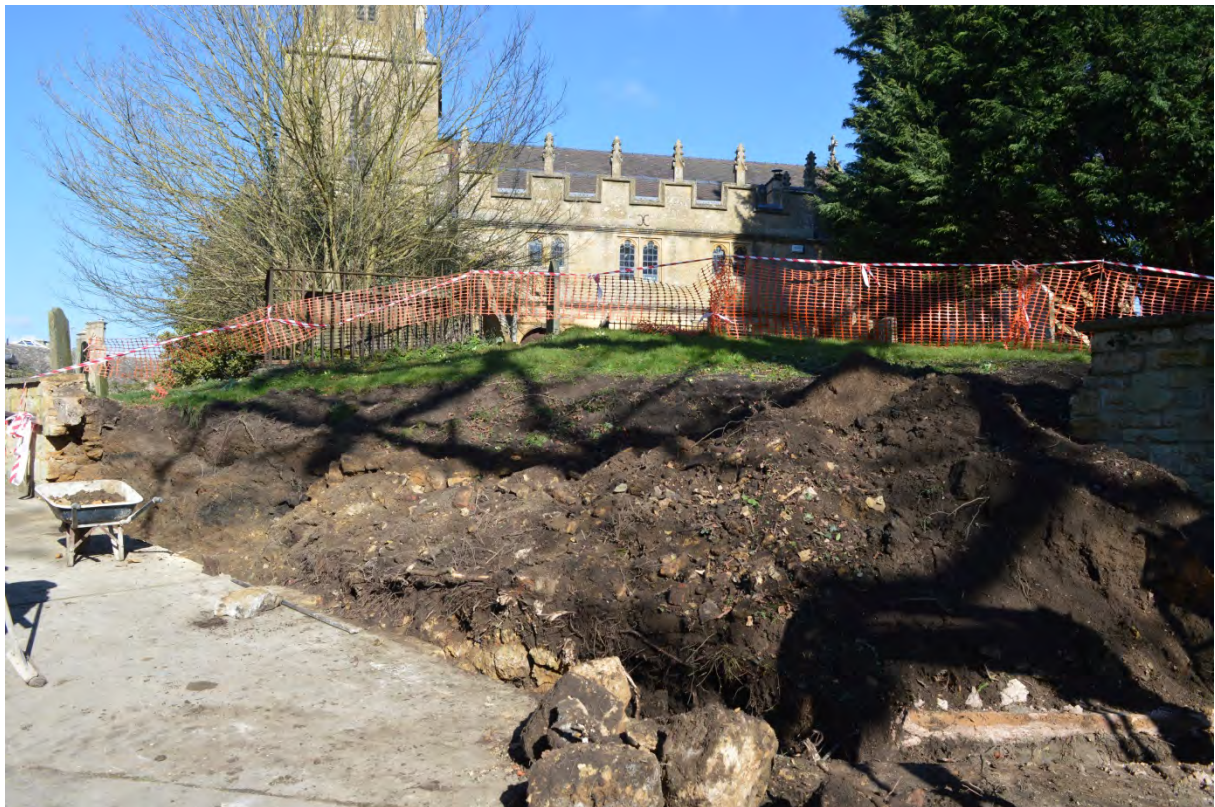
6 Graded bank covering remains of wall 1
