Land to the rear of The White House, Ansty Warwickshire

HISTORIC BUILDING RECORDING AND ARCHAEOLOGICAL EVALUATION

Archaeology Warwickshire Report No 2070

AUGUST 2020

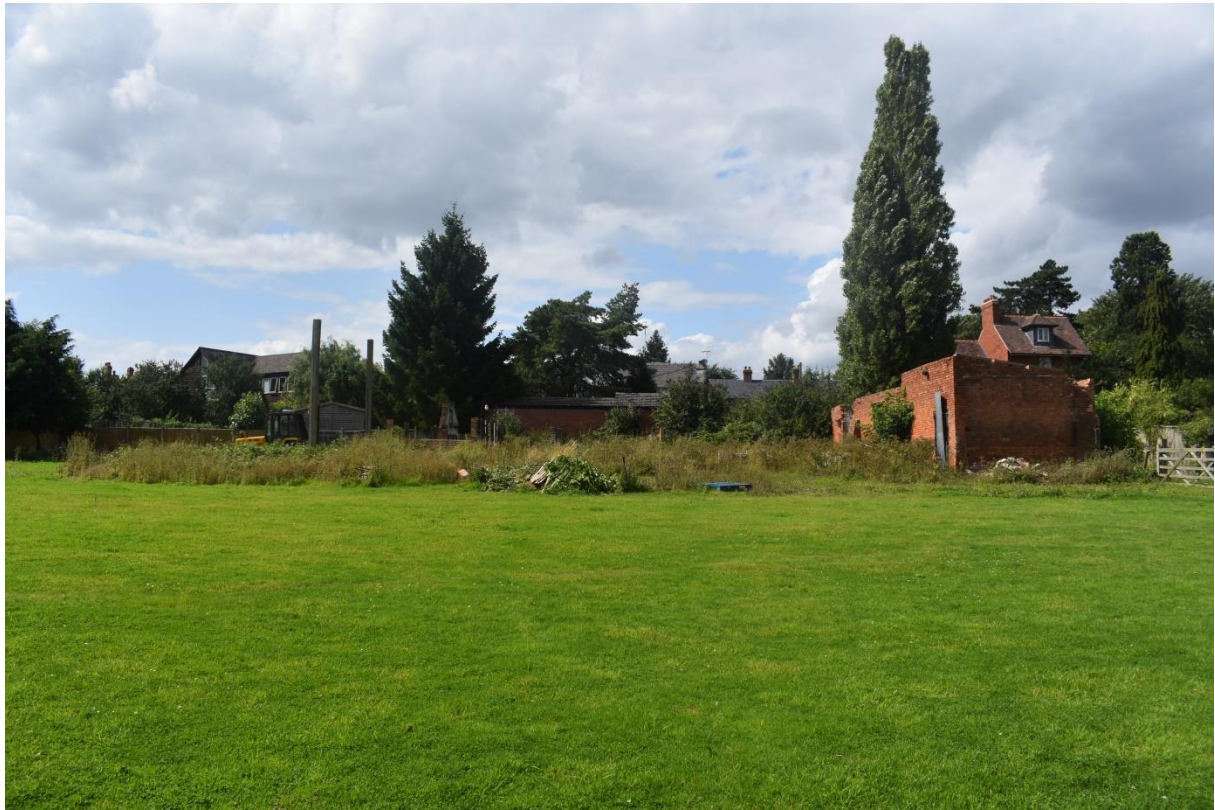
- 5.2 The farm buildings were in a somewhat ruinous state, having lost their corrugated iron roofing over the preceding years. The buildings were being encroached upon by vegetation, particularly the north-western one (Building 2; Photo 1). However, the walls were standing, allowing some rudimentary analysis to be undertaken. The remains of three buildings exist on the site, in positions shown on the 1880s Ordnance Survey map. One of these buildings (Building 3, the south-western one) is an entirely modern construction with a concrete floor and timber uprights which appear to be cut-down railway sleepers; this building has been constructed in the footprint of an earlier structure.

1: The farm buildings from the canal

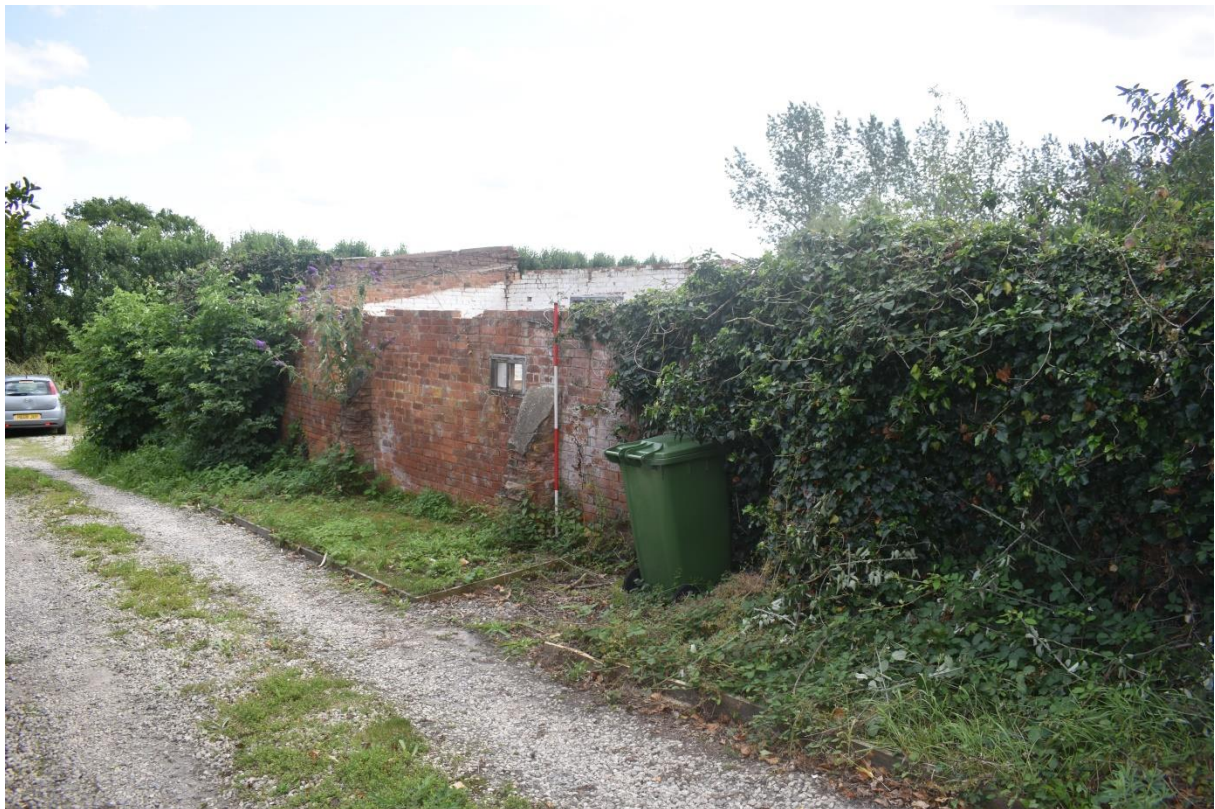
- 5.3 The two remaining buildings have elements of historic fabric but have been subject to alterations in the 20th century. The north-eastern building (Building 1) which backs on to the side access road, appears to have been originally two stories, but the original roof had been lowered to a mono-pitch roof, sloping down from the courtyard side. The rear wall has two small inserted windows, and later buttressing on both rear and front walls (Photo 2). Some original features include a small rectangular window with a segmental brick arch (Photo 3). The lean-to that formerly stood against the gable is no longer in place but can be located from its footprint and wall scar (Photo 4). The room at this end of the building was not accessible at the time of the survey. The lower part of the building is constructed in Flemish Stretcher Bond, with bricks measuring 220mm x 110mm x 62mm (this bond consists of three rows of stretchers between rows of alternating headers and stretchers). The upper part of the building has been rebuilt.

2: The north-east elevation of Building 1

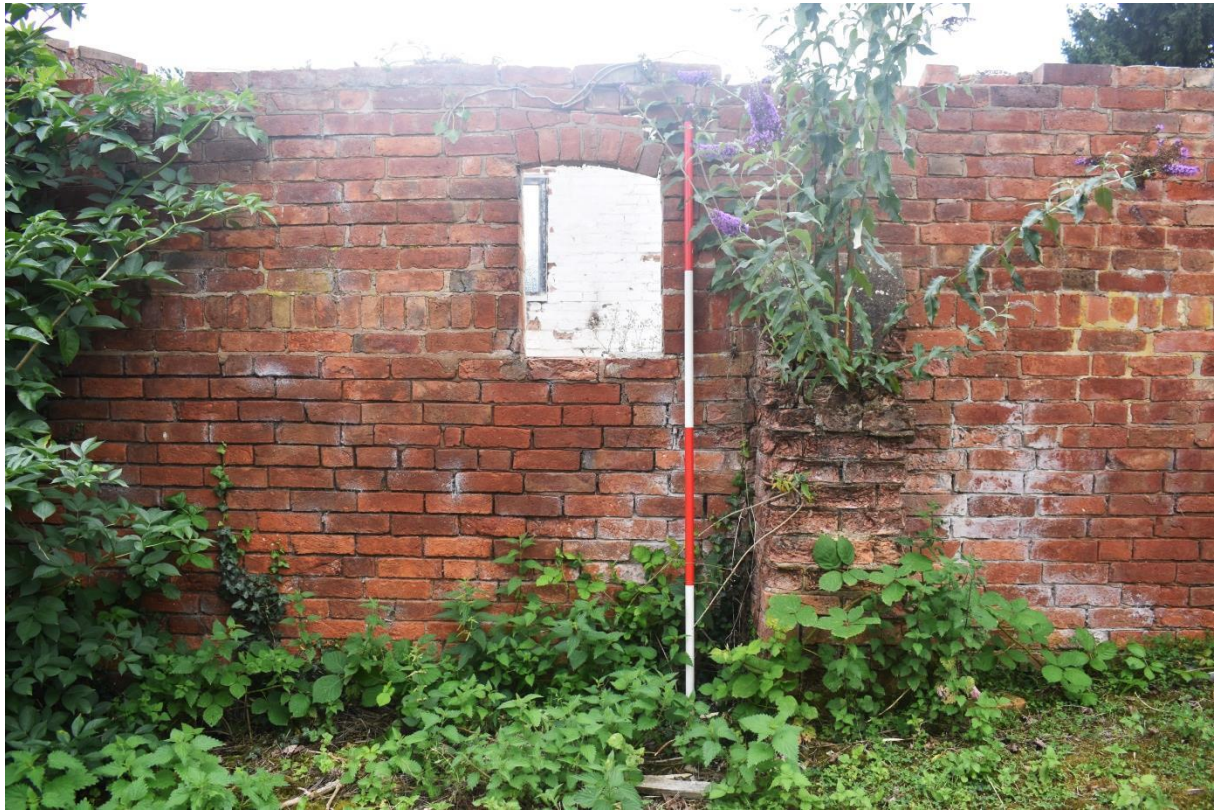
3: Original window and later buttress on NW side of Building 1

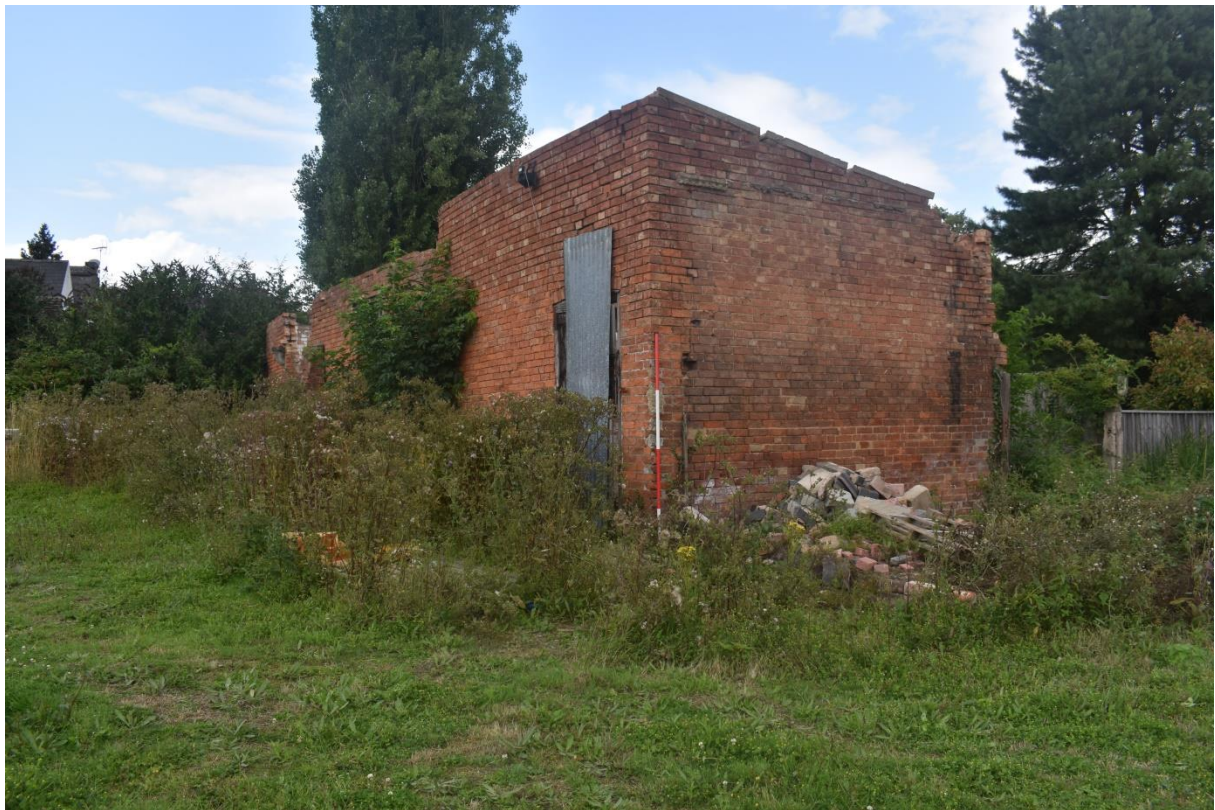
4: Building 1, looking north

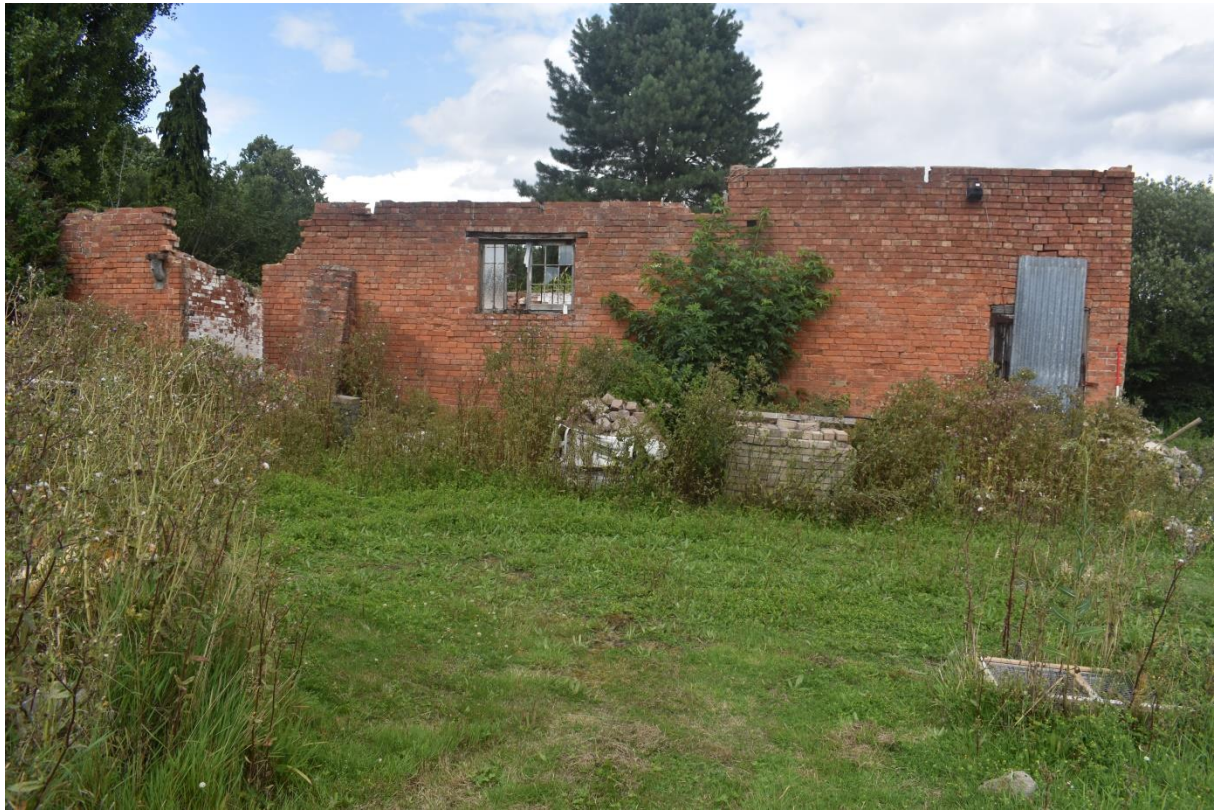
- 5.4 The south-west elevation of Building 1 has a glazed window and a doorway opening into the upper part of the building (Photo 5). A relieving arch was recorded low on the wall (Photo 6). The interior had been whitewashed and subdivided with a part-height

5: Building 1, SW elevation

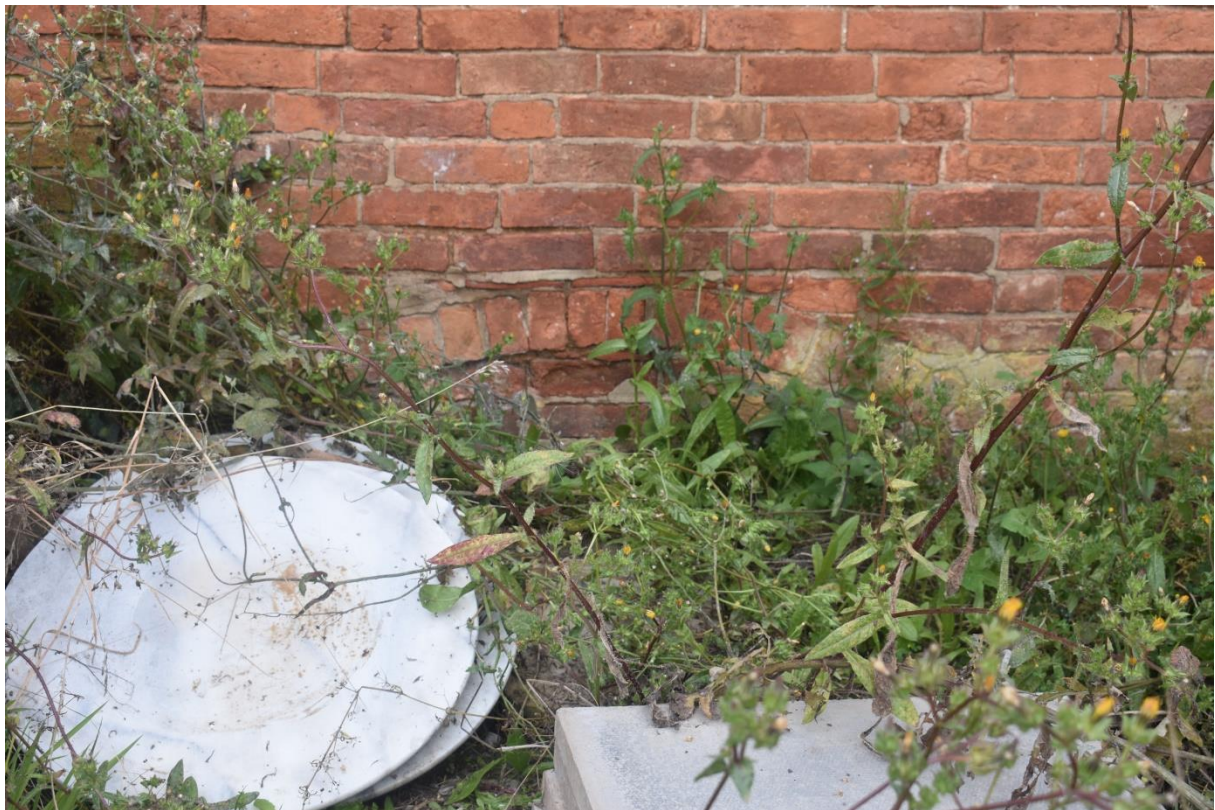
6: Relieving arch on SW wall

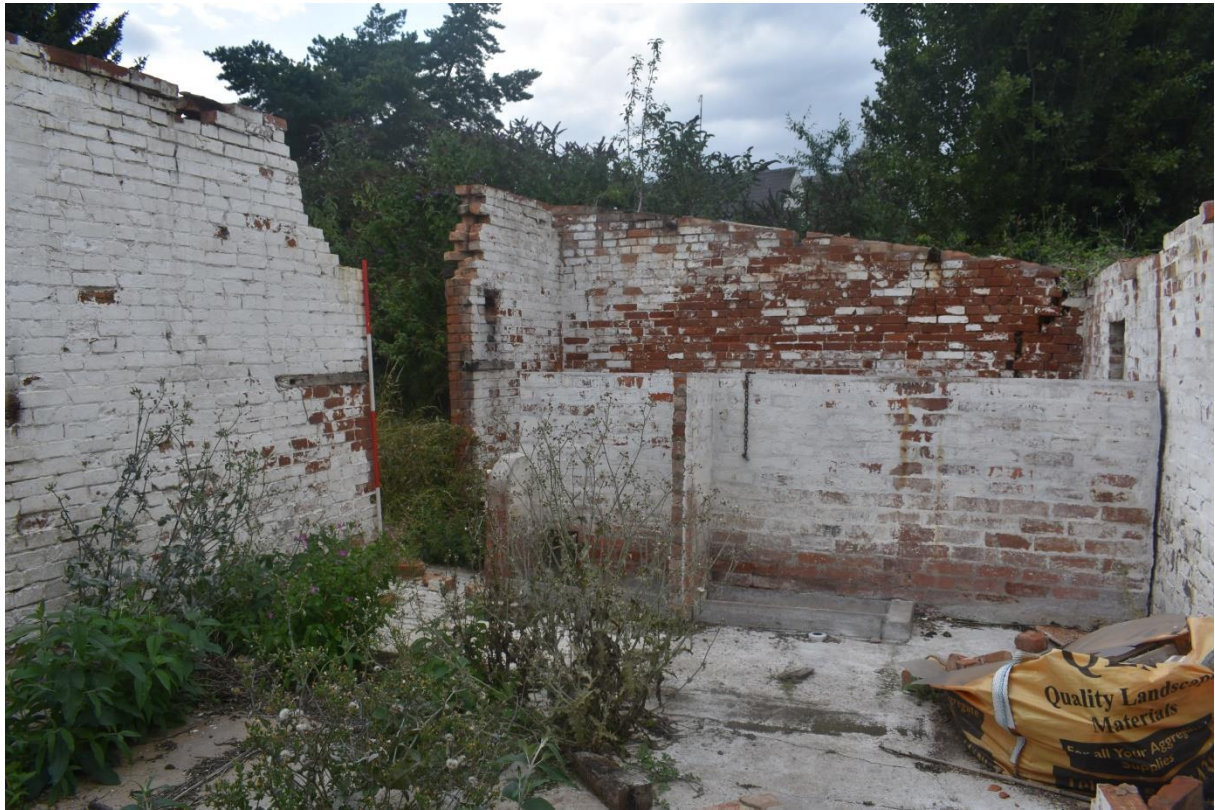
brick cross wall with feed troughs on its south-east side (Photo 7). The brick feed chute on the other side of the wall strongly suggests that this was for pig feed, and that the latter use of the building was as a pigsty (Photo 8). Such chutes were used for pouring pigswill and would have protected the feeder from the over-enthusiastic rush at feeding time (Brunskill 1982, 76). A 1962 inscription on the interior gable wall may give us a clue to when this building was used as a pigsty (Photo 9). The floor in the northern bay is brick; it may well be brick throughout, below the modern concrete (Photo 10).

7: Interior of Building 1 with inserted part-height wall fronted with shallow troughs

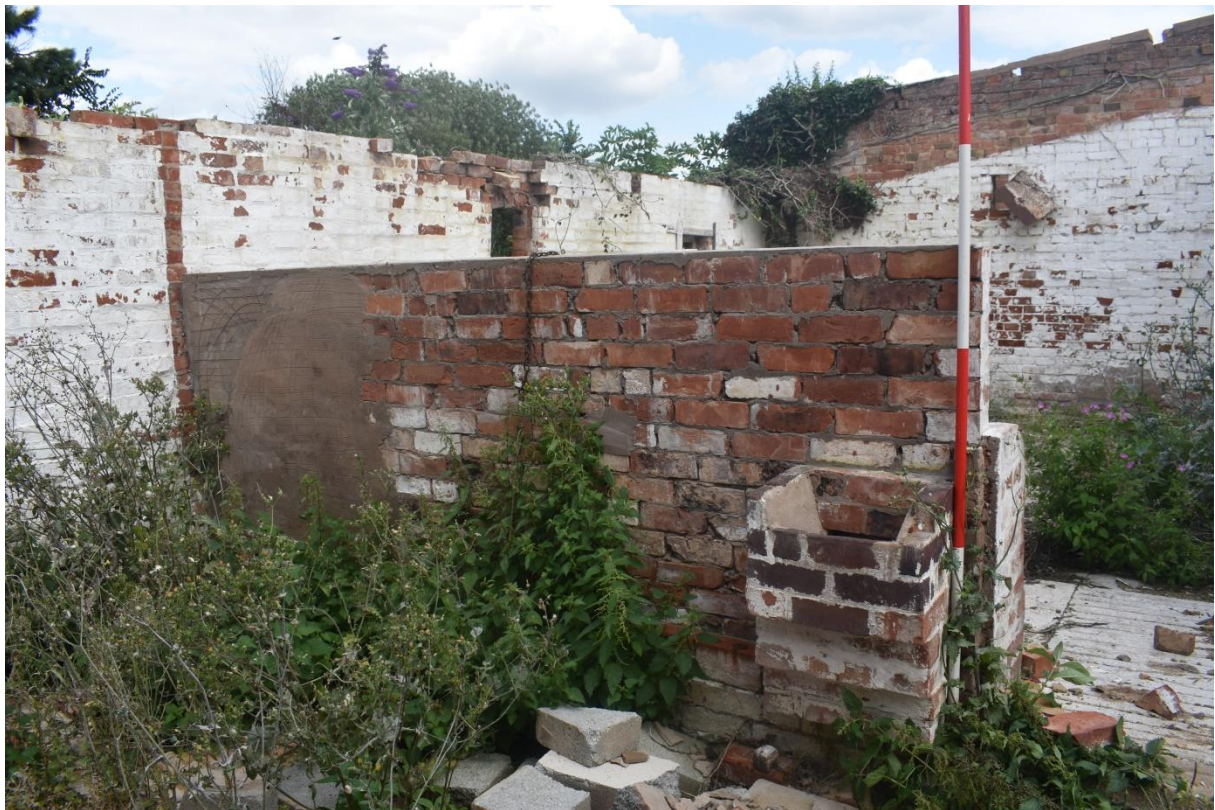
8: Rear of wall with brick feed chute

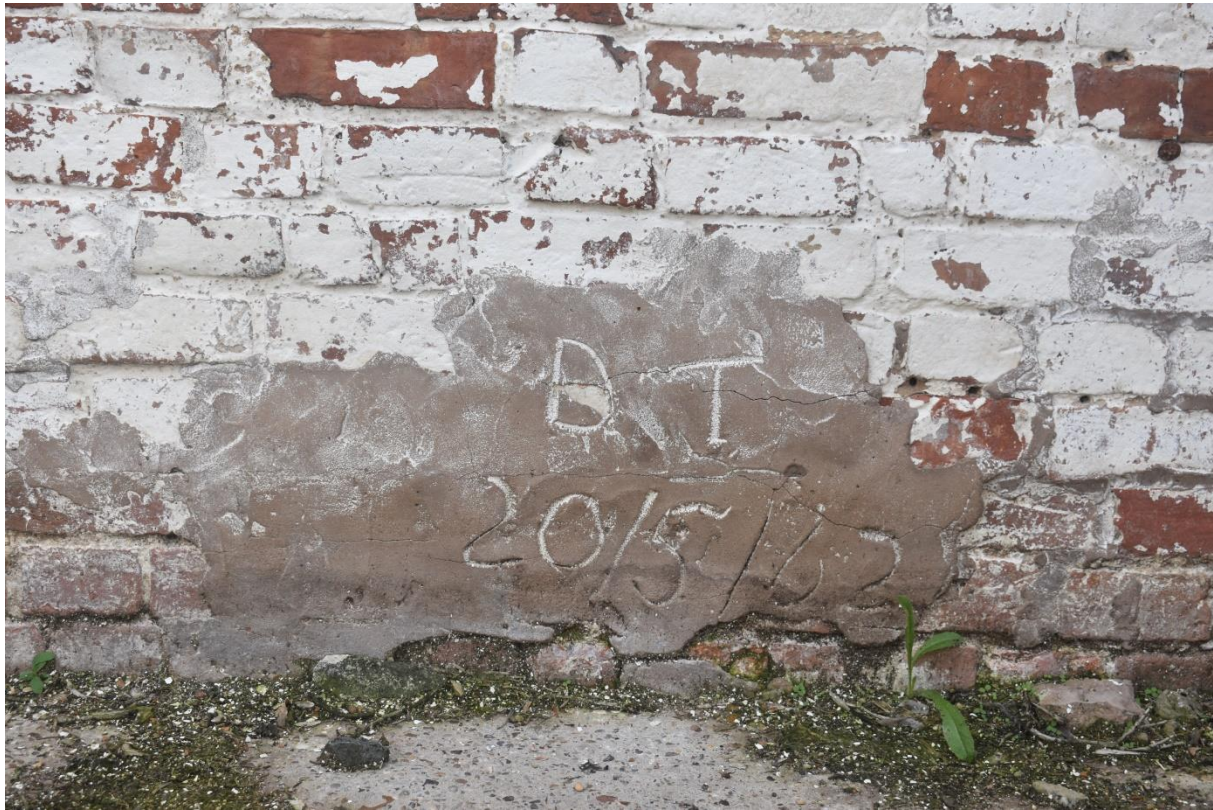
9: DT 20/5/62 on mortar

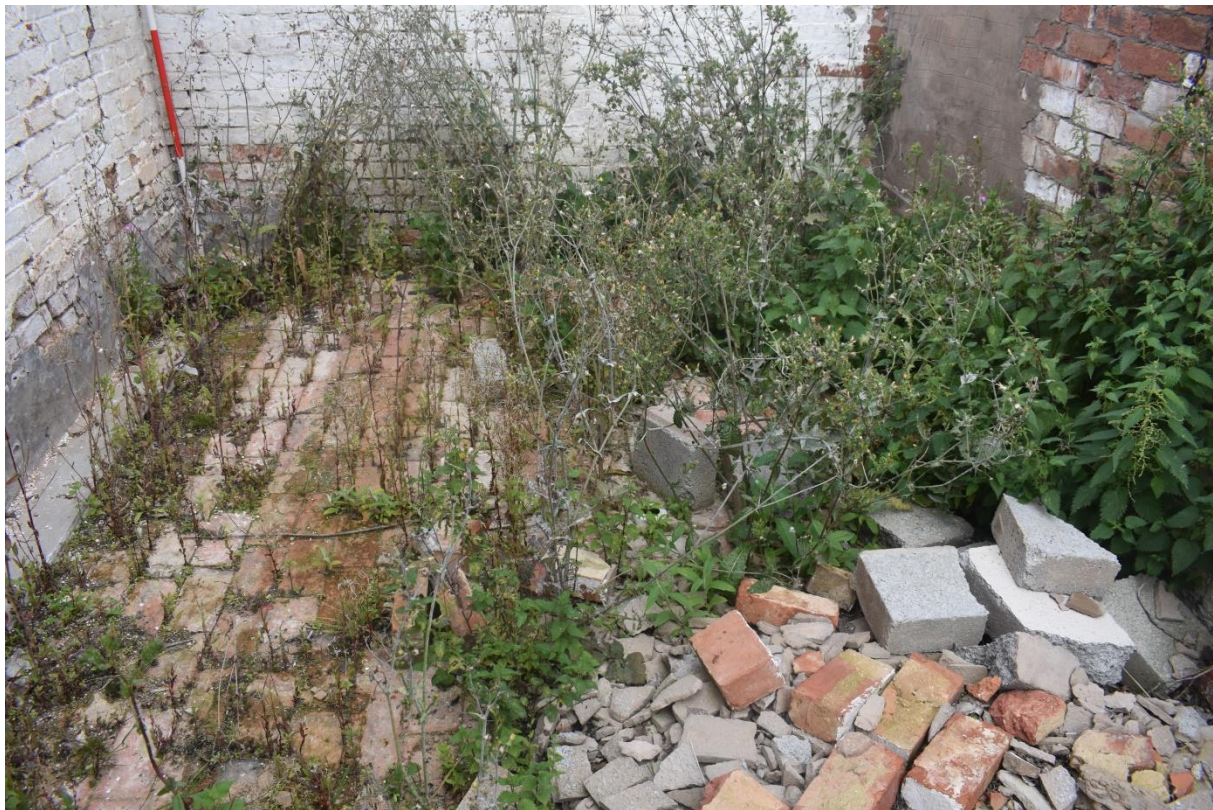
10: Brick floor in north-western room

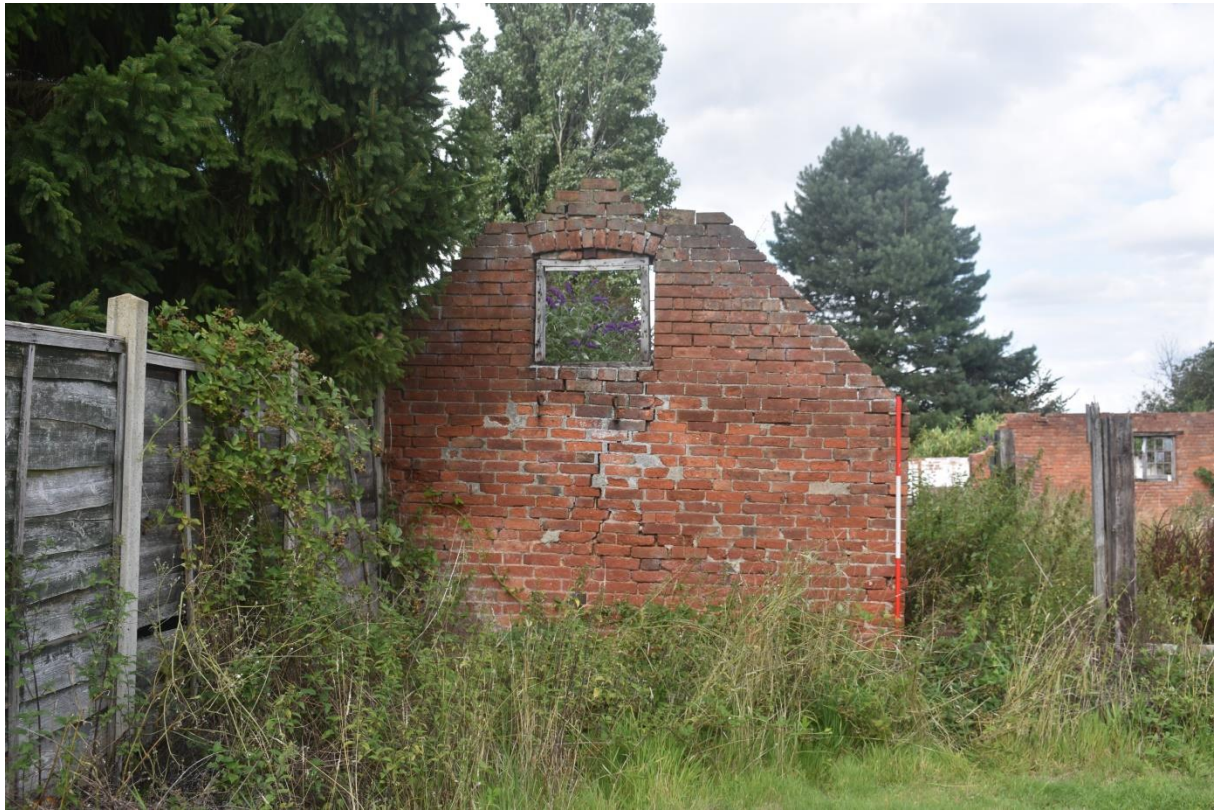
- 5.5 The north-western building (Building 2) backed onto the garden at the rear of The White House and that side was not accessible. The south-west gable end was still standing, with a pitching window suggesting there may have been high-level hay storage within the building (Photo 11). The lower part of the building is constructed in Flemish Garden Wall bond (also known as Sussex Bond), with bricks measuring 230mm x 115mm x 60mm. The upper part of the gable appears to have been rebuilt, with five rows of stretchers alternating with a row of headers (English Garden Wall Bond/Scottish Bond). The front of much of the building was obscured by vegetation with significant Buddleia growth in the northern part (Photo 12). The First Edition mapping suggests part of the building may have been open fronted, possibly a shelter shed, and two of these panels have been infilled, one with wooden boards and another with concrete (Photos 13 and 14). A rough blue brick wall has been constructed within the building.

11: Gable of building 2

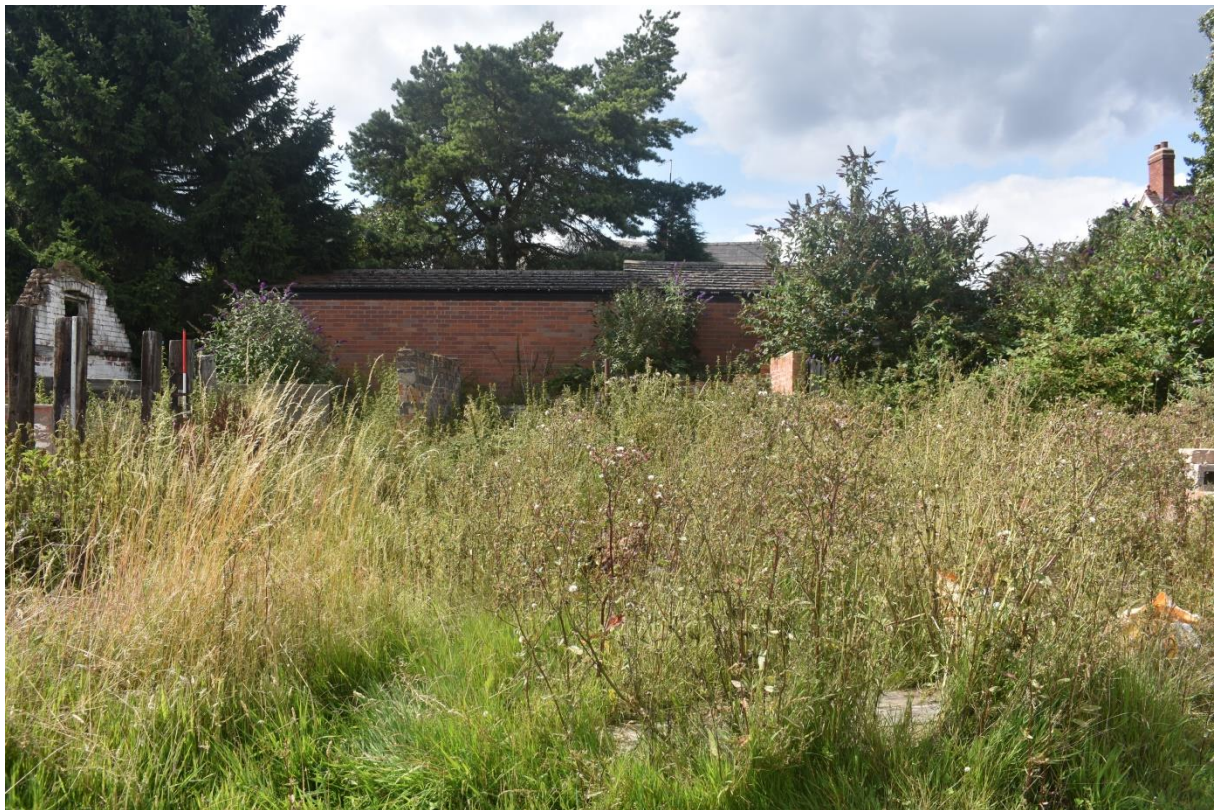
12: Front of Building 2, obscured by vegetation

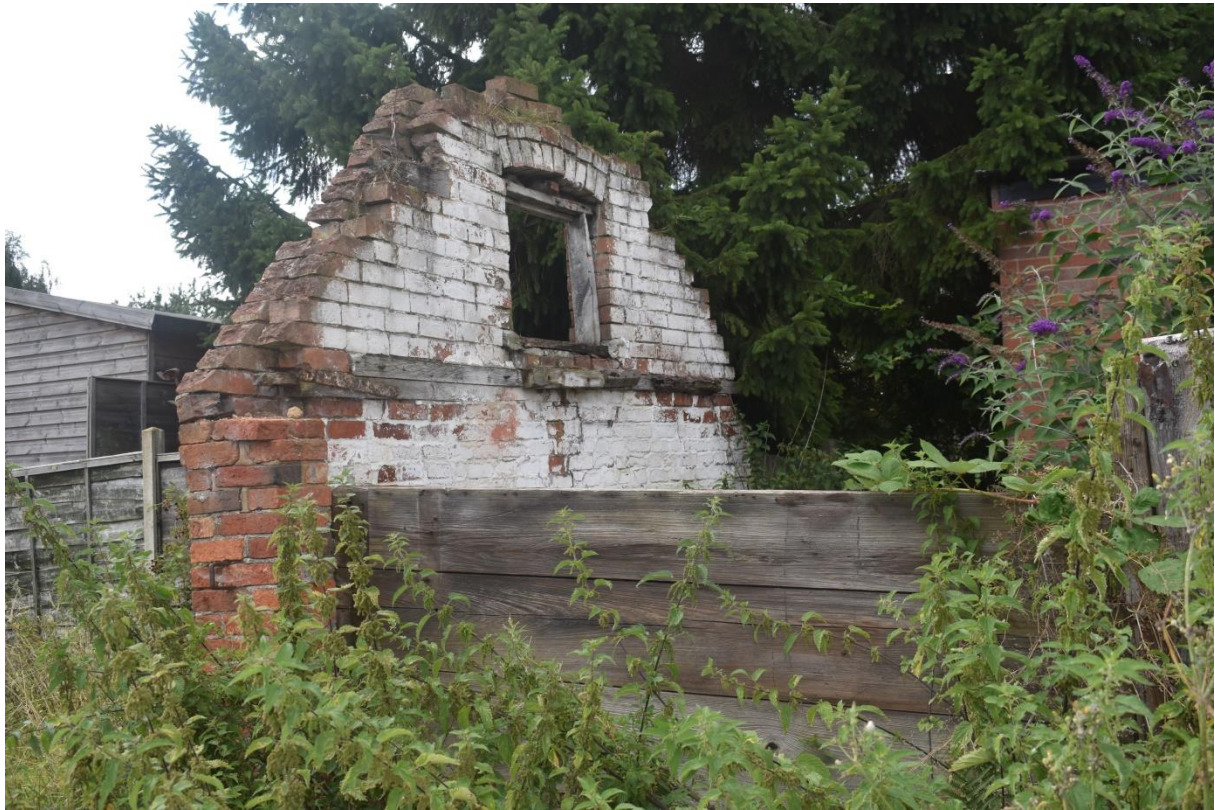
13: Wooden boards used to infill SW bay of Building 2

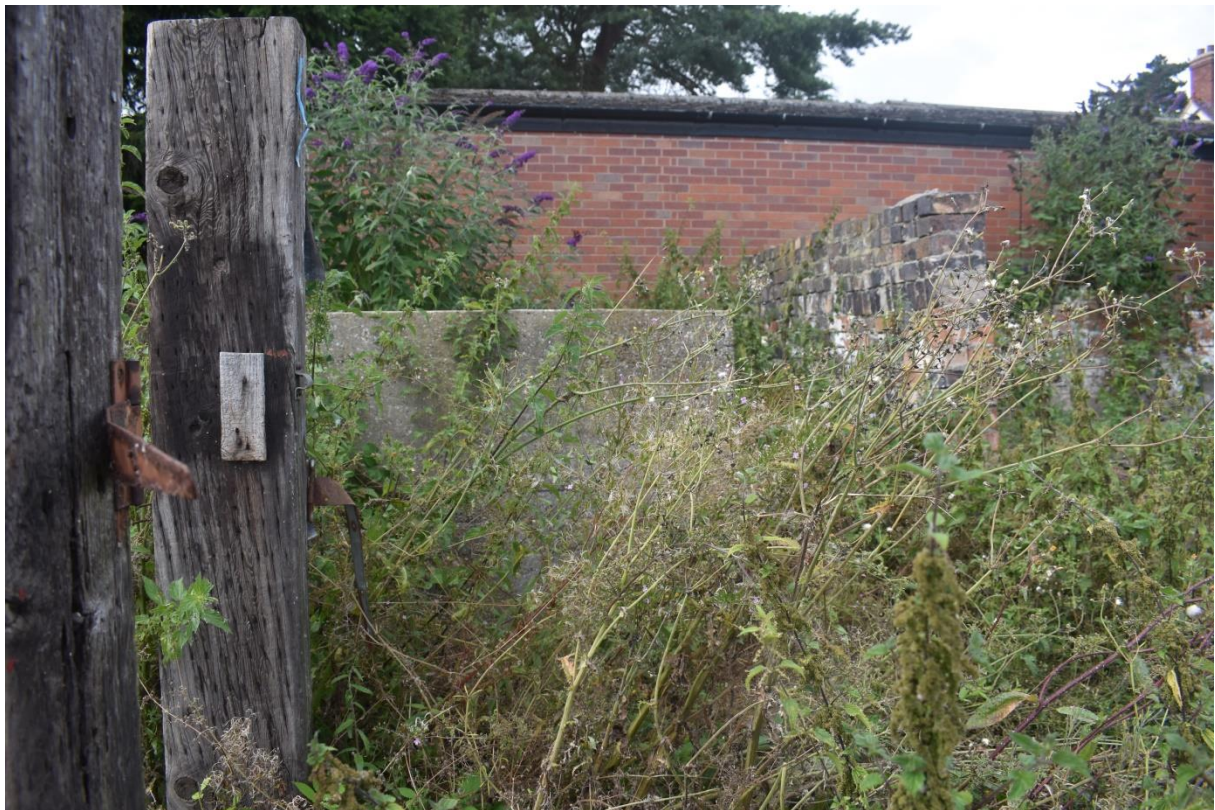
14: Concrete infill and blue brick cross-wall within Building 2

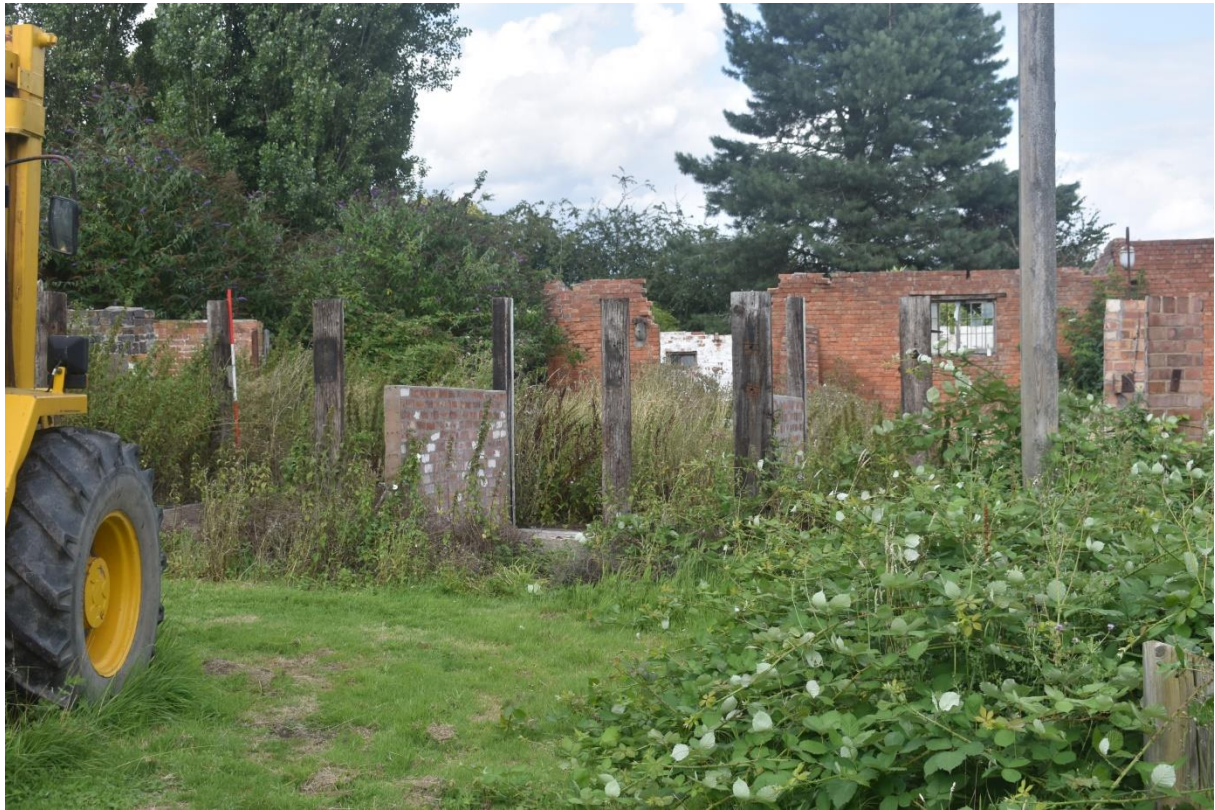
- 5.6 The south-western building (Building 3) appears to be an entirely modern construction, made using old railway sleepers, concrete floors and cement-mortar bonded cross walls (Photos 15 and 16). The building formerly had a pitched roof covered in corrugated metal.

15: Railway sleeper posts of Building 3

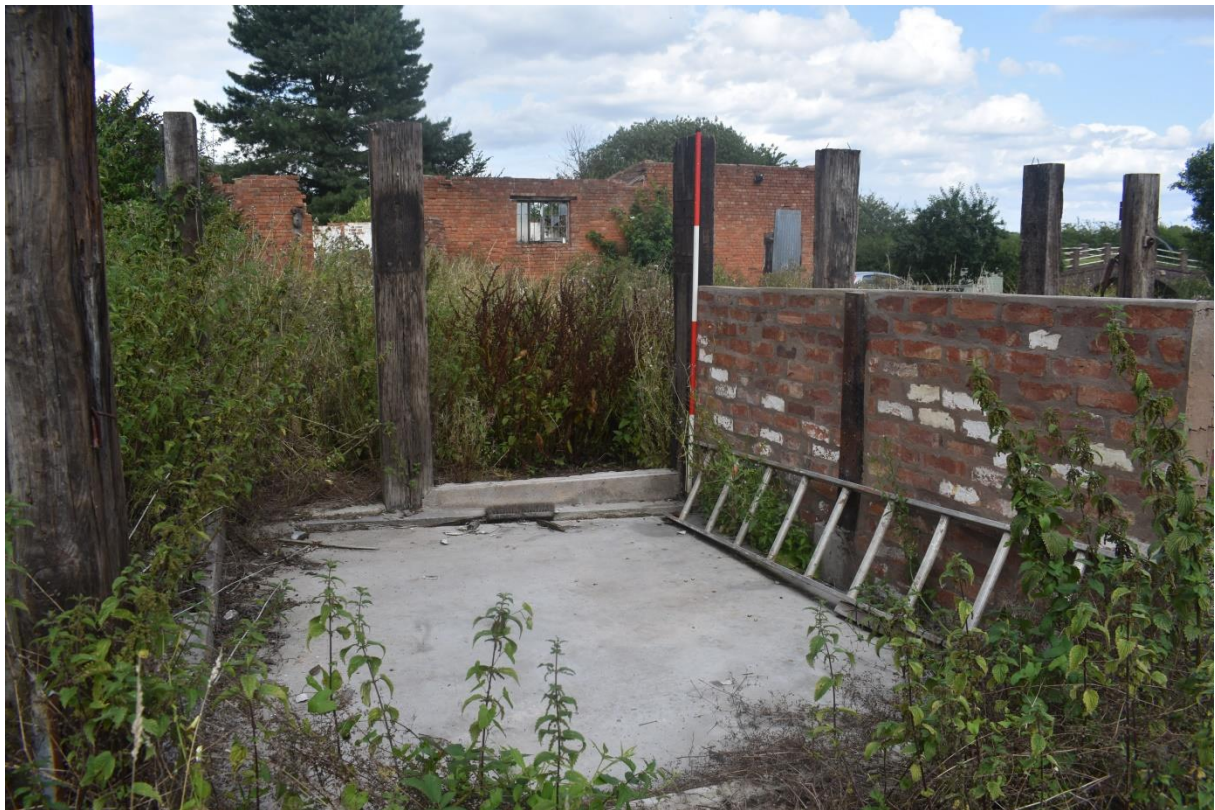
16: Concrete floor and brick cross-wall in Building 3

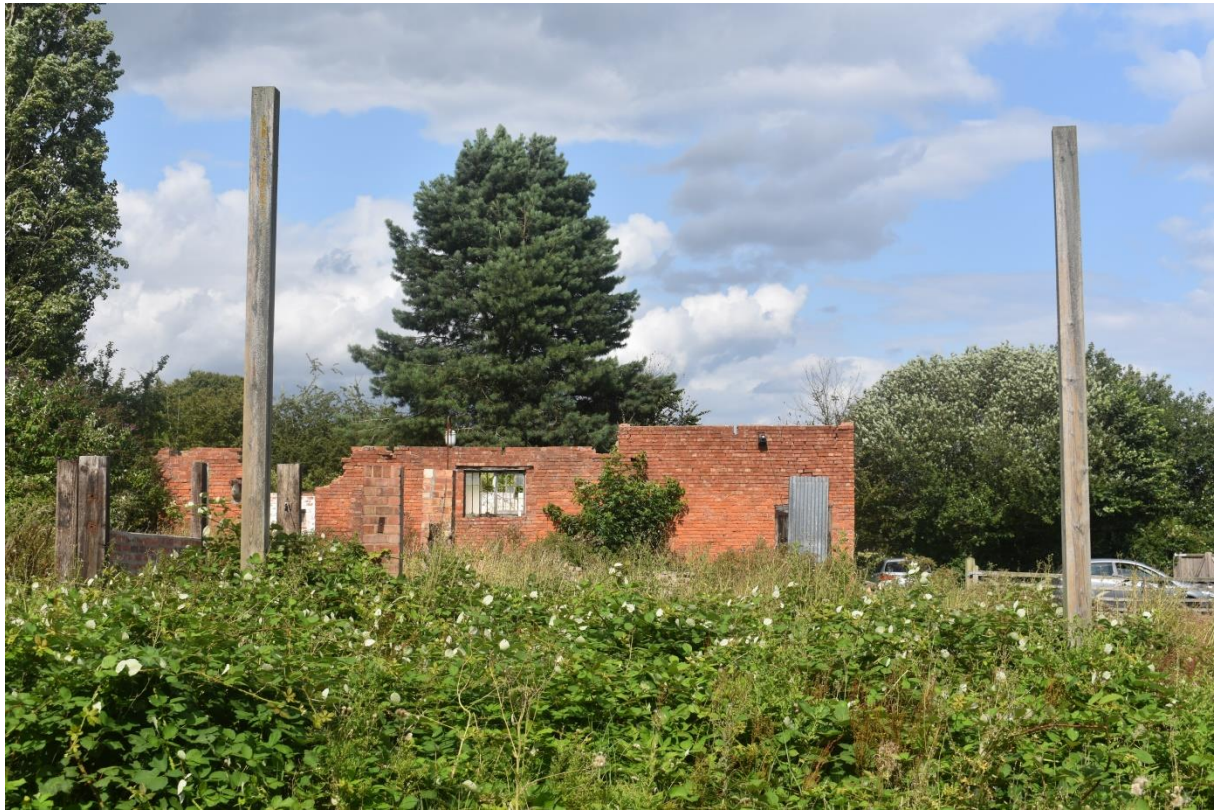
- 5.7 The pole barn footprint was heavily overgrown. The barn roof, extant in 2007, had collapsed by 2012 (Google Earth images used in Vagdia and Holmes Planning Statement, 2019). Only two poles remained upright (Photo 17).

17: Two poles of the pole barn, with Building 1 beyond

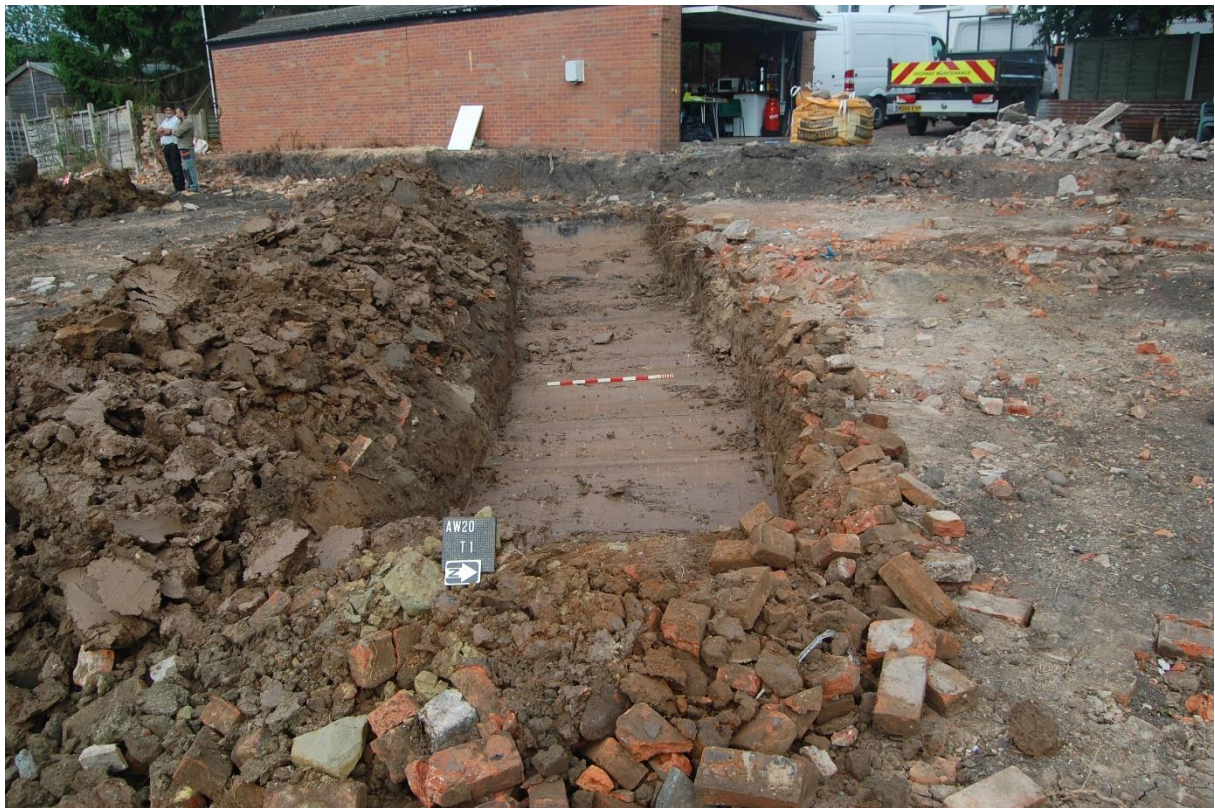
18: Trench 1

- 5.9 Trench 1 ran west to east, with the western part located over part of Building 2 and the eastern end in Building 1. Geological natural clay (103) was recorded at a depth of 0.50m below current ground level. This was overlain by 0.20m of dark yellowish brown silty clay (102) and this was in turn overlaid by 0.20m of hardcore, sand etc (101). In the western end of the trench a layer of large cobbles was recorded (104), which lay immediately below the brick flooring of the former building (100). Brick flooring was also noted in the eastern part of the trench, within the former Building 1 (105). No finds were recorded.

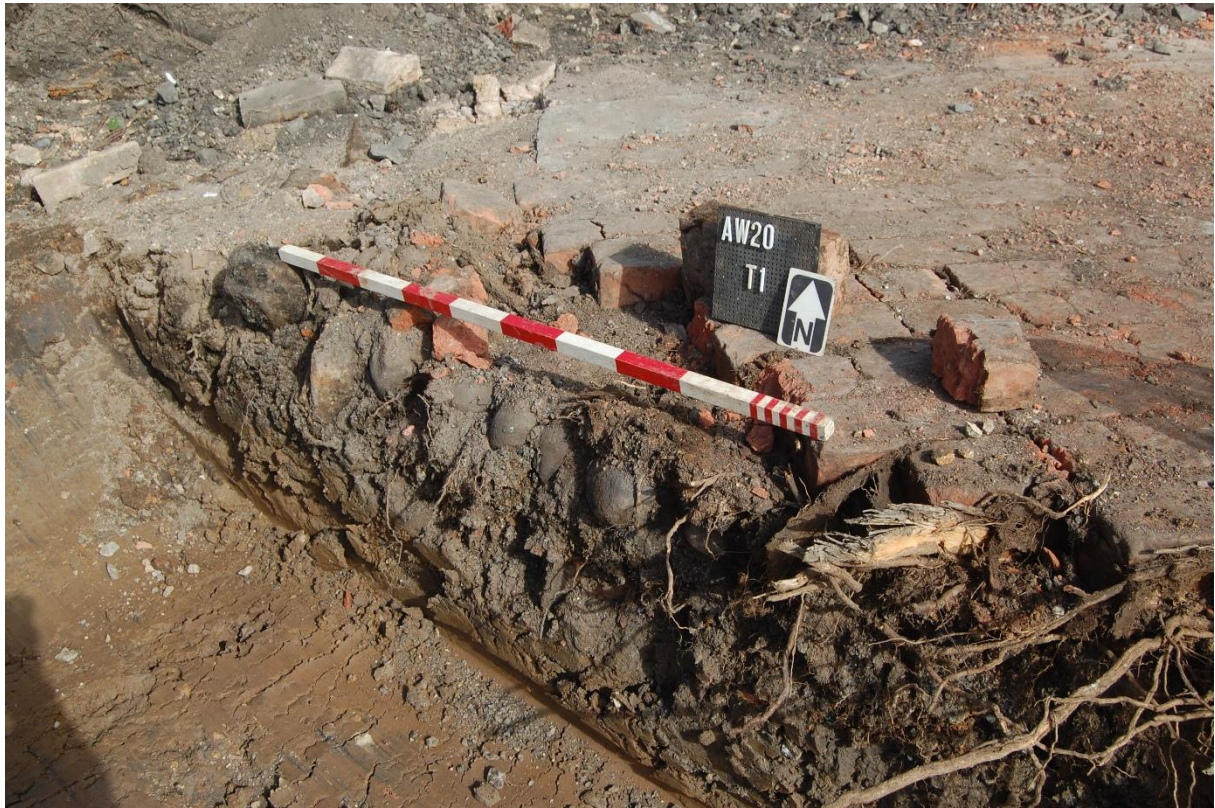
19: Brick and cobble floors of Building 2

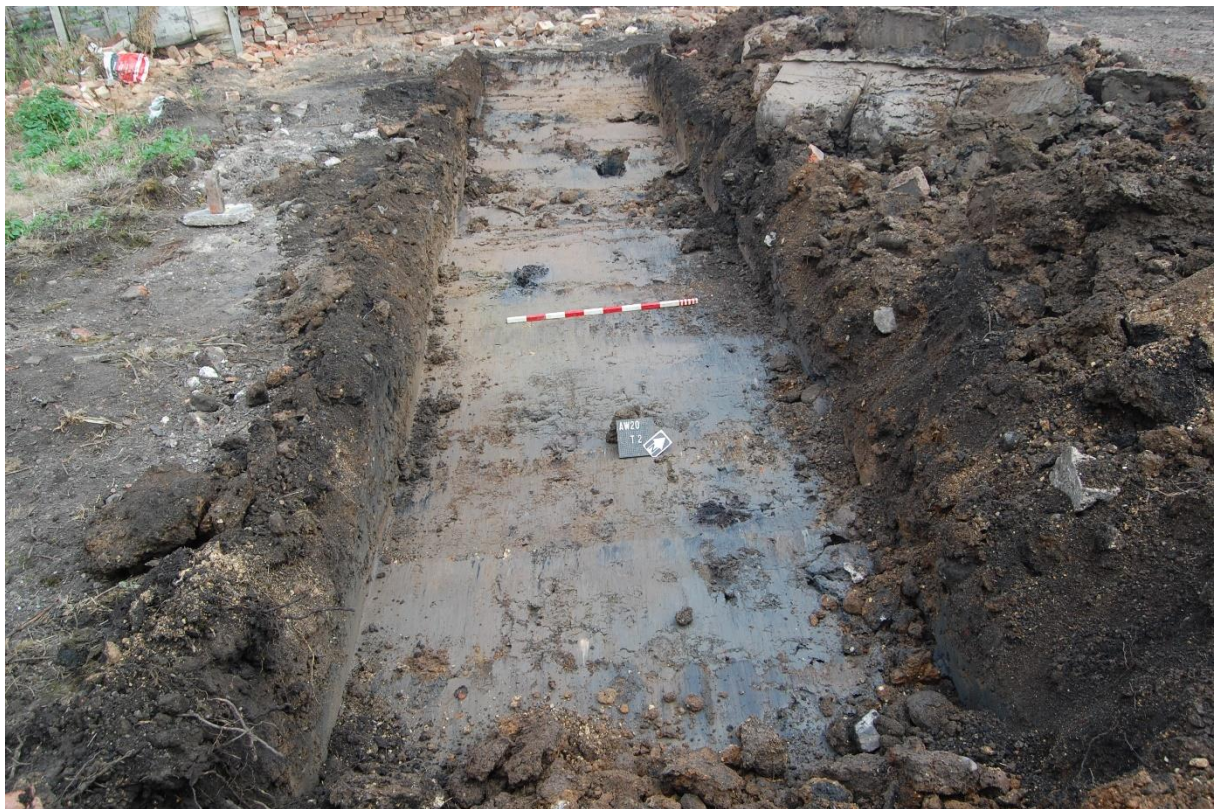
20: Trench 2

- 5.10 Trench 2 ran NNE-SSW, with its northern part lying in the outer part of Building 2 and the majority of the trench under the footprint of Building 3. The 20th-century concrete slab of Building 3 had already been removed. Geological natural brown clay (202) was recorded at a depth of 0.40m below ground level and was overlain by 0.20m of brown silty clay (201), in turn overlaid by 0.10m of grey silty clay loam (100). Traces of where the modern creosoted posts of Building 3 had stood had penetrated the natural clay. No evidence for the building shown on the First Edition map of 1888 in the area of Building 3 were recorded and no finds were recovered.
