## Report on the Conservation and Stabilisation of Small Finds from Torksey

Date: 15<sup>th</sup> July 2015

York Archaeological Trust Conservation Report Number 2015/41

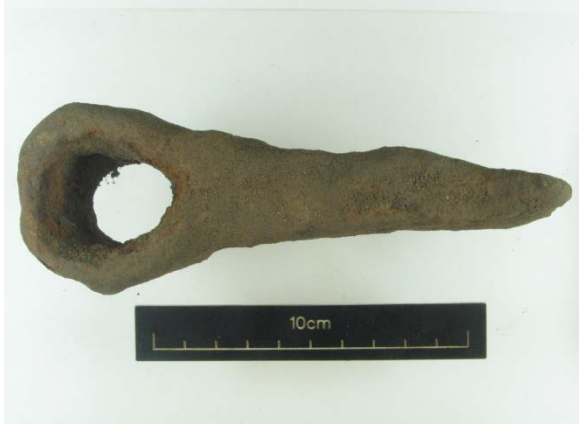
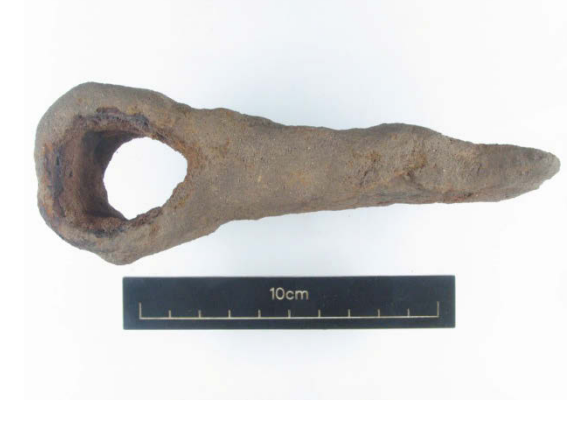
<p><b>SF1 (X8573)</b></p> <p>Sand and silt covers the entirety of the surface of the object, sitting in loose clumps around the head. The soil easily becomes dislodged during handling. Cracks and flaking are visible on the surface of the object.</p> <p>Treatment: Loose soil was removed with a stiff bristle brush to allow access to the cracks and fragile areas. Larger clumps were removed using the air abrasive with air only. Cracks and fragile areas were consolidated with 10% w/v Paraloid B72 in acetone applied with a brush. Once dry excess Paraloid on the surface was removed using a scalpel under the microscope.</p>

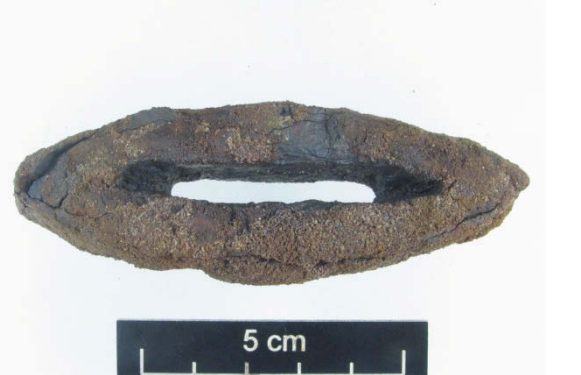
<p><b>SF2 (X8573)</b></p> <p>Sand and silt covers the surface of the object forming a thin layer of concretion and filling the central hole of the cross guard. Cracks are visible throughout the surface of the concretion with some small areas missing.</p> <p>Treatment: The central hole of the cross guard was investigated using air abrasive with 29 micron aluminium oxide powder which removed the concretion and corrosion products. Cracks and fragile areas were consolidated with 10% w/v Paraloid B72 in acetone applied with a brush. Once dry excess Paraloid on the</p>

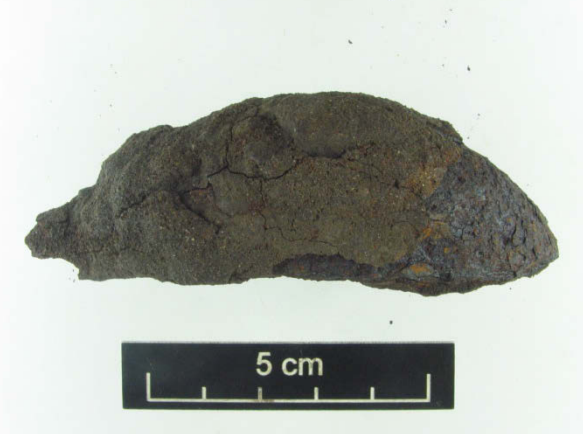
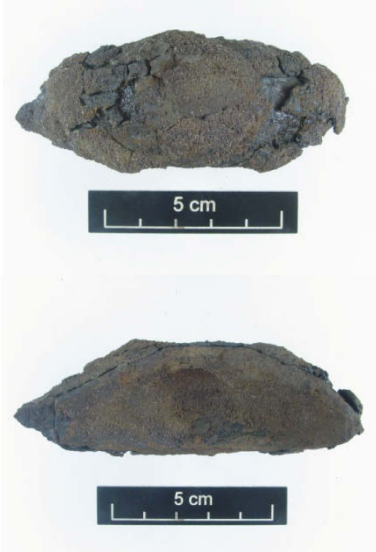
<p><b>SF3 (X8573)</b></p> <p>Sand and silt covers the surface of the object over a layer of concretion. Various fragments of concretion sit loose in the finds bag. Cracks run along the remaining concretions on the object. Some areas of the metallic surface are exposed.</p> <p>Treatment: Loose soil was removed with a stiff bristle brush to allow access to the cracks. Cracks and fragile areas were consolidated with 10% w/v Paraloid B72 in acetone applied with a brush. Large loose fragments from the finds bag were reattached if the correct position could be ascertained. Once dry excess Paraloid on the surface was removed using a scalpel under the microscope. After consolidation the larger clumps of soil on the interior were removed with the air abrasive with air only.</p>

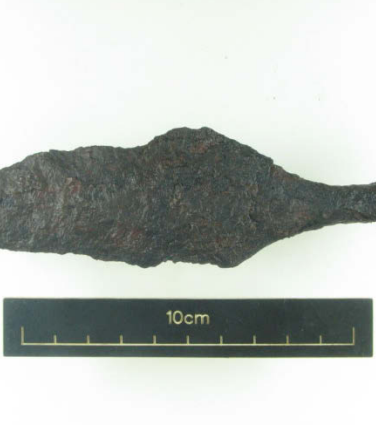
<p><b>SF4 (X8574)</b></p> <p>Sand and silt sit in the shaft of the object. The surface is dark and shiny indicating the object has been cleaned and a coating applied. Patchy areas of concretion cover the surface with small areas of active corrosion visible in places.</p> <p>Treatment: The coating was removed using the air abrasive with 29 micron aluminium oxide powder. Cracks and fragile areas were consolidated with 10% w/v Paraloid B72 in acetone applied with a brush. Once dry excess Paraloid on the surface was removed using a scalpel under the microscope. The entire surface of the object was coated with 10% w/v tannic acid in 50:50 Industrial Methylated Spirits (IMS) and reverse osmosis water applied with a paint brush after which Renaissance™ micro-crystalline wax was buffed over the surface with a brush.</p>

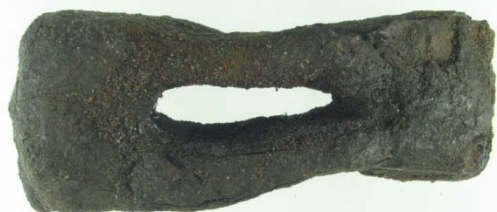
**SF7 (X8574)**

Sand and silt covers a thin layer of concretion which sits on the surface of the object. The surface is dark and shiny indicating the object has been cleaned and a coating applied. Cracks are visible throughout the concretion with a small area missing revealing the metallic layer underneath.

Treatment: The coating and selective areas of concretion was removed using the air abrasive with 29 micron aluminium oxide powder to allow full access to the cracks. Large flakes were quickly removed. Cracks and fragile areas were consolidated with 10% w/v Paraloid B72 in acetone applied with a brush. As many large flakes as possible were reattached to the surface of the object. Once dry excess Paraloid on the surface was removed using a scalpel under the microscope.
