**PITSLIGO CASTLE**  
**ROSEHEARTY**  
**ABERDEENSHIRE**  
**-TEST PITS-**

**- Excavation and Recording of Test Pits -**  
April 2010

by  
**Murray Archaeological Services Ltd**

**Report No: MAS 2010-09**

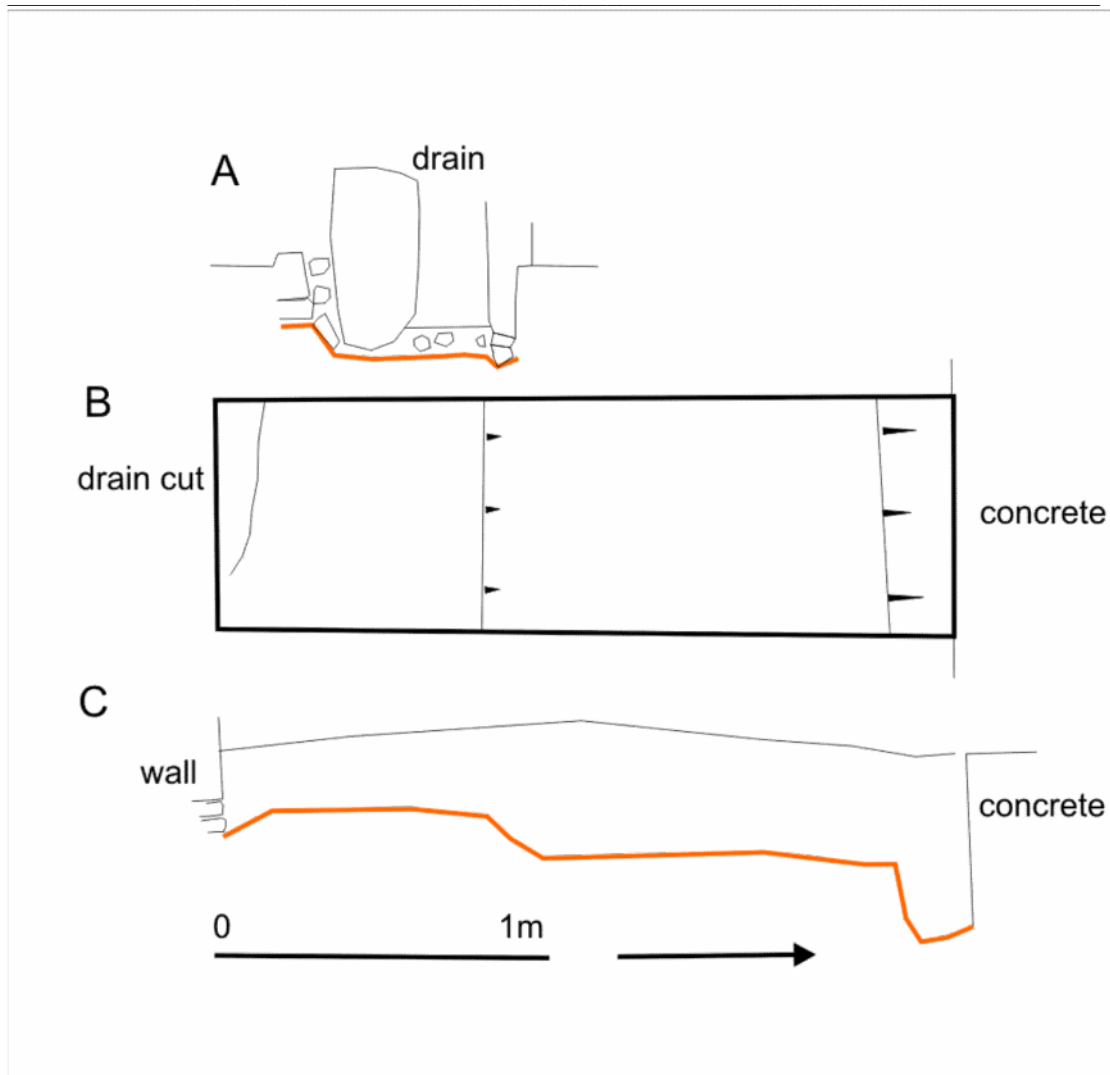
*Results:* The main wall extended only 180mm below the present surface and was built directly on natural, the drain outlet extended to 280mm below the present surface, being cut c 100mm into the natural – this cut had been made to accommodate the side stones of the drain and only extended c 100 mm away from the face of the wall. The drain itself was partially blocked with rubble and silt.

400mm away from the wall face the natural appeared to have been cut down c 100mm. At the N end of the test pit there was a machine cut 500mm deep dug to insert the concrete base of the buttresses. The concrete was c 400mm to the base, with a slight additional depth where the concrete had extended under the shuttering when it was poured. The machine cut had been backfilled with rubble and topsoil.

Illus 2 TP 1 A: Elevation of drain/wall, B: plan, C: W section (orange = natural)

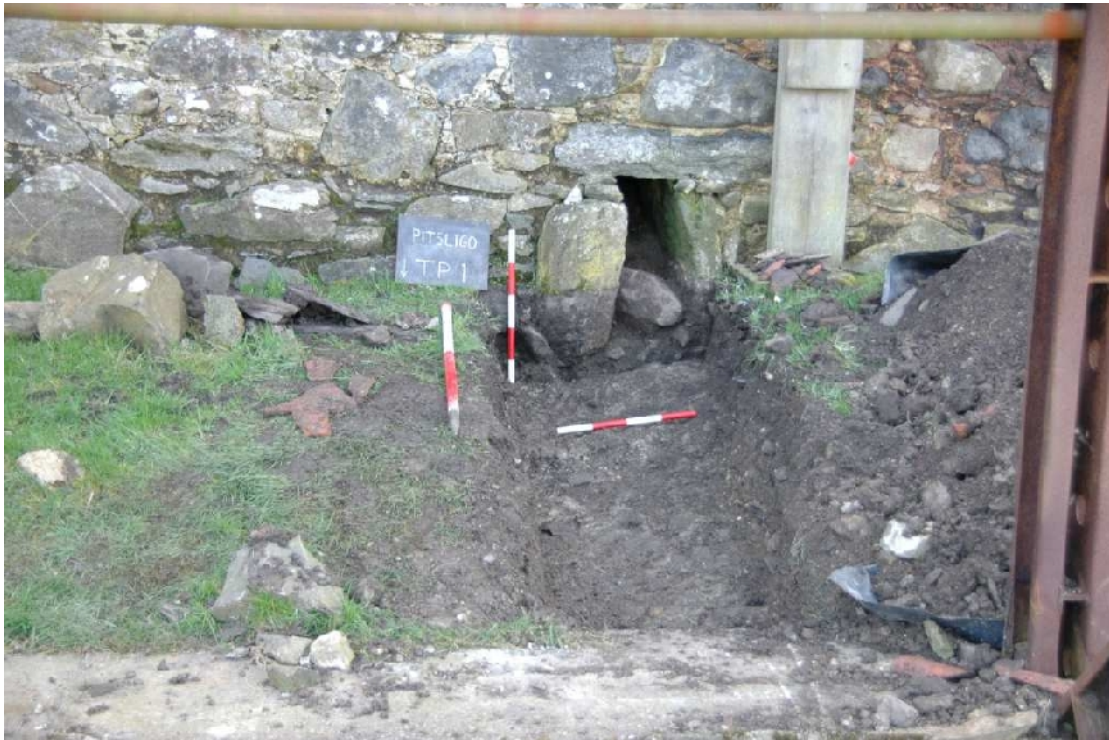
Illus 4 TP 1 looking S

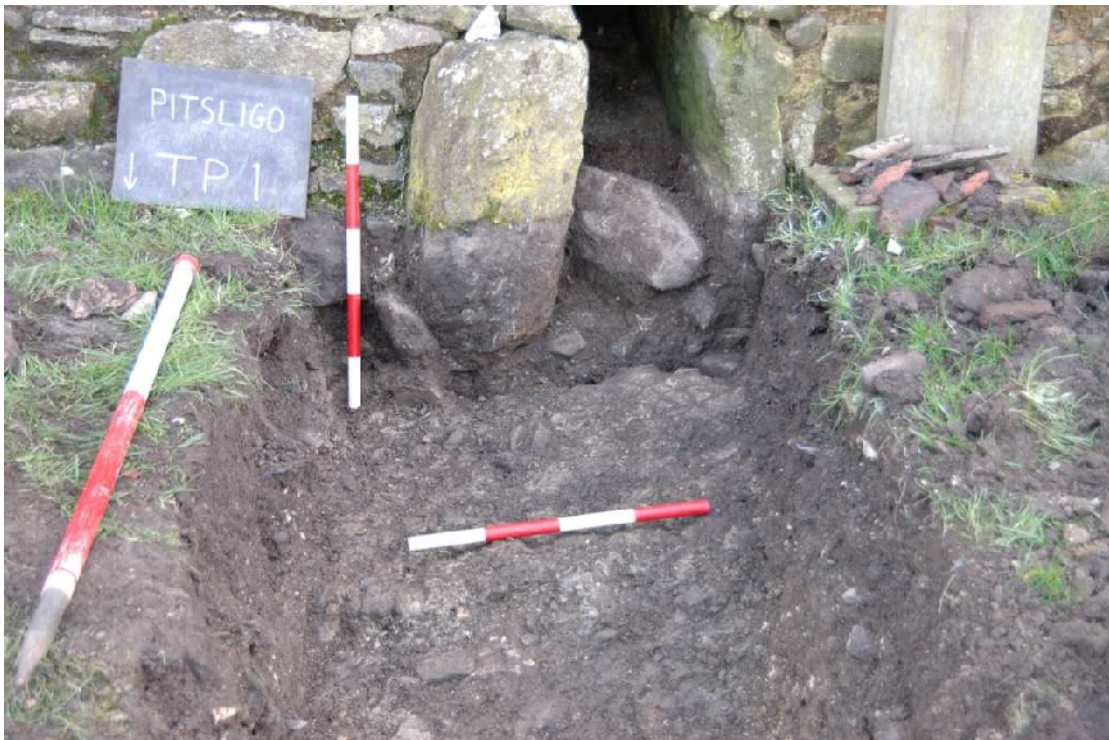
Illus 5 TP 1 detail of wall base and drain

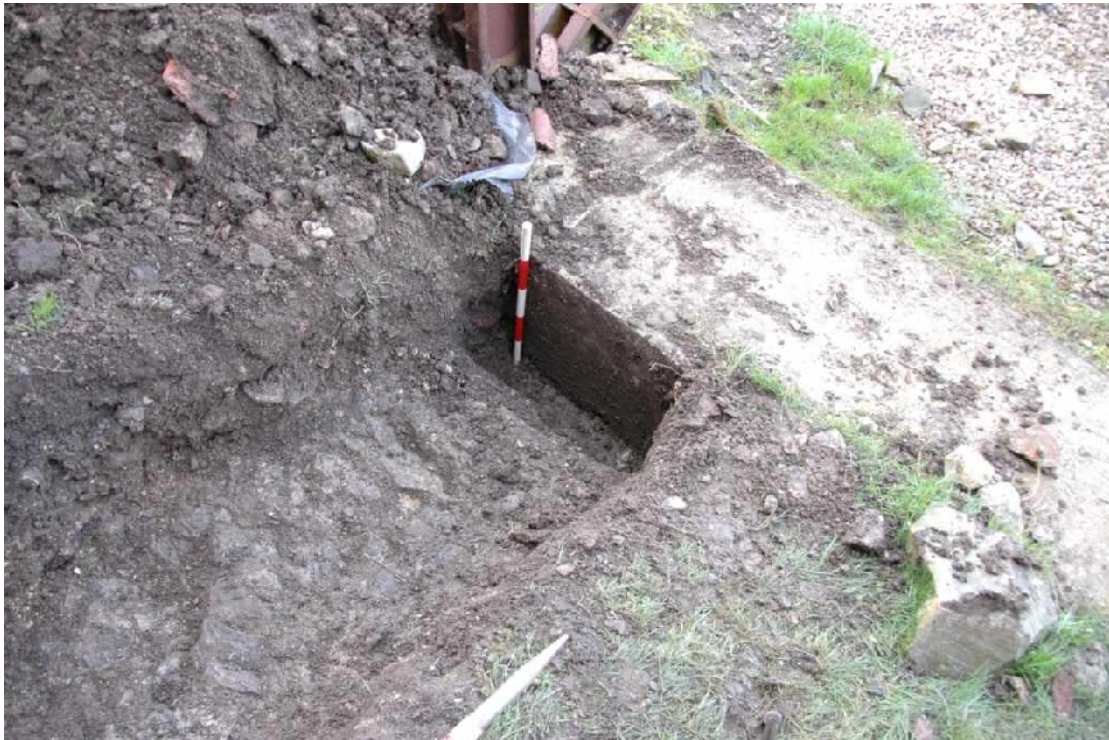
**Illus 6 TP 1 detail of buttress base**

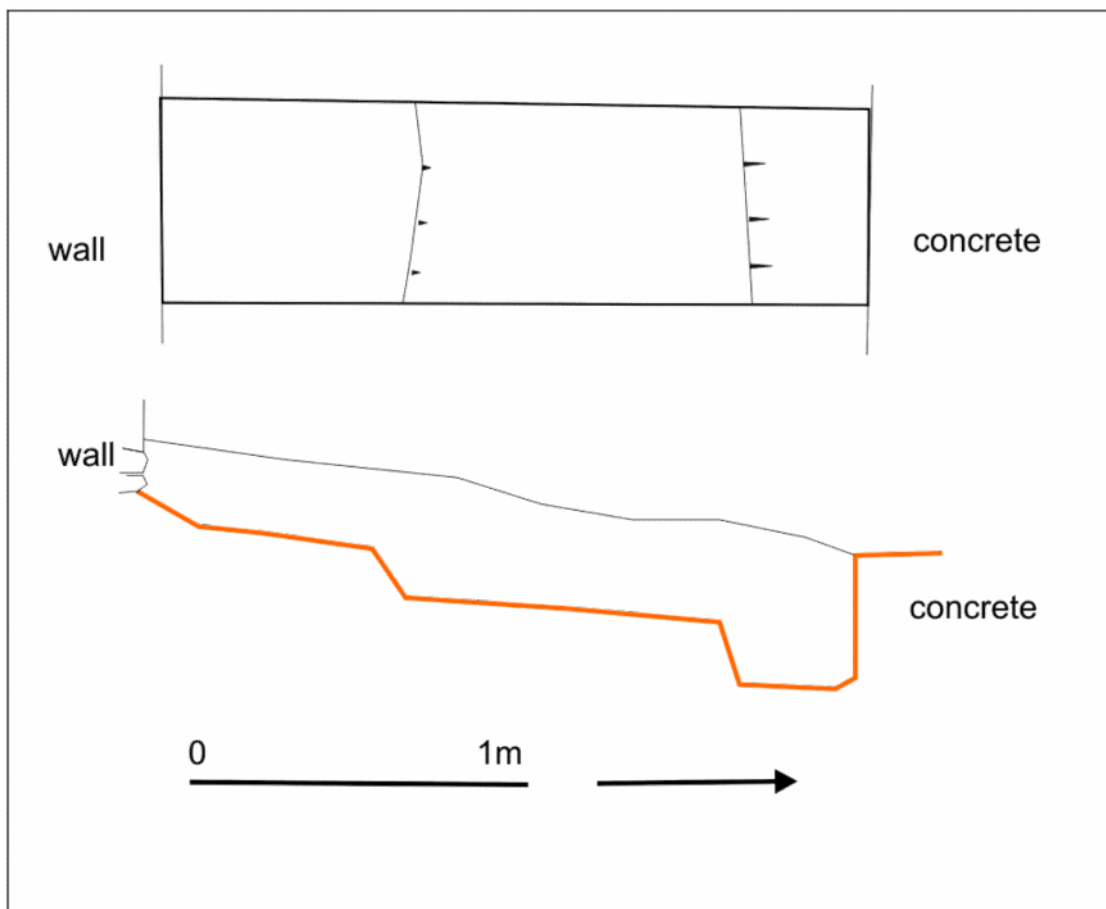
*Results:* The main wall extended only 160mm below the present surface and was built directly on natural with some crushed stone and mortar (construction surface) below the base stones. The drain outlet extended to c 300mm below the present surface, being cut c 150mm into the natural – this cut, made to accommodate the side stones of the drain, did not extend away from the face of the wall. The drain itself was partially blocked with rubble and silt – as this rubble was loose it was not cut right back to the wall face.

400mm away from the wall face the natural appeared to have been cut down c 200mm. At the N end of the test pit there was a machine cut 450-500mm deep dug to insert the concrete base of the buttresses. The concrete was c 400mm to the base, with a slight additional depth where the concrete had extended under the shuttering when it

Illus 7 TP 2 Plan and W elevation (orange = natural)

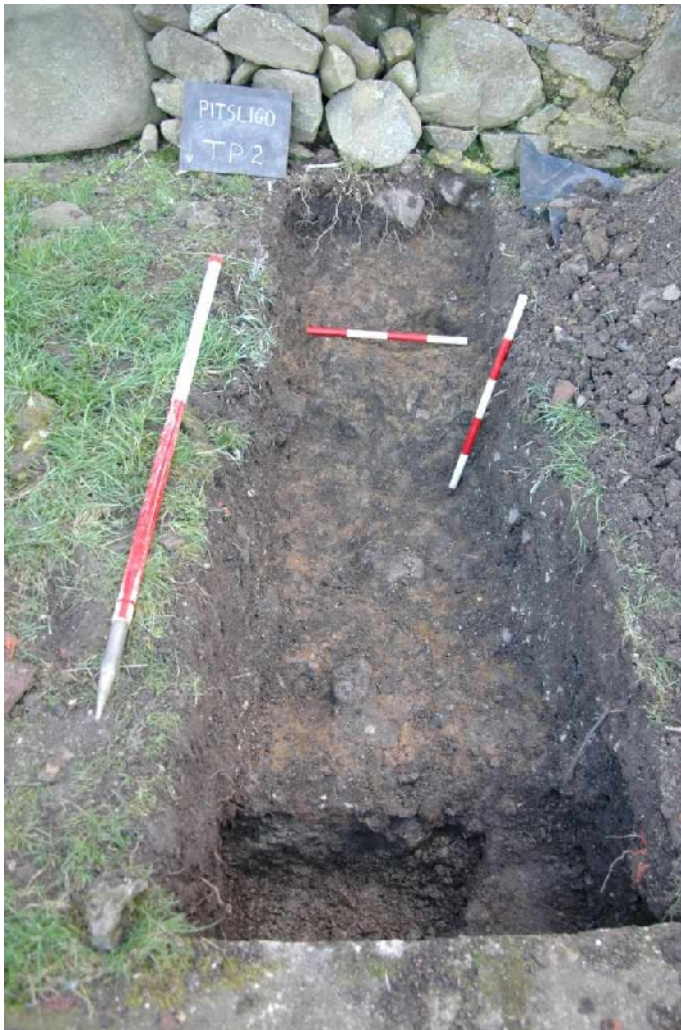
**Illus 9 TP 2 looking S**

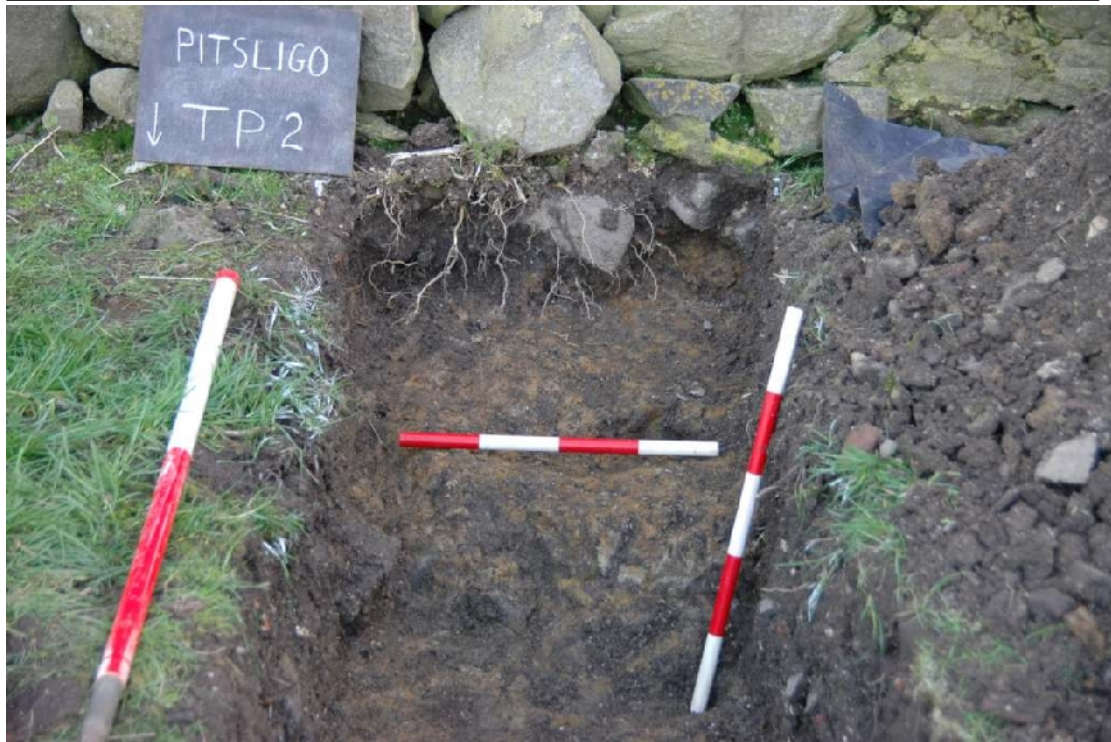
**Illus 10 TP 2 detail of wall base**

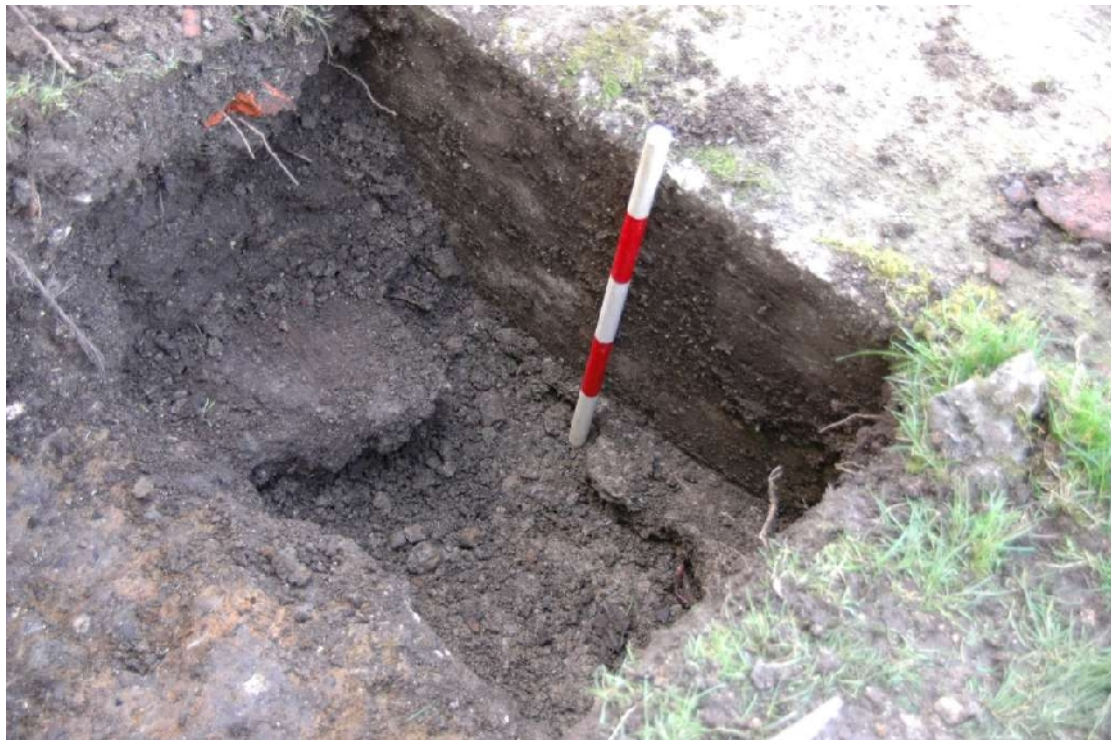
**Illus 11 TP 2 detail of buttress base**

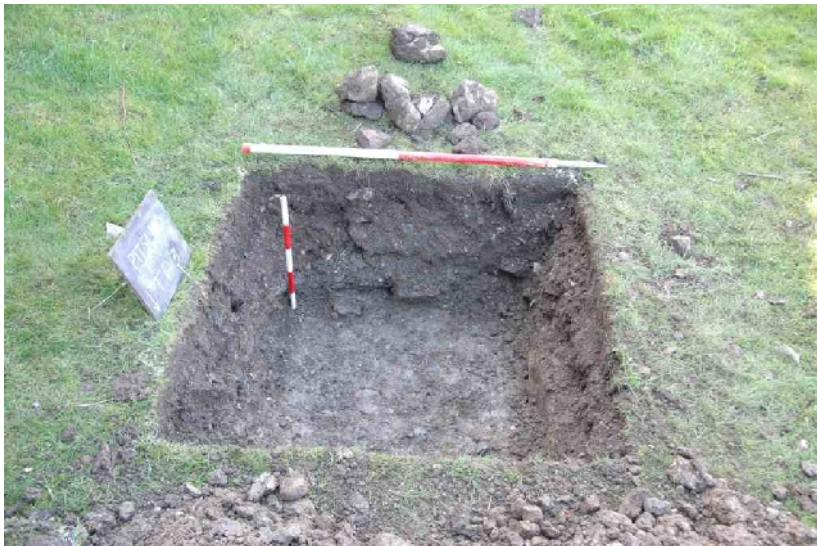
*Results:* Rubble on to natural.

*Soil profile:* 480-500mm of very stoney rubble, mortar and slate directly down to the top of natural. In this test pit natural was compact yellow boulder clay.

**Illus 13 TP 3 detail**

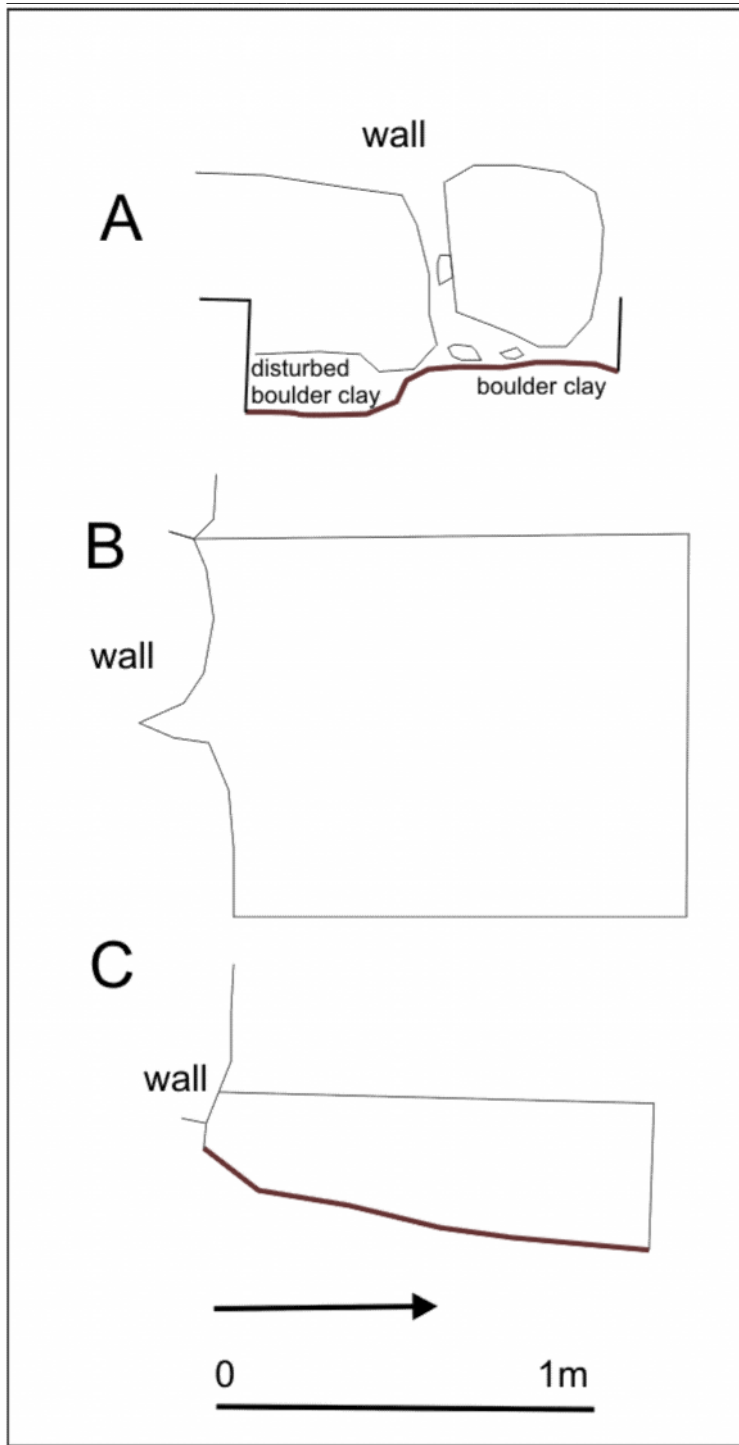
*Results:* Two of the wall foundation course boulders were exposed, they extended 100-150mm below the present surface. The gap between the boulders was packed with small filler stones. The W foundation boulder was directly on natural boulder clay. The front (N) face of the E boulder was on 100-120mm of disturbed boulder clay with some mortar fragments – this is likely to be the construction surface. It merged into undisturbed natural boulder clay.

Illus 14 TP 4 A: elevation wall, B: plan, C: W section (brown=natural)

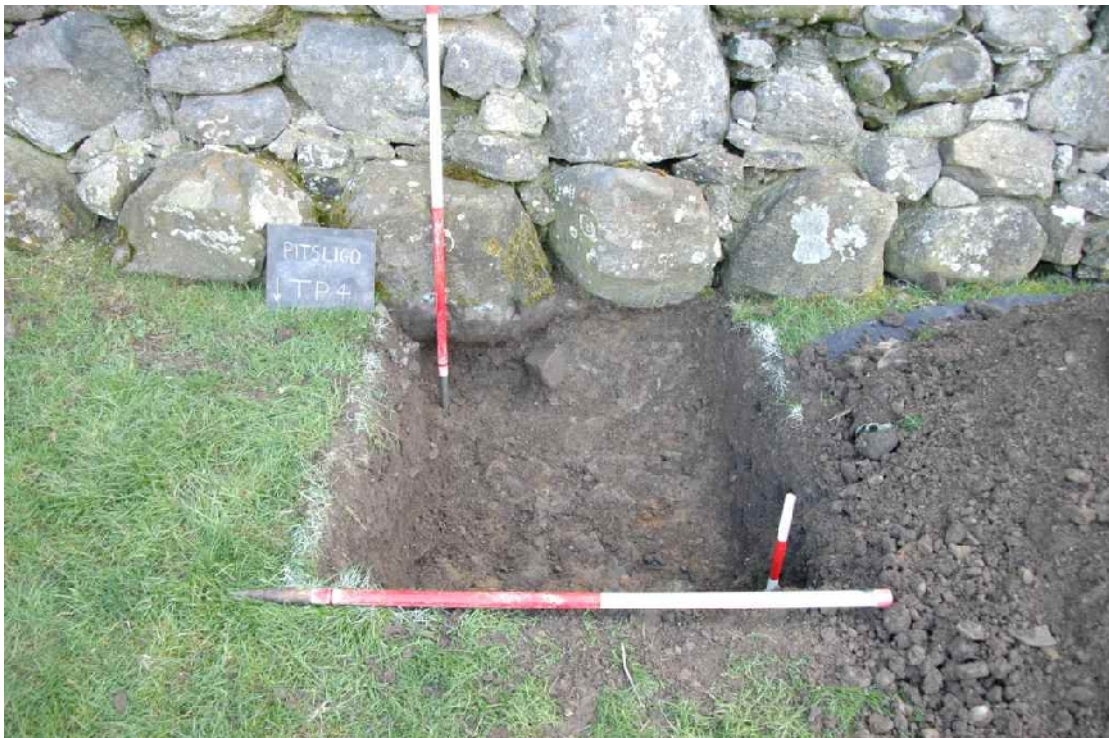
**Illus 16 TP 4 looking S**

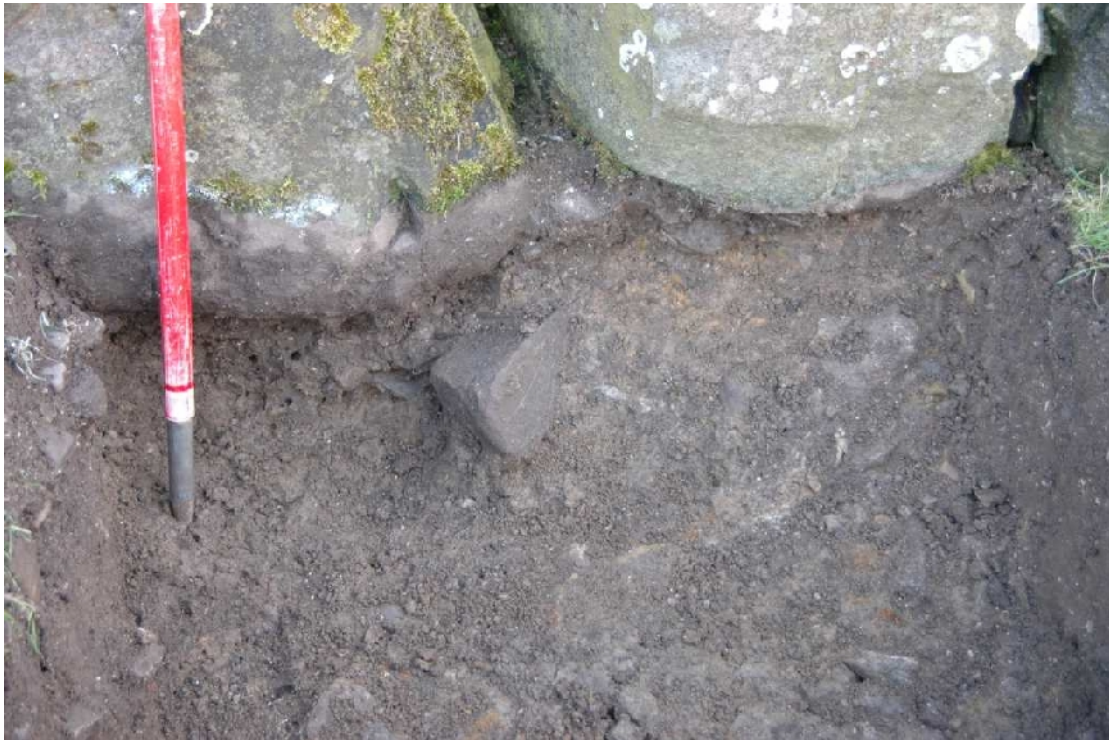
**Illus 17 TP 4 detail of wall base**

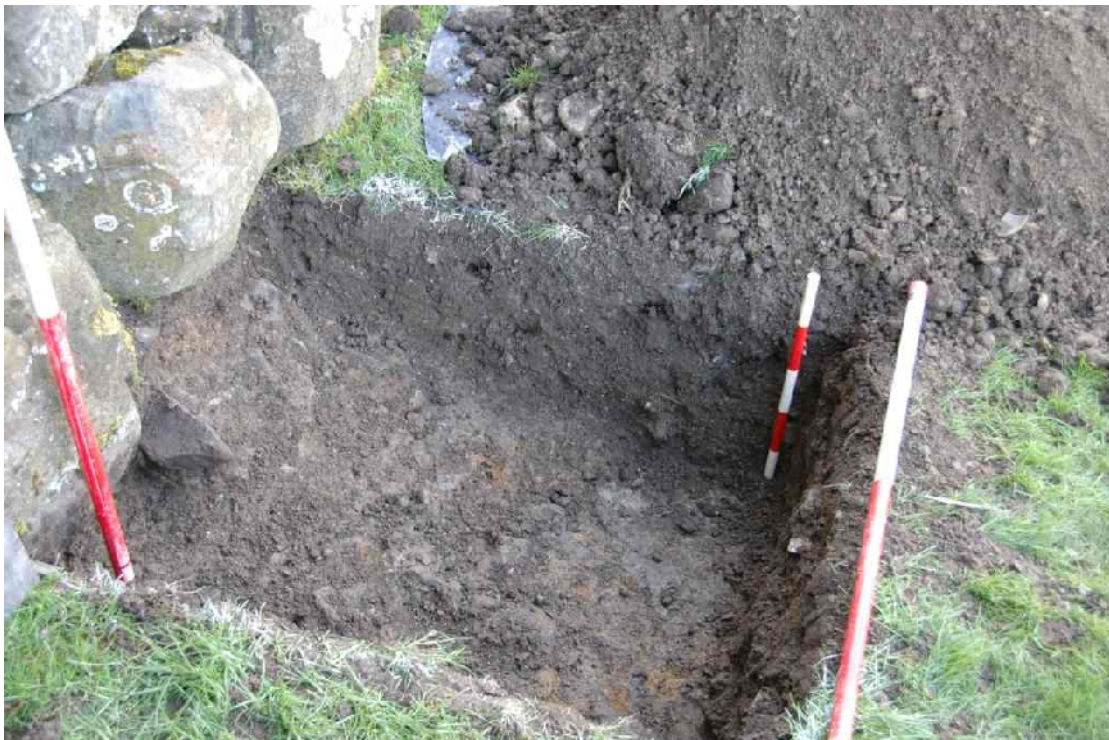
**Illus 18 TP 4 W section**

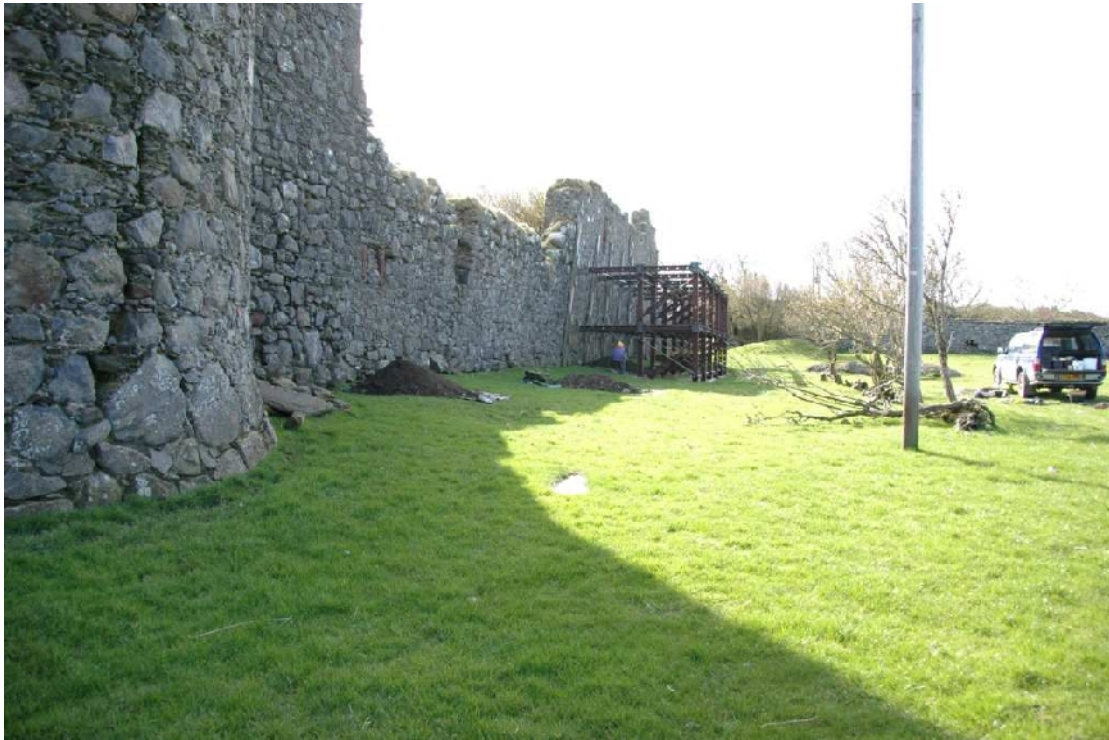
**Illus 19 Looking W along N wall N range, TPs 4 and 3 in foreground**

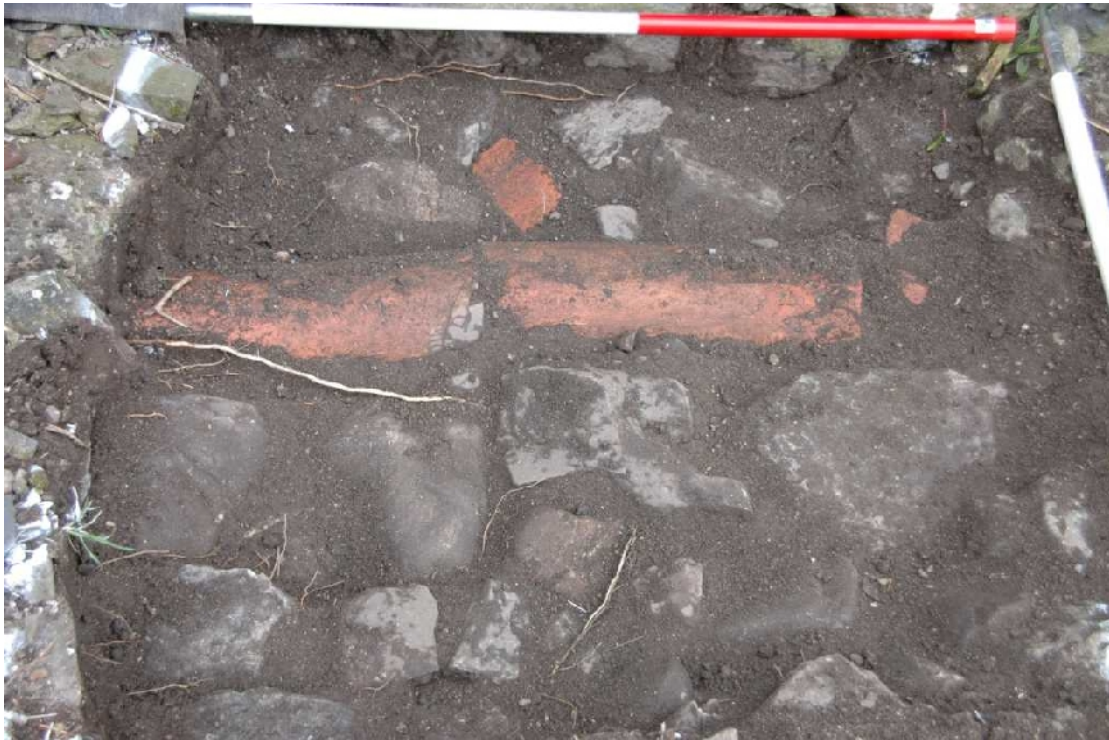
When this upper surface was removed, two sections of 6" clay drain were exposed running E-W. Below these were carefully set overlapping clay pantiles which possibly

**Illus 21 TP 5 clay drain**

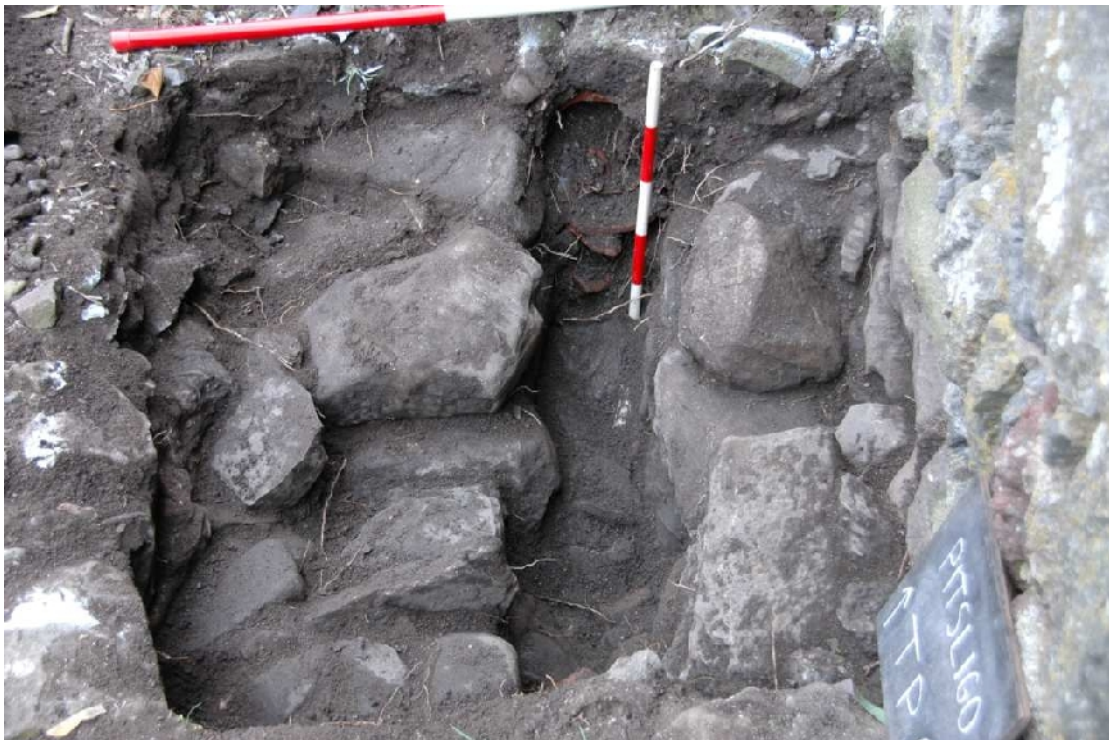
formed an earlier drain base. These were all set within an earlier stone drain. The stone drain which was 200-240mm wide internally was well built with up to 3 courses of mortared stone surviving to 400mm depth. It ran below the line of the larger stones noted in the yard surface which appear to have been the original capstones. Within TP 5 these had been partially removed when the clay pipes were put in. However, TP 5 was extended by 350mm to the E to test that the drain ran below the very large threshold stone of the guest chamber doorway. It is worth noting that the capstone next to the threshold runs below the S wall of the N range, indicating that the construction of the stone drain almost certainly pre-dates the construction of the N range accommodation- although possibly only as different stages in the building process.

**Illus 22 TP 5 stone drain looking W**

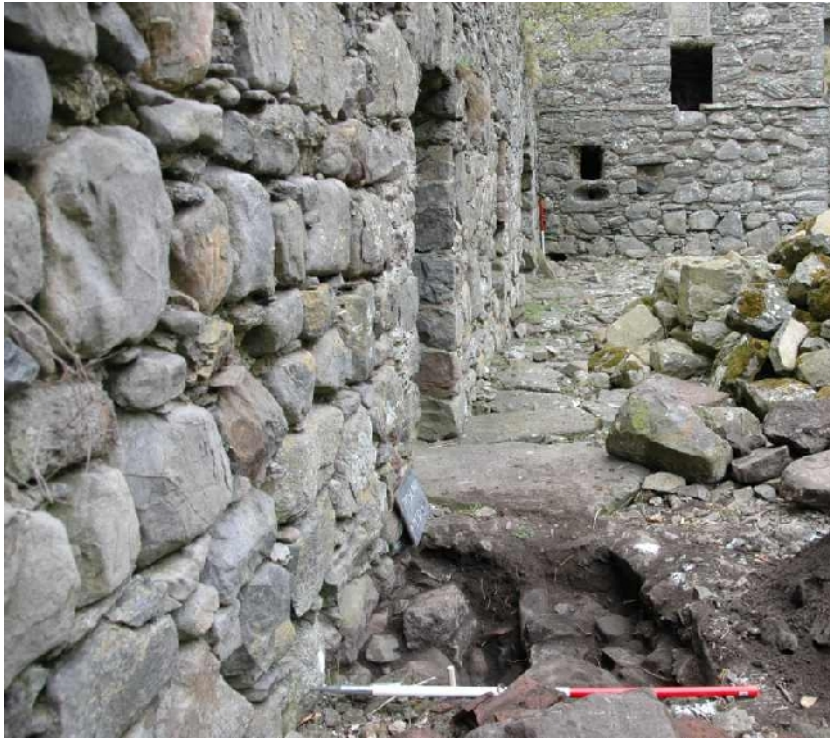
The stone drain in TP 5 appears to run along the S side of the S wall of the N range below a series of large capstones. At least one of the capstones runs below the range

**Illus 23 TP 5 stone drain looking E showing capstones extending to drain outlet from stair tower**

It would be worth planning the original drainage system indicated by the capstones- and attempting to see if this drain linked to the outflows in each of the guest chambers (as seen in the N wall of the N range in TPs 1 and 2).

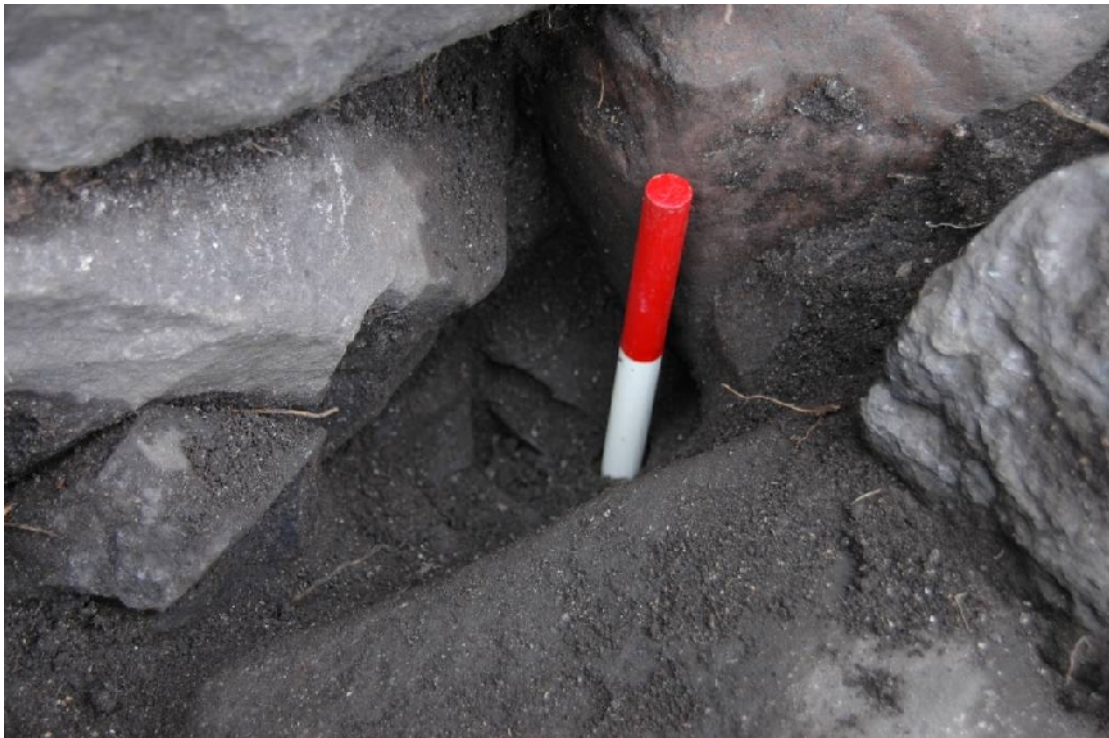
The base of the drain was cut to natural boulder clay so it appears probable that this also underlies the N range S wall. However this was difficult to test as the N wall of the drain and the S side of the N range S wall had a gap of only 10-50mm between them. This gap was packed with small angular stones so it was decided to remove some of these to look at the N range wall without moving or damaging the drain wall which would possibly weaken the base of the range wall. This showed that the S wall of the N range at this point extends 1 ½ courses (c 400mm) below the present yard (and threshold) level. At the base of the lowest course there appeared to be some small angular stones- these may be on the natural but this could not be established without damage to the wall. Natural boulder clay at the base of the drain is c 500mm below the top of the threshold (although the base of the drain may have been slightly cut in or eroded).

**Illus 24 TP 5 showing detail of base of S wall of N range and infill between it and the N side of the stone drain**

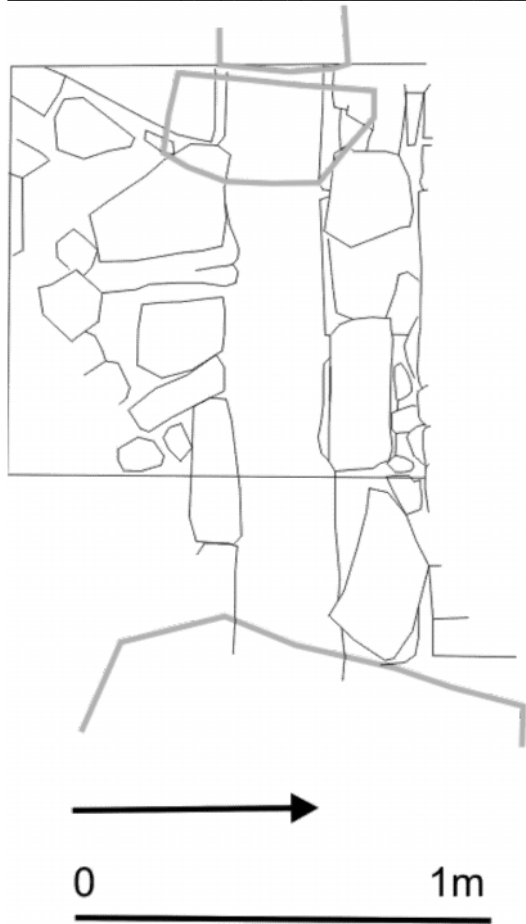
**Illus 25 TP 5, plan of stone drain with surviving capstones in thick grey (threshold to door of chamber at bottom of plan)**
