BARRA CASTLE OLDMELDRUM ABERDEENSHIRE

- Archaeological Watching Brief -
Carried out 19th September 2012
by
Murray Archaeological Services Ltd

Report No: MAS 2012-27
by
H K Murray & J C Murray

-Archaeological Watching Brief-

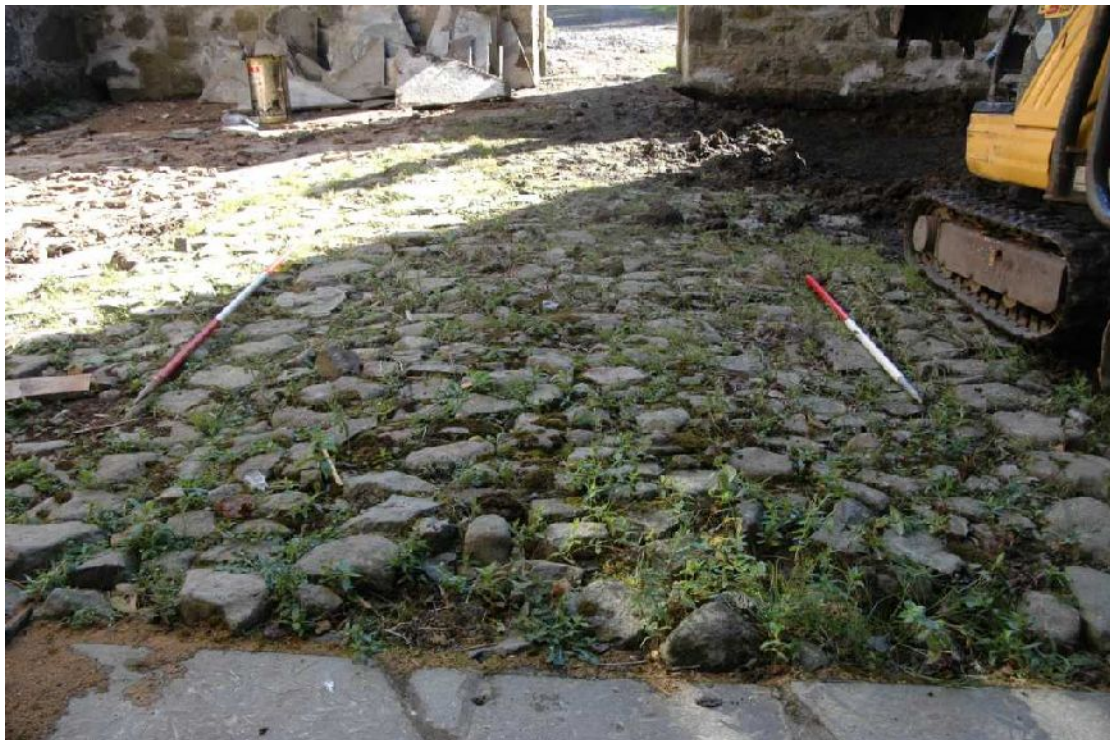
Illus 2 Courtyard looking E towards gate. Ranging rods indicate lines of larger cobbles leading to gate.

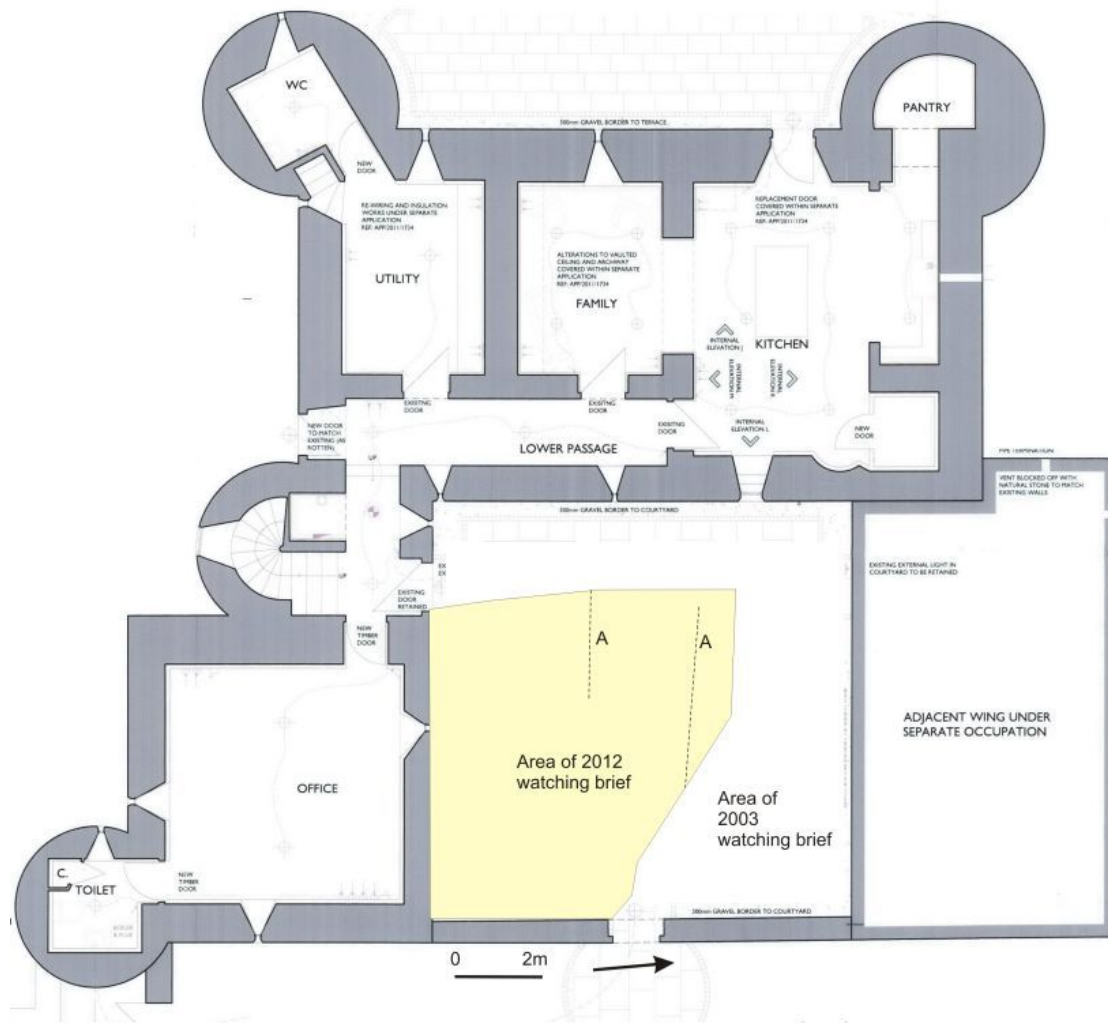
Illus 3 Plan of the castle and courtyard annotated to show area of watching brief. A,A = lines of larger stones in cobbles.

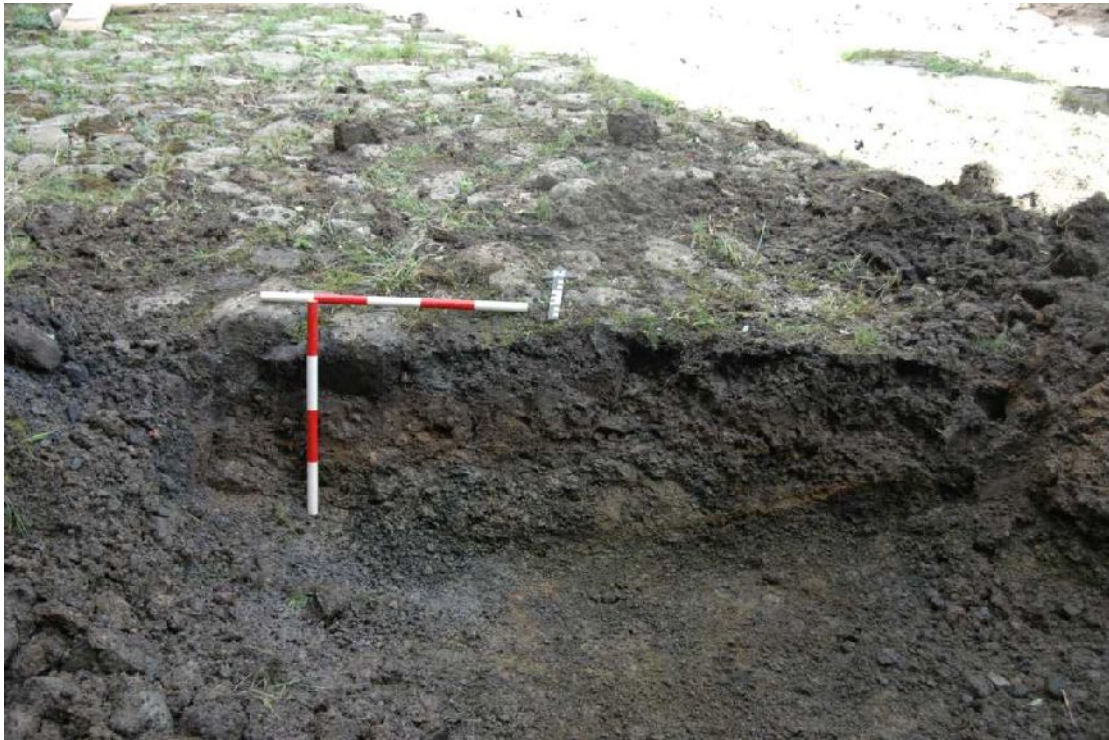
5.1 The cobbles had been set in a mixture of topsoil and redeposited natural clay. In the central area this lay to a depth of up to 500mm below the upper surface of the cobbles and extended directly onto an irregular surface of natural rock outcrop. At the S side of the courtyard there was only c. 180-200mm of topsoil and disturbed cobbles above the rock. The natural boulder clay which would normally be over and around the rock appeared to have been removed when the topsoil mix had been used to level the cobbles at the time they were set in the courtyard. The E wall of the courtyard was built on the natural rock with some boulder clay surviving over the rock beside the wall.

Illus 4 Section in central area showing topsoil/clay mix over natural rock below cobbles.

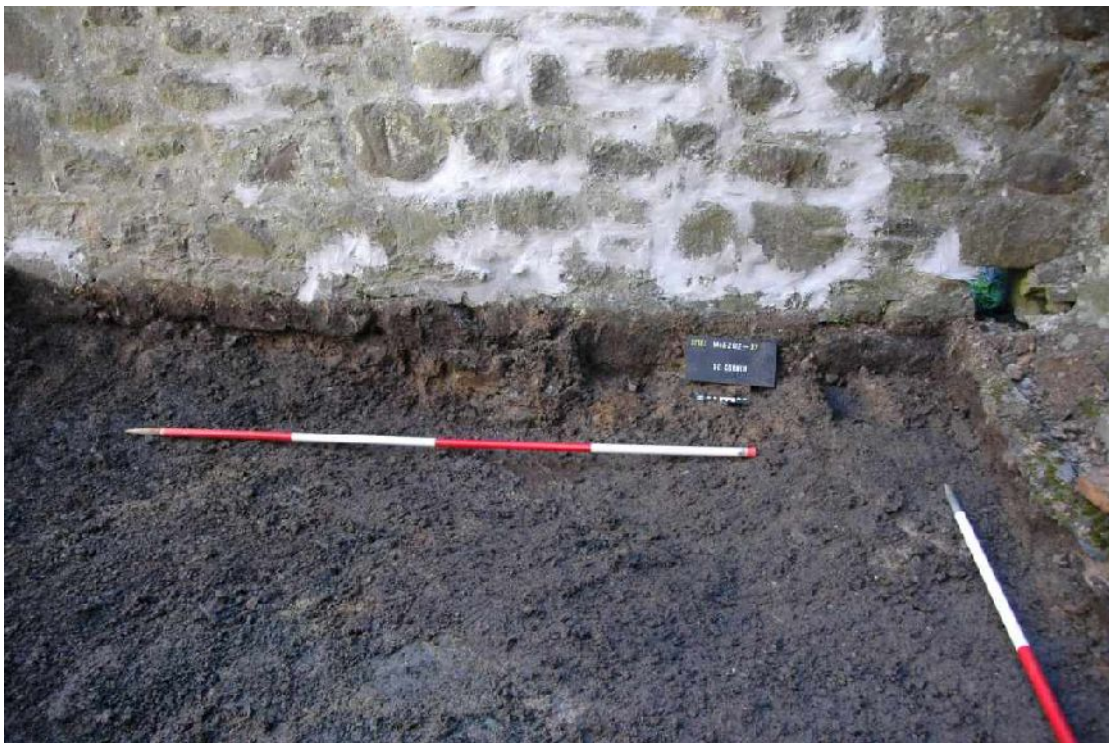
Illus 5 Detail of S end of inner side of E courtyard wall showing boulder clay surviving on natural rock beside wall.

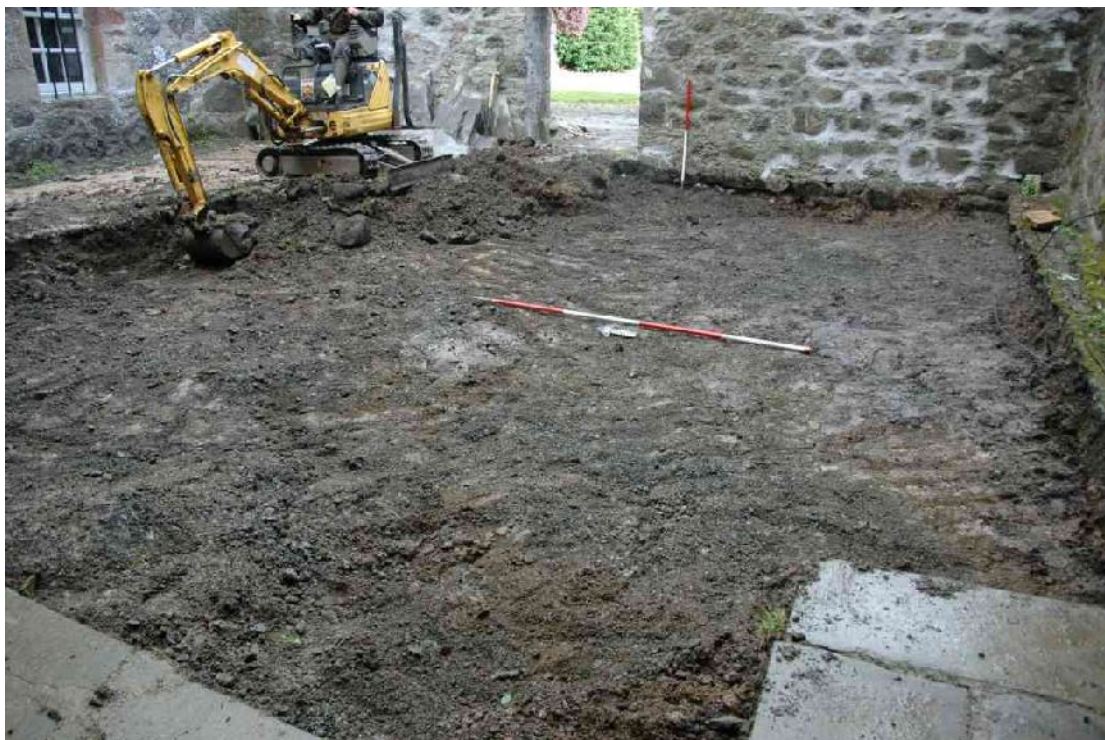
- 5.2 With the exception of two small undiagnostic pieces of clay tobacco pipe stem, there were no artefacts in the soil below the cobbles.
- 5.3 There was no evidence of earlier surviving features below the topsoil mix under the cobbles.

Illus 6 Courtyard from SW corner showing natural rock below the cobbles and leveling topsoil/clay mix.
