SEWER PIPE REPLACEMENT PITMEDDEN HOUSE ABERDEENSHIRE

- Archaeological Watching Brief -
Carried out 27th November 2012
by
Murray Archaeological Services Ltd

Report No: MAS 2012- 33
by
H K Murray

PITMEDDEN HOUSE ABERDEENSHIRE SEWER REPLACEMENT PIPE

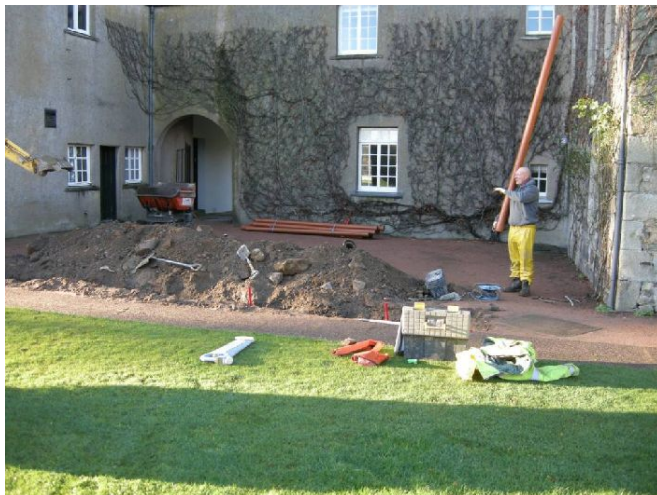
Illus 2 Location of trench across courtyard looking W

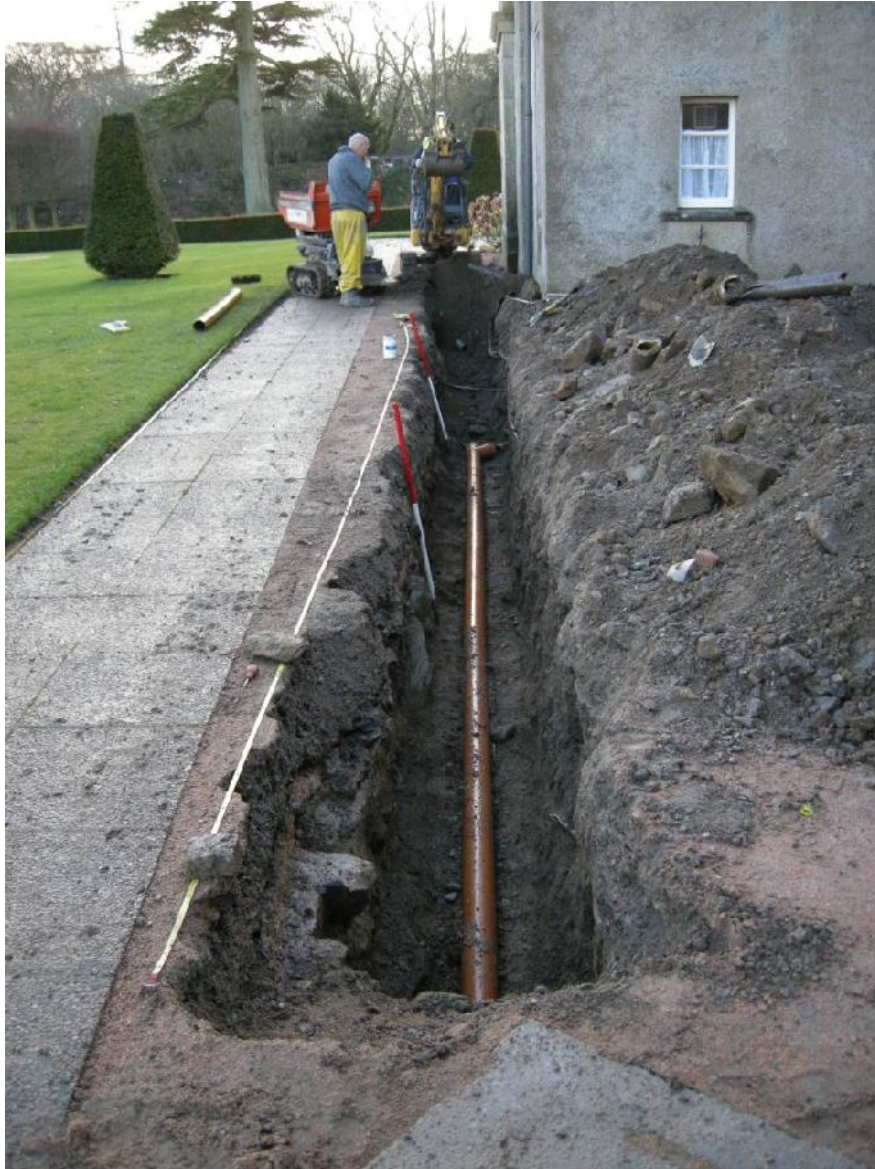
Illus 3 Looking S along trench

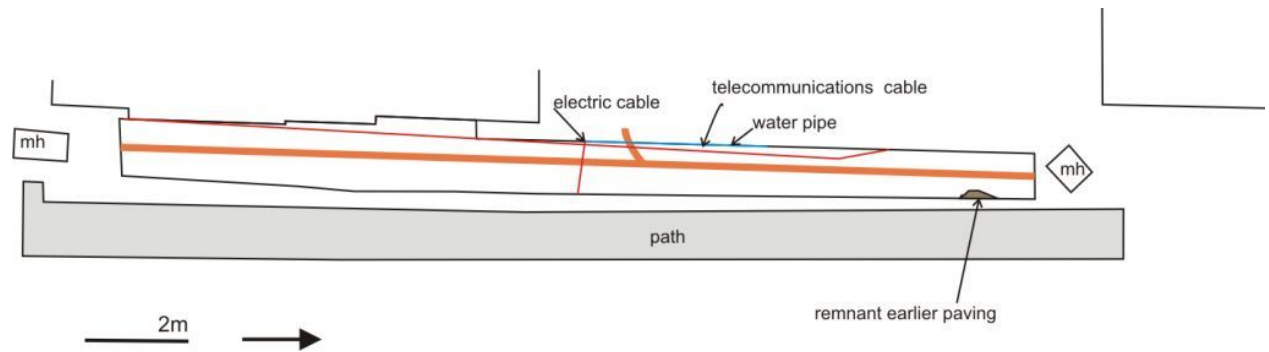
Illus 4 Plan of trench

Apart from the sewer pipe being replaced, a water pipe and electricity and telecommunications cables (as well as an old disused water pipe and a disused electricity cable) were identified (see plan Illus 4).

overlying natural appeared to be a levelling deposit of stony, gritty earth (2). This was noticeably free of any rubbish or obvious building debris and may even have been brought in from elsewhere. A short section of small, flat paving stones (rather than cobbles) at the N end of the trench appear to have been an earlier path or yard- probably post-dating the mid 19th century reconstruction (Illus 4; Illus 5: layer 4; Illus 6).

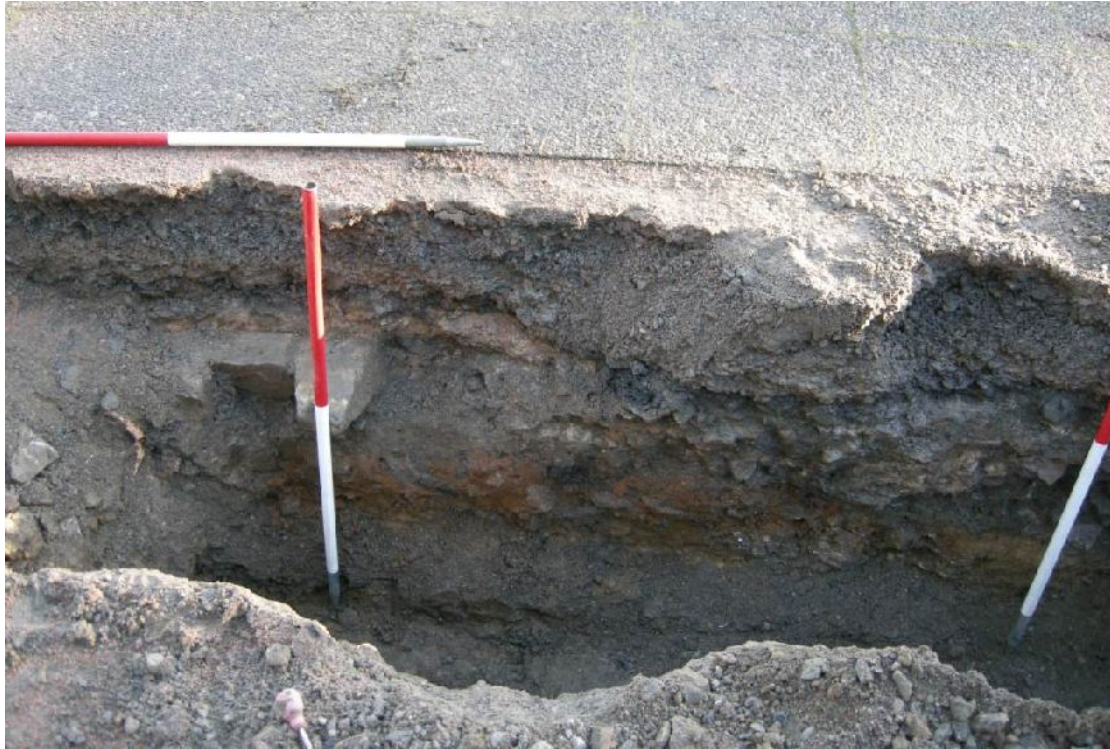
Illus 6 E face of N end of trench showing paving setts (Layer 4). Note orange = natural. The grey at base of trench is original backfill.

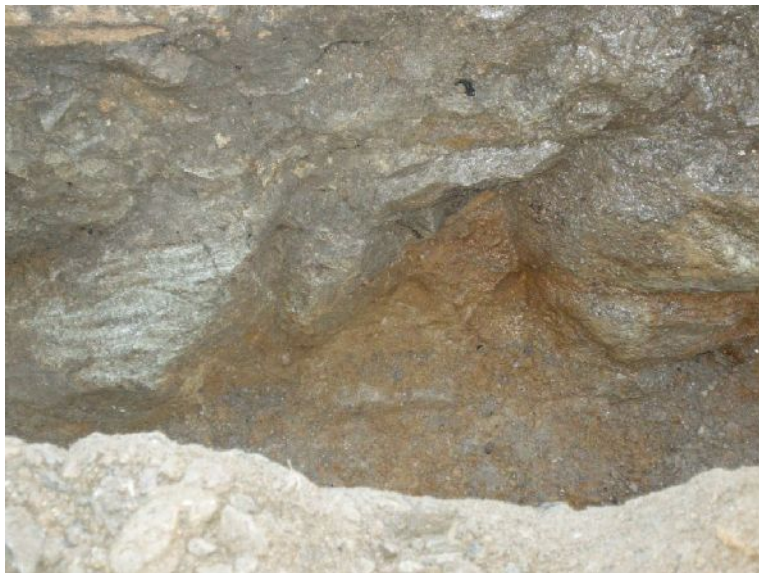
The natural comprises very hard compact bright yellow boulder clay with frequent large boulders in it. Some of these protruded above the top of the clay and gave the impression that the top of the natural may have been scarped.

Illus 7 Boulders in natural

In regard to any possible geophysical survey it is worth noting the large boulders in the natural boulder clay (Illus 5; Illus 7). It is also worth noting that the original drain trench had been backfilled with similar boulders clearly dug out of the trench. These were not replaced.
