# CRATHES CASTLE ABERDEENSHIRE DRAINAGE

**- Archaeological Watching Brief -**  
Carried out 24<sup>th</sup> July 2013  
by  
**Murray Archaeological Services Ltd**

**Report No: MAS 2013-23**

**CRATHES CASTLE  
ABERDEENSHIRE  
DRAINAGE  
-Archaeological Watching Brief-**

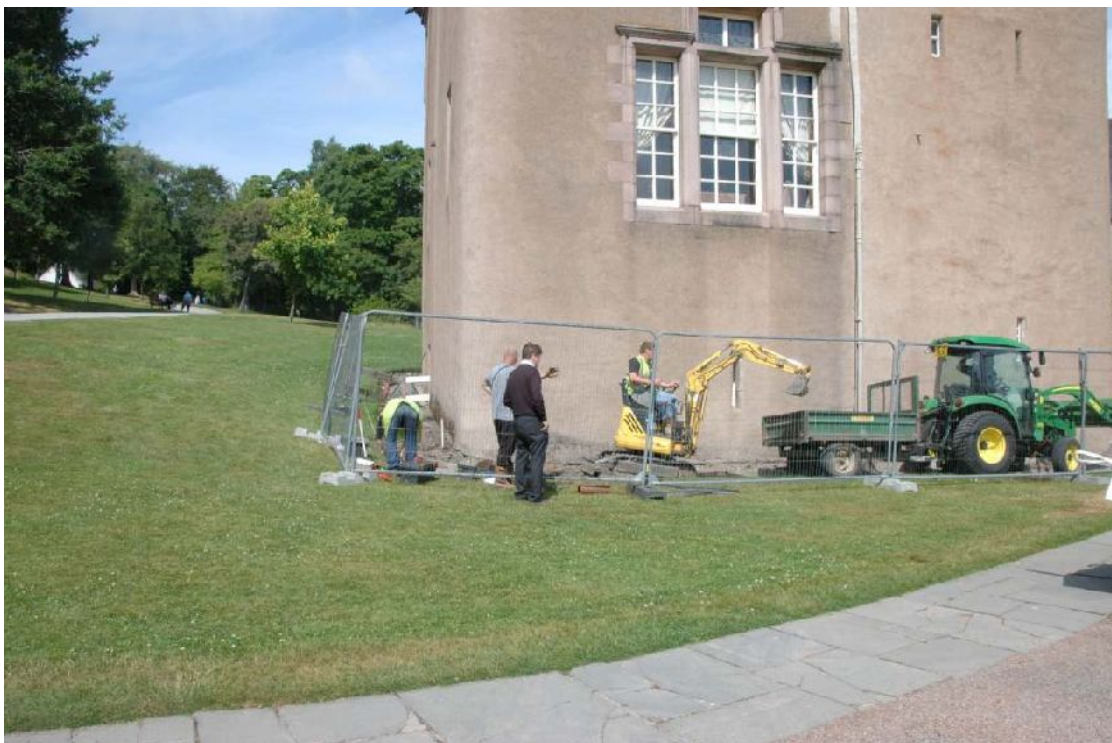
**Illus 1 SW corner of tower showing position of the works.**

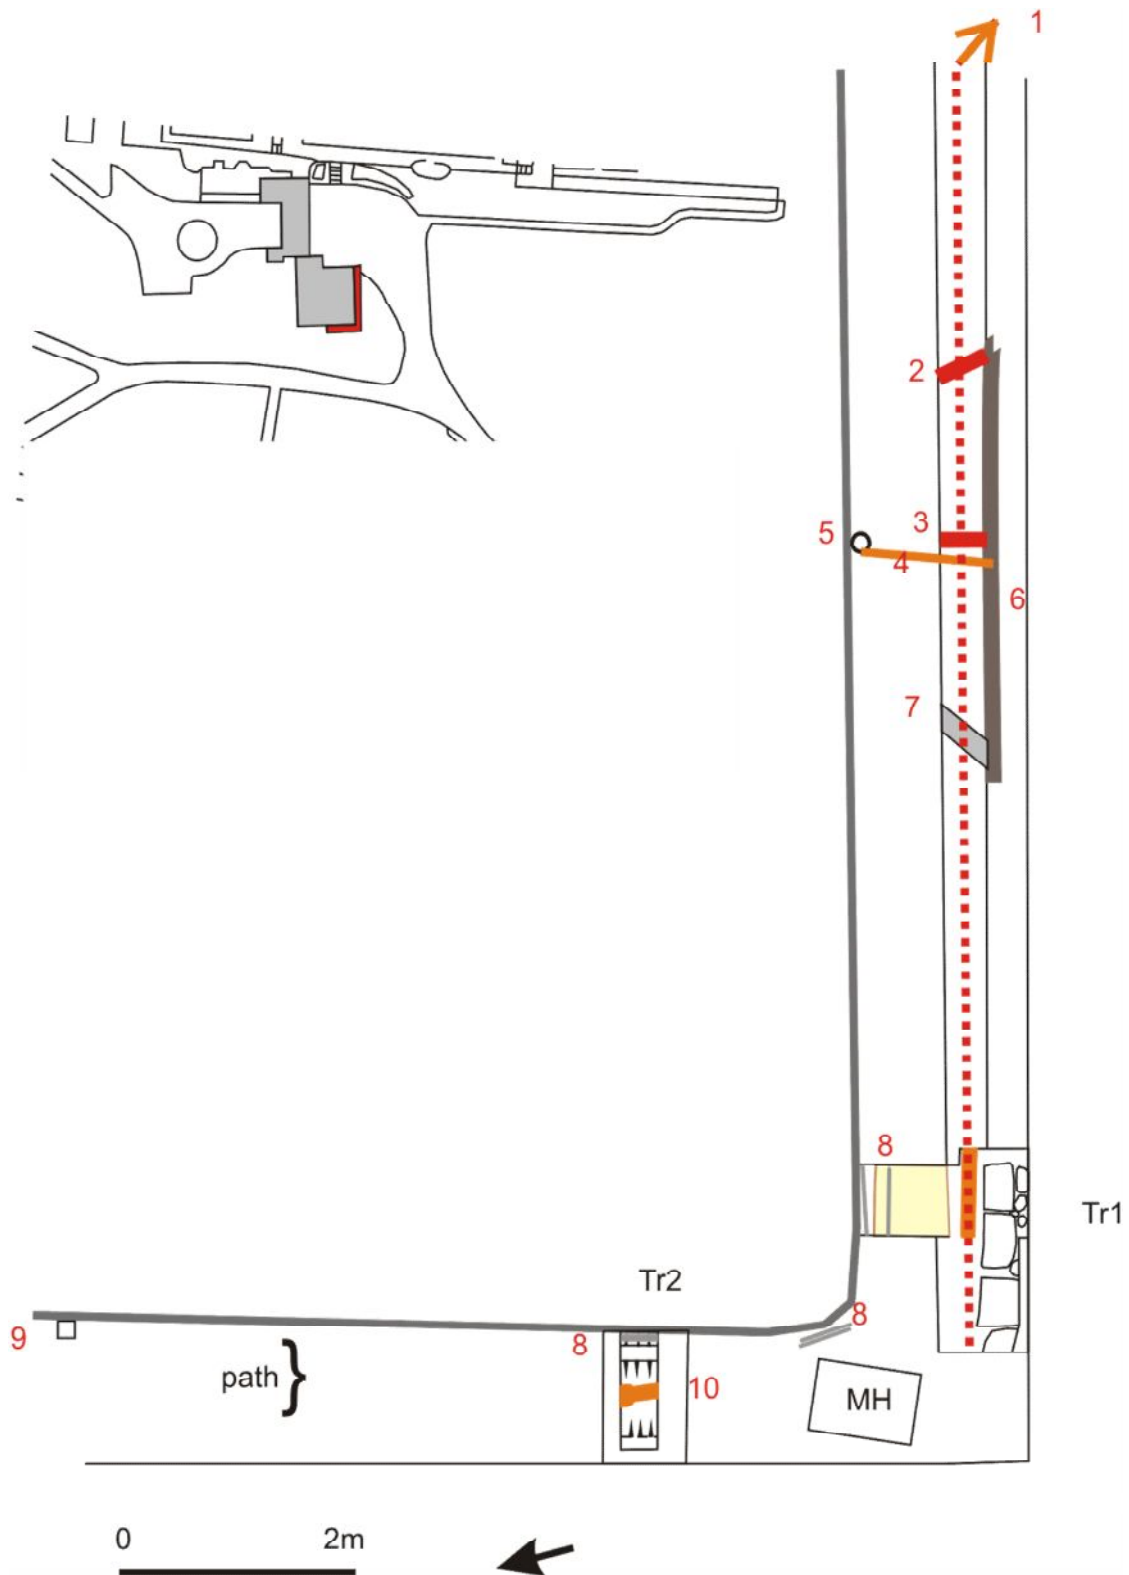
**Illus 2 Location of trenches and services. Details of numbering of services see below. Reproduced from Ordnance Survey digital map data, © Crown Copyright, All rights reserved. 2012. License No 100041040**

Trench 1 was initially cut N/S across the path to locate the sectional clay pipe drain. It revealed that the clay pipe had been put in the trench originally cut for the far deeper ceramic pipe (Illus 2:10). The pipe trench had been filled with gravel and archaeologically this was all disturbed ground. The old sectional clay pipe and its replacement drain only extended along the S façade as far W as the man hole (Illus 2: red dotted line).

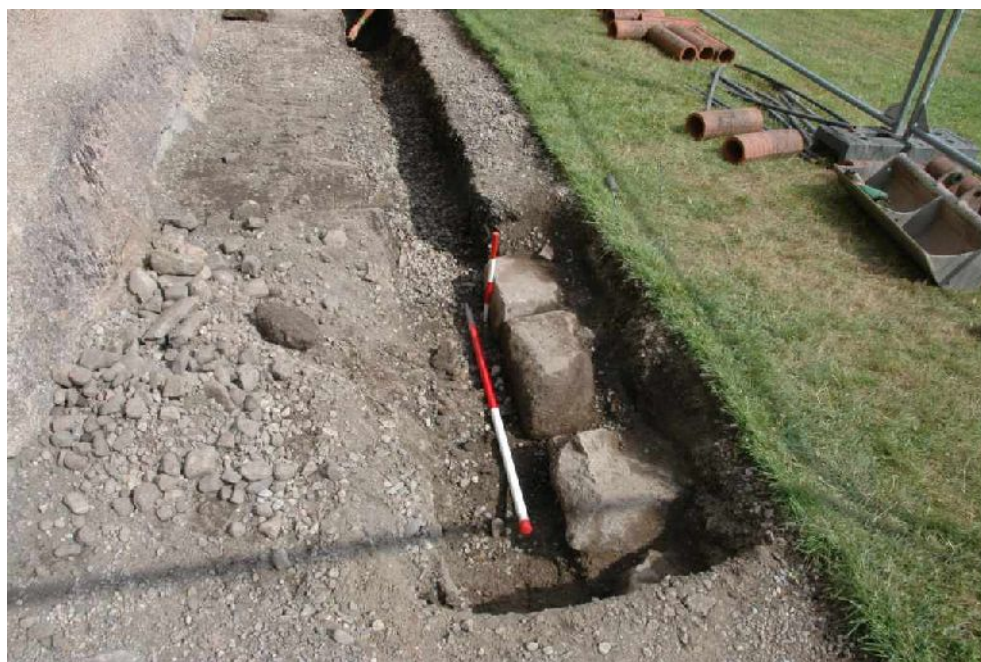
Four slabs (< 450 x 280mm) formed an E/W line c 1.70m long as revealed. It clearly did not extend to the E, but may have extended to the W. The N edge appeared straight (except for the W, possibly disturbed, stone), with far smaller stones set in on the S side. As the grass could not be cut back it is unclear if this (330mm) is the full width of the feature or if the smaller stones were infill between two wall faces. The upper surface of the stones was quite level and projected slightly above the level of the cobbled surface to the N and which was probably contemporary.

**Illus 3 Full extent of stone feature as revealed.**

The stones were only a maximum of 100-170mm in height and appeared to be set on a brown earth with mortar fragments, which also seemed to be between the stones. The stones were not however mortared together.

Whilst this feature pre-dates the cutting of the deep ceramic drain (? Early 20<sup>th</sup> C), there is no precise evidence to indicate its construction date.

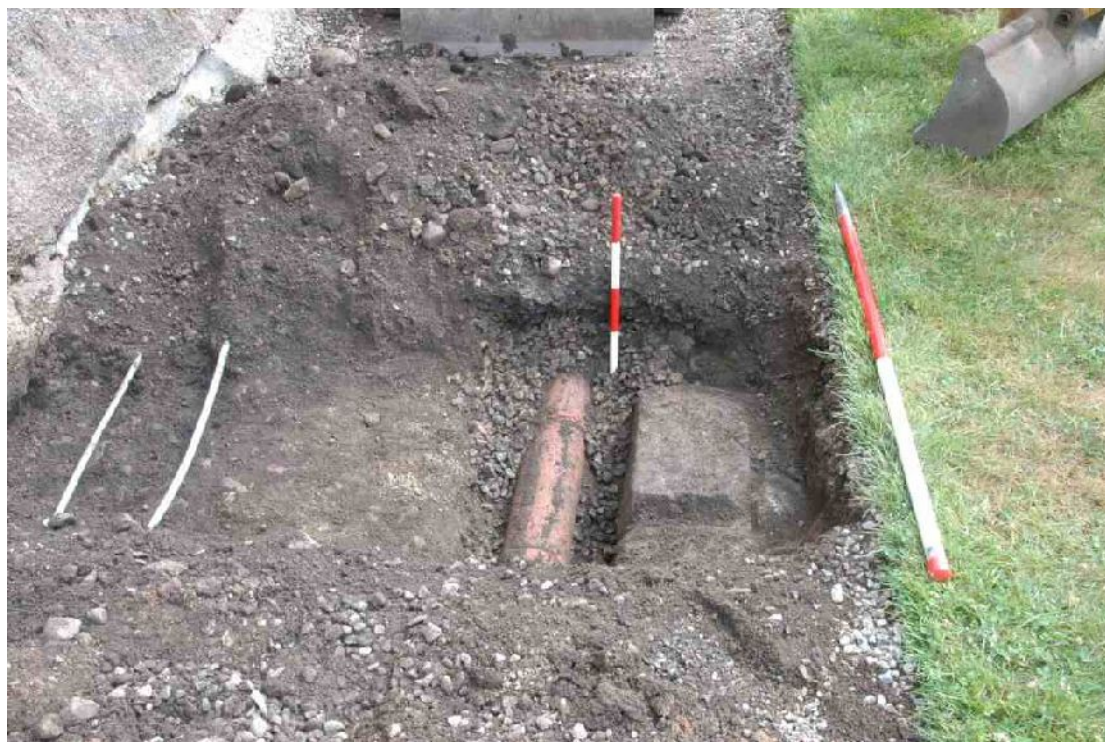
A layer of small water worn cobbles set in a yellow mortary base, with some angular stones in the make-up, was on a level with the stone feature. It was set on clean natural boulder clay. The top was very slightly below the level of the top of the stones and it appeared to have been an associated surface or path. It had been cut by the trench for the deep ceramic pipe (Illus 2:10). A layer of garden earth c 100mm deep lay over the cobbling, below the gravel of the present path. It contained some midden material (see Finds below).

**Illus 4 Trench 1 as first excavated showing stone feature (RHS) and the cobbled surface (to LHS of pipe cut).**

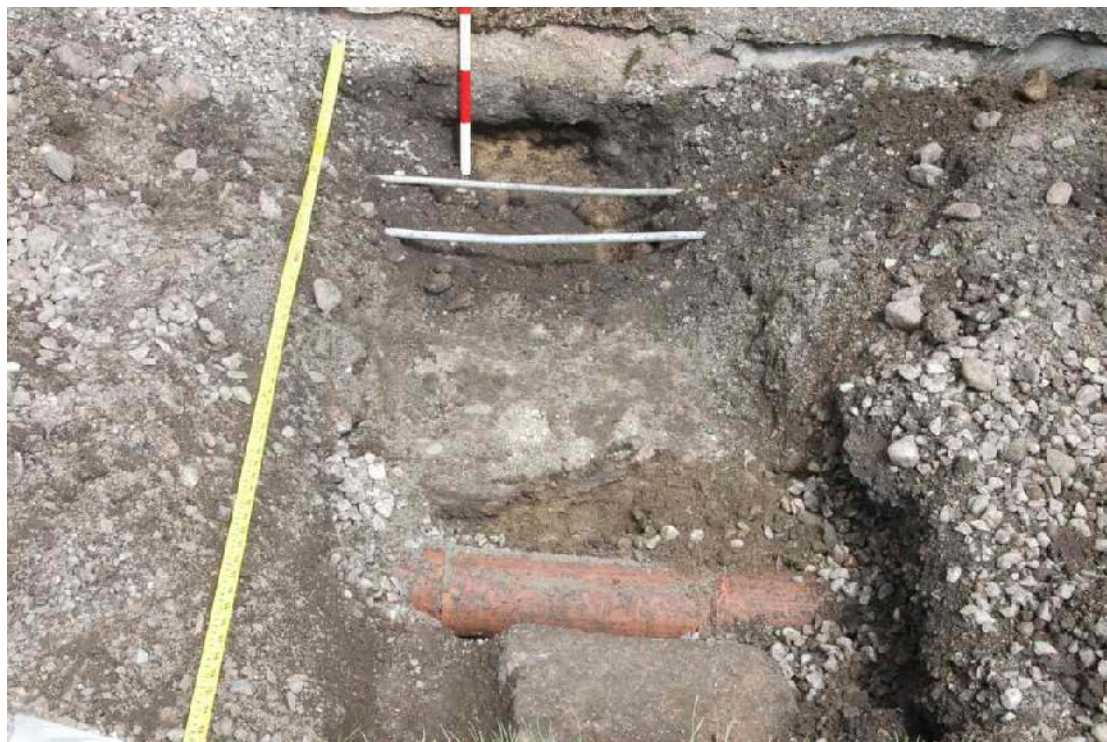
In Trench 1, the base of the tower wall appeared to be on a level with the existing path, set on clean natural boulder clay. This was probed and a small section excavated

back by 100mm but no lower stone foundations were found. This appears odd as it is in variance with the foundations revealed in Trench 2.

**Illus 5 Detail of base of tower wall in Tr 1**

- Castle foundation. While the difference in the depths of the tower foundations between the S and W walls of the tower is puzzling, the very shallow foundations on the S wall are similar to those found at Craigievar (Murray, 2003, 5-6).

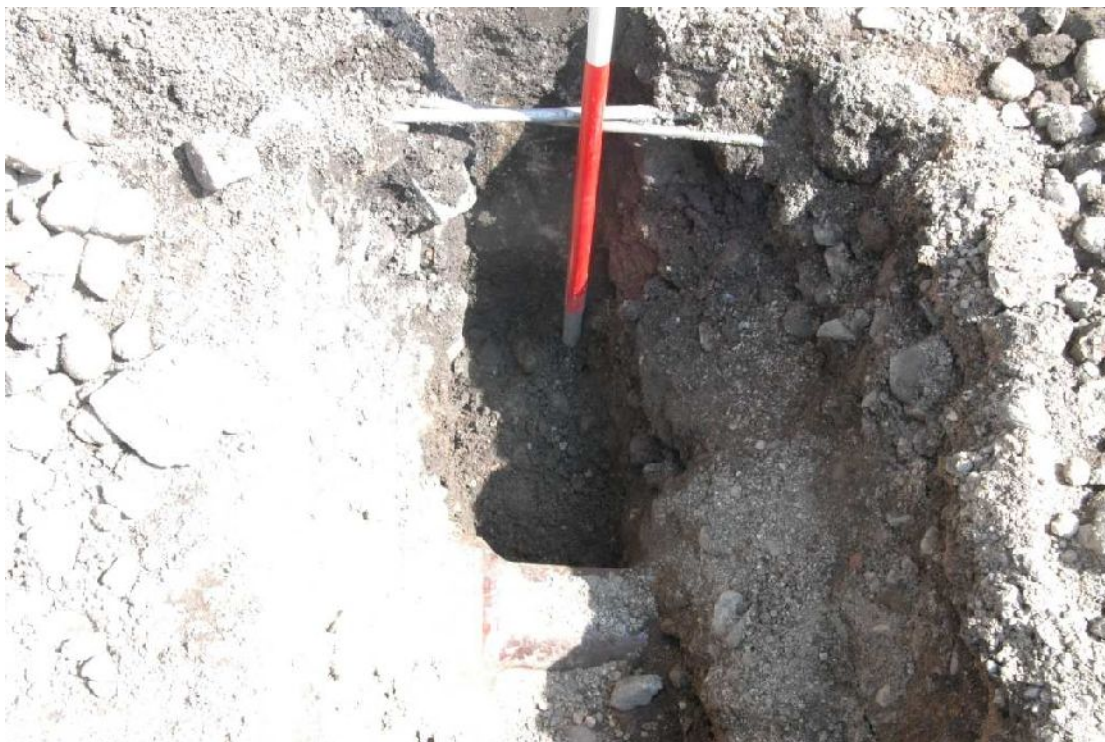
The natural was also cut by what appeared to be the foundation for the castle wall – or possibly a later cut made to examine the wall. This was c 100mm wide from the wall face and surface indications suggest it extended the width of the façade. On this side the castle wall goes down at least 650mm deeper than the present surface of the

path/base of the harling. The infill between the castle wall and the hard natural was filled with small rounded pebbles and is retaining water.

**Illus 6 Trench 2 showing depth of wall foundation**

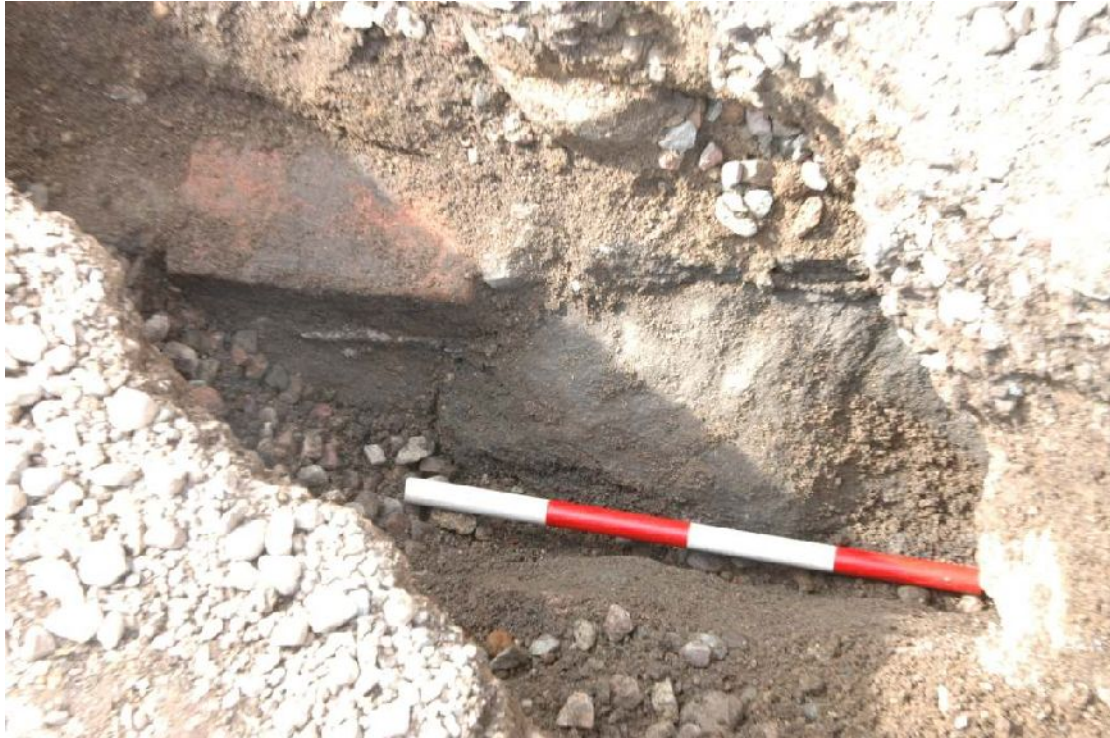
A V shaped stone drain was crossed by the pipe trench on the S side of the tower. It had been cut by the earlier sectional clay drain and one side repaired with two bricks. It is not clear where the deeper ceramic drain is at this point.

The V shaped drain was of stones set at an angle forming a 'V' 250mm wide internally at the top and 250mm deep. Some slate had been used at the base.

The drain was clear and drained quite steeply down away from the castle. It was recovered and the new drain runs over the top of it.

**Illus 7 V shaped stone drain below new pipe trench**

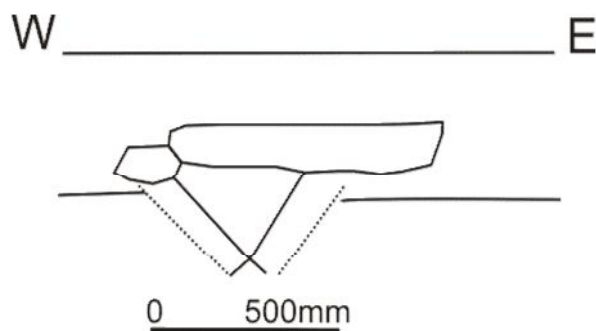
**Illus 8 Section of V shaped drain**
