# GLASSHOUSE BRODIE CASTLE MORAY

**- Building Recording -**  
Carried out 13<sup>th</sup> May 2014  
by  
**Murray Archaeological Services Ltd**

**Report No: MAS 2014-27**  
by  
H K Murray and J C Murray

1. Background
  - 1.1 An early 20<sup>th</sup> century glasshouse in the walled garden at Brodie Castle, Moray was in a state of collapse and required to be taken down. In consequence it was decided by the National Trust for Scotland that a standing building survey of the structure should be undertaken.
  - 1.2 It was requested that special attention should be placed on joints and structural elements so that should a replica of the glasshouse ever be considered, the construction would be as accurate as possible.
  - 1.3 Murray Archaeological Services Ltd was commissioned to undertake the work by the National Trust for Scotland. The field work was undertaken on 13<sup>th</sup> May 2014.

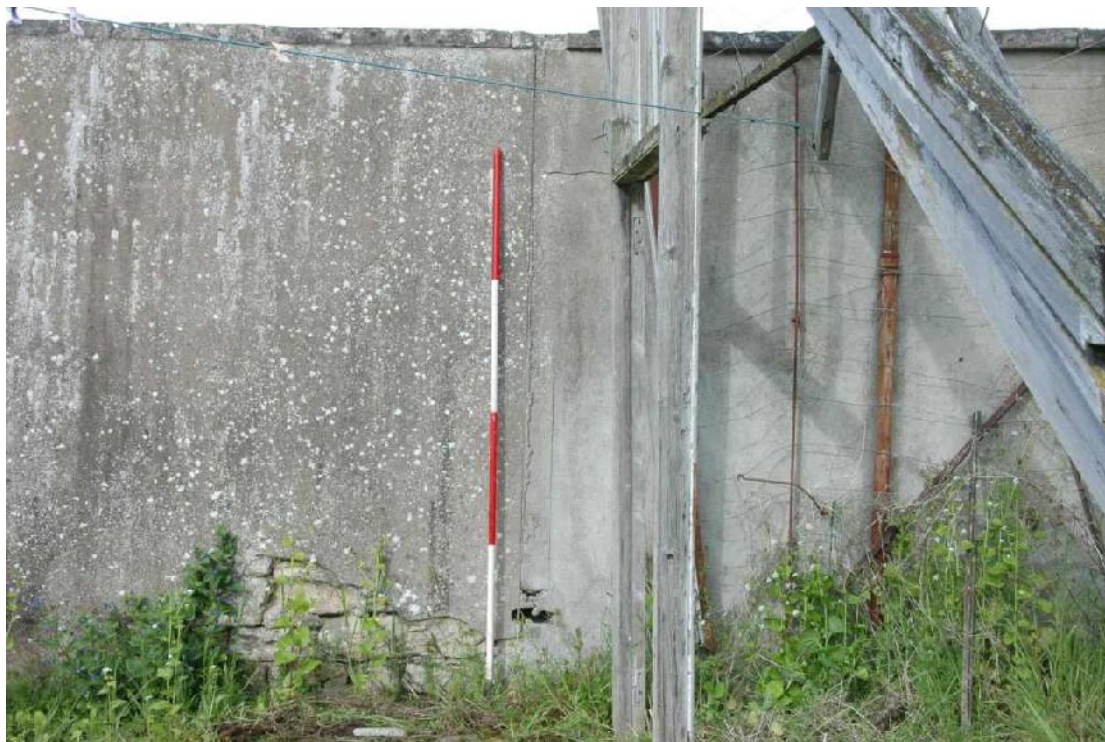
**Illus 5 NW gable, looking E to the garden wall. The raggle of the original wall line of the glasshouse is visible to the RHS of the ranging rod, with an angled slot in the wall face where the wall plate of the gable wall would have been set.**

This end had been largely destroyed and the door jambs were out of position set in the ground to the S of the wall foundation. The former position of the door was indicated by a cast iron grill path outside. The wall line was indicated by the foundation bricks. The position of the wall-side vertical of the gable can be seen in the vertical rattle in the garden wall (Illus 5), with an angled slot for the wall plate of the part of the glasshouse to the E of the door.

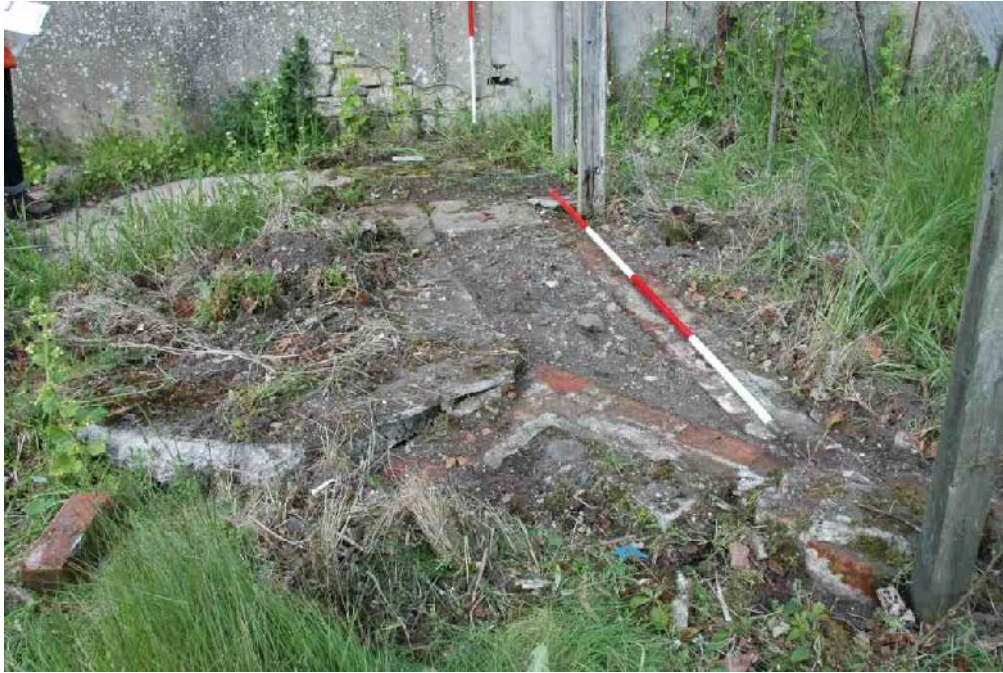
This is a three-quarter plan glasshouse, with a shortened back rafter resting on the enclosing wall of the walled garden, which is c. 2.55m high at this point with a flat cope c 70mm wide. While the SE end of the glasshouse was rectangular, at the NW gable the wall line was oblique (Illus 27). This was clearly shown by a vertical raggle in the face of the garden wall and by the line of the brick foundation (Illus 5, 6). The reason for this angled wall may lie in the plethora of concrete and brick foundations to the NW which suggest the former presence of other structures in this direction, as appears on the 1960s drawing (Illus 3) and in the 1920s photographs (Illus 4). There had been a door at each end.

**Illus 6 NW end, looking E, showing the line of the original wall foundation (below horizontal ranging rod). The raggle of the original wall and the slot for the wall plate can be seen in the garden wall to the RHS of the vertical ranging rod. The displaced door jambs can be seen to the RHS of the foundation. To the LHS of the wall foundation can be seen the brick and concrete foundations of a path and other possible structures.**

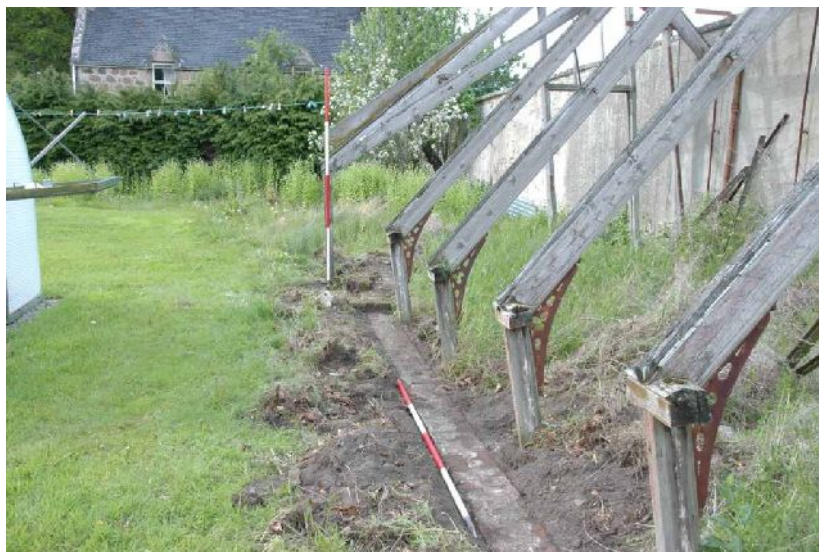
**Illus 7 Looking N along side wall showing brick foundation and displaced wall timbers**

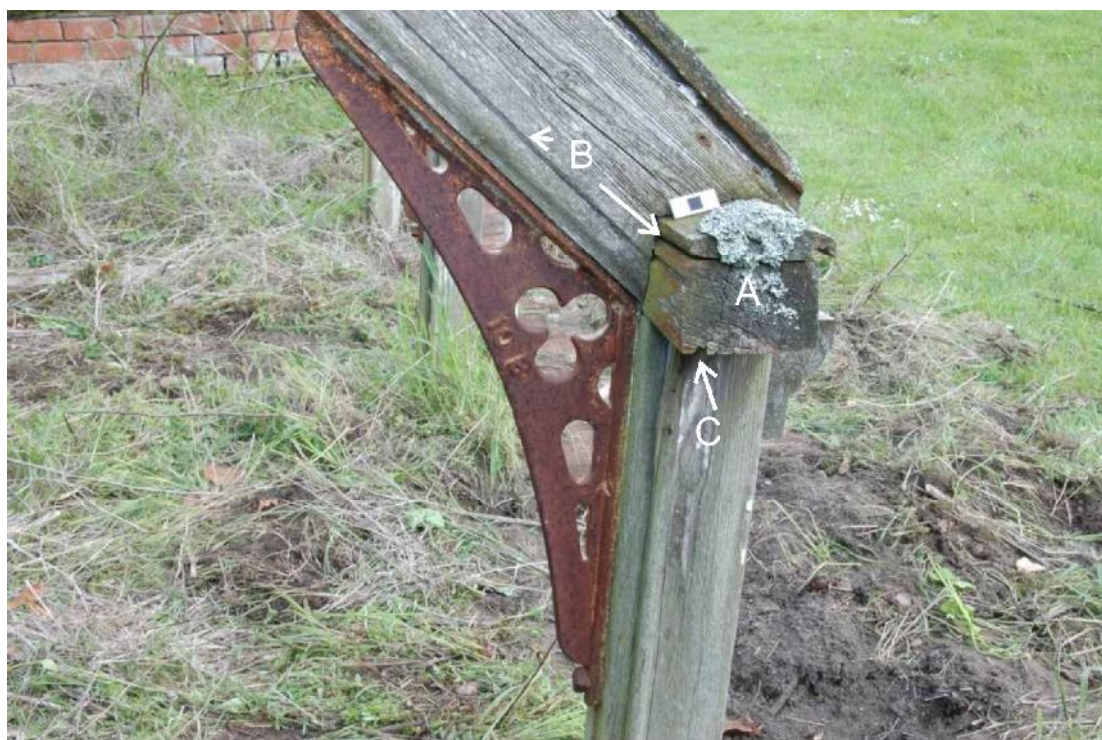
The timber has not been identified. On visual inspection it looked like pine although the marginal note on the 1960s sketch says that it was teak. As can be seen in the SE elevation, apart from the door jambs, the vertical timbers (each 100 x 52mm) were set into a wall plate that ran along the top of the low brick wall. In the long side wall, these vertical timbers have been displaced and now rest on the ground. A horizontal timber (105 x 60mm) ran along the top of these vertical timbers. Along the top of it was an almost triangular-sectioned horizontal timber (115 x 30mm) which projected slightly and had a groove, possibly to hold the upper edge of a gutter resting on small wooden brackets on the outer face of the vertical wall timbers (Illus 8).

**Illus 8 Detail of bracket between vertical wall post and rafter, also showing the horizontal timber (A) that ran along the top of the wall posts. Note the glazing grooves (B) for the sloping glass in the rafter and in the LHS face of the horizontal timber. Note also the glazing groove (C) in the base (LHS) of the horizontal.**

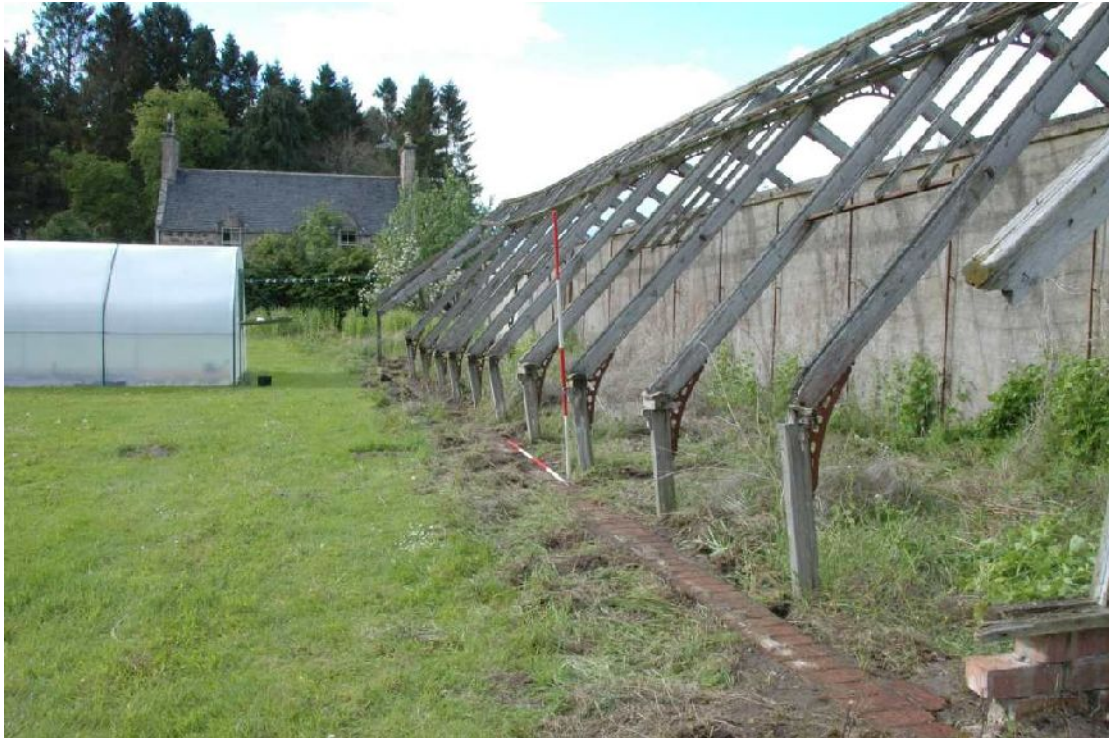
Originally there would have been a low brick wall around all sides. This only survives at the SE gable, where it is 380mm high comprising 4 courses set as stretchers, set on a foundation of bricks set as headers (Illus 12). The bricks were 225 x 105 x 85mm. Elsewhere, only the foundation course survived (Illus 9).

Illus 9 Looking N along long wall showing main structural elements

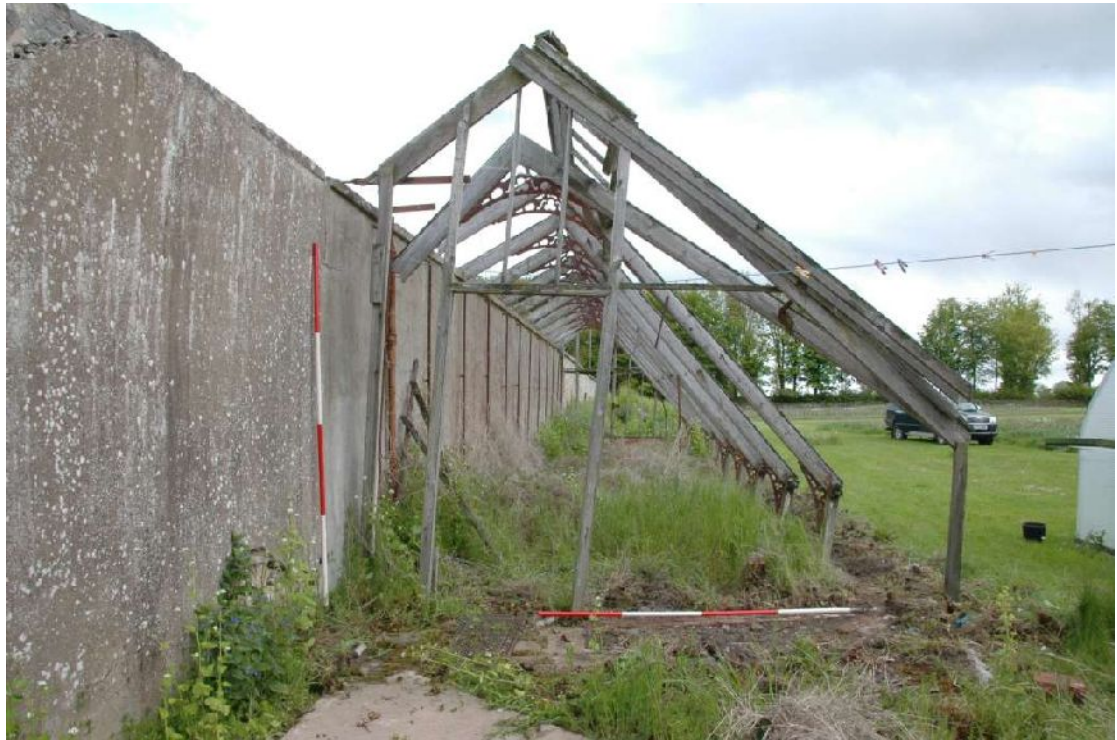
**Illus 11 NW gable showing displaced door jambs.**

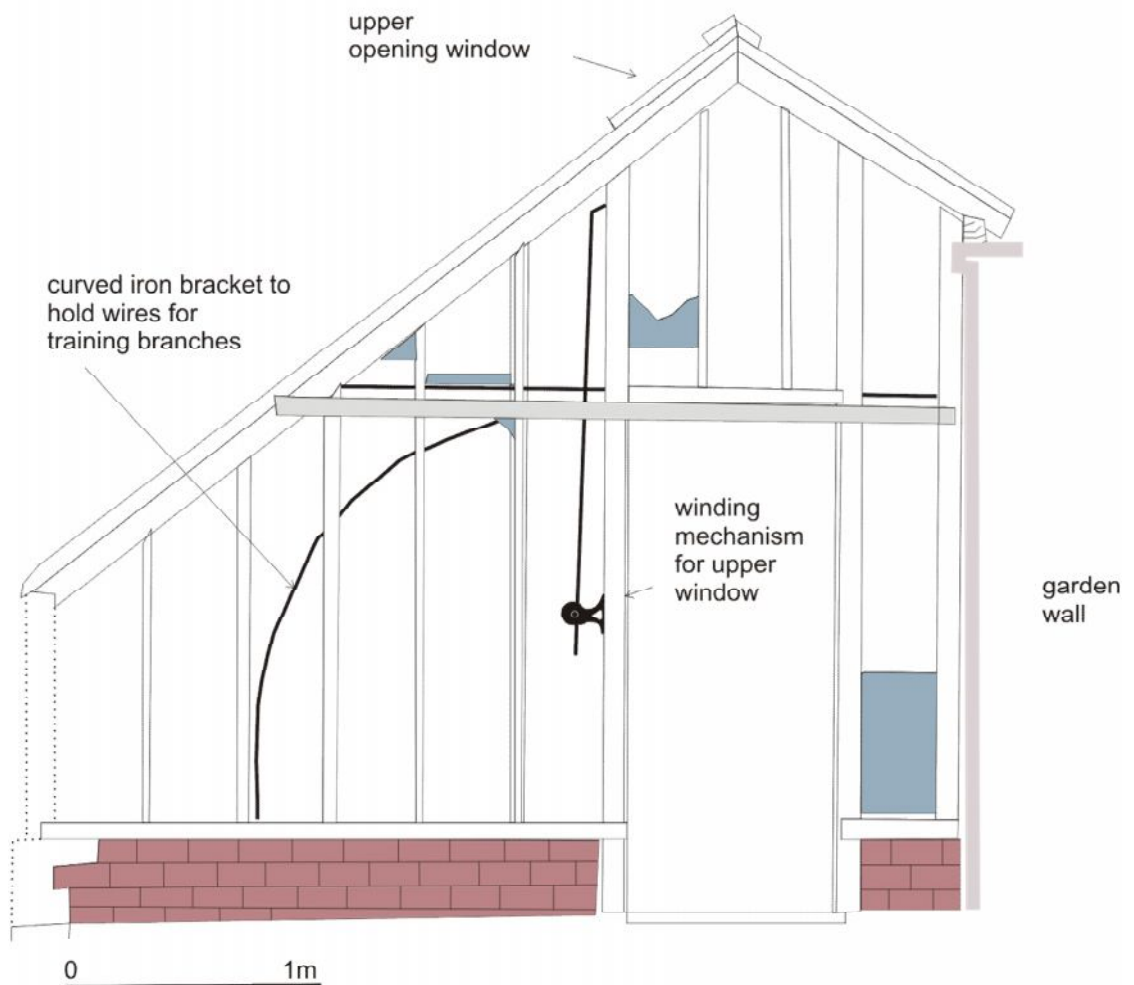
The SE gable was fairly intact. There was a doorway (W: 0.87m H: 2.05m), the door was missing but had hung on two hinges on the E side, with marks of the hinges surviving. The door jambs ran from the ground to either side of the ridge, where they were bolted to the rafters. On either side of the door, the wall comprised a low brick wall with a horizontal wall plate. The vertical timber was missing from the W corner, but an intermediate vertical timber (90

Illus 12 Elevation of SE gable wall

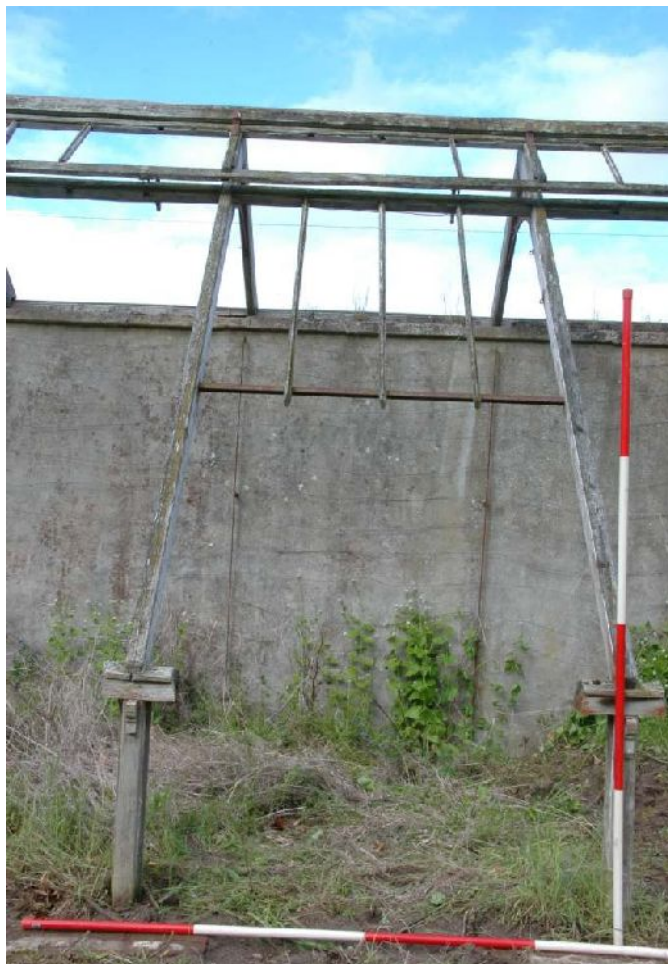
Some of the glazing bars of the upper windows survived, showing there were 4 panes to each bay. The timber glazing bars were 60 x 30mm with rebates on the outer edges to hold the glass.

**Illus 13** Bay 4 from S end showing glazing bars

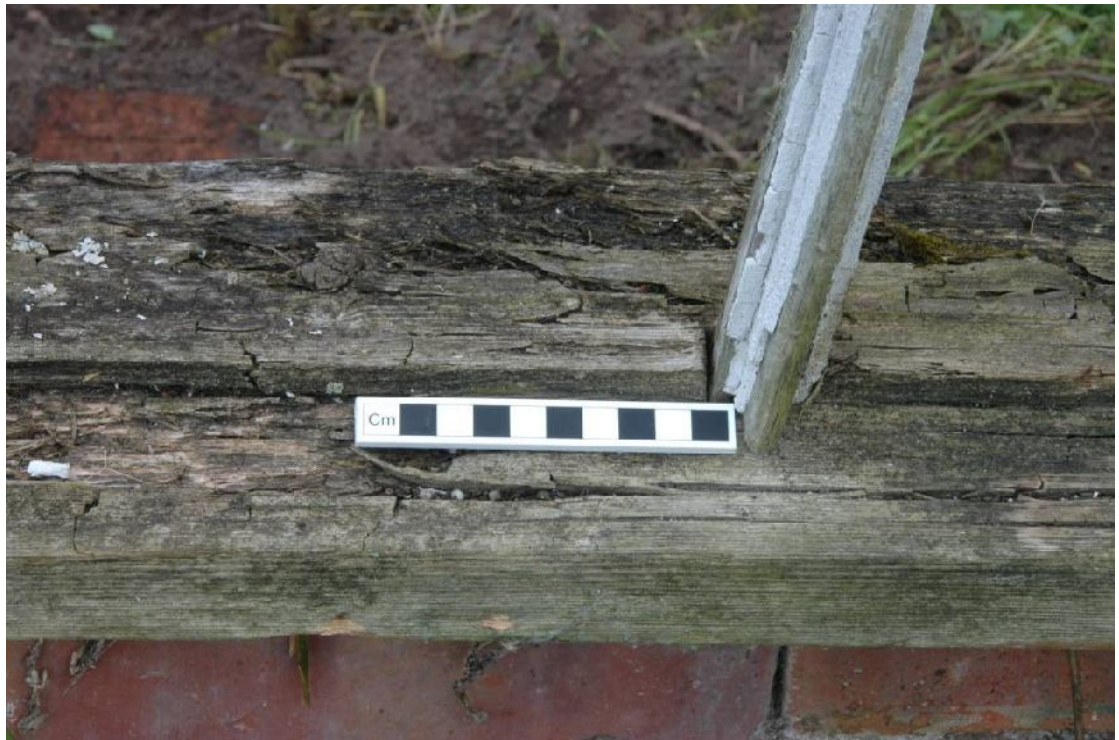
**Illus 14** Detail of base of glazing bar mortised in wall plate in SE gable

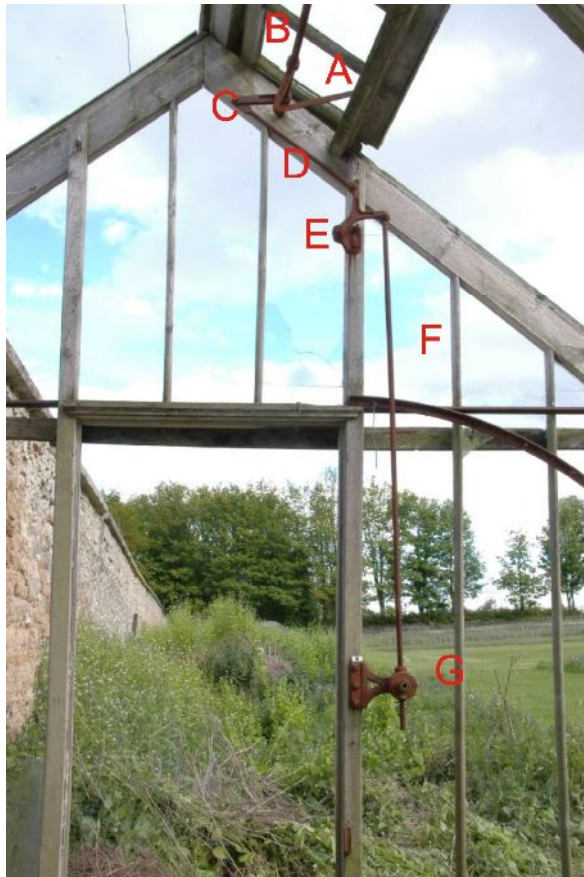
The small paned windows at the top SW facing angle of the ridge were in two sets – one set of 6 bays operated by a mechanism at the N end of the building. The other set of 6 bays operated from the S end of the building. The windows were hinged by stepped strap hinges from the ridge, one hinge to each rafter. The main elements of the window mechanism had been removed from the S end. This description applies to the presumably identical system at the N end.

**Illus 16** The mechanism at SW end of building.

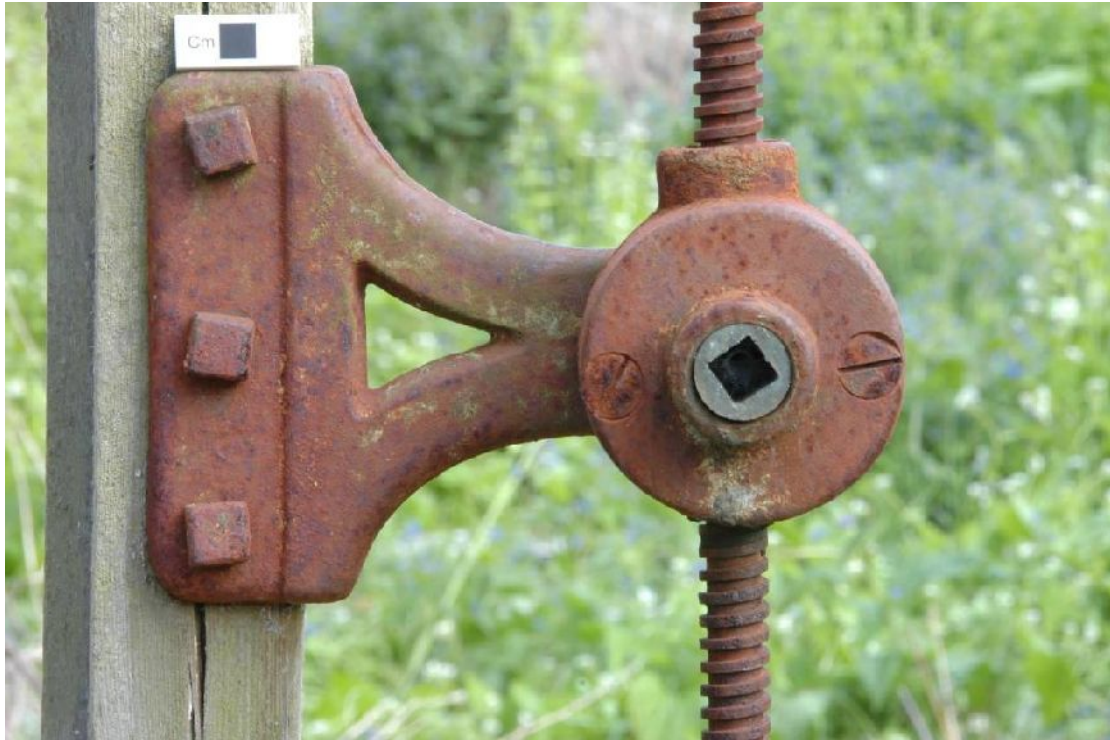
**Illus 18 Ratchet at bracket (G) and threaded rod (F). Winding handle appears to be missing**

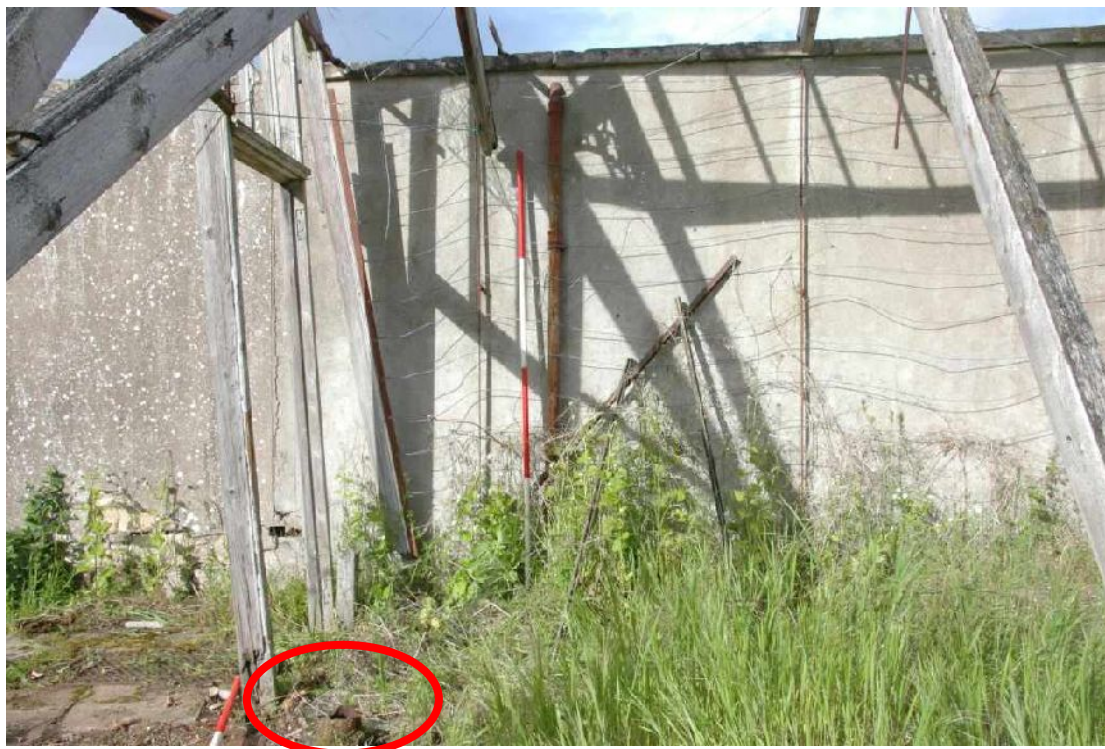
Two cast iron pipes at the N end of the structure may have been part of a heating system. The larger pipe, 150mm (6") diameter was broken off where it came up through the ground near the middle of the NW end. A smaller pipe 50mm (2") in diameter ran up the face of the garden wall and at the top went through the wall.

**Illus 21 NW end. Large cast iron pipe in foreground marked by red circle, smaller diameter pipe up wall beside ranging rod**

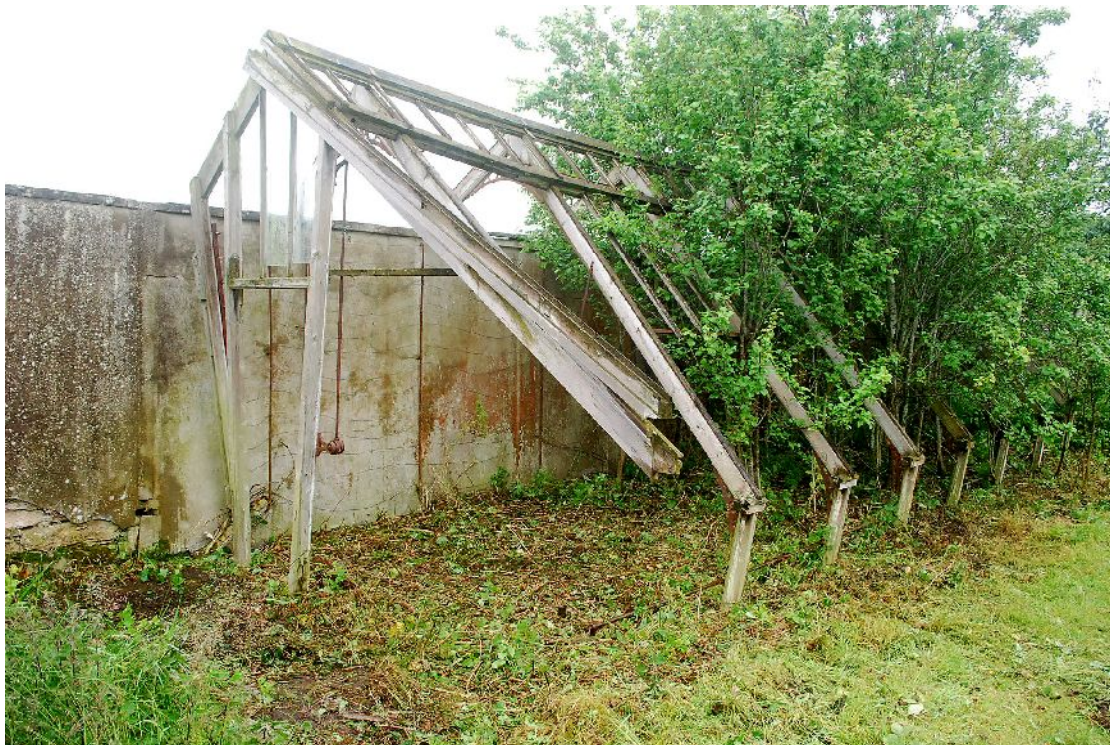
- The iron rod and winding mechanism for the upper windows for the N six bays of the glasshouse had been removed for re-use at Pitmedden. This resulted in further skewing of the NW gable end and the N two bays. At some point a fence post was used as a replacement support at the NW corner. Prior to the removal of the window mechanism the structure had been photographed in detail in 2009 and some of these photographs are included to illustrate features no longer extant (Illus 22-26).

**Illus 22 Overgrown state of glasshouse in 2009 showing N gable with winding gear (Photograph R Grant).**

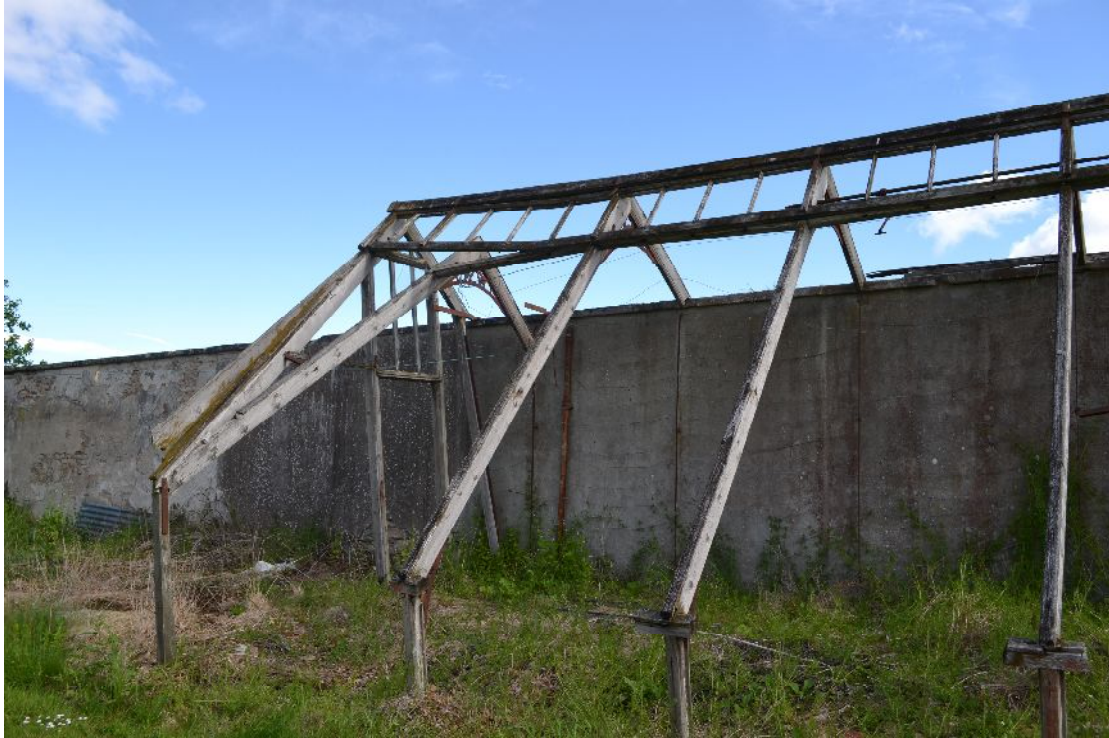
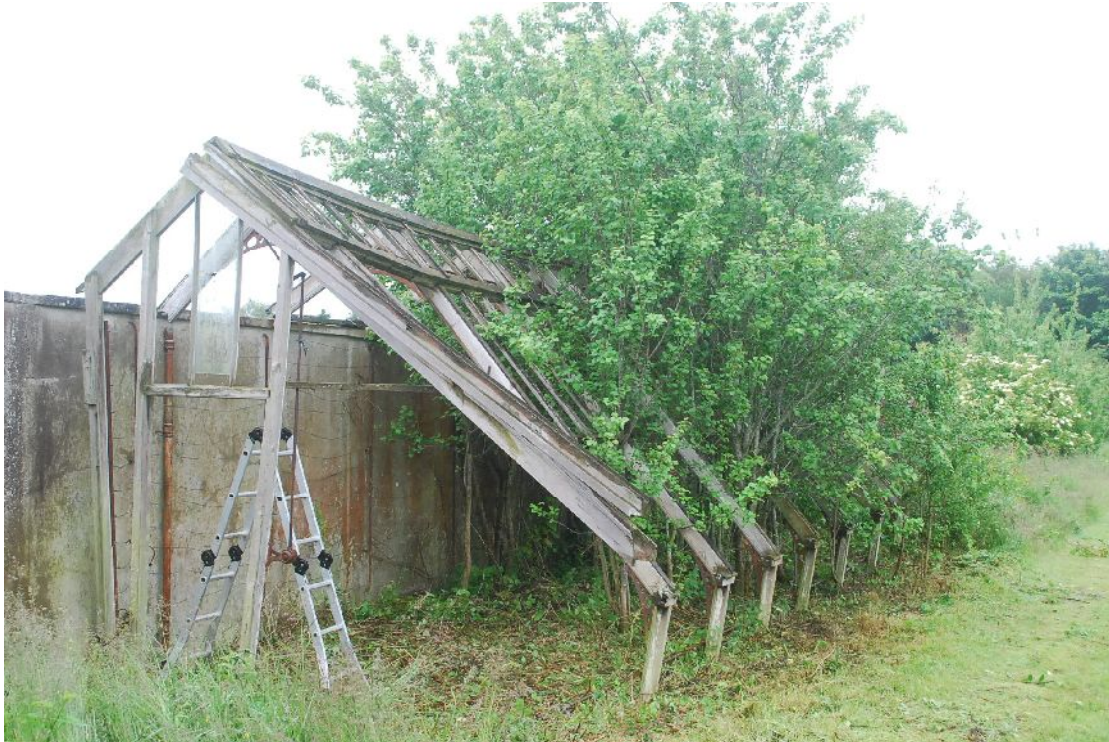
This is basically a 12 by 1 bay structure, but the bay at the N end is truncated by the asymmetric line of the N wall and is essentially a half-bay, having only two panes in the top opening windows, not four as in the full bays. This shows most clearly on the 2009 photographs, prior to the further dilapidation of the building (Illus 22-24).

**Illus 23 N end in 2009, clearly showing the truncated N bay. (Photograph R Grant).**

**Illus 24 N end in 2009, clearly showing the truncated N bay. (Photograph R Grant).**

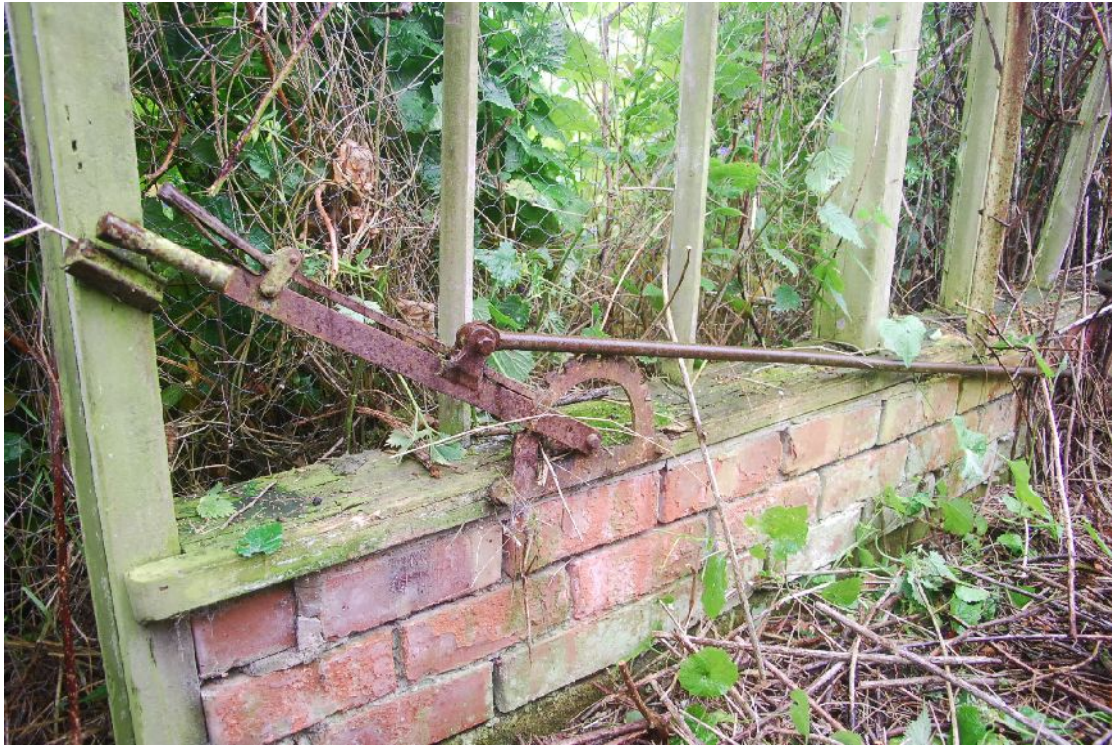
Some, or all, of the lower, vertical windows were opened by a similar mechanism of rods moved on a ratchet system. This was removed for re-use at Pitmedden, Aberdeenshire but some photographs taken by Robert Grant in 2009 indicate how it operated (Illus 25-26).

**Illus 25** S gable in 2009, showing ratchet mechanism for opening the lowest (vertical) windows. This mechanism was removed and is now in use at Pitmedden, Aberdeenshire. (Photograph R Grant).

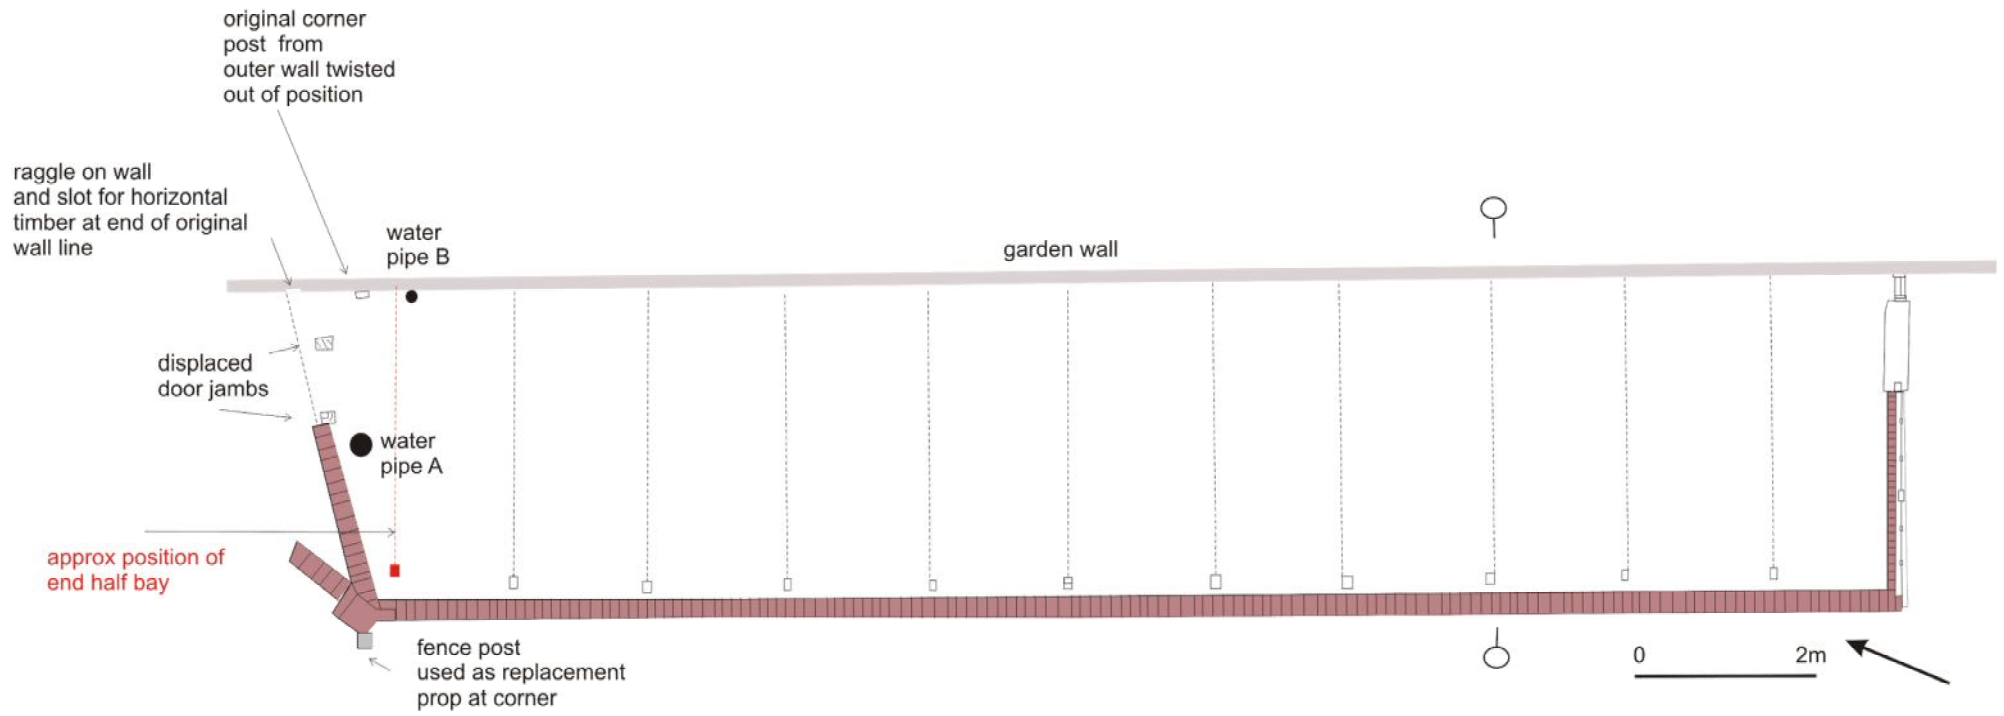
**Illus 27 Ground plan showing brick foundations and displaced timber uprights (bay shown in red augmented from 2009 photograph)**
