## BELDORNEY CASTLE GLASS ABERDEENSHIRE

# - Archaeological Watching Brief Carried out July 30<sup>th</sup> & August 5<sup>th</sup> 2014 by Murray Archaeological Services Ltd

Report No: MAS 2014-29 by H K Murray & J C Murray

### BELDORNEY CASTLE GLASS ABERDEENSHIRE -Archaeological Watching Brief-

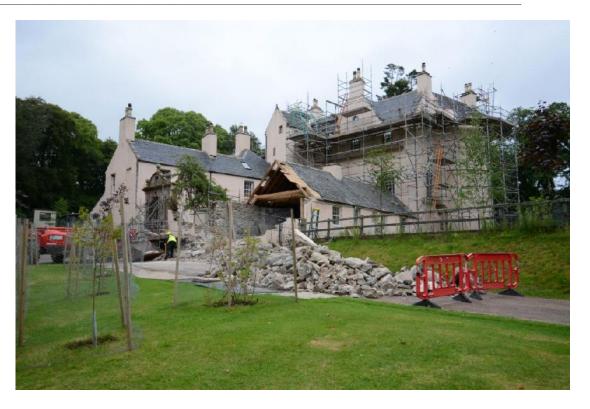
Illus 3 View of the castle from the SW showing the S wing with the W gable removed

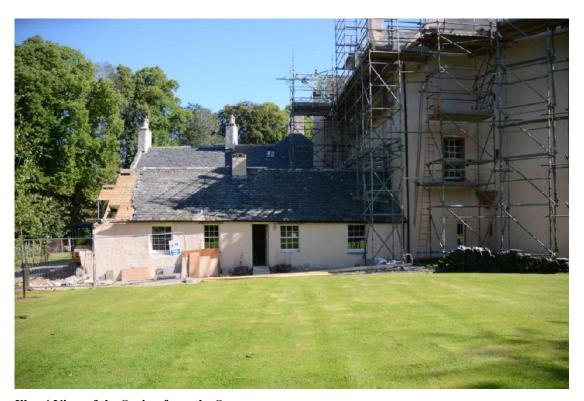
Illus 4 View of the S wing from the S

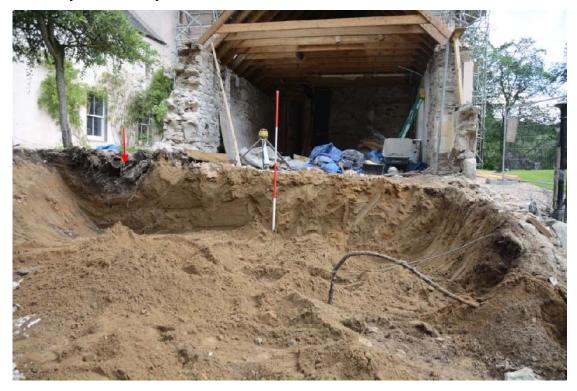
There was no foundation to the wall which was built directly on a bank of natural sand which was cut away to a maximum depth of 1.2m on the line of the gable, tailing down to the level of the drive (illus 5). There were no foundation trenches for the gable or side walls of the S wing or for the wall of the courtyard. The only cut in the sand was for a modern ceramic drain.

Illus 5 S wing, looking E, showing the excavation of the bank and the foundation for the replacement of the W gable. Red arrow shows cut for a modern ceramic drain.

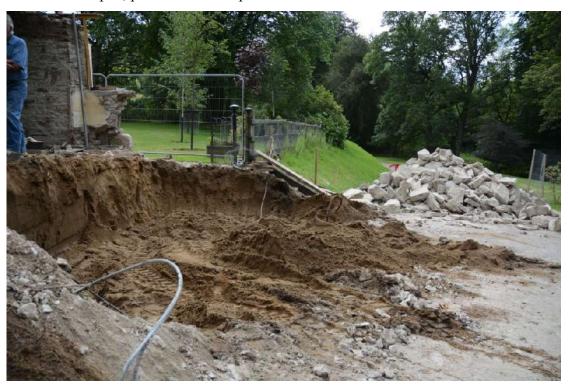
The instability of the existing wing is likely to have been caused by the terracing of the ground level directly to the W between the drive and the haha (illus 6). This layout is shown on the 1<sup>st</sup> and 2<sup>nd</sup> OS maps (illus 7) and is likely

Illus 6 Looking S across the front of the excavated line of the W gable of the S wing, showing the line of the slope between the upper garden and the drive and lower lawn.
