CASTLE FRASER ABERDEENSHIRE DRAIN TEST PIT

- Archaeological Test Pit -
Carried out September 17th 2014
by
Murray Archaeological Services Ltd

Report No: MAS 2014-35
by
H K Murray & J C Murray

CASTLE FRASER
ABERDEENSHIRE
DRAIN
-Archaeological Test Pit-

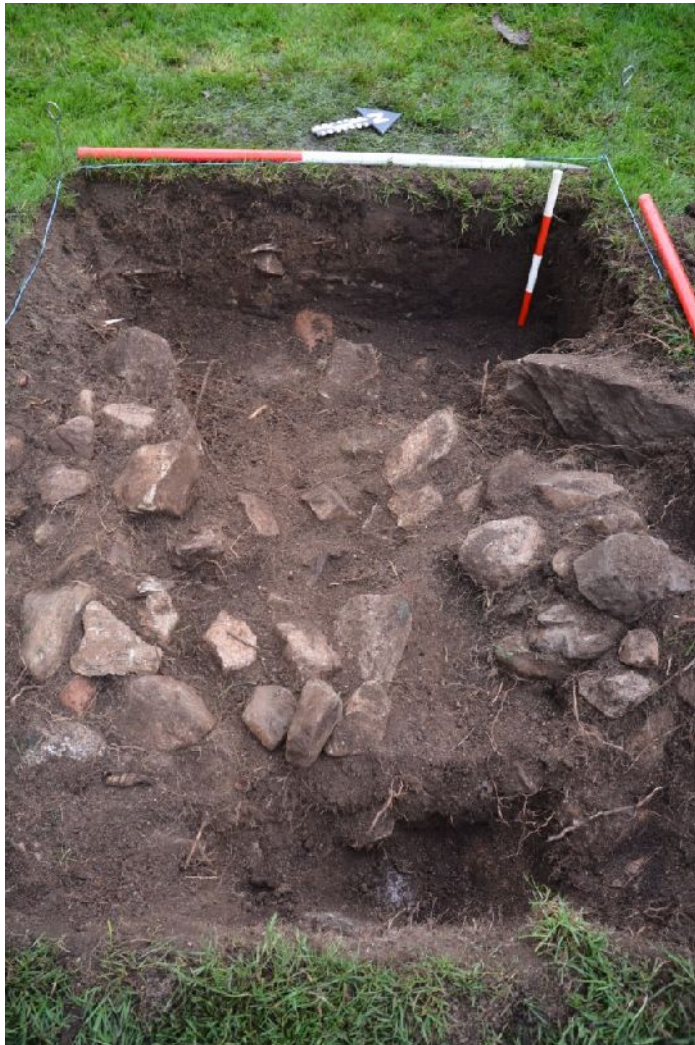
Where TP 1 cross-sectioned the bank, along the scanned line of the drain pipes from the septic tank, there was an irregular layer (1) of sandy brown topsoil with rubble stones backfilled in the central area and a more coherent but equally random patch of stones forming the bank (Illus 2).

Illus 2 TP1 looking W showing rubble backfill over drain pipes

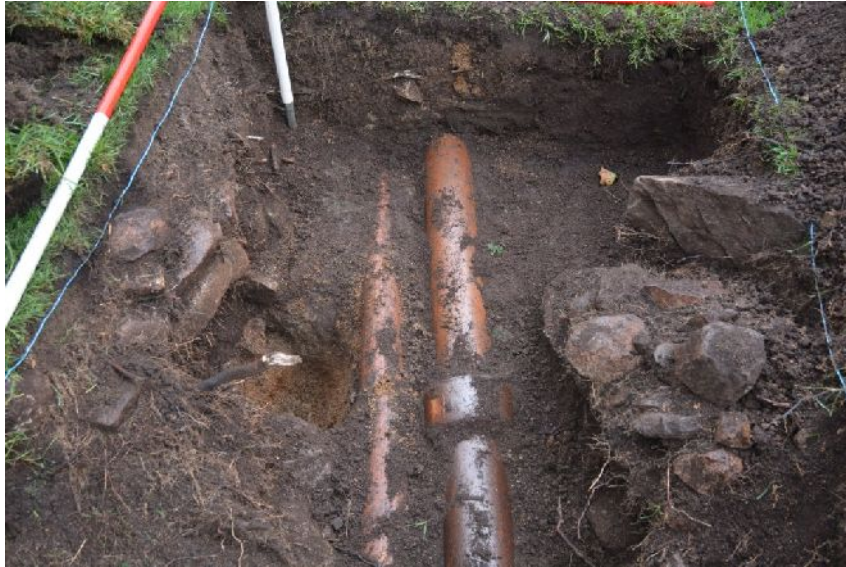
When the rubble backfill of the drain cut was removed two modern pipes were revealed- the ceramic pipe from the septic tank to the bree pit and a sectional clay field drain alongside it (Illus 3, 4).

Illus 3 TP 1 looking W after rubble removed and drain pipes revealed

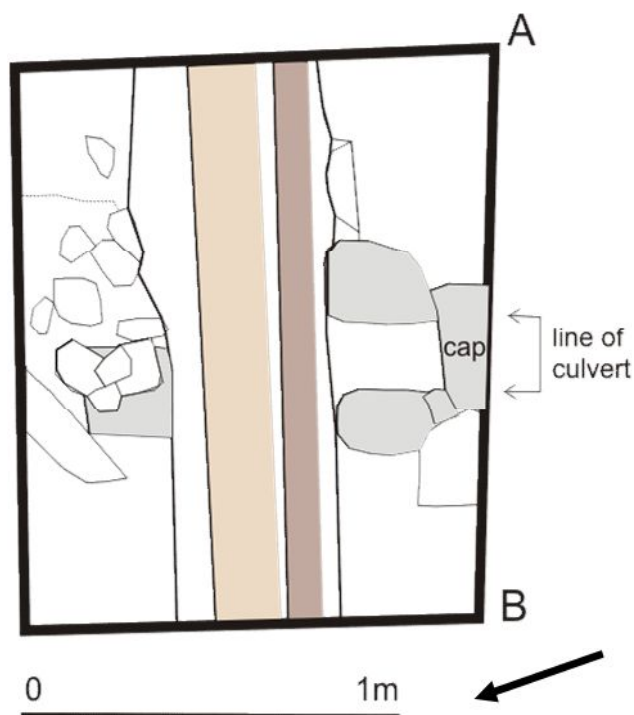
Illus 4 Plan of TP1. Modern drains shown coloured.

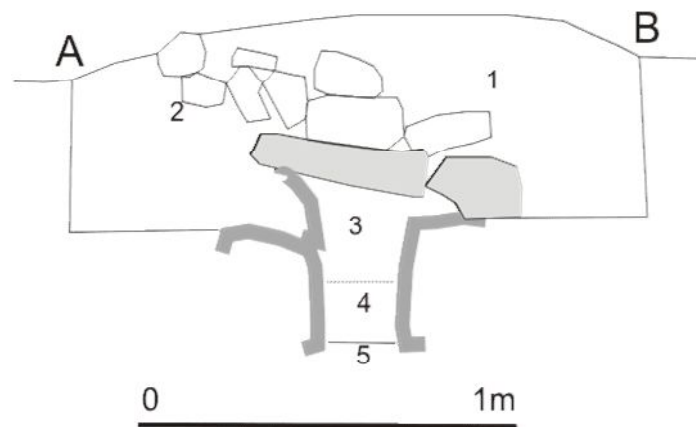
The N section appeared very disturbed by the drain trench but in the S section (Illus 4, 5), there were the side stones and capstone of a culvert or drain running along the line of the linear feature. Internally the drain was 280mm wide and 450mm from the underside of the cap to the base of the side stones. It was completely filled; the upper fill was c 250mm brown humic earth (illus 5:3) above c 200mm of clean yellow sand (illus 5:4) down to a very fine silt above clay/silt which appeared to be the base (illus 5:5).

The loose stones over the capstone may have been a backfilling over the culvert/drain or may have been field gatherings- they appeared too random to be convincing as the remnant of a drystone dyke although this remains a possibility.

Illus 5 Section of S side of TP1 showing culvert/drain.

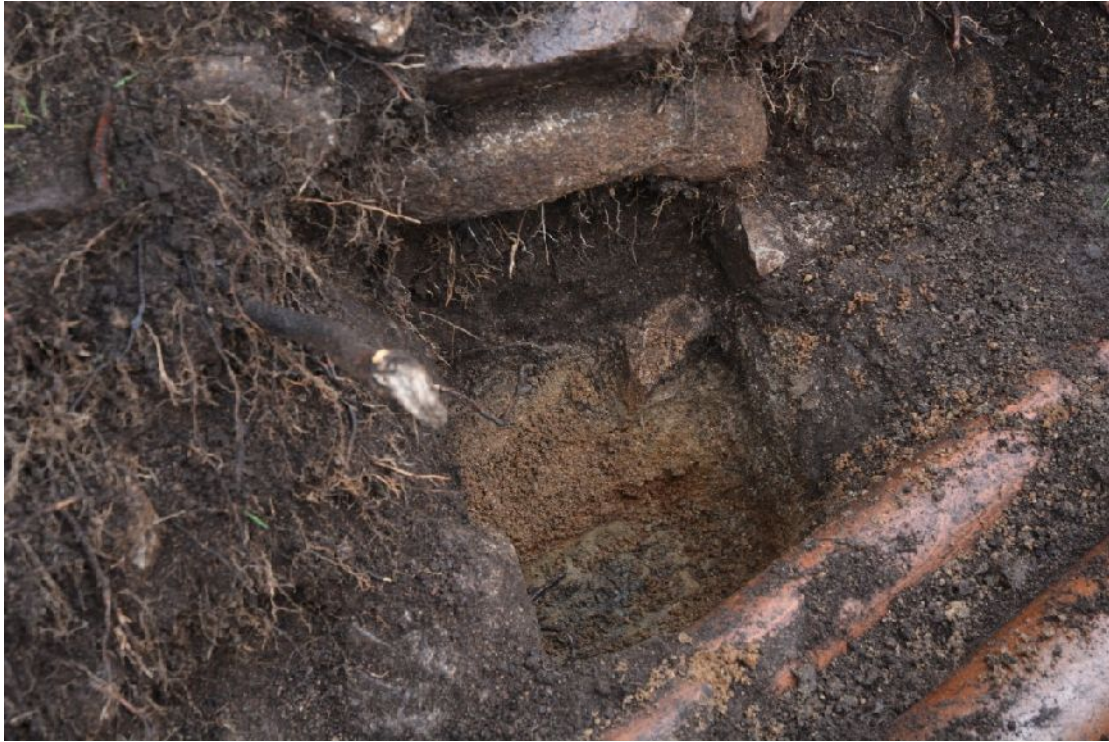
Illus 7 Detail of section of culvert/drain in S section of TP 1

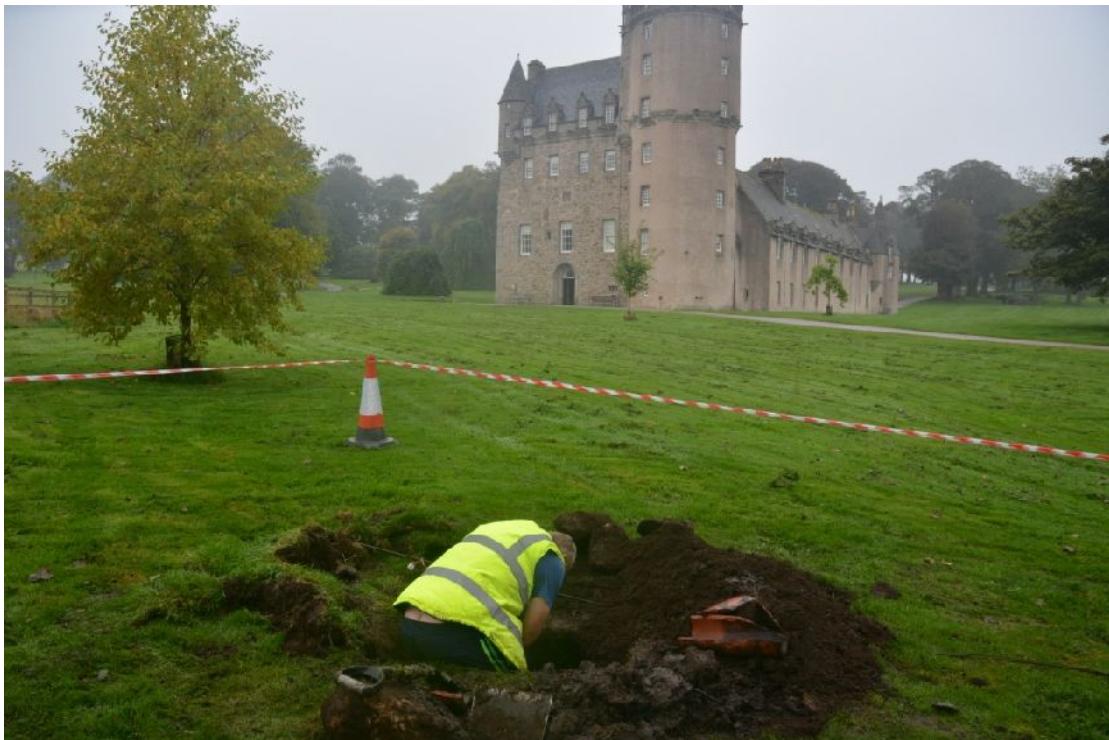
Illus 8 Location of TP 2 looking NW

4.2 **Test Pit 2 (TP2)** was c.1m square. GPS 372319,812497. It comprised stoney rubble over a broken 6" clay drain. There was nothing of archaeological significance.

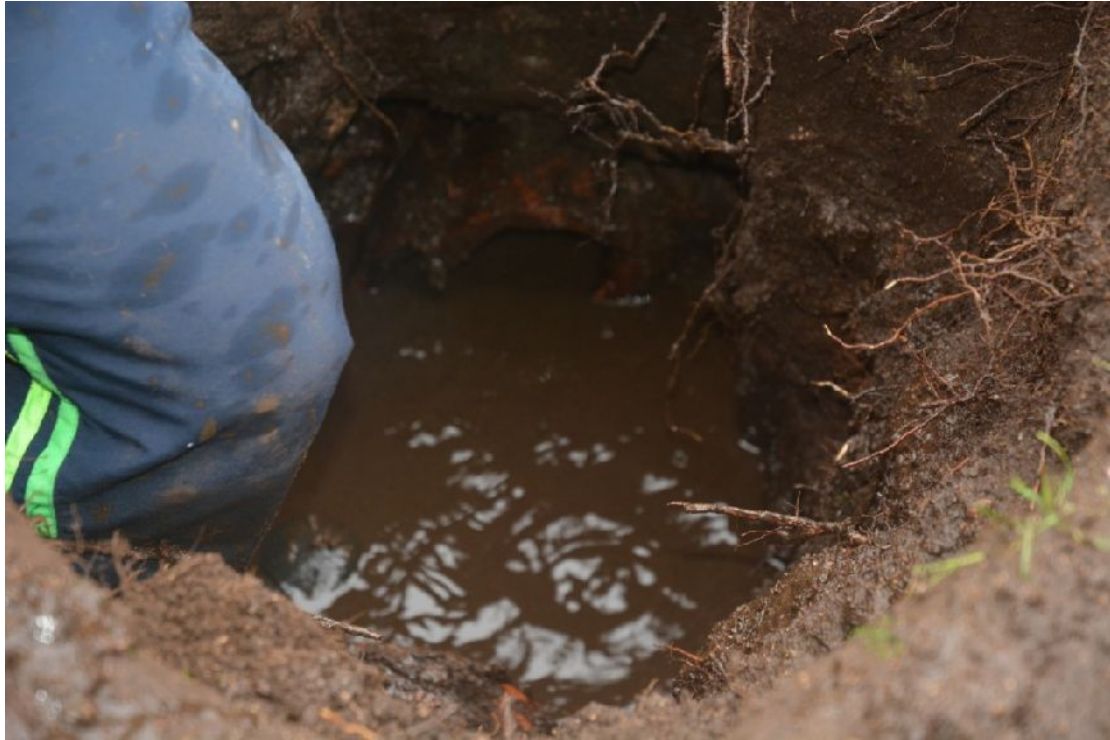
Illus 9 Broken clay drain in base of TP 2
