**ADEN HOUSE  
MINTLAW  
ABERDEENSHIRE**

**- Structural Recording -**  
Carried out 2<sup>nd</sup> July, 13<sup>th</sup>-15<sup>th</sup> July 2015  
by  
**Murray Archaeological Services Ltd**

**Report No: MAS 2015-21**  
by  
**H K Murray & J C Murray**

**ADEN HOUSE  
MINTLAW  
ABERDEENSHIRE  
RECORDING OF ENTRANCE HALL  
AND TEST PITS**

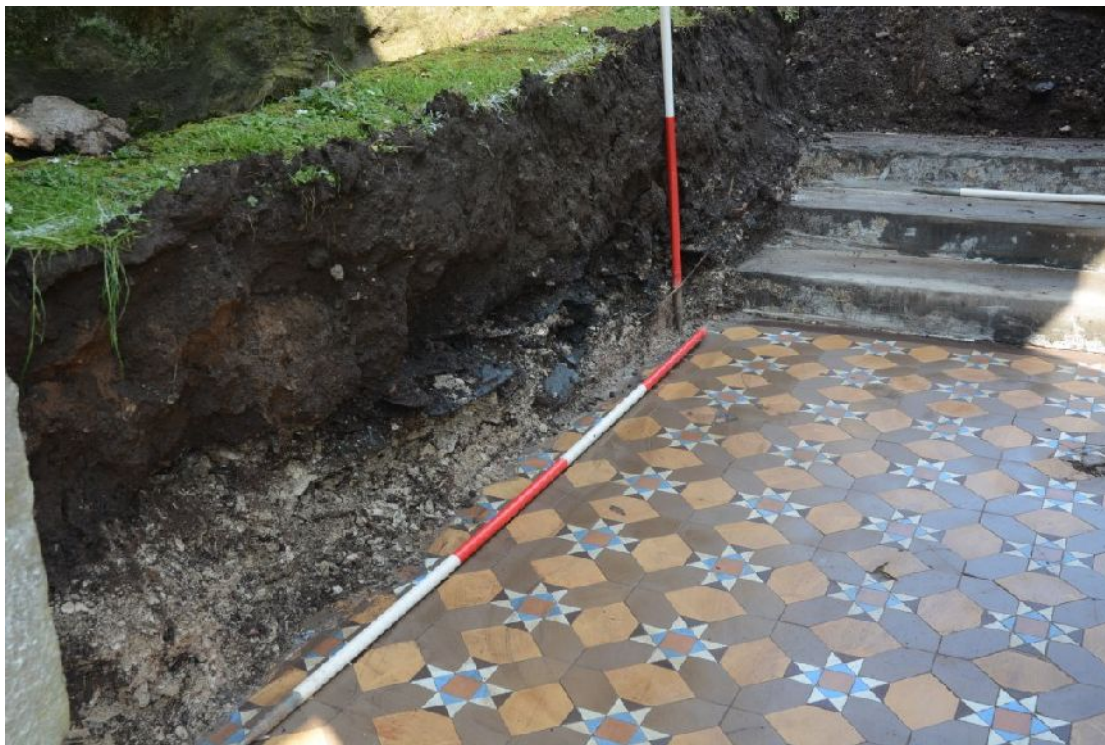
The soil dug from beside the E and W walls of the outer area consisted of c. 750-850mm of deliberate build up; comprising 350-400mm of building rubble, covered by c. 400mm imported garden soil (Illus 3). The building rubble included mortar, plaster, some slate, glass near the window and some slate. It appears to have been levelled and covered at the time of demolition.

**Illus 3 Detail of overburden beside W wall of Entrance Hall. July 2<sup>nd</sup> 2015**

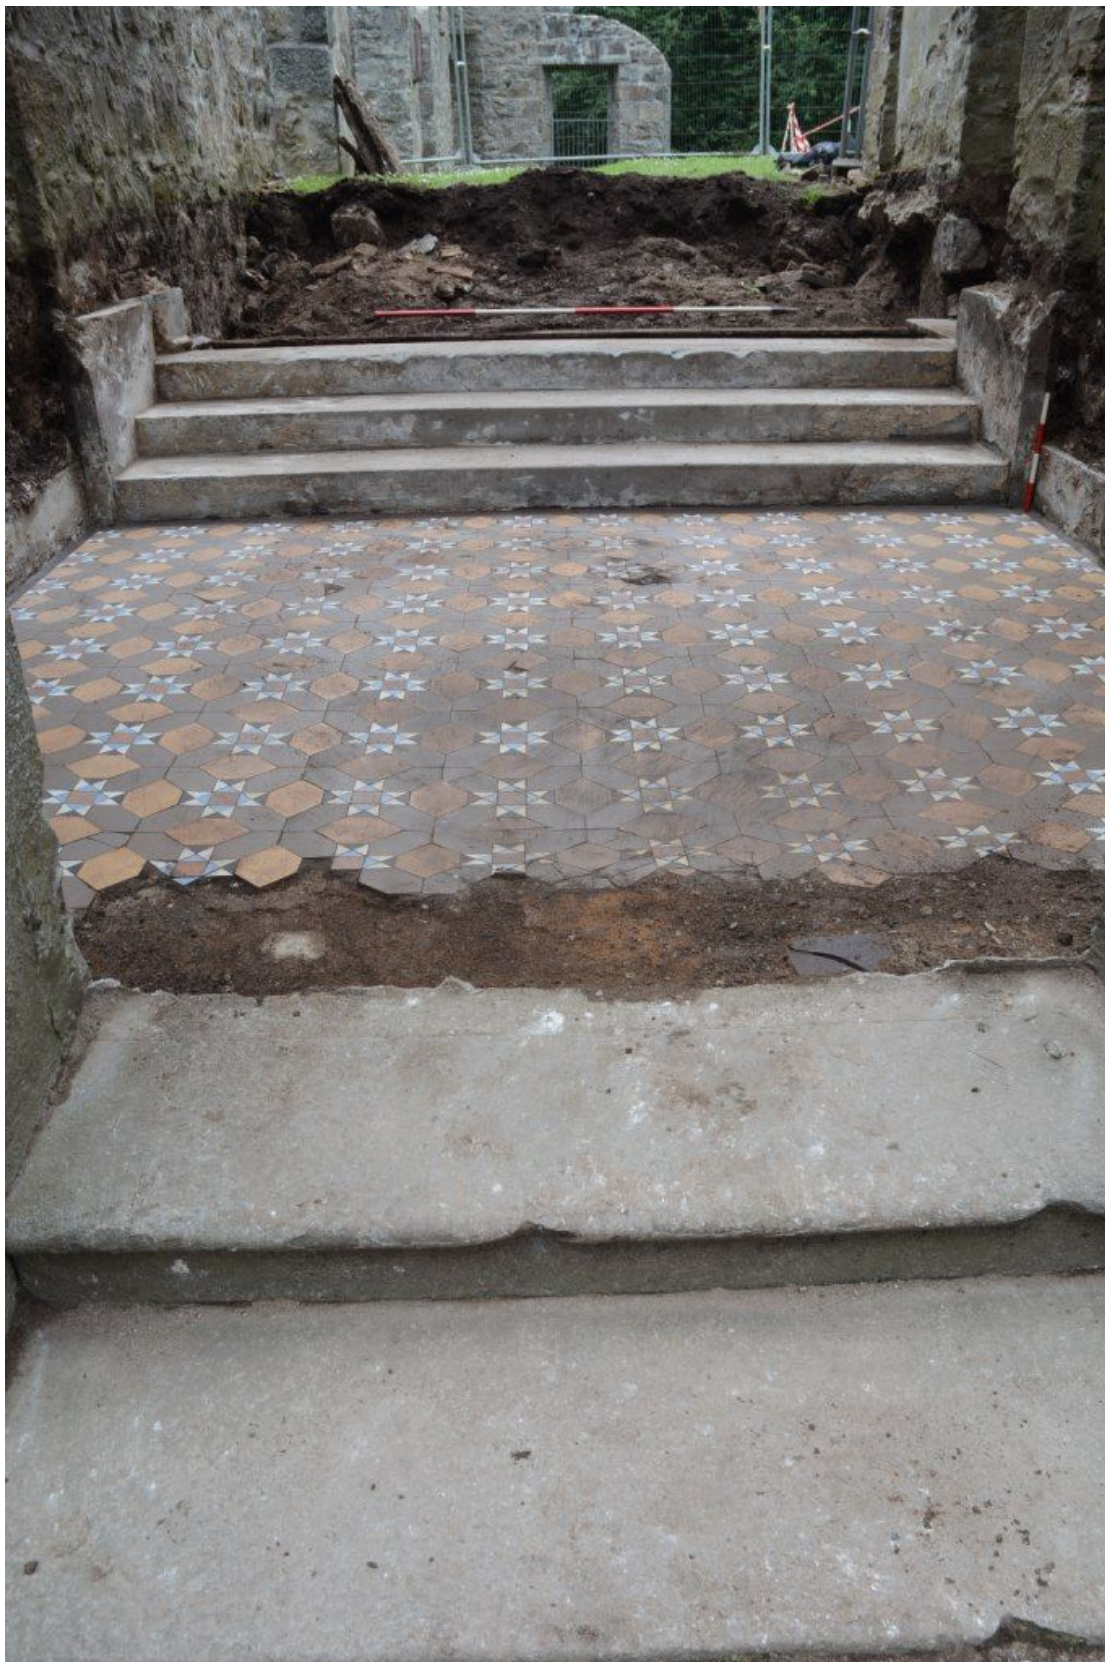
In the outer area of the Entrance Hall there was a well-preserved floor of geometric pattern tiles, extending the full width of the hall and into the window bay (Illus 2, 4-5, 21). These had only been removed just at the S end where they had been broken by the insertion of one of the access steps. There was also an area where the tiles had sunk, forming an area that puddled; the cause of the sinking was not clear.

**Illus 4 View of tiles in lower area of Entrance Hall, looking N**

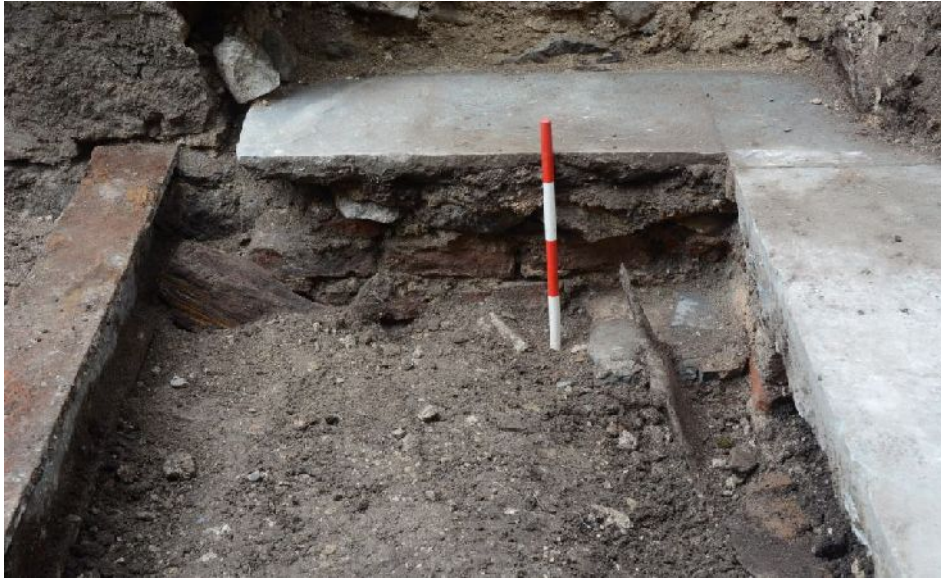
**Illus 12** Detail of E end of I-beam slotted into main wall. Note vertical timbers in building rubble infill.

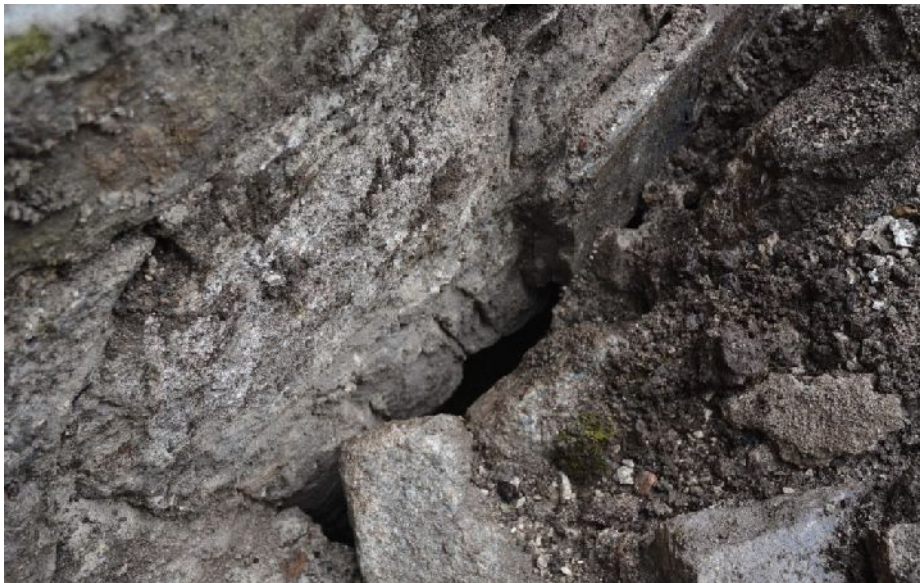
**Illus 13** Detail of arch built into base of wall

The area N of step 5 appears to have been cellared. As noted above, probes between the fill stones extended to at least 1.5m. The infilling material was compact and was not removed. On the W side of the Entrance Hall and N of the I-beam, part of an arch

built into the base of the 18<sup>th</sup>-century wall was observed, with a void below the wall itself (Illus 13).

There is clear indication of cellarage to at least 1.5m below the 19<sup>th</sup>-century floor level in the area N of Step 5 in the Entrance Hall. This cellarage is likely to be of 18<sup>th</sup>-century date as the arch below the W side of this area is an integral part of a wall thought to be of 18<sup>th</sup>-century date.

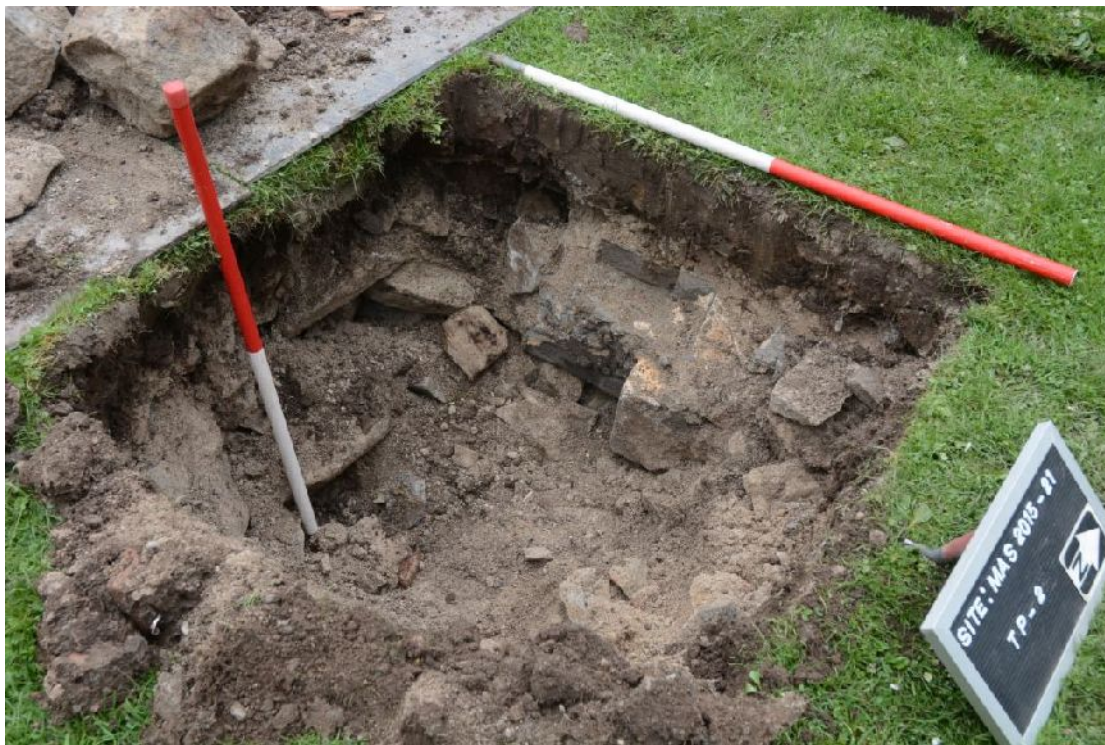
**Illus 17** Section of TP2

650mm+ Building rubble. Stone, mortar, occasional brick, including a block of firebricks. Not excavated to base of rubble which was very firm and showed no evidence of voids or cellarage.

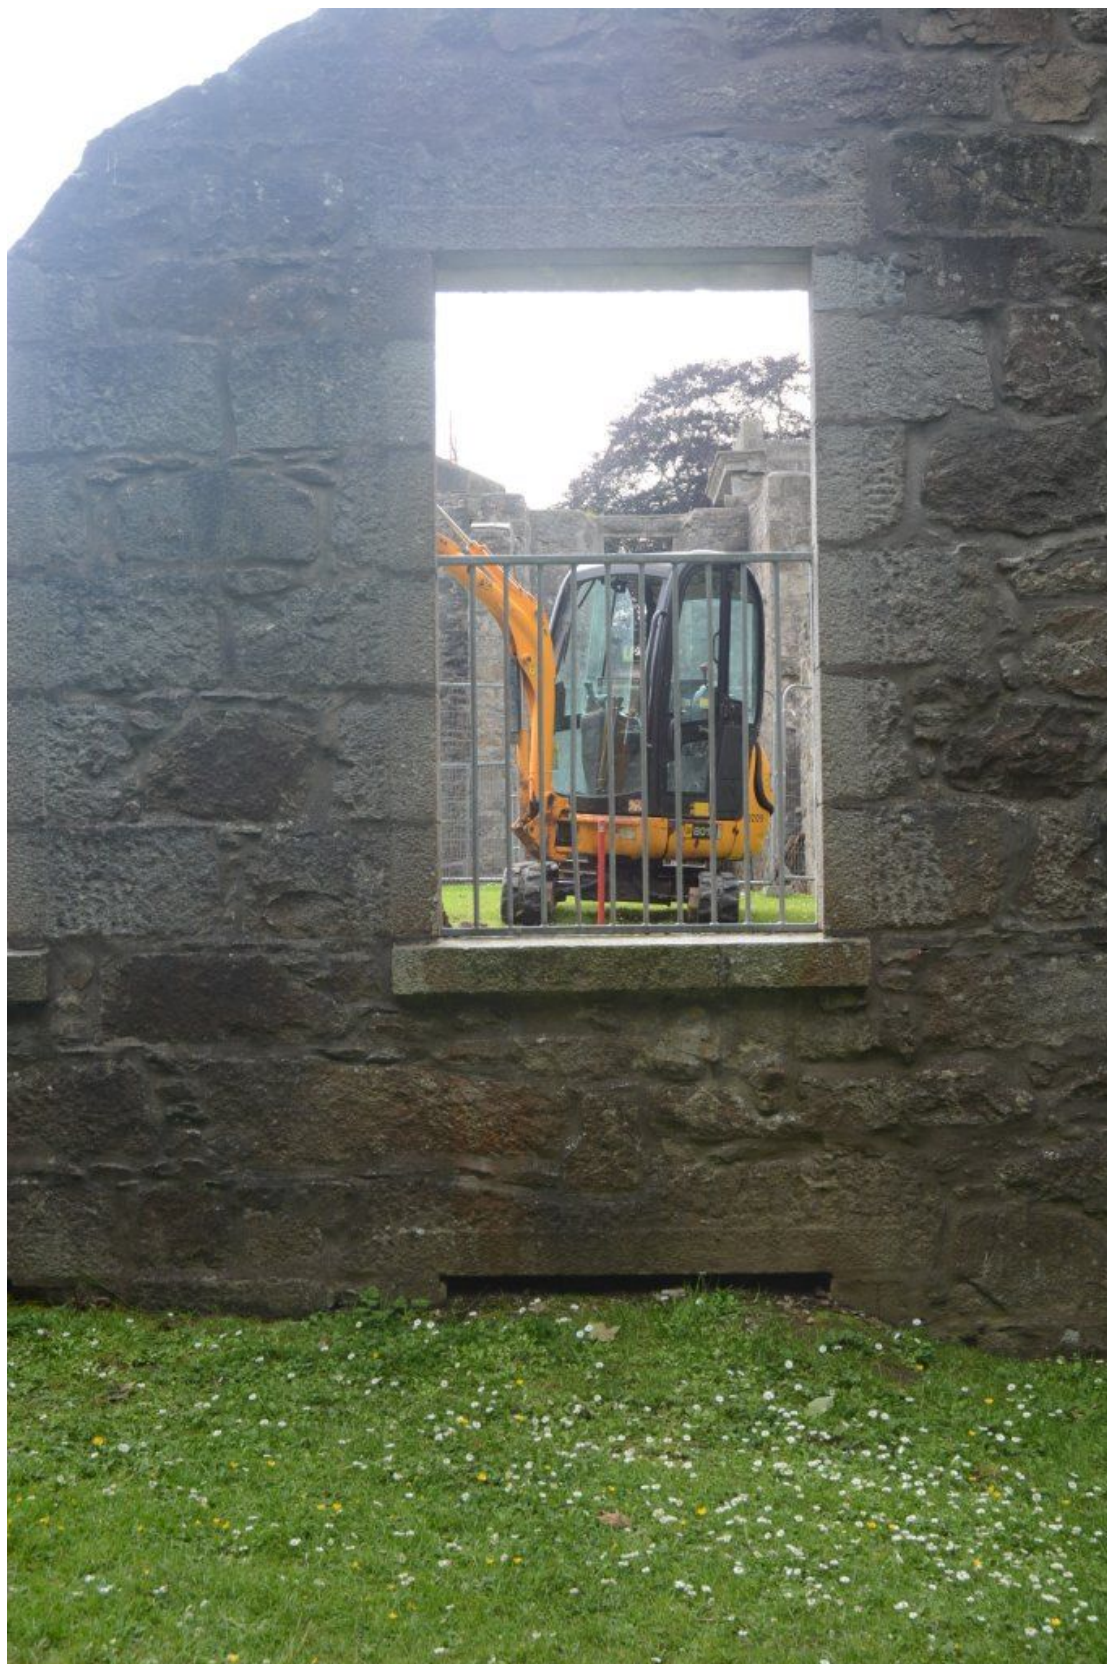
Below this window on the outside, there is the visible top of a lower 'vent', 930mm below the sill of the upper window (Illus 20).

**Illus 20 Location of TP3 in relation to window and vent in N wall of Small Pantry**
