DRIVEWAY REPAIRS
DRUM CASTLE
ABERDEENSHIRE

Archaeological Watching Brief
Carried out between February and May 2015
by
Murray Archaeological Services Ltd

Report No: MAS 2015-9
by
H K Murray and J C Murray

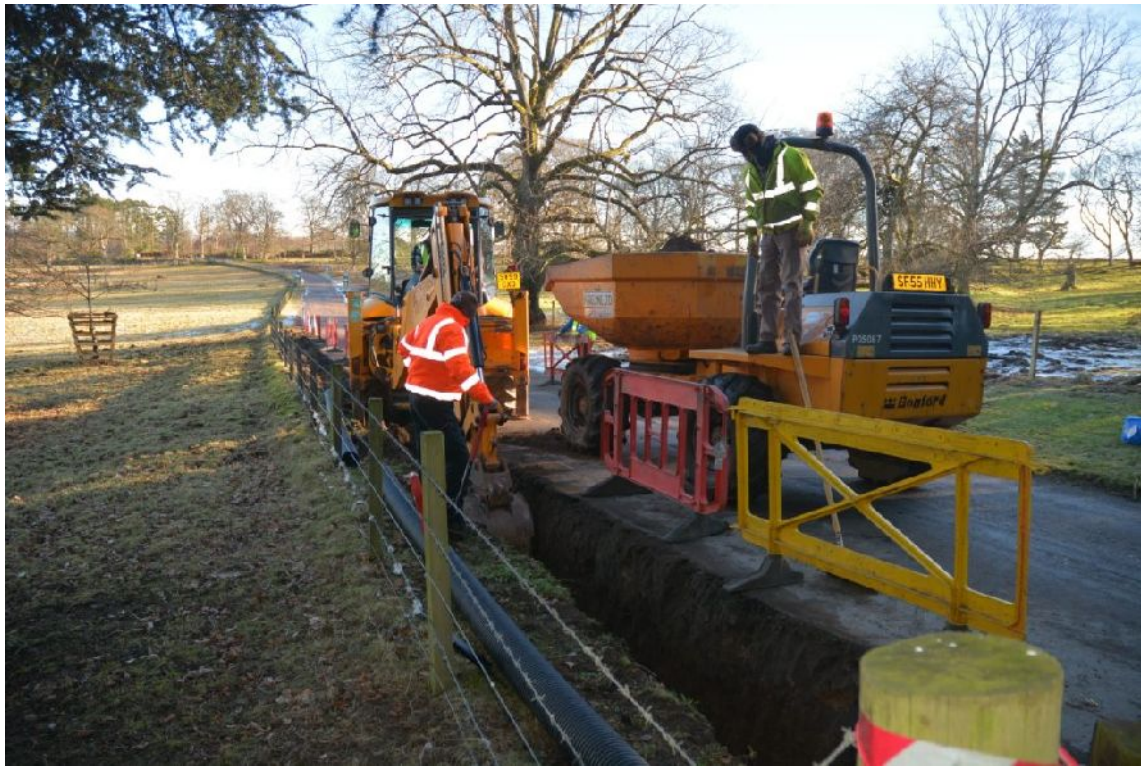
Illus 1 Cutting drain trench 1

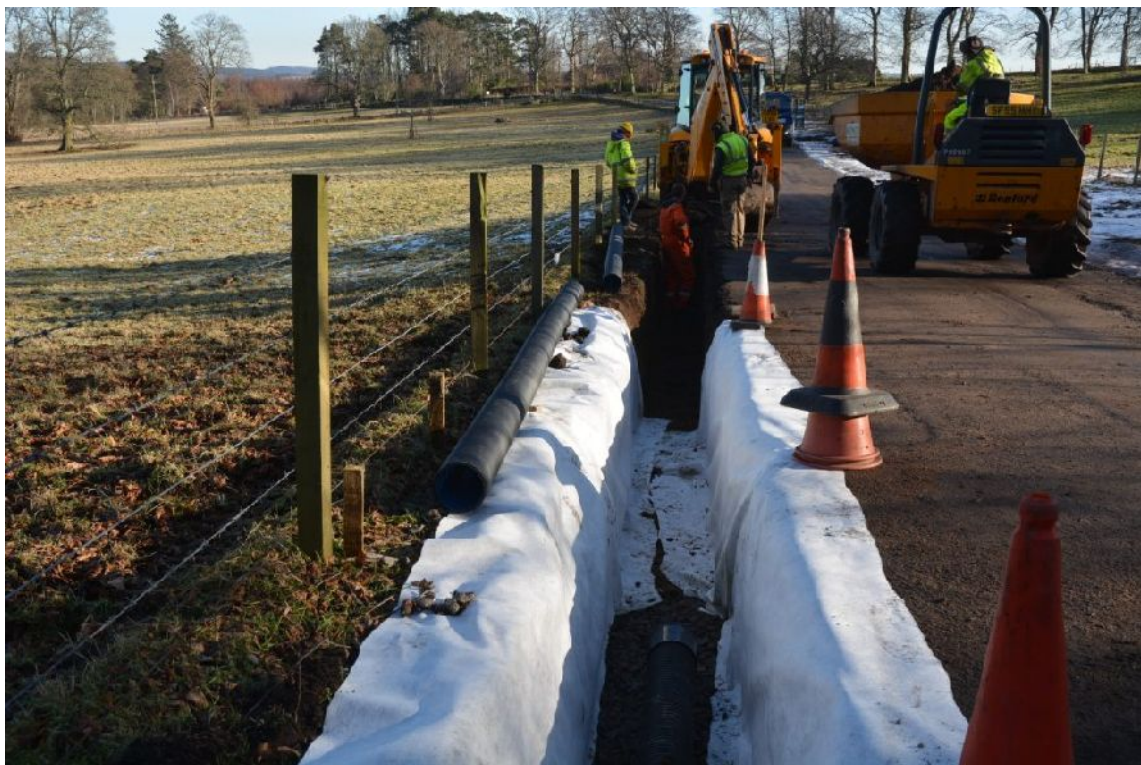
Illus 2 Drain trench lined with geotextile. Plastic pipe and gravel filled in.

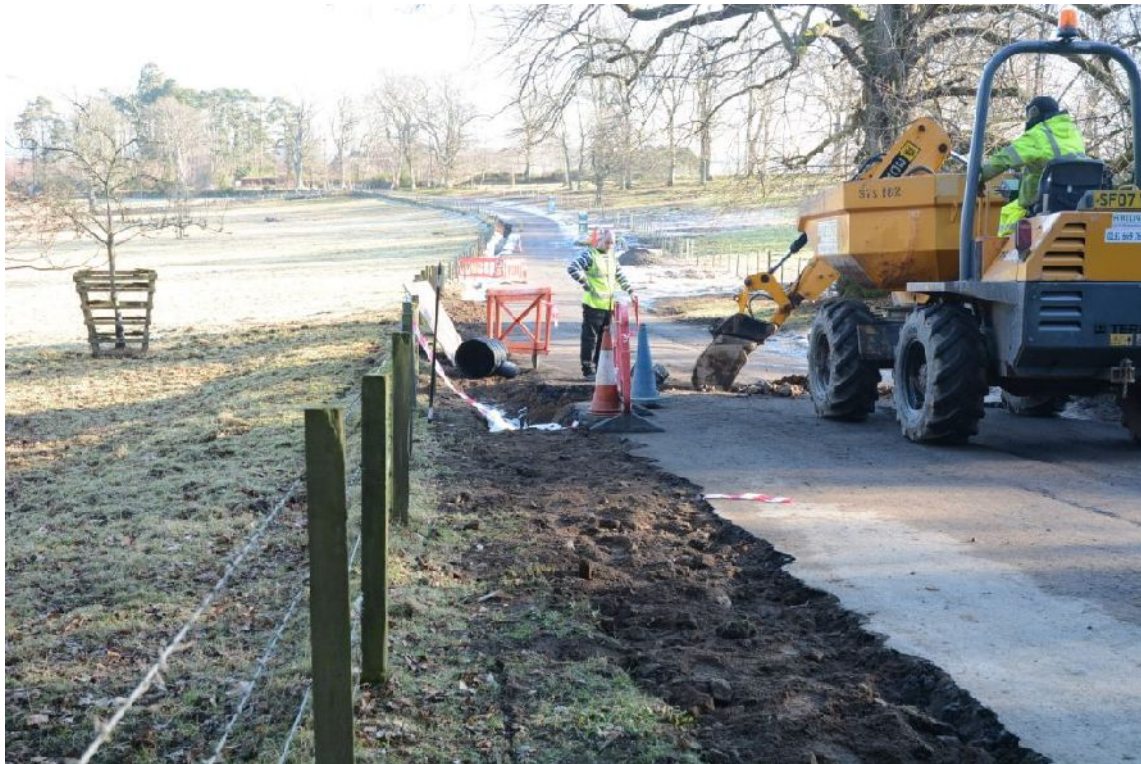
Illus 3 Thin layer of topsoil recovered over gravel in drain trench

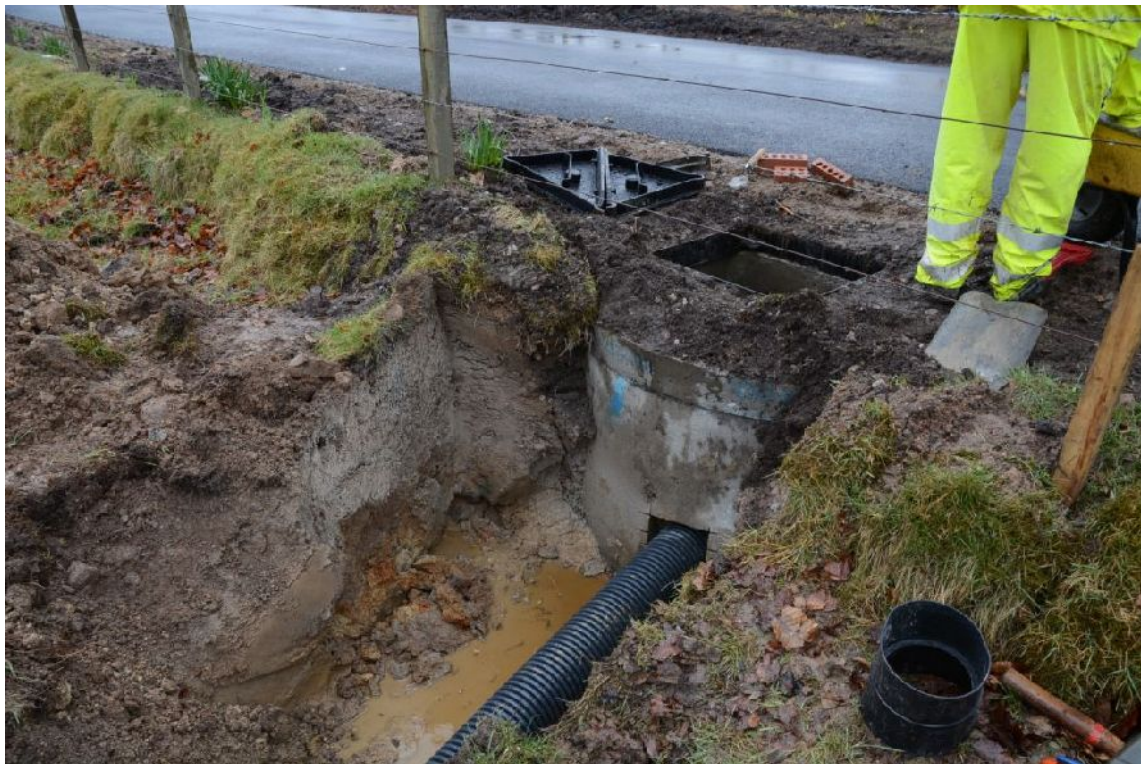
Illus 4 Silt trap in drain trench 1 with outlet to drain trench 2 into field

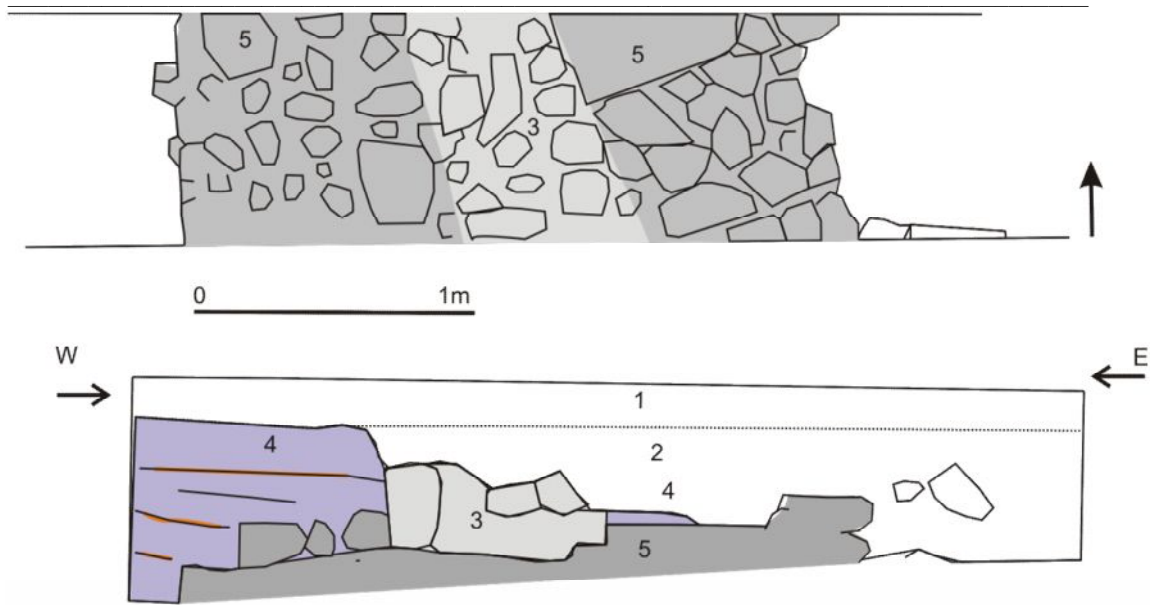
Drain trench 3 cut across the basal foundations of a substantial stone wall (illus 6-9) at GPS: 379655,800546. The wall (illus 6: layer 5), which appears to run N/S at this point, was c. 2.25m wide. A fairly good straight edge survived on the W side but the E side had been damaged by the machine. An old drain had cut across the middle of the wall leaving an area of more disturbed stones c. 500mm wide (layer 3: paler on plan and elevation in illus 6). The wall was directly on natural. After it had been demolished it had been sealed by a black and orange layer of burnt material (section: layer 4. illus 6, 9) – this was cut by the later drain. Layer 2 (illus 6) comprised disturbed yellow clay/redeposited natural with stones and may have included debris from the wall. Layer 1 (illus 6) comprised road make-up on the N side and grass and topsoil on the S side. A single, very abraded, sherd of medieval or post-medieval pottery was found in the disturbed layer 2 and does not give any reliable dating for the wall itself.

Illus 6 Plan and section of wall Context 28.

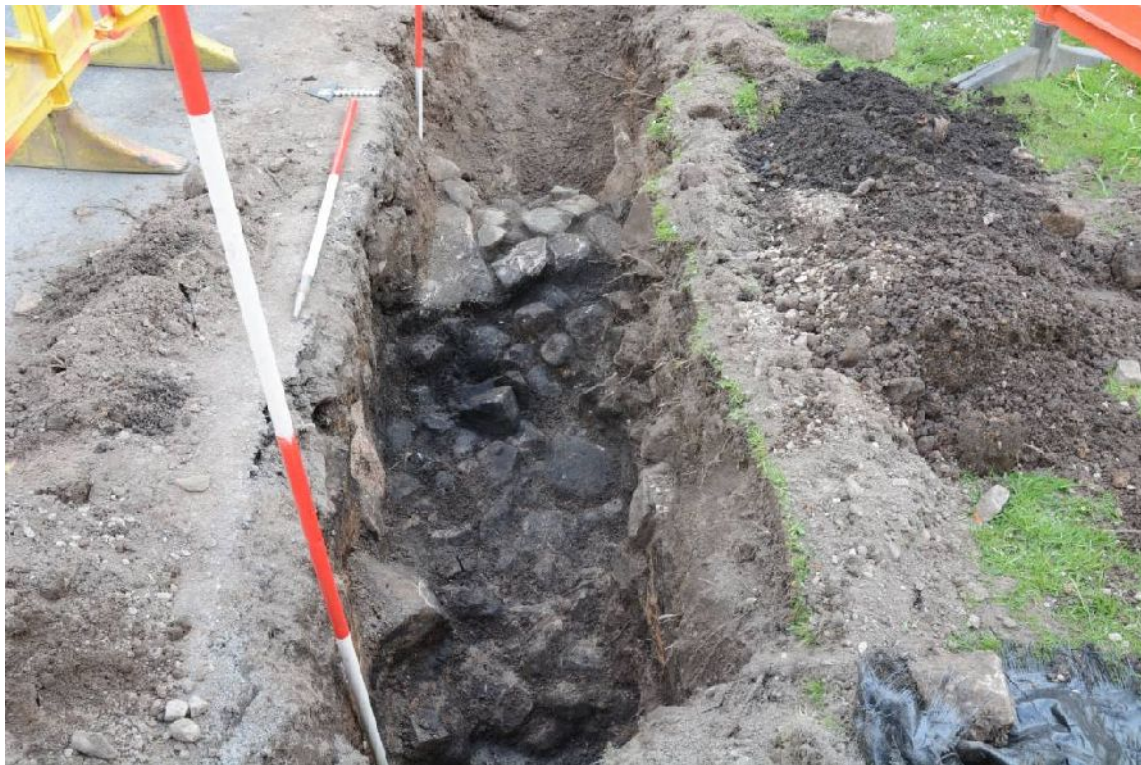
Illus 7 Wall 28, looking E

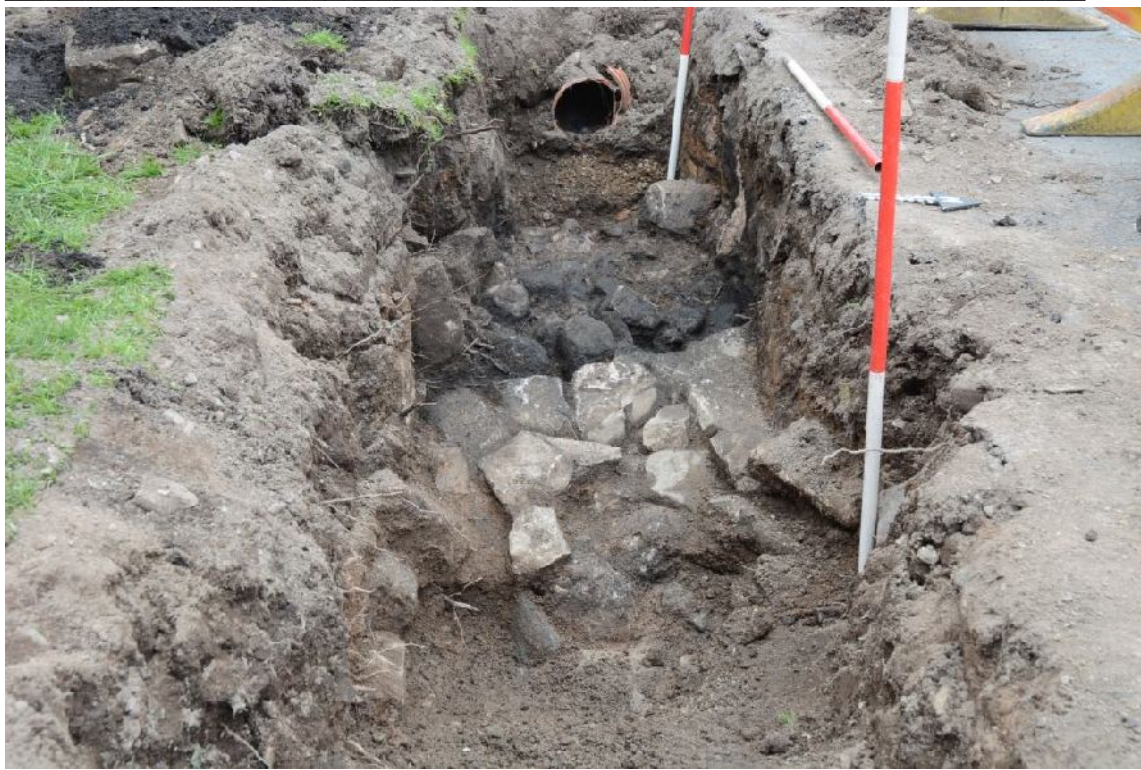
Illus 8 Wall 28 looking W

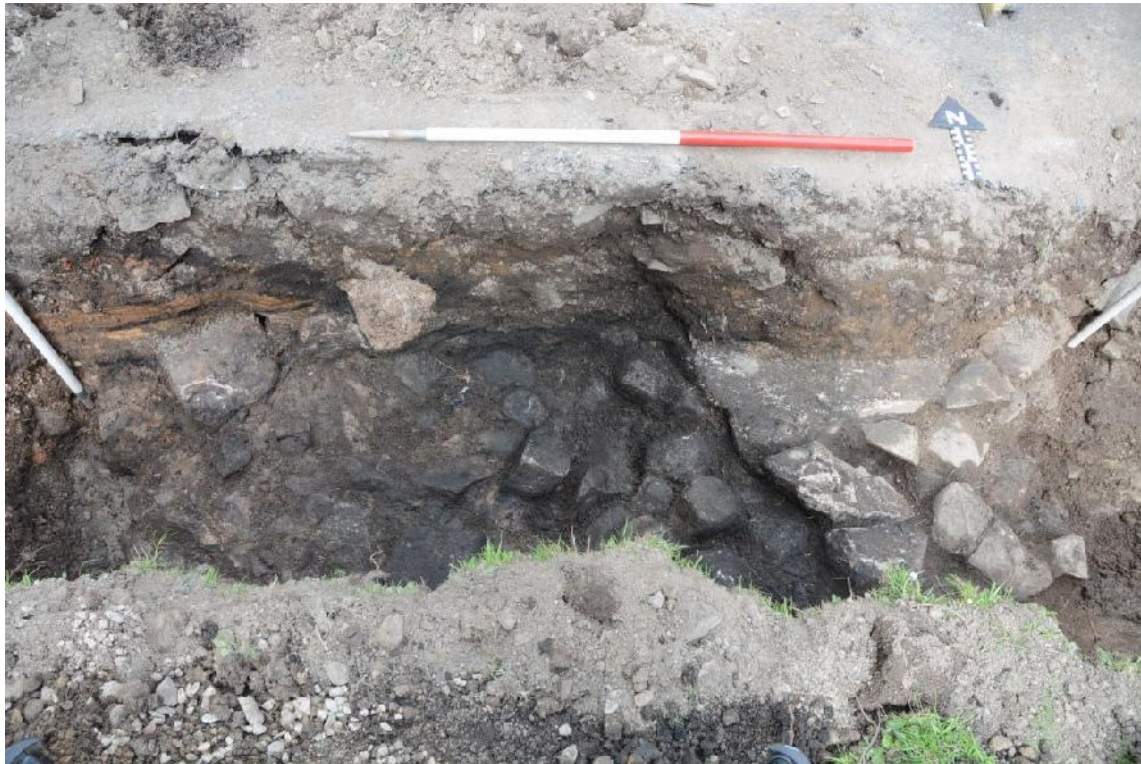
Illus 9 N section across wall 28 showing burnt layers and the disturbed central drain cut

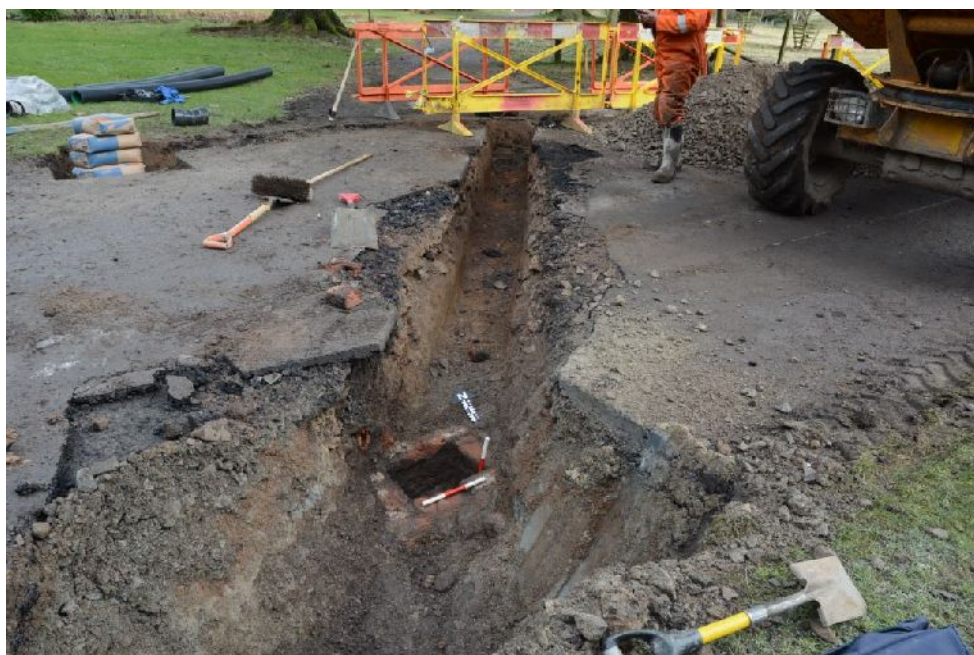
An early drain sump (illus 10-12) was excavated at 379709, 800531 in Road Crossing 2, 1.20m N of the S side of the drive. It was 360 x 260mm formed of a red brick surround, and 250mm deep with a base onto natural. The bricks were 200-250 x 100 x 60mm. The associated pipe was 70mm (3") in diameter. Dressed granite slabs and an iron grill found in the overlying disturbed ground appeared to have been displaced from the sump.

Illus 10 Road crossing 2 with drain sump 27

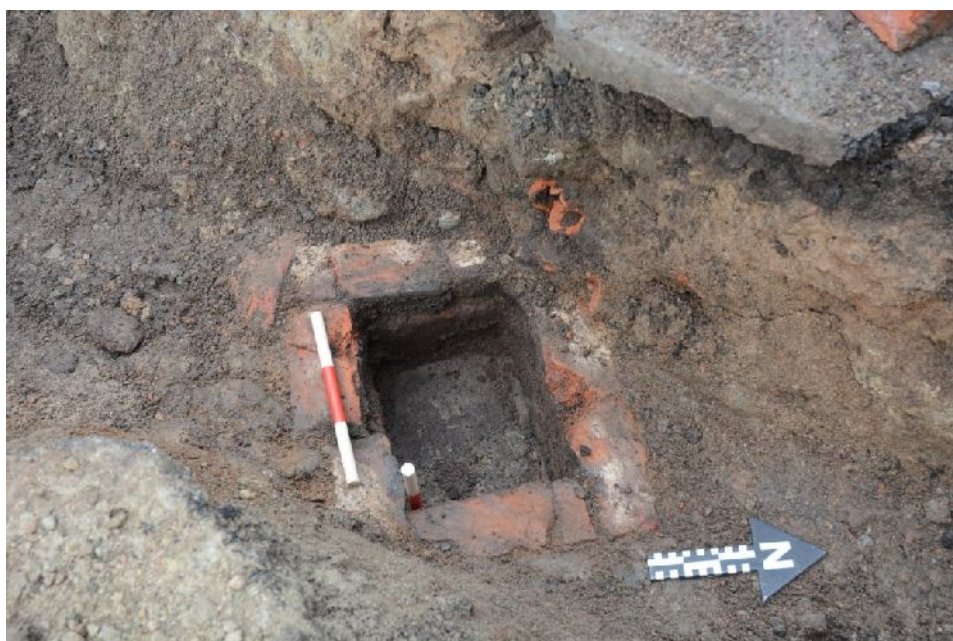
Illus 11 Detail of brick drain sump 27

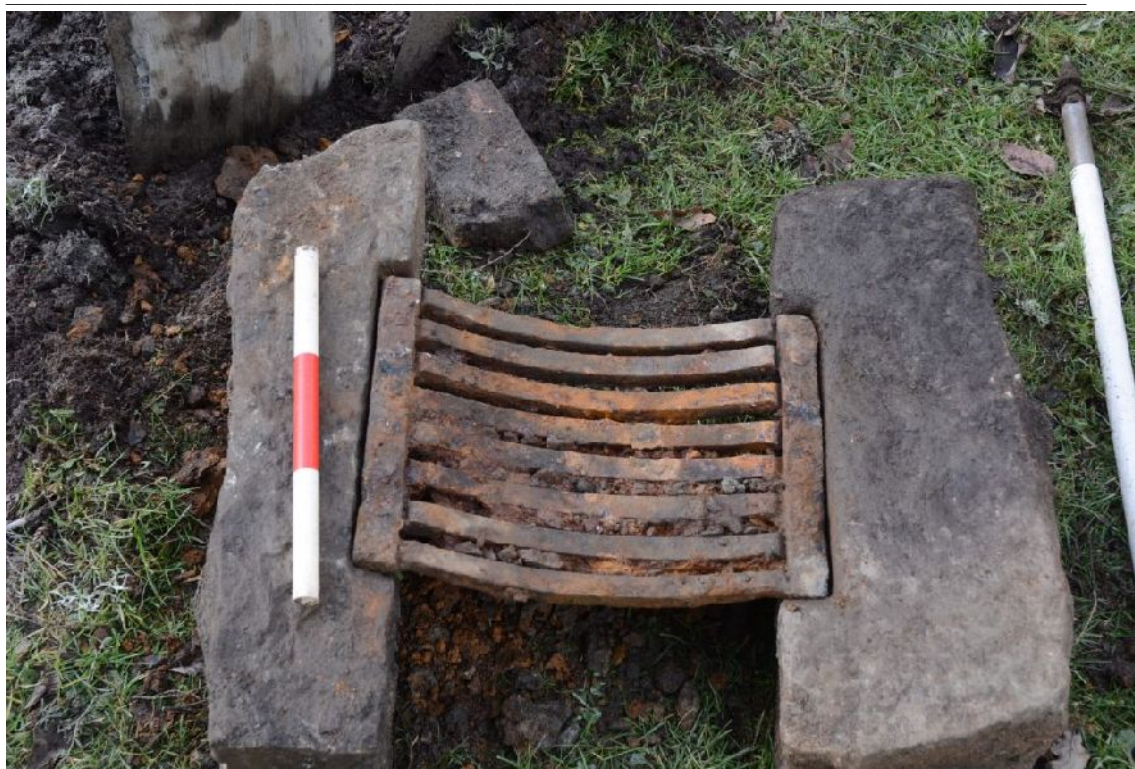
Illus 12 Stone surround and iron grill displaced from drain sump 27

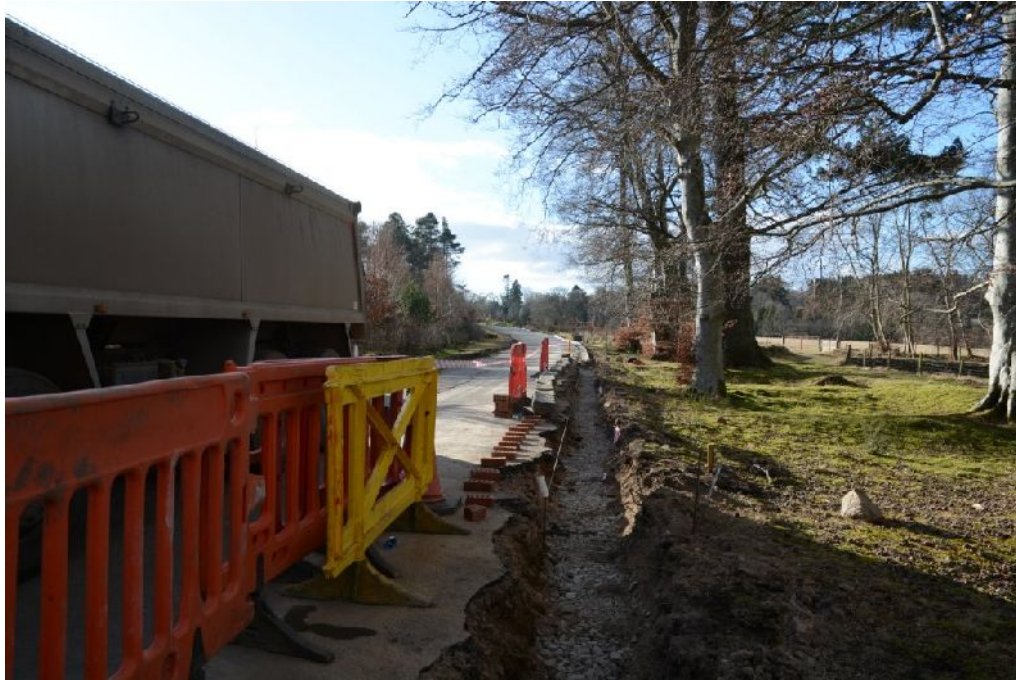
The trench in this area was only 300mm deep to set a stone kerb. It did not cut through the rig and furrow (NMRS No: NJ80SW166 Canmore id 339496) which does not survive this close to the road.

Illus 13 Kerb trench at N side of drive beside rig and furrow (which is just visible to RHS of trees).

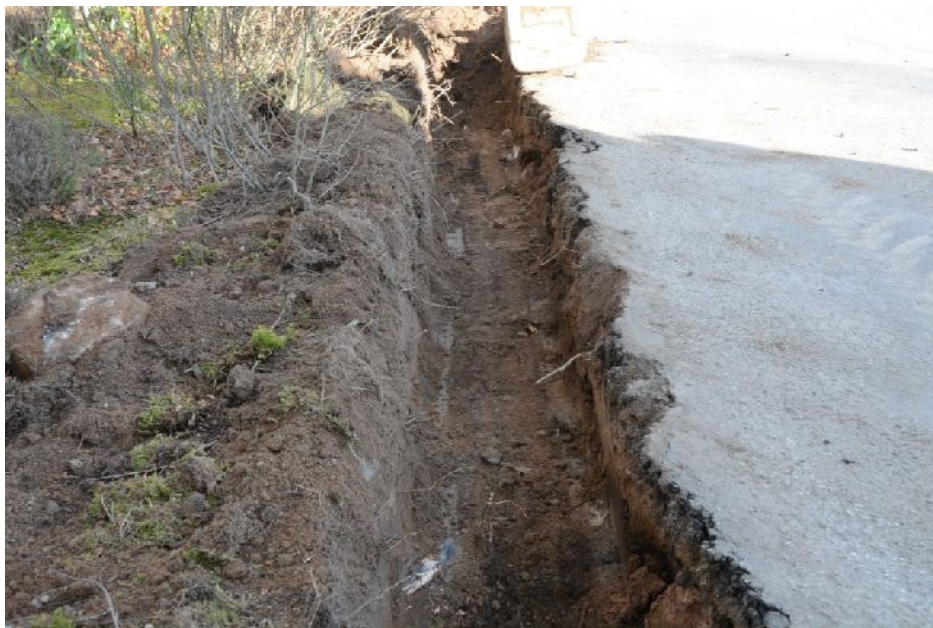
Illus 14 Detail of kerb trench beside rig and furrow

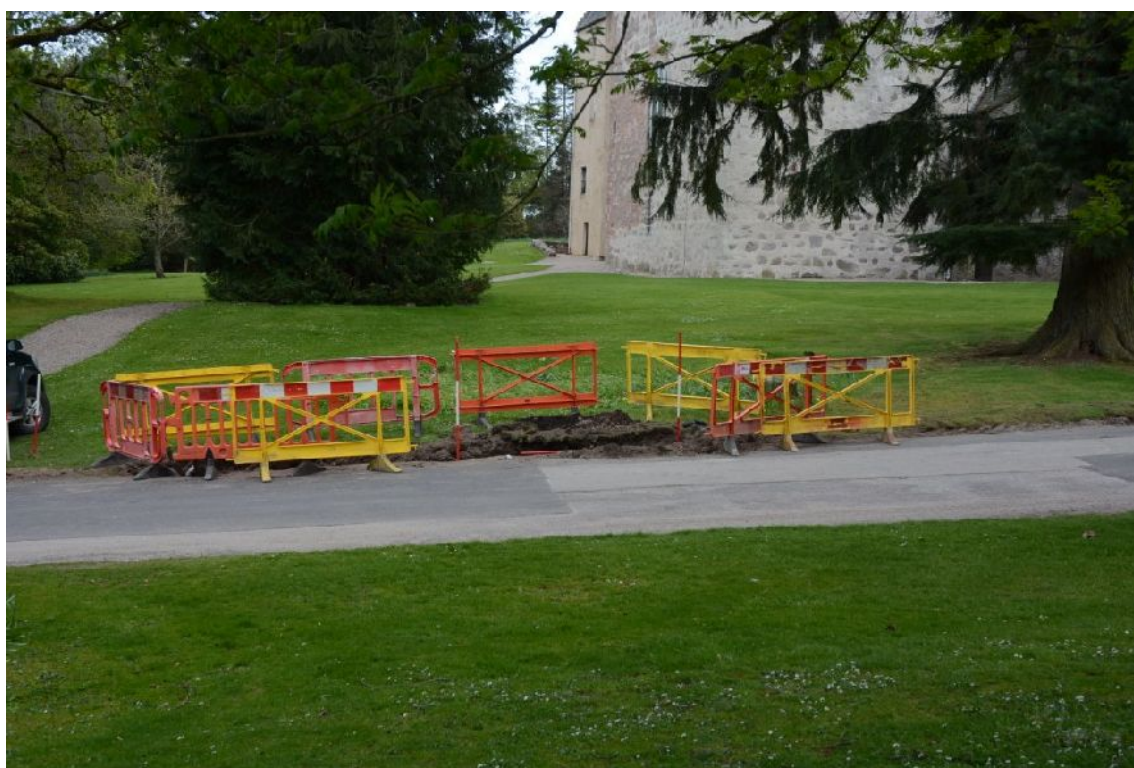
The wall (28) recorded in this area appears to show on the resistivity survey as an isolated area of high resistance (Ovenden, 2014, fig 4: No number). The isolation may however be illusory as there are large uncharted areas because of the nearby trees. The width of the wall suggests that this potentially may have been the base of an early wall enclosing the tower. It is however perhaps surprising that it comprised relatively small stones and some caution should be given to its interpretation. It is very different from the stones observed on the N side of the driveway in 1995 by Robin Turner (Drum archive DRU/A054) which were interpreted, probably correctly, as a garden feature.

Illus 15 Wall 28 in relation to tower. (Ranging rods indicate the E and W faces of wall.)
