**DRIVEWAY REPAIRS
CASTLE FRASER
ABERDEENSHIRE**

Archaeological Watching Brief
Carried out between April and June 2015
by
Murray Archaeological Services Ltd

Report No: MAS 2015-18
by
H K Murray and J C Murray

-Archaeological watching brief-

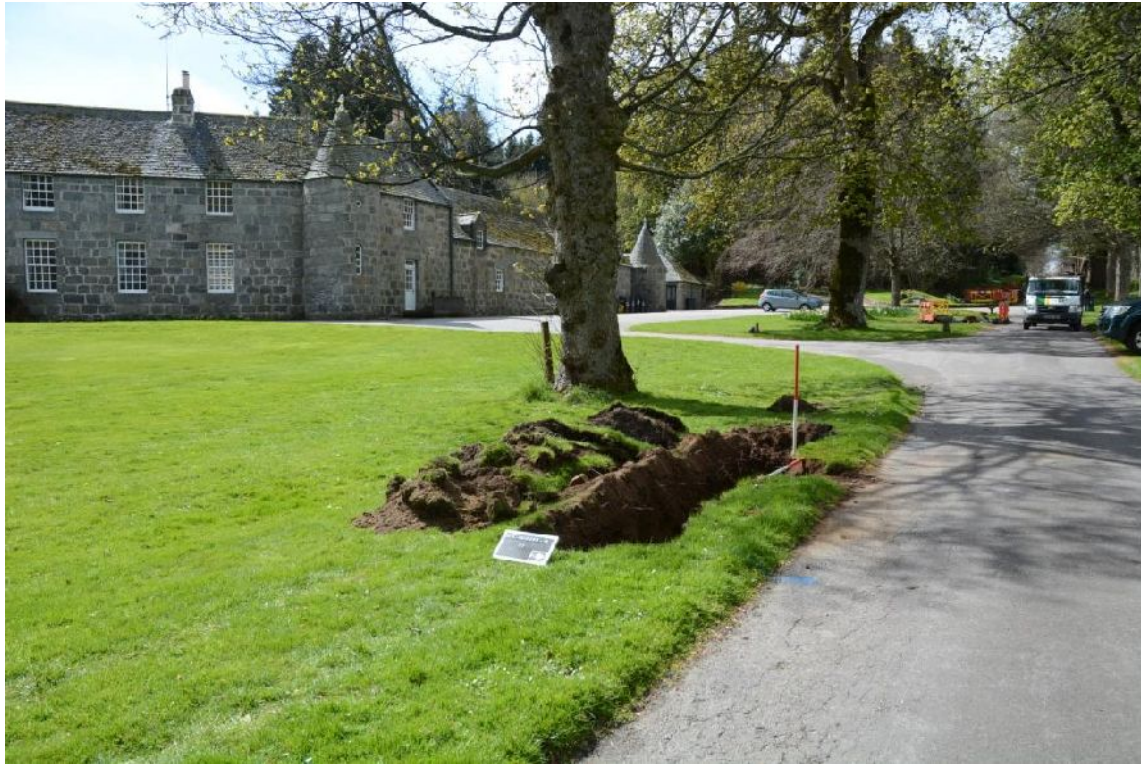
Illus 1 Position of grip 9 (originally numbered T3)

Drainage grips 1-3 and 7-14 showed that there is a considerable deliberate build up of deposited earth and, in the case of grips 1 and 2, rubble, used on either side of the W drive. This was not apparent in grips 4-6 which were placed further from the road to avoid the water main. While it is possible that some of this deposit may be derived from the construction of the water main trench along the S side of the drive, it may also have been a deliberate attempt to create a level carriageway. No road crossings were undertaken in this area so it is unclear to what extent the road itself was built up.

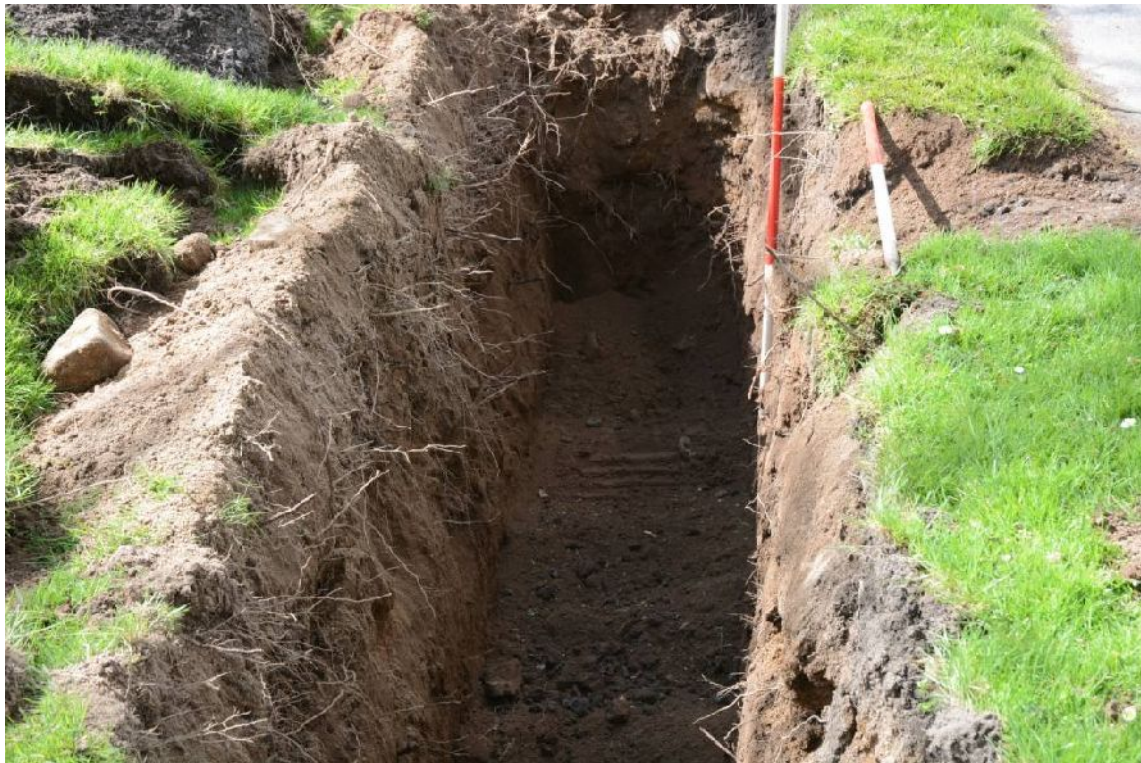
Illus 2 Detail of grip 9 showing depth of build-up.

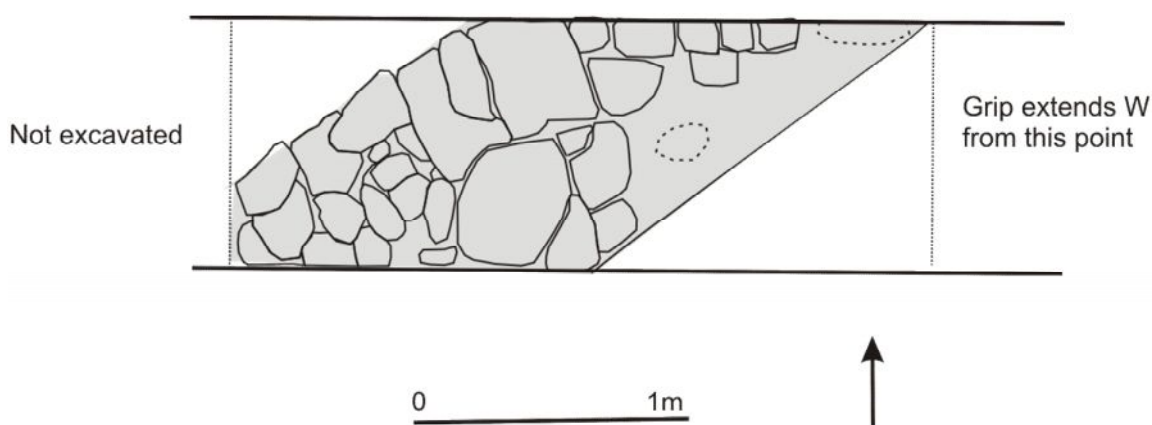
When topsoil was excavated in grip 17 the top of a wall running NE/SW across the trench was revealed. This was further excavated by hand, recorded and backfilled and the grip was extended E of the wall.

The wall was c.900mm wide and c.2.5m was revealed. There were larger stones on the less disturbed N edge but many of the stones in the wall core were fairly small. The base was on natural but no obvious wall cut was visible within the trench. Up to c.400mm height survived. It was sealed by 600-780mm topsoil and there was 50-100mm of light yellow sandy soil, possibly mortar, over the N edge. To the N the ground below the level of the wall was dark brown, more compact earth with some charcoal. To the S undifferentiated topsoil extended to c. 900mm on to the natural. This gives some impression that NW was 'within' an enclosed area relating to the castle and SE was 'outside' that area.

Illus 5 Plan of wall A

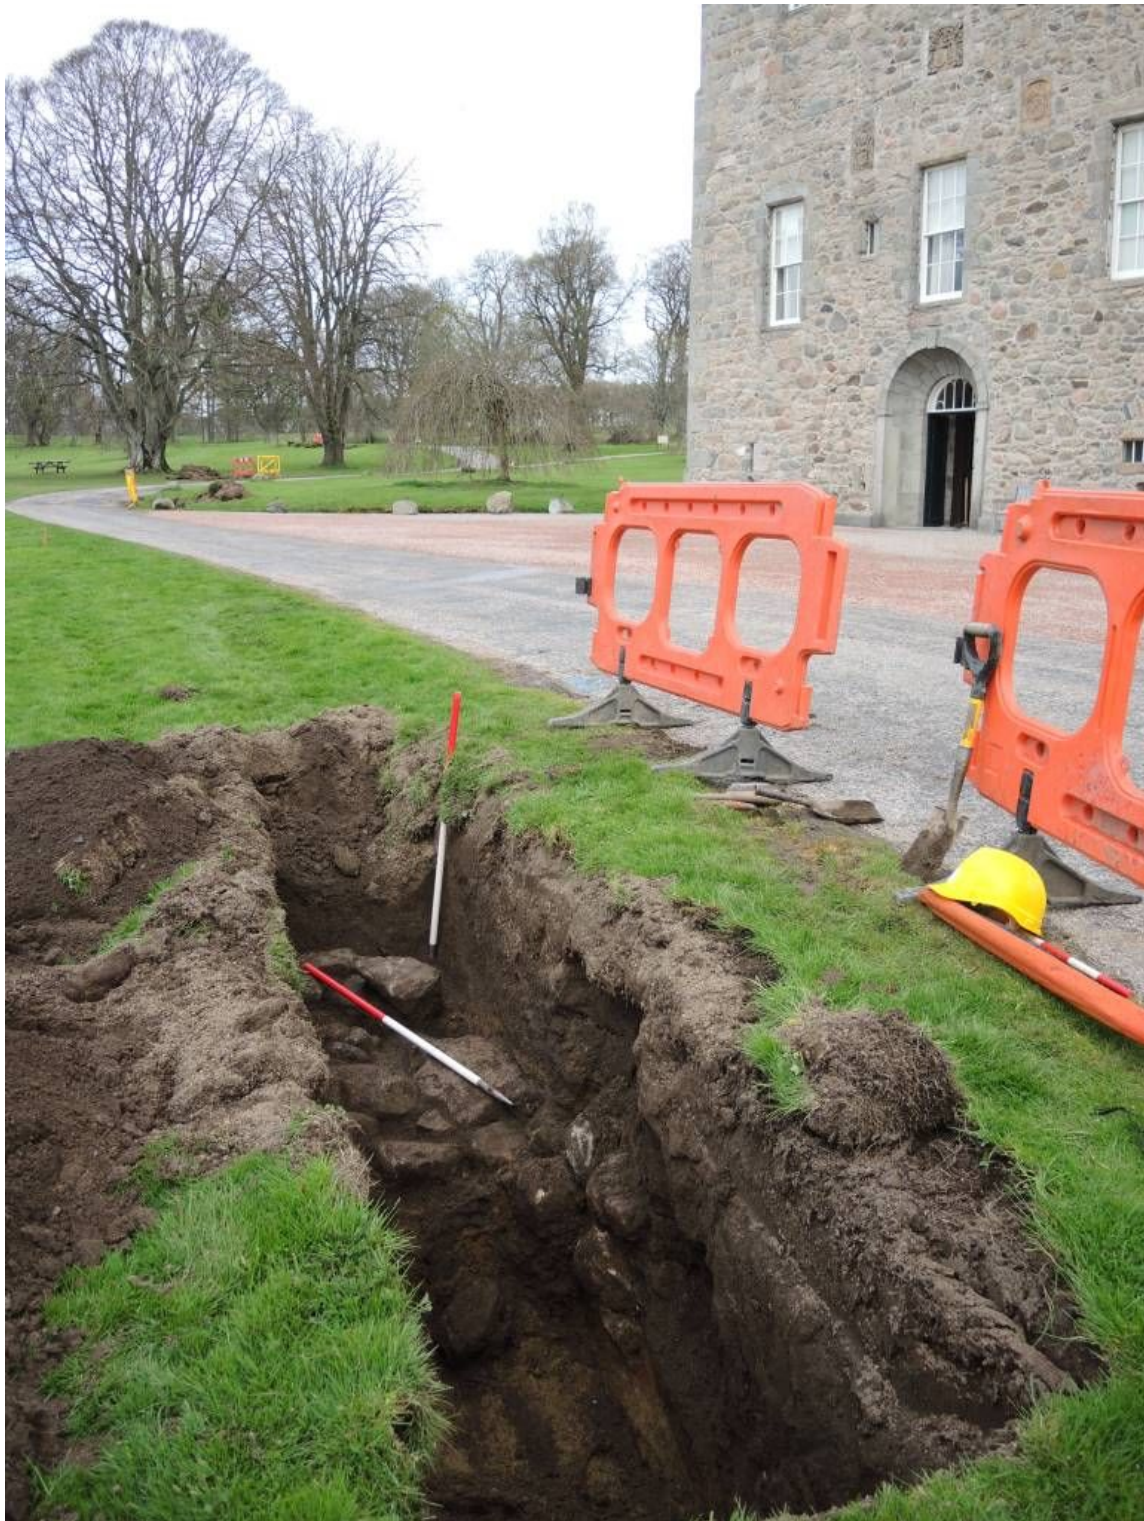
Illus 6 Position of wall A in Grip 17 in relation to castle

Drainage grip 15 showed only shallow (300mm) topsoil, but the three grips (16-18) S and SE of the castle all had up to 1m of deposited topsoil and rubble, indicating perhaps some of the levelling of the immediate castle environs in the late 18th century. This is likely to have happened in or around 1796 when the old garden at the E of the castle was dismantled and moved and the present landscape developed (Murray & Murray 2010). Wall A in grip 17 is not shown on the 1799 estate map or subsequent OS maps. Nor is it shown on the 1788/9 estate plan that shows the earlier garden layout. It does not appear to relate to the stone culvert found further E in 2014 during drainage works (Murray & Murray 2014). It is possible, therefore that this may be a late medieval wall.

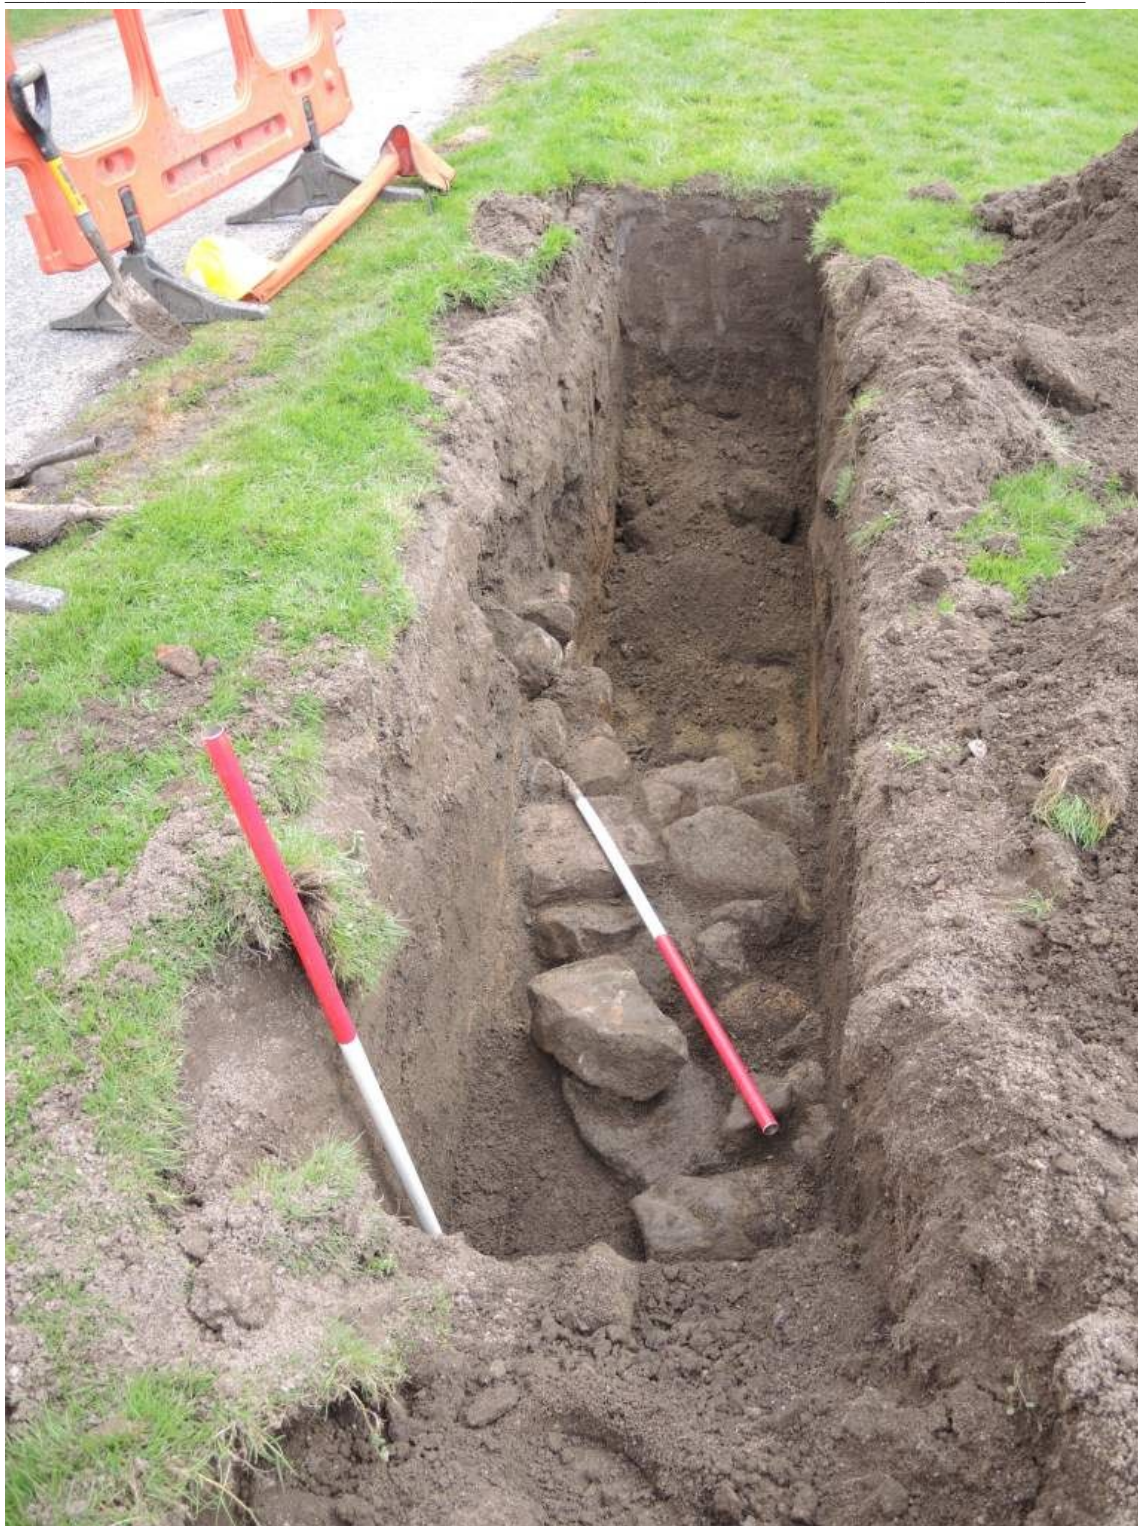
Illus 7 Detail of wall A looking E

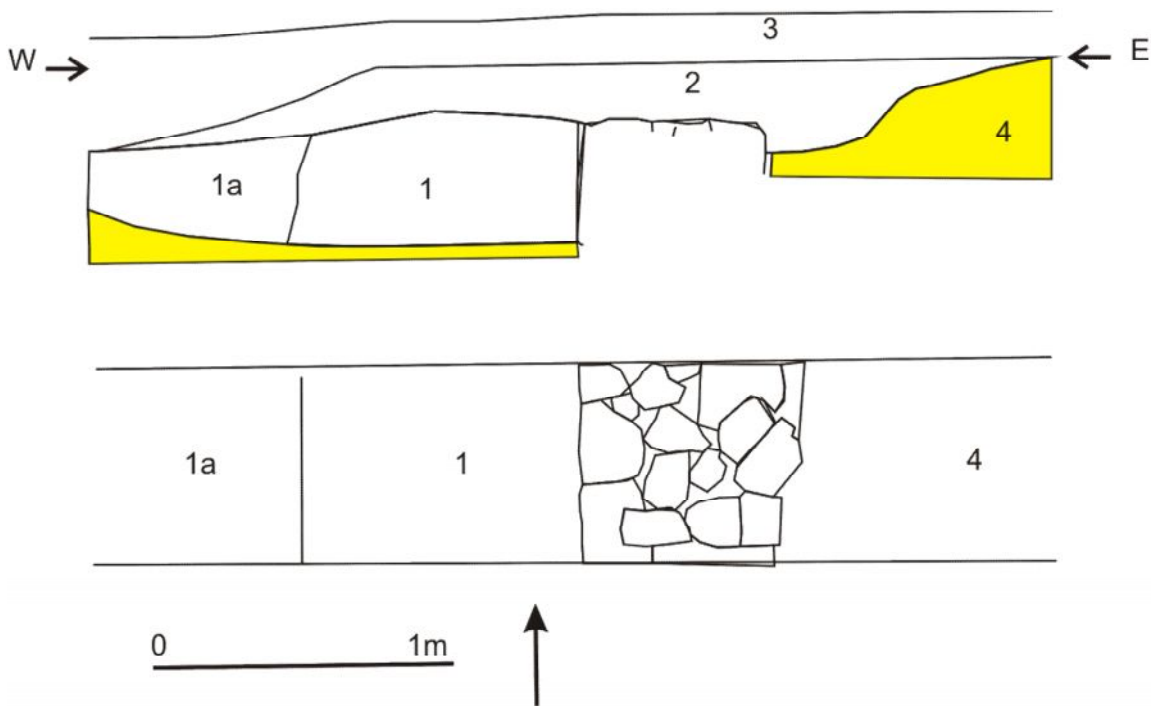
Wall B ran N/S across drain trench 1, in the grass to the NE of the archway into the courtyard. The wall was 800mm wide and survived to 400mm and up to 3 courses on the W face. The wall was of rubble stones but set with a good vertical face to the W. It had been mortared with a pale white/yellow sandy mortar. The E face was cut into the natural (Illus 8: layer 4). There was a difference of c. 600mm in the depth of natural on either side of the wall; it appears to have been used as a revetting wall against a deliberate cut into the natural. The lower ground to the W had been built up to the height of the surviving wall with brown earth (Illus 8: 1) containing some rubble, stone, slate and mortar and fragments of glass and animal bone, all of probable 19th century date. The amount of stone reduced away from the wall face (Illus 8:1a). A layer of yellow redeposited natural with some stone rubble (Illus 8:2) sealed both this infill to the W and the natural on the E side of the wall, below topsoil (Illus 8:3).

Illus 8 South Section and plan of wall B

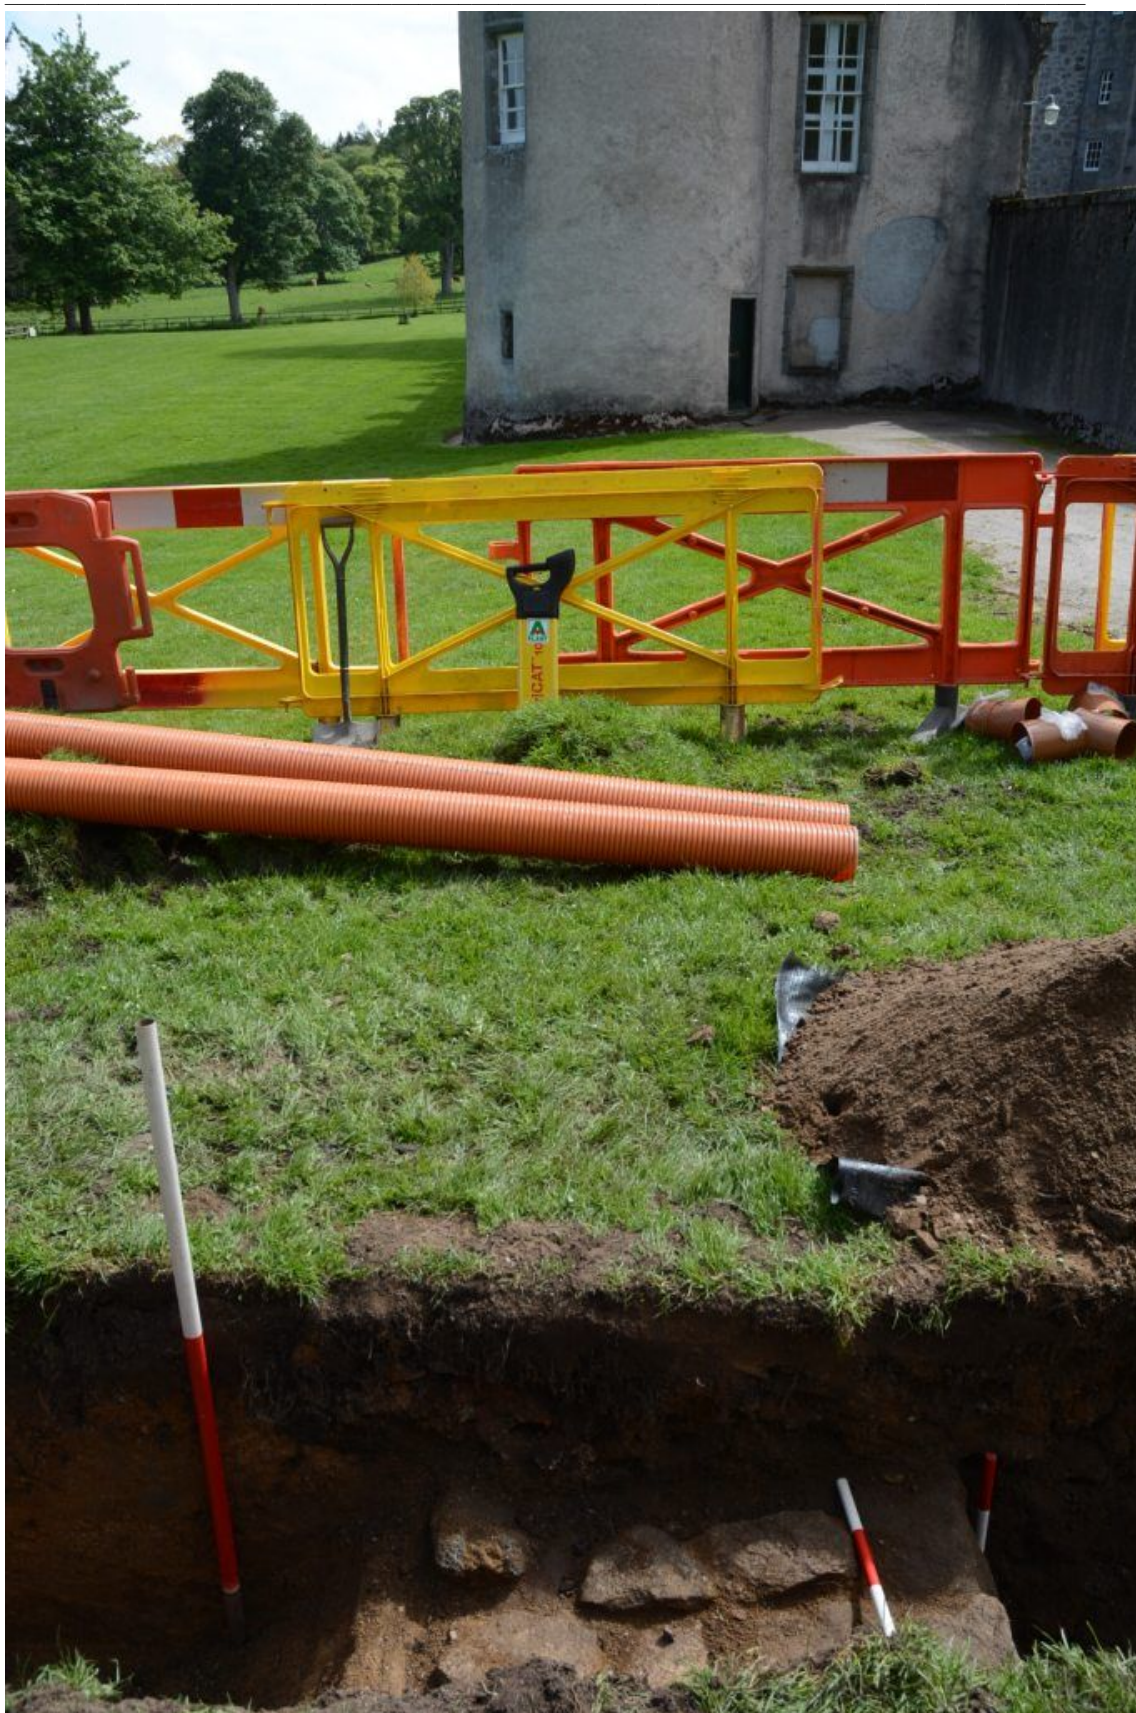
Illus 9 Position of wall B in relation to castle

While it is possible that wall B might be the W wall of the building/structure shown on the 1788/9 estate map in this area N of the original formal gardens (Illus 17), this seems unlikely given the fact that the natural was cut back on the W side and that the good face of the wall lay on the W. It is perhaps possible that this is a revetting wall as indicated on the 1788/9 map and still retained on the OS maps of 1864 (Illus 18) and 1899.

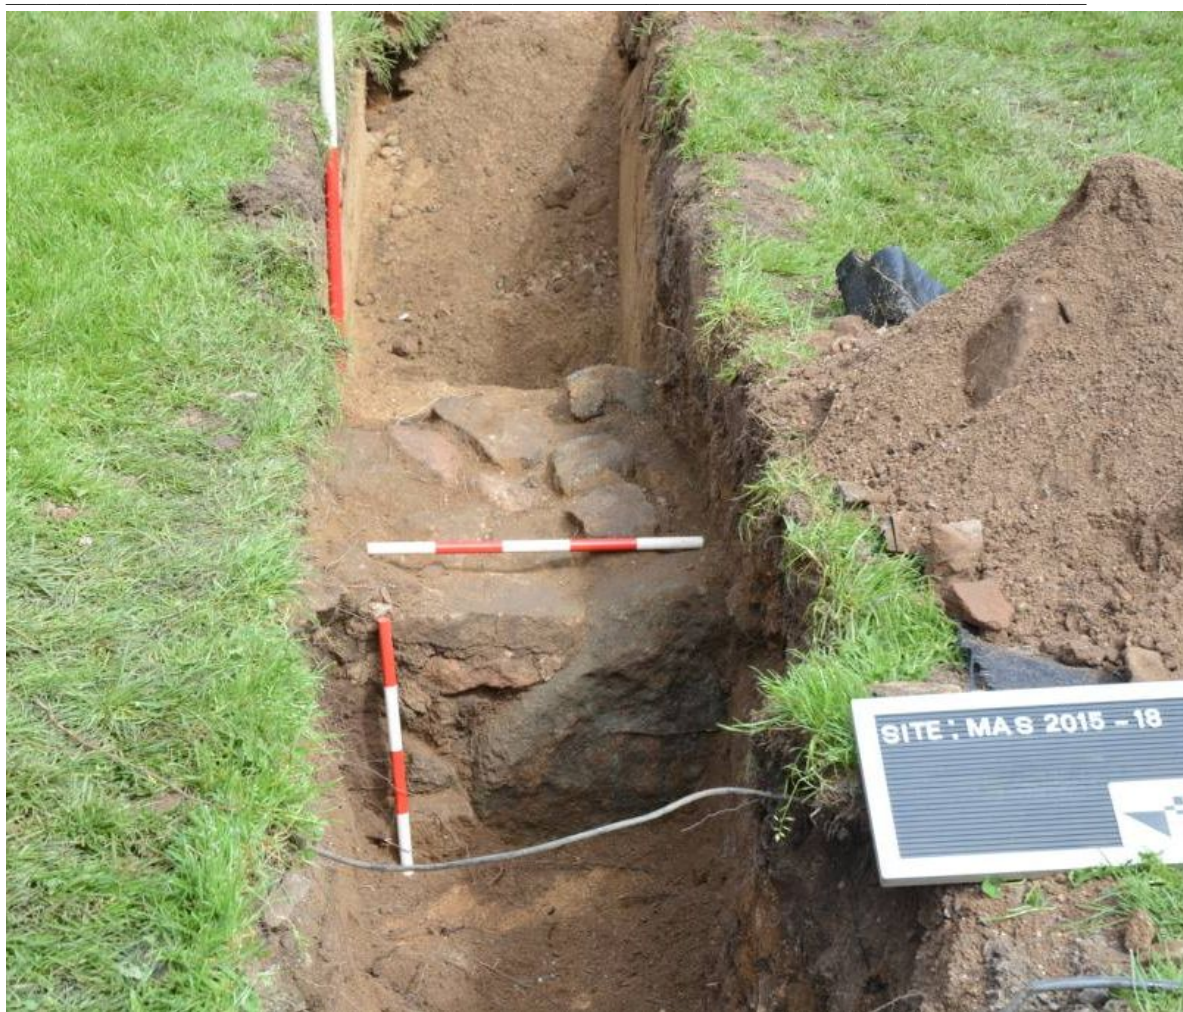
Illus 10 Detail of wall B in Drain trench 1, looking E

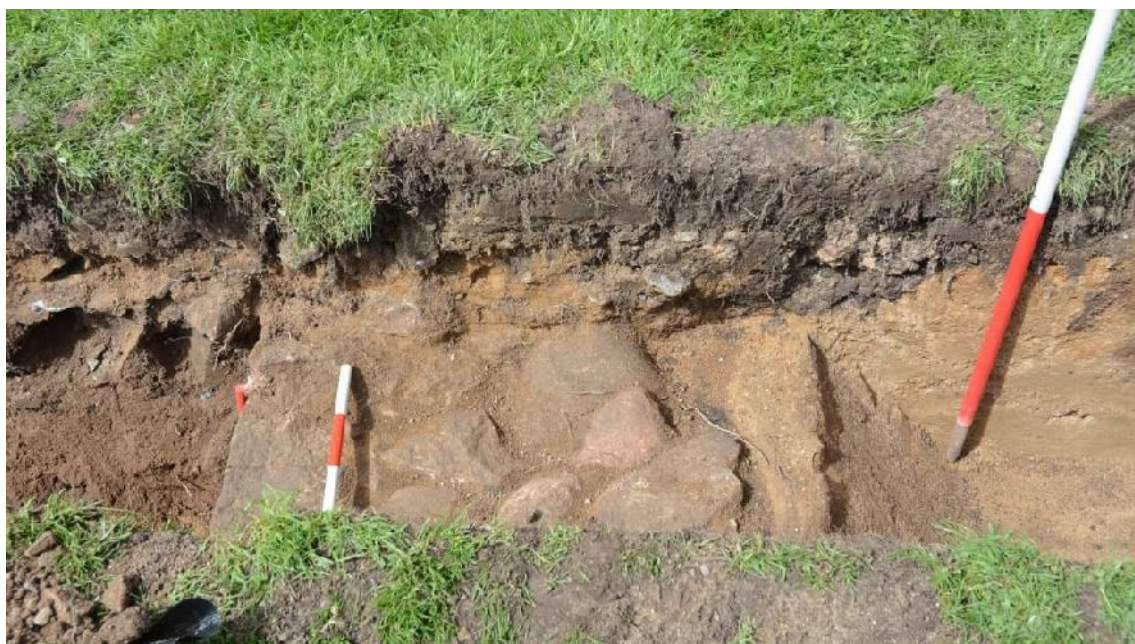
Illus 11 Detail of wall B from above looking S

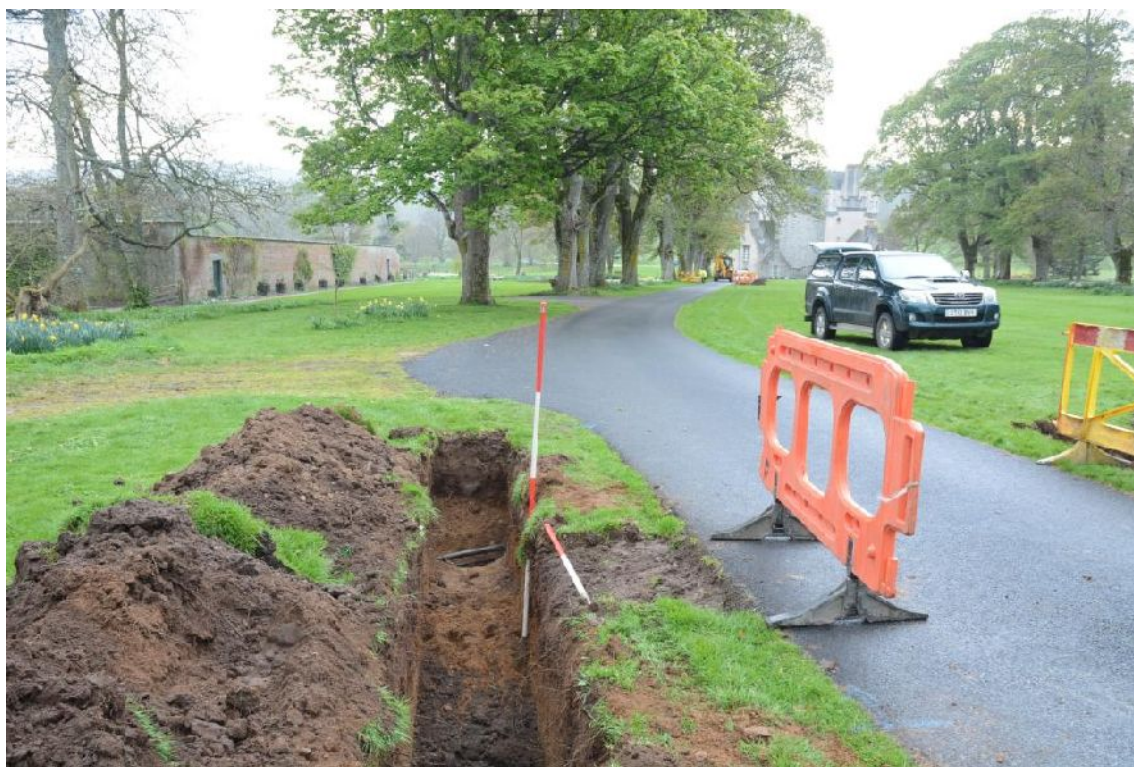
Unlike the W driveway, the N driveway (drainage grips 19-23 and road crossing 1) only had 300-400mm of topsoil above natural.

Illus 12 Grip 23 showing shallow topsoil. Water pipes (F) across S end of trench.

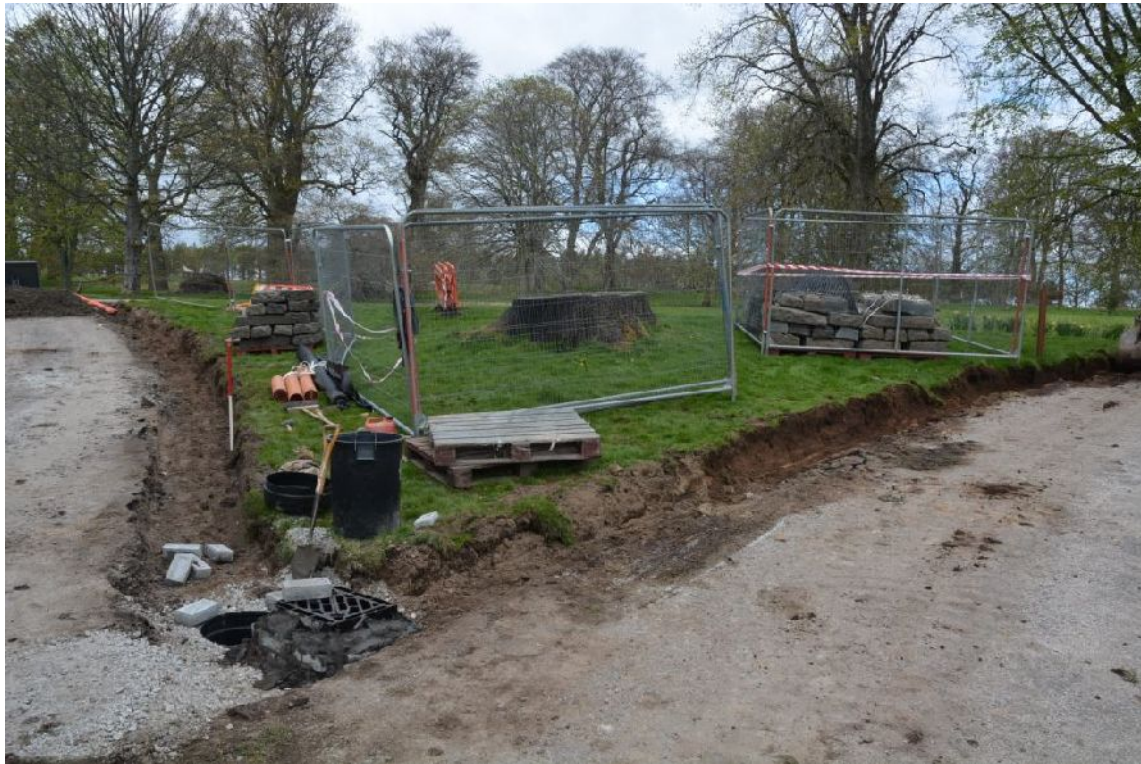
The area W of the castle around the road 'triangle' and in the grass to the W showed only a moderate degree of soil deposition, with up to 600mm topsoil, such as might have

Illus 13 Triangle area

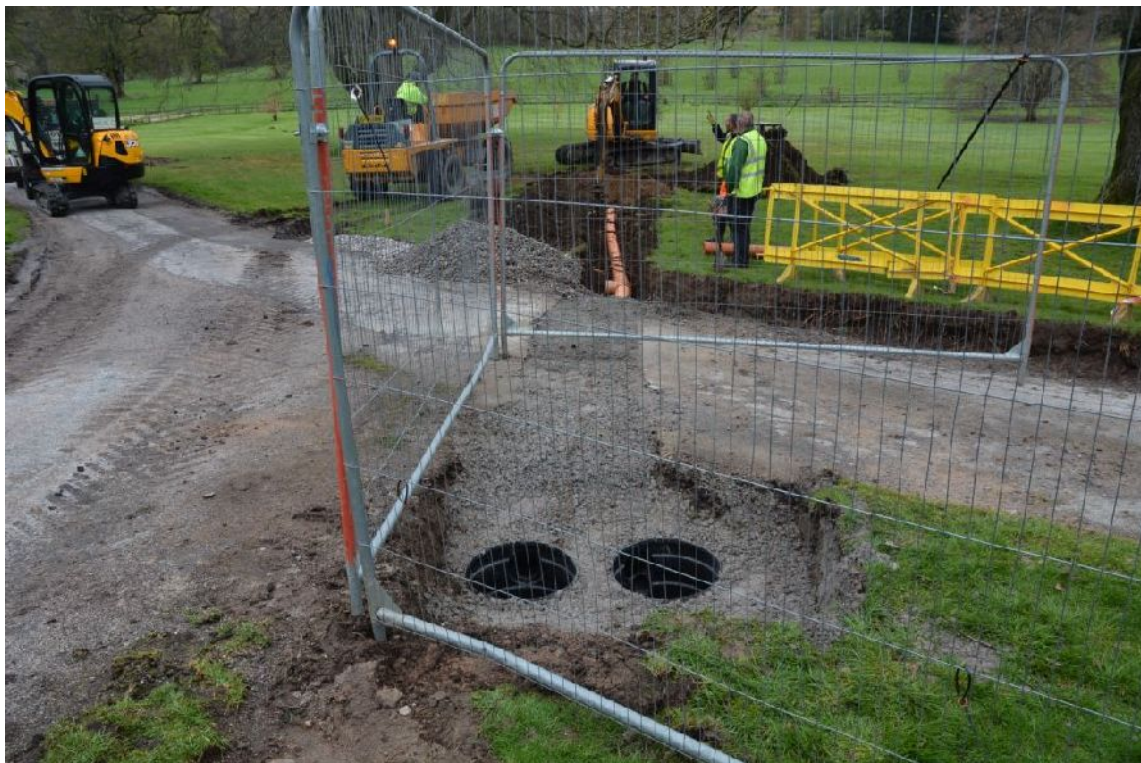
Illus 14 Drain from triangle to soakaway in grass to W of castle

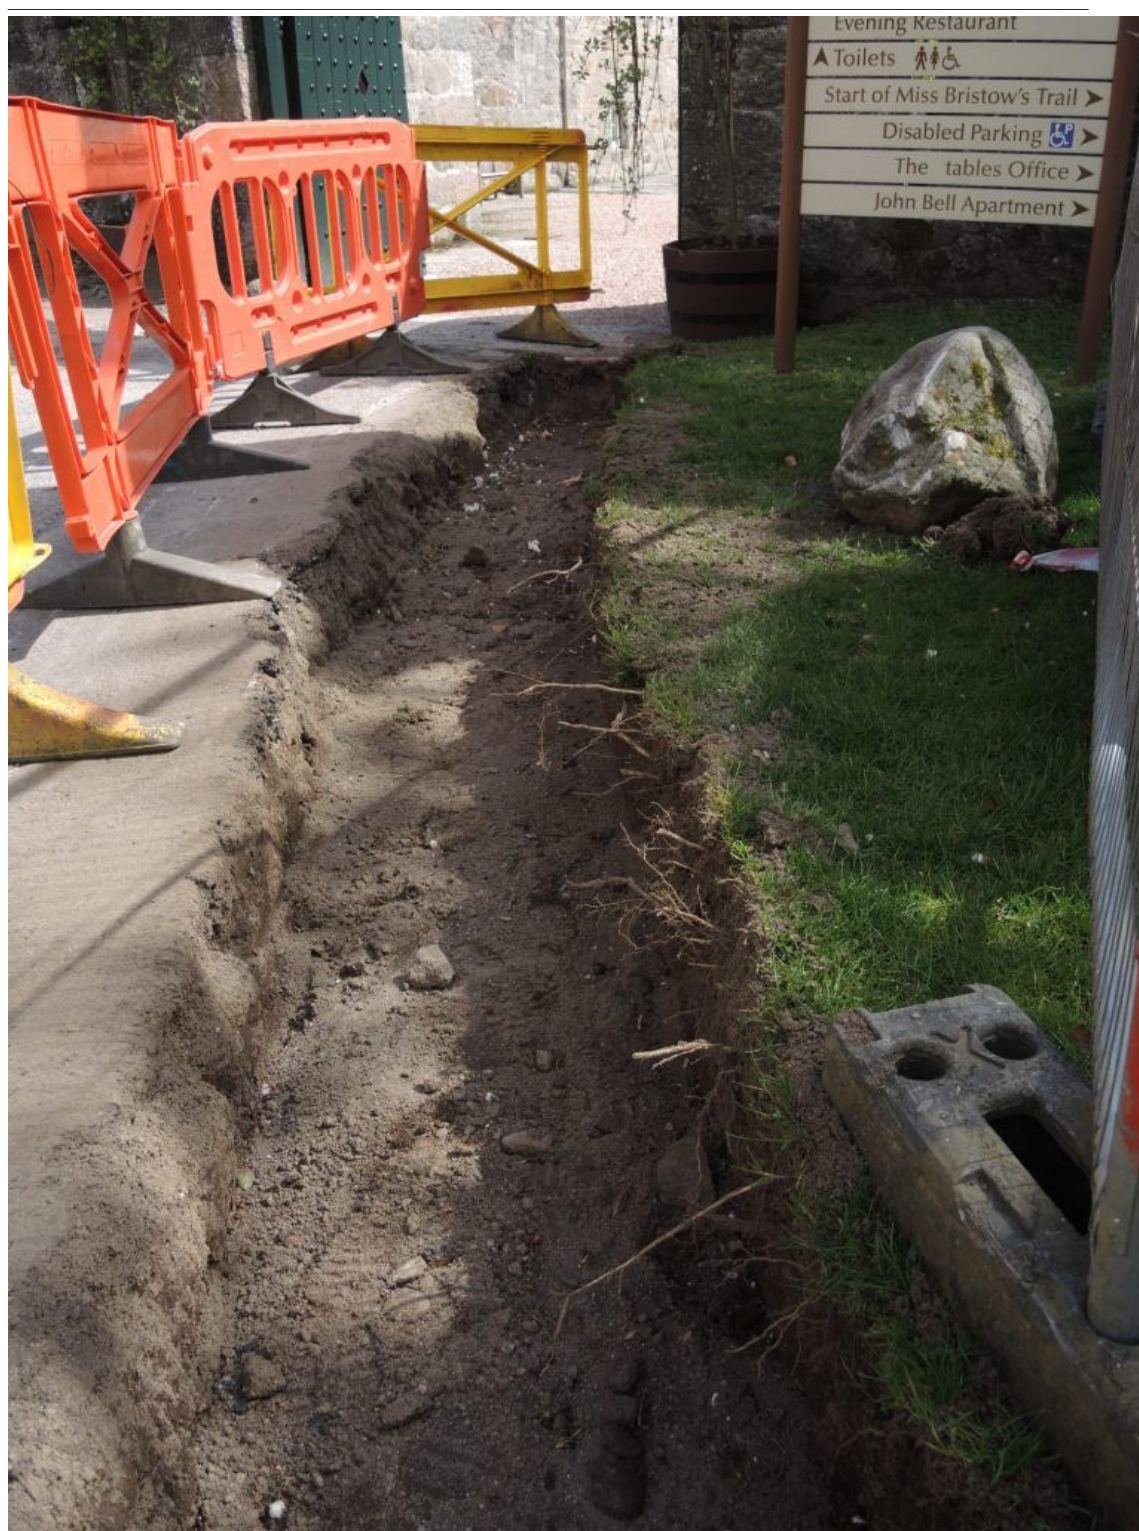
Illus 16 Gully running to W side of archway
