GARDEN WALL PITMEDDEN HOUSE ABERDEENSHIRE

- Test pits and watching brief -
Carried out 18th -23rd March 2016
by
Murray Archaeological Services Ltd

Report No: MAS 2016-5
by
H K Murray & J C Murray

-Test pits and Archaeological Watching Brief-

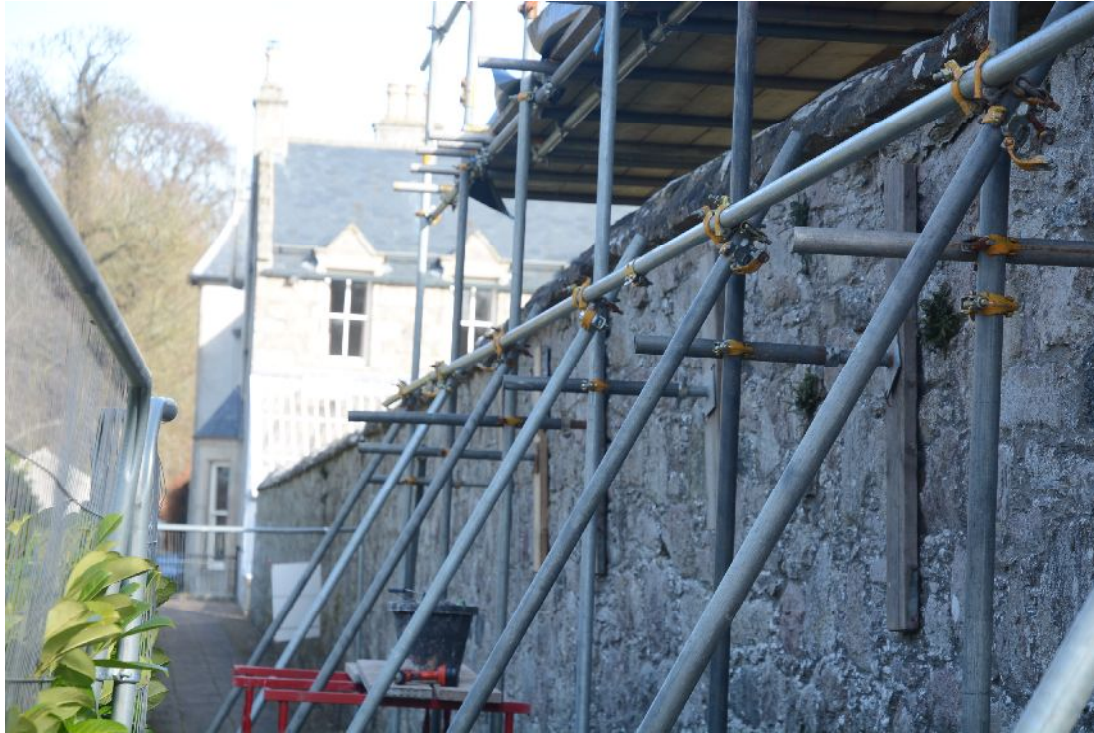
Illus 8 View along the W face of the W wall, looking towards the house. 2016 during remedial work on the wall

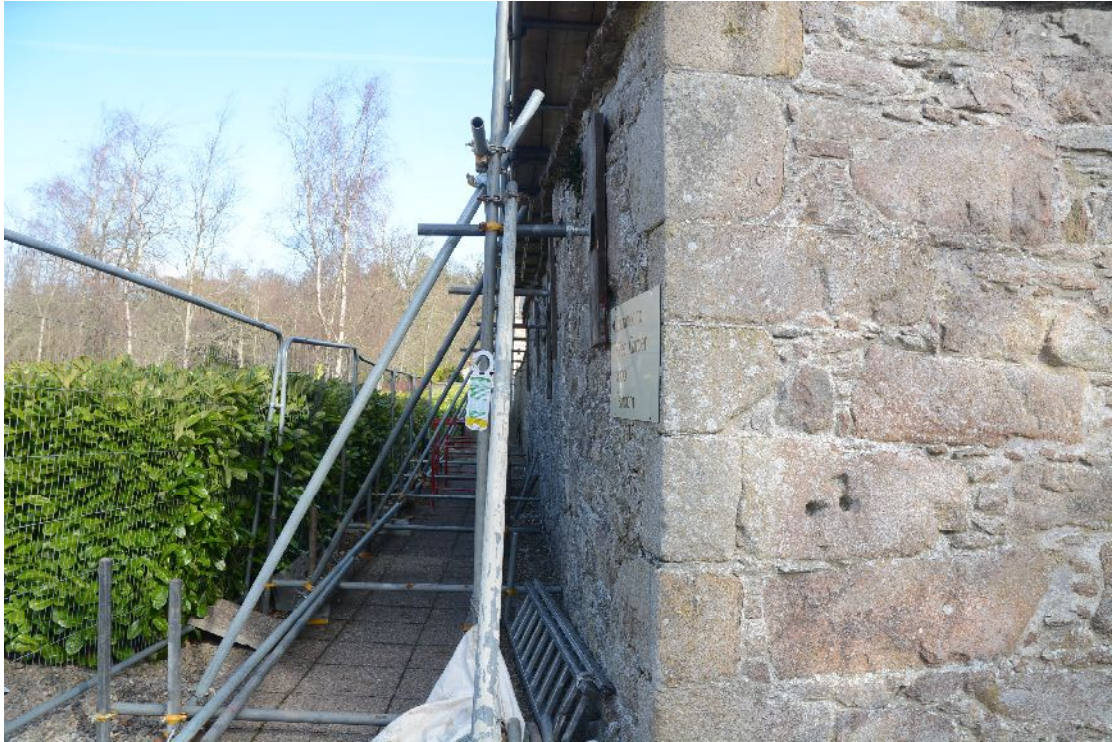
The watching brief was applied in the context of remedial works being undertaken on the S end of the W wall where a number of cracks were apparent and where the wall was bulging on the outer face. The project was designed by David Chouman, Architect and the work was directed by John Addison of Addison Conservation and Design, Consulting Engineers and undertaken by Steven Harper of Harper and Allan Masonry.

Illus 9 W wall looking N from SW corner showing bulges

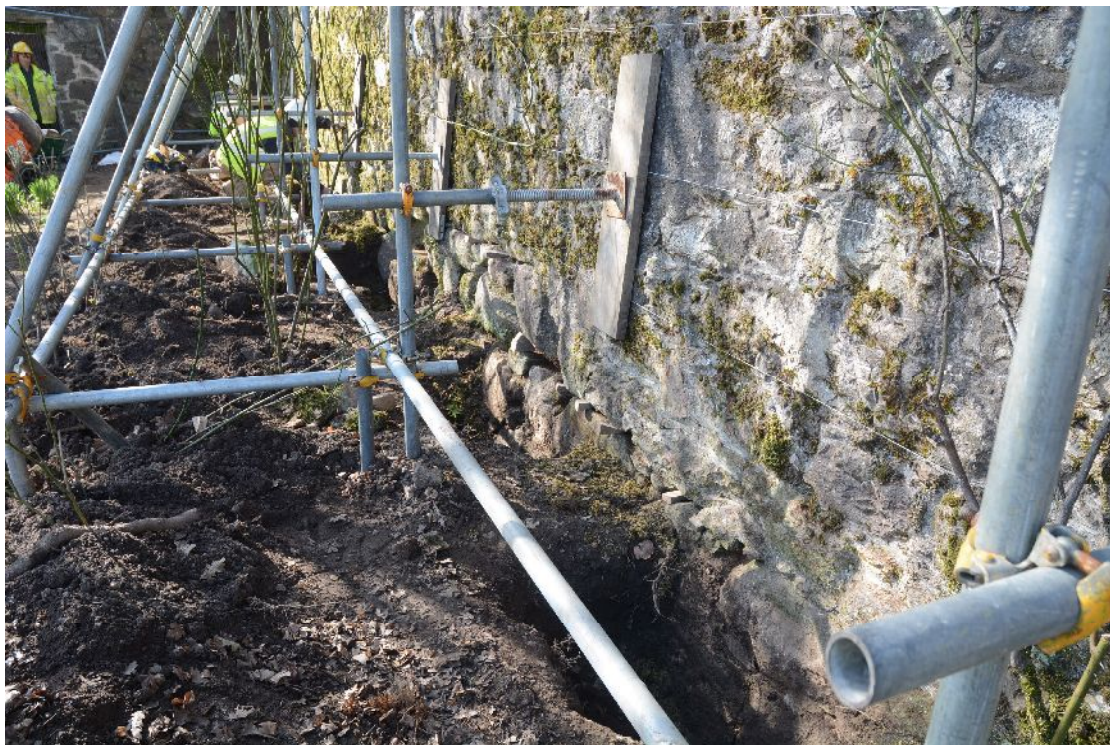
Illus 10 Inner face of W wall looking S, showing wedges placed in cracks before wall straightened

A number of test pits (illus 18) were excavated at the base of the wall to establish the nature of the ground below the wall and the depth of the foundations. As part of the process of stabilisation, the horizontal cracks in the inner face were wedged while pressure was placed on the outer face of the wall to straighten it; photographs were taken at the beginning of this process.

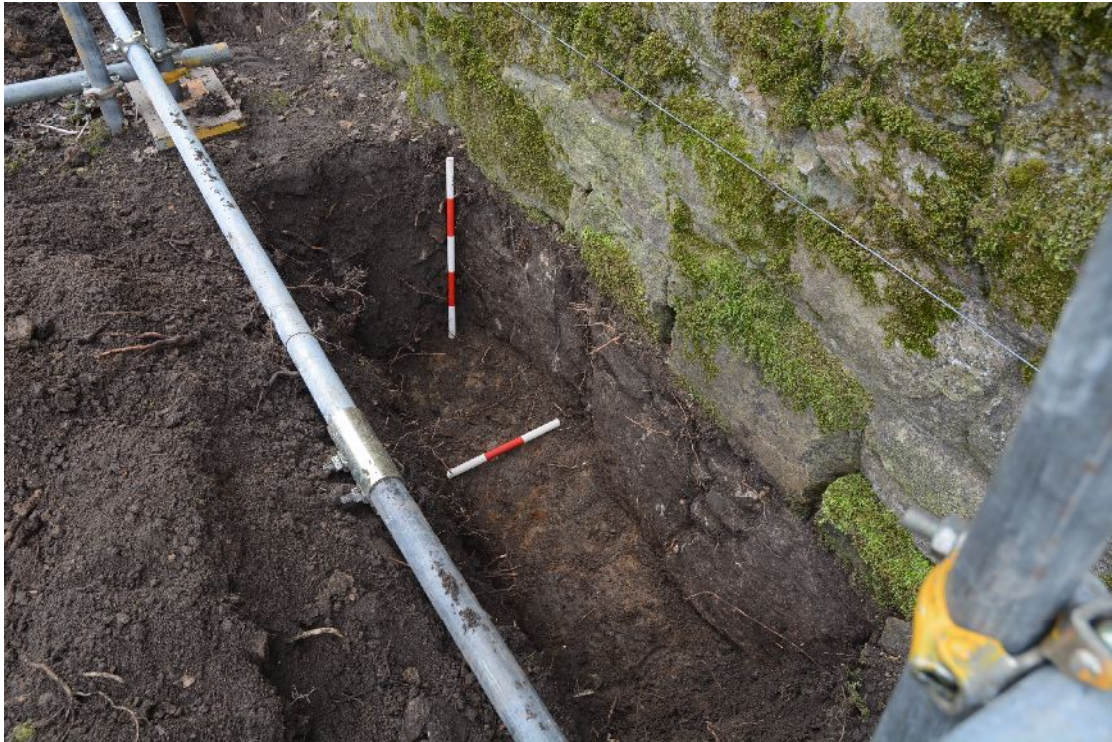
Stratigraphy: Topsoil 470-500mm over natural clay. The topsoil included occasional fragments of slate, plant pot etc. Some mortar fragments on top of natural clay. Wall stones set on the clay.

Illus 11 Test pit 2 showing base of wall on top of clay

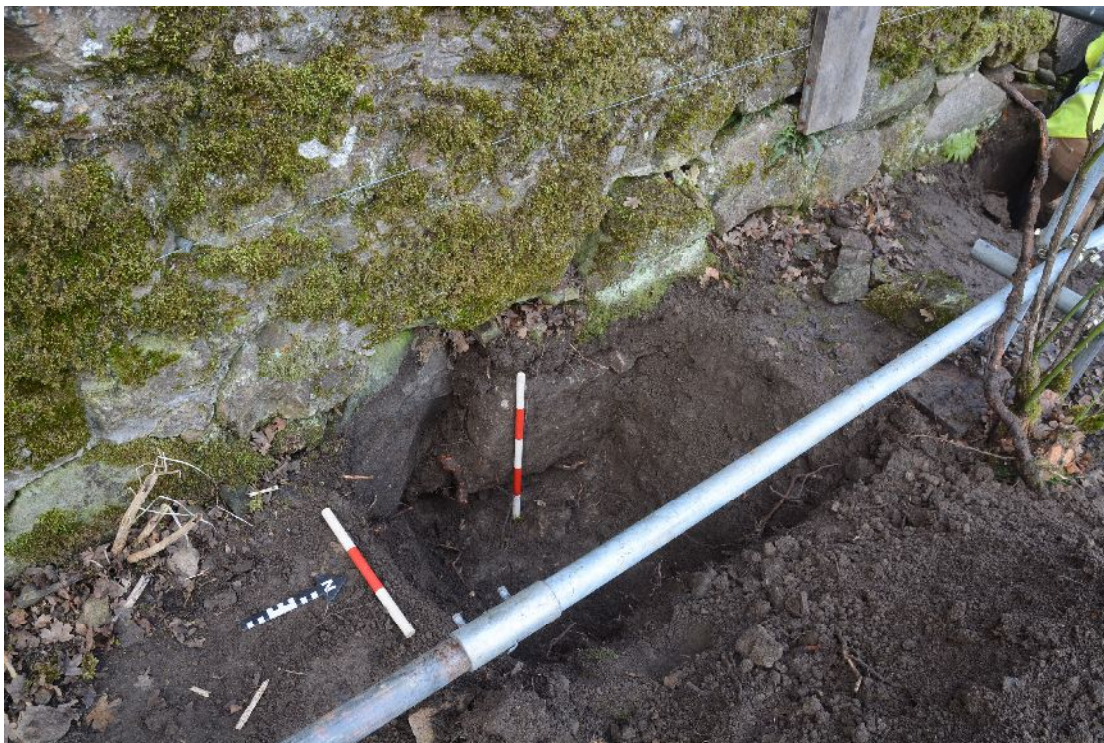
Stratigraphy: Topsoil 600mm over natural clay. Stones set on the clay.

Illus 12 Test pit 3 showing base of wall on clay

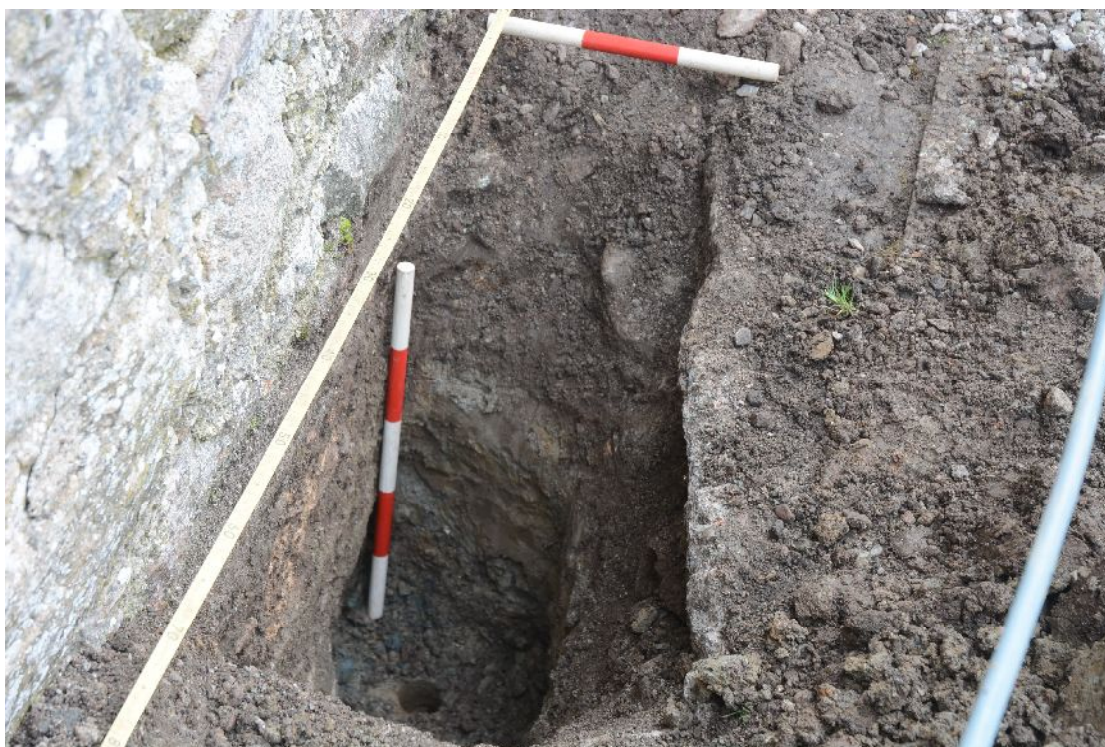
Stratigraphy: Beside the wall there was a layer of c100mm of gravel covering an edging stone set flush with the wall face. The edging stone was set on a thin layer of topsoil over natural clay. The base of the wall was 750mm below present path surface. The wall had been cut 400mm into the natural clay.

Illus 13 Test pit 7 showing wall cut into clay

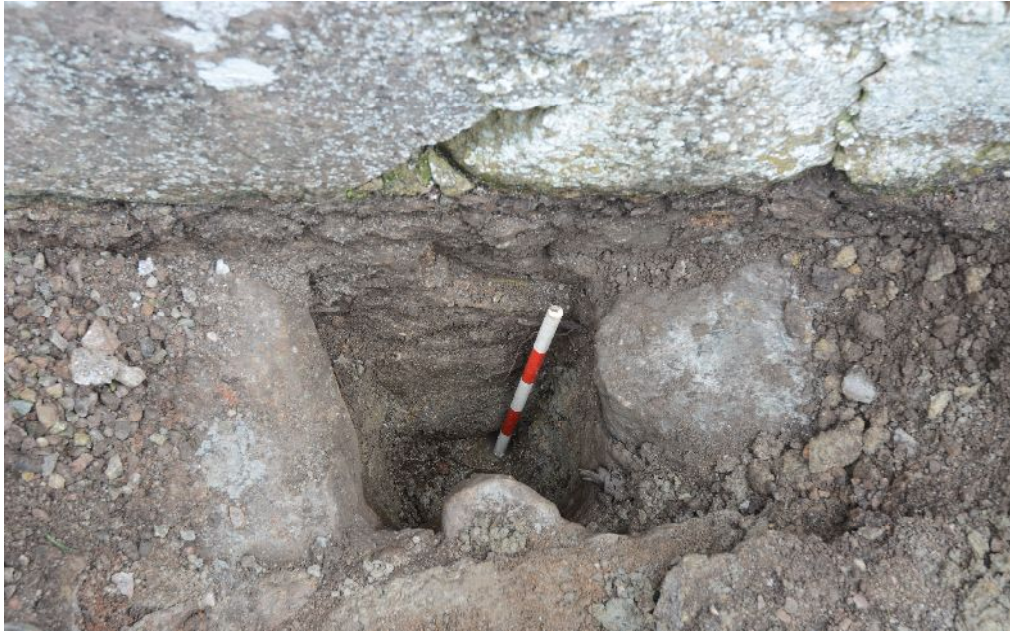
Stratigraphy: Beside the wall there was a layer of c100mm of gravel covering an edging stone set flush with the wall face. Below the edging stone there was c150mm humic garden soil above natural clay. The clay was excavated to the base of the wall which was cut 300mm into the clay.

Illus 14 Test pit 8 showing wall cut into clay and path edging stones flush against wall face

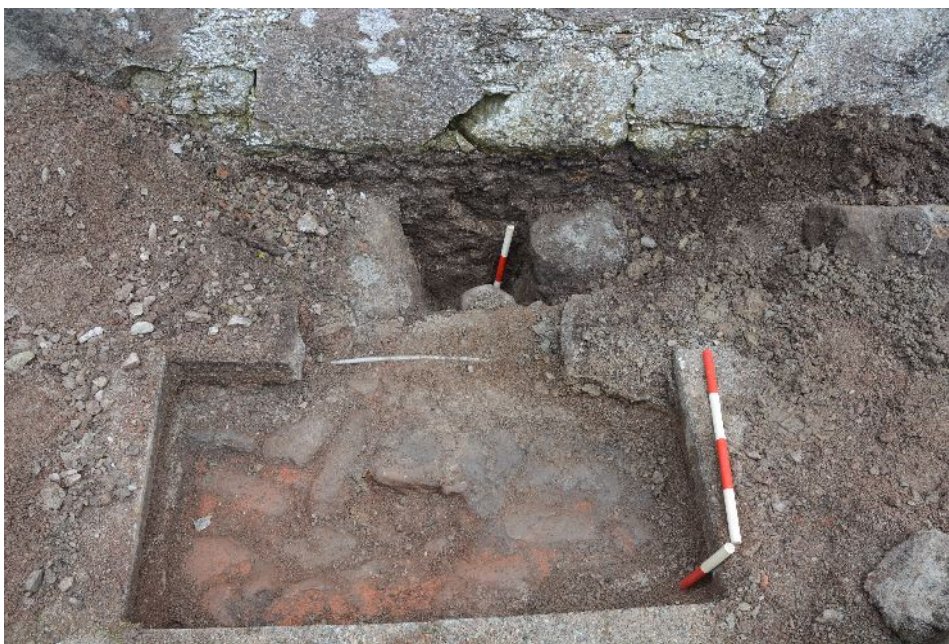
The wider area showed a cobbled path survives c 180mm below the paving stones of the present path. The cobbles extend up to the edging stones and were tightly locked against them, suggesting that the edging was laid first, flush to the wall face, and then the cobbling laid. The cobbles were covered by red and black burnt material, suggesting that they were the pathway that was in use at the time of the fire in 1807. A telephone cable had been laid along the top of the cobbles, below a band of concrete. The scaffolders had cut this cable, so a repair cable was partly lying on the ground surface.

Illus 15 Test pit 8 showing burning on cobbled path below modern slabs.

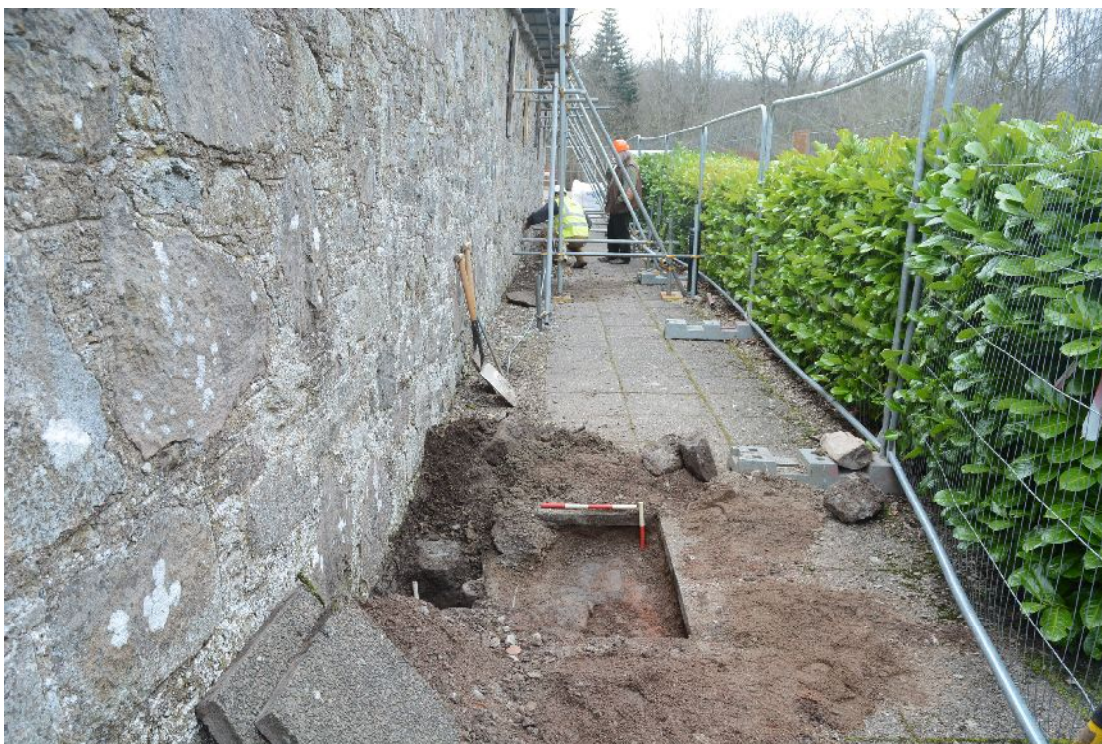
Illus 16 Looking S along W wall with earlier cobbled path in test pit 8 in foreground

A section of cobbled path pre-dating the 1807 fire at Pitmedden was exposed against the outer face of the wall. The structure of the path indicated that it was built when the wall was in situ; this suggests that at least the foundation of the wall is the 17th-century structure. There is tenuous documentary evidence to suggest that this section of the wall may have been reduced or partially dismantled and then rebuilt in the 1860s when the house was demolished and rebuilt.
