**DRAINAGE  
DRUM CASTLE  
ABERDEENSHIRE**

**Archaeological Watching Brief**  
Carried out between October and November 2016  
by  
**Murray Archaeological Services Ltd**

**Report No: MAS 2016-27**  
by  
H K Murray

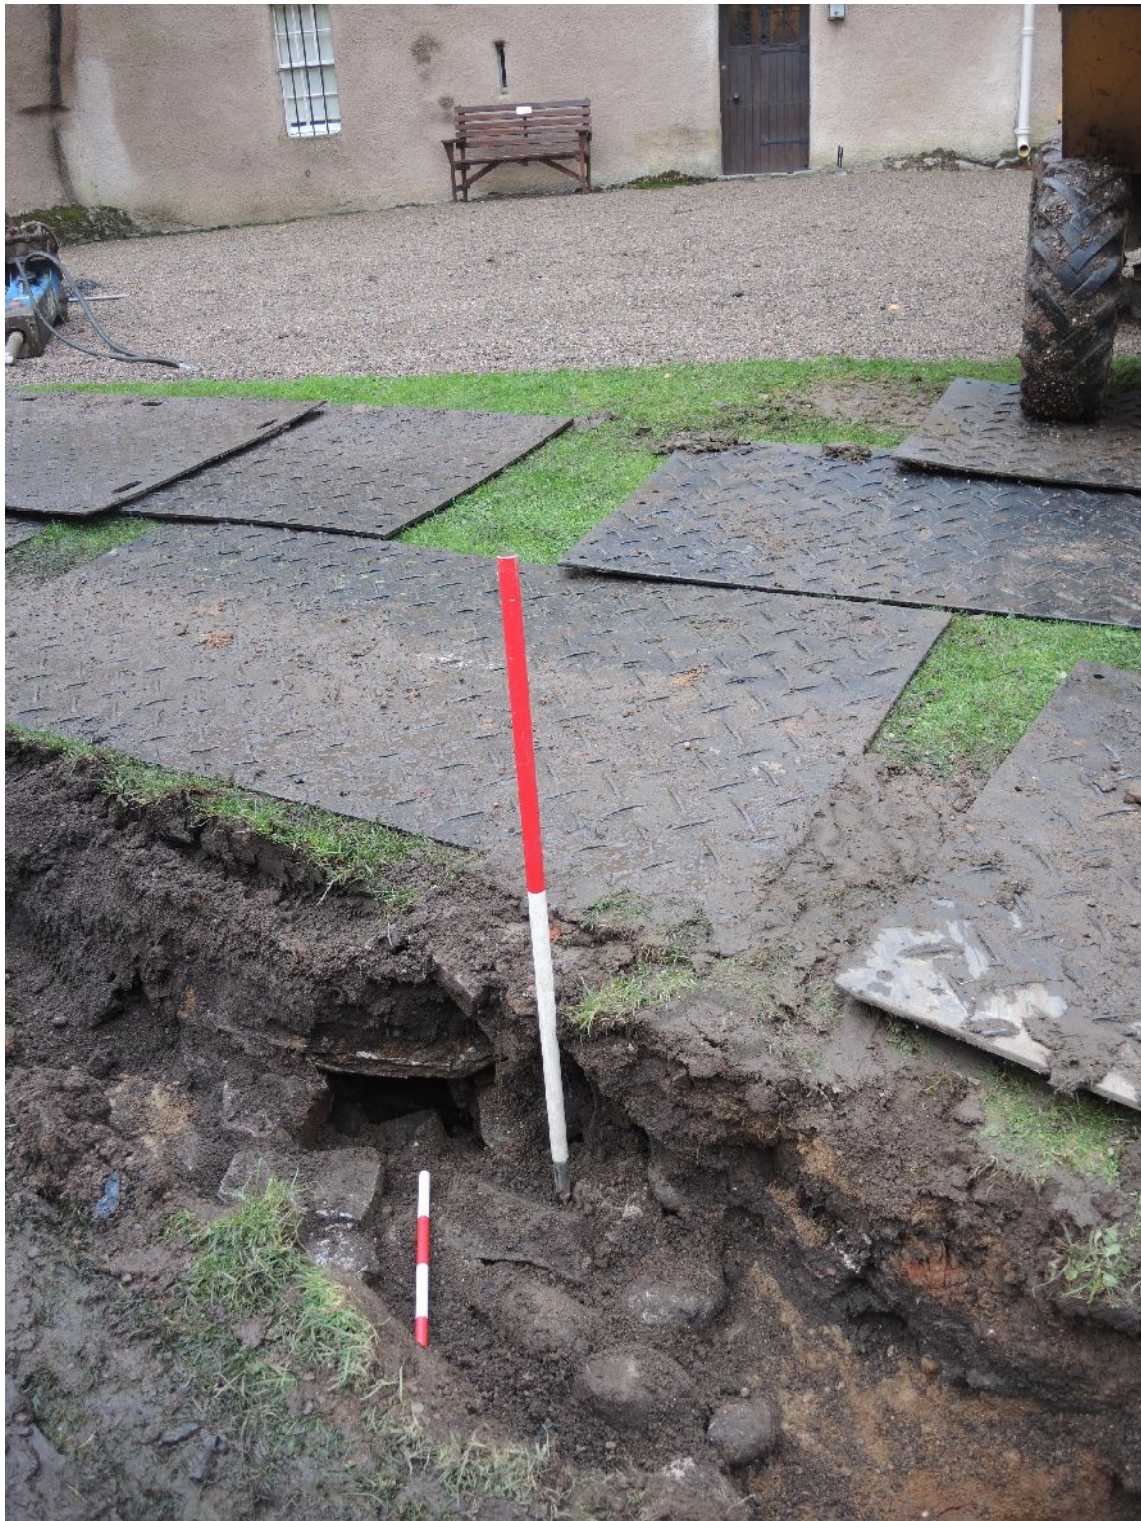
A stone drain ran SW/NE obliquely across line of earlier trench for c 800mm. It had been destroyed on the trench line (although the line of its cut was visible across the base of the trench) and was only clear in the W section. The capstone on the W side of the earlier trench was sealed by 150mm of topsoil. The drain was c. 300mm wide and c 300mm deep set in a cut in natural c 900mm wide. The base of the drain was 400mm below the present surface. It was not possible to get a full section of the drain. It may be a continuation of the V-shaped drain (31) excavated to the W in 2014 (illus 3) although this is uncertain as drain 5 appears to be smaller in internal dimensions than 2014 drain 31 (Murray & Murray 2014, 27, 57).

**Illus 4 Stone drain 5 in relation to E facade of castle**

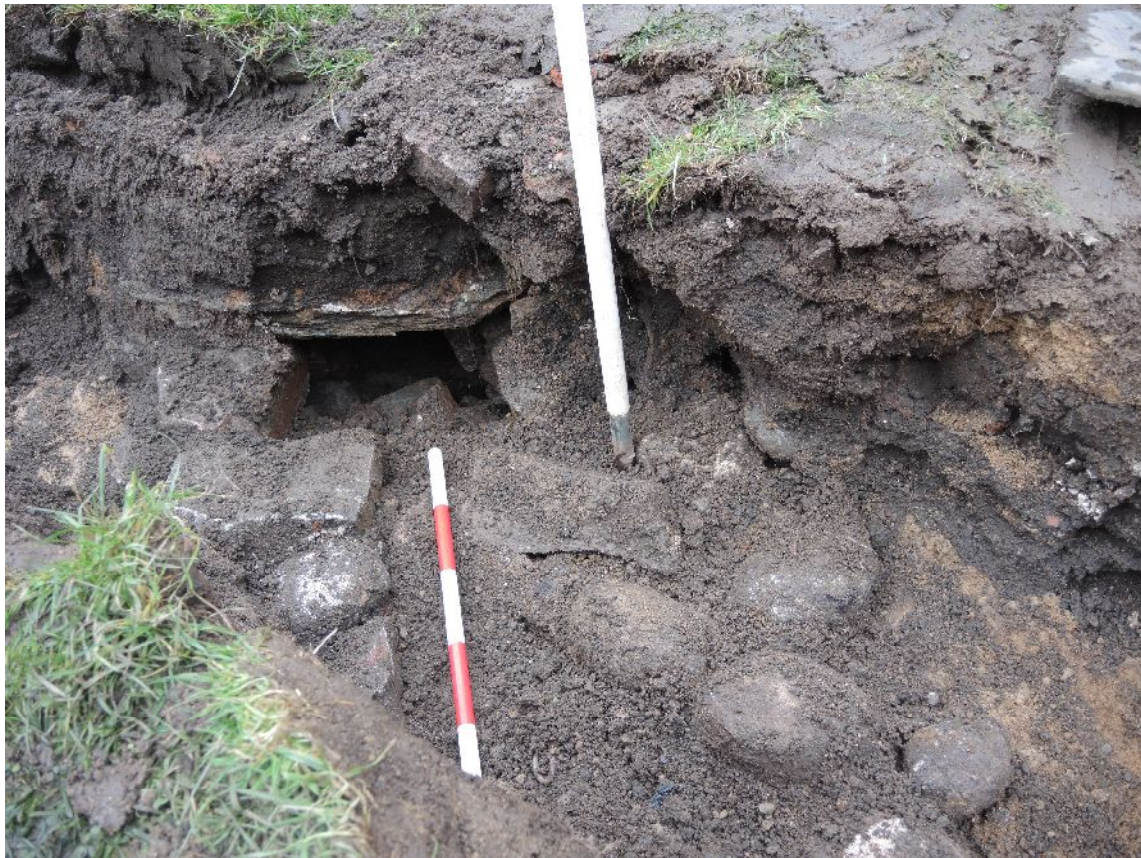
**Illus 5 Detail of stone drain 5**

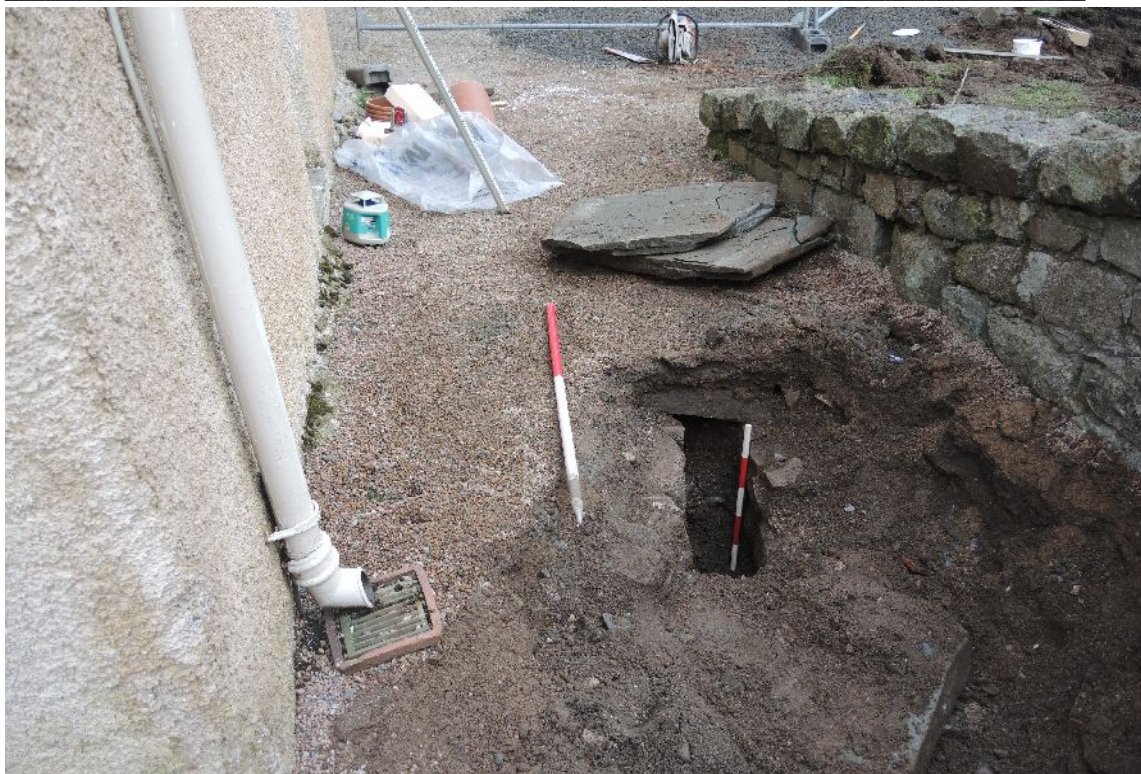
A stone drain was exposed for some 700mm which extended from level with SE corner of castle to N, it ran N/S roughly parallel to castle E wall and c 1m to W of it. The S end had been cut away by the earlier drains and manholes being replaced in 2016. It had flat slate lids across 3 courses of drystone walls. It was 470mm high from the base of the lid to the base of drain on natural rock. The internal width was 200-220mm. The lids were only sealed by c100mm gravel. Fill: gritty soil, occasional slate. 1 sherd 20<sup>th</sup>-century china, 1 sherd 20<sup>th</sup>-century glass (not retained).

This may equate to drain (13) excavated to the N in 2014 (Murray & Murray 2014, 25, 54) which was of similar size and construction (illus 2).

**Illus 6 Location of stone drain 8 in relation to E wall of SE tower**

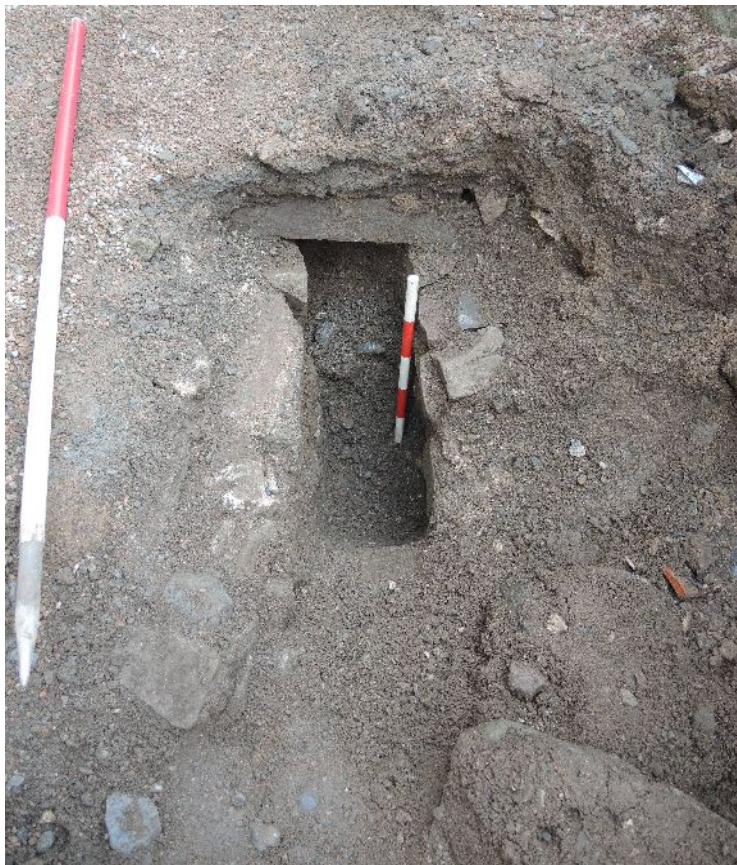
**Illus 7 Detail of stone drain 8**

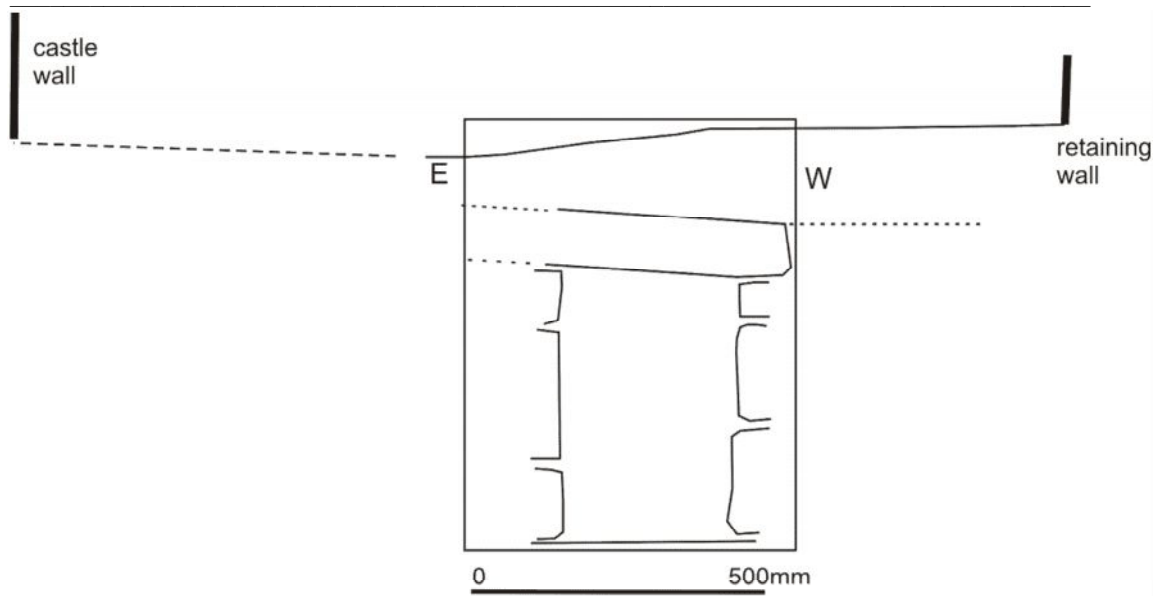
**Illus 8 Section of stone drain 8**

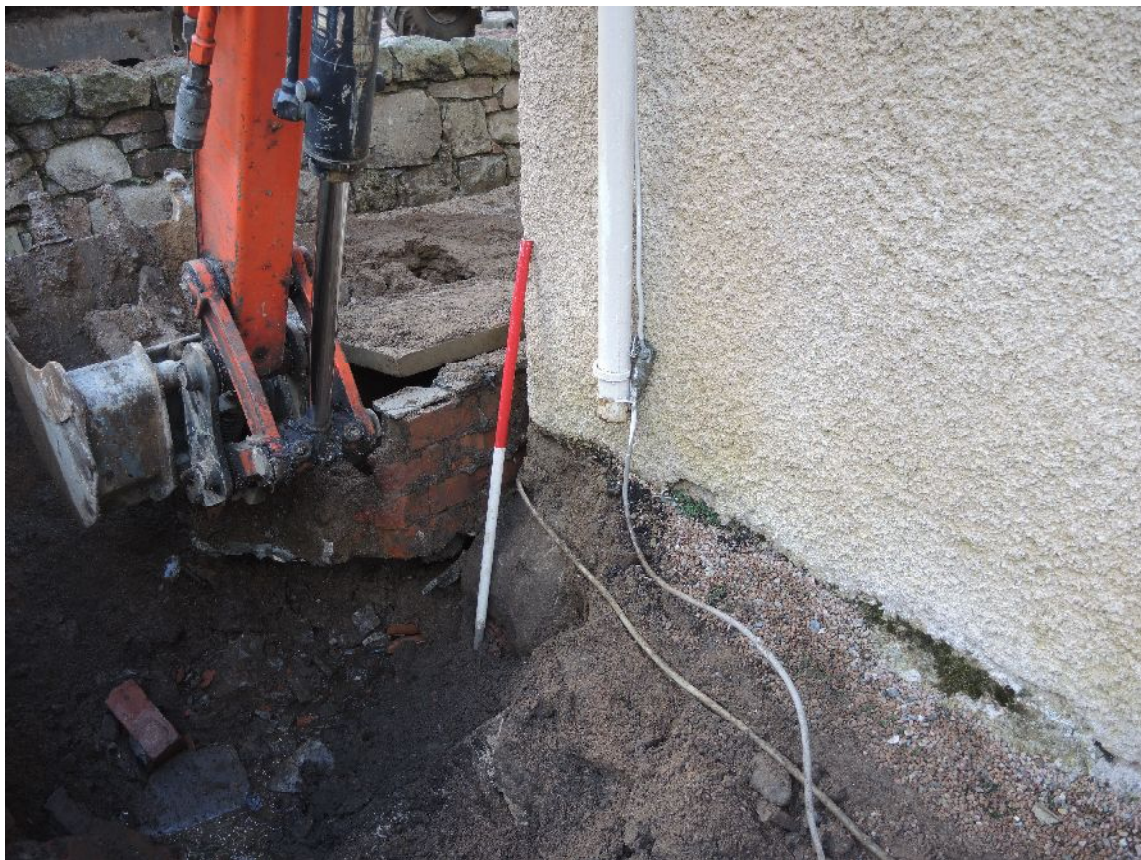
The corner stone foundation at the SE corner of the S facade was exposed during removal of the previous manhole; it projected c150mm out beyond wall face and c500mm below present surface.

**Illus 9 SE corner of SE tower showing removal of earlier brick manhole**

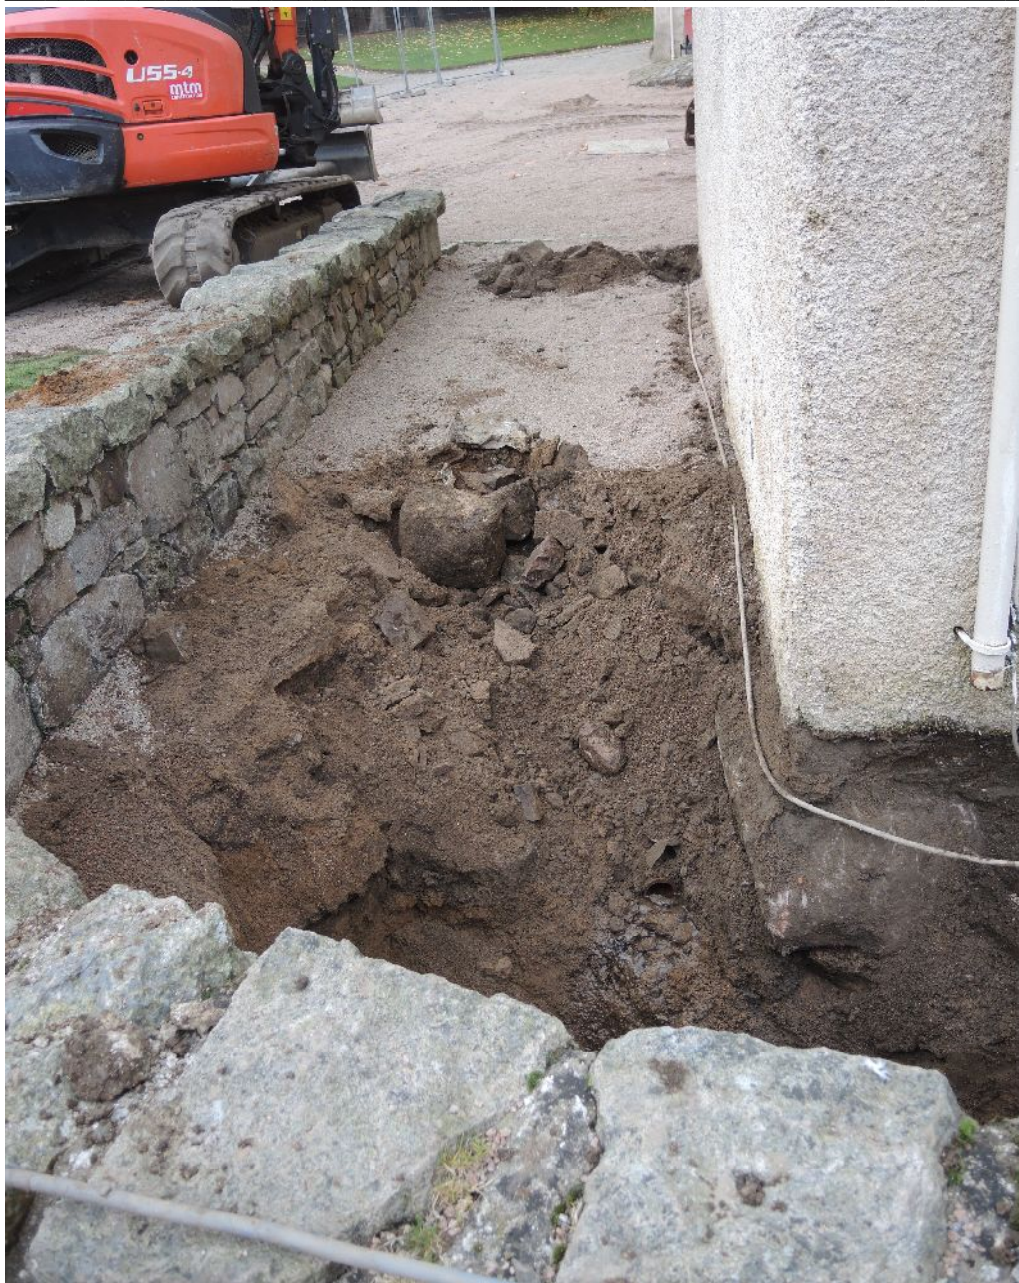
**Illus 10 Detail of boulder foundation of SE corner of SE tower**

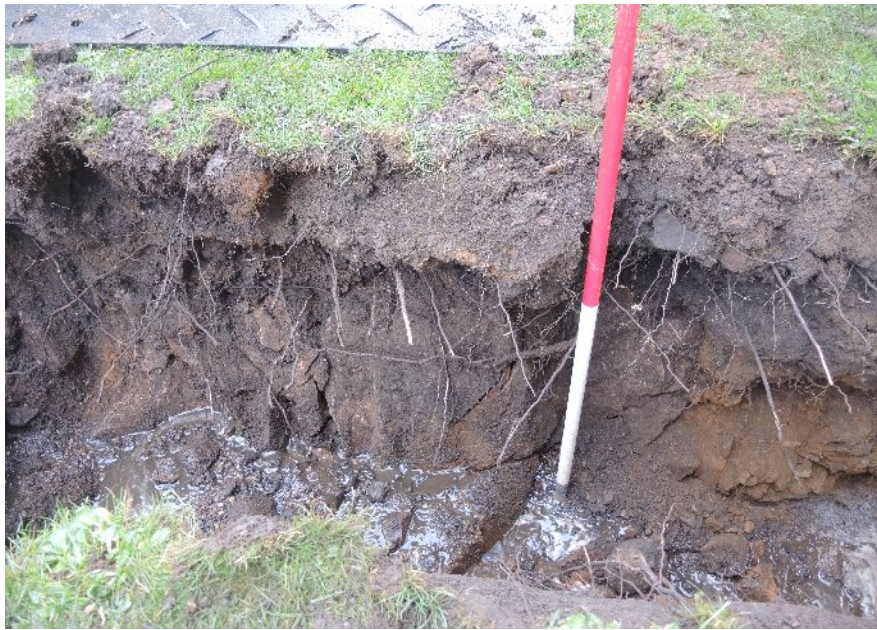
The depth of the new drainage trench gave a useful insight into the levels of bedrock around the castle. It is clear that there is bedrock just below the surface from near the N end of the E part of the drainage trench (illus 10) and past the tower (illus 11), confirming the results of the excavations in 2014 (Murray & Murray 2014) showing the Tower was set on a rock outcrop which extended into the courtyard area.

**Illus 11 Rock directly below surface at N end of E line of new drain**

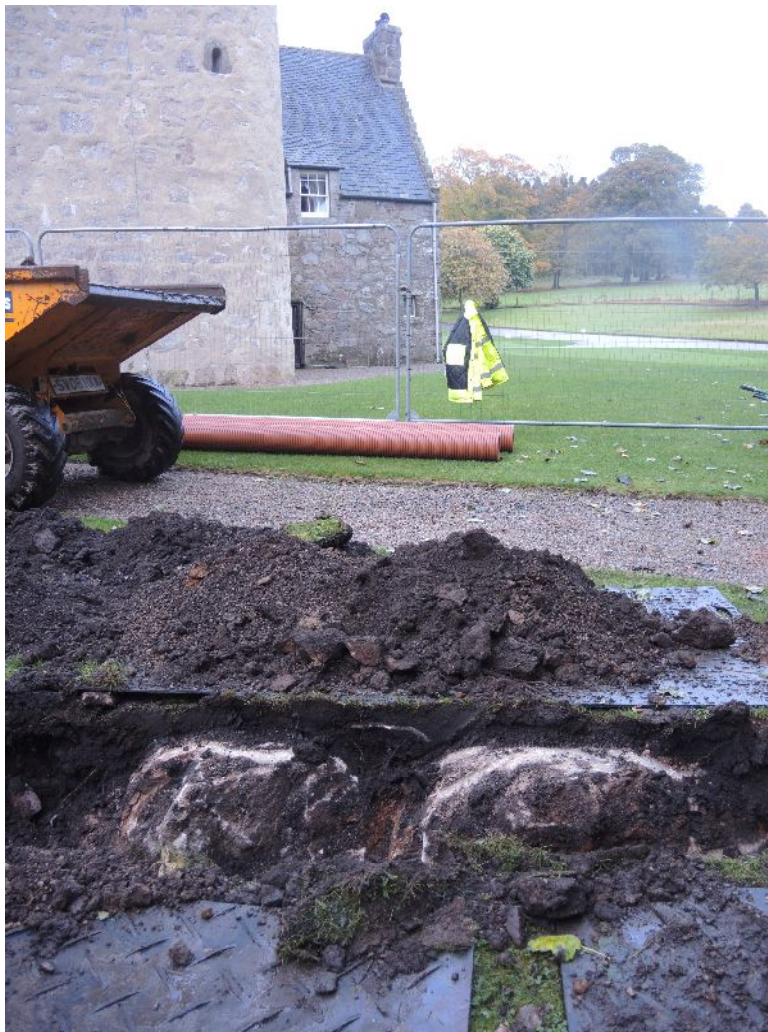
**Illus 12 Rock directly below surface in E line of new drain opposite Tower**

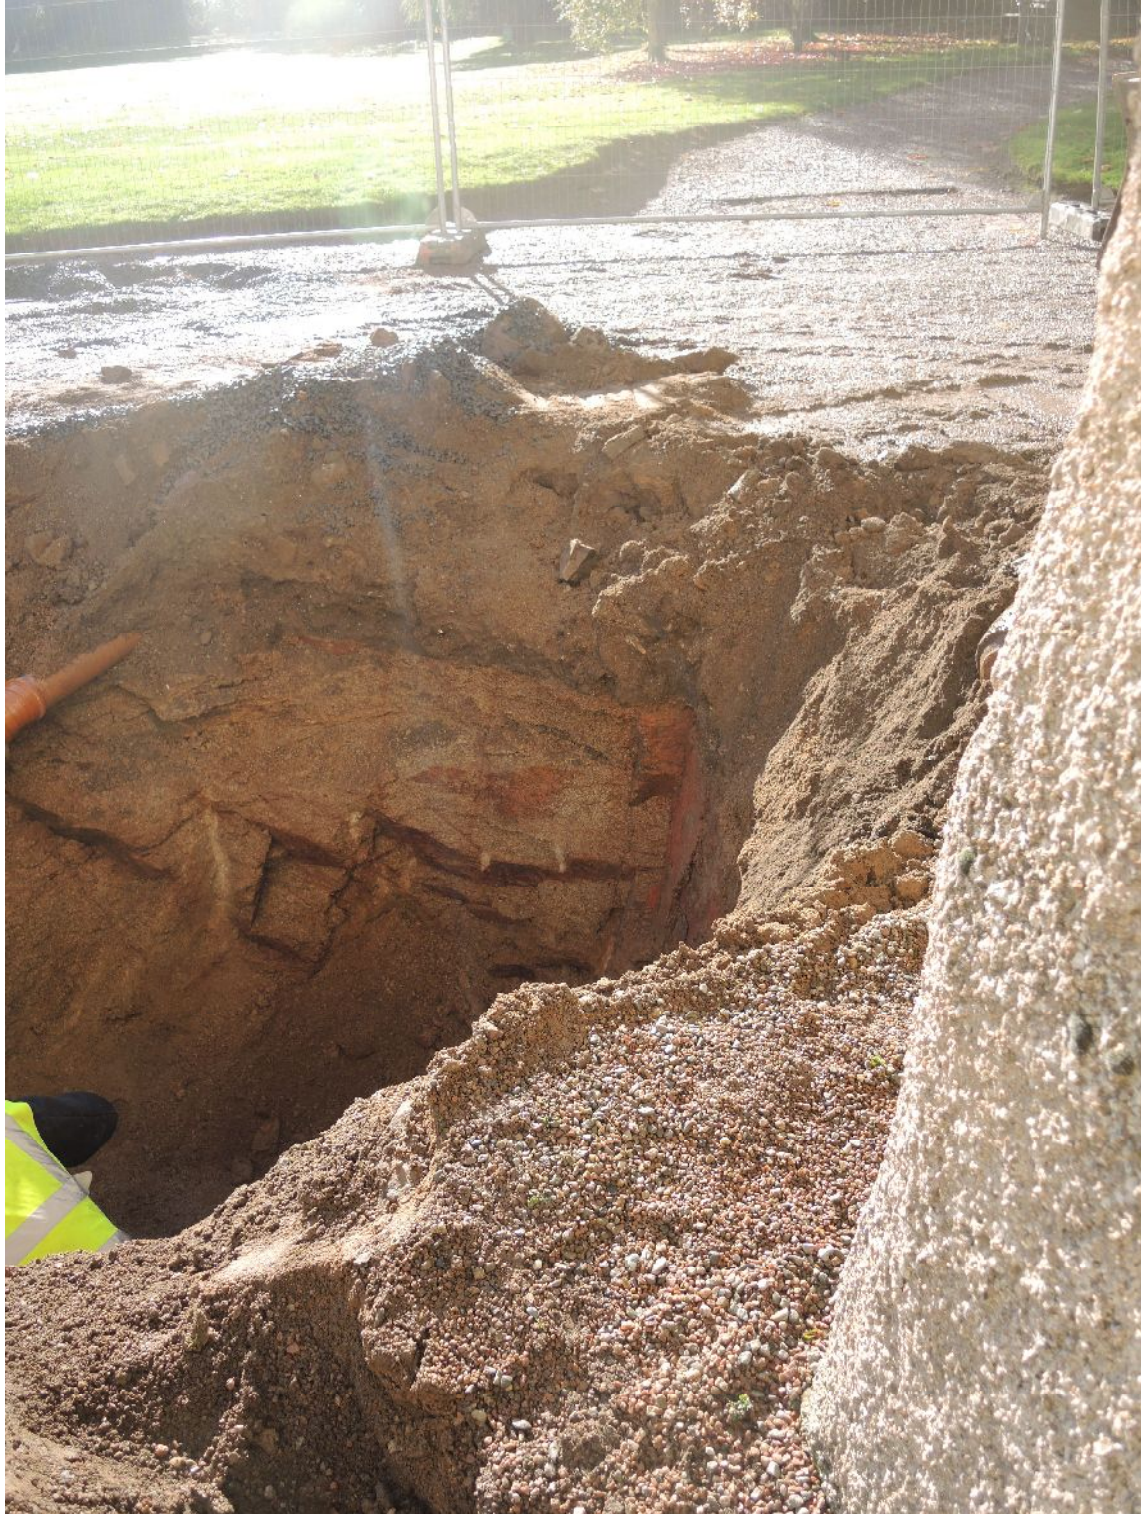
The natural rock is far lower across the S facade of the 17<sup>th</sup> century mansion, with the exception of an outcrop near the SW tower (illus 12, 13) where it is just below the surface, but shelved down to c 2.5m just around the corner of the tower, in the W side of the drainage trench- at this point there was a hard compact sandy natural above the rock.

**Illus 13 Rock below surface between manholes 4 and 5, with path to chapel in background**

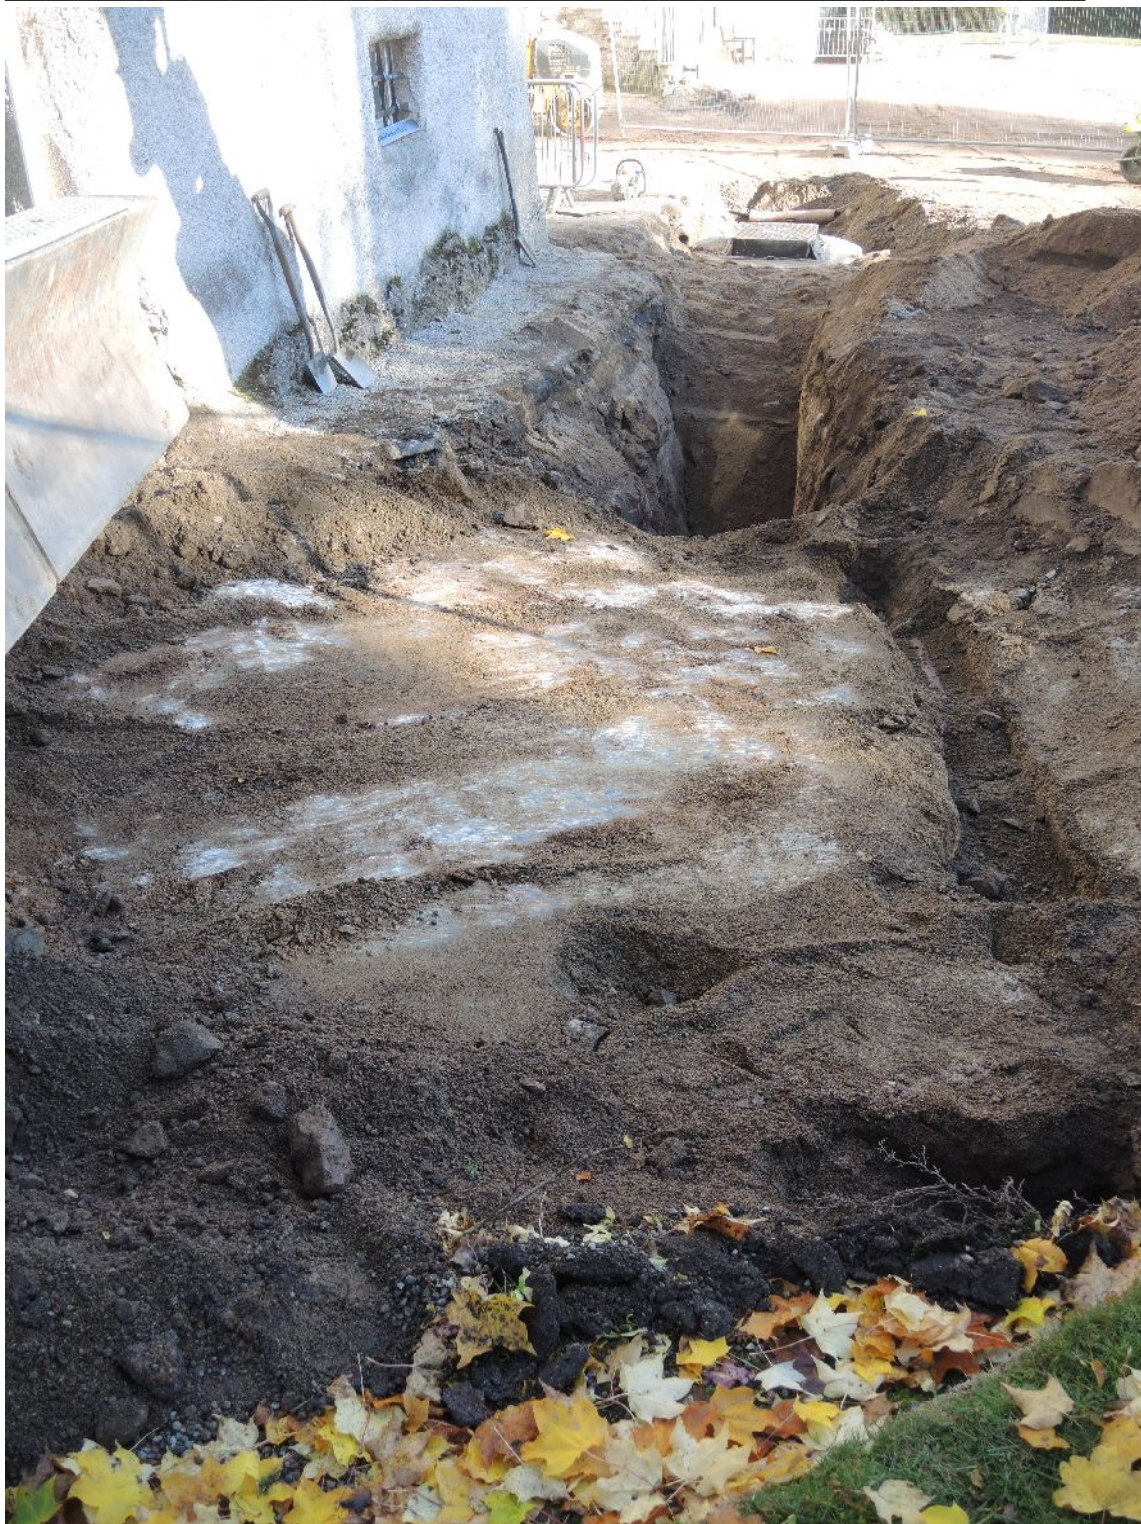
**Illus 14 Rock at surface at SW corner of castle beside manhole 5**

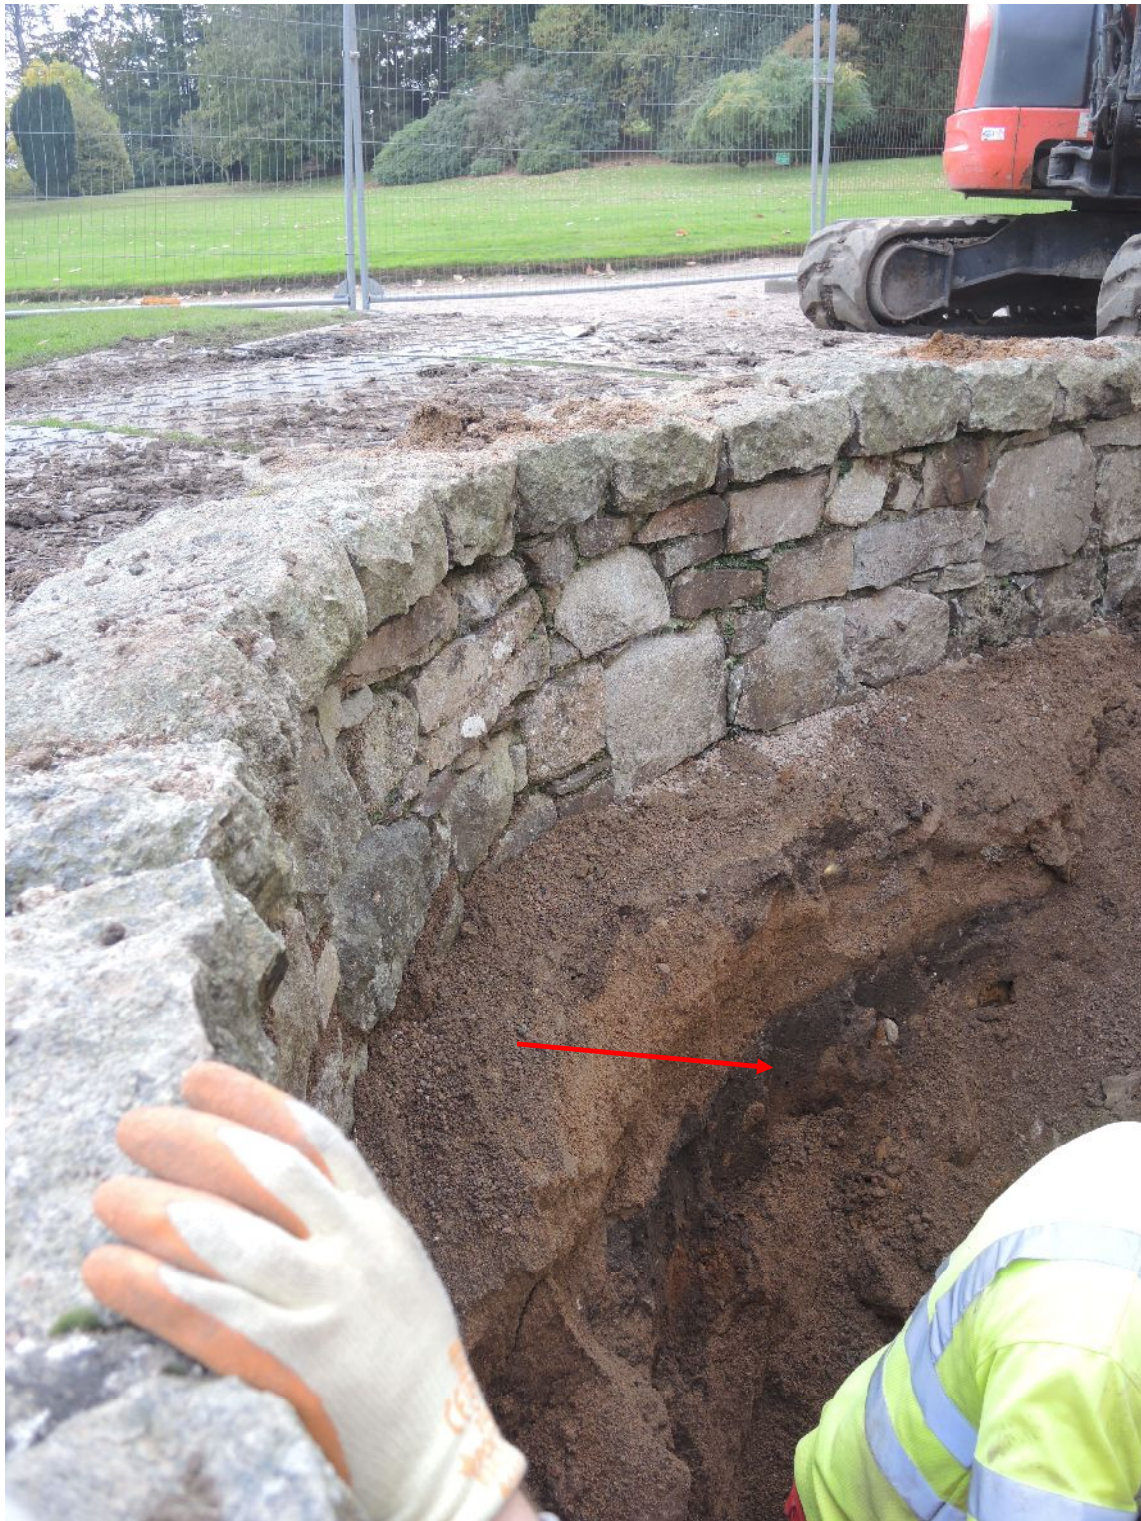
Across the S facade of the mansion there was evidence of a deliberate deposition of material in places over buried topsoil (illus 14, 16) and elsewhere directly above natural (illus 15). Across much of the frontage this comprised c 500mm of grey, often stoney

**Illus 15 Retaining wall at SE corner showing build-up below wall over buried topsoil (dark line indicated by arrow)**

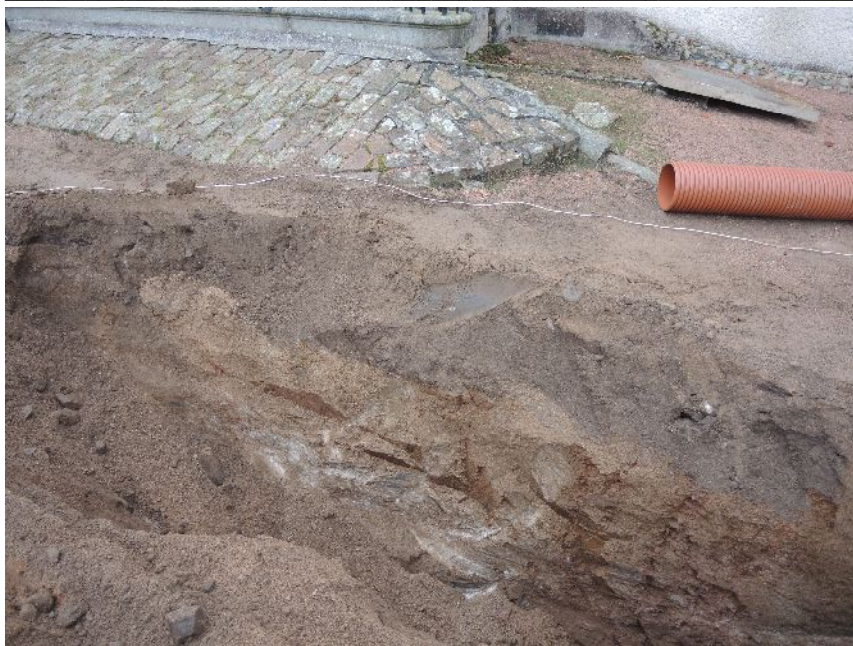
**Illus 16 Stratigraphy beside central steps of S facade**

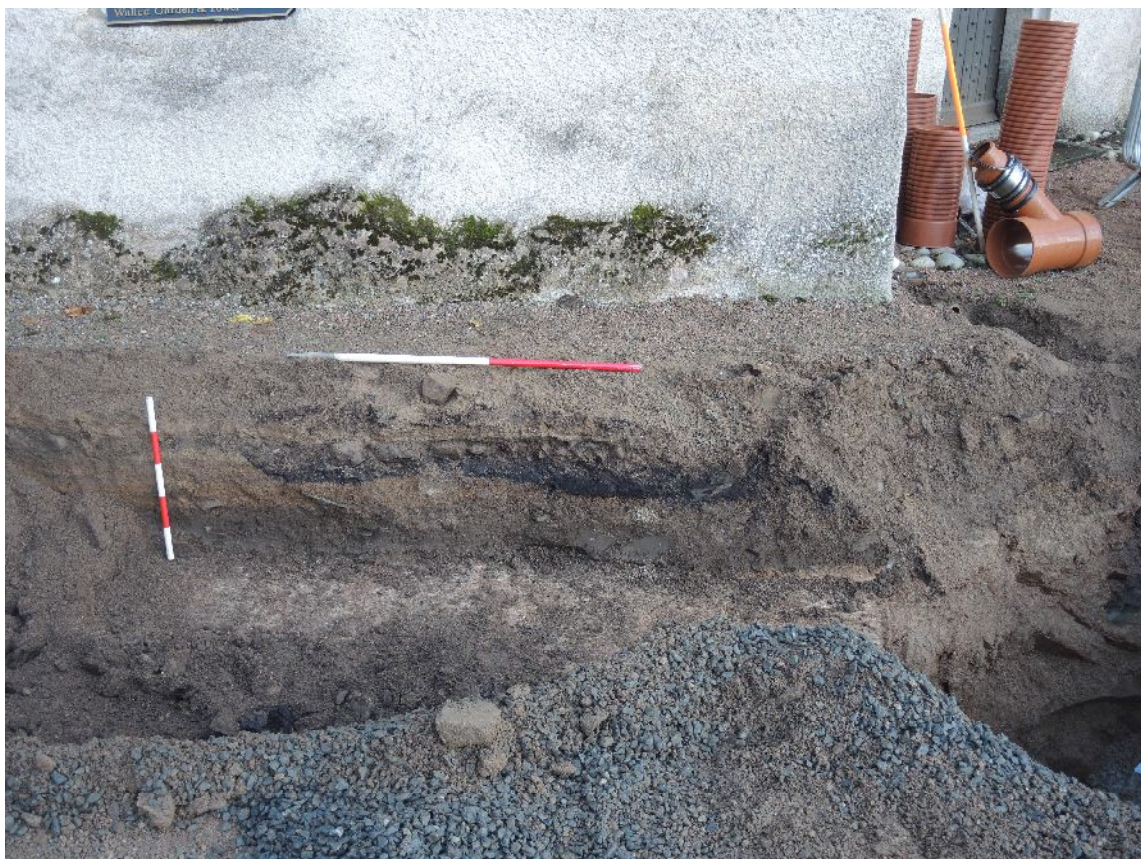
**Illus 17 Stratigraphy beside S facade SW tower**

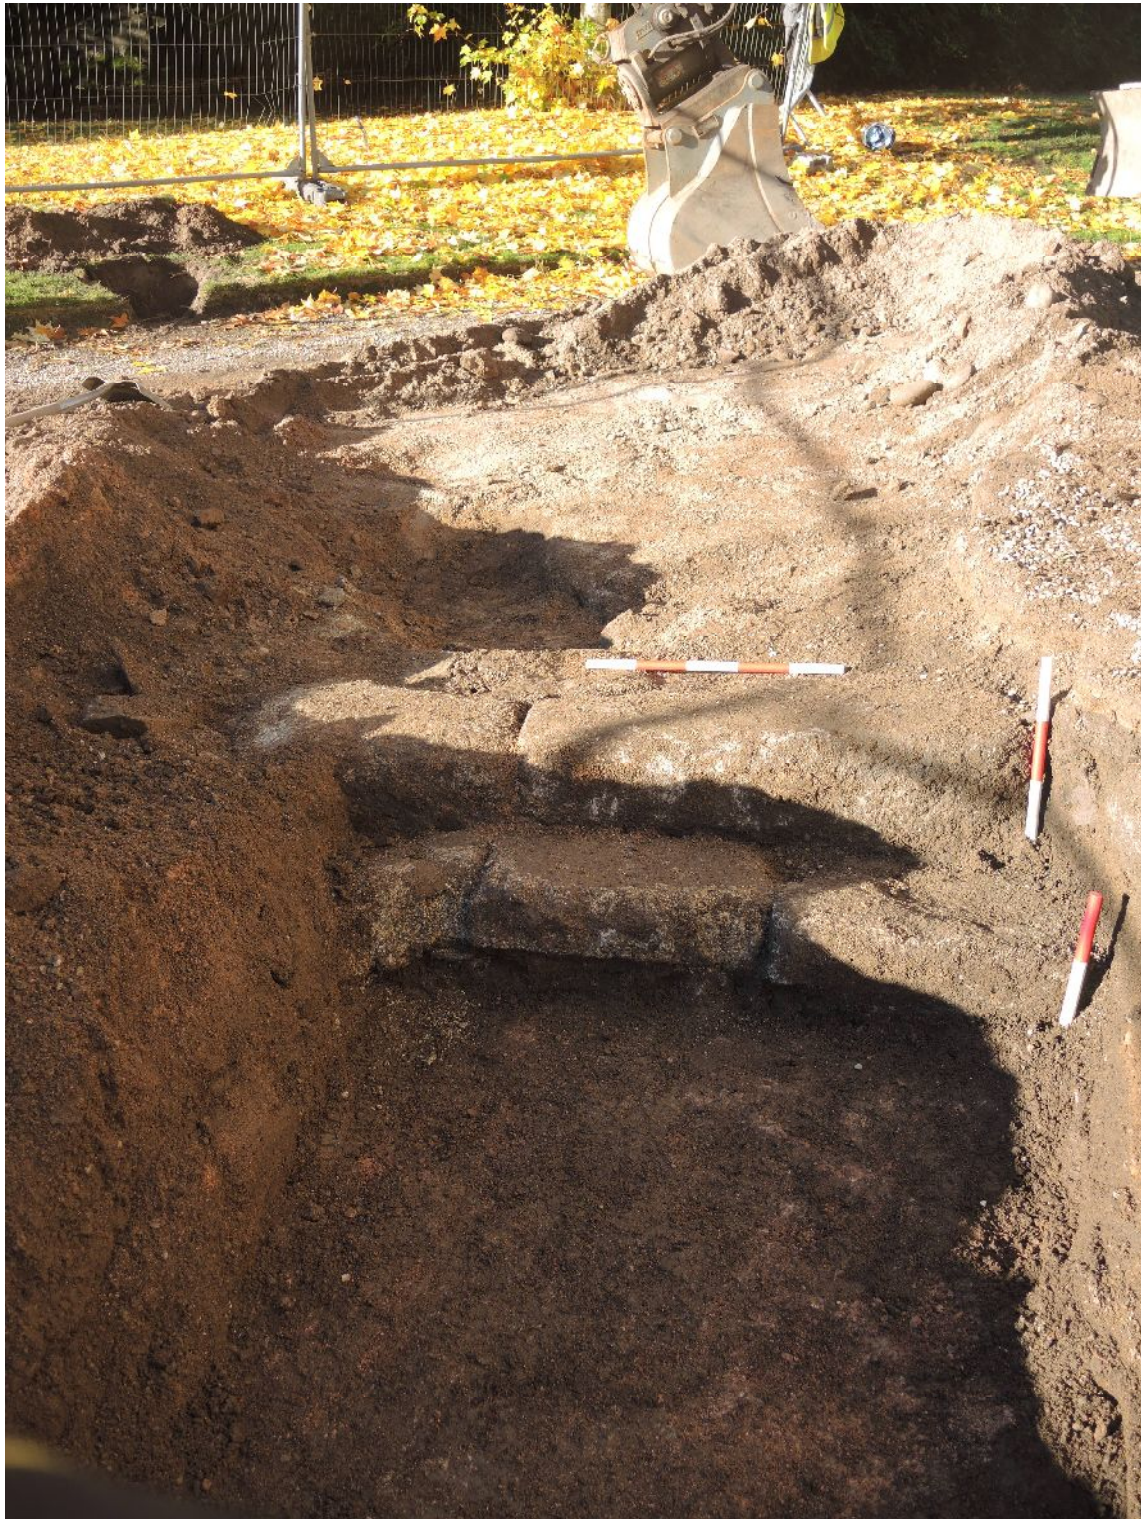
Two steps were excavated lying WSW/ENE at a slightly off-perpendicular angle to the SW tower of the S facade. They were built on the natural rock, with the top of the lower step level with the grey layer (illus 20:5) interpreted as the construction layer- a thin drift from this extended on the top of the lower step but is probably the result of normal soil movement created by footfall across the steps. The upper step was almost level with the rock outcrop, with a patch of a stony levelling layer (illus 20:7) surviving. The surviving width of the steps was c1.4m, with a total rise of c 350mm (although if the lower step was level with the construction level the rise would have been only c200mm).

The steps appear to have been of probable 17<sup>th</sup>-century date and related to the formal gardens buried below the S lawn. They formed a transition down from the steep rock outcrop at this corner.

**Illus 18 Steps: detail**

They were removed as they were in the line of the new drain and manhole 5.

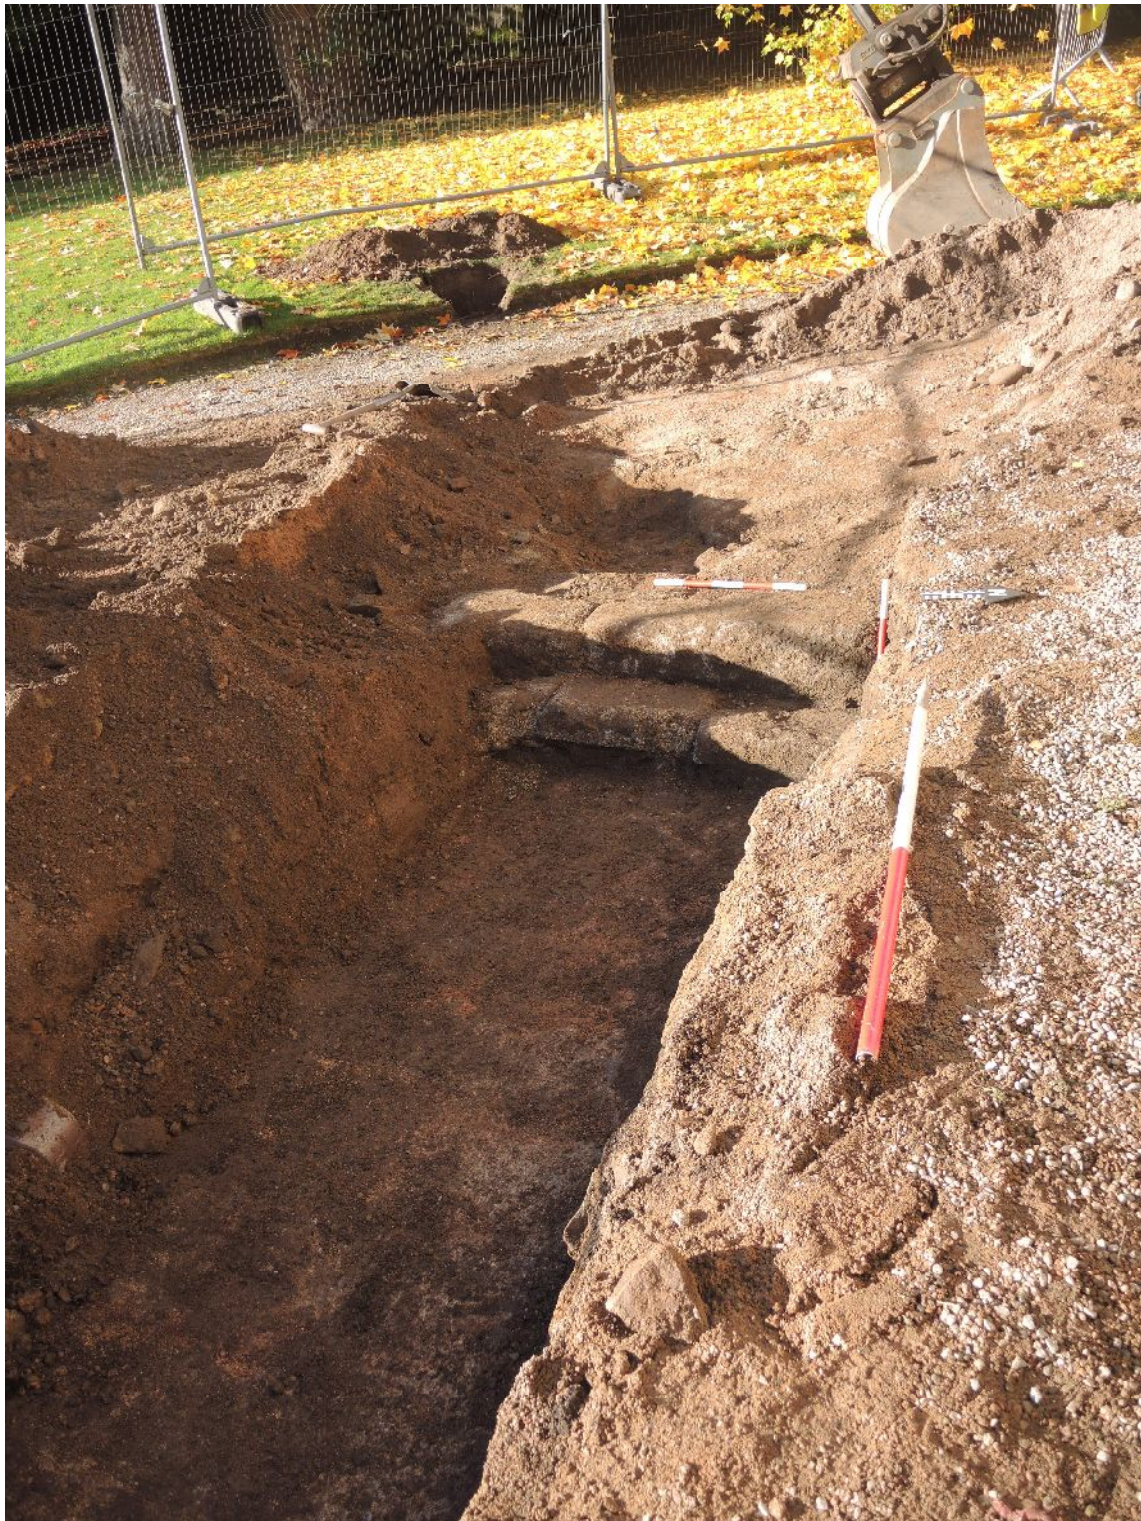
**Illus 19 Steps looking W**

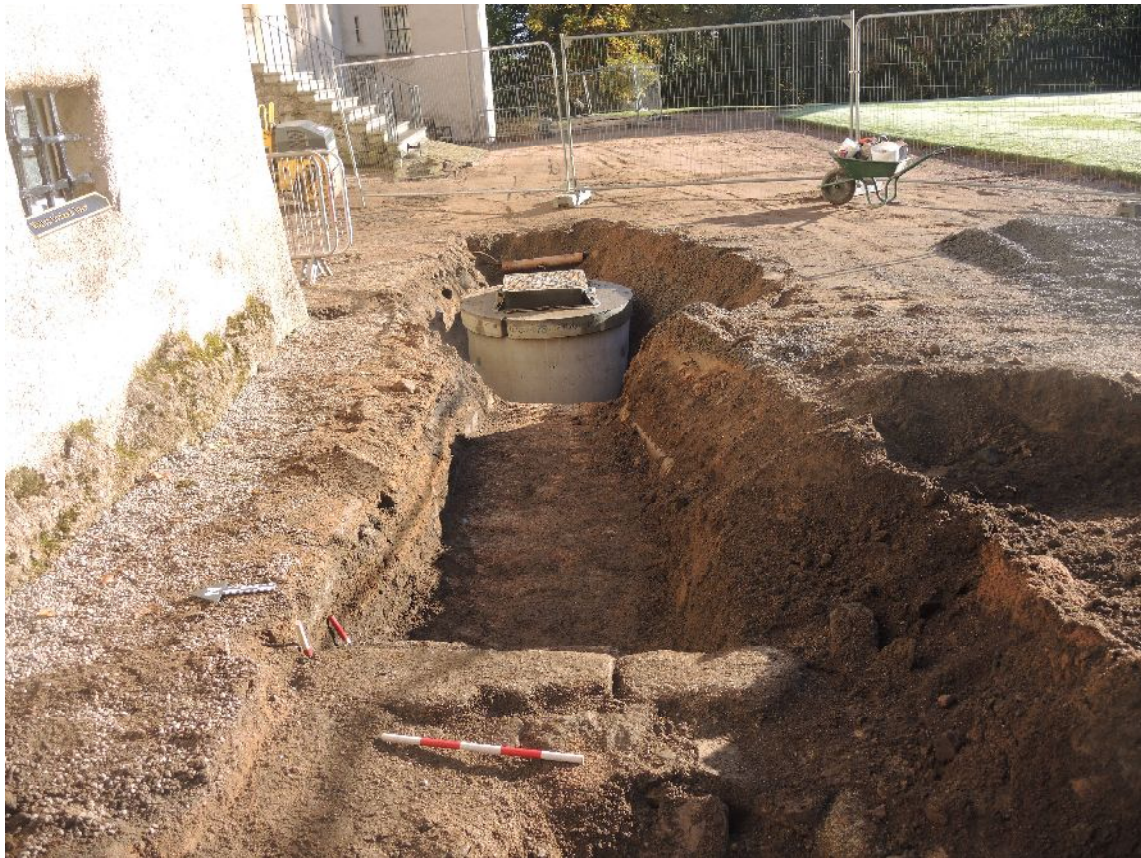
Illus 20 Steps looking E

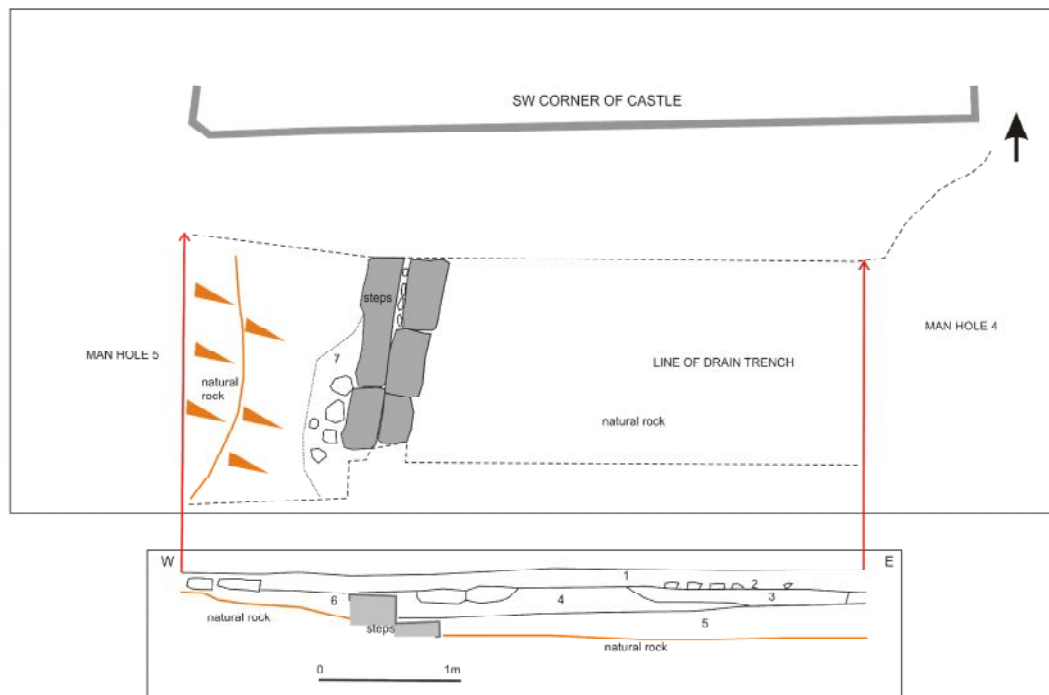
Both steps were sealed by redeposited natural sand with lenses of topsoil and occasional slate (illus 20:4). The S side of the steps had been removed by the ceramic drain (the new drain ran along the N side of the old drain at this point).

Illus 21 Plan and section of steps (1= gravel of modern surface. 2= small stones over soft patch. 3= black silt in localised hollow. 4= redeposited natural with lenses of topsoil and occasional slate (deliberate levelling). 5= grey compact soil, occasional slate (probably construction level). 6=gritty disturbed natural. 7=remnant of stone layer levelling between top step and rock outcrop.
