**DRAINAGE  
DRUM CASTLE  
ABERDEENSHIRE**

**Archaeological Watching Brief**  
Carried out between October and November 2016  
by  
**Murray Archaeological Services Ltd**

**Report No: MAS 2016-27**  
by  
H K Murray

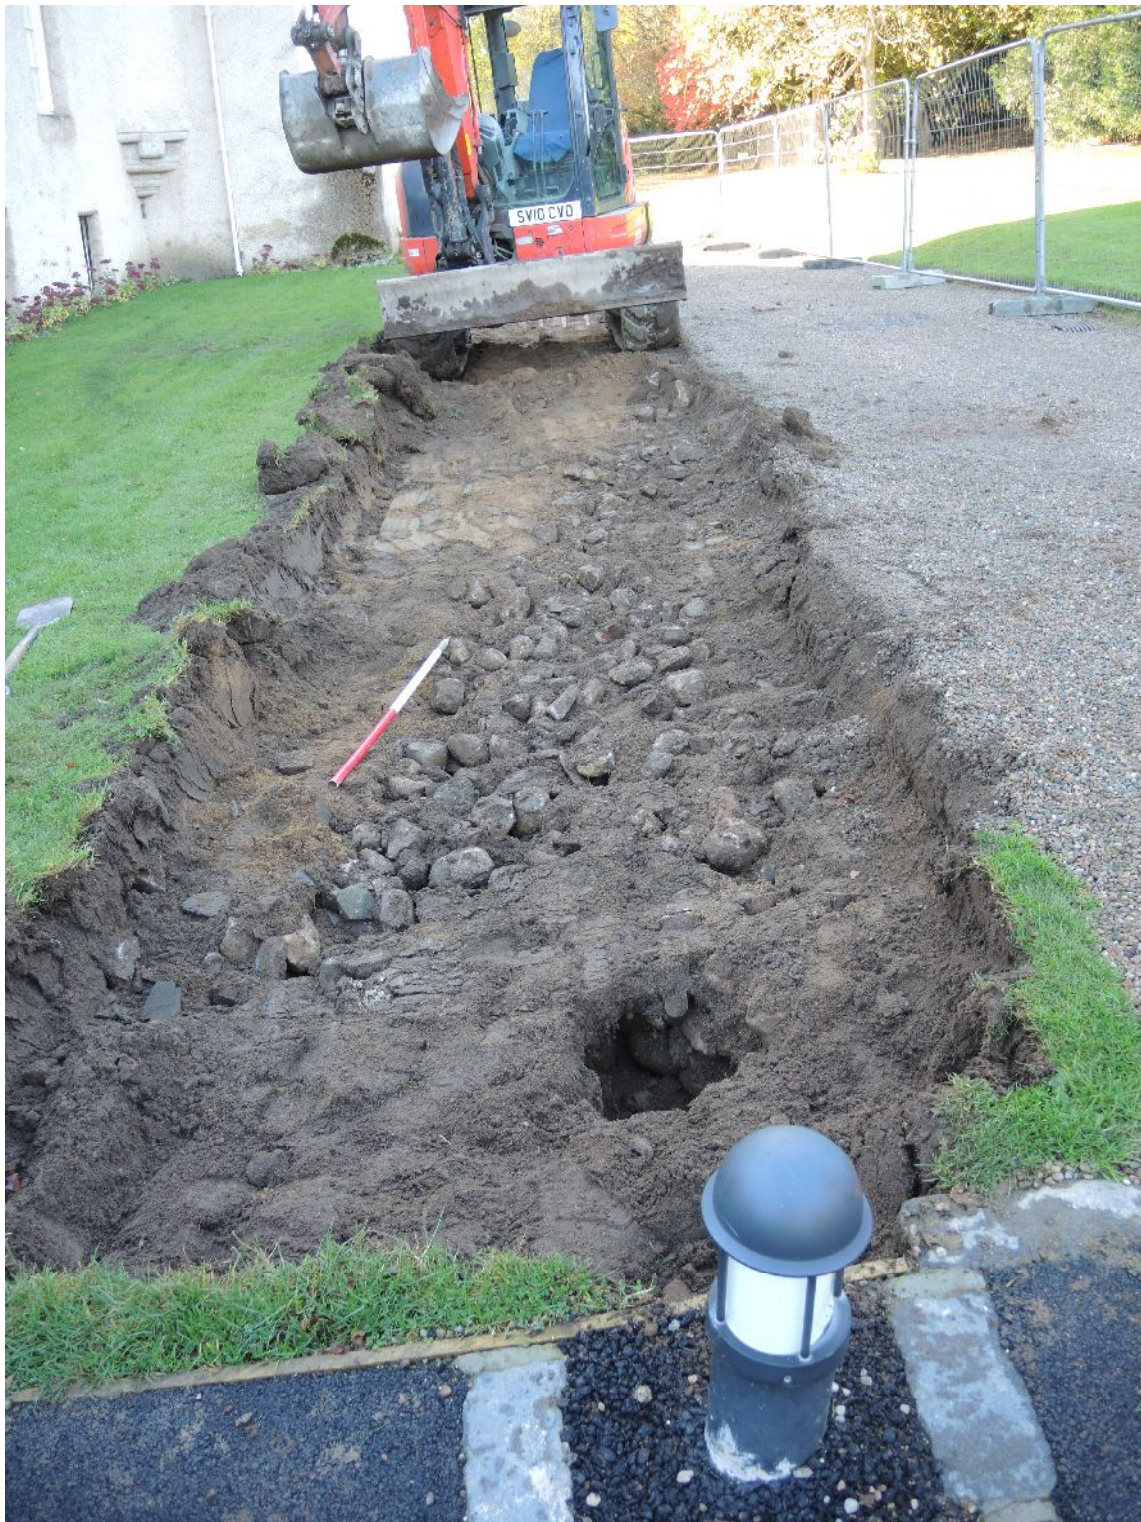
A c 1.2m wide trench extended c 7m NNE/SSW across the line of the new drain trench from just S of the tarmac path to the car park and into the grass W of the gravel path (illus 23, 24, 25).

This can only be interpreted as some sort of soakaway but it is hard to understand where it was intended to drain to.

**Illus 23 Soakaway (14) looking S**

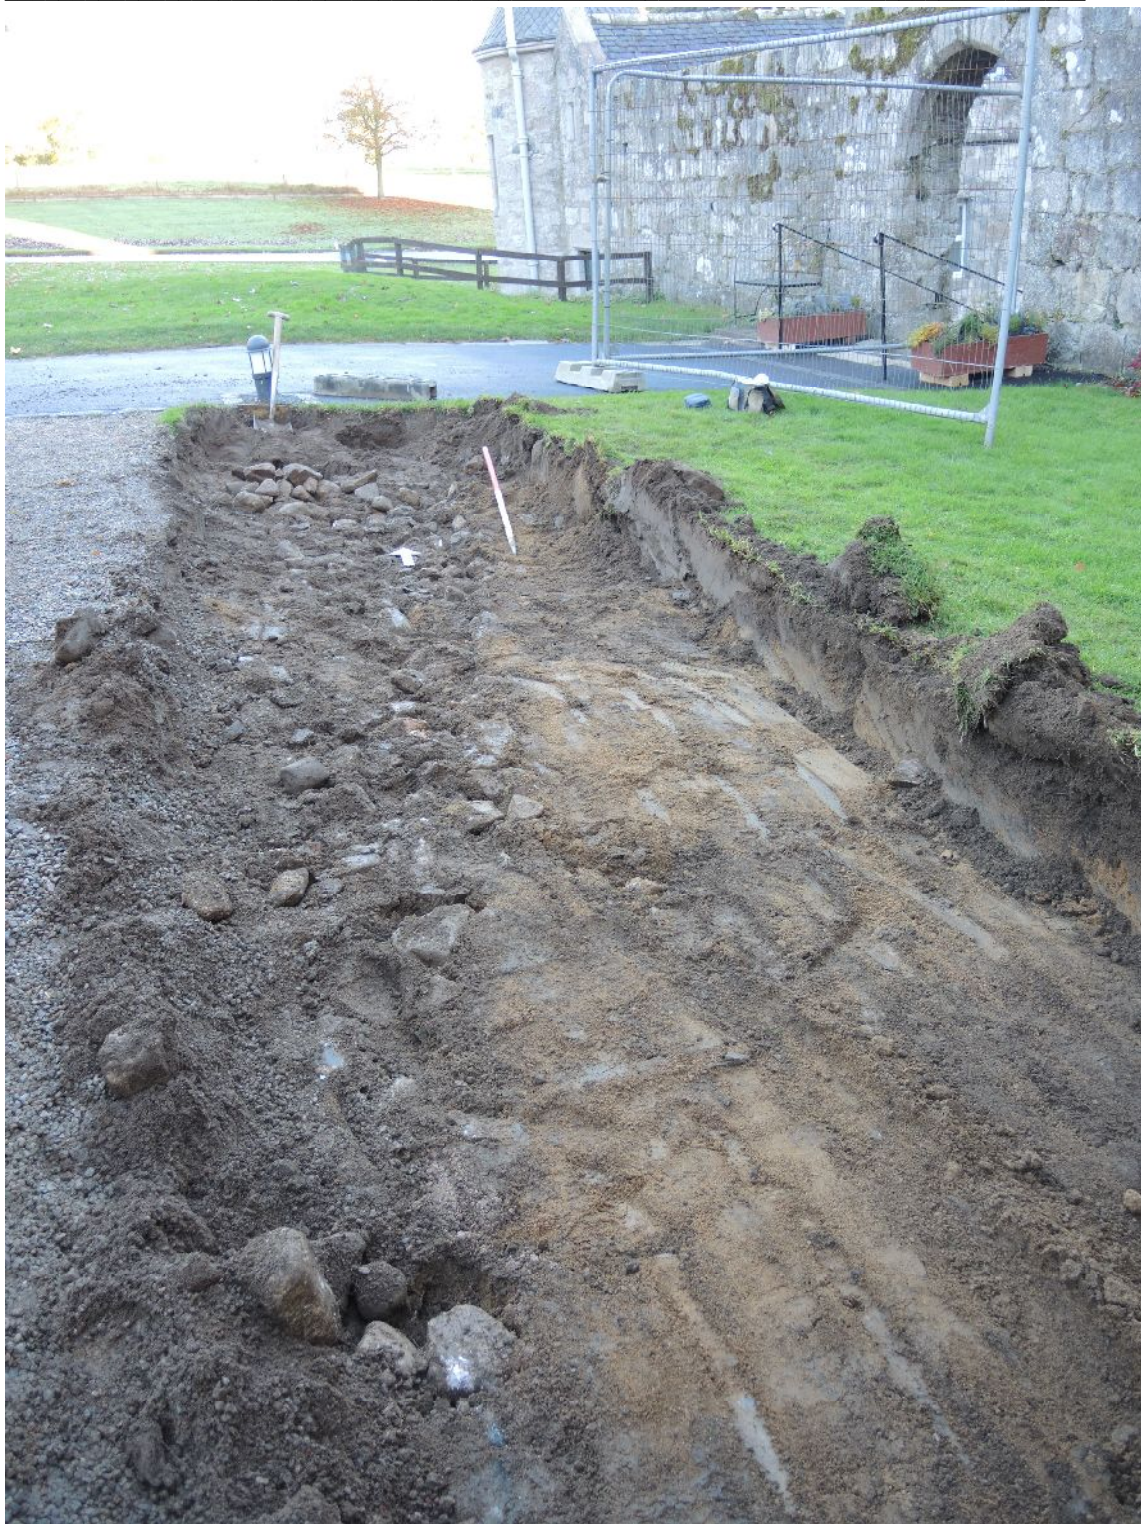
A section was cut through this feature by machine (illus 24) and showed it to be c 1m deep sealed by c 250mm topsoil or path gravel. The fill was of medium sized rounded field stones. The S end may have been cut when fire main put in as there was a scrap of blue water hazard tape in the edge of the fill.

**Illus 24 Soakaway (14) looking N**

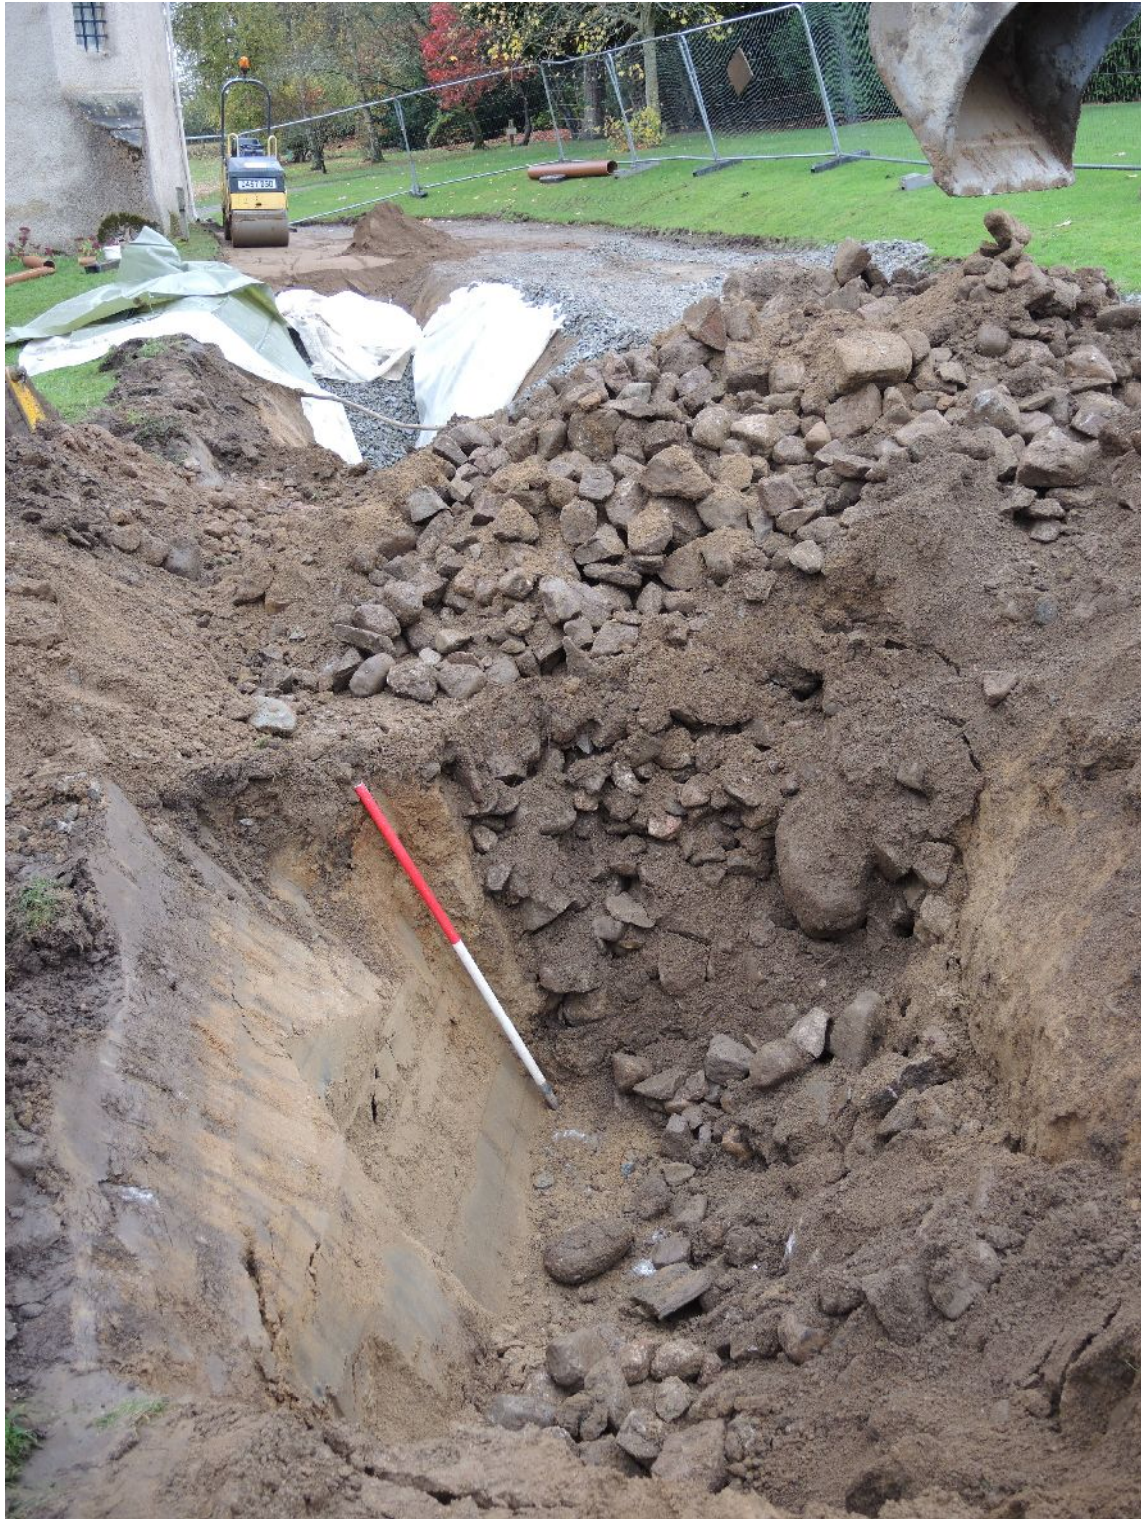
**Illus 25** Section of soakaway c 2m S of tarmac path

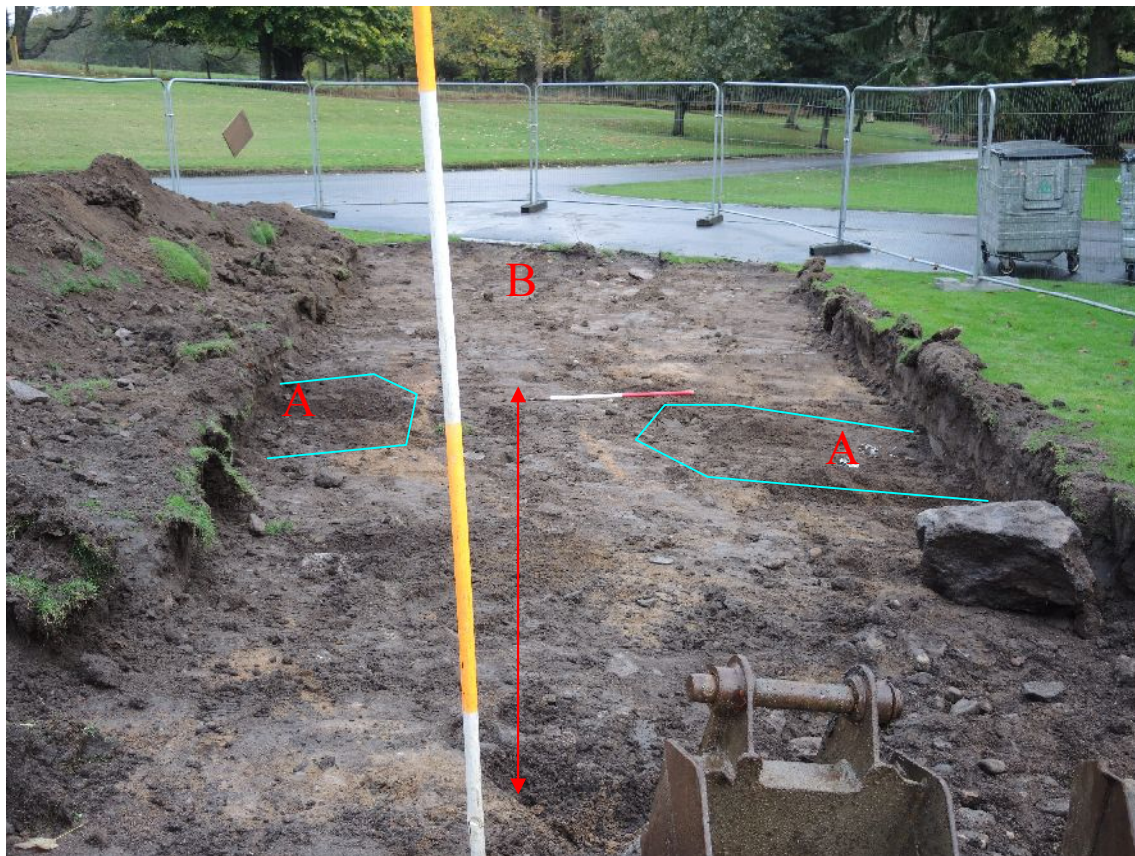
A thin spread of rubbish dumping lay across the trench and was cut by drain 23. The dumping included a small quantity of large pieces of one, or possibly two, 19<sup>th</sup>-century Willow Pattern dishes, several fragments of 19<sup>th</sup>-century wine bottle glass and a small

quantity of animal bone from food remains. The dumping extended for c1.6 x 3m and appeared to continue to the W of the soil strip. It lay on the top of natural and was only sealed by between 350mm (W) to 450mm (E) of topsoil; the fill around the pottery etc was indistinguishable from the overlying topsoil.

**Illus 26 Dumping 22 (A- marked by blue line) bisected by drain 23 (B- marked by red arrow)**
