LOANHEAD COTTAGE DRUMBLADE HUNTLY ABERDEENSHIRE

Standing Building Survey

Carried out 1st August 2018 by **Murray Archaeological Services Ltd**

Report No: MAS 2018-18 by H K Murray and J C Murray

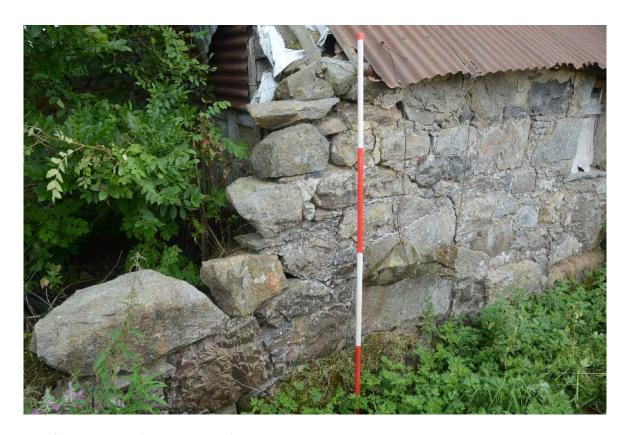
<u>Plan</u> Rectangular. The E end of the building was roofless and with only partial survival of the walls. While the junction of the main cottage and the E end was obscured by render on the front (S) wall, there was good evidence of stones running across the junction of the N wall, suggesting that the E end was part of the original plan (Illus 8). There was no evidence of any direct access between the main cottage and the E end but the wall was obscured on both sides so this is indefinite.

Illus 8 N wall. Junction between main cottage and E end.

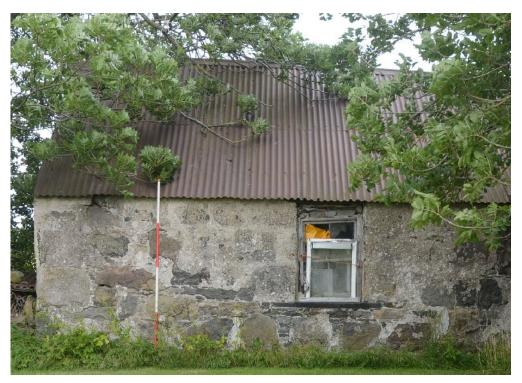
<u>Walls</u> Rubble stone. Some render on exterior obscures detail but S elevation where render has worn shows split rubble with small angular pinnings. Large boulders in basal course.

Illus 10 Detail of W end of S wall showing detail of stonework

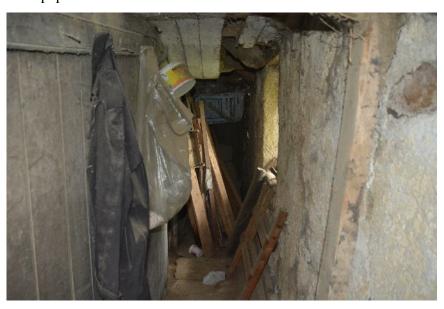
Internally the outer walls were plastered. Internal partition walls were of pine and had been papered.

Illus 11 Inside door D2, looking E along passage, showing plaster on inner face of main wall.

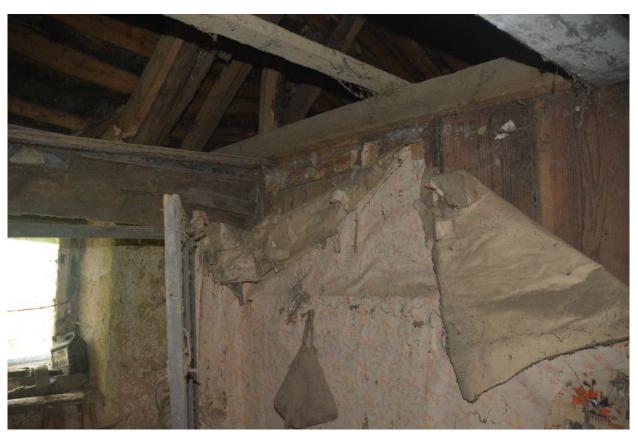
Illus 12 Inside room 2 looking towards passage and W2, showing wallpaper on internal wooden partition wall.

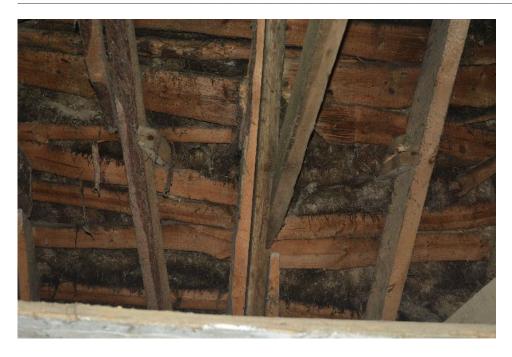
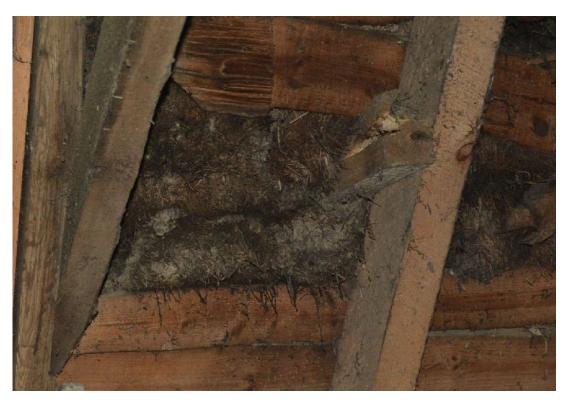
Observation of the underside of the roof from inside the cottage shows a layer of turves lying below the tin over horizontal rough plank sarking (Illus 13, 14). For safety reasons these could not be examined more closely.

Illus 13 Underside of roof from within cottage

Illus 14 Detail of turves below corrugated iron

The use of turves below the corrugated iron of the roof is interesting; they may have been intended as insulation, or may be a relict from a thatched roof, as thatch (which could be reeds, straw, heather or even broom) was often laid on a bedding of turves. Fenton and Walker 1981, fig 42) illustrate a very comparable example of turf under corrugated iron from Hill of Hatton, Auchterless, Aberdeenshire.

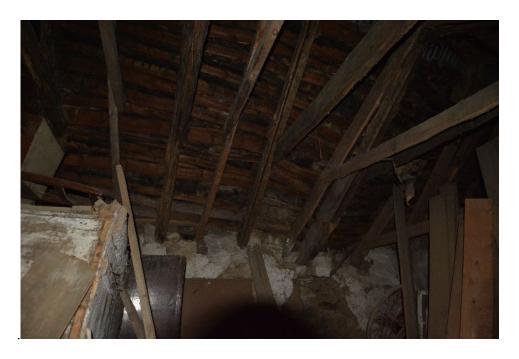
<u>Roof</u> Corrugated iron. The roof framework comprised A-frame couples of fairly rough timber with some bark remaining; these had been augmented and propped by more recent squared timber.

Illus 15 Roof structure in Room 1

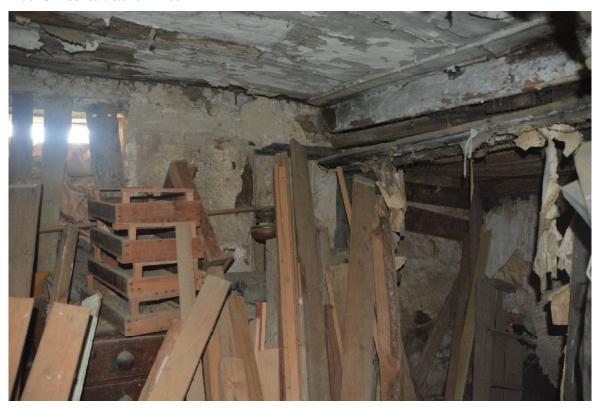
A ceiling of thin planks survived in some places, with traces of it having been painted or papered over in the kitchen (Illus 16)

Illus 16 Ceiling in kitchen

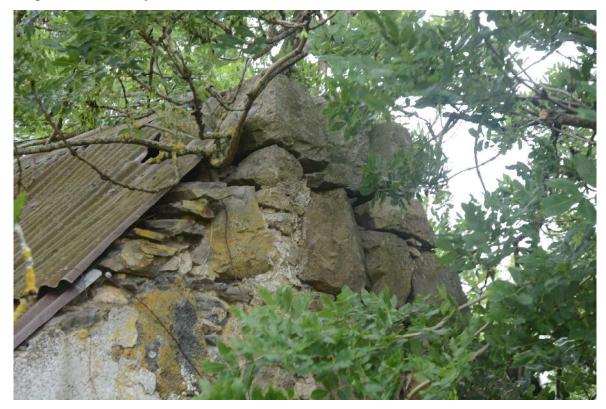
<u>Chimney</u> Only a few stones at the apex of the W gable (Illus 17) survived of the chimney that is implied by the position of the kitchen hearth. There was no other evidence for fireplaces or chimneys.

Illus 17 Remnant of stone chimney at W gable

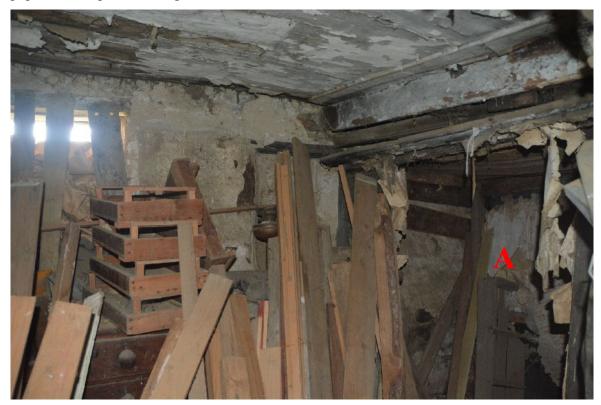
Internal partition walls had been used to form a recessed area c 2.2 x 1.2m at the NE corner of the room. This is likely to have enclosed a box bed that could have been closed off from view with the doors that survived. The interior of this recess had been wall papered. The plank ceiling was lower than that of the main kitchen area.

Illus 22 NE corner of kitchen with box bed recess (A)

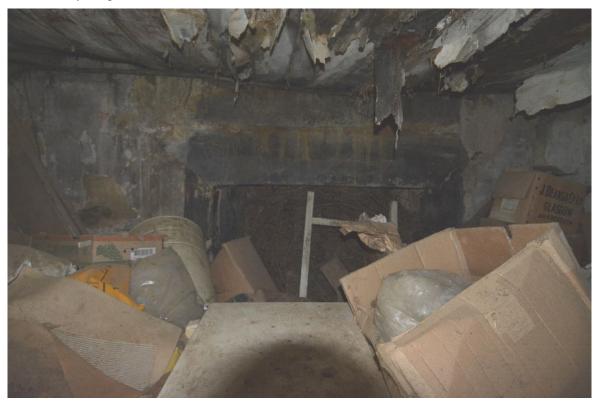
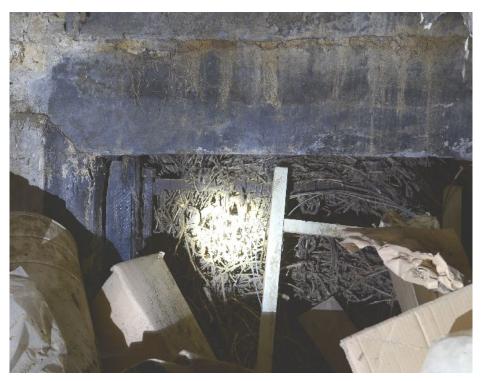
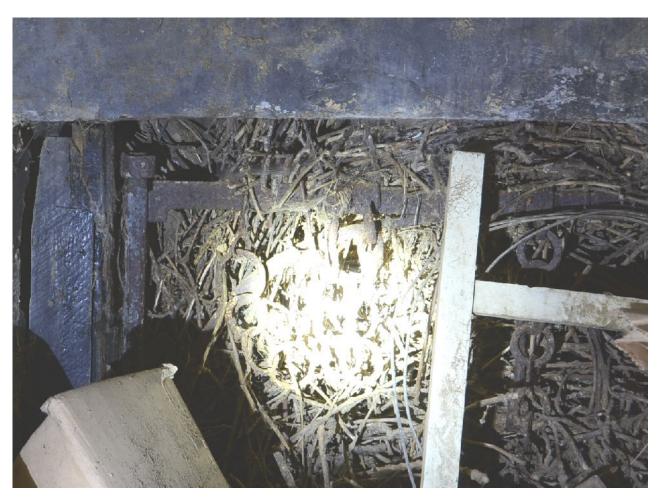
On the opposite side of the room, on the inner side of the W gable, there was a large hearth (estimated width 1.5m) with a wide stone lintel. The hearth itself was filled with a tangle of branches so was difficult to photograph but it was clear that the original iron swey and pot chains survived.

Illus 24 Kitchen. Hearth at W end

Illus 25 Hearth. Light used to highlight swey and chains

Illus 26 Detail of swey and pot chains

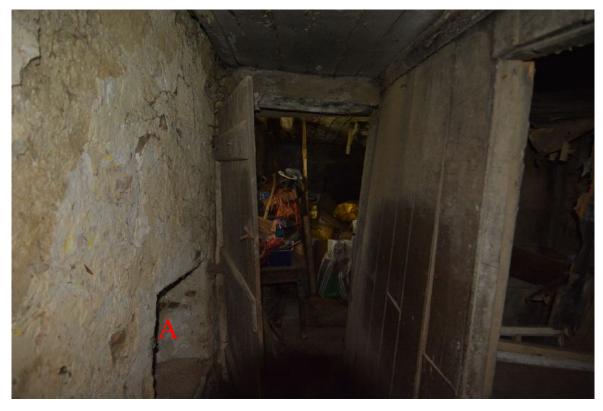
The passage extended along the front of the building from the kitchen, giving access to Rooms 1 and 2. It was not possible to determine if it also gave access to the E end of the building. Just inside the main door (D2) and partially obscured by the kitchen door when it was open, there was a low alcove on the inner face of the wall. There was no evidence of its function- possibly a cool place to store a milk can.

Illus 27 Passage, looking towards kitchen showing alcove on inner face of the front wall (A). Room 1 on RHS $\,$

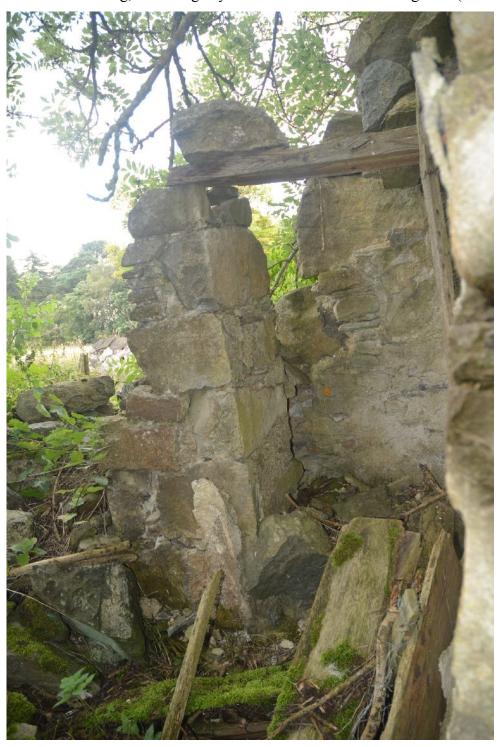
The E end of the building was a ruin so few details survived. However a cupboard built into the thickness of the E gable (Illus 28) suggests that this was additional accommodation, rather than a byre. The collapse of the gable made it impossible to determine if there had been a hearth at this end of the building. Corrugated iron and wood

Illus 28 Cupboard on inner face of W gable

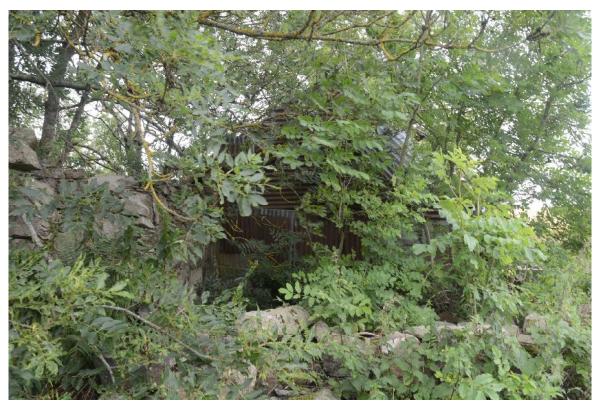
had been used to insulate the outer face of the party wall between the main cottage and this end of the building, obscuring any evidence of a communicating door (Illus 29)

Illus 29 E end of building looking towards the party wall with the main part of cottage

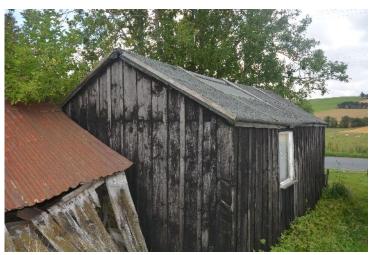
This is a small timber building of no significance.

Illus 30 Garage
