NORTH BAY PATH DUNNOTTAR CASTLE STONEHAVEN ABERDEENSHIRE

Watching brief

Report No: MAS 2019-02

NORTH BAY PATH DUNOTTAR CASTLE STONEHAVEN ABERDEENSHIRE

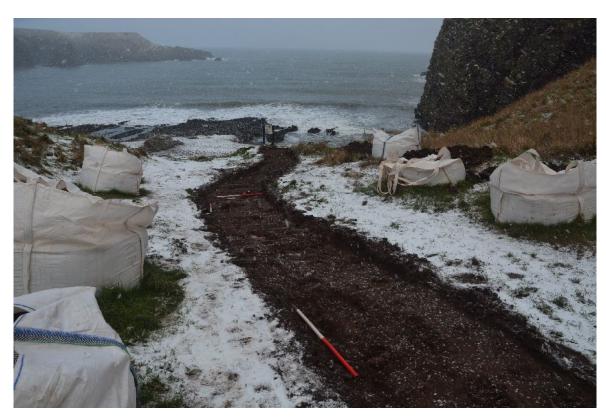
Illus 4 Path after topsoil stripping looking E towards North Bay

The topsoil was between 80 and 160mm deep and overlay natural pebbles to the lower (beach end) and a mixture of pebbles and fragmented rock at the upper end. There was no evidence of any archaeological features or finds.

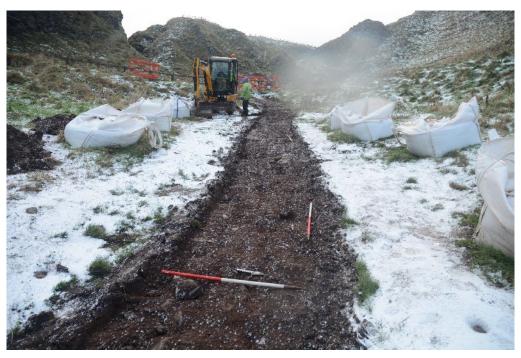
Illus 5 Path after topsoil stripping looking W towards existing path to castle

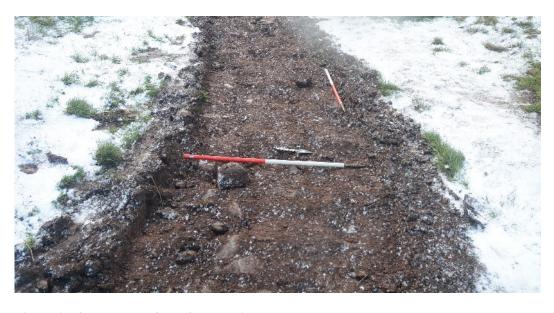
Illus 6 Detail of the path surface after topsoil removal
