West Coast Archaeological Services

Generator Installation and Access Upgrade, Nerabus, Islay

Desk-based Assessment and Archaeological Watching Brief Data Structure Report

| WCAS Report No: | 72/NER/18 |

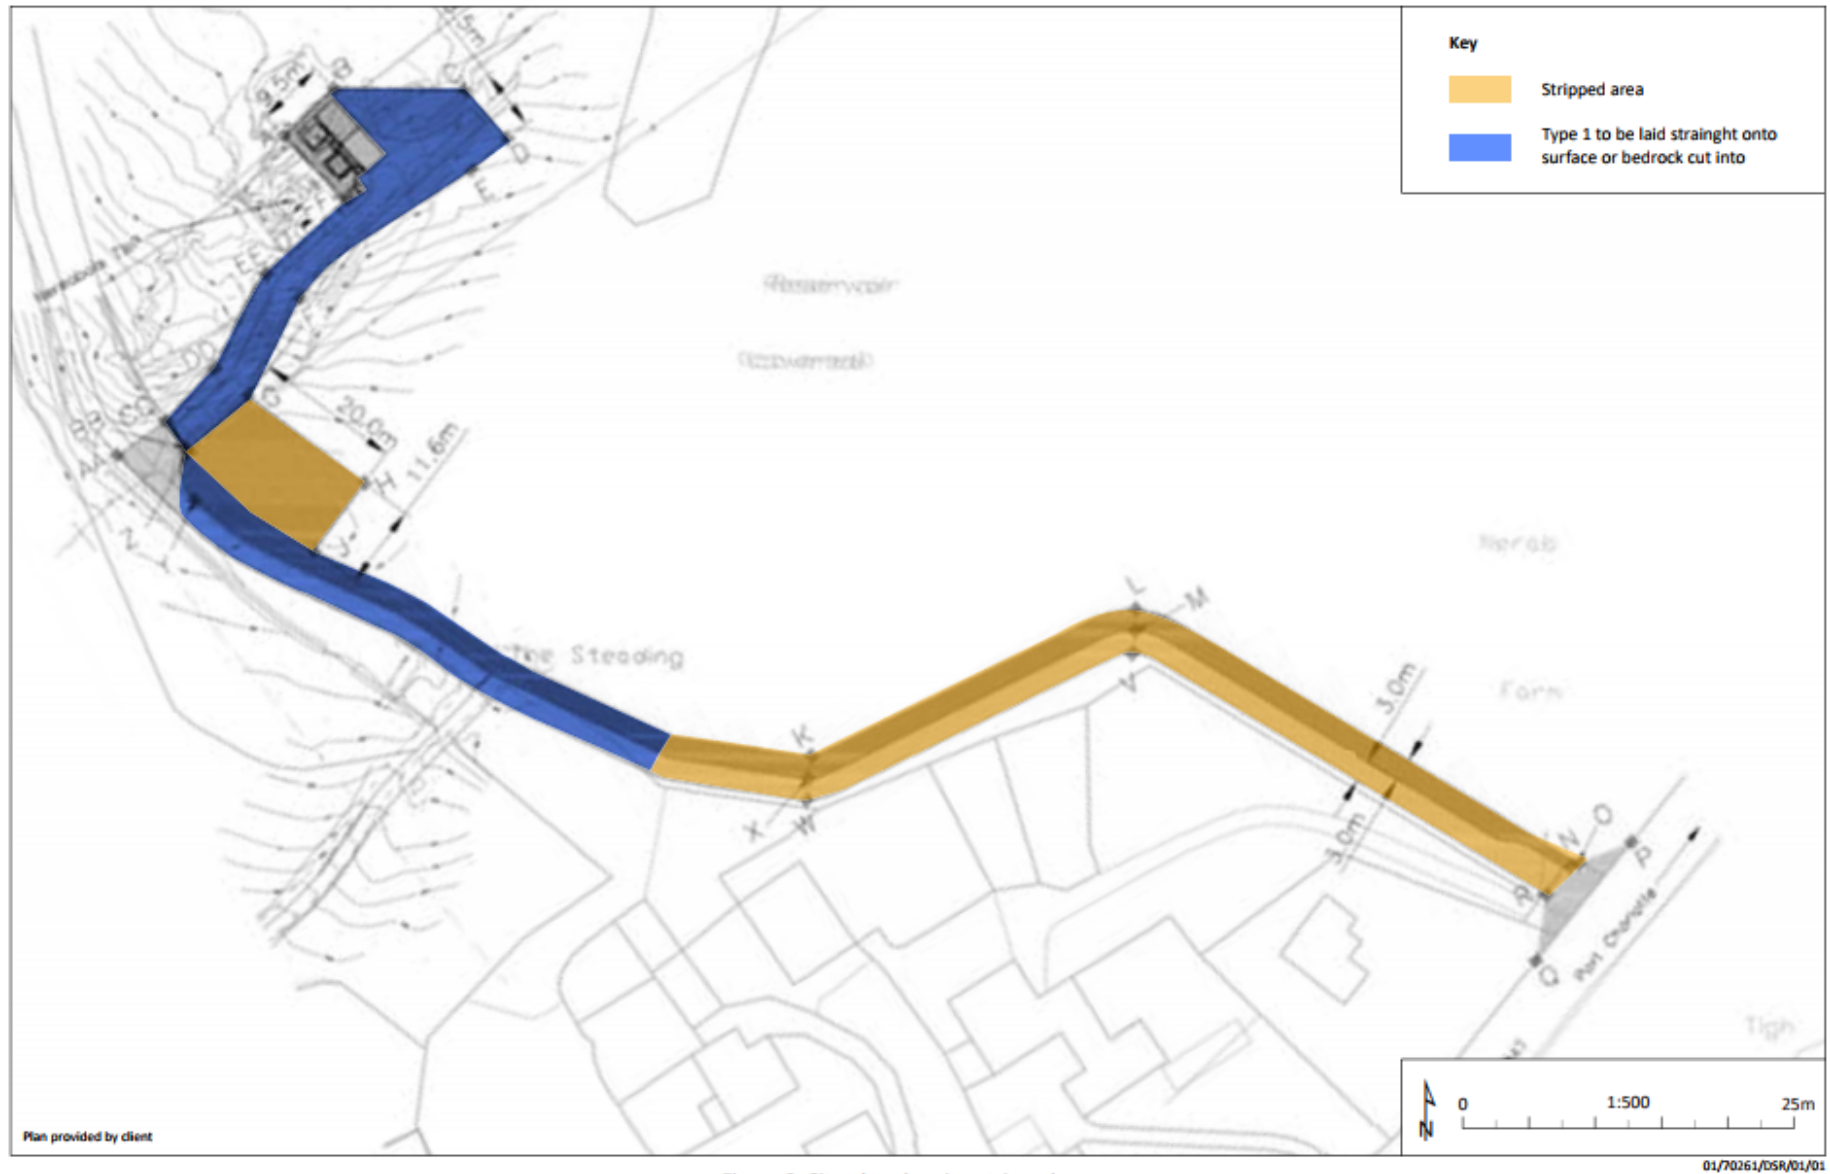
Figure 3: Site plan showing stripped areas (background mapping provided by Scottish Water)

- 5.2.1 Fieldwork was carried out on 19th - 20th February 2018. The 3m-wide access track route ran NW from the A847 along a fence-line and up a gradual slope to join with the existing field track (**Figure 3; Plate 1**). The depth excavated was very shallow (0.15-0.2m deep). This was simply to remove topsoil which overlay a compact medium grey brown silty clay with gravel inclusions or bedrock. In places visibility was poor due to the fragmentary nature of the bedrock. The compound area measured no more than 10m x 20m and was excavated to a maximum depth of 0.4m (**Plate 2**). This was a particularly boggy area where topsoil again overlay a compact medium grey brown silty clay with gravel inclusions as well as a natural medium orange brown sandy clay subsoil in patches. Two spoil heaps from the construction of the road and existing field track were removed (**Plates 3, 4**).

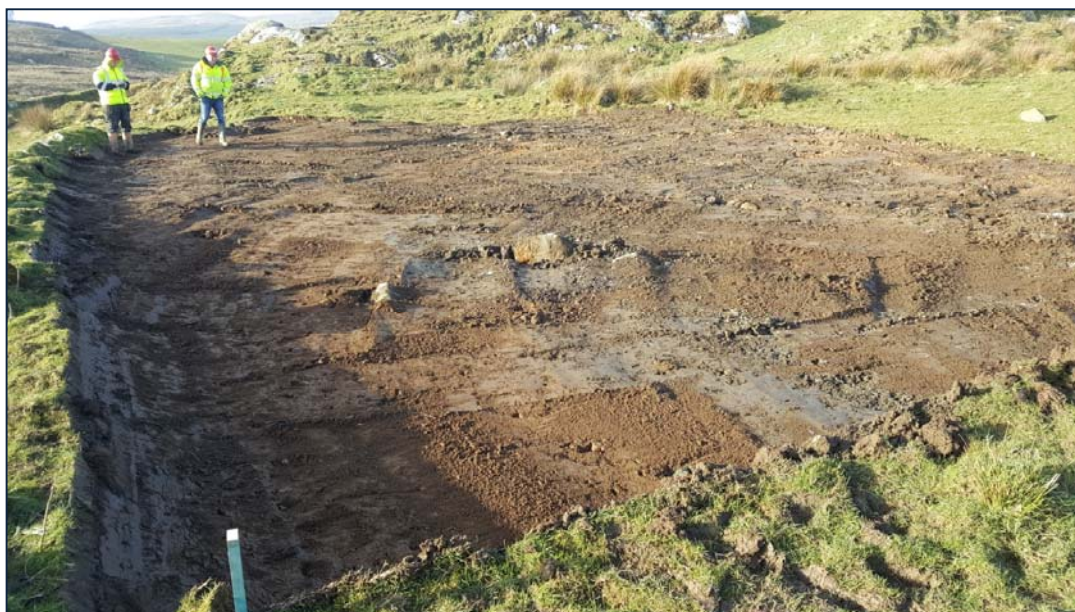
Plate 2: Post-excavation photo of the site compound looking N

- 5.2.2 No archaeological features were observed during the groundbreaking works. At the top of the hill where the compound area is located, topsoil was slightly deeper overlying the compact medium grey brown silty clay and natural subsoil. (**Plate 2**). Several small fragments of 19th or 20th century ceramics were scattered within the topsoil. No features

were identified in association with these artefacts suggesting that they have been deposited on the surface and have become buried over the years.
