BEVAN HOUSE, CRAIGHOUSE, EDINBURGH

ENHANCED BUILDING SURVEY

September 2015

DATE ISSUED:	September 2015
JOB NUMBER:	CP11336
OASIS REFERENCE:	wardella2- 223687
REPORT NUMBER:	RPT-001/1
GRID REFERENCE:	NT 2335 7068

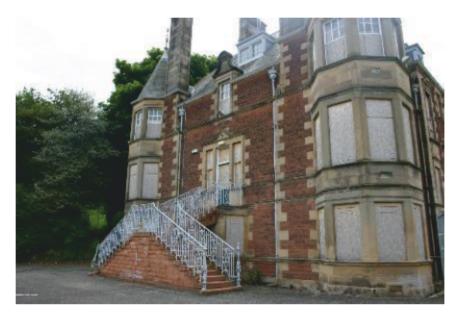
Plate 1: East elevation.

- 4.2.2 The entrance on the east elevation is reached through a branched perron staircase made of red sandstone with a solid ornamental handrail. Some damage can be noted on the staircase with mainly the metal handrail being affected. Semi-octagonal side towers give the front elevation a symmetrical appearance. Only the north-west corner lacks such a tower.

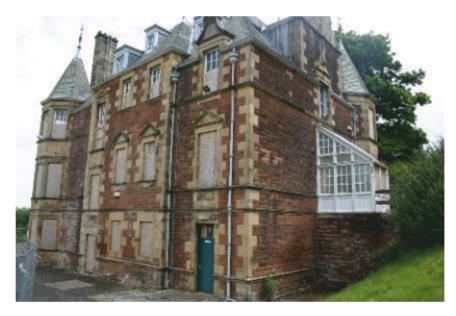
Plate 2: North elevation.

4.2.4 On the north side, the blocked skylights are visible of the tunnel leading to East Craig. All windows, except the ones in the attic floor, have been boarded up.

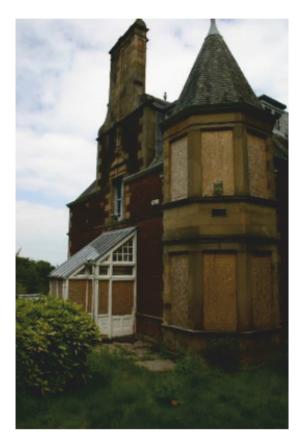
Plate 3: West elevation.

- 4.2.3 On the west elevation to the rear, several red sandstone ashlars seem to have been replaced in recent times. The wooden veranda is in a reasonably good condition.

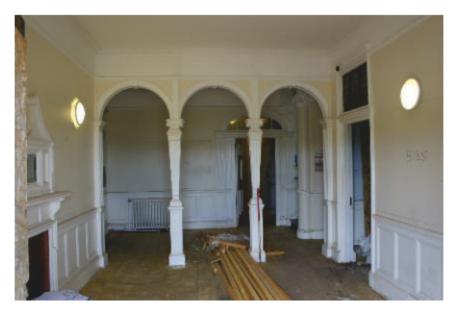
Plate 5: R 1, entrance Hall

- 4.3.2 *R 1 (Plate 5-8):* One of the main features of the upper ground floor is the elaborate entrance hall. The decorative frieze and features have survived nearly undamaged during the past century of changing ownership and use. Heavy layers of paint tarnish the décor. The tiles of the chimneypiece, with mirror over mantel on the south elevation, have been overpainted a light brown. Through chipping off the paint, blue and white decorative painting is visible. Three decorative arches with pillars going from north to south divide the room. On the northern elevation two decorative arches with a column lead to the staircases. A modern partition wall with doorway has been built just after the decorative arch to the basement staircase (Plate 7).

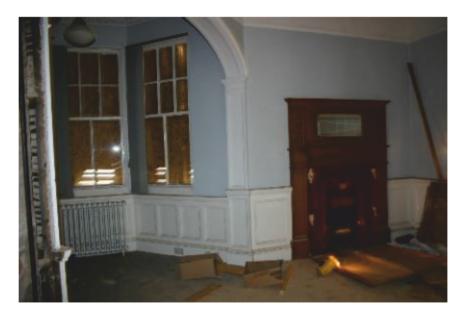
Plate 9: R 3.

- 4.3.3 *R 2 &3:* Both designed as parlours within the hospital, R 2 and 3, have sustained major damage through wet rot. In R 2 the west wall has been stripped of its plaster. The decorative plaster ceiling has been damaged and it is structurally unstable as a result of rot. The same issue arises in R 3 (Plate 9), with the north elevation and parts of the ceiling being stripped. There are several highly representative chimneypieces on the ground floor, most of which have been blocked. The dark red tiled fire surround of R 3 is slightly damaged from previous alterations.

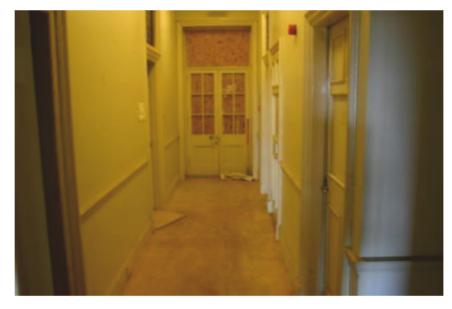
Plate 10: R 4, corridor.

- 4.3.4 *R* 4: The main corridor of the upper ground floor (Plate 10) has a dado rail. The hallway leads to the veranda to the west, and several doorways branch off to the north and south. A stained glass over door light is over the doorway to R 7 and R 8. The white timber veranda has a red tiled floor. Original leaded stained glass panels survive on the south elevation, but most other panels have been replaced by modern safety glass (Plate 23).

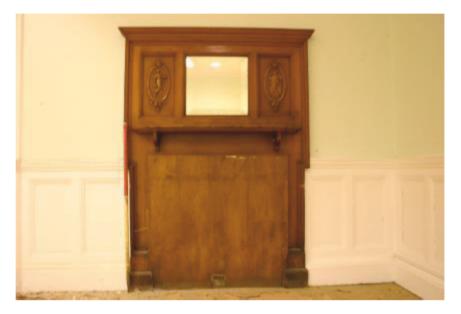
Plate 11: R 7.

- 4.3.6 *R 6:* No fabric of archaeological interest is visible.
- 4.3.7 *R 7:* The chimneypiece of R 7, while being firmly boarded up, has a slightly different carving design to other rooms. The mirror over mantel is framed by two figurine reliefs. The same kind of chimneypiece can be found in Queen's Craig, R 39. This difference in design may reflect the original status of the room which may have been

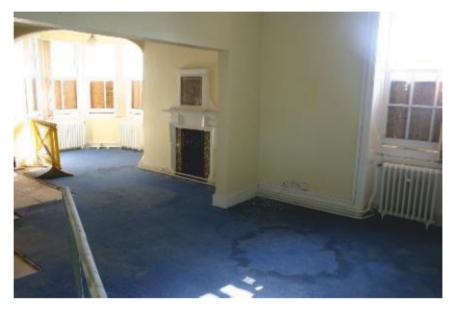
Plate 13: R 13, general view.

- 4.4.6 *R 13:* This large room used to be two rooms (Plate 13). Remains of the partition wall (north to south) are still visible; one doorway has been blocked on the western elevation. The room was only partly accessible, as water damage effected the structural stability of the flooring. The two chimneypieces are of the same design, but differ in the tiled fire surround. One fire surround contains blue-green tiles with floral decoration (Plate 14), while the other is comprised of white tiles with yellow and green floral décor.

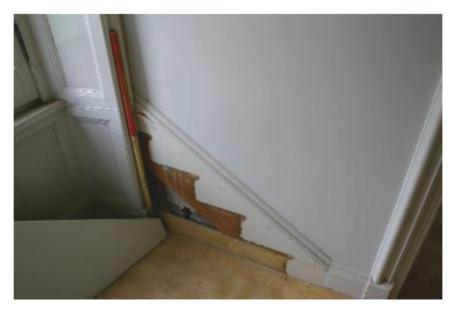
Plate 15: R 14, detail.

- 4.4.7 *R* 14: At the west end of this long corridor, traces of four stairs which used to lead to the now replaced and closed French windows are visible (Plate 15).

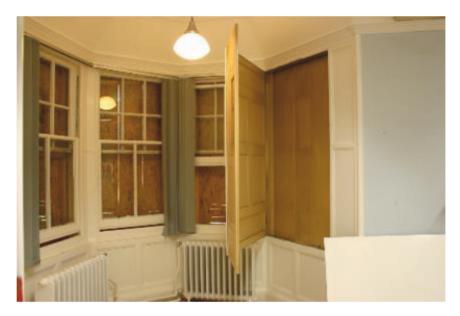
Plate 16: R 17, detail of bay.

- 4.4.8 *R* 15: No further archaeological material is visible.
- 4.4.9 *R* 16: No further archaeological material is visible.
- 4.4.10 *R* 17: The ceiling of R 17 had been damaged in some places, uncovering pieces of light blue fresco painting with a light cream coloured floral design beneath the
