QUEEN'S CRAIG VILLA, CRAIGHOUSE, EDINBURGH

ENHANCED BUILDING SURVEY

December 2015

DATE ISSUED: December 2015
JOB NUMBER: CP11336
OASIS REFERENCE: **wardella2- 223782**
REPORT NUMBER: RPT-005/2
GRID REFERENCE: NT 2335 7068

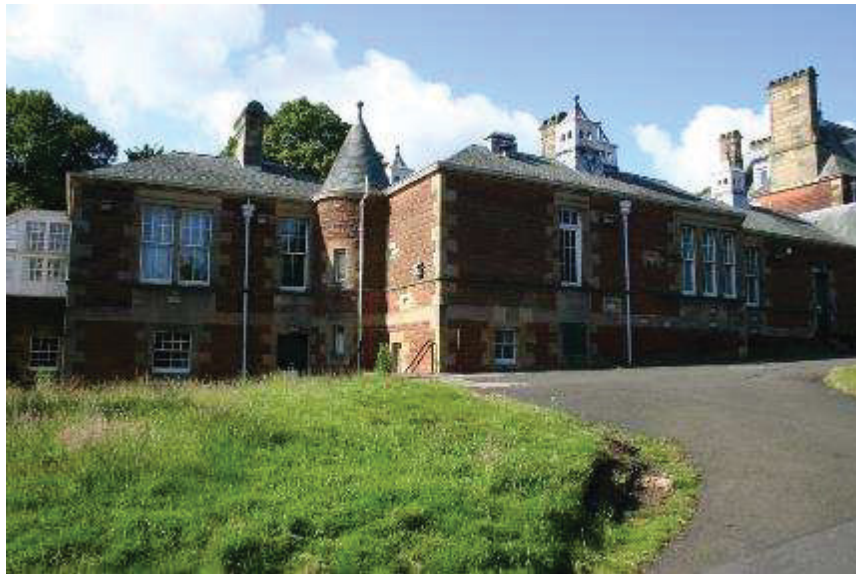
4.2.4 On the north elevation traces of rising damp are visible. The majority of the original decorative fittings, e.g. the ridge turrets and drainage pipes, appear to be in a good condition.

Plate 5: north elevation, east part

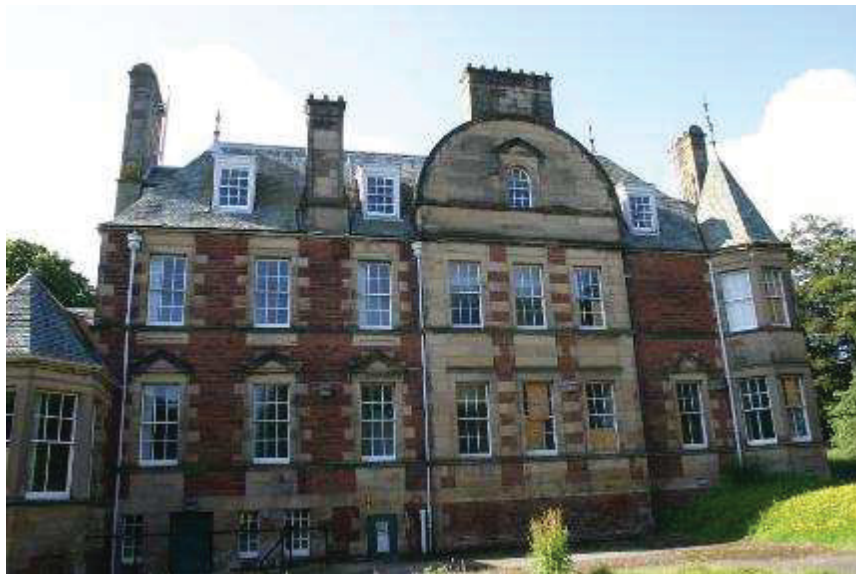
Plate 6: north elevation, west part

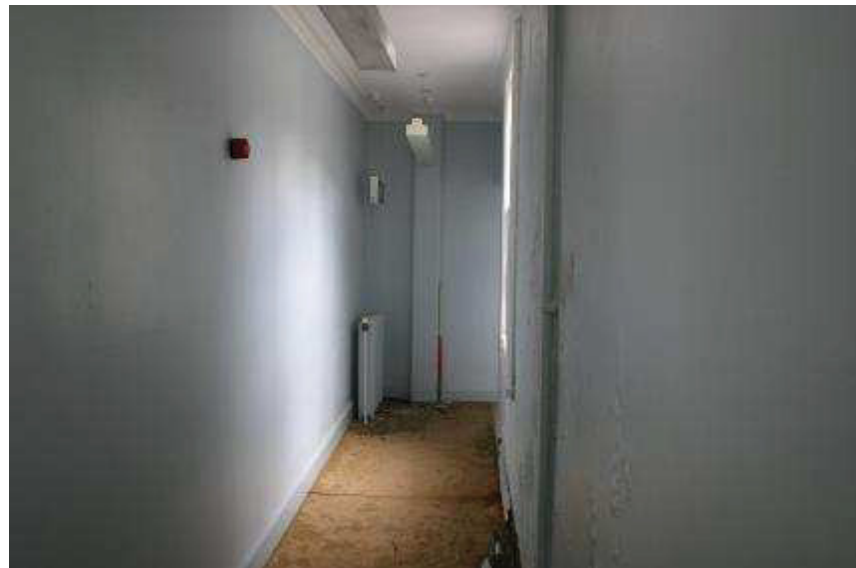
- 4.3.24 *R 25*: No material of archaeological interest was visible.
- 4.3.25 *R 26*: No material of archaeological interest was visible.
- 4.3.26 *R 27*: To the north of hallway 24 leads a smaller L-shaped hallway 27 around the exterior light well (Plate 24). This part is affected by mould and rot caused by structural problems with the light well.

Plate 24: hallway 27, some water damage visible on the right

5.1.3 Further treatment for rot and water damage would be recommended, and while the roof appears to be intact, there were some small areas of water damage.

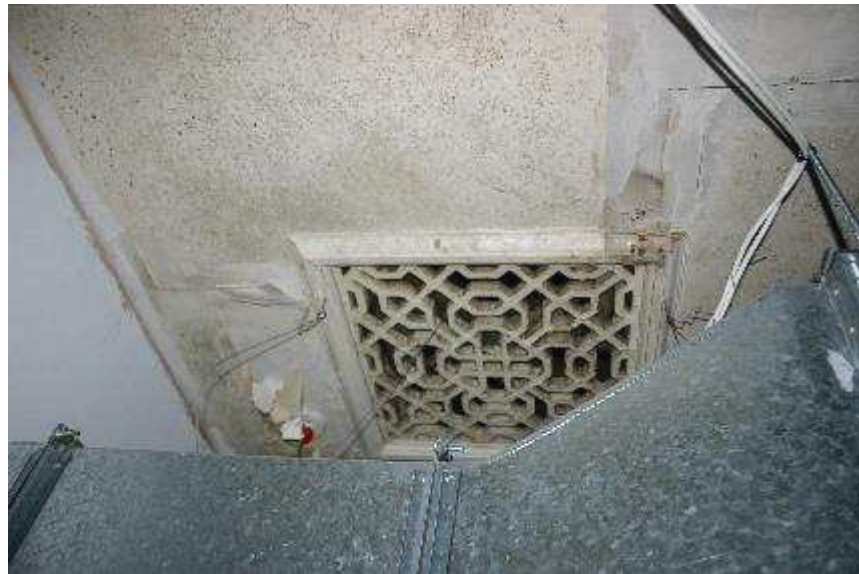
- 4.3.31 *R 32*: There are few historic features left in R 32 following its conversion into a toilet area. Some classical coving and a decorative air vent is visible, although they are in a poor condition (Plate 27).

Plate 27: R 32, ceiling toilet room

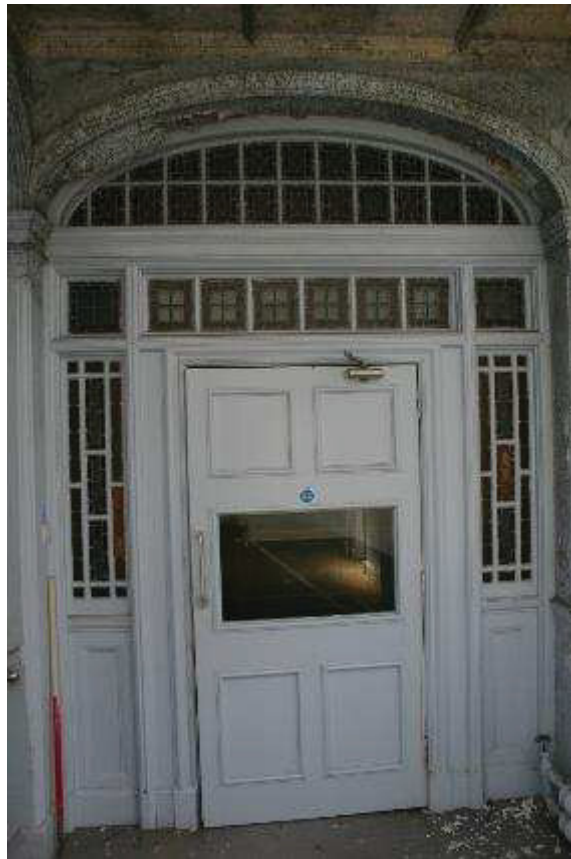
4.3.35 *R 36/Conservatory*: The timber framed, glazed conservatory to the east is severely affected by mould infestation (Plate 29 & Plate 30), but still retains the original timber framed stained glass doorway. The glass panels of the conservatory are most likely later replacements.

Plate 29: doorway with stained glass, heavy mould infestation R 36

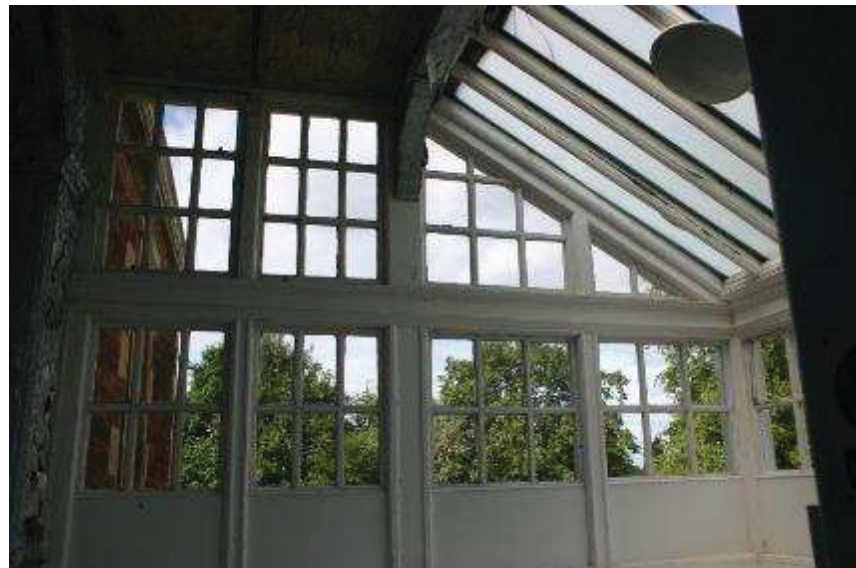
Plate 30: glazed timber conservatory R 36

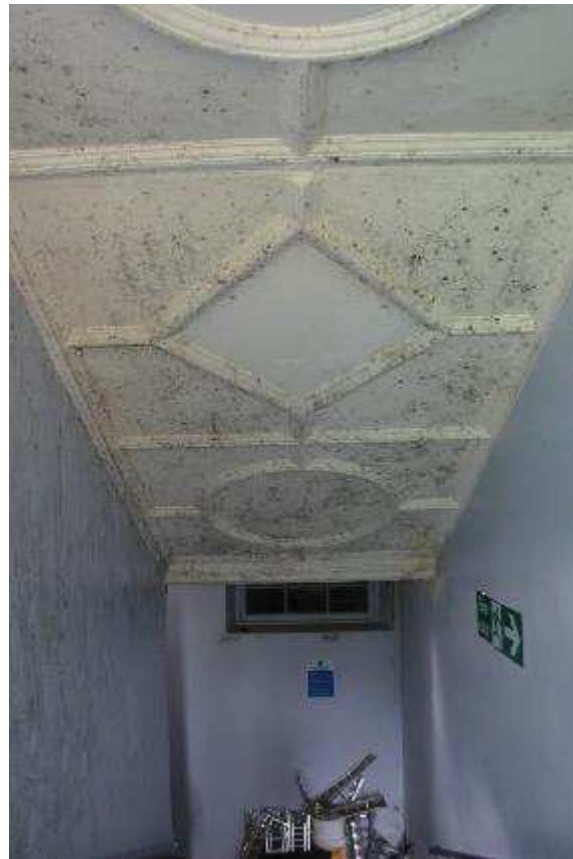
Plate 41: mould infestation in R 64

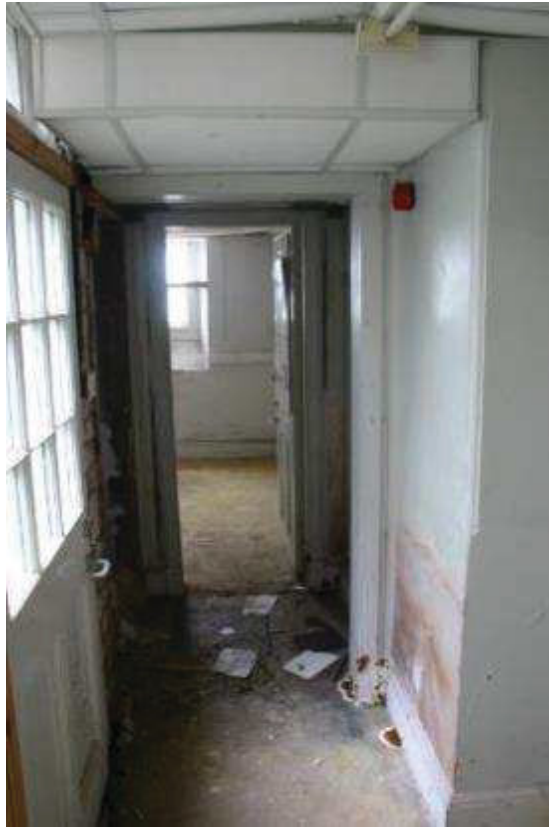
Plate 44: dry rot/fungus infestation in R 71

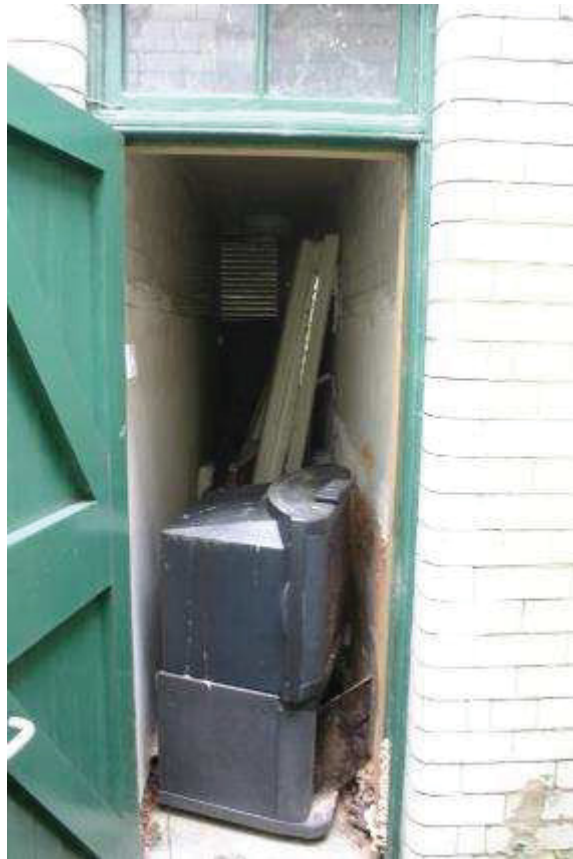
- 4.6.5 *R 72 to 75*: The unroofed open space within the building forming a small courtyard which serves to illuminate spaces (R 72, Plate 43) can be accessed through R 71. It is in the same architectural and decorative style as the light well of East Craig. The rooms surrounding the light well, R 70, 71, 73, 75, and in parts R 68, are all affected by water damage resulting in dry rot, for which treatment is underway (Plate 44). Consequently, the majority of the wall plaster within these rooms is being removed. R 75 could not be accessed at the time of the survey as it was blocked by bulky waste (Plate 45).

Plate 45: bulk waste in R 75
