**HAUSE GILL, SEATOLLER, BORROWDALE, CUMBRIA**

**Measured Photographic Survey**

**DATE ISSUED:** July 2016  
**JOB NUMBER:** CP11842  
**OASIS REFERENCE:** wardella2-259291

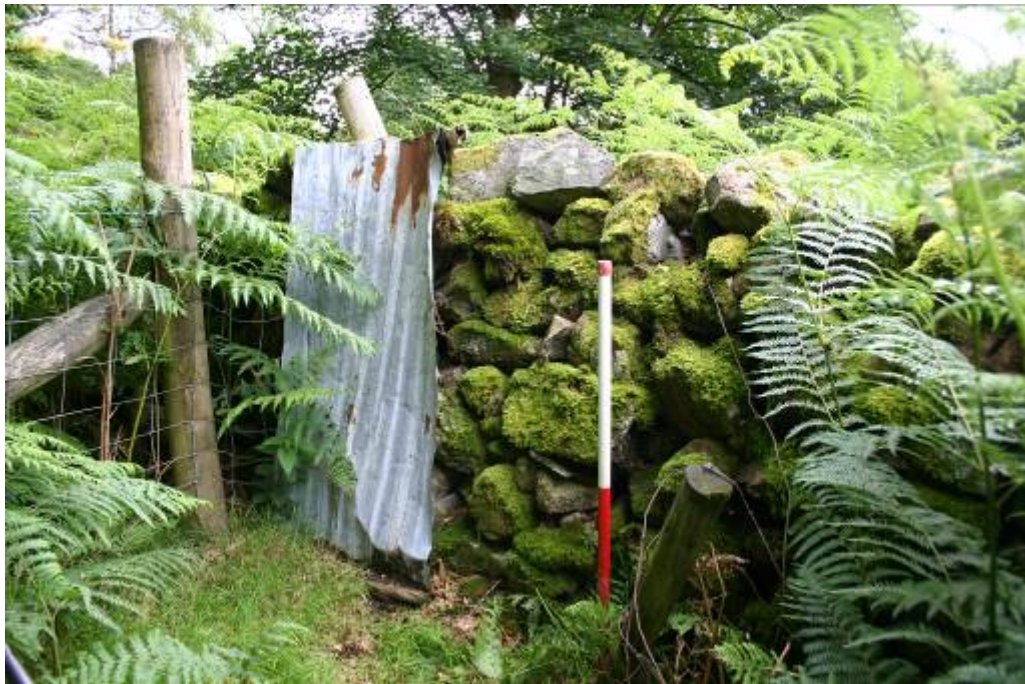
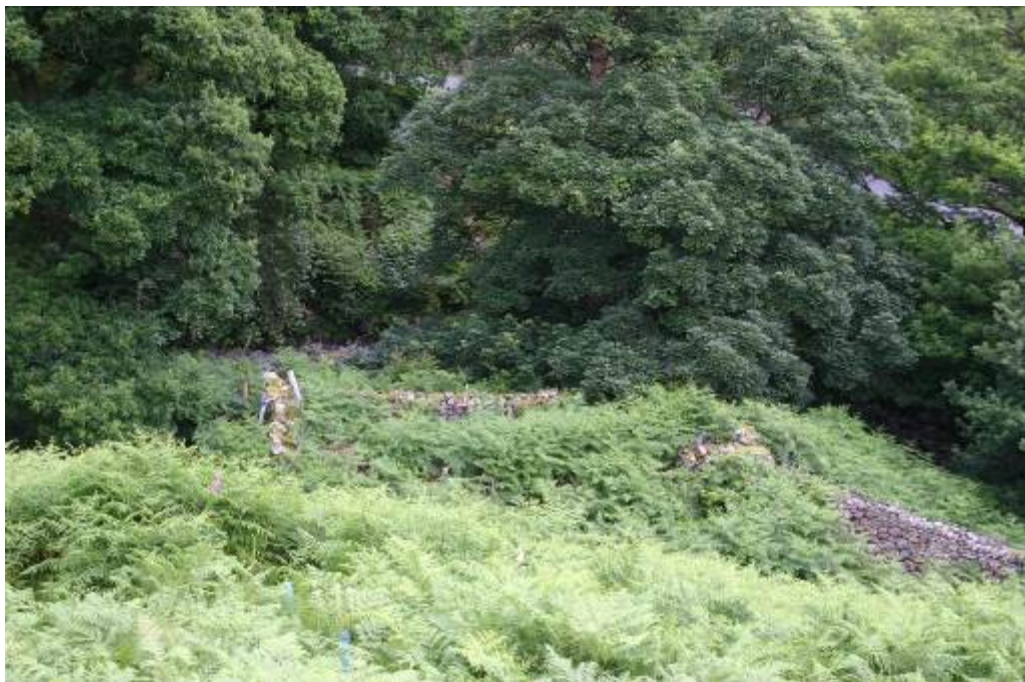
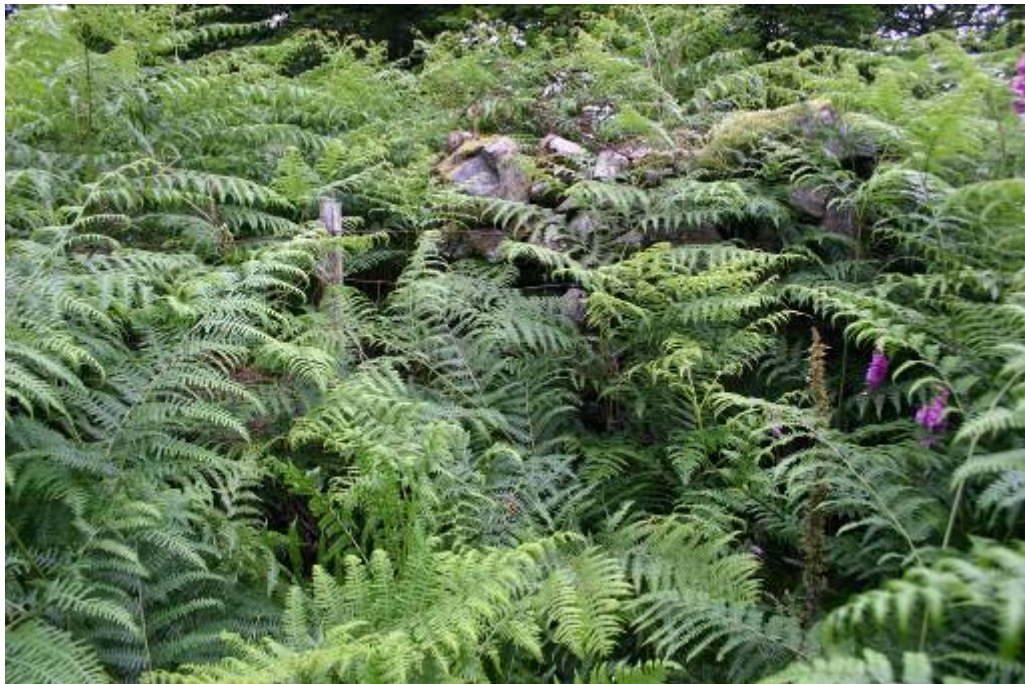
5.3.1 *Ruined Building* (PRN 22572). The ruinous building is north-west to south-east aligned. It is positioned at the northern end of a north-north-west to south-south-east aligned boundary wall. Only the north-east and parts of the south-east and north-west facing elevation are still present. The masonry consists of uncoursed and unmortared rubble stone. The walls are covered in moss growth. A high timber and wire fence had once been positioned around it, but is now completely covered by bracken. Remains of a corrugated iron roof and several timbers are visible on the interior of the building. The building may have been built in connection with the slate quarry (PRN 22573). As a ruinous building the site is in good condition at present. The building is at high risk of being damaged through bracken infestation.

Plate 1: Remains of building, north-north-west facing elevation

Plate 2: view of the building from elevated position

Plate 3: Remains of the south-south-east elevation

- 6.1.2 No clear use could be ascertained for the ruinous building (PRN 22572). It may have been built in association with the quarry as a storage shed but could have other origins. It at some point contained a now collapsed timber and corrugated iron roof. The asset is in a good but deteriorating condition.

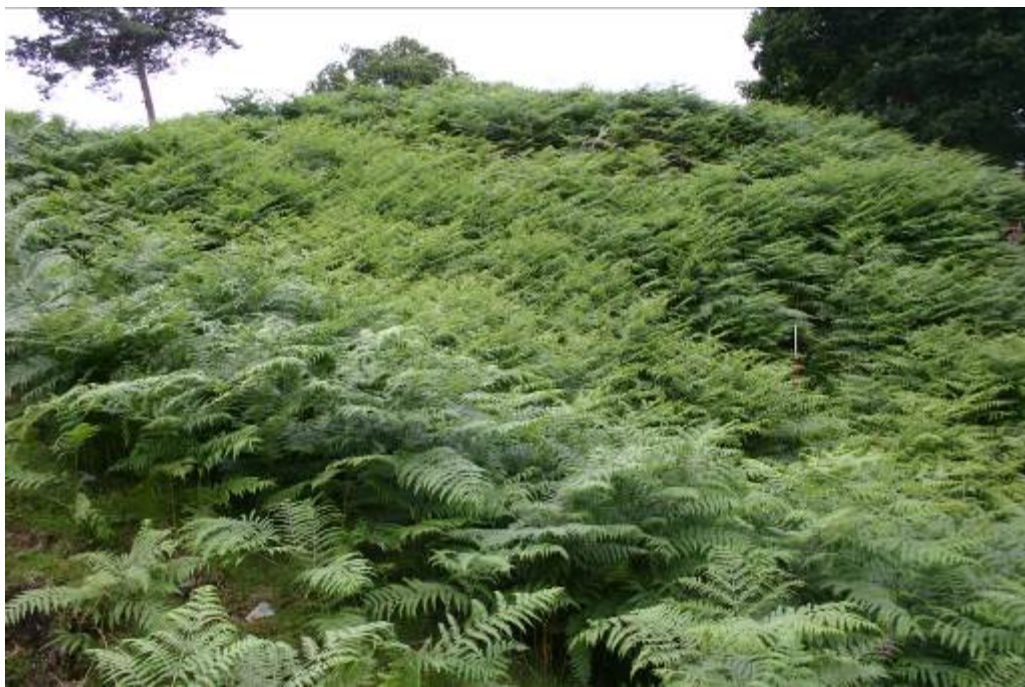
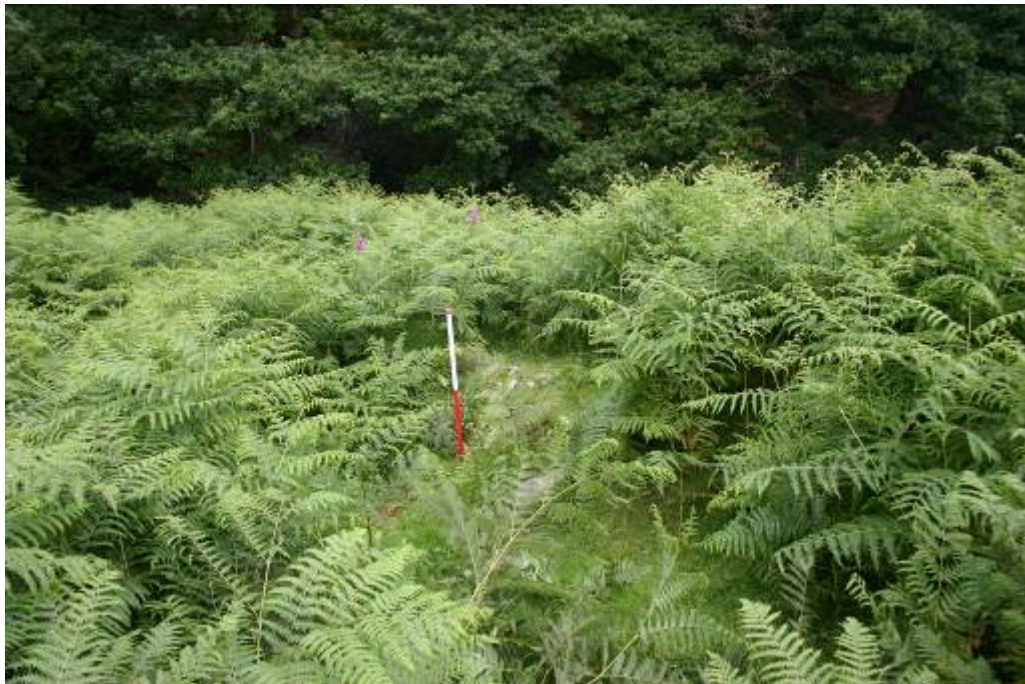
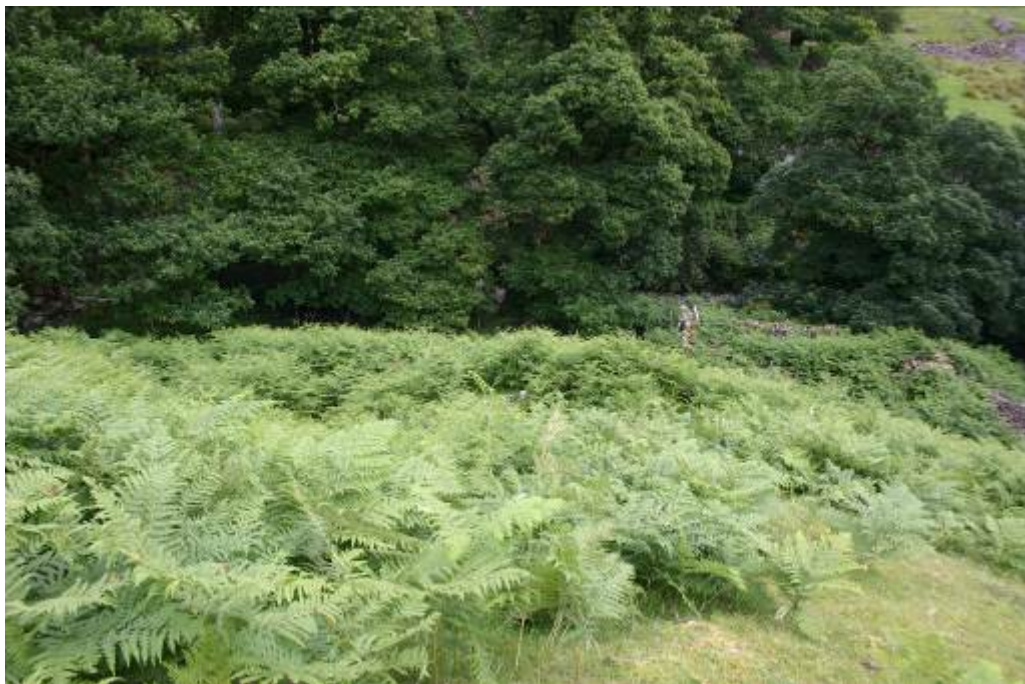
5.3.2 *Quarry* (PRN 22573). The site is described as a small quarry and wall remains, possibly used as a source for walling stone (OA 2007). A pathway is situated along the lower south-west side of the hill. The whole area is largely covered in bracken, which makes a clear identification of its features difficult, thus the full extent of the site could not be assessed. A distinctive slope to the south-east and a large central incline could be identified within the quarry. The quarry is in a mediocre condition at present. Although the site is largely obscured by bracken its heritage risk is low because of the robust and non-structural remains of the quarry.

Plate 4: view of quarry, facing north

Plate 5: slope in the centre of the quarry area, facing north

Plate 6: view of quarry, facing north-east, with ruinous building to the east

- 6.1.3 The quarry (PRN 22573) covers a large area at the eastern slope of a slight hill, which made it difficult to mark out the area with the stakes. Clear indications of quarry activity could be found at several points along the hill slope. The asset is in a mediocre but stable condition.

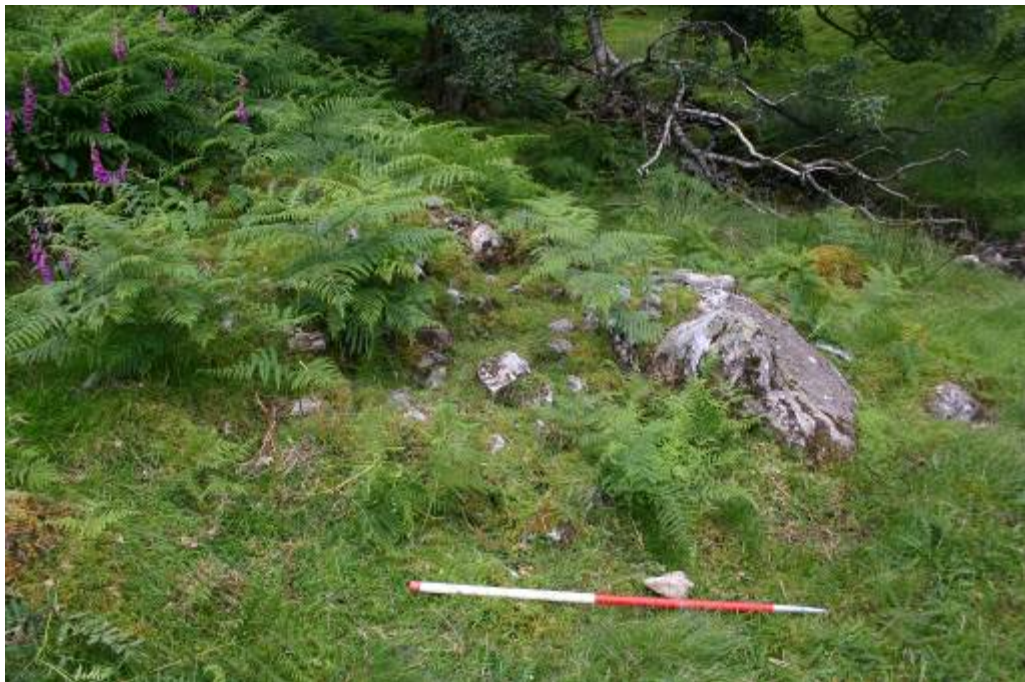
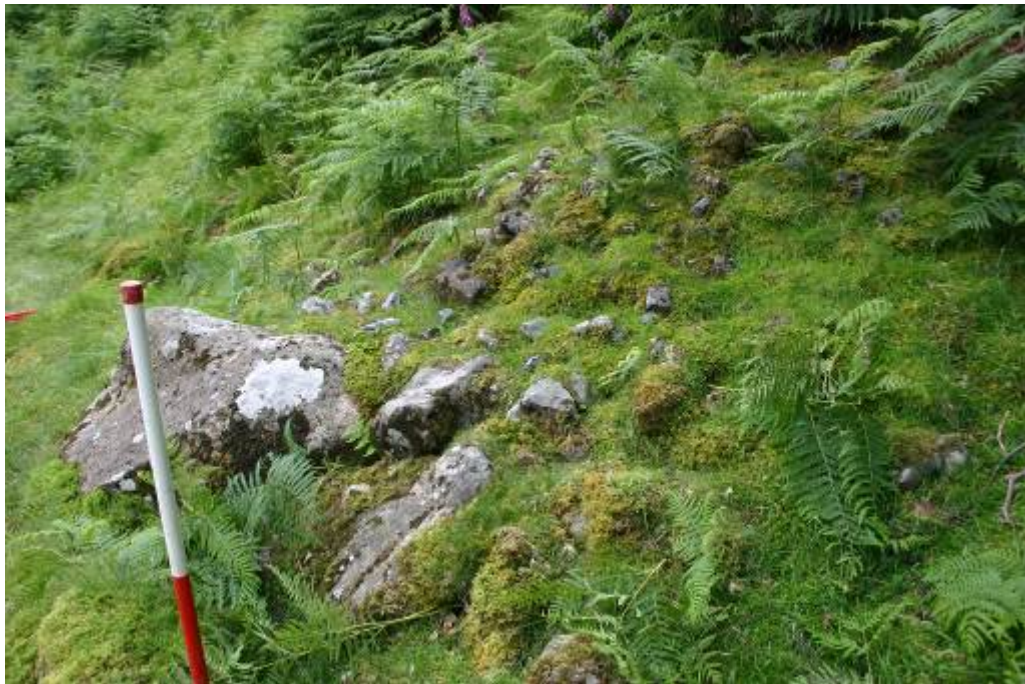
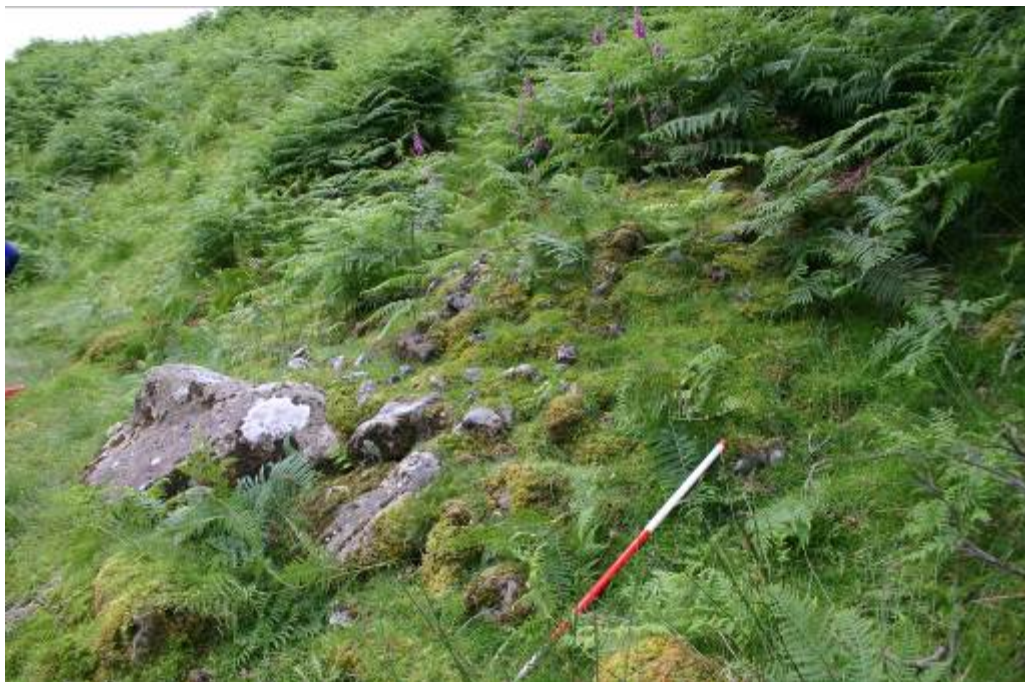
5.3.4 *Cairn* (PRN 22574). The cairn is situated at the bottom of a hill slope in a pasture area with the beginning of an open forestry area. A small, east to west aligned stream is to the north of the site. Bracken, moss and grass growth is covering the greater part of the cairn. The size of the stones varies between approximately 0.5m to 0.1m. They are of irregular shape. The cairn lacks a curb and would appear to be a result of localised land clearance. The cairn appears to be in a good condition at present. The heritage significance of the cairn is at moderate risk from bracken infestation.

Plate 7: view of cairn, facing west

Plate 8: view of cairn, facing south

Plate 9: view of cairn, facing south-east

- 6.1.4 The cairn (PRN 22574) is in good but slowly deteriorating condition. The heritage asset is mainly overgrown with grass, which made a distinction between the stones and its surroundings unclear.

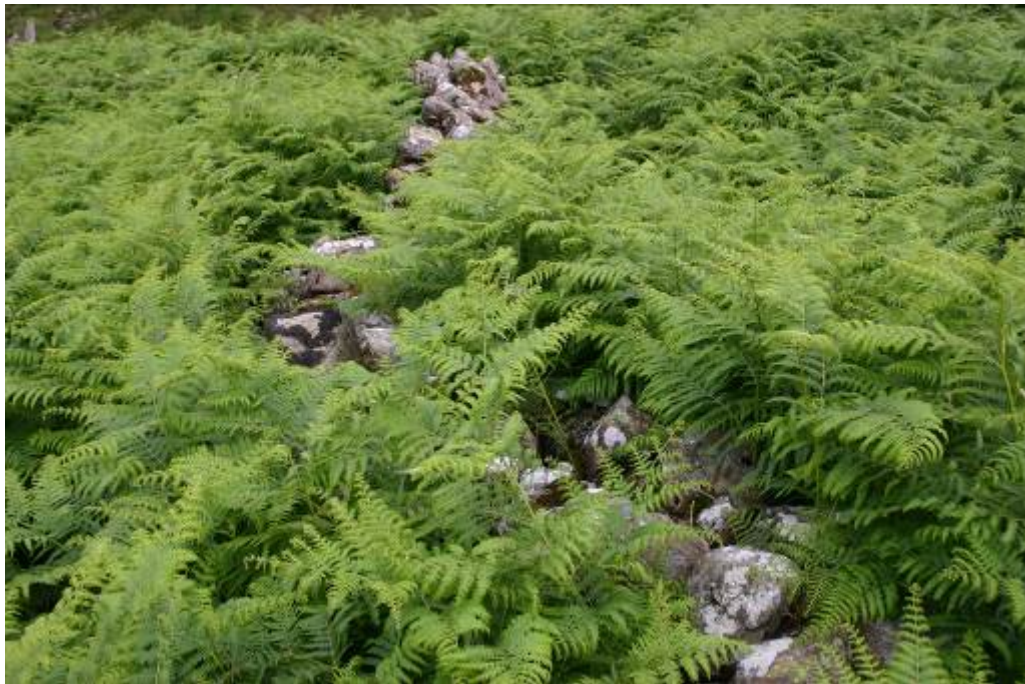
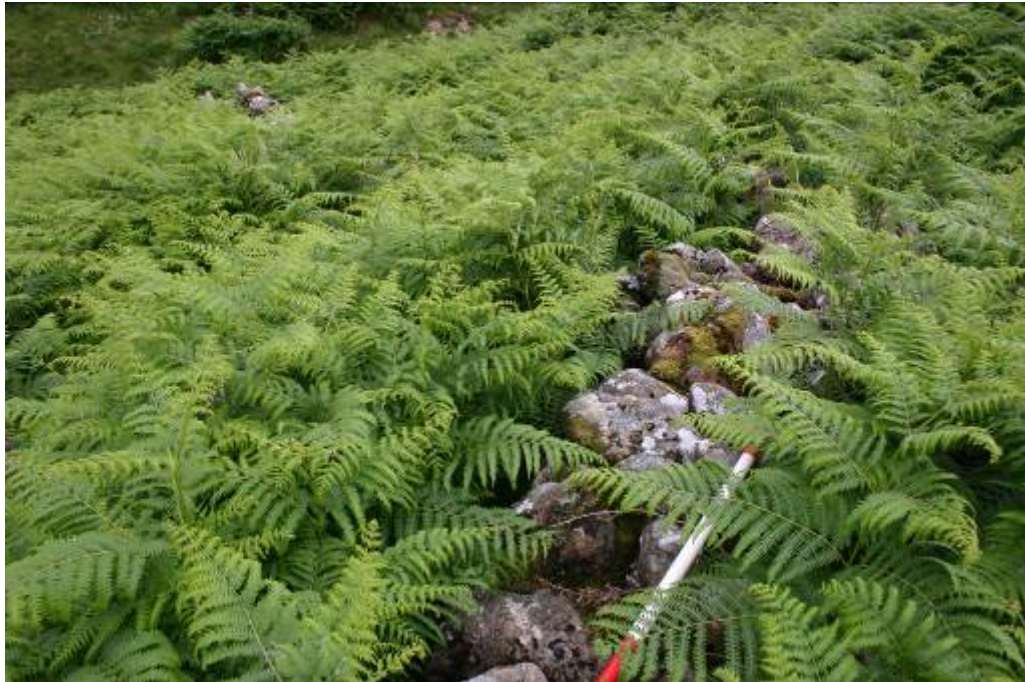
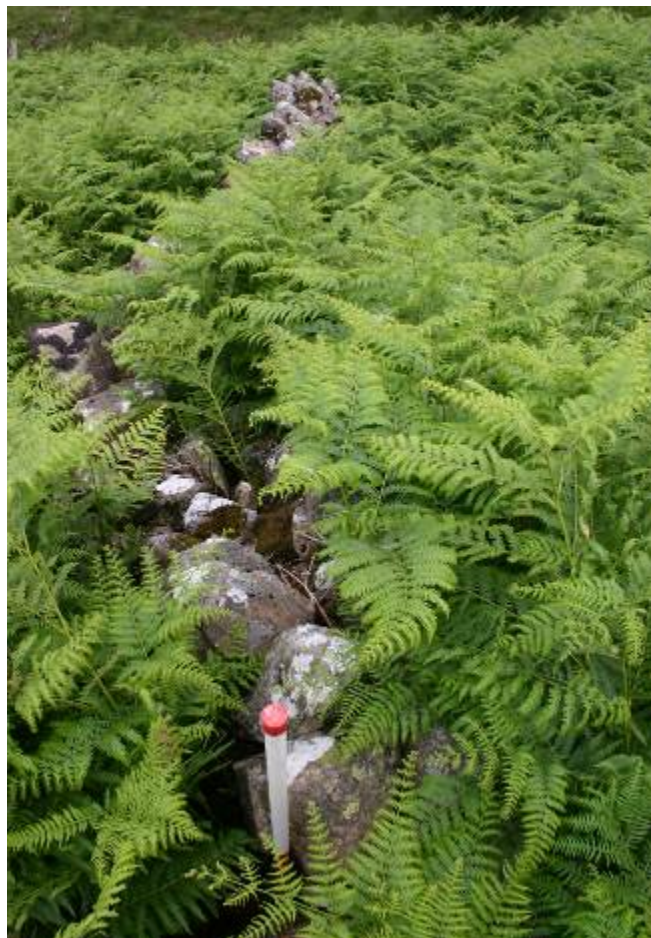
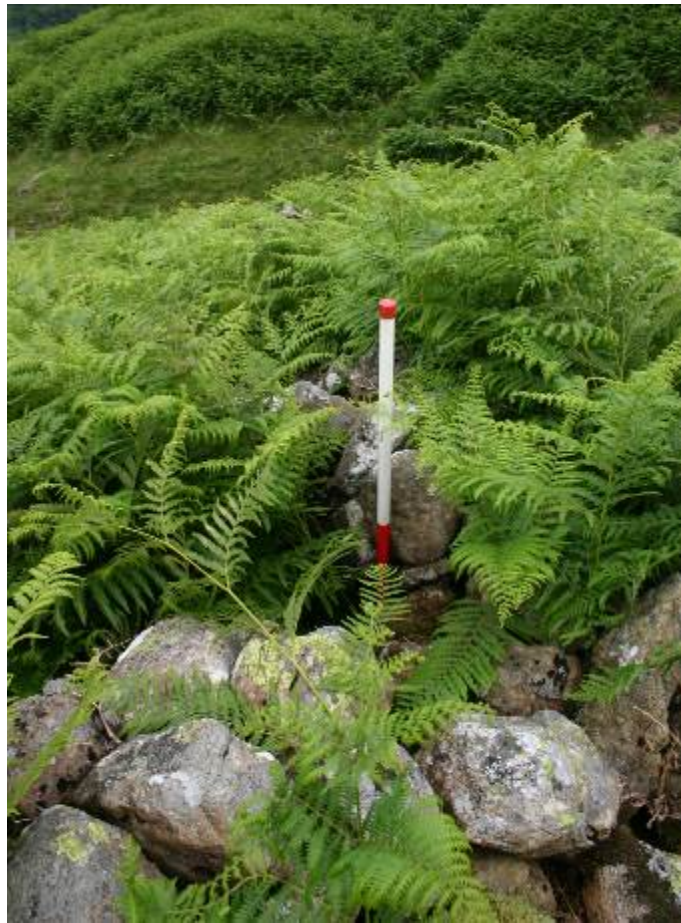
5.3.3 *Bield* (PRN 22575). The westernmost bield is positioned at the north-eastern section of a large area of pasture. It is to the north of a small stream. The bield consists of an irregular aligned approximately 0.5 to 0.8m high dry stone wall of roughly coursed rubble stone masonry. The whole area was covered in bracken. The masonry was affected by moss and lichen growth. The bield is in good condition, however the degree of bracken infestation renders it unusable for sheltering sheep at times of high bracken growth. The structure is at high risk of being damaged through bracken infestation, either through the direct impact of rhizome development within the structure or through accidental damage because of the structure's visibility being compromised.

Plate 10: general view of the bield

Plate 11: view of the bield

Plate 12: view of bield

Plate 13: view of field

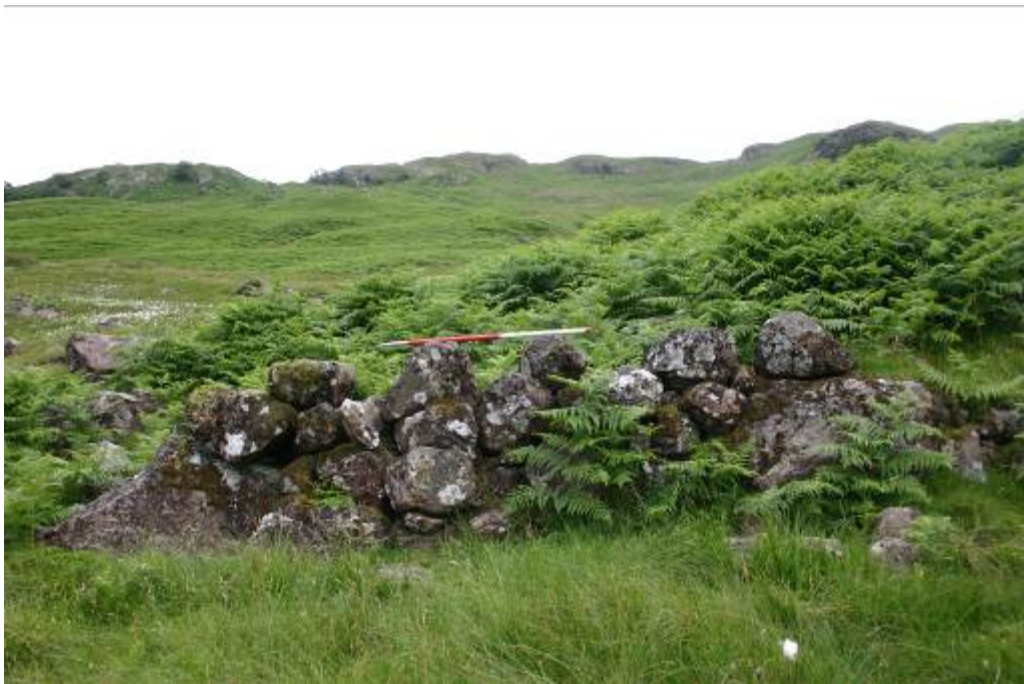
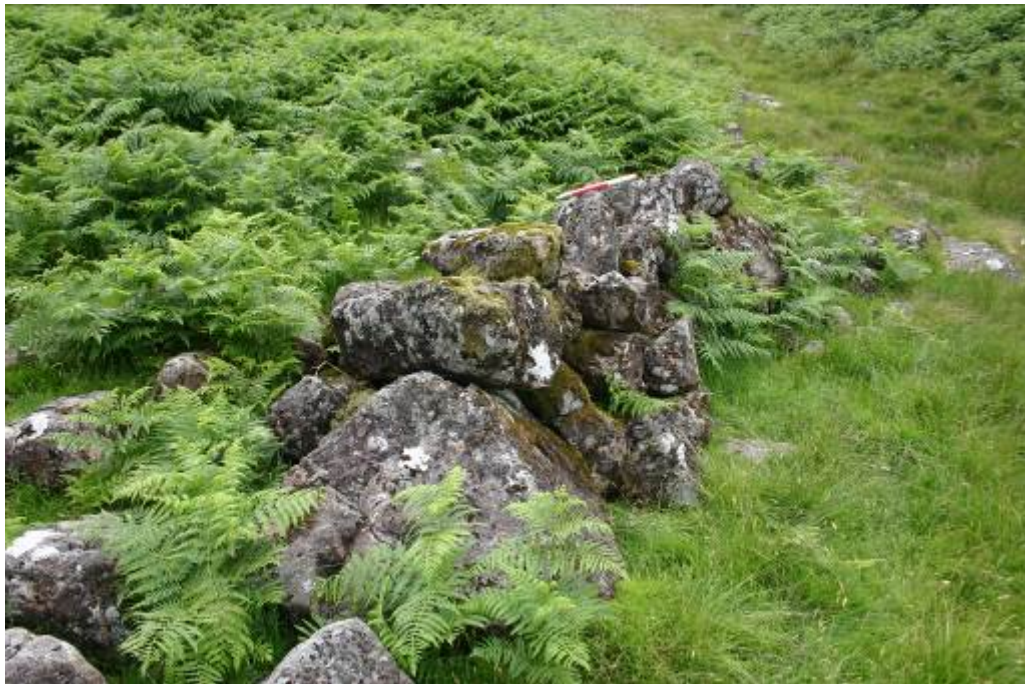
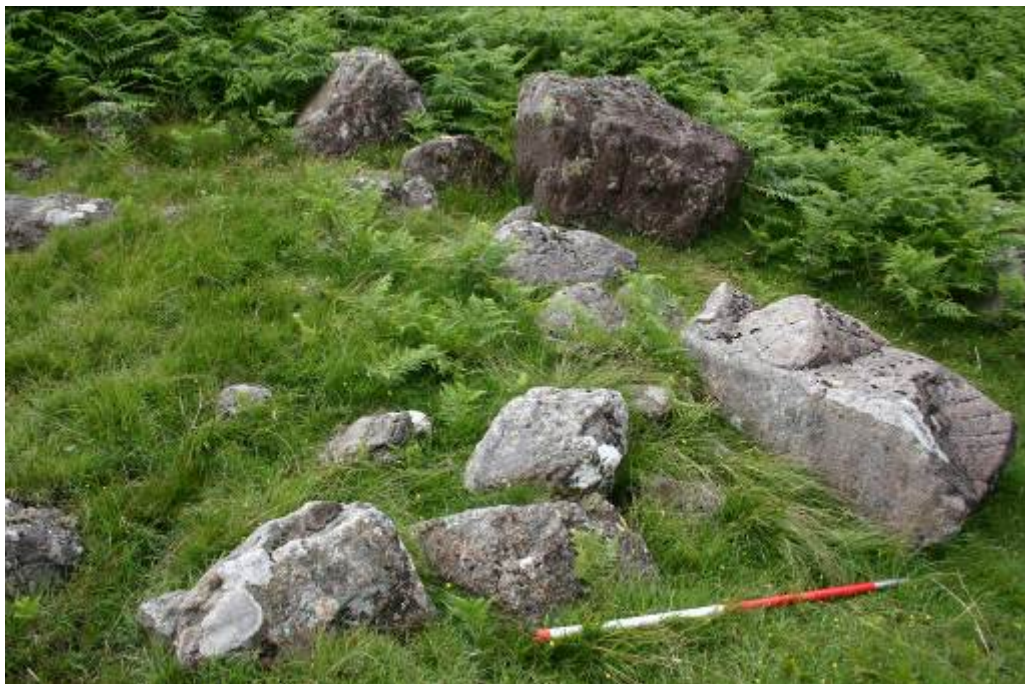
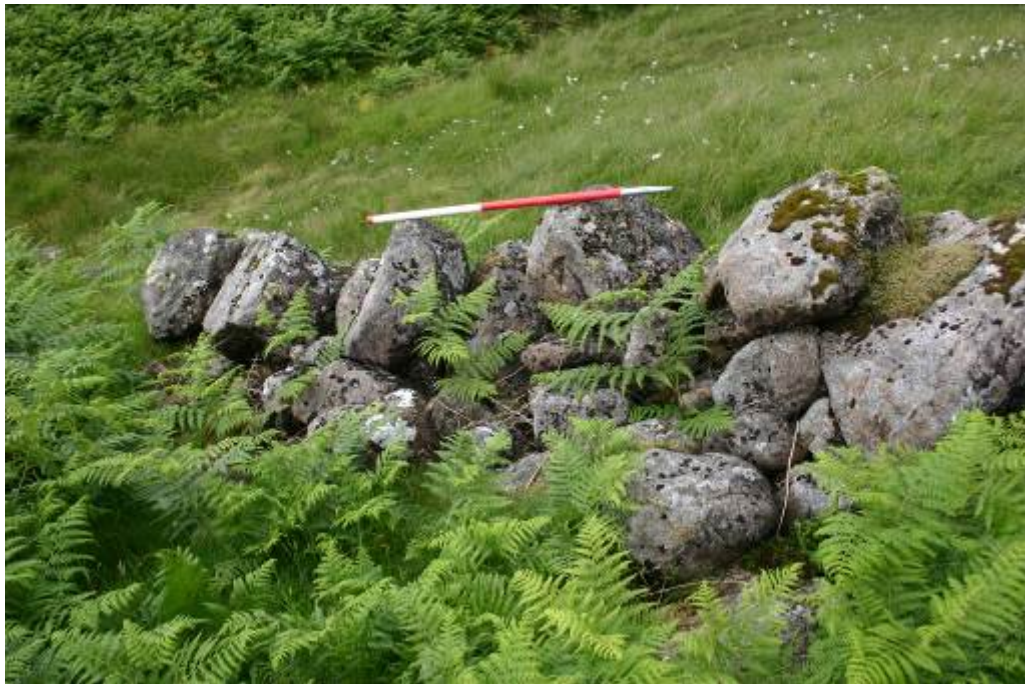
5.3.4 *Bield* (PRN 22576). There were difficulties in regard to the position of the second bield. The given NGR: NY 23951384 had no evidence of any possible structure. However, a structure appearing to be a bield was situated at NGR NY 23922 13787. Only a small section of rubble stone masonry was still upright, scattered stones in the surrounding area indicate a former wider extent of the wall. Some larger boulders were situated in close proximity, and may have once formed part of the bield. The bield is in poor condition. The structure is at moderate risk of being damaged further through bracken infestation.

Plate 14: view of bield, facing south

Plate 15: view of bield, facing west

Plate 16: remains of bield, facing north-west

Plate 17: View of the field, facing north

- 6.1.5 While the first bield (PRN 22575) was in good condition, although heavily obscured by bracken, the second bield (PRN 22576) was in poor condition. Furthermore, the position of the bield differs from the given information, which should be rectified in the National Trust's Sites and Monuments Record to ensure the structure is managed in the future to reduce risks to its heritage significance.

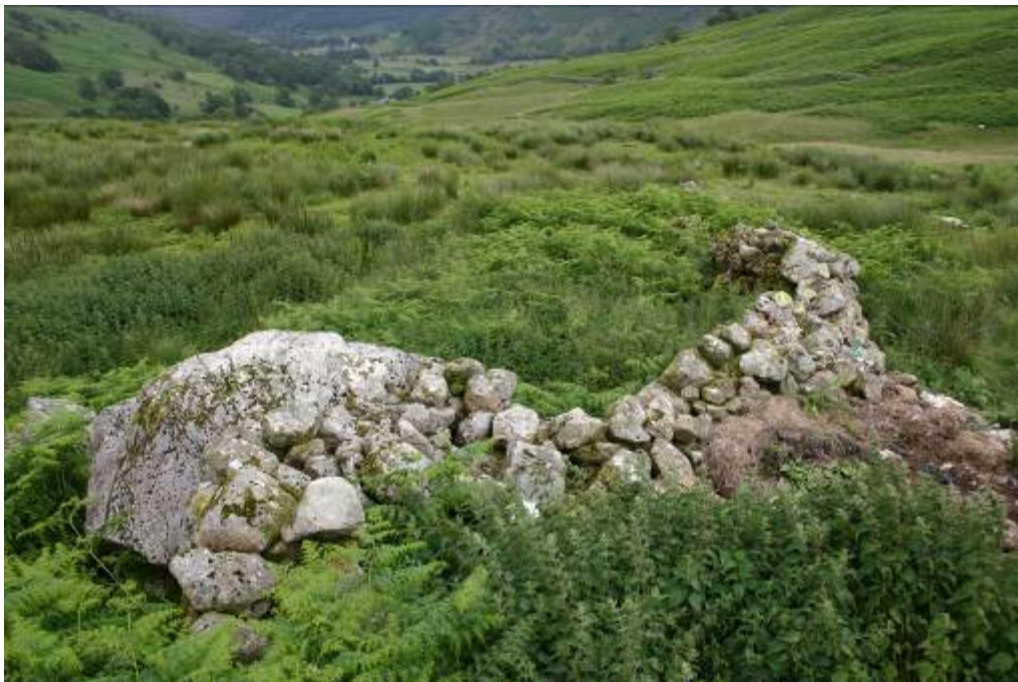
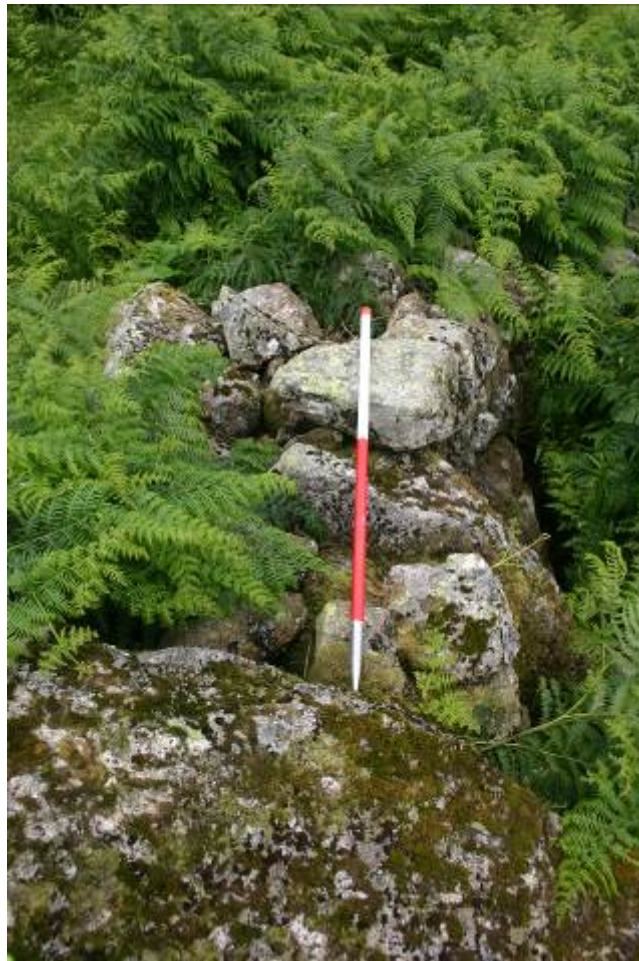
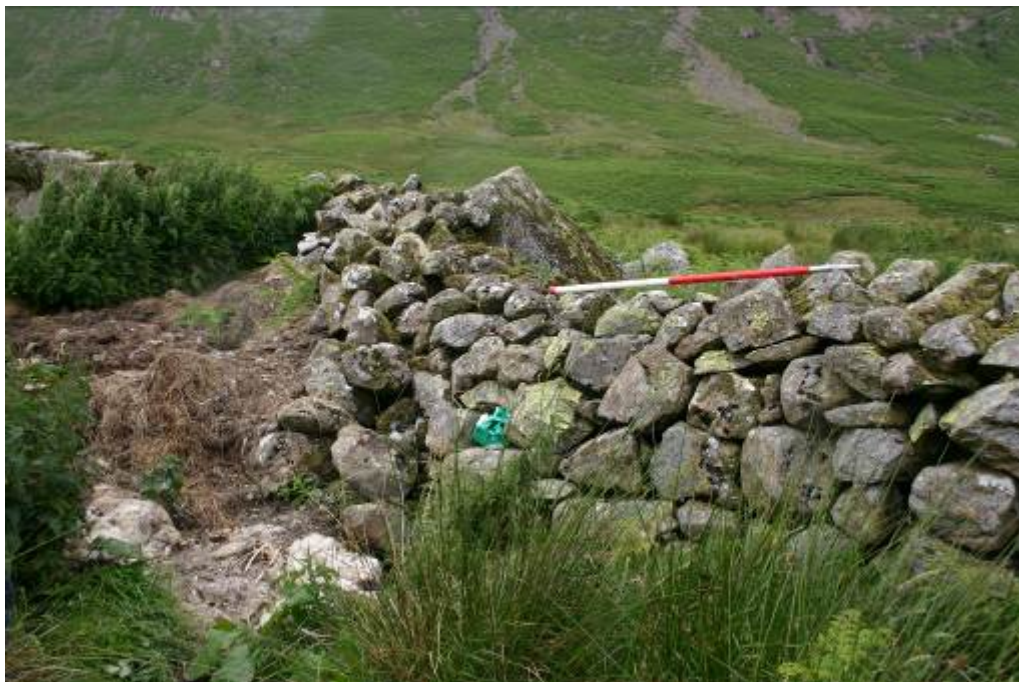
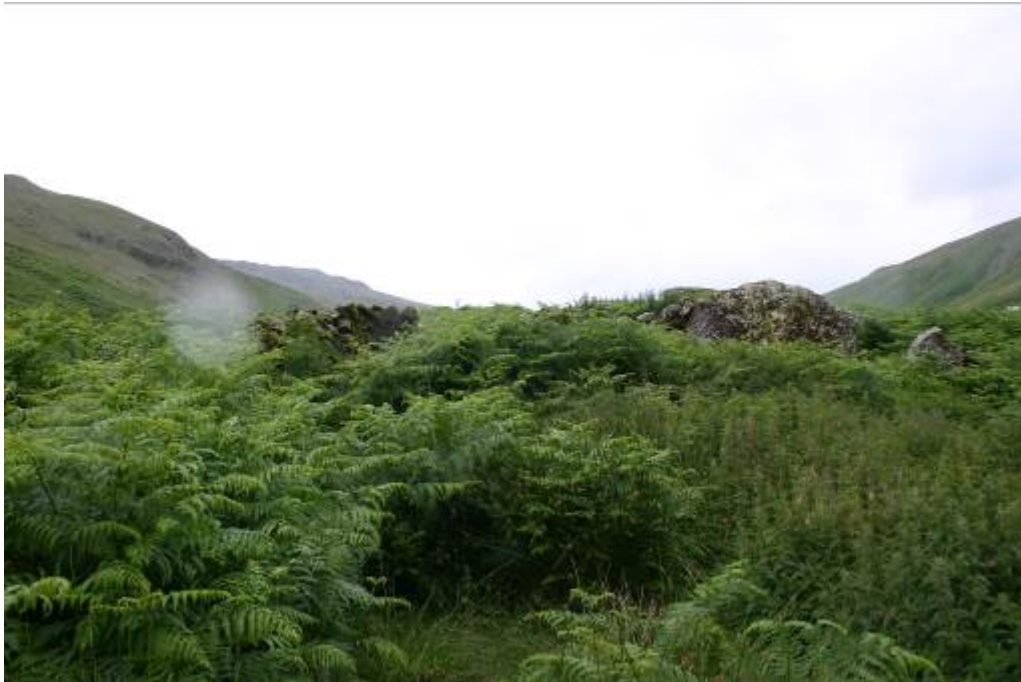
- 5.3.5 *Sheepfold (22577)*. The sheepfold is abutted by a north to south aligned boundary wall at its north-western corner. The wall of the sheepfold is approximately 1m high and consists of very roughly coursed, unmortared rubble stone. The structure is semi-circular, with large boulders integrated into the dry stone wall. These boulders were possibly in-situ before the building of the sheepfold and fortuitously incorporated during construction. It is situated in a relatively flat, but boggy area at the western end of the site. A field trackway to the north-east of the site connects with the Honister Pass to the north.

- 5.3.6 The interior of the sheepfold appears to not have been in use in recent time, however an area to the west has been used to feed sheep. Remains of dead sheep could be seen within the sheepfold. The sheepfold is semi-ruinous but is in a mediocre condition. The area is covered in nettles and bracken and the sheepfold is at moderate risk of further deterioration caused by bracken infestation.

Plate 18: general view of the sheepfold, facing east

Plate 19: boundary wall abutting the sheepfold, facing north

Plate 20: general view of the sheepfold exterior, facing north

Plate 21: general view of the sheepfold, facing south-west

- 6.1.6 The sheepfold (PRN 22577) is in good condition. It is not as hidden by vegetation as the other sites, only the high density of nettles made the interior inaccessible.
