**FORMER CARRS BILLINGTON PREMISES,  
23-25 HIGH STREET,  
ANNAN**

**Archaeological Building Survey report**

**DATE ISSUED:** February 2018  
**JOB NUMBER:** CL12092  
**OASIS REFERENCE:** wardella2-308485  
**PLANNING APPLICATION REF:** 17/2051/FUL and 17/2052/CAC

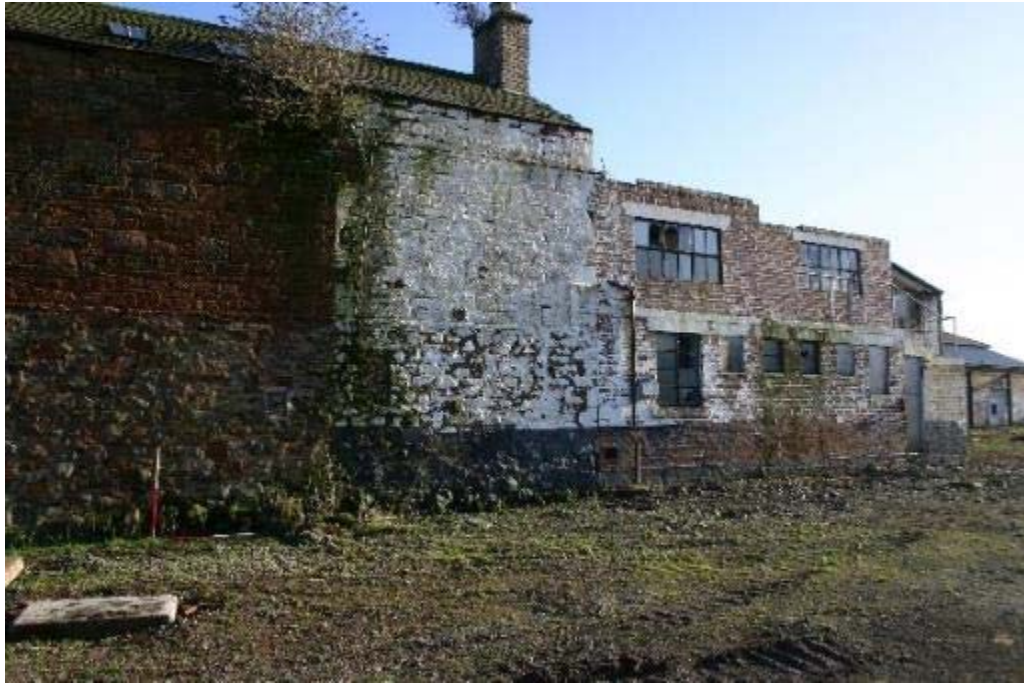
- 4.2.6 The fourth section is a fairly deteriorated modern red brick structure (Plate 10). There are six windows with concrete lintels at the ground floor level, and two larger window fronts at the second floor level. There is a simple metal balustrade at the first floor, connected with a staircase leading to this level at the south elevation. The roof appears to be mostly deteriorated.

Plate 10: West facing elevation, southern central section and southern modern addition of No 23

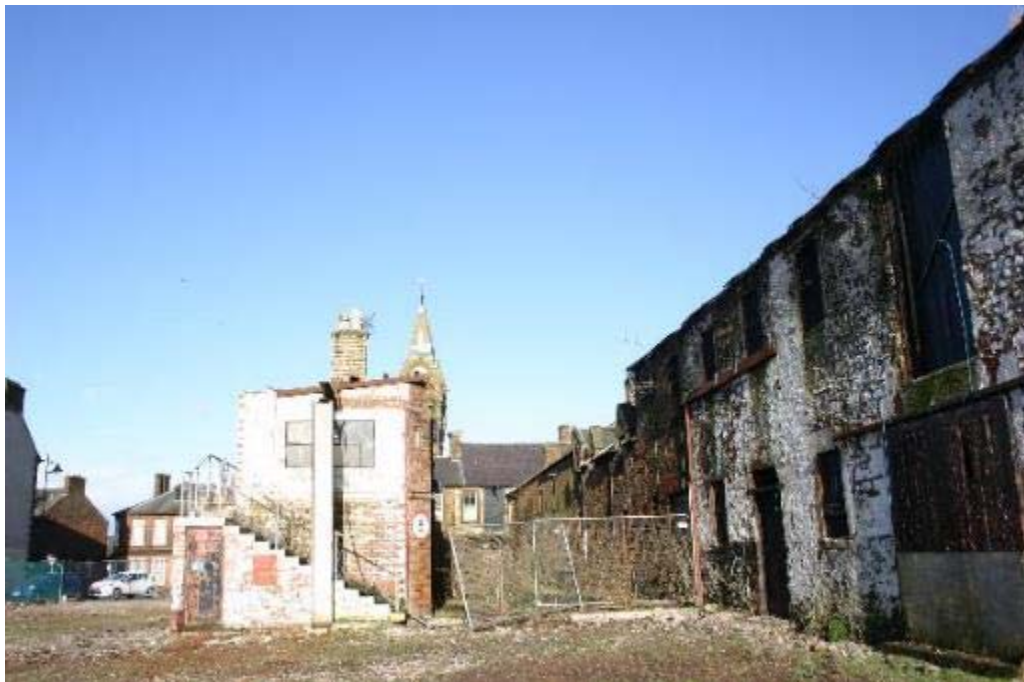
- 4.2.7 The west facing elevation of No 25 comprises two structures facing the old Pool's Court (Plate 11). The northern structure appear to be of later date than the southern structure. The two storeys high northern structure is built of rusticated roughly coursed ashlar sandstone (Plate 12). A built up doorway is situated at the far northern end of the structure (Plate 13), within the driveway between No 23 and 25. There are a further two blocked off doorways and four blocked off windows (Plate 14 and 15). There are a further four windows at the first floor level of the structure. The building is roughly interlocked with the older structure (Plate 16), with part of the elevation sitting on top of the roofline of the other structure.

Plate 11: General view of west facing elevation of No 25

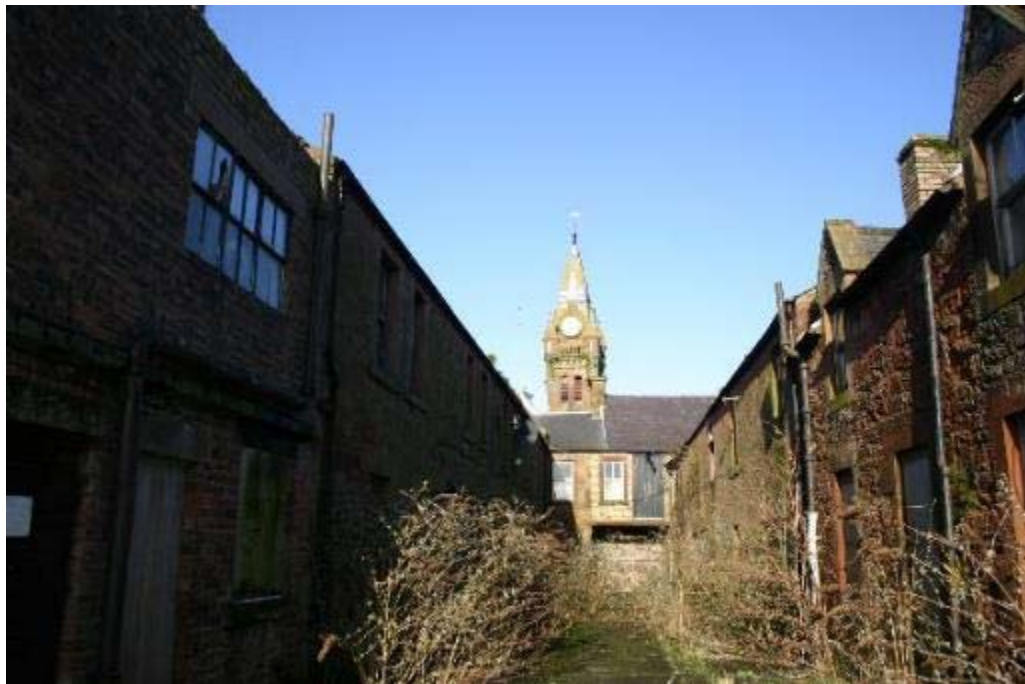
- 4.2.12 *East Elevation:* The east facing elevation of No 23 comprises five structures (Plate 24). The modern brick structure to the south, three slightly earlier structures in the middle and the Victorian frontage to the north. The brick structure contains three doorways and one window at the ground floor level (Plate 25). There are two further windows at the first floor level. The southern and central structures appear to be of similar style and masonry and are interlocked in some areas, thus are most likely contemporary builds (Plate 26- 28). Their roughly ashlar sandstone masonry is rusticated with tool marks. Some modern brick repair works are visible within the more southern structure. There are four doorways and six windows at the ground floor level of the three structures. All these openings have been boarded up. There are a further eight sash windows at the first floor level. At the southern end of the centre structure is a

Plate 24: General view of east elevation of No 23

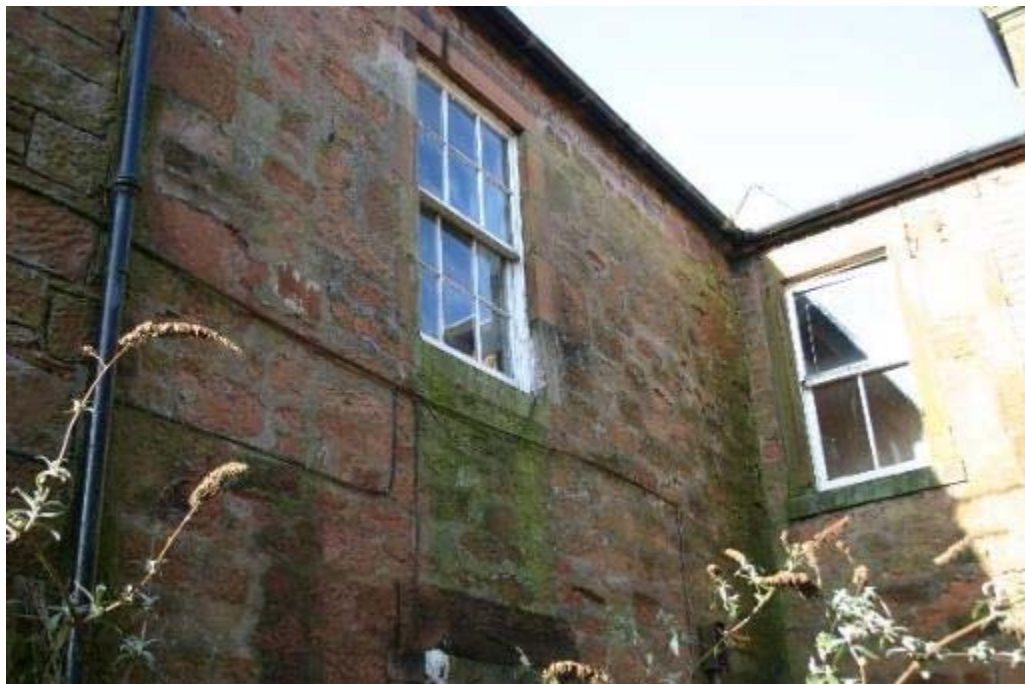
Plate 28: East elevation, visible break in fabric at the level of the drainage pipe

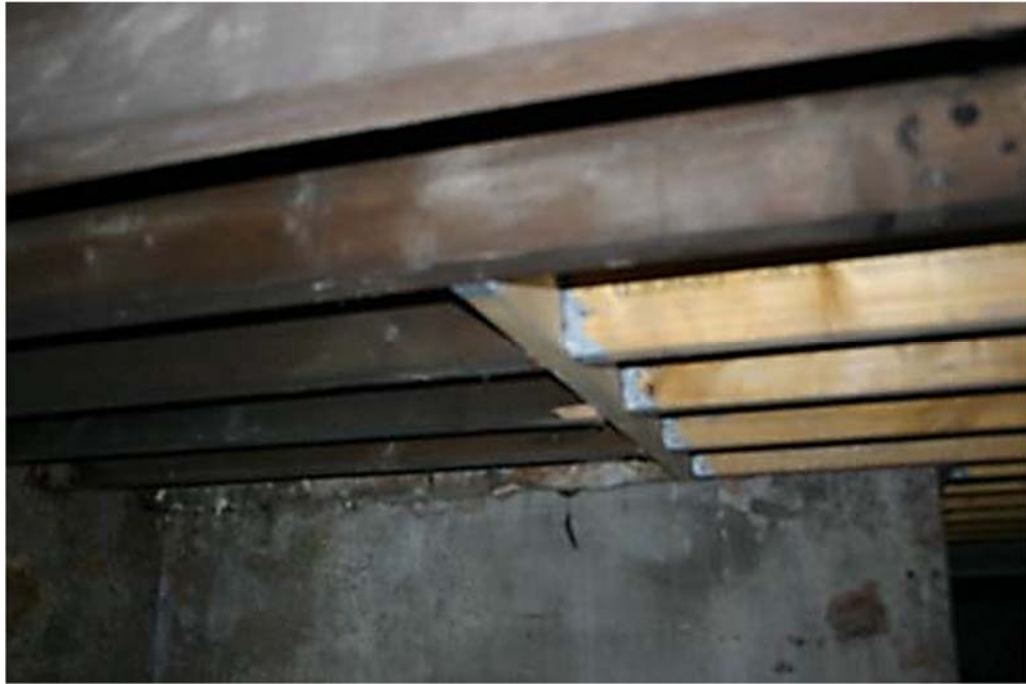
- 4.3.2 *Cellars:* Below the northern structures of both No 23 and No 25 are cellars. The cellars of No 23 were accessible via an inserted timber staircase at GF5. The cellar comprised two rooms interconnected with a hallway (Plate 33 and 37). The cellar is paved with flagstones (Plate 35), while the elevations show remnants of several layers of paint. Within the hallway are the remnants of the original staircase into the cellar (Plate 36). Only one and a half flights of stairs are still present. Parts of the ceiling (flooring of GF5) were replaced due to moulding and decay of the timber (Plate 34).

Plate 34: replacement of timbers due to rot

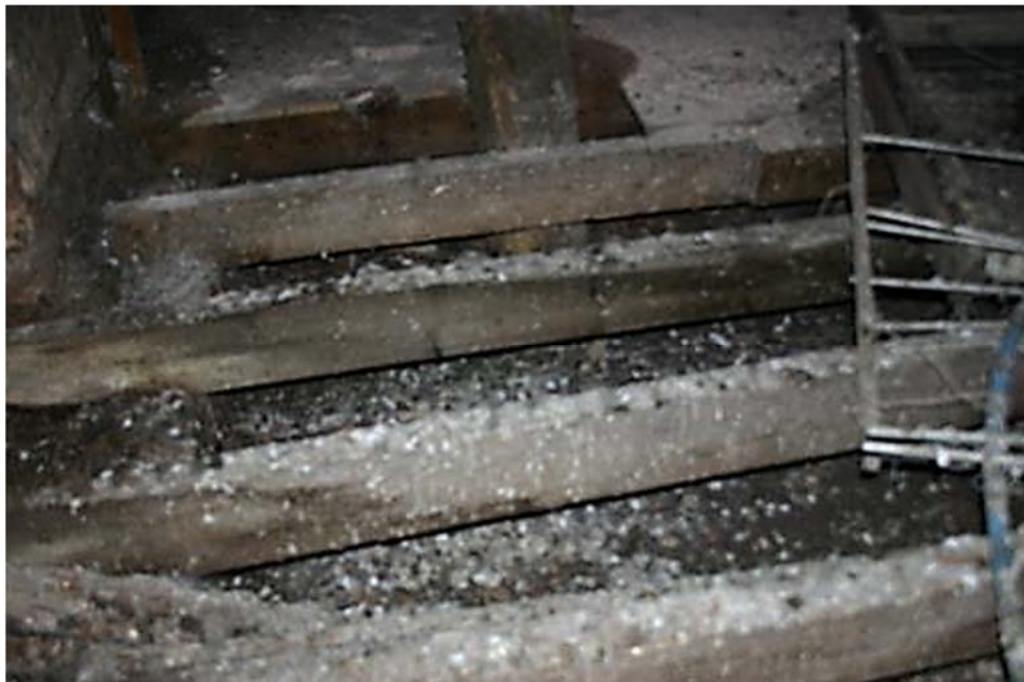
- 4.3.10 *GF6*: This room was accessible via a doorway at the south elevation of GF5 (Plate 57). Due to the bad condition of the interior structures, the room was not entered during the survey. Parts of the floorboards were missing (Plate 58), as was a section of the ceiling. It is an elongated room, with a modern partition wall at the southern end.

Plate 58: No 23, GF6 current state of the flooring

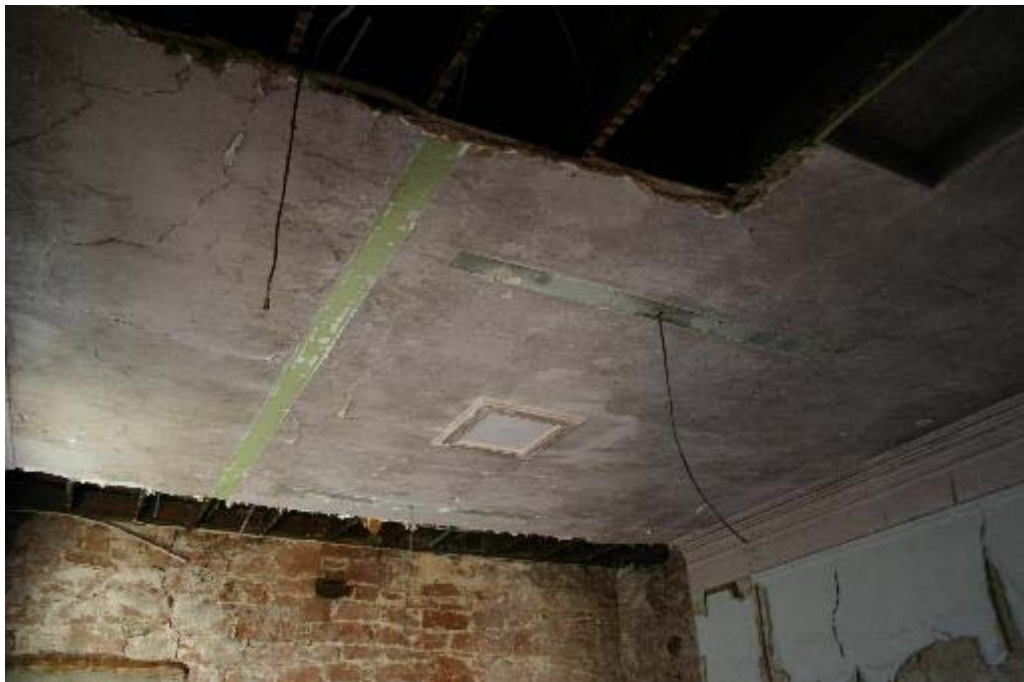
- 4.3.15 *FF4*: A medium sized room within No 23. The wall and ceiling plaster has been partially removed (Plate 69). Some remnants of the classical coving and picture rail are visible at the west elevation (Plate 67). Parts of the timber floor have been replaced, with older timber flooring remaining within the southern section of the room (Plate 65). A boarded up fireplace is located at the south elevation. Also blocked up at this elevation is a doorway in the eastern section towards the now inaccessible southern range of No 23 (Plate 65). A splayed reveal sash window with six over six panels and hidden timber shutters is located at the east elevation (Plate 66). A possible large double doorway with modern brick repair works is located at the north elevation (Plate 68). This would have led into the inaccessible *FF3*.

Plate 69: No 23, FF4 partially removed ceiling

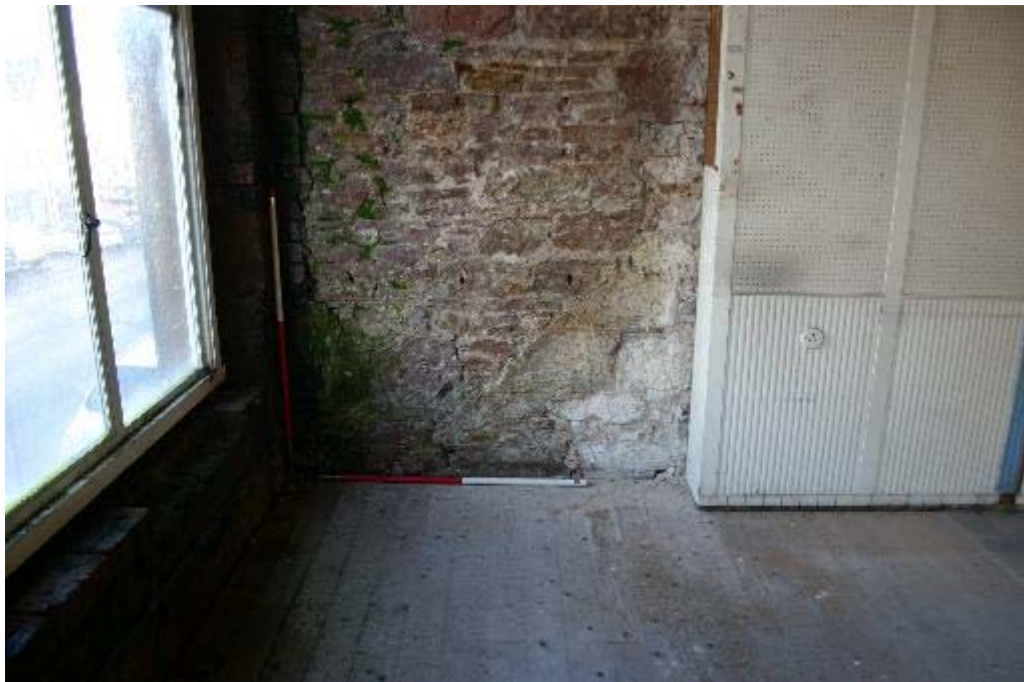
Plate 71: No 25, FF5 roof scarring at the east elevation

- 5.1.3 Changes also occurred through the northern structures of No 23 and 25, between 1861 and 1900. Both buildings expand in their layout to the north, which is consistent with its current floorplan. The roof scarring in FF5 (Plate 71) of No 25, may indicate that an earlier, one storey structure has been integrated within this building. Altogether, the structures used to have three chimneys. Only one is now still visible to the exterior. The staircases noted on the 1859 plan have been removed. It can be assumed that the houses have been redesigned as shop fronts at this point and possibly even interconnected with each other on the first floor.
