Archaeological Building Survey report

DATE ISSUED: May 2018
JOB NUMBER: CL12154
OASIS REFERENCE: wardella2-317322
PLANNING APPLICATION REF: 2/2018/0090

Church Hill Farm, Westward, Wigton, Cumbria

Archaeological Building Recording

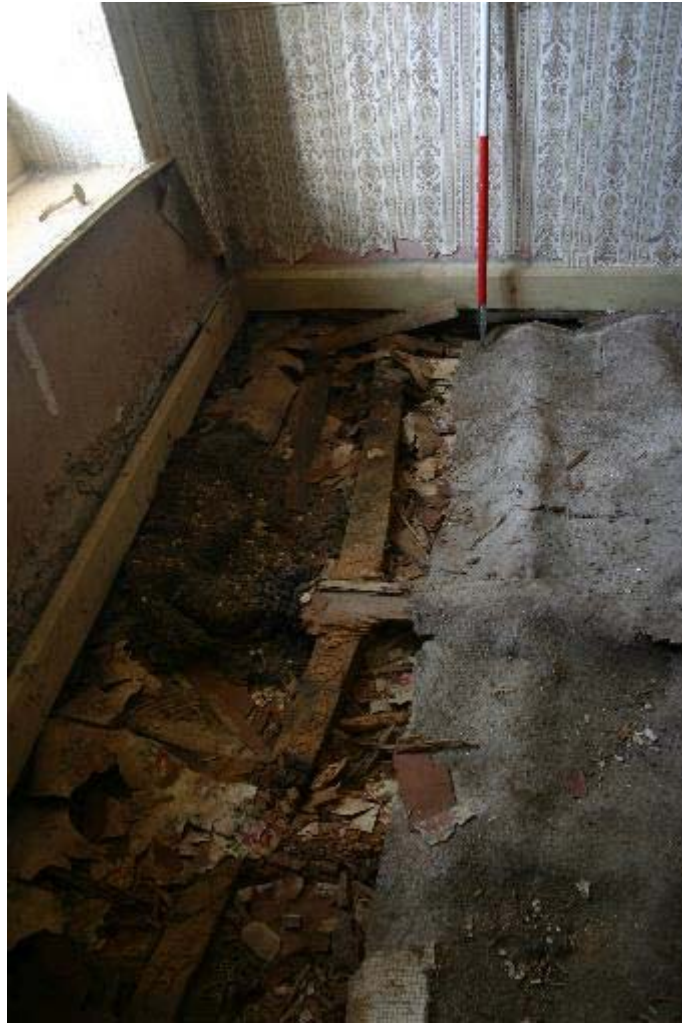
- 4.3.5 *GF-3*: This room needed to be accessed with caution, as most of the timber floor has rotten away (Plate 14). This is the only room on the ground floor with timber flooring. A north to south aligned beam is set centrally along the ceiling. The entire eastern elevation is covered with built in cupboards and a central Victorian cast iron fireplace with red tiled fire surround (Plates 12 and 13). The stone masonry was exposed at the back of the cupboards. A dado rail runs along the west and north elevation. An additional, small built in niche cupboard is situated at the south elevation, to the east of the splayed reveal window.

Plate 14: GF-3, current condition of the flooring

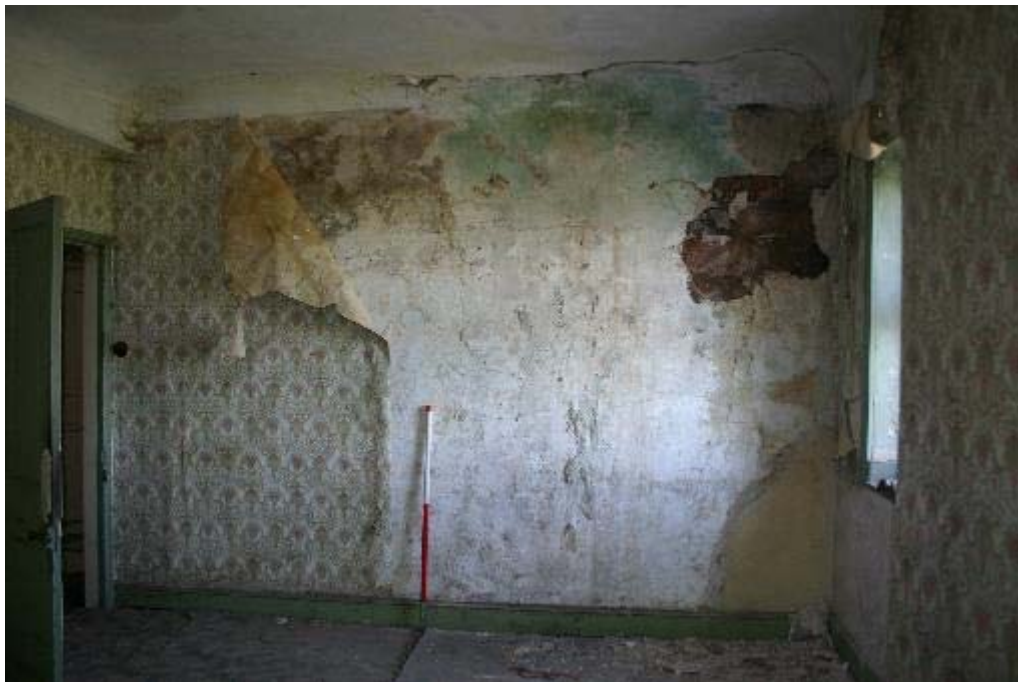
- 4.3.12 *FF-3*: A medium sized room with timber flooring covered with linoleum (Plate 32). The edges towards the ceiling are curved. A Victorian cast-iron fireplace is situated at the west elevation (Plate 33). To the north of it, in the north-west corner, is a small built in cupboard. A six over six timber framed sash window is situated at the north elevation, while a later, 20th century one over one sash window is situated at the west elevation. Some of the internal sandstone masonry has been exposed at the south elevation (Plate 34).

Plate 34: FF-3 damage to wall

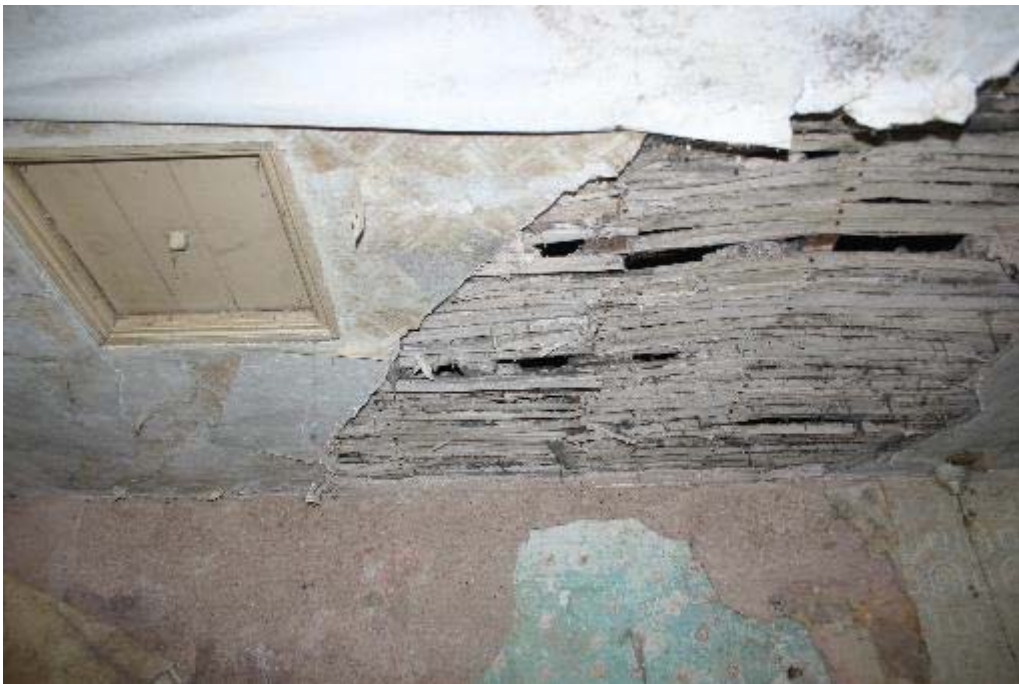
- 4.3.13 *FF-4*: A medium to large bedroom with timber flooring (Plate 35), accessible with a step up from FF-1. Although the fireplace itself is removed, the chimney breast is still clearly present along the west elevation (Plate 36). To the south of it is a large built in cupboard. A splayed reveal 20th century window is situated at the south elevation. A small built in niche cupboard is situated immediately to the west of the window. A large section of the ceiling plaster at the northern end of the room has been removed, possibly because of to water damage in that area, revealing the timber ceiling material (Plate 37). There was some visible water damage and mould at the northern end of this room.

Plate 37: FF-4 damage to ceiling and wall

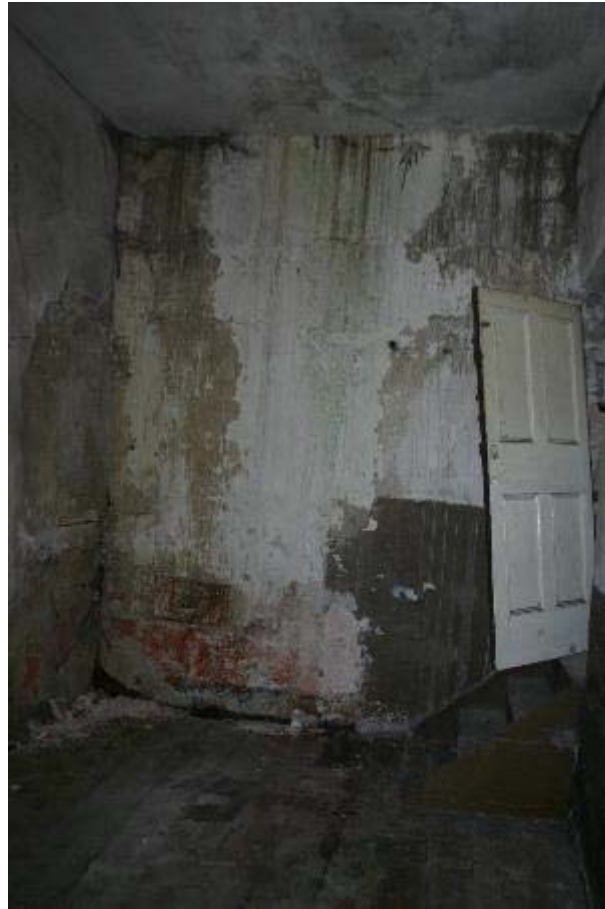
Plate 40: FF-6 damage to wall and flooring

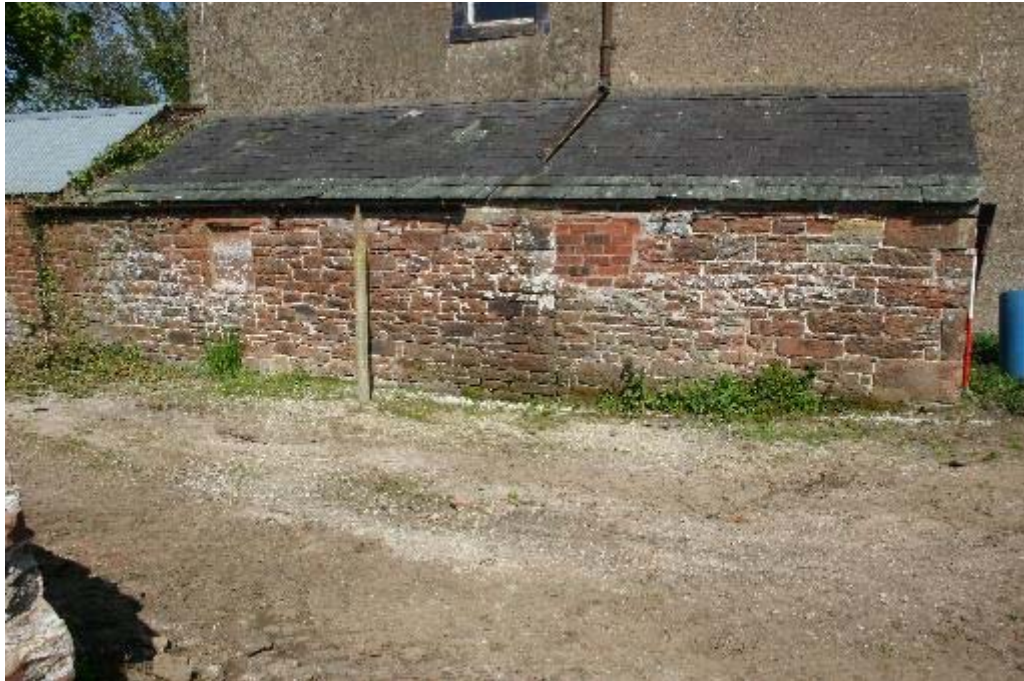
Plate 45: Break in fabric to the north of the red brick repair

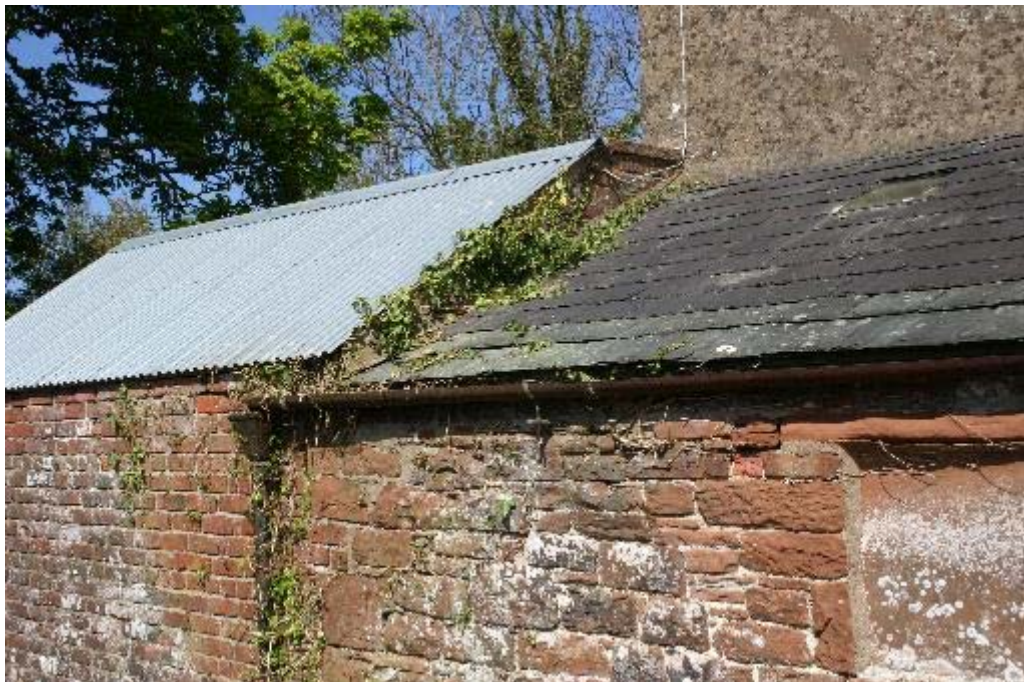
Plate 46: Modern lean-to slightly overshoots the historic lean-to

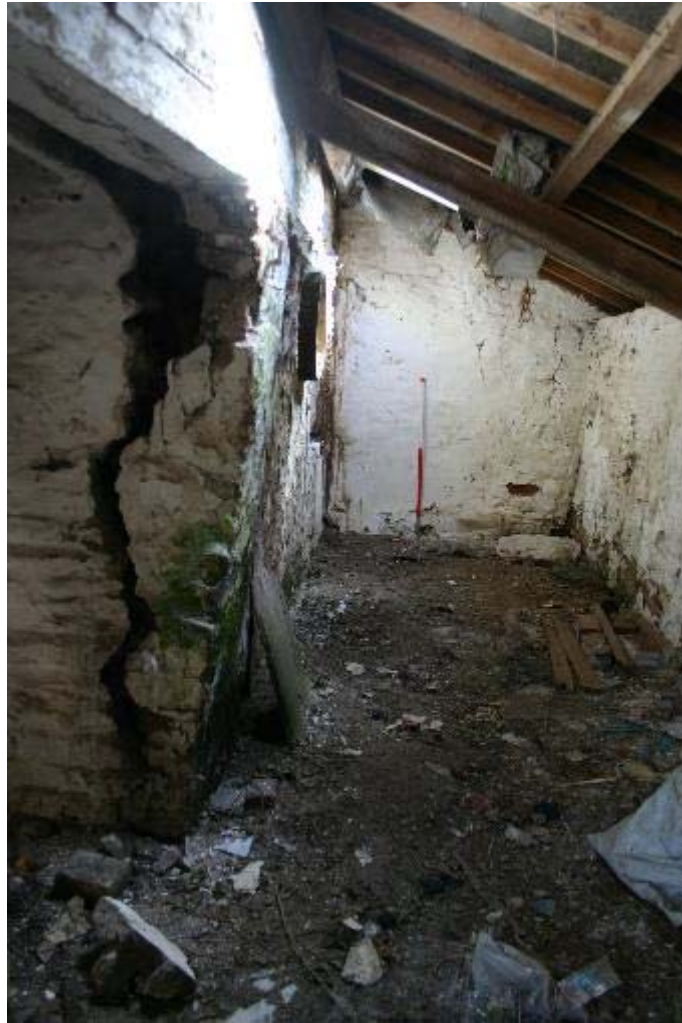
Plate 49: General view of the central lean-to with tilting chimney
