Hamsterley Hall  
Hamsterley  
County Durham

Emergency Archaeological Building Recording  
and Watching Brief

*Report 064-13-HS | July 2013*

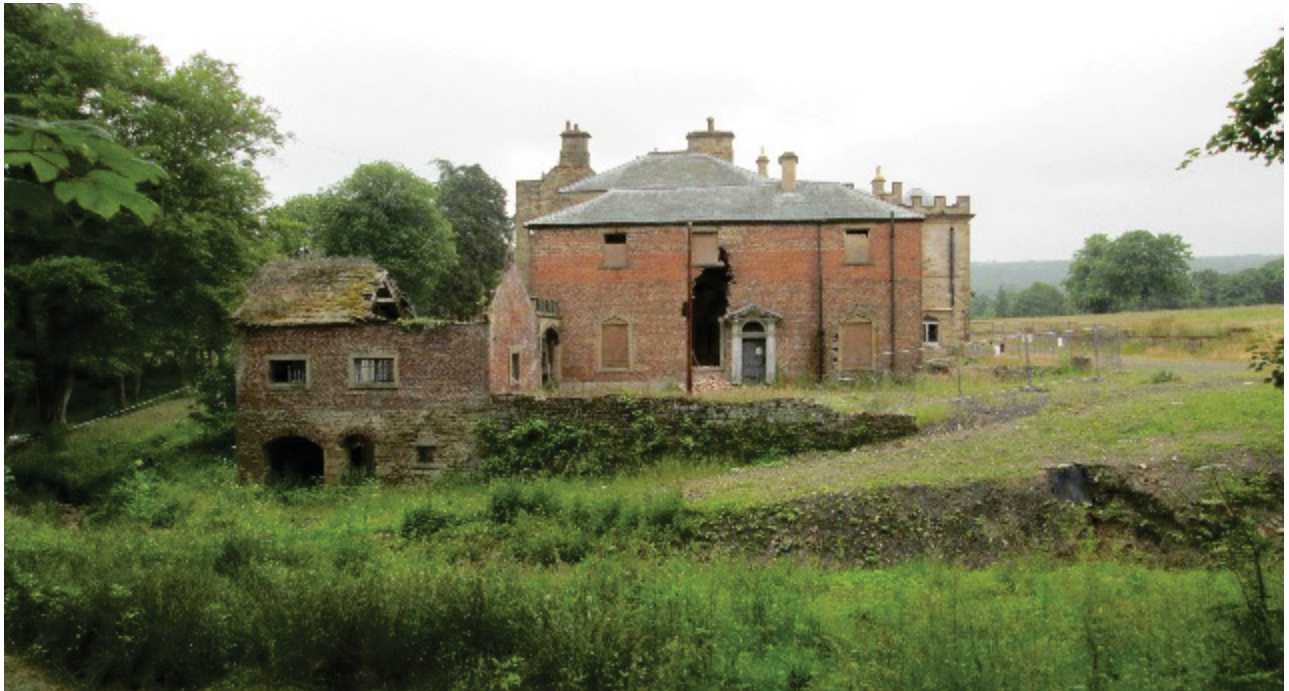
**Plate 1.** View of the western elevation of the brick wing of Hamsterley Hall, looking east, prior to demolition and showing the severe collapse north of the main door (photo reference: HHH13J017).

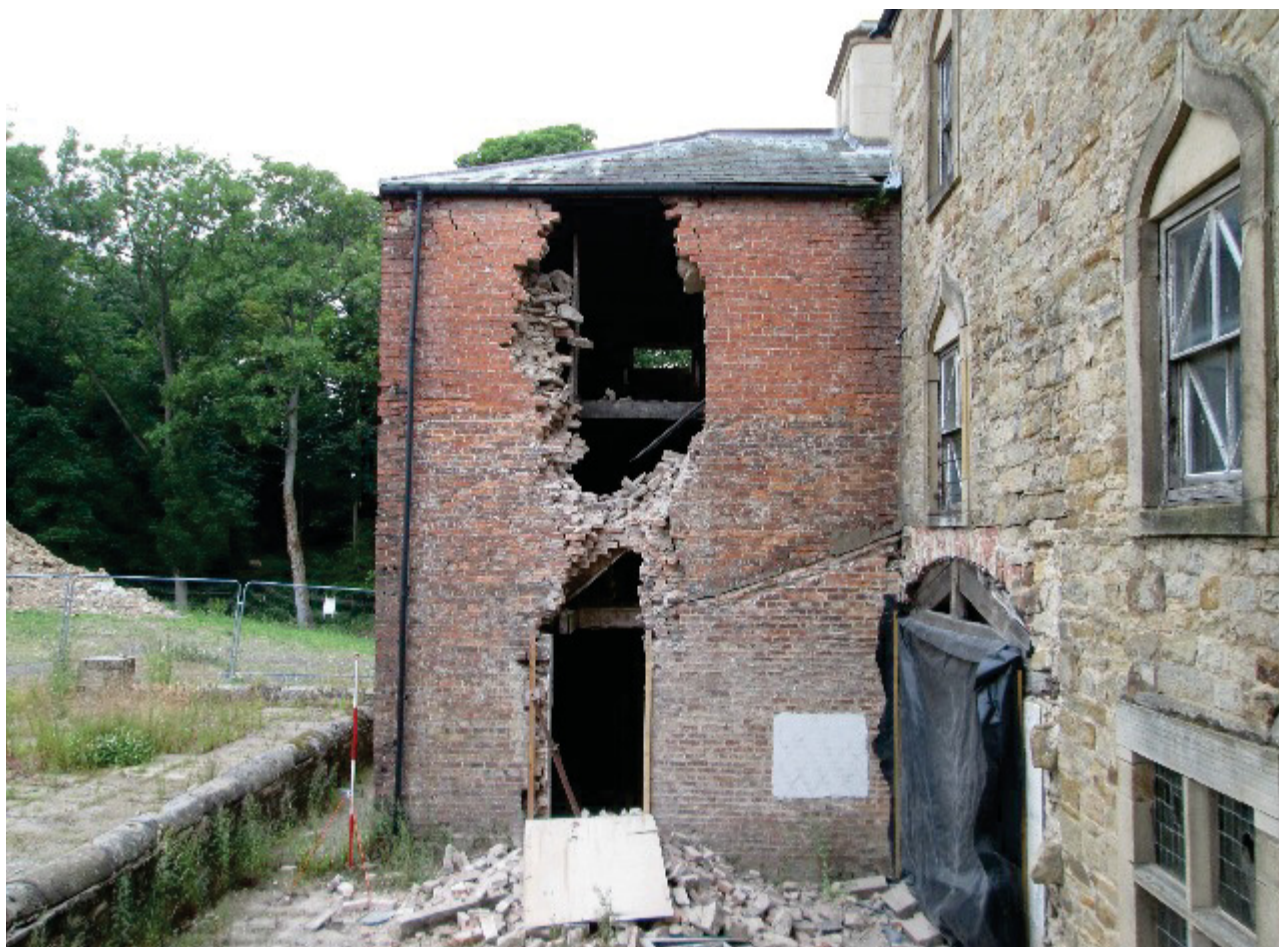
**Plate 2.** Eastern elevation, showing outward collapse of window and door (photo reference HHH13J007).

3.4.1 On the initial site visit in June, this elevation was observed to be intact, but visibly bulging outwards, especially around the upper floor window. By the time of the initial photographic survey in July 2013, the central section had collapsed, taking with it the window and door and removing 28% of the elevation fabric.

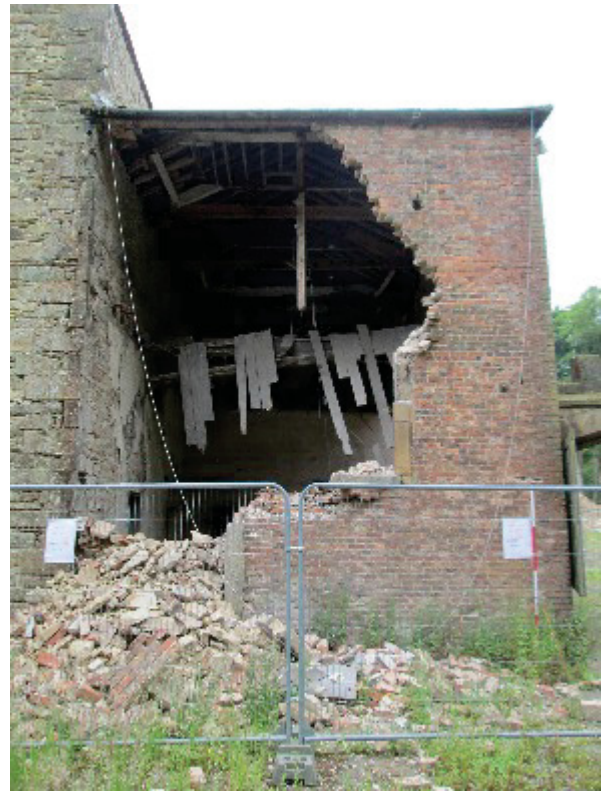
**Plate 3.** Northern elevation of brick wing, showing catastrophic collapse (photo reference HHH13J002).

3.1.1 The northern elevation suffered the greatest loss of fabric through collapse of all four elevations, in terms of area lost. The area lost was 51.5% of the elevation fabric, including the majority of the architectural features including the door and windows. A fraction of the stone jamb of the ground floor door was still *in-situ*, as was a section of the ground floor window sill. However, both architectural elements were broken. The elevation measured at 6.2m wide and 6.78m tall from floor height to the eaves.

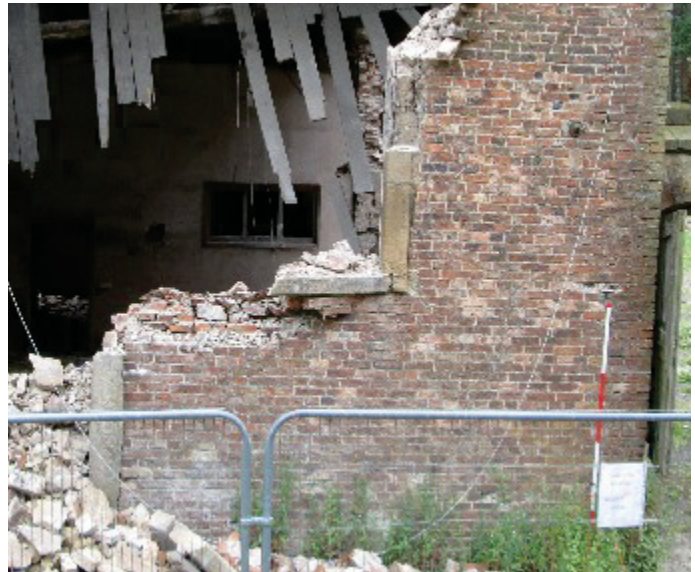
**Plate 6.** Northern elevation of brick wing, showing remaining remnants of Window 02 and Door 01 (photo reference HHH13J031).

3.1.5 Window 02: Window 02 is depicted on the original elevation as a 24-pane sash window. Originally, the window was 2.16m tall and 1.2m wide, with a further 0.18m wide stone surround, likely of pre-1774 Georgian style as if the elevation drawing is correct it shows an exposed sash box. If the window had been built after 1774, the construction would have been governed by the 1774 Building Act, and the box would have been hidden behind the brick wall. No evidence of external shuttering was observed.

3.1.6 Door 01: Unfortunately, little is known about the door in the northern elevation, save that the lintel was 1.75m tall by 0.87m wide, and set in a stone surround 0.18m thick.

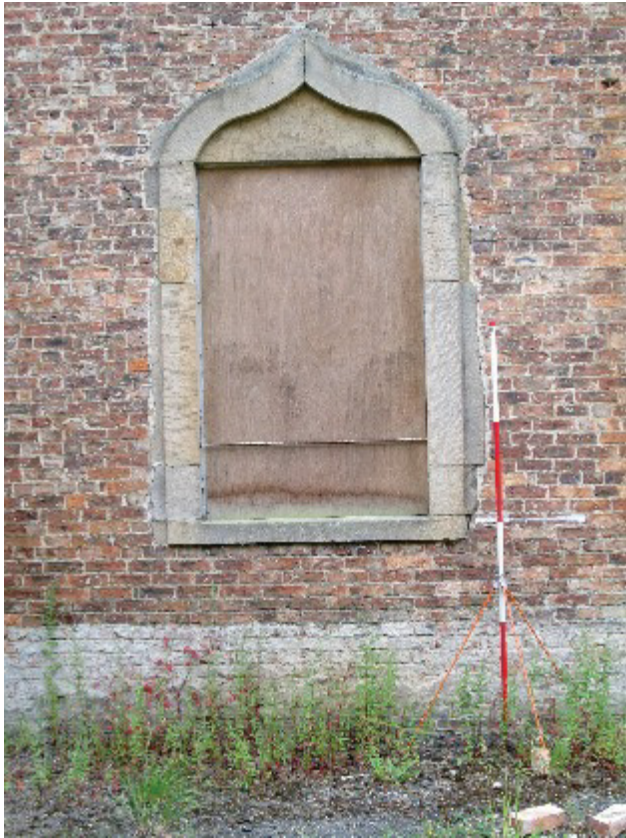
- 3.2.8 Window 06 (Plate 9): Window 06 was one of three potentially identical windows in this elevation, alongside Windows 07 and 08. The sill, jambs and heads were sandstone: the

**Plate 9.** Western elevation of brick wing, showing detail of Window 06 (photo reference HHH13J024).

recessed sill measured 1.55m long by 0.13m high, and the jambs, each made of four sections of stone were 0.20m wide. The head of the window was a Georgian-Gothic ogee arch (0.63m high): this coupled with the irregular brickwork surrounding the window suggested that this window was a later addition to the building, potentially replacing earlier windows in the mid-late 1800s. The window was boarded up (though the elevations provided by Jane Darbyshire and David Kendall Architects suggest a 20-pane horizontal sash window), and a metal bar noted running horizontally along near the base of the window, suggestive of potential exterior shuttering, now gone. The height of the head was 95.62m OD and the sill 93.82m OD.

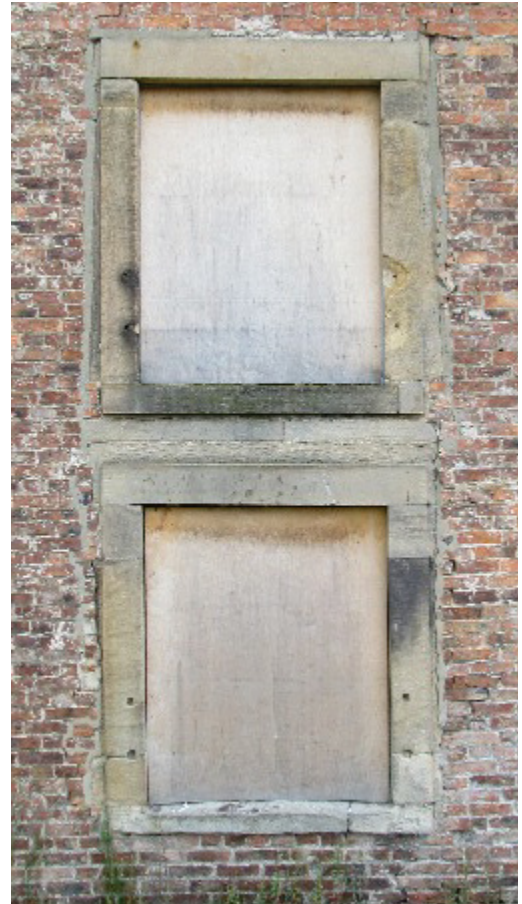
- 3.3.6 Window observations: Examining the setting for Windows 09 and 10 proved interesting, as potentially the remains of an earlier lintel or sill 1.65m long and 0.09m tall was seen directly above Window 10, with the gap between that lintel and Window 09 set with flat-faced sandstone blocks. Coupled with the irregular nature of the wall brickwork, as well as the presence of the earlier lintel/sill (with brickwork aligned normally to the earlier feature), both Windows look like a later likely Victorian addition to the elevation, replacing an earlier window(s).

**Plate 11.** Southern elevation of brick wing, showing detail of Windows 09 and 10 (photo reference HHH13J012).

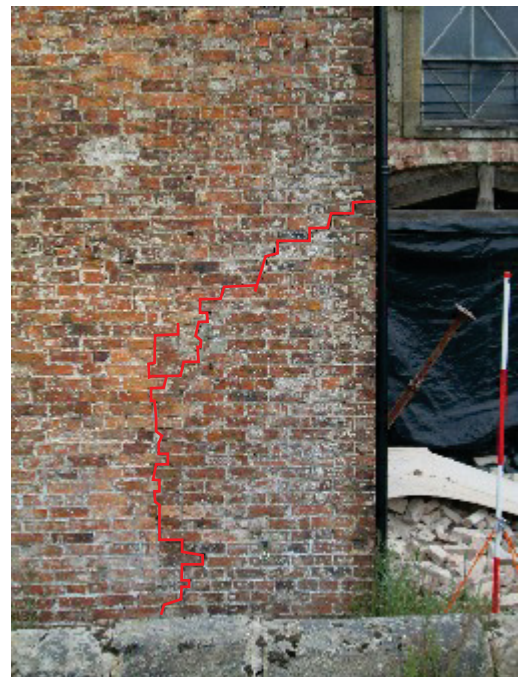
- 3.3.1 The southern elevation was the only elevation of the brick wing that did not suffer a collapse before the beginning of the demolition works, though stress fractures were clearly visible up the eastern side, and the wall was visibly bulging outwards.

**Plate 12.** Southern elevation of brick wing, showing detail of stress fractures, marked in red (photo reference HHH13J013).

3.3.7 Structural sinking (Plate 12): Stress cracking was especially notable on the southeastern base corner.

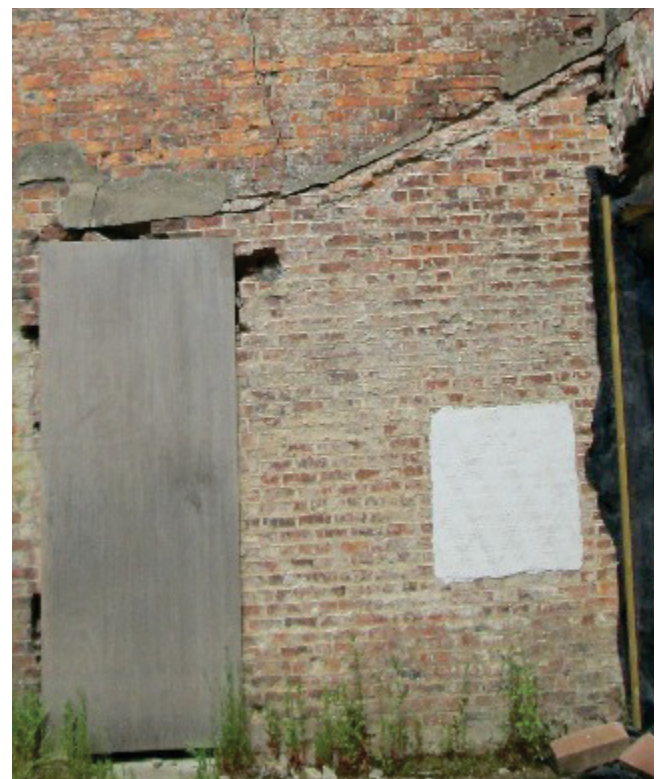
3.4.7 Scar 01: Scar 01 marks the old line of the roof belonging to the former room that adjoined the main range to the brick wing. It is uncertain when the adjoining room

**Plate 14.** Eastern elevation of brick wing, showing detail of Blocked 01, Door 03 and Scar 01 (photo reference HHH13J003).

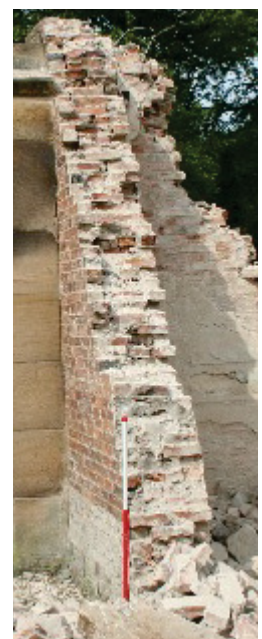
- 4.3.1 The walls of the brick wing appeared to have been built in a more solid form to what was usual for the original Georgian construction type, averaging a depth of 4 bricks deep (0.47m), rather than the usual 1 or 2. Two different types of brick were observed in the wall construction (in an English Garden Wall bond), with no evidence of external rendering and a lime mortar blend (Plate 21).
- 4.3.2 The walls were not keyed into the central range in any way, the wall collapse and subsequent demolition demonstrating that the wing was built *against* the central range using straight joints. This attests as to why the subsiding west wing had little immediate affect on the central range, and also why

**Plate 21.** Thickness of wall construction (photo reference HHH13J168).

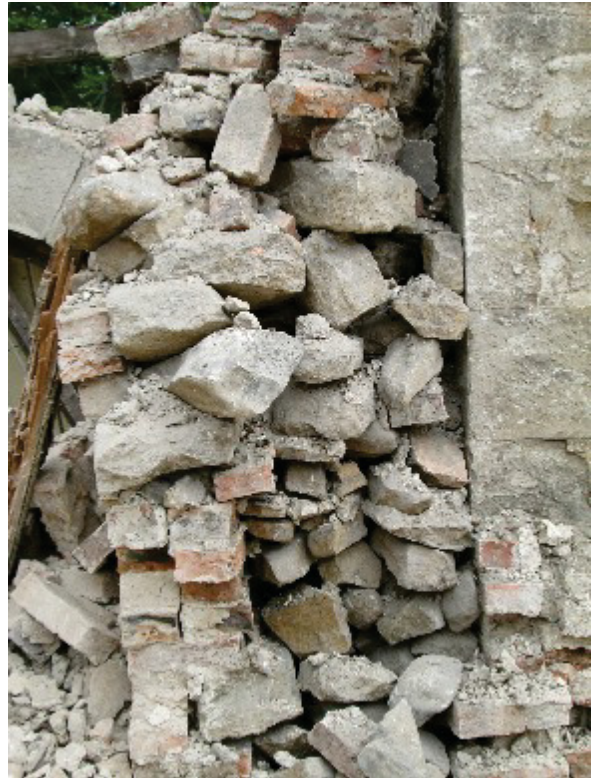
**Plate 22.** Rubble wall core (photo reference HHH13J138).

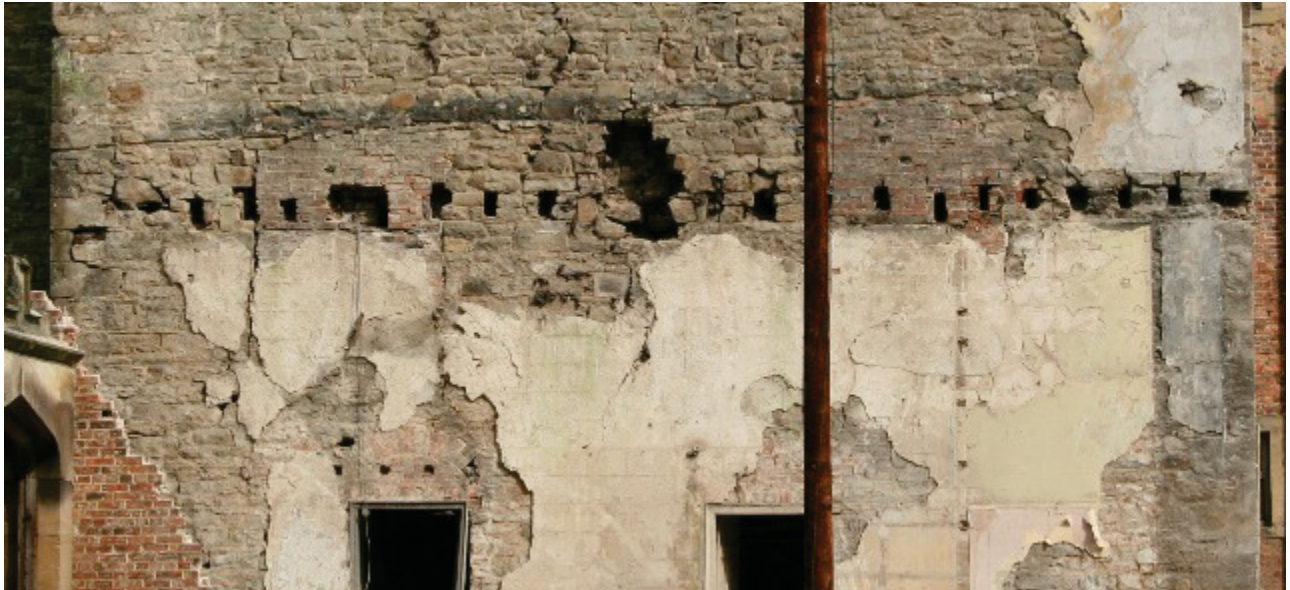
**Plate 35.** The old roof line from when the brick wing was single storey can be seen as a stain above the 2<sup>nd</sup> storey floor joist sockets (photo reference HHH13J166).

- 4.7.5 Roofline: The roofline of the brick wing's 2 storey block is marked on the new western elevation by roof joist sockets in the stonework and by lead flashing and wooden blocks that joined the old brick wing roof to the western structure.
- 4.7.6 Old roofline: The old roofline (for when the structure was a single storey) can potentially be seen 5.35m from the ground as a stain on the side of the elevation. If this is indeed the line of the old roof, then it means that the ogee windows would have been removed from the main western elevation of the stone range when the brick wing was originally built.
